**CITY OF BLOOMINGTON, COMMON COUNCIL
 JACK HOPKINS SOCIAL SERVICES FUNDING
 COMMITTEE
 2014 GRANT APPLICATION**

Prepared For:
Monroe County United Ministries

Prepared By:
Sherlock Homes Inspection Svc., Inc.

Report Number:
131014MF

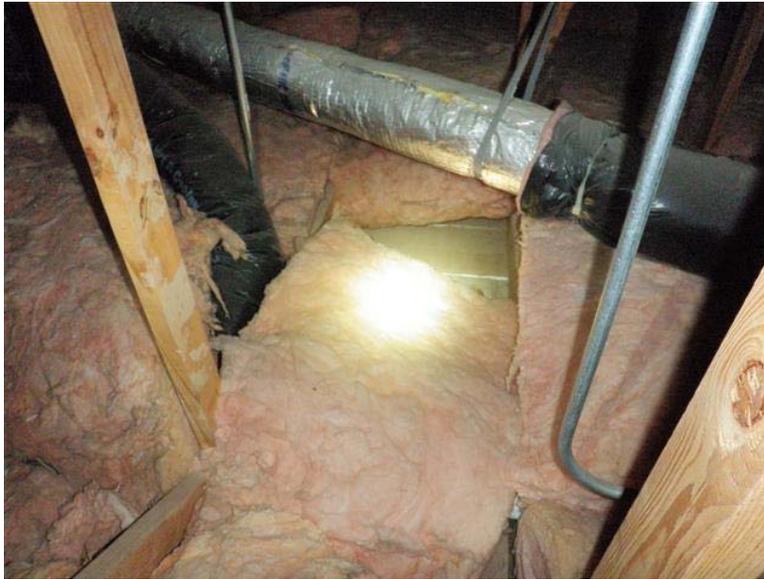
- **Improve:** There is an inadequate amount of insulation in the attic. The lack of insulation will contribute to energy loss and comfort complaints. Insulation levels are specified by R-value. R-value is a measure of insulation's ability to resist heat flow. The higher the R-value, the better the thermal performance of the insulation. The recommended level for most attics is to insulate to R-38 or about 10 to 14 inches, depending on insulation type.

Location of condition: There are some areas of low insulation and a few spots where there is no insulation. First all air sealing should be completed and then more insulation added to the low spots at a minimum. Ideally the added insulation would also be mounded over the ductwork.

Area of missing insulation

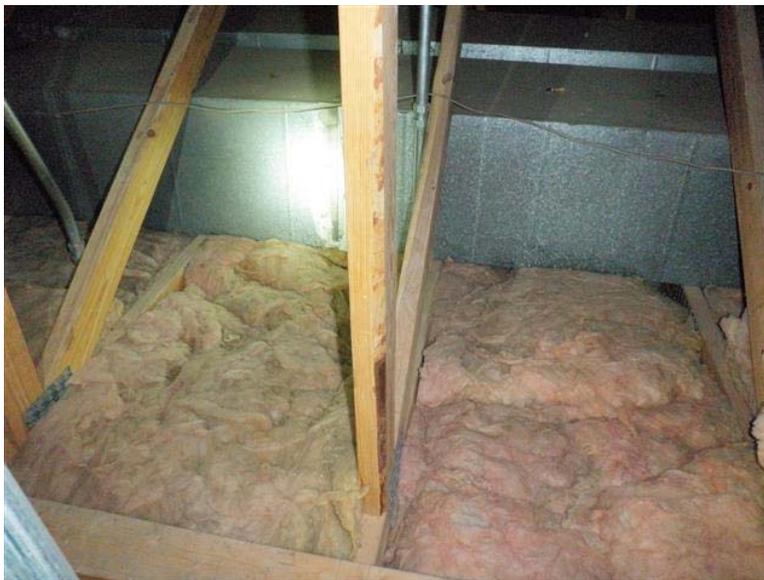
Areas of low insulation below ductwork

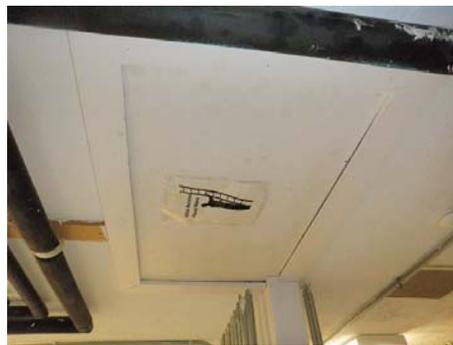
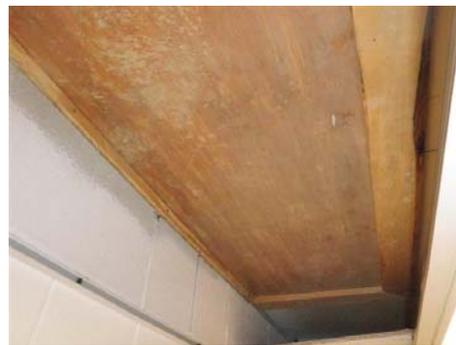
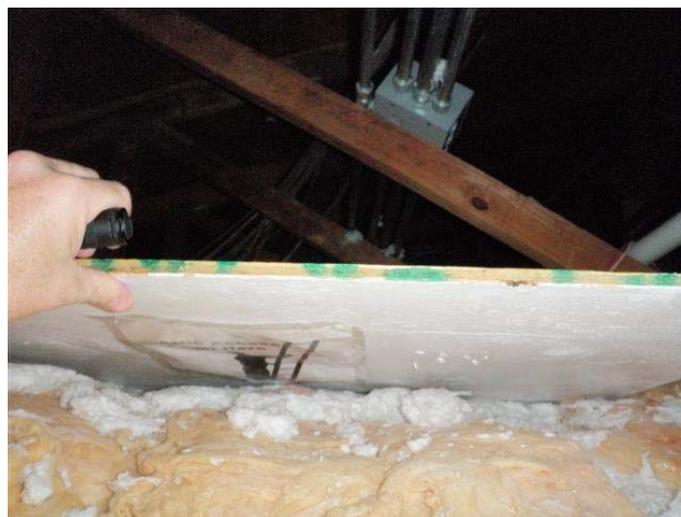
Location of condition: Three hatches.

- **Improve:** The attic access hatch is not properly insulated or air sealed. The hatch should be insulated to an R38, curbing installed around the opening to prevent insulation from falling into the living area, and the hatch lid should receive a gasket.

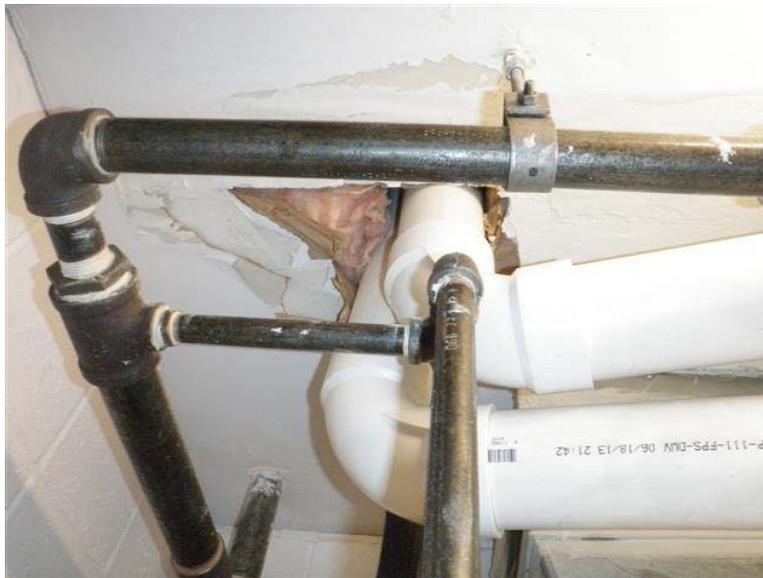
- **Improve:** There are air by-passes present between the attic and living space. Attic bypasses are hidden air passageways that lead from the heated space into the attic. Because warm air rises, it is continuously moving up these passageways and escaping into the attic during cold weather. These bypass leaks can cut the effectiveness of attic insulation by 30 to 70 percent. The by passes should be sealed with a rigid material to help prevent air flow.

Location of condition: Visible at the furnace piping penetrations.

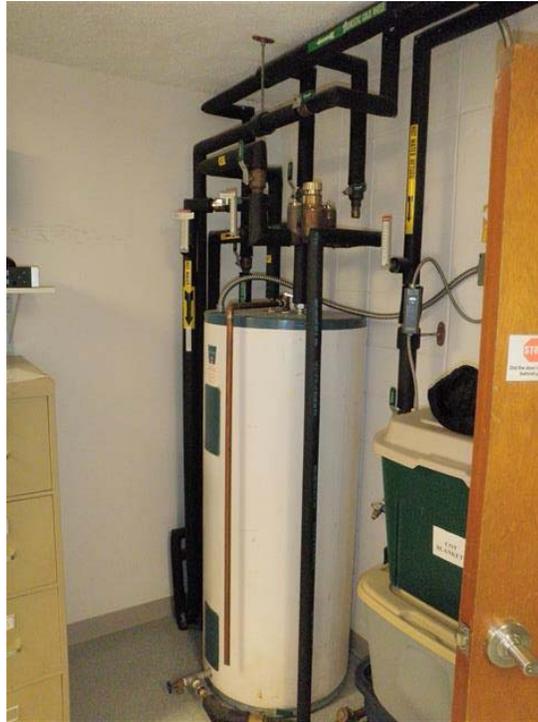
- **Repair:** The water heater has a circulating loop that appears to run constantly. The pump should be connected to a timer so that circulation occurs only when needed.

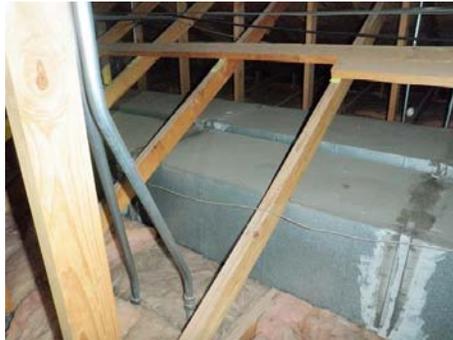
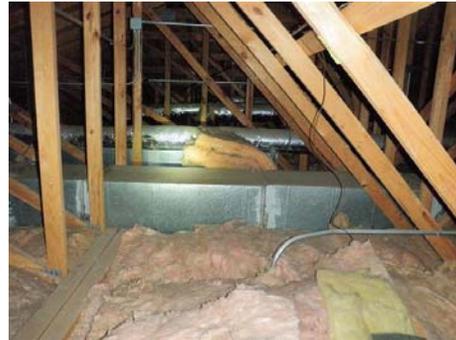
Building too leaky for accurate duct leakage measurements. Seal building and then test ducts.

Ductwork does appear to have all joints sealed with mastic.
