**PUBLIC HEARING
BOARD OF HOUSING QUALITY APPEALS
CITY HALL McCLOSKEY CONFERENCE ROOM
August 17, 2016, 4:00 P.M.**

Staff Report: May 9, 2016: Received complaint about mold in unit 1523
May 13, 2016: Conducted complaint inspection
May 17, 2016: Complaint report mailed
June 3, 2016: Remaining complaint violations report mailed
June 7, 2016: Owner called, stated most repairs are made, has bid for regrading work. Advised him to apply for extension of time
June 16, 2016: Received appeal

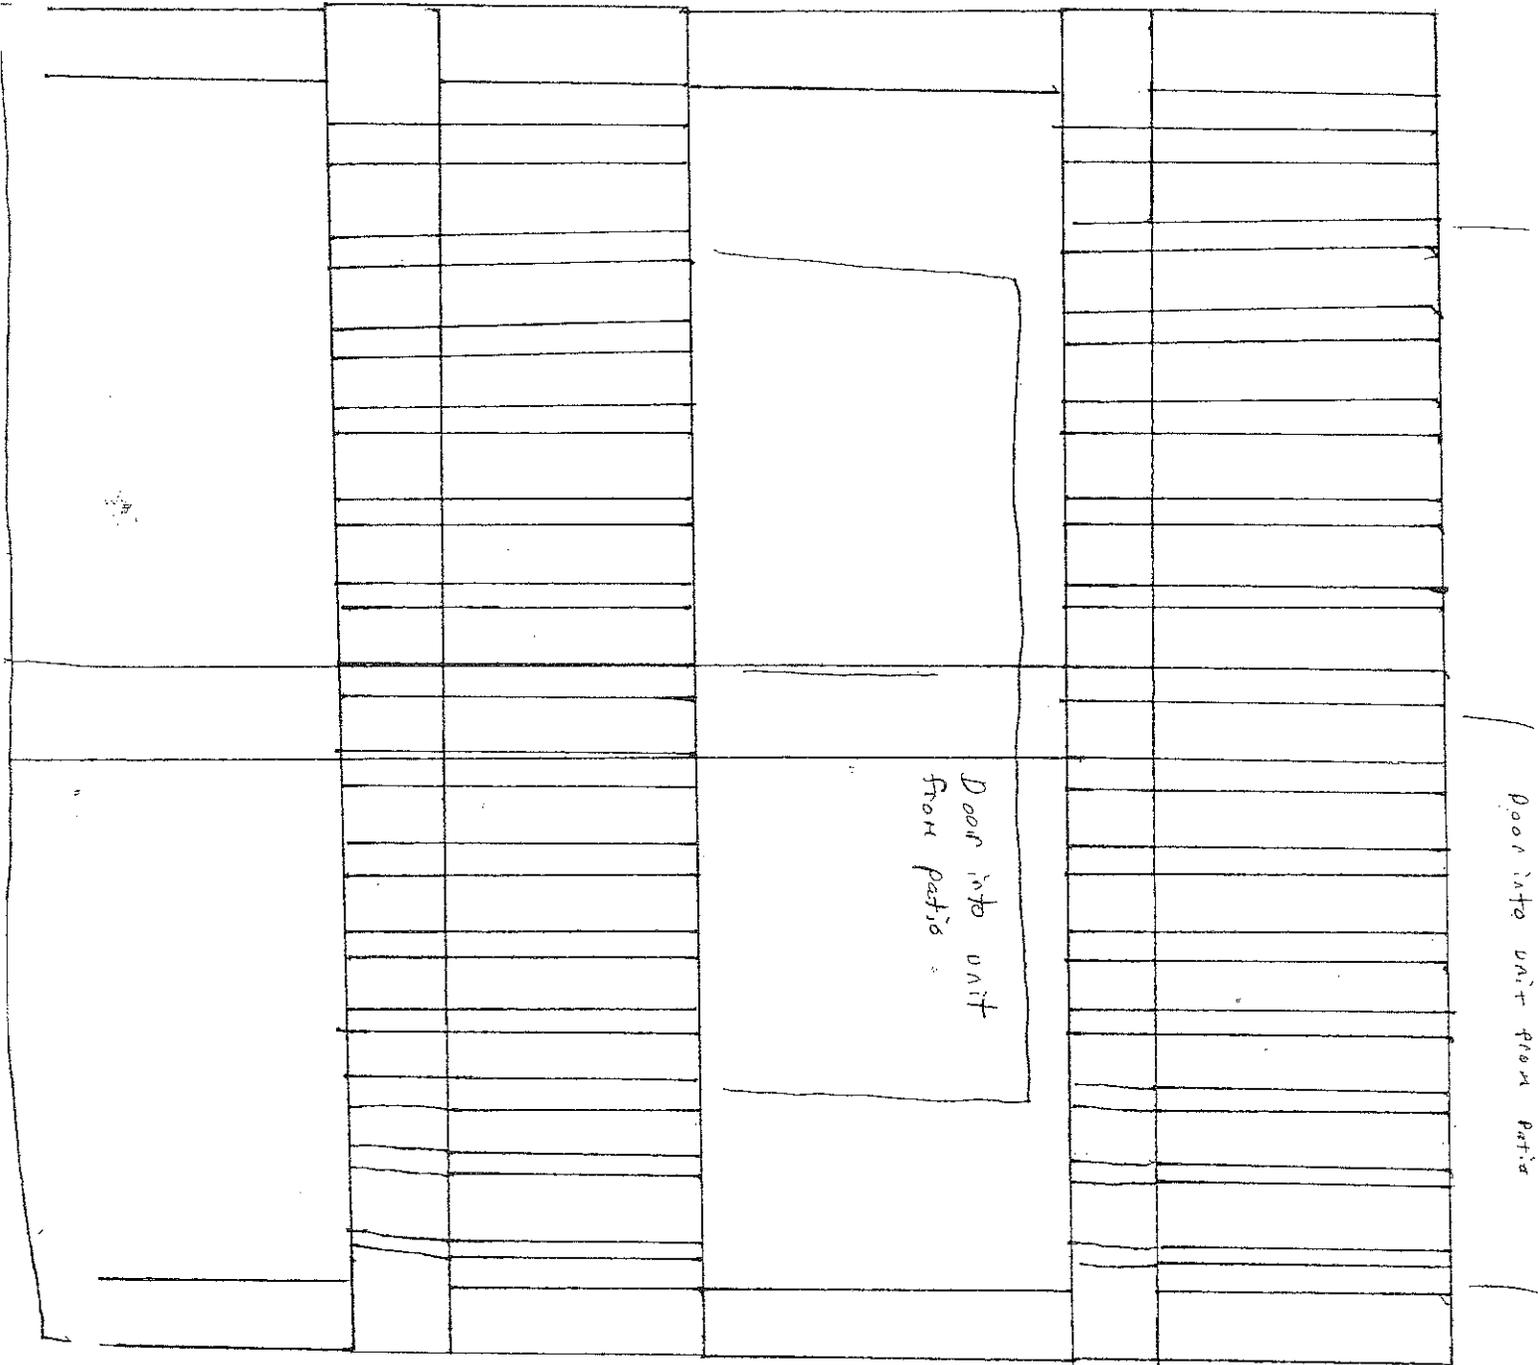
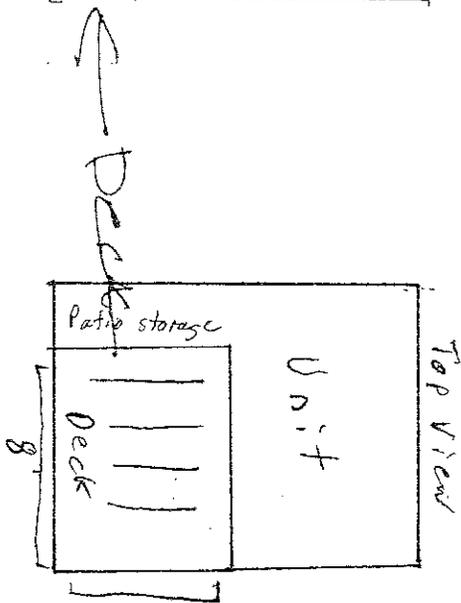
Top View

Joists - 2" X 8" 16" on center. Both ends secured w/ hanger brackets.

Deck - 42" ^{from} deck boards to top of nails. Spine 4" on center.

- UNITS
- 176, 178, 194, 196, 238, 408
 - 410, 405, 407, 327, 329, 331
 - 333, 313, 311, 309, 307, 229
 - 231, 211, 209, 207, 205

1. This permit approves balcony repairs and replacement. The balconies/decks cannot be expanded. No other changes are approved at this time.
2. No increase in number of bedrooms or additional dwelling units is approved with this permit.
- 3.
- 4.

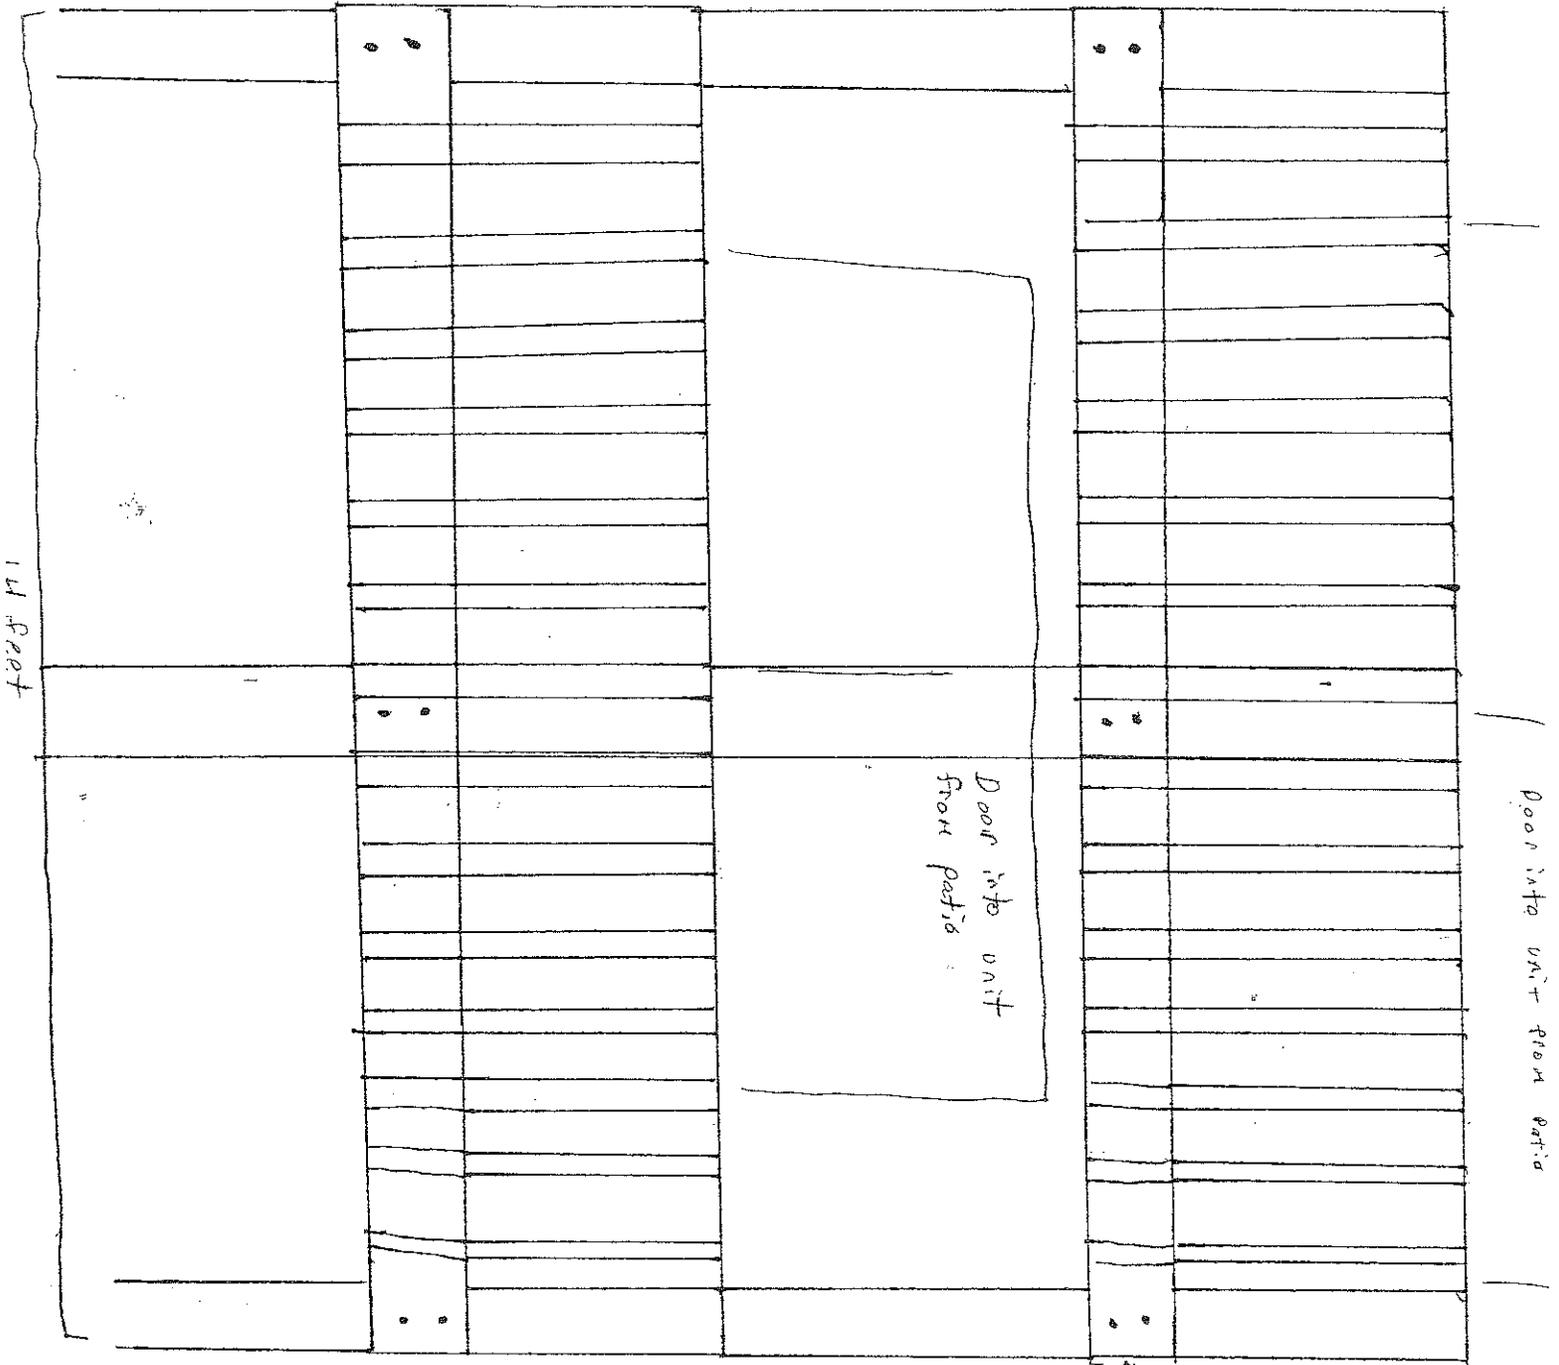
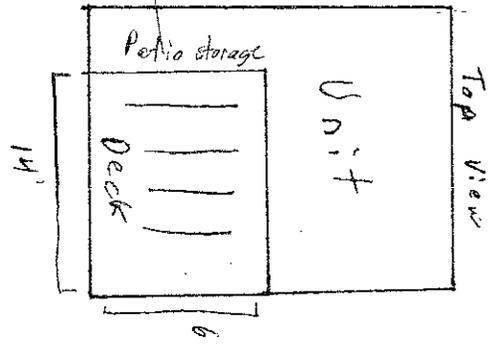
Brownston Back Patio Decks

Joists - 2" X 8" 16" on center.
Both ends secured w/
hanger brackets.

Posts - 4" X 6" length dependent
on deck location w/in
property. Three posts per deck

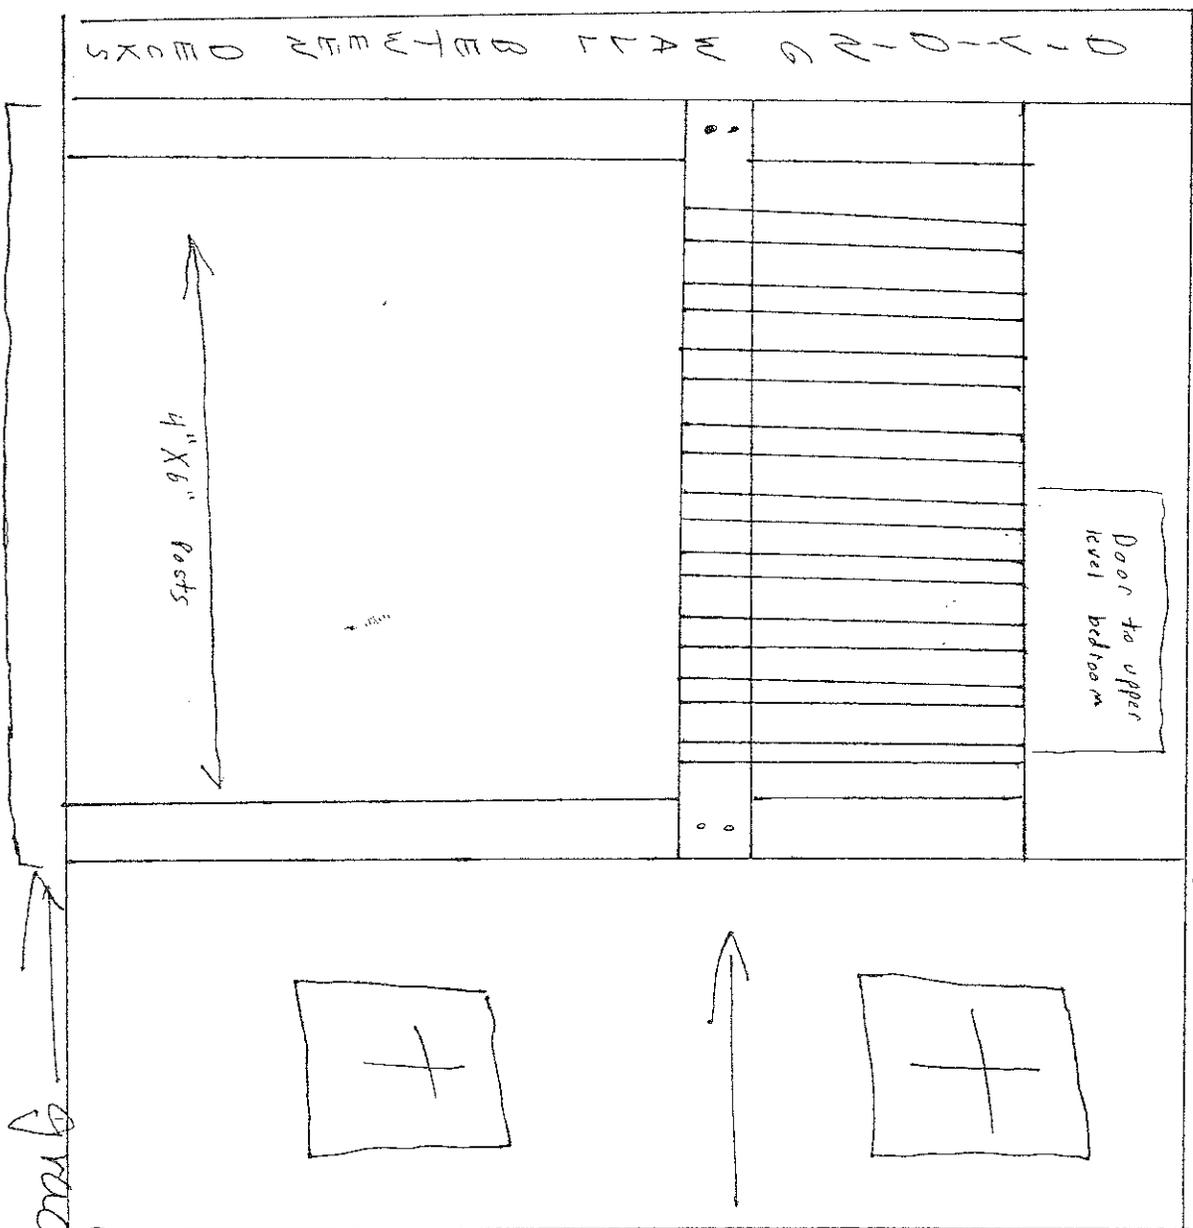
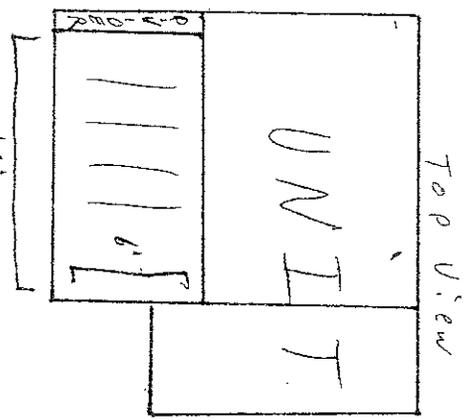
DECK

- Joists - 2" X 8" 16" on center
Both ends secured w/ hanger brackets.
 - Posts - 4" X 6" length dependant on location w/in property
Two post per deck.
 - Band boards - 2" X 10" X 10'
 - Hand Rails - 42" ^{9/16"} deck boards to top of rails.
Spindles 4" on center
- UNITS
- 235, 233, 223, 221, 219, 217
 - 215, 213, 203, 201, 172, 174
 - 184, 186, 188, 190, 200, 202
 - 204, 206, 212, 214, 216, 218
 - 220, 222, 224, 226, 228, 230
 - 232, 234, 310, 312, 314, 316
 - 330, 332, 334, 336, 400, 402
 - 412, 414, 416, 418, 428, 430
 - 432, 434, 444, 446, 415, 413
 - 225, 323
