Board of Public Works Staff Report

Project/Event: Resolution to uphold the Modified Unsafe Order for the Johnson Creamery Smokestack
Petitioner/Representative: HAND
Staff Representatives: Michael Arnold, John Zody, Daniel Dixon
Date: April 12, 2022

Johnson Creamery Smokestack

Re: Johnson Creamery Smokestack
Bloomington, Indiana

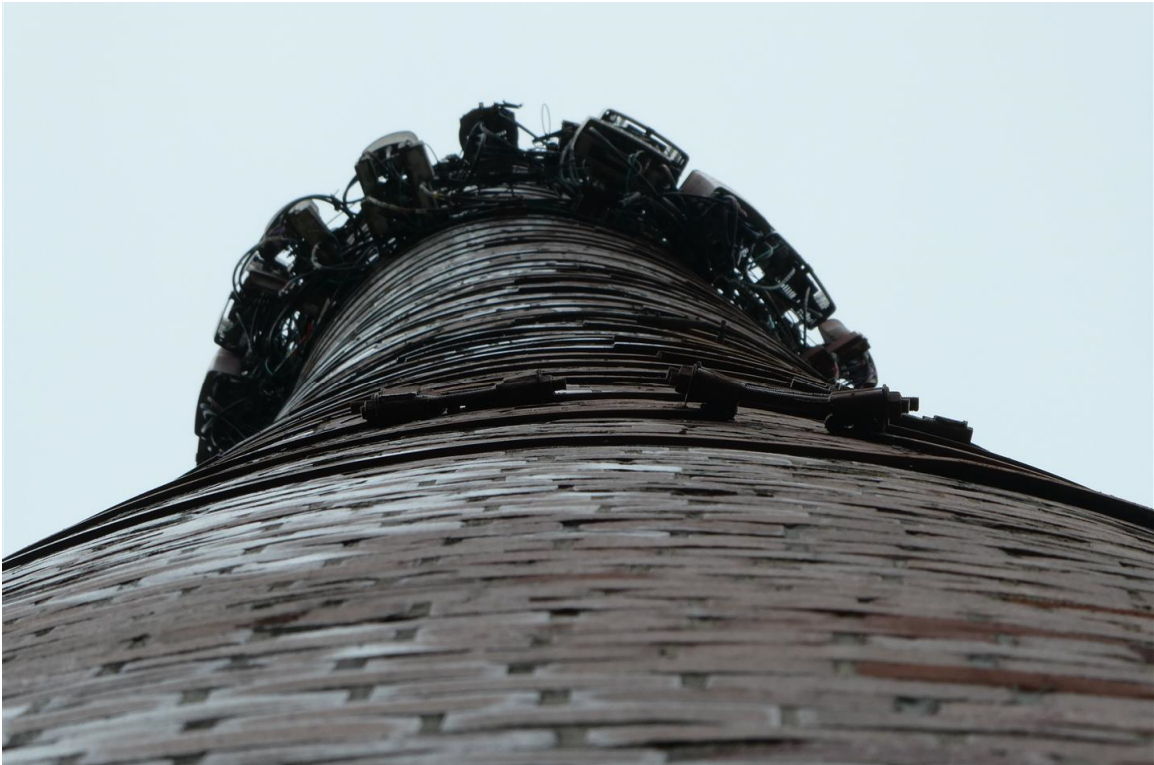
The smokestack leans or tilts to the southeast. This is severe enough that it can be seen from ground level with the naked eye as shown in Photos 1 and 2. In 2017 we determined that the top of the stack was leaning 1 foot in every 10 and estimated that the overall tilt was in the order of several feet.

Photo 1 Looking up the wall of the stack on the southeast face.

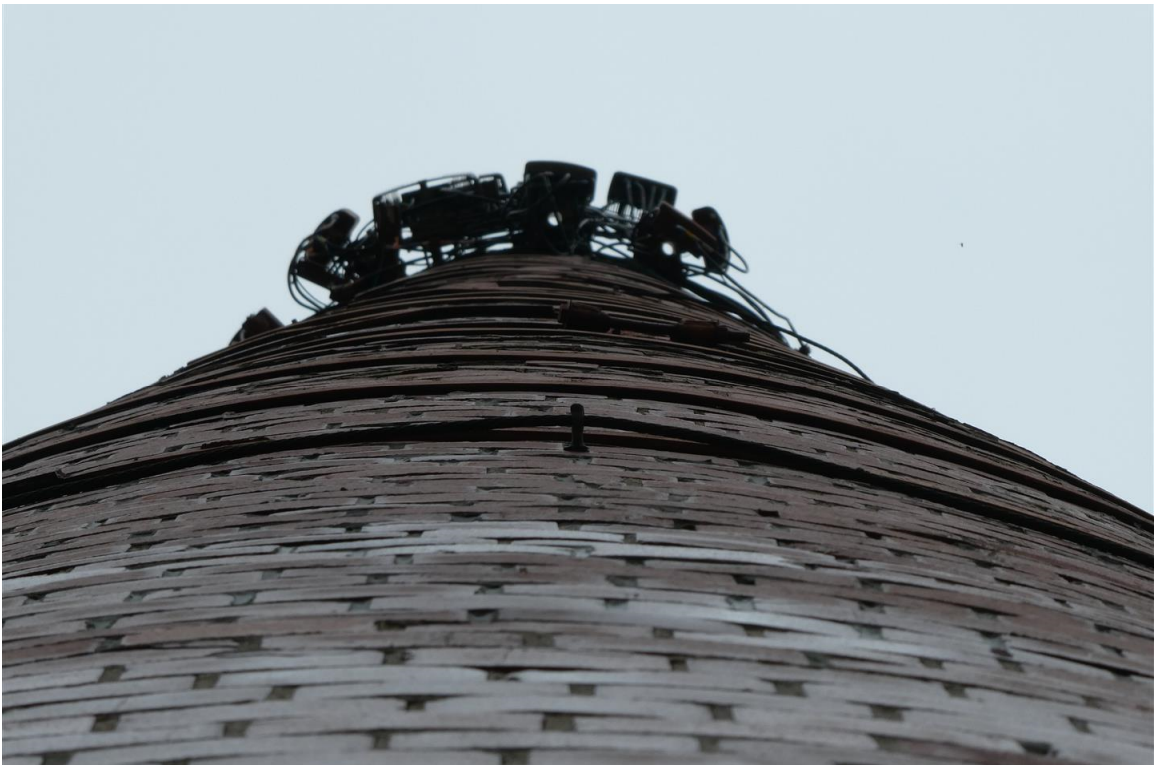
Photo 2 Looking up the wall of the stack on the opposite side as Photo 1.

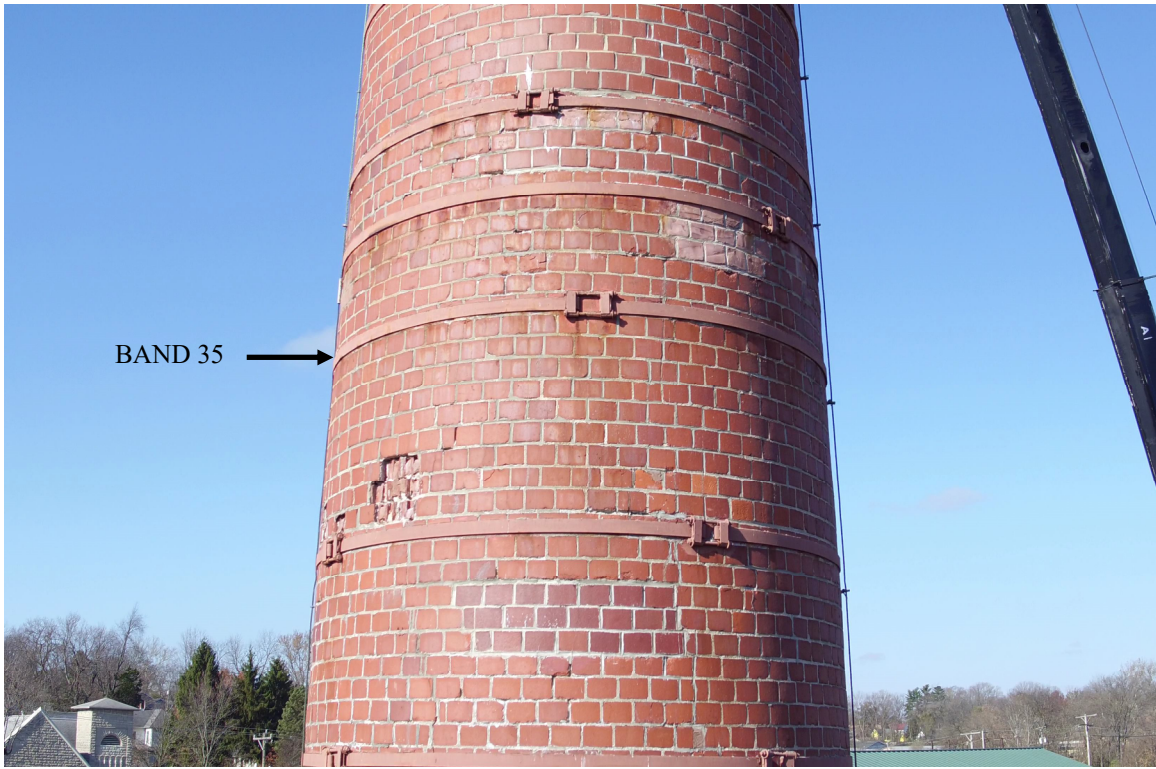
Photo 3 Photo taken in 2017.

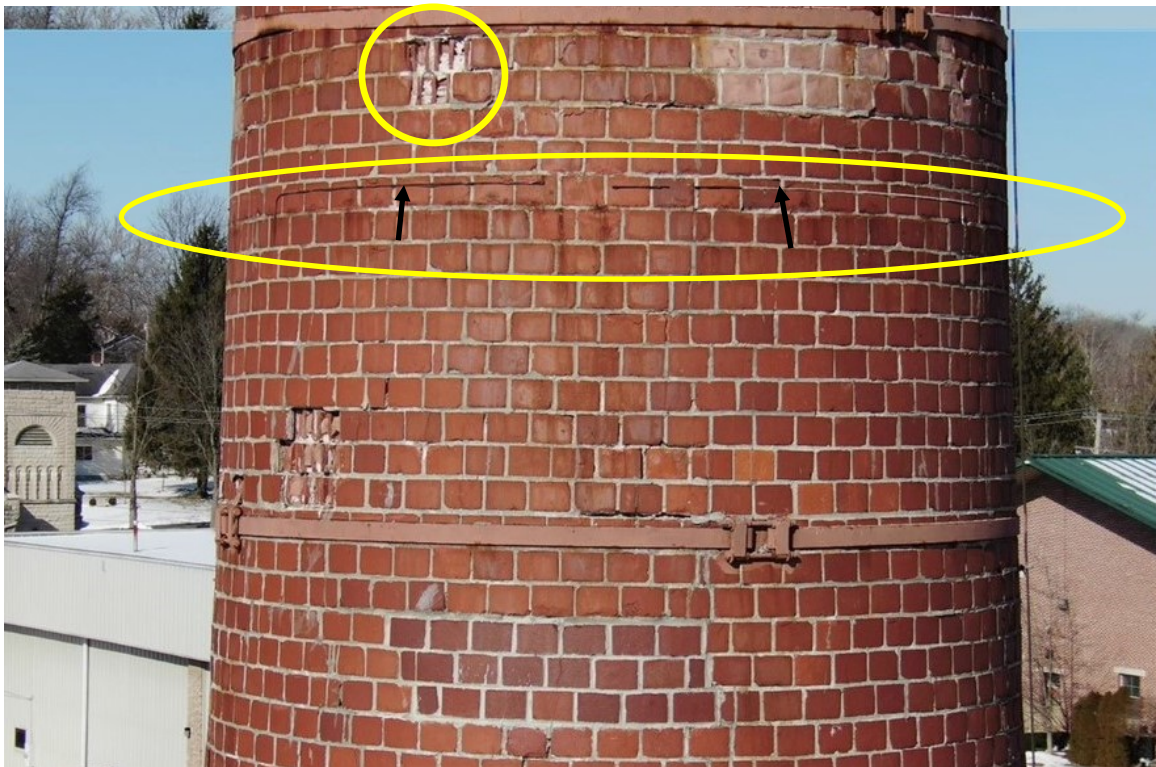
The drone was also utilized to create a series of vertical montages of the stack from different angles. The orientation of the montages attempted to copy a similar set of montages taken in 2017 so that the two sets could be compared. See Figures 14 through 16. In 2017 we observed 38 steel bands in the stack. The 2022 montages show band #35 down from the top is now missing. R & P reported only 37 steel bands when they performed their assessment in 2020 and noted there was evidence of one missing. Photos 3 and 4 show this location in 2017 and 2022. Rust stains and a bead of sealant are visible in the 2022 photo where the band was located.

Photo 4 Photo taken in 2022. Band 35 is gone. Remnants of sealant at the top of the band are highlighted as is a new spall.

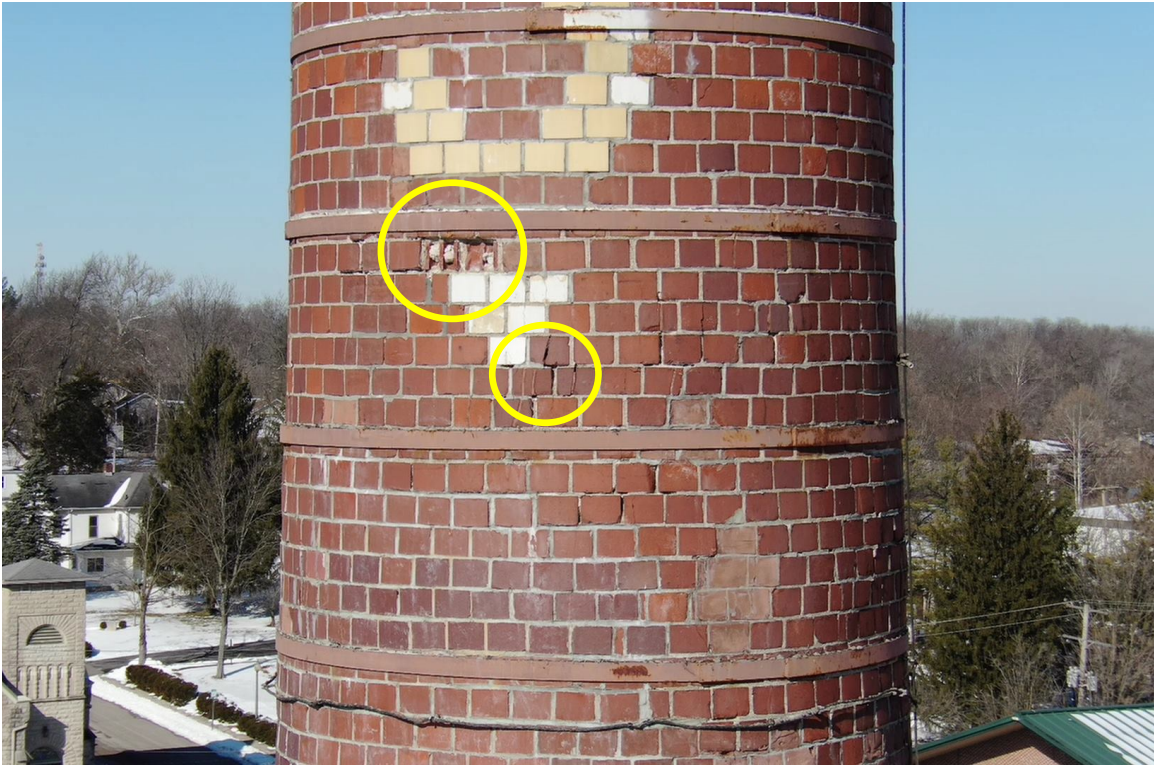
Evidence of spalling was also compared between the 2017 and 2022 montages. There are 11 locations in 2022 where new spalling is visible. These generally occur in the south to southwest face of the stack between 60 and 100 foot levels. Examples are shown in Photos 5 and 6. Face shell spalling was also more evident at the foundation as shown in Photos 7 and 8.

Photo 5 New spalls are highlighted in this 2022 photo.

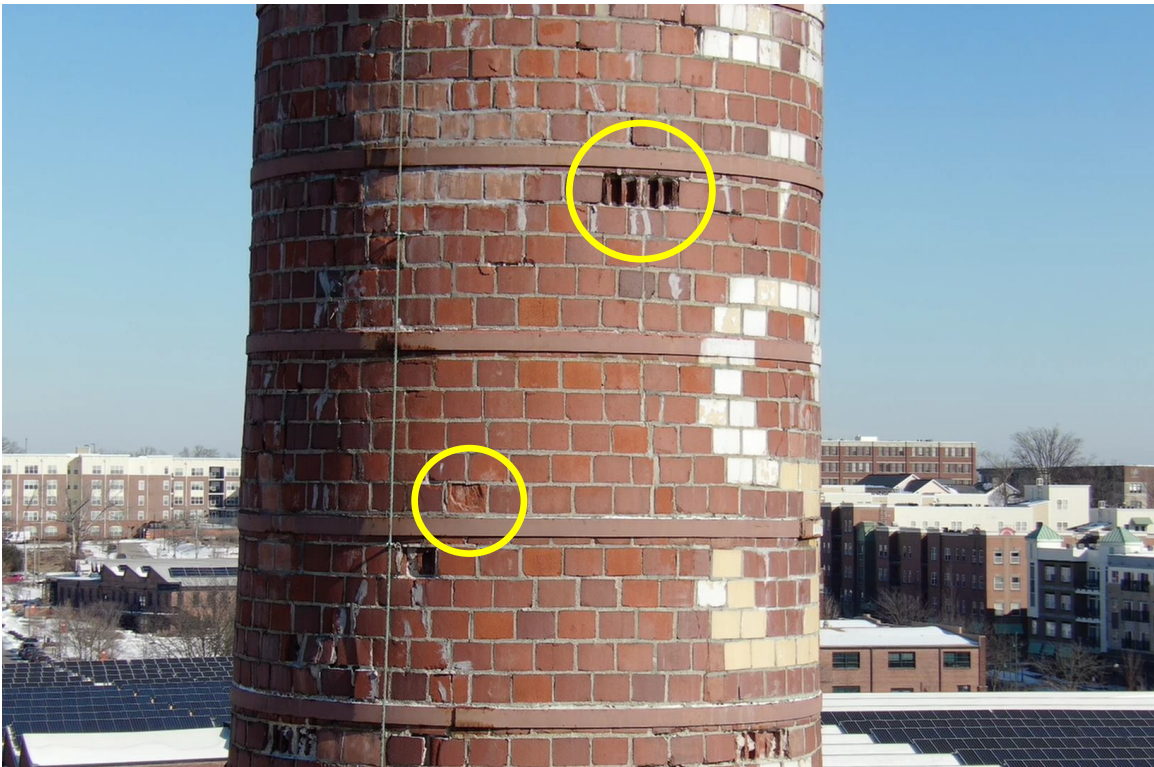
Photo 6 More new spalls are highlighted.

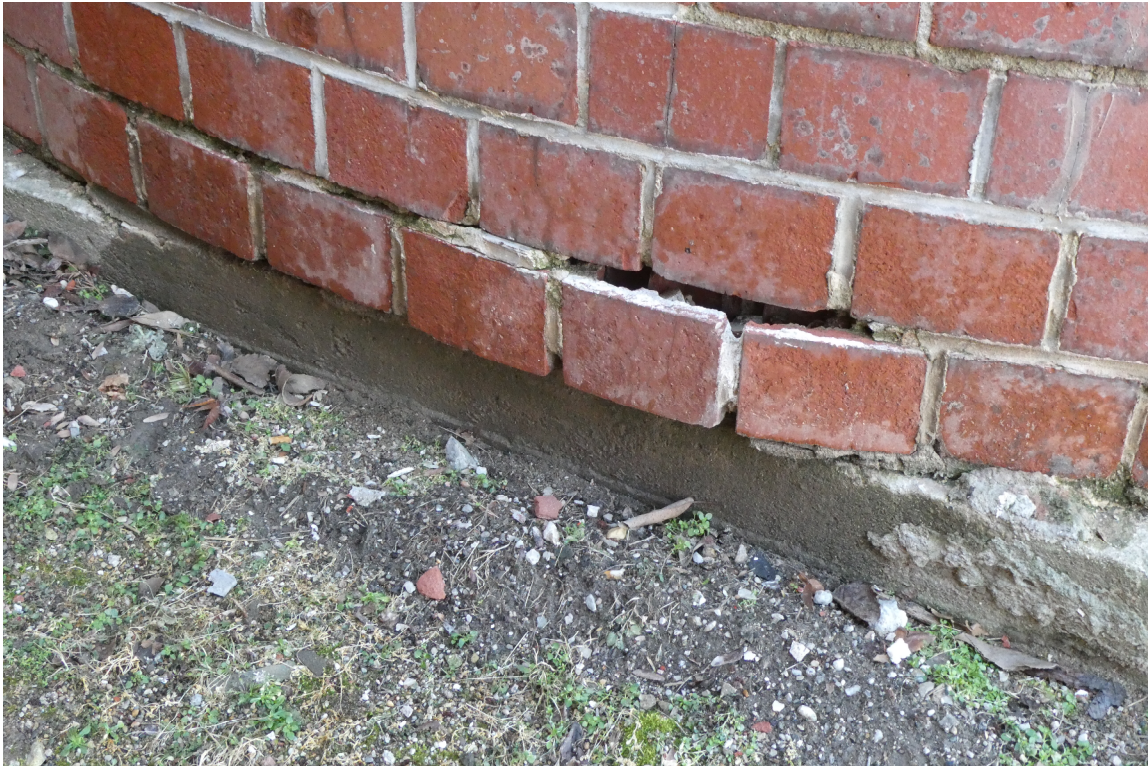
Photo 7
Spalling extends to the
base of the stack.

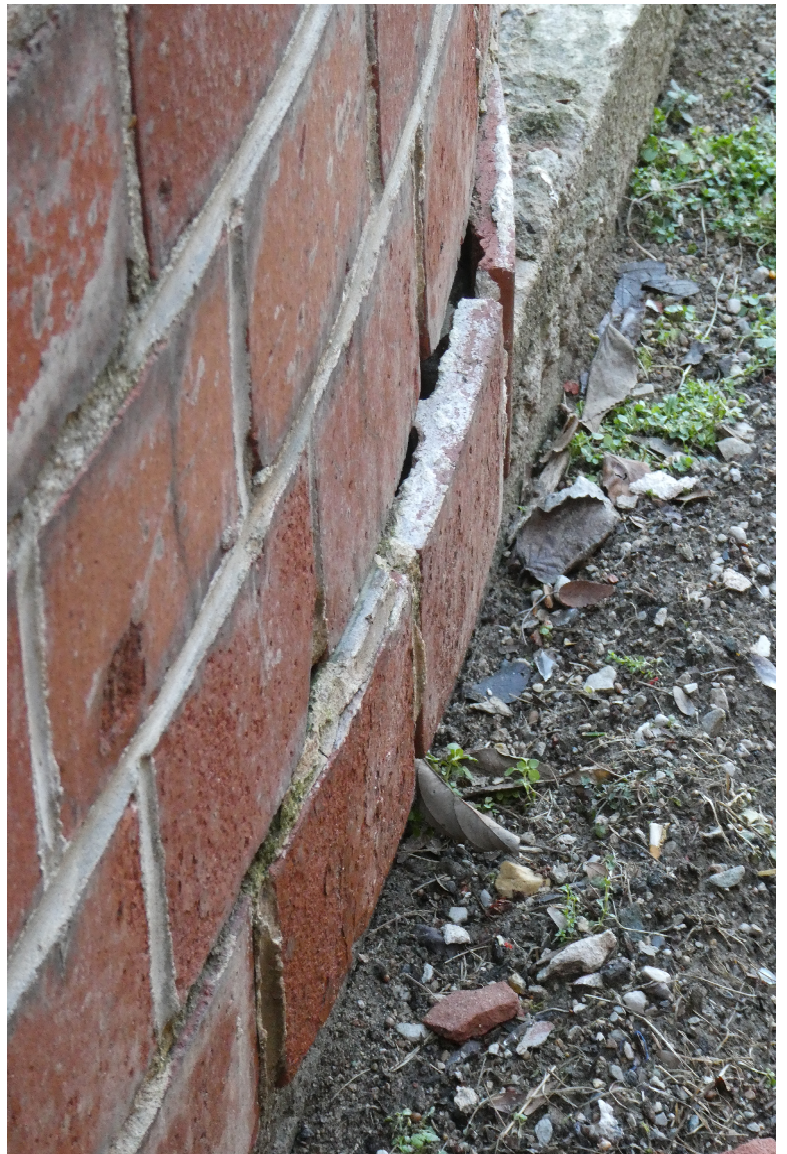
Photo 8
The face shells are splitting off from the body of
the brick.
