**Bloomington Historic Preservation Commission, Zoom Virtual
Meeting, Thursday June 11, 2020, 5:00 P.M. AGENDA**

C. Johnson Creamery Stack Inspection Report

On April 6, 2020, a representative from R+P Industrial Chimney Company performed an inspection of the Johnson's Creamery chimney at 400 West 7th Street in Bloomington, Indiana. The purpose of the inspection was to examine the condition of the chimney and determine if any immediate maintenance work was required to bring it up to sound capacity. The chimney possessed a noticeable lean of the upper elevations and had not been thoroughly inspected for several years.

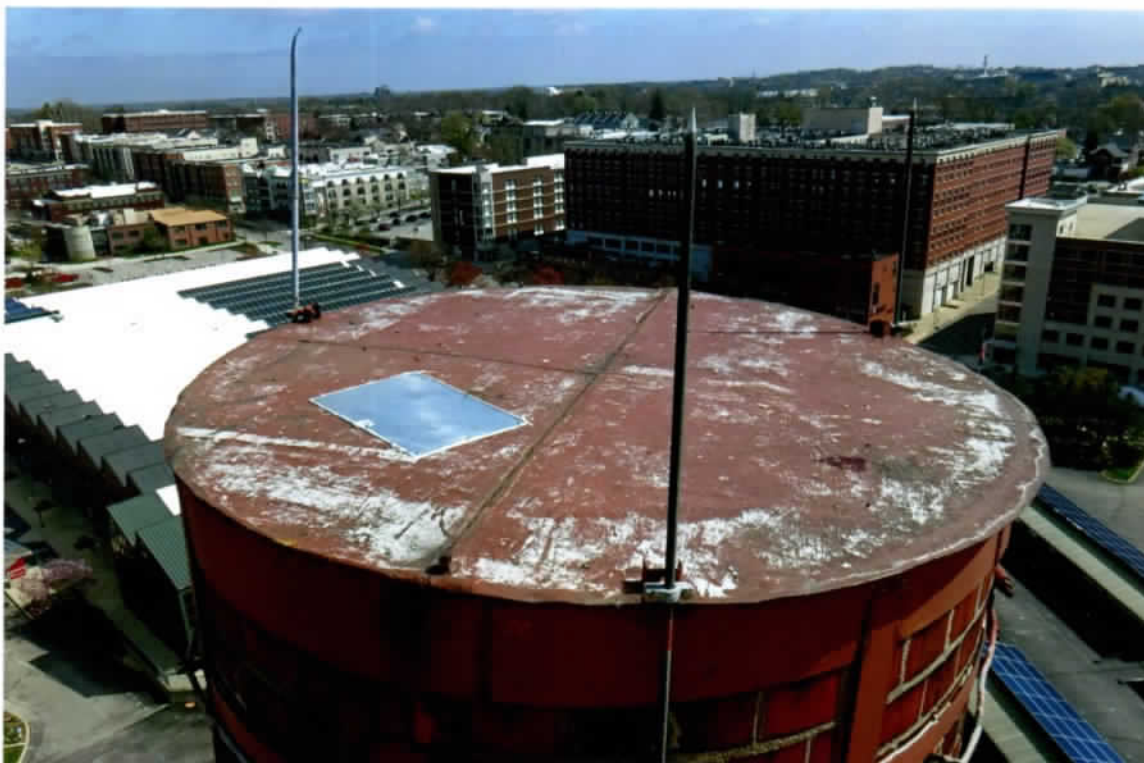
The ¼" thick steel roof plate and five, 4" deep support beams were secure and in good condition. With the exception of the weathered paint of the roof plate, no concerns were identified. The plate measured 7'-2" in diameter and overhung the vertical curb plate by approximately 1". Connection welds of the curb plate to roof plate appeared sound and no open gaps or defects along welds were noticed. Very few areas of rust were seen along the five support beams. A small hole was cut into and then patched to allow for the internal inspection. Photos 1 - 40 show the roof with the patch plate.

Photo 1. Good condition of the steel roof atop the chimney. Note only the weathered paint. The patch plate was recently installed.

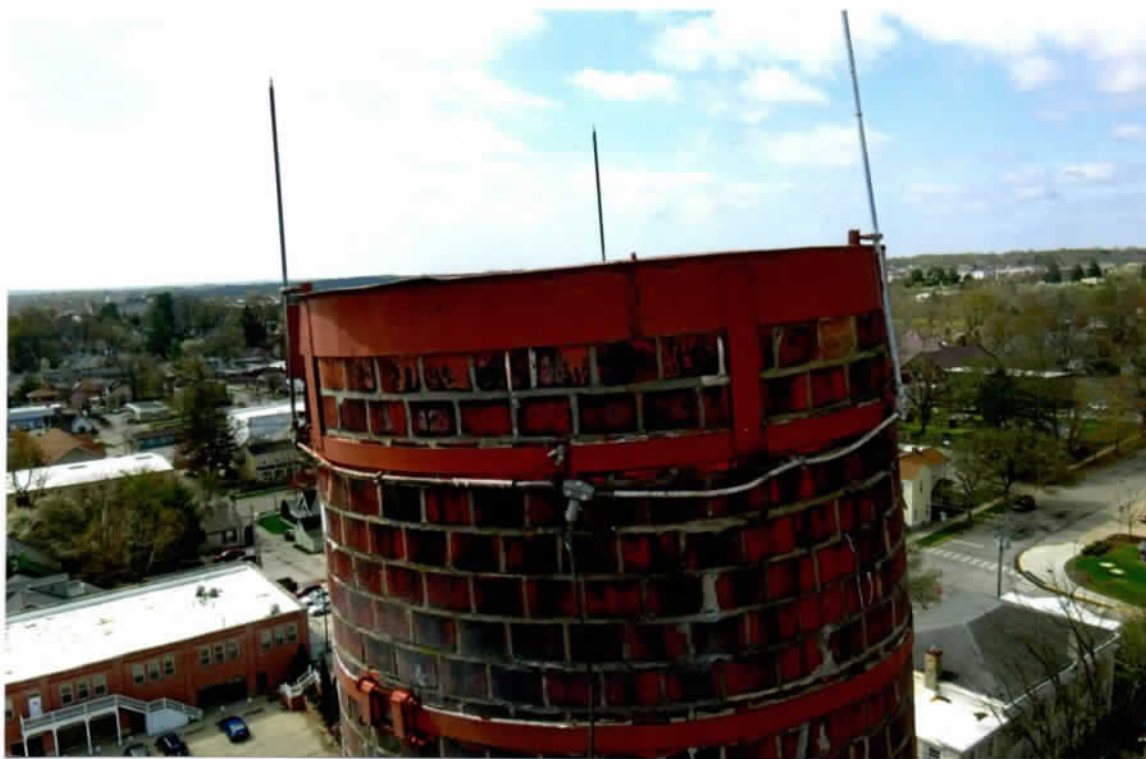
Photo 2. Good condition of the encircling plate and connections to the upper band. Note the slope ($\pm 4^\circ$) of the top of the chimney due to the lean toward the southeast direction.

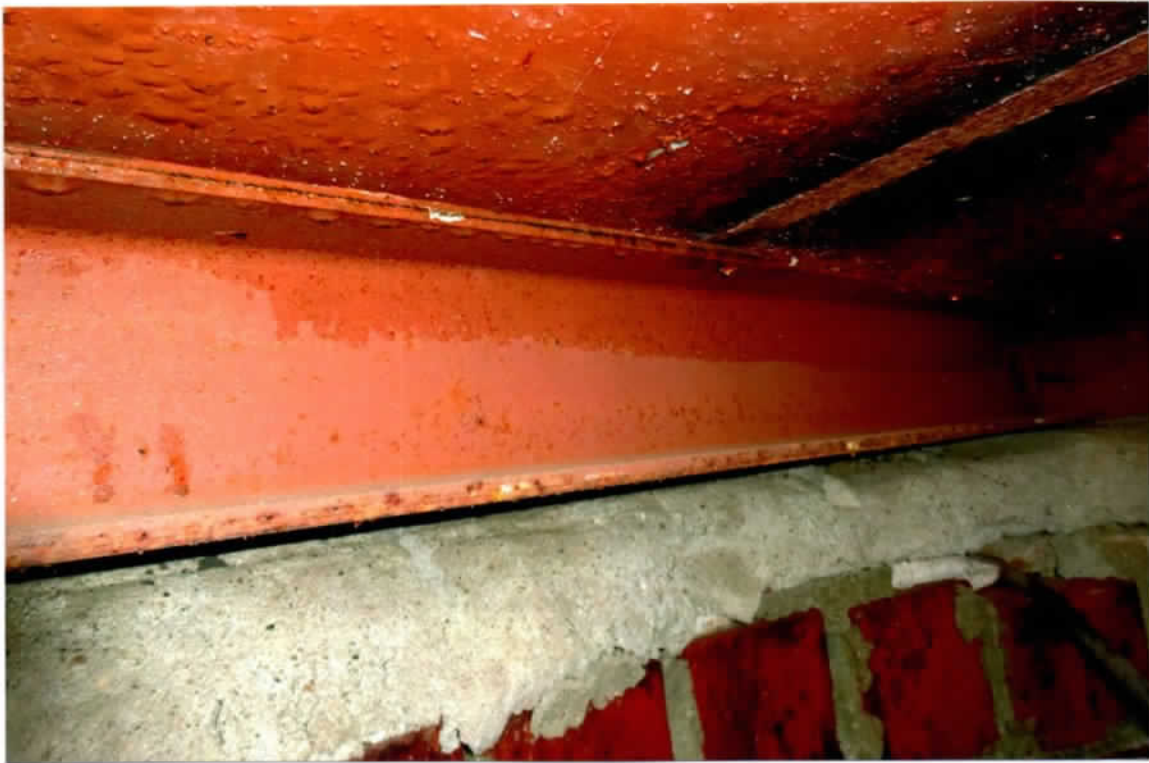
Photo 3. Good condition of the roof plate underside and 4" deep support beam (north side). Also note the good condition of the 3" thick cement cap atop the uppermost course.

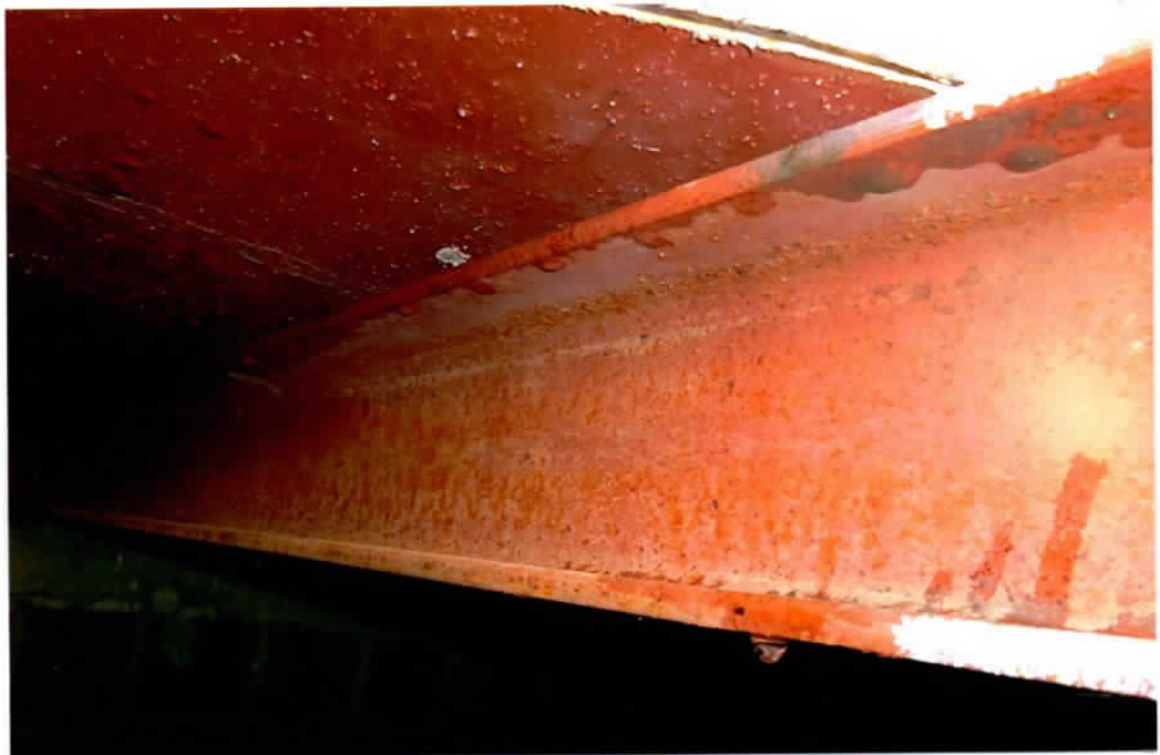
Photo 4. Good condition of the roof plate underside and 4" deep support beam (near center of roof).

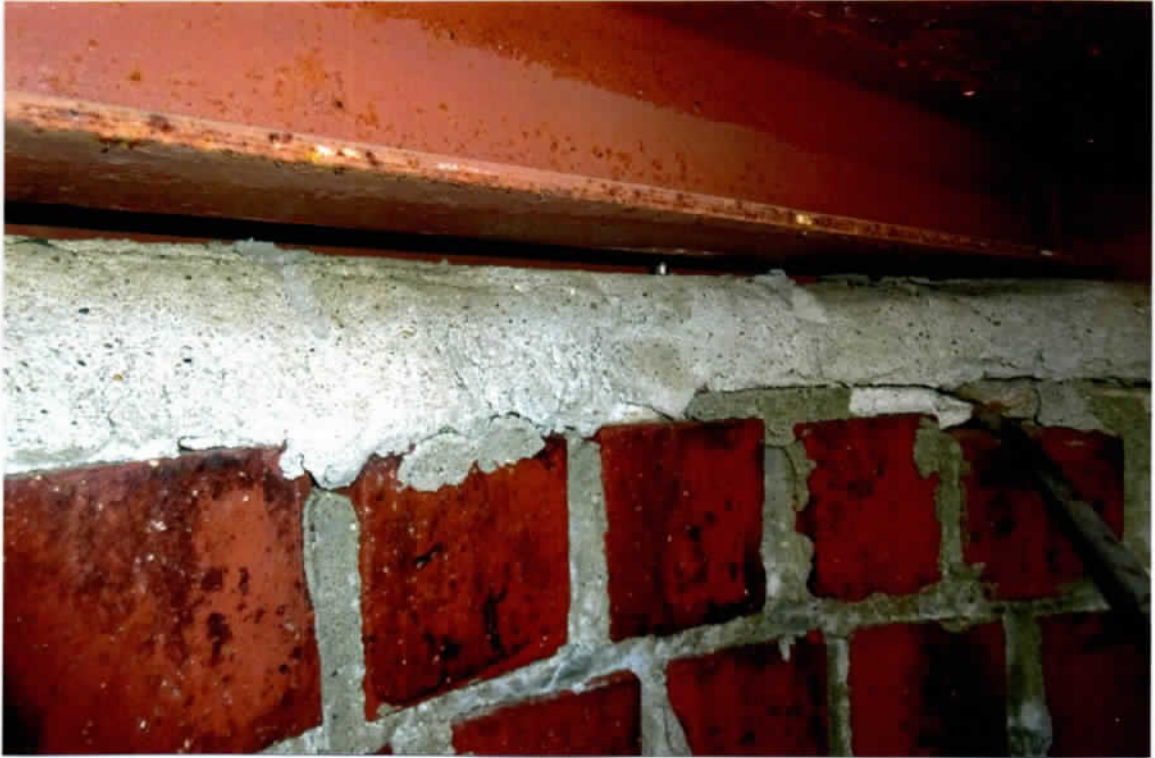
- Cement cap (3" thick) – When viewed from the interior, the condition of the cement cap atop the brick wall was good. The cement appeared sound for the full perimeter of the wall and was providing support for the five beams on the underside of the roof. Photos 5 – 8 show the cement cap atop the brick wall.

Photo 5. Good interior condition of the cap, brick faces and mortar joints (upper courses of north side). Mortar joints in the upper elevations appeared repointed. No concerns were identified.

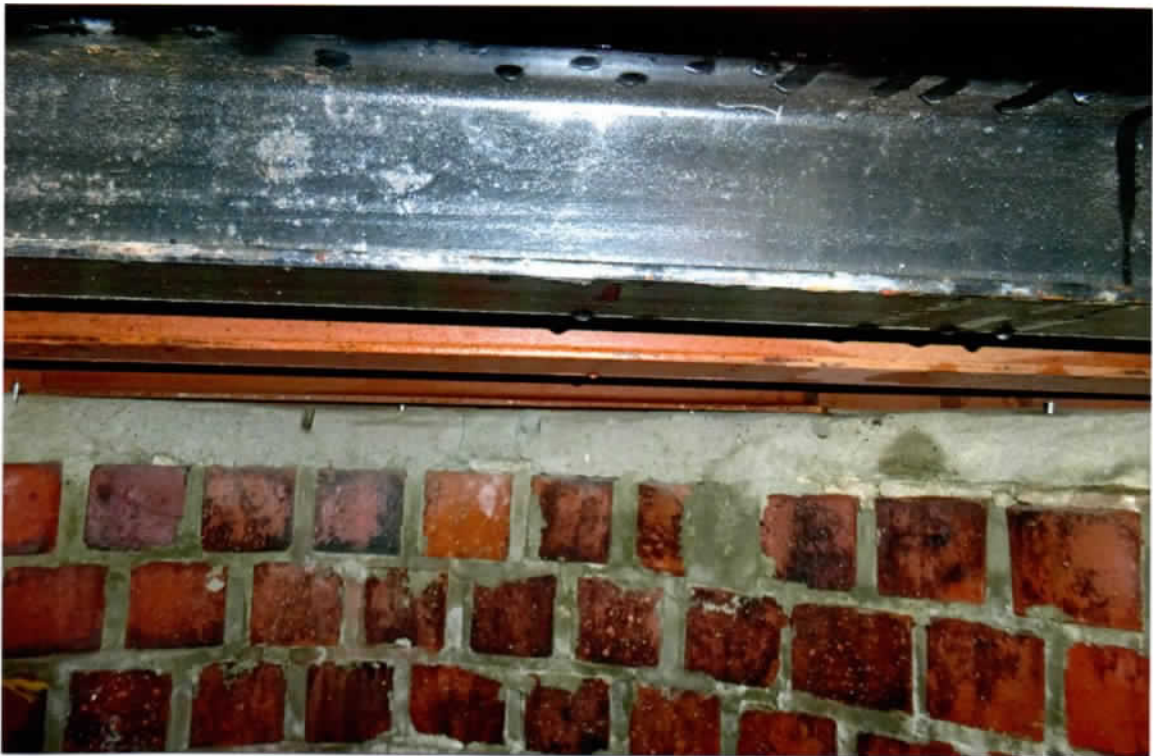
Photo 6. Good interior condition of the cap, brick faces and mortar joints (upper courses of south side). Note the good condition of the $\pm 3"$ cement cap atop the brick wall.

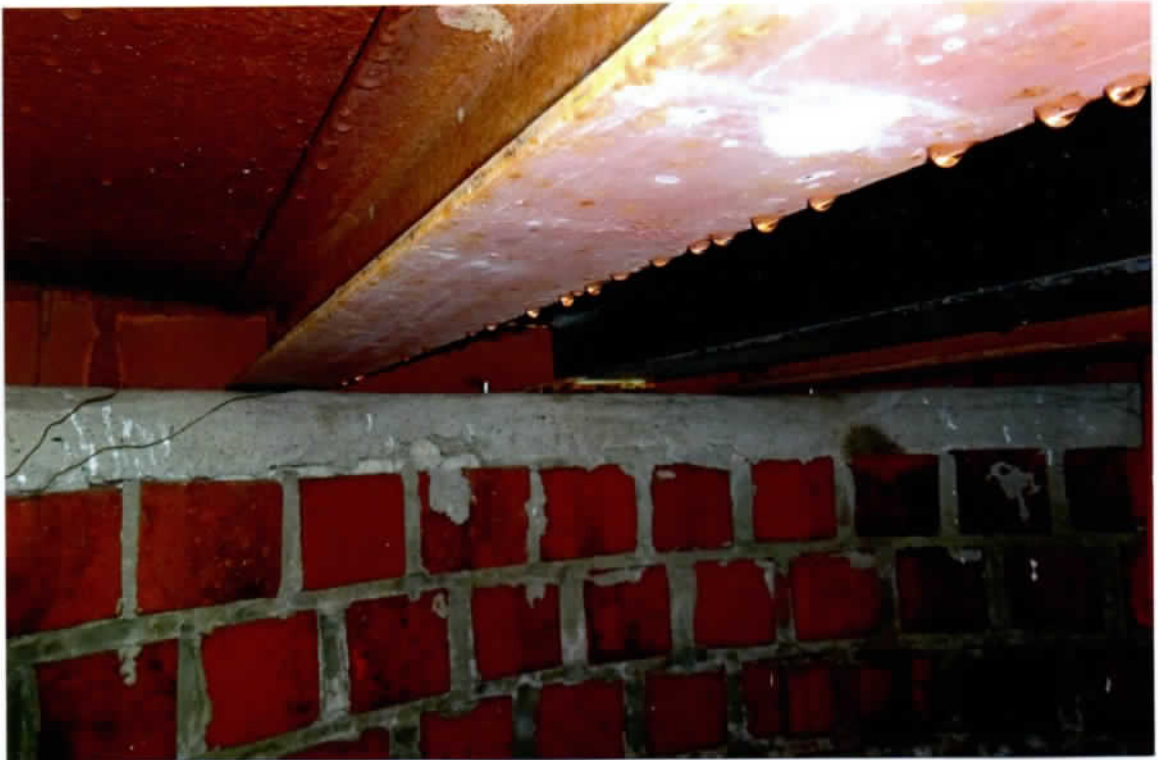
Photo 7. Good interior condition of the cap, brick faces and mortar joints (upper courses of east side).
Note the good condition of the ± 3 " cement cap atop the brick wall.

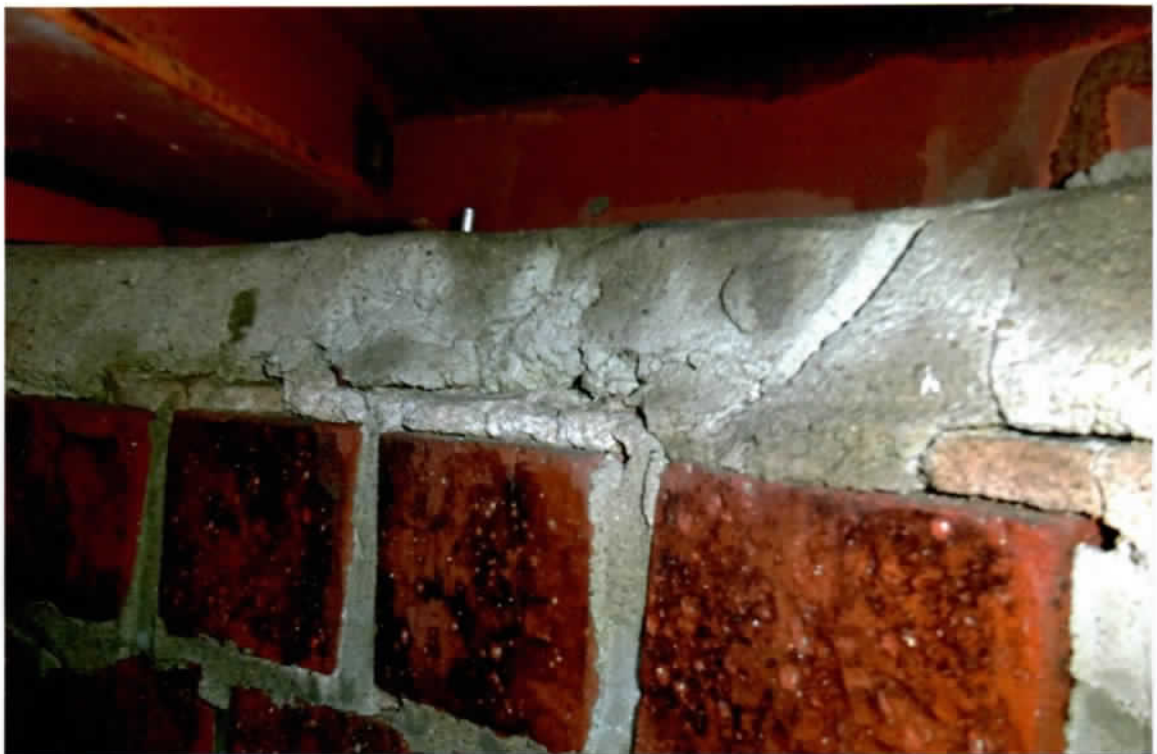
Photo 8. Good interior condition of the cap, brick faces and mortar joints (upper courses of west side).
Note the good condition of the ± 3 " cement cap atop the brick wall.

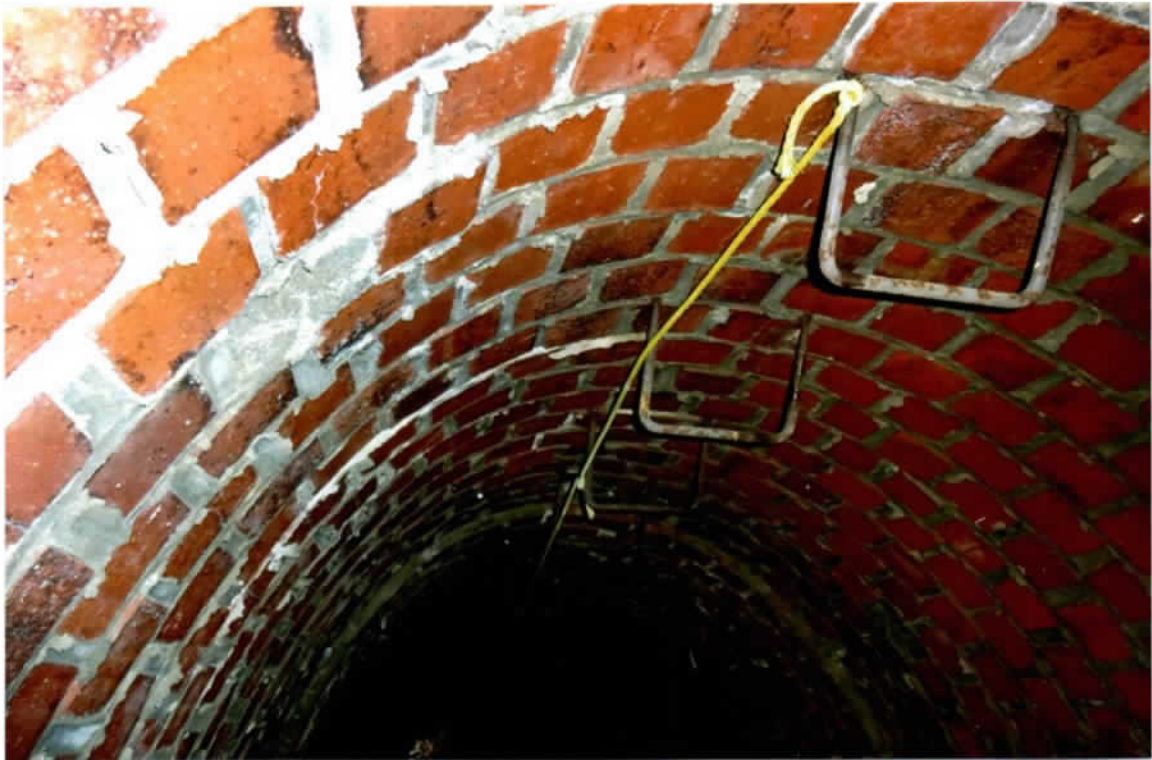
Photo 9. Good interior condition of the upper elevations looking down from the roof (north side). Mortar joints in the uppermost $\pm 15'$ appeared to have been repointed.

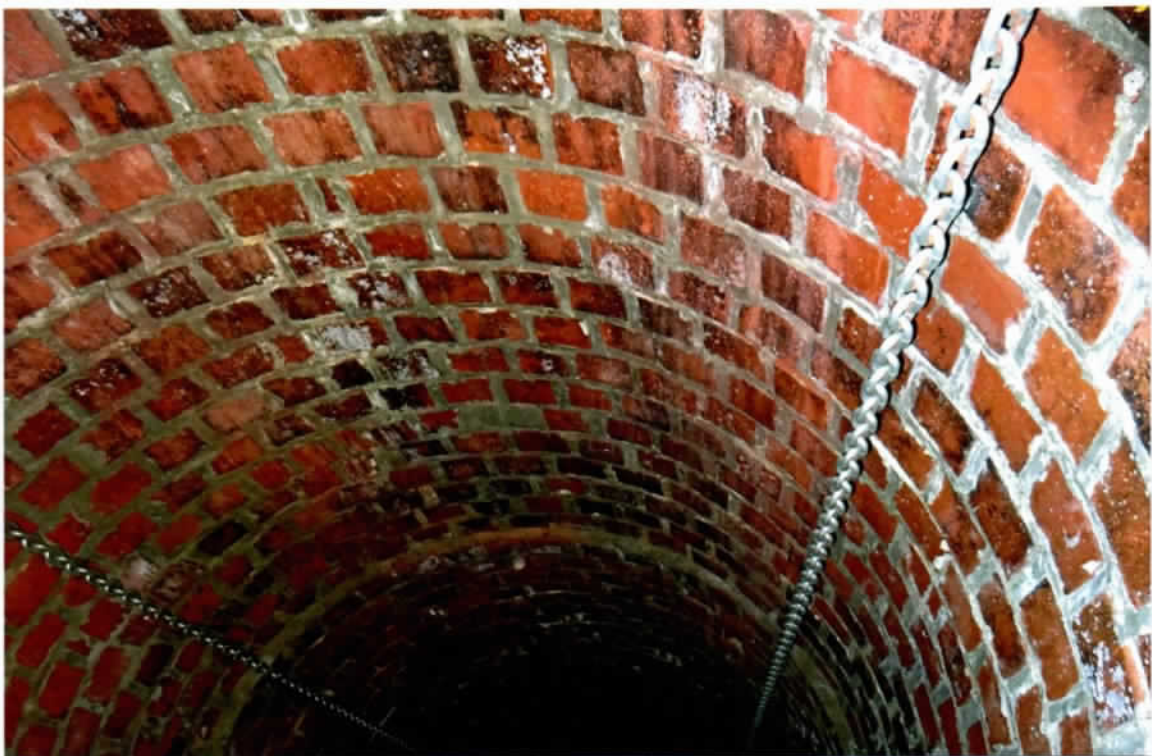
Photo 10. Good interior condition of the upper elevations looking down from the roof (south side). Mortar joints in the uppermost $\pm 15'$ appeared to have been repointed.

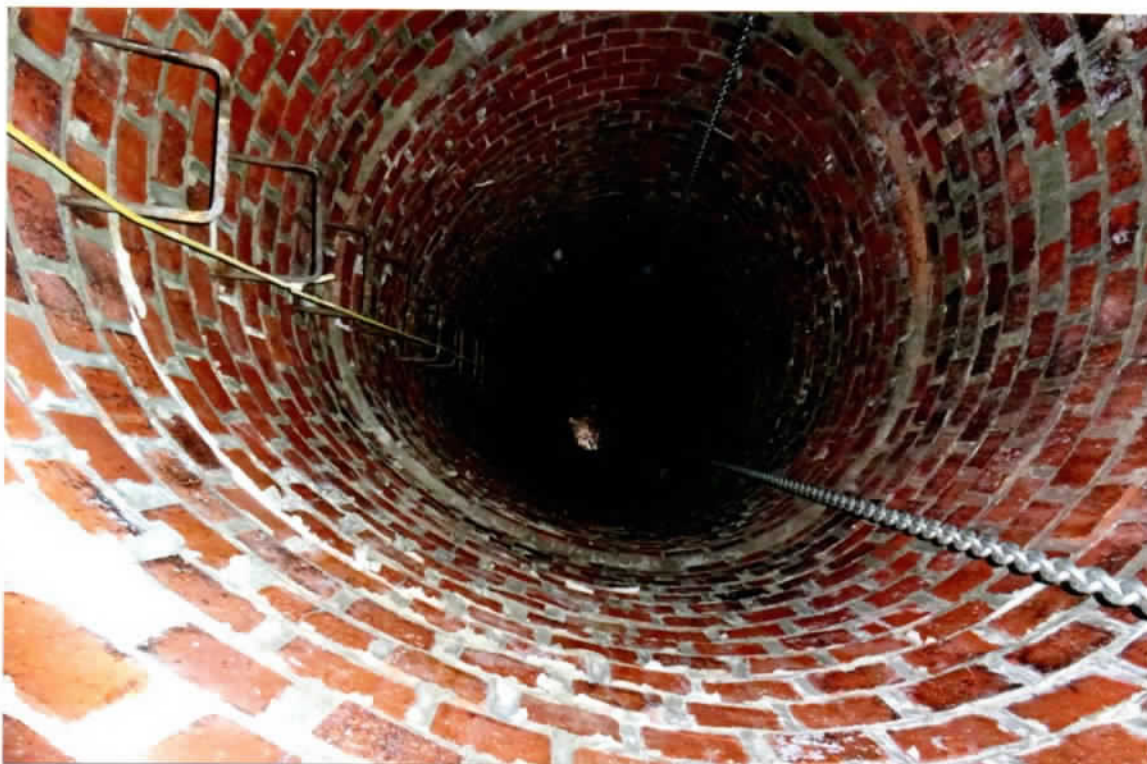
Photo 11. Good interior condition of the upper elevations looking down from the roof. Mortar joints in the uppermost $\pm 15'$ appeared to have been repointed.

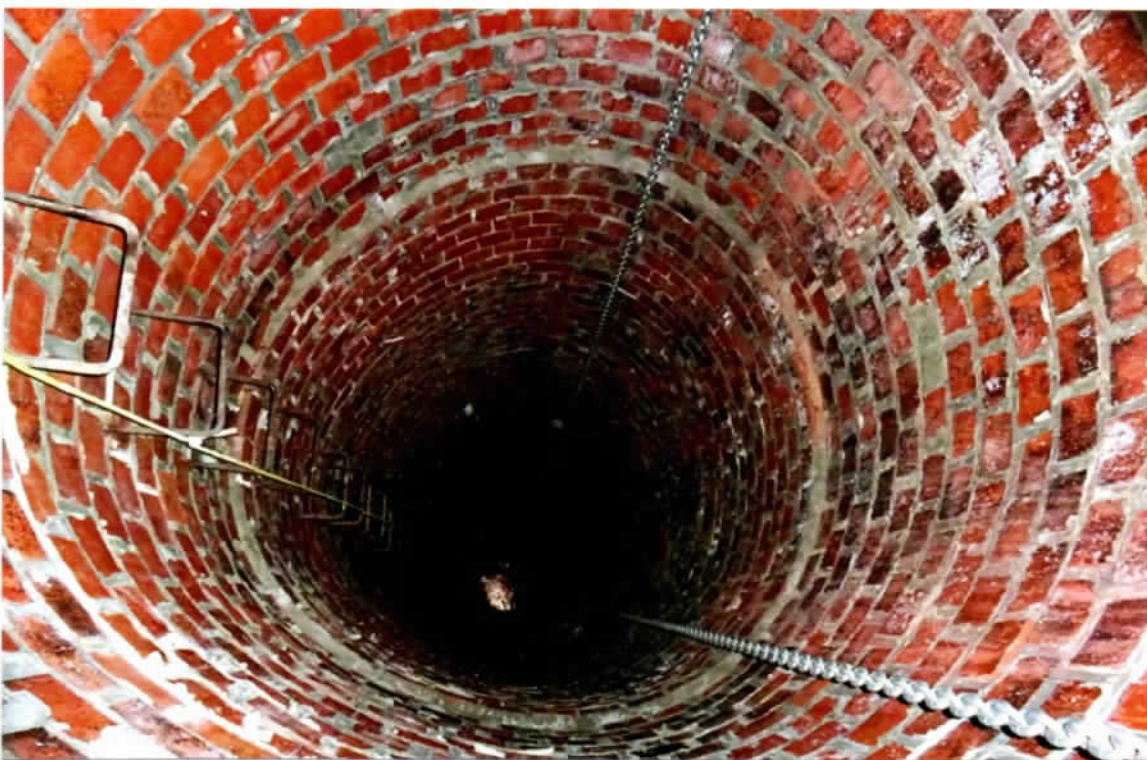
Photo 12. Good interior condition local to the 132' level shelf (wall thickness change). Mortar joints below the 125' level were in fair condition as open and cracked joints were identified.

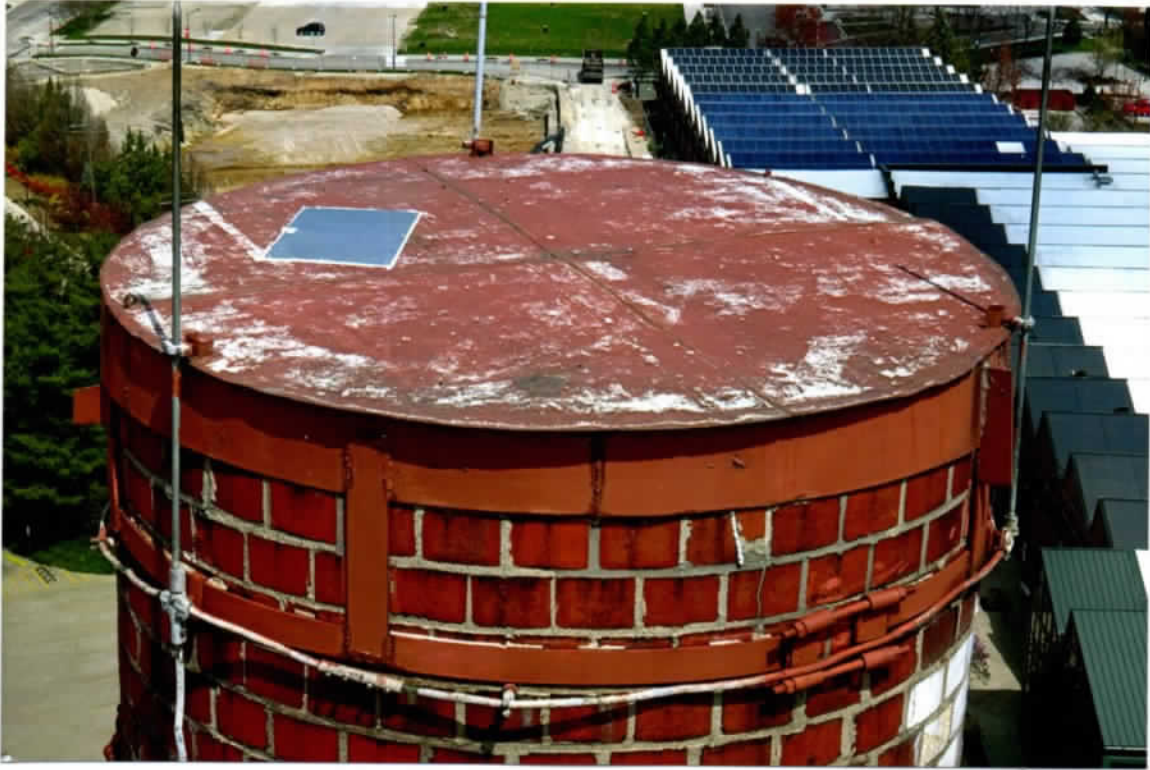
Photo 13. Overall good exterior condition of the upper elevations of the south side. Mortar joints appeared repointed within the past 15 years. LPS cables, bands and roof were secure.

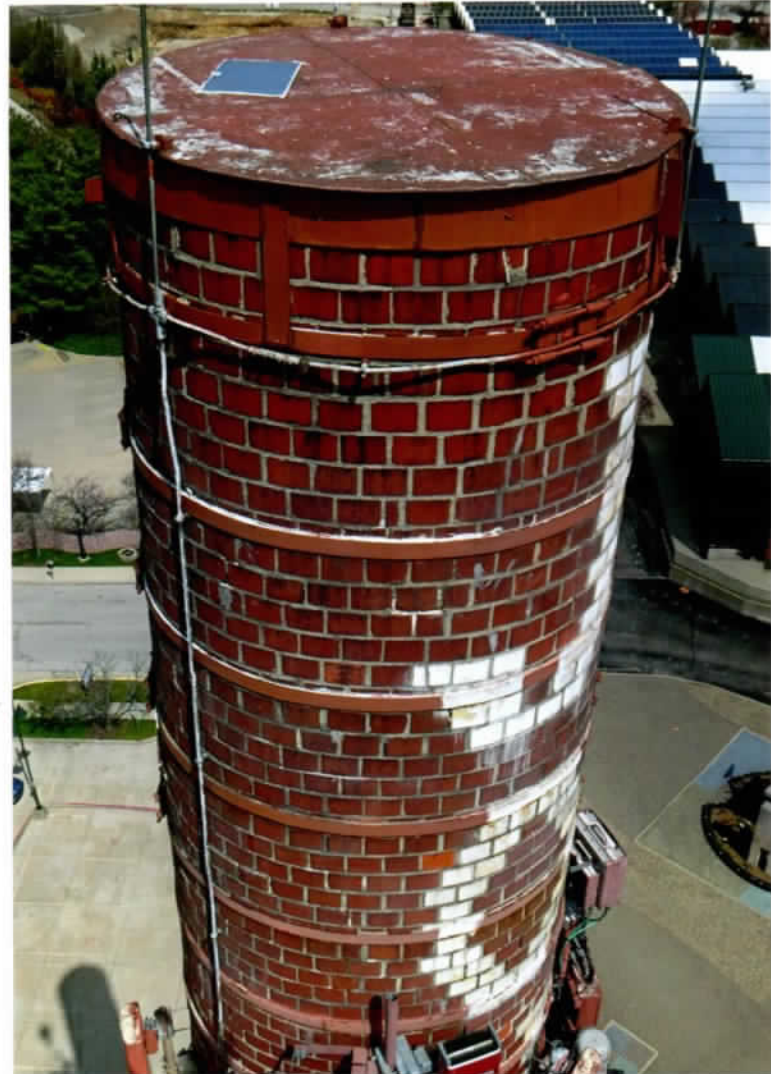
Photo 14.
Overall good exterior condition of the south side above the 126' level. Mortar joints appeared to have been repointed within the past 15 years and no immediate concerns were identified in this region. The lightning protection components and exterior bands were secure.

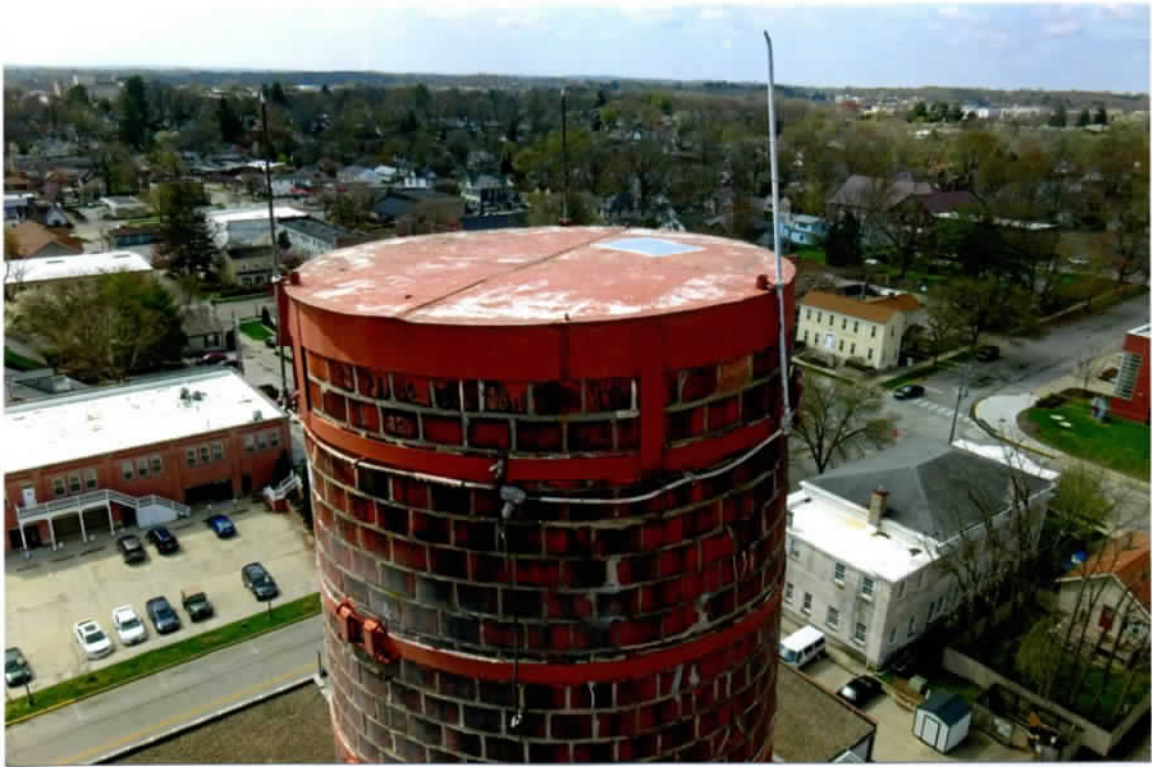
Photo 15. Overall good exterior condition of the upper elevations of the northeast side. Mortar joints appeared repointed within the past 15 years. LPS cables, bands and roof were secure.

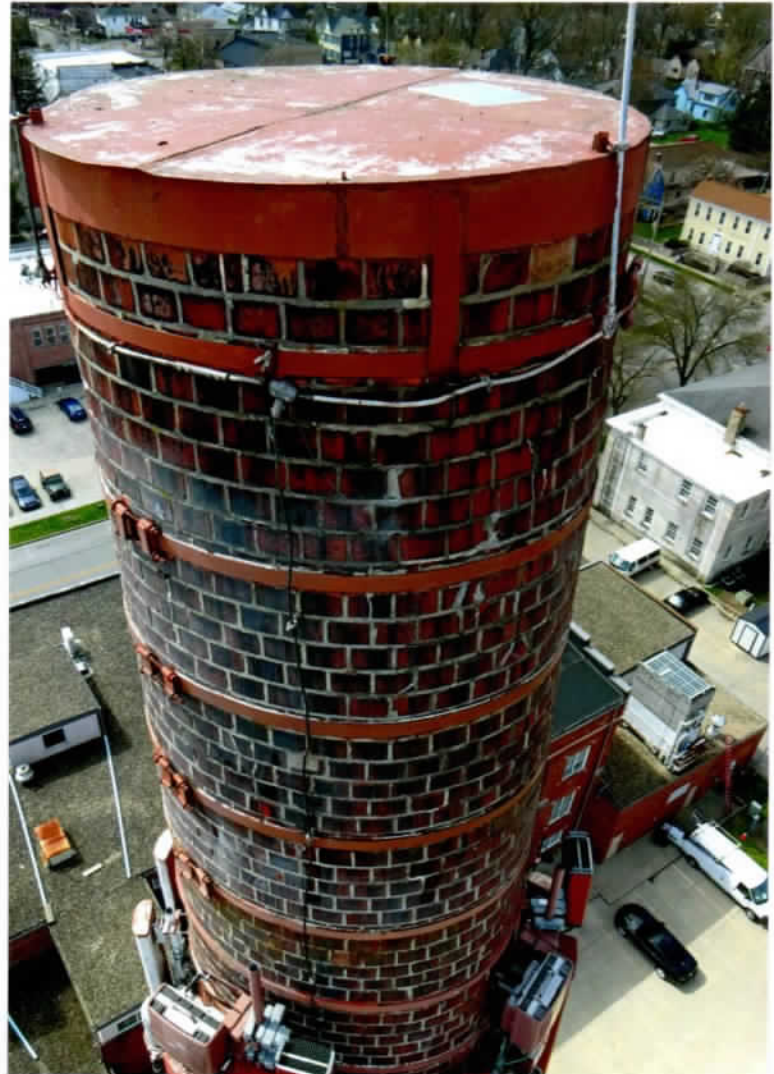
Photo 16.
Overall good exterior condition of the northeast side above the 126' level. Mortar joints appeared to have been repointed within the past 15 years and no immediate concerns were identified in this region. The lightning protection components and exterior bands were secure.

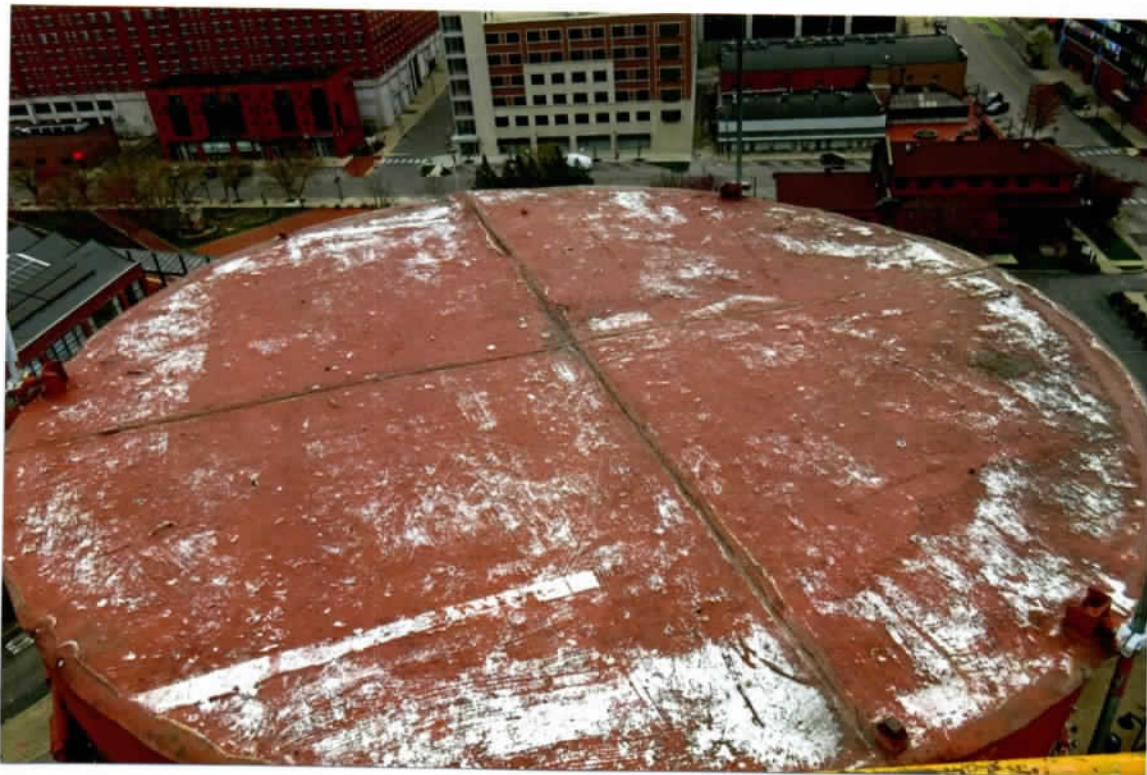
Photo 17. Good condition of the roof plate (looking from west side).
Note only the weathered paint. The roof plate and support beams on the underside were secure.

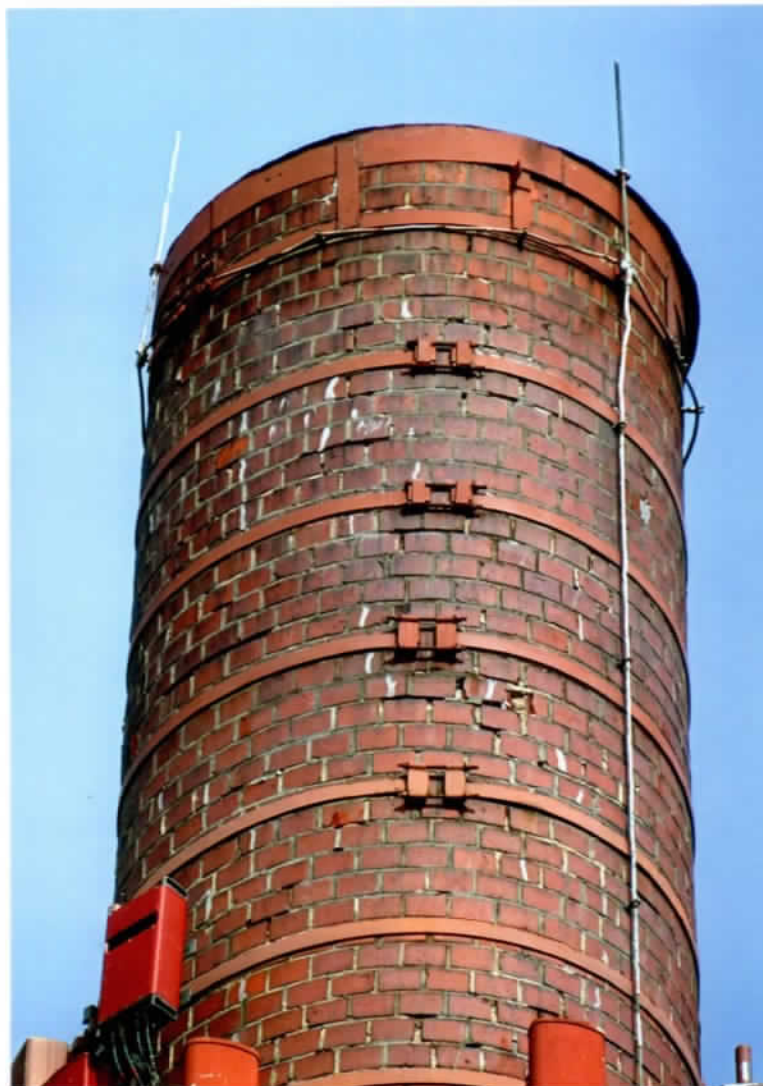
Photo 18.
Overall good exterior condition of the west side above the 126' level. One region of concern was identified near the 130' level (see next page). The lightning protection components and exterior bands were secure.

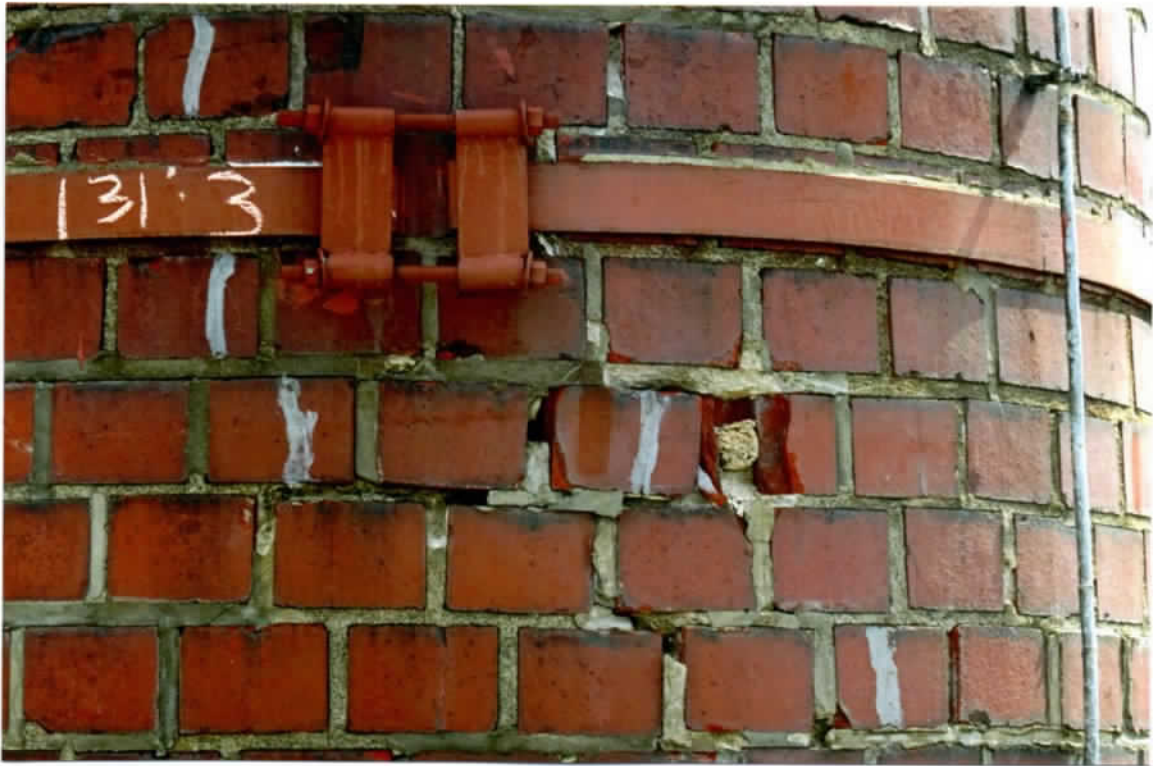
- 140'-10" (top) to 126'-0" – With the exception of the significant lean to the southeast direction, the overall condition of this region was good. Only one spalled brick face was identified, and the majority of mortar joints appeared sound. Photos 19 and 20 show the one local areas of concern were mortar is missing from several joints and the one spalled brick exists. Past repairs to thin cracks were also identified in this 15' region. Photos 13 – 20 show this region.

Photo 19. Local area of cracked and spalled bricks and dislodged mortar (130' level, west side). Mortar joints below the damaged region were cracked and partially dislodged.

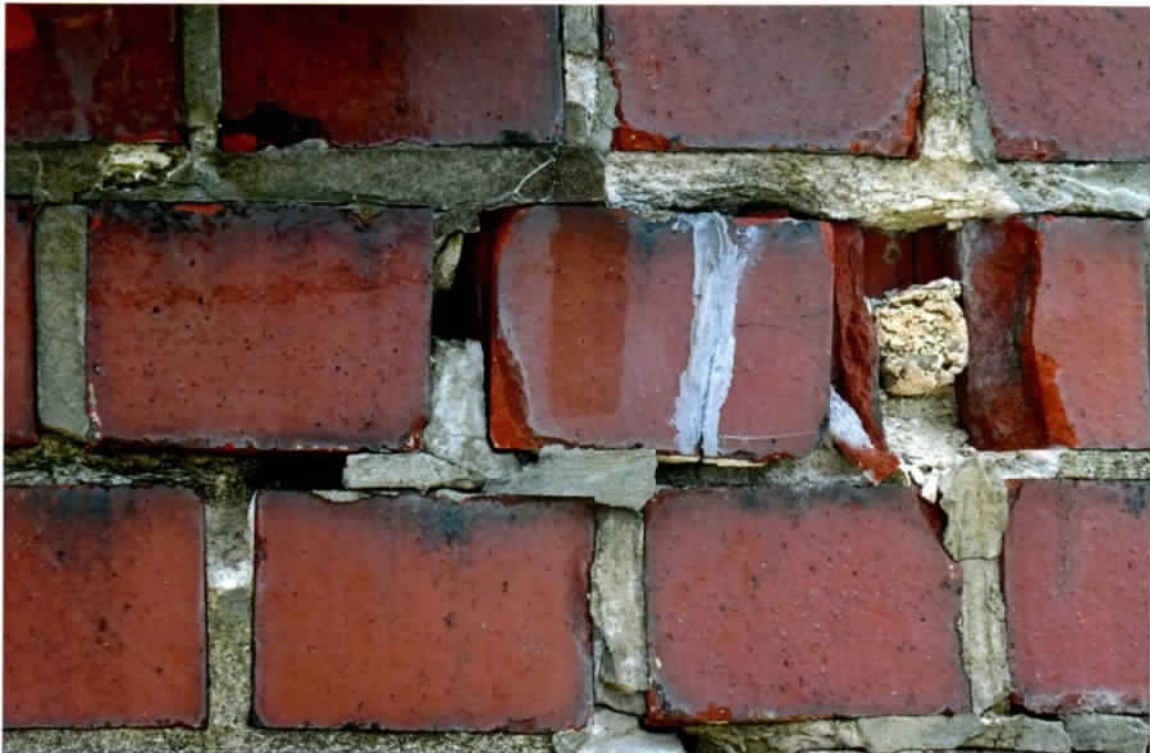
Photo 20. Close-up of the cracked and spalled bricks and dislodged mortar (130' level, west side).

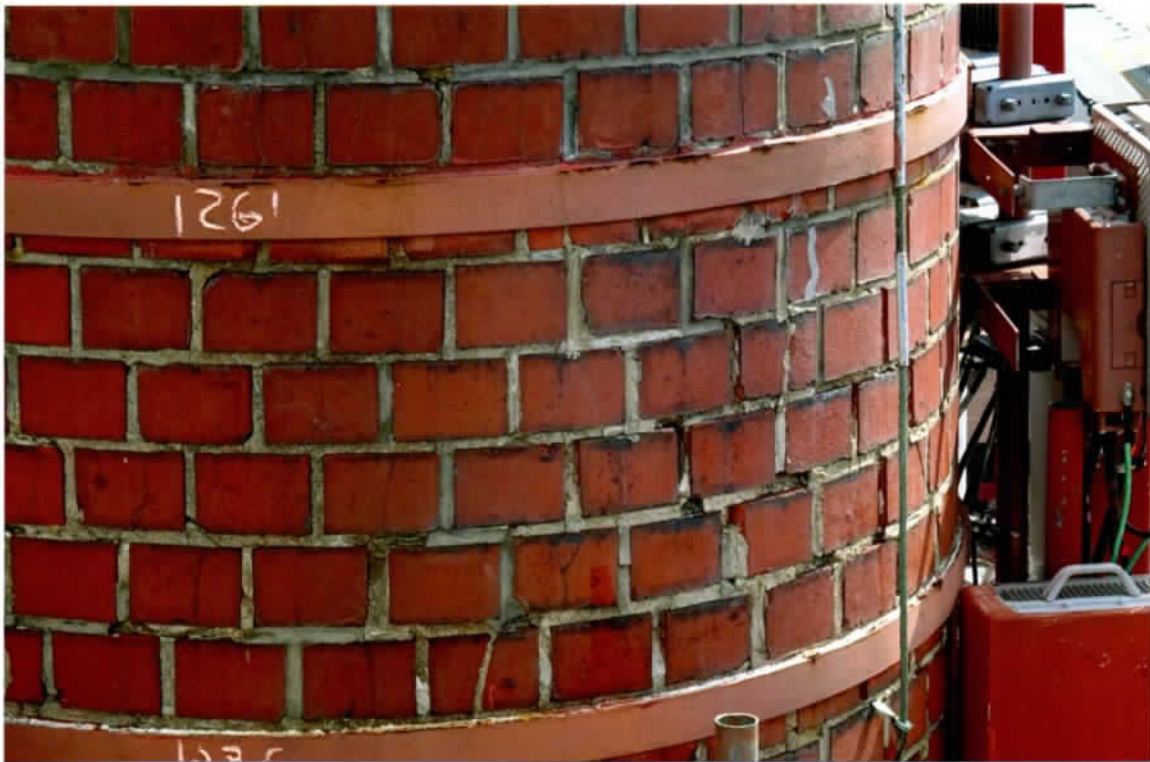
- 126'-0" to 115'-0" (region of cellular antenna) – The exterior condition of this region ranged from fair to poor. Several spalled bricks existed on the southwest side and quality of the most recent repointing work was somewhat crude. It appeared the repointing work was performed with the antennas and RRU units in place, which most likely prevented proper grinding of joints before being refilled. Photos 21 – 24 show this region.

Photo 21. Local area of cracked and dislodged mortar (124'-6" level, southwest side). The overall condition of brick faces in this region remained sound.

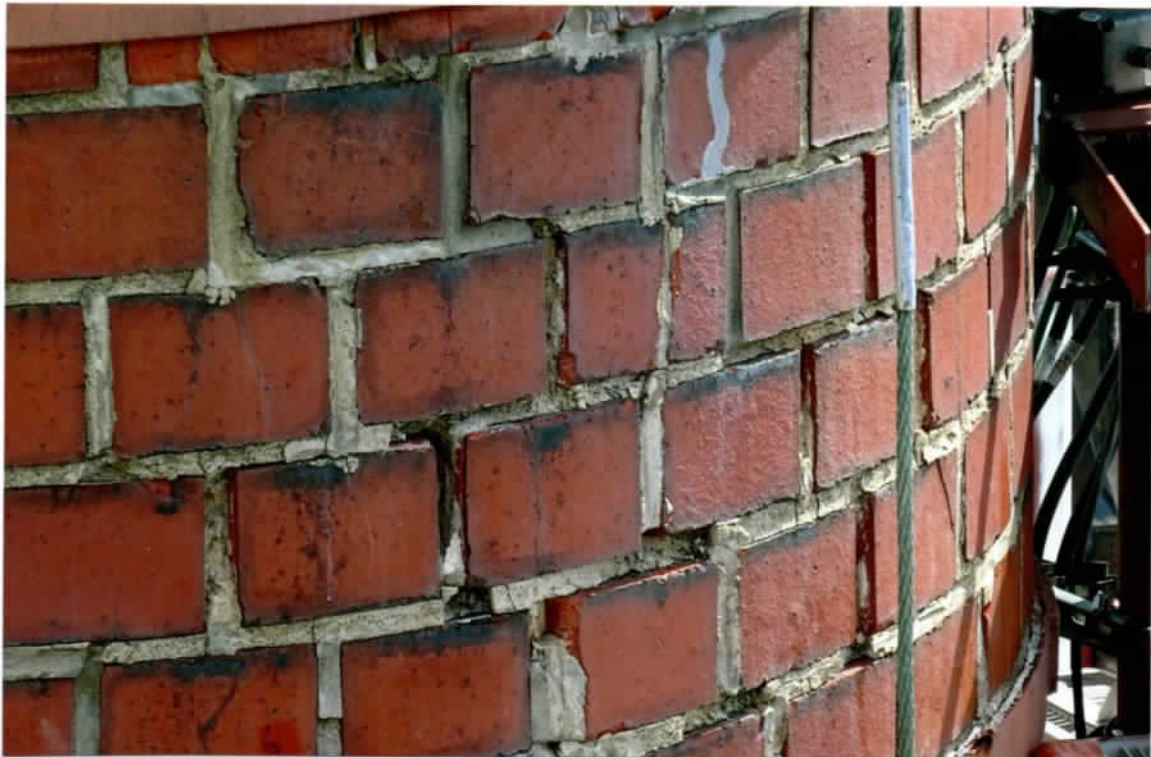
Photo 22. Close-up of the cracked and dislodged mortar (124'-6" level, southwest side).

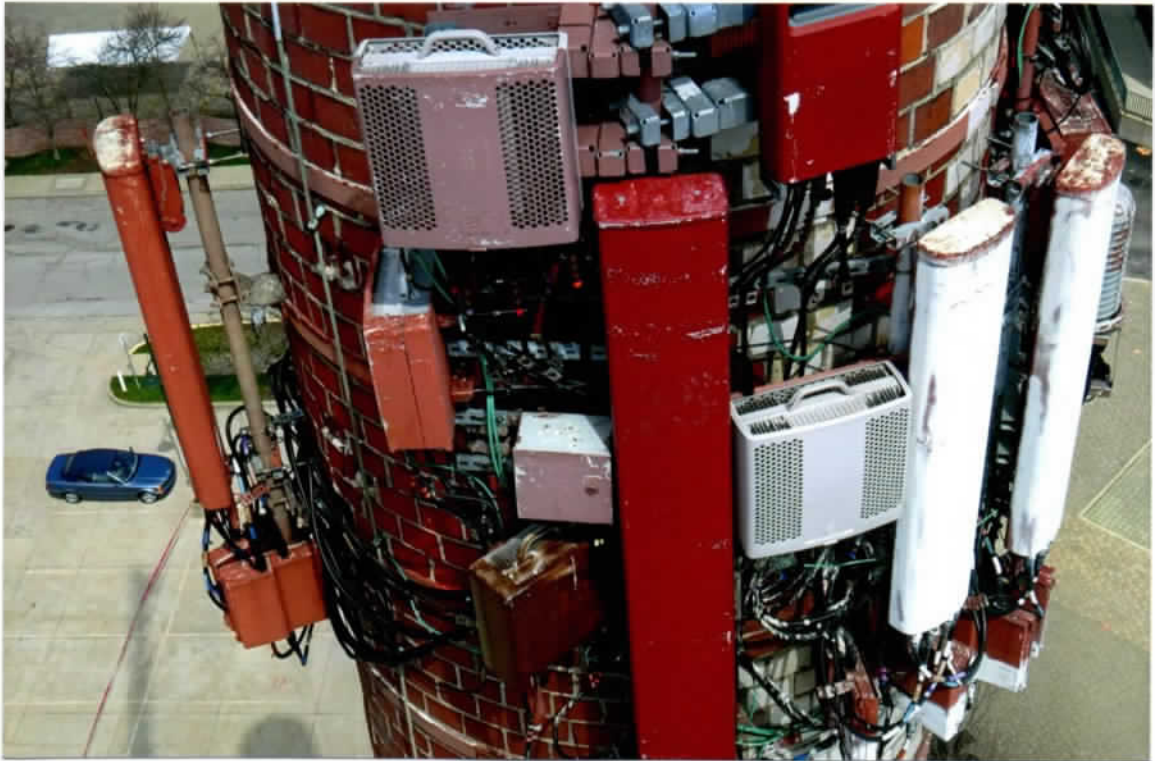
Photo 23. Good condition of the existing antennas and RRF units (south side). Nearly all components were supported by three exterior bands (123'-6", 121'-6" and 118'-4" levels).

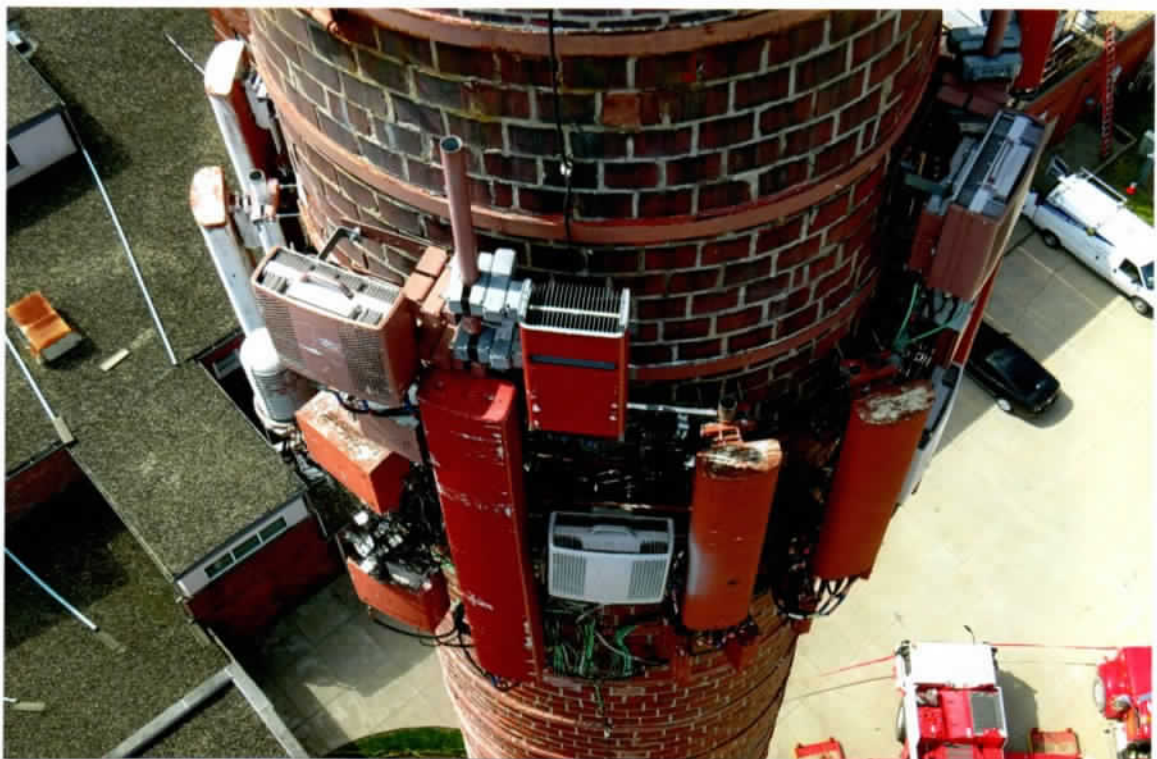
The condition of antennas, RRU's support components and coaxial attachments throughout the one level of antennas appeared good. When viewed from grade and the manbasket, no obvious defects or deteriorated components were seen throughout any of the numerous antennas or support components. Photos 23 – 24 show the antennas and support components.

Photo 24. Good condition of the existing antennas and RRF units (northeast side). Nearly all components were supported by three exterior bands (123'-6", 121'-6" and 118'-4" levels).
