**Bloomington Historic Preservation Commission, Zoom Virtual
Meeting, Thursday June 11, 2020, 5:00 P.M. AGENDA**

C. Johnson Creamery Stack Inspection Report

On April 6, 2020, a representative from R+P Industrial Chimney Company performed an inspection of the Johnson's Creamery chimney at 400 West 7th Street in Bloomington, Indiana. The purpose of the inspection was to examine the condition of the chimney and determine if any immediate maintenance work was required to bring it up to sound capacity. The chimney possessed a noticeable lean of the upper elevations and had not been thoroughly inspected for several years.

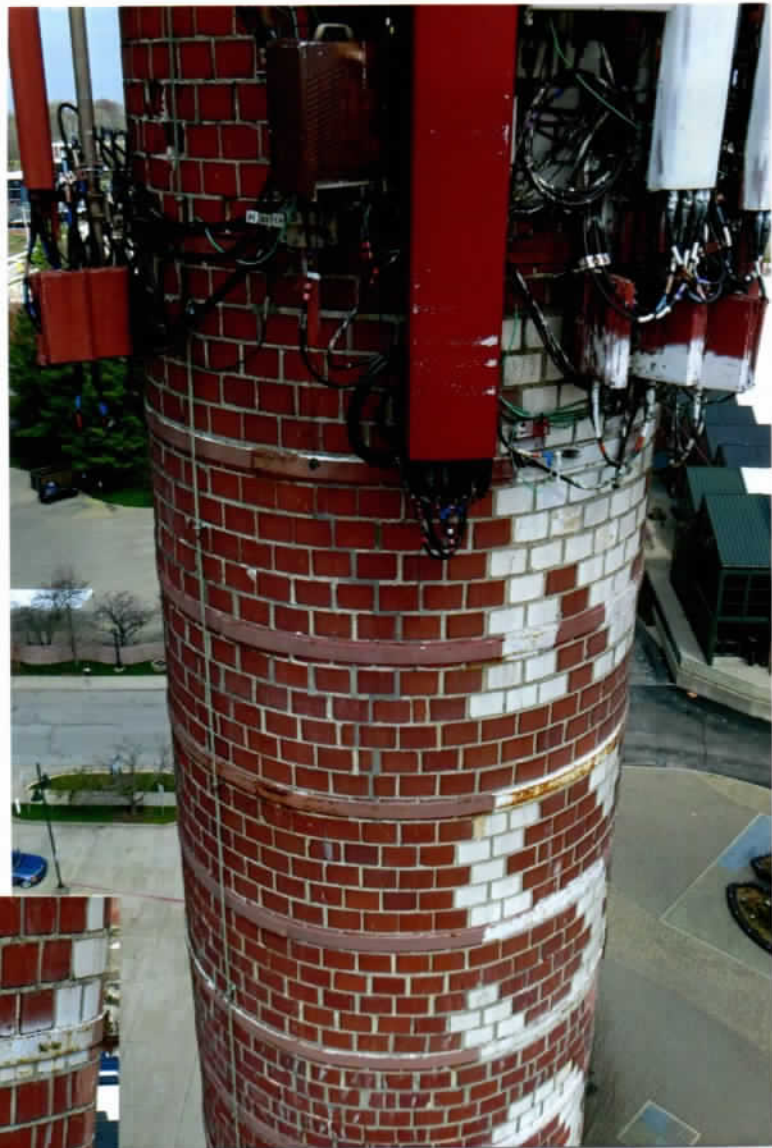
Photo 25.

Fair exterior condition of the south side between the 122' and 108' levels. Mortar joints were weathered and local areas of cracked and dislodged mortar were identified. The lightning protection downlead cable and exterior bands were secure.

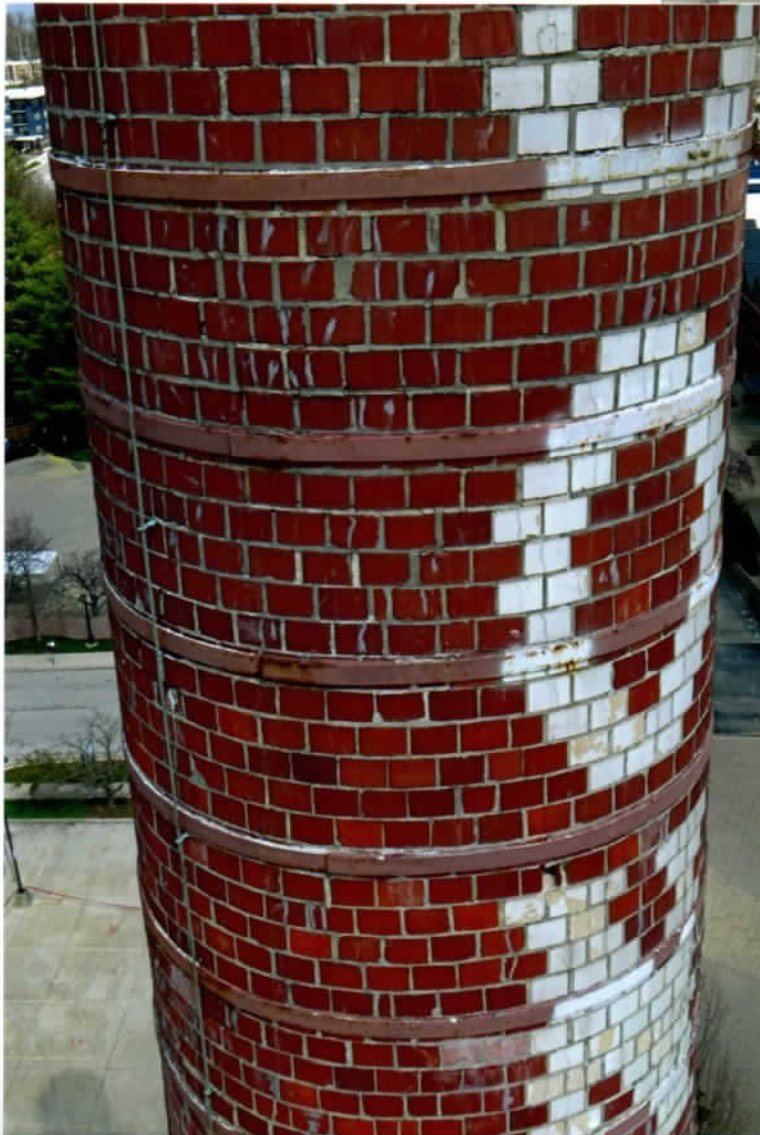
Photo 26.

Fair exterior condition of the south side between the 110' and 100' levels. Mortar joints were weathered and local areas of cracked and dislodged mortar were identified. The lightning protection downlead cable and exterior bands were secure.

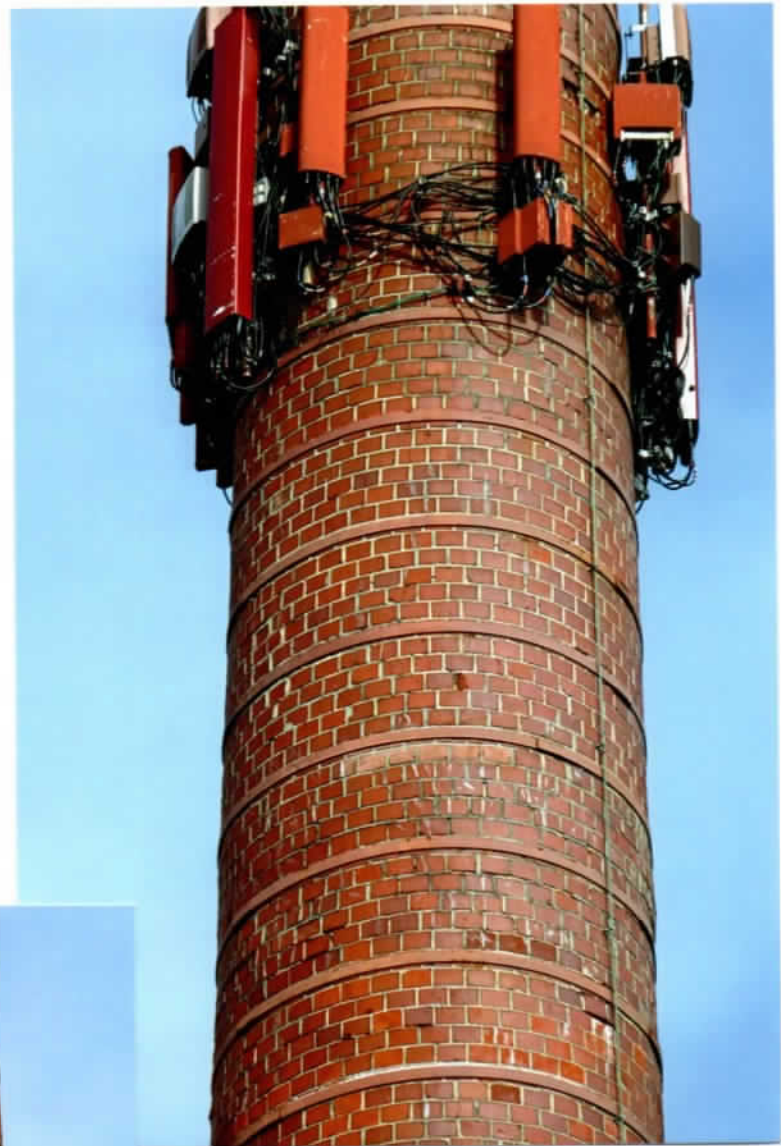
Photo 27.

Fair exterior condition of the west side between the 120' and 100' levels. Mortar joints were weathered and local areas of cracked and dislodged mortar were identified. The lightning protection downlead cable and exterior bands were secure.

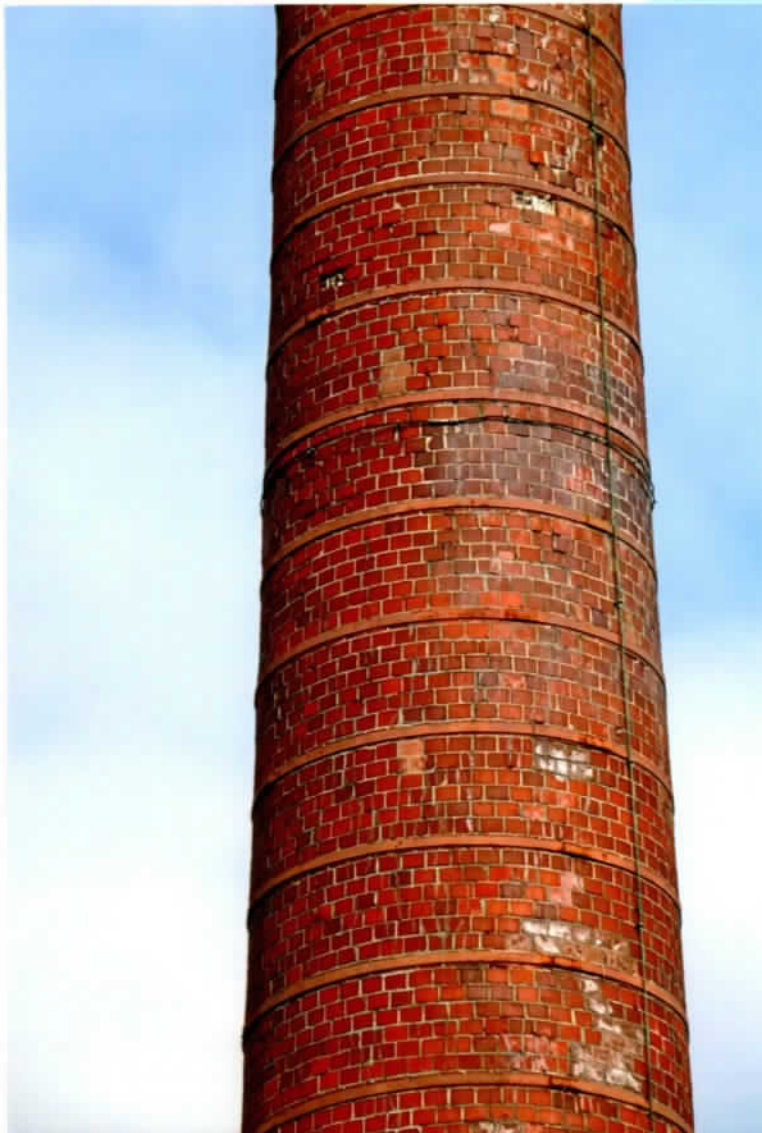
Photo 28.

Poor exterior condition of the west side between the 88' and 60' levels. Numerous areas of cracked and spalled bricks were identified. Mortar joints were also in poor condition from water infiltration and freeze-thaw cycles. The lightning protection downlead cable and exterior bands were secure.

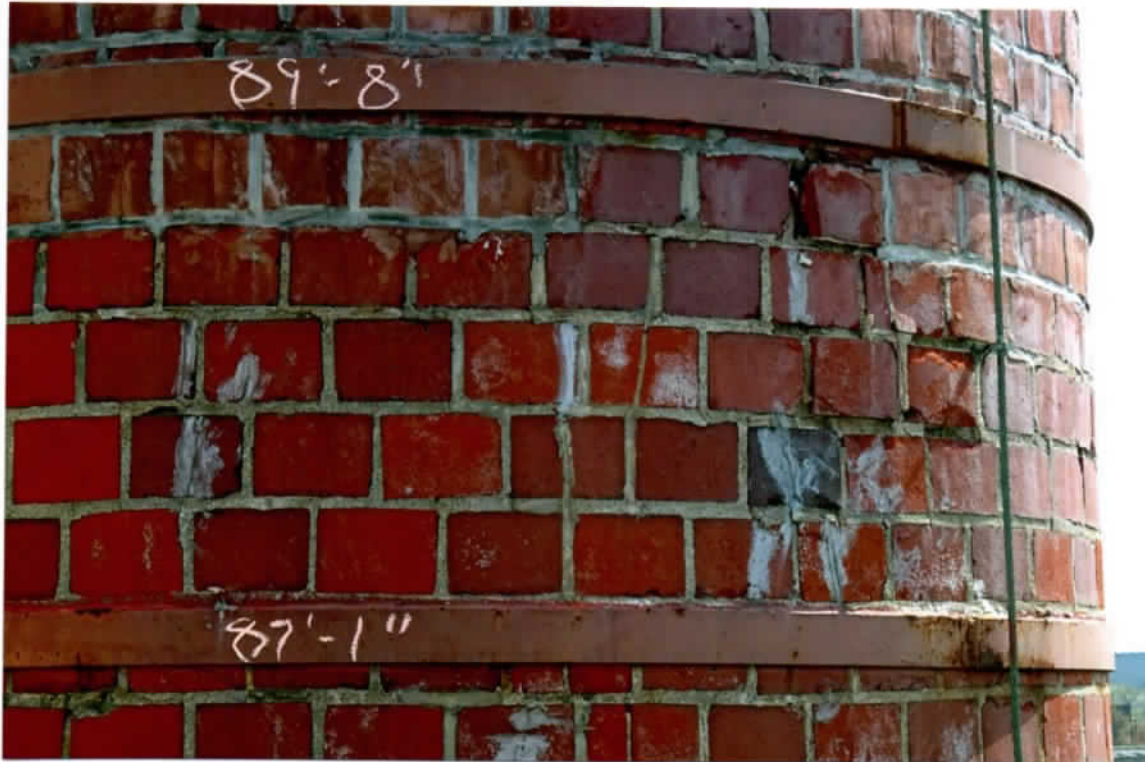
Photo 29. Local area of cracked and spalled brick faces (89' level, southwest side). Numerous generations of repointing work were identified in this region.

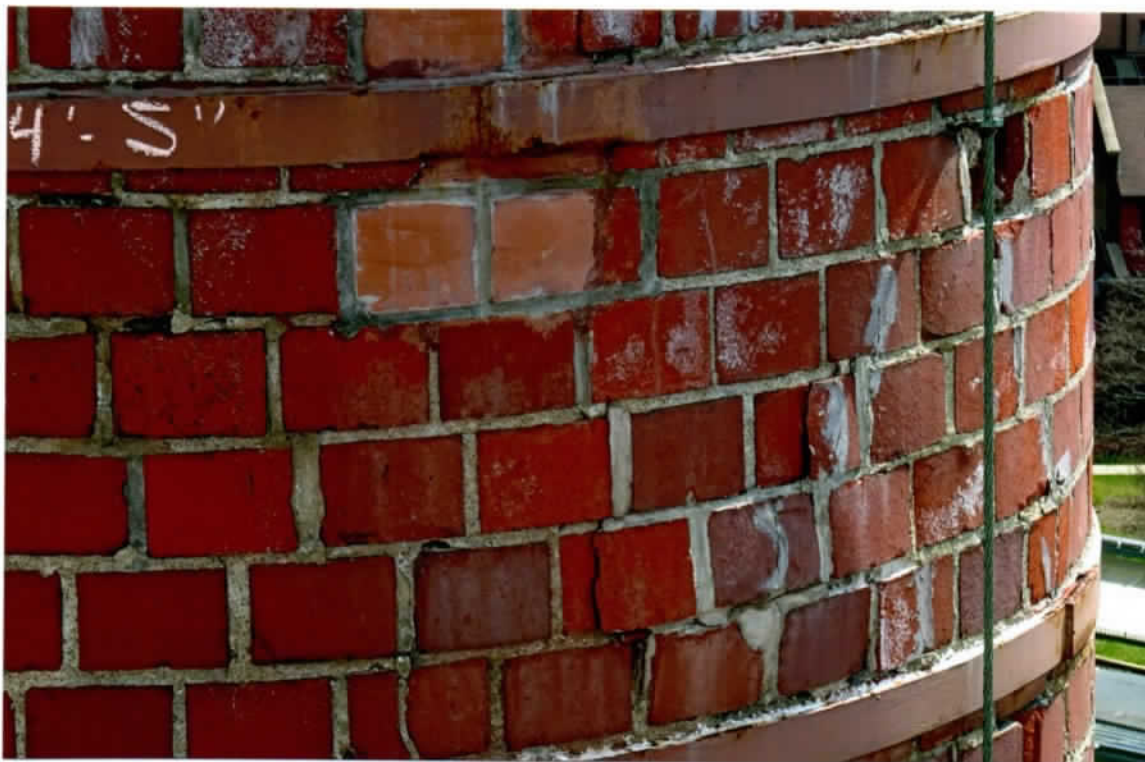
Photo 30. Local area of cracked and spalled brick faces (83' level, southwest side). Note the past repairs to replace several bricks near the upper band.

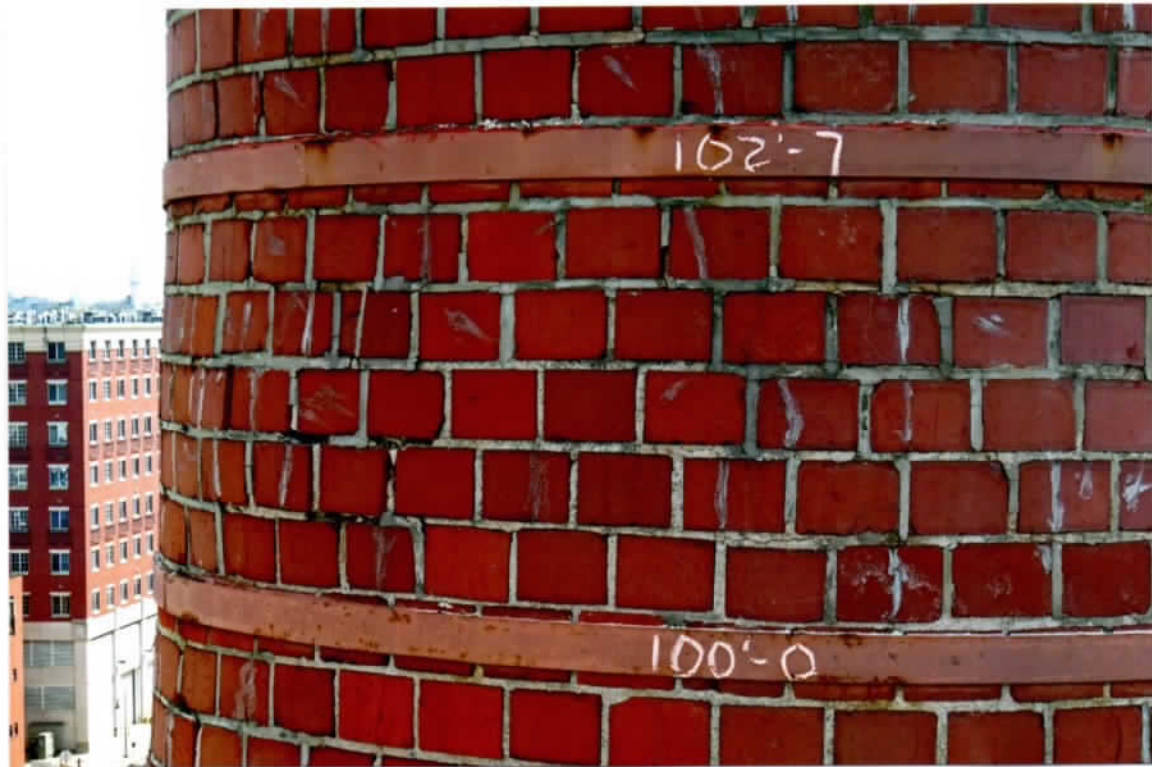
- 115'-0" to 40'-0" – The overall condition of this region was poor. Numerous spalled bricks, loose brick faces, bulged regions, dislodged mortar and cracked mortar were identified. The loose brick faces (Photos 31 and 39) were in danger of falling to grade. The highest levels of damage existed on the northeast side between the 80' and 70' levels (Photos 37 – 40) and on the south side at the 41' level (Photos 45 – 46). Based on visual observations, the lean of the upper elevations initiates near the 75' level. Photos 25 – 47 show this region.

Photo 31. Local area of bulged brick and severely eroded mortar joints (101' level, northwest side). Several brick faces were partially dislodged.

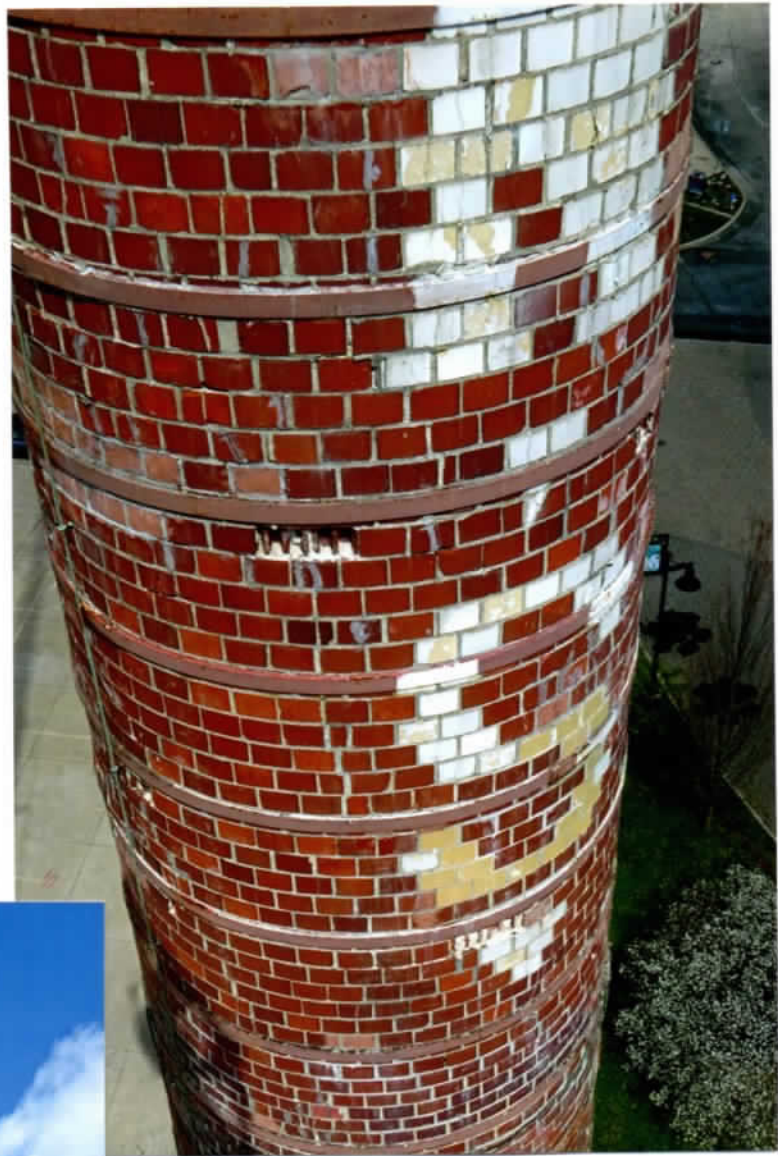
Photo 33.

Fair exterior condition of the south side between the 95' and 75' levels. Three spalled faces existed below the 89'-8" level band. Note the past crack repairs and brick replacement. The download cable and bands were secure.

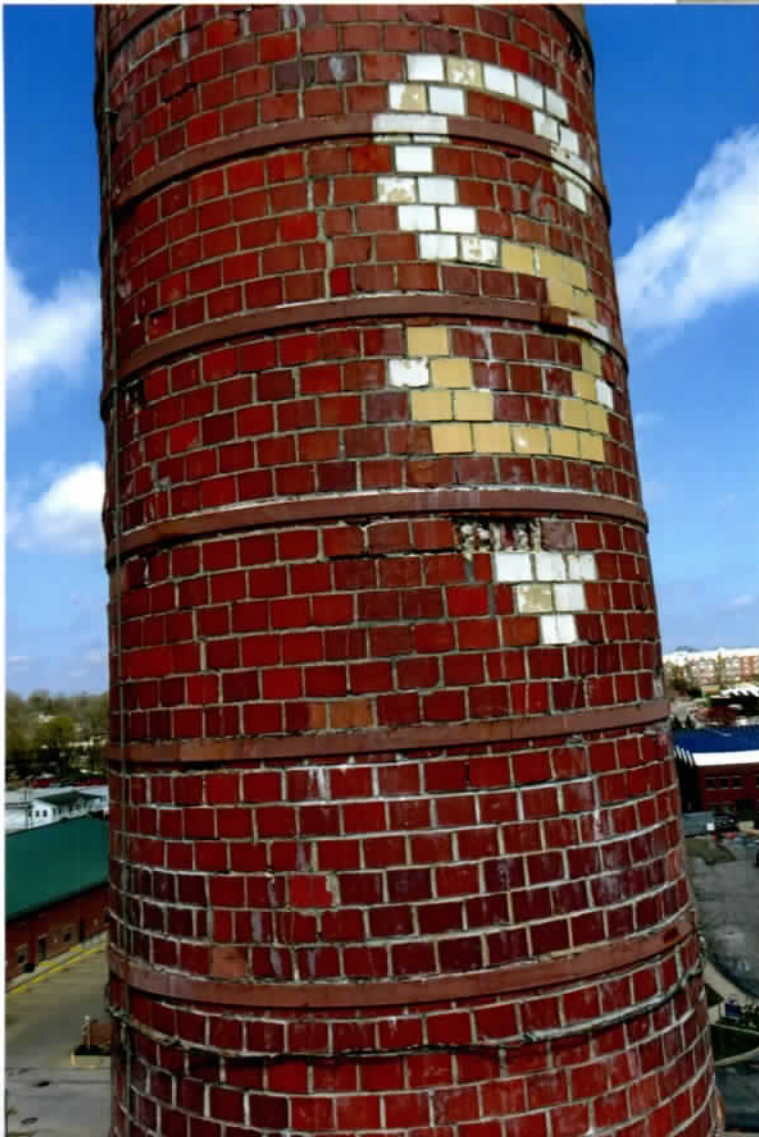
Photo 34.

Fair exterior condition of the south side between the 86' and 74' levels. Two spalled faces existed below the 81'-10" level band. Note the past crack repairs. The download cable and bands were secure.

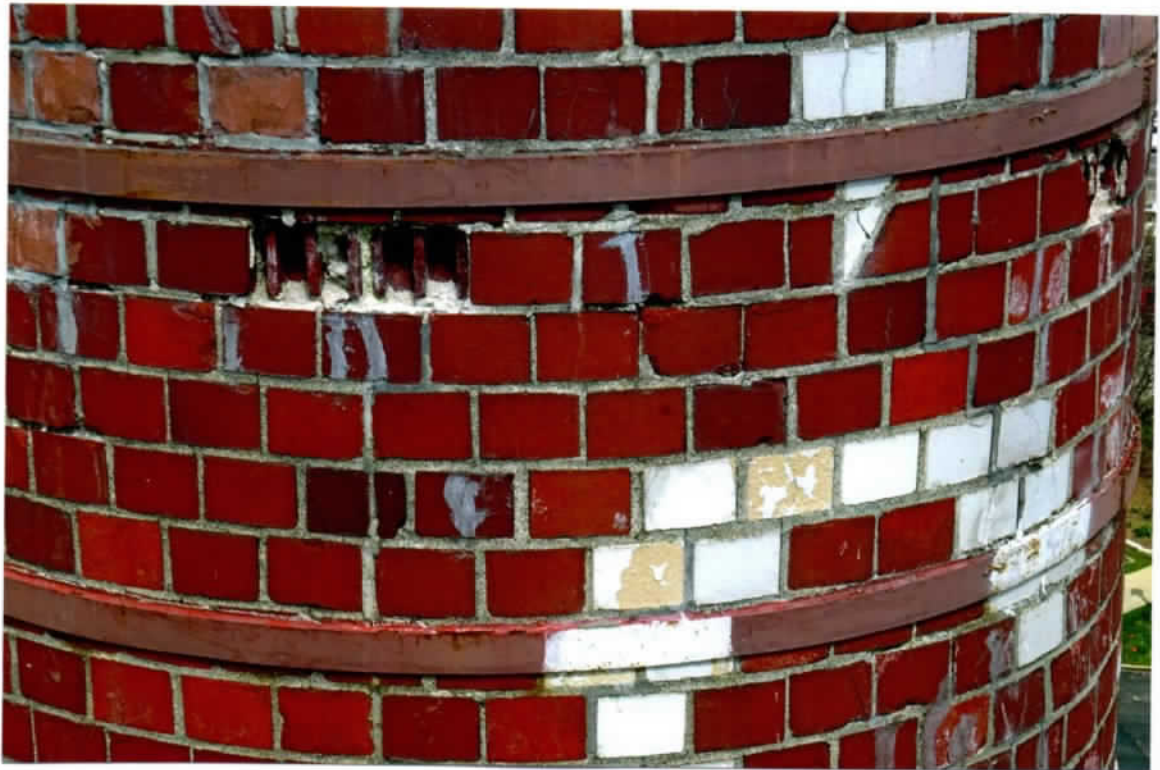
Photo 35. Close-up of the spalled brick faces in the course below the 89'-8" level band, south side.

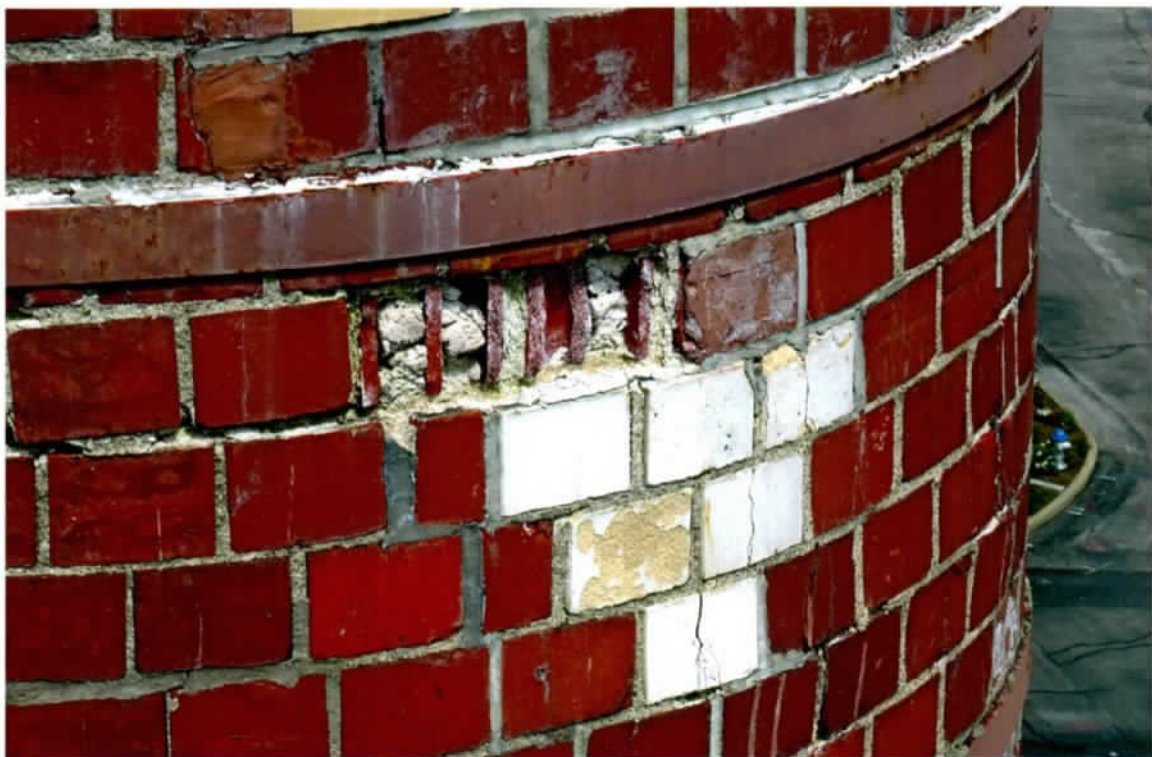
Photo 36. Close-up of the spalled brick faces and eroded mortar joints in the course below the 81'-10" level band, southwest side.

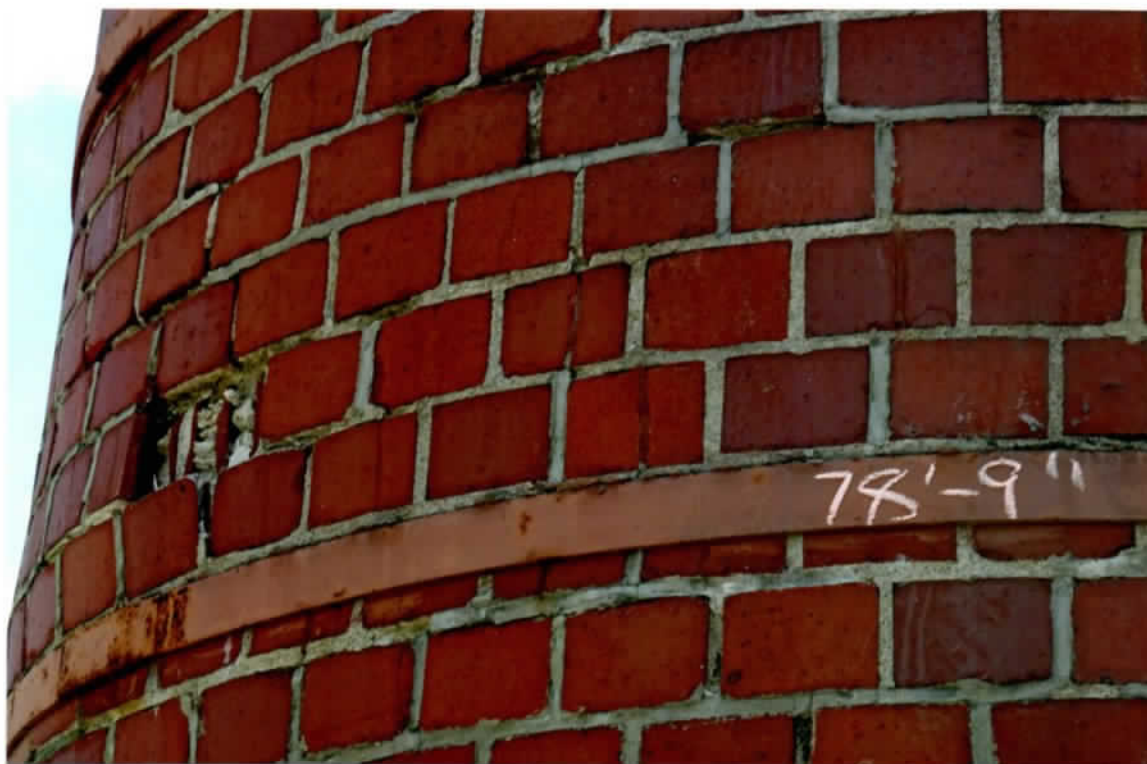
Photo 37. Local area of bulged and spalled bricks (80' level, northwest side). Several brick faces were partially dislodged.

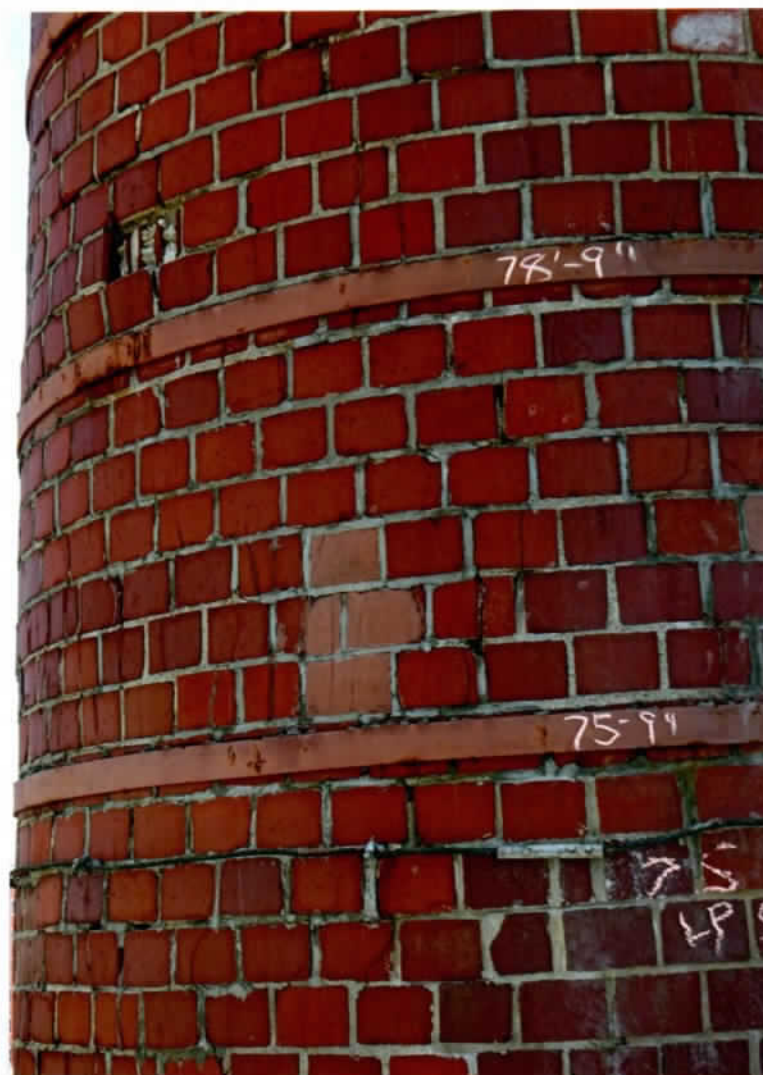
Photo 38.
Poor exterior condition of the northwest side between the 80' and 73' levels. Mortar joints were cracked and partially dislodged in this region. The bands and midheight LPS encircling cable were secure.

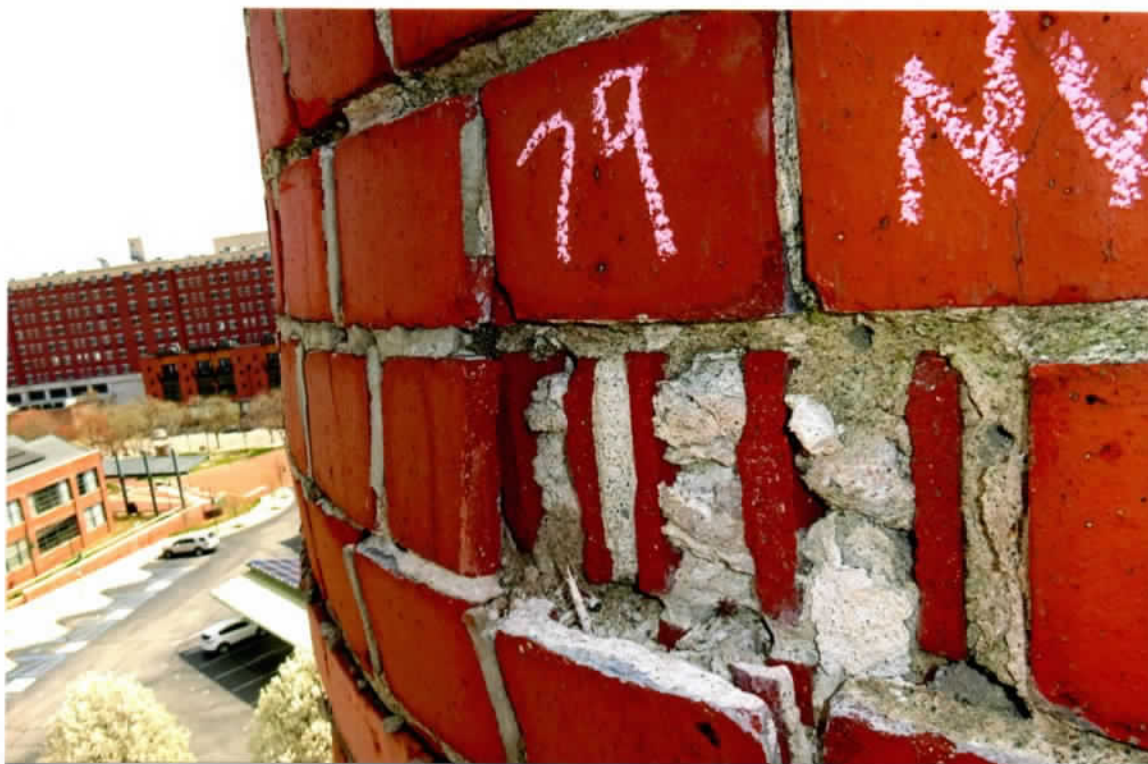
Photo 39. Close-up of the spalled and partially dislodged brick faces near the 80' level, northwest side.

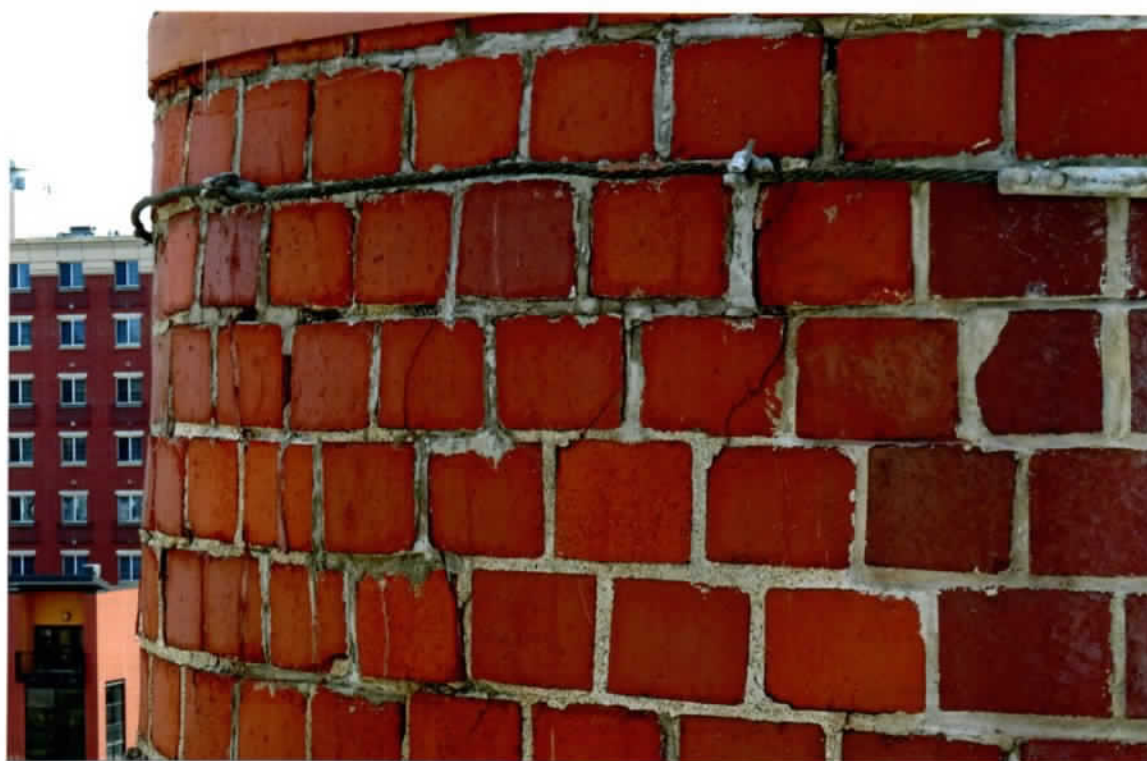
Photo 40. Close-up of the slightly bulged region of the northwest side near the 74' level. Mortar joints in this region were cracked and allowing moisture to enter the wall.

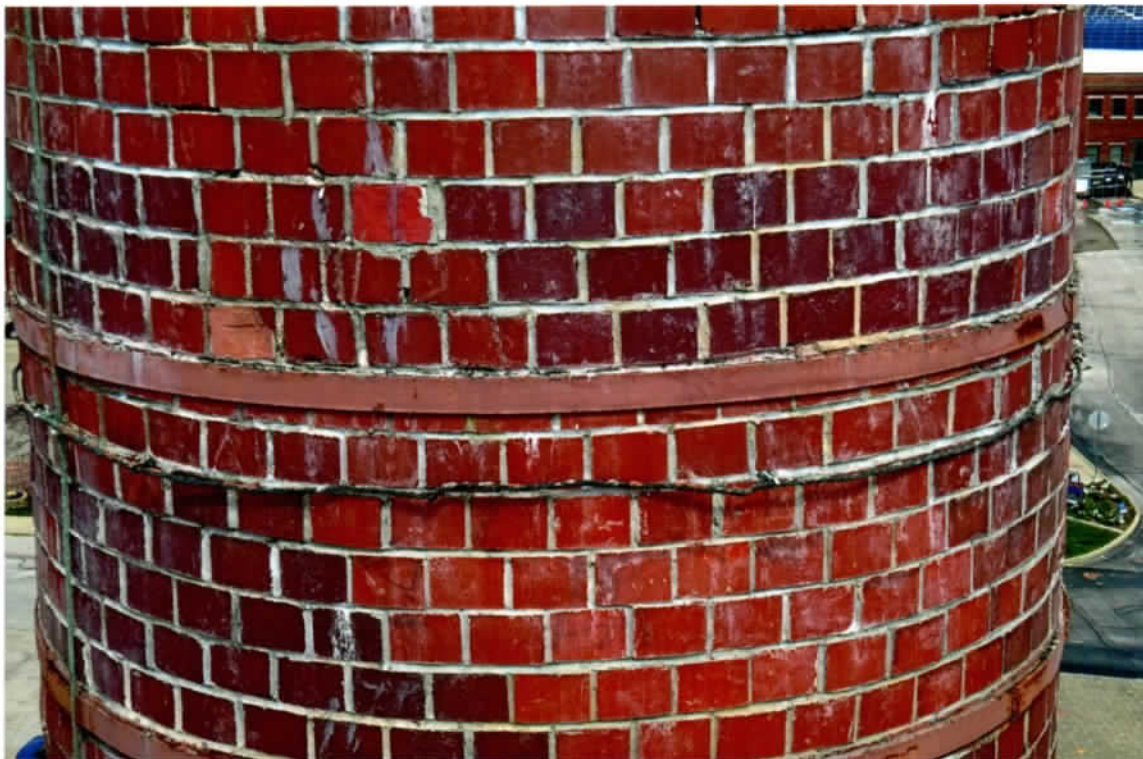
Photo 41. Fair exterior chimney of the south side between the 78' and 73' levels.
No spalled bricks existed in this region. All LPS cables were secure.

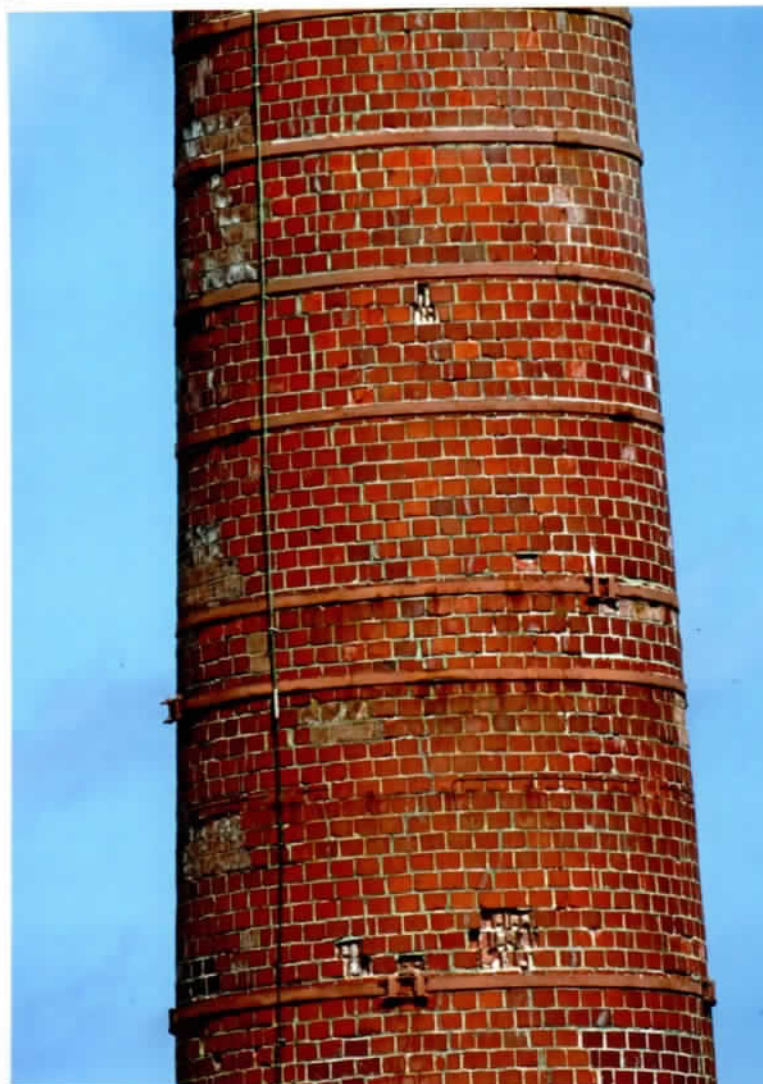
Photo 42.
Poor exterior chimney of the south side between the 60' and 40' levels. Note the numerous spalled and eroded brick faces. A band appeared to have previously dislodged from the 45' level.

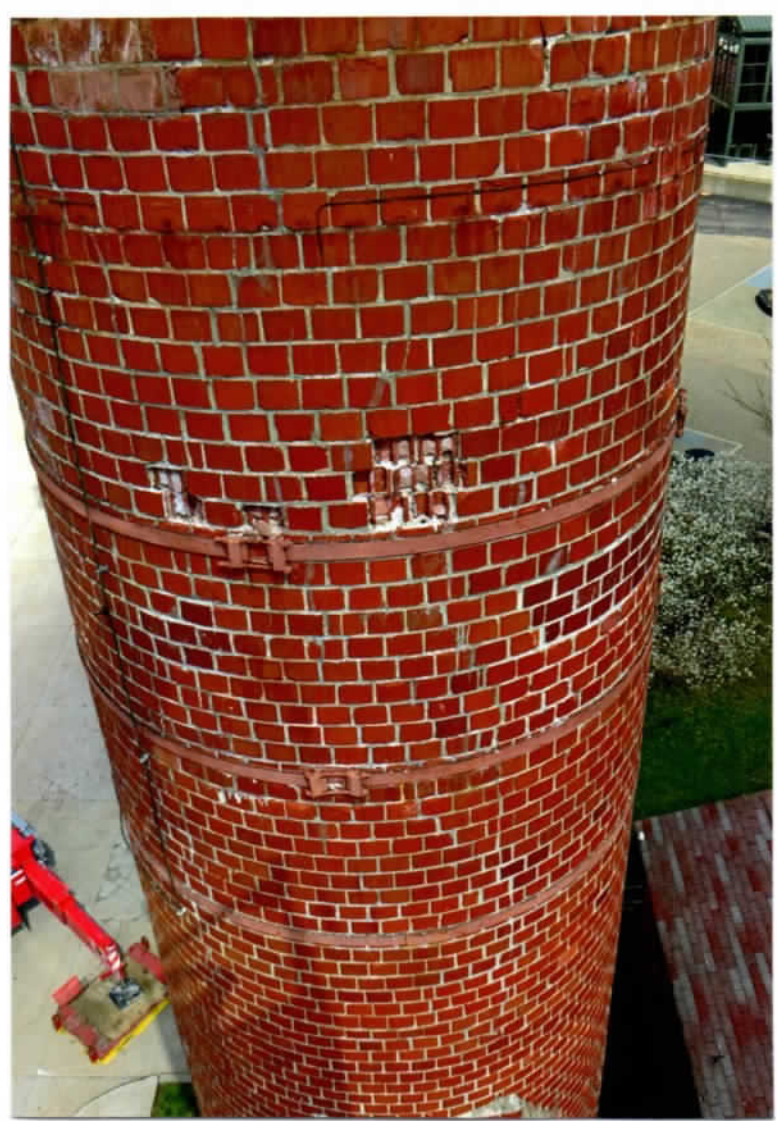
Photo 43.

Poor exterior chimney of the south side between the 47' and 25' levels. Note the numerous spalled brick faces above the 41'-11" band. A band also appeared to have previously dislodged from the 45' level.

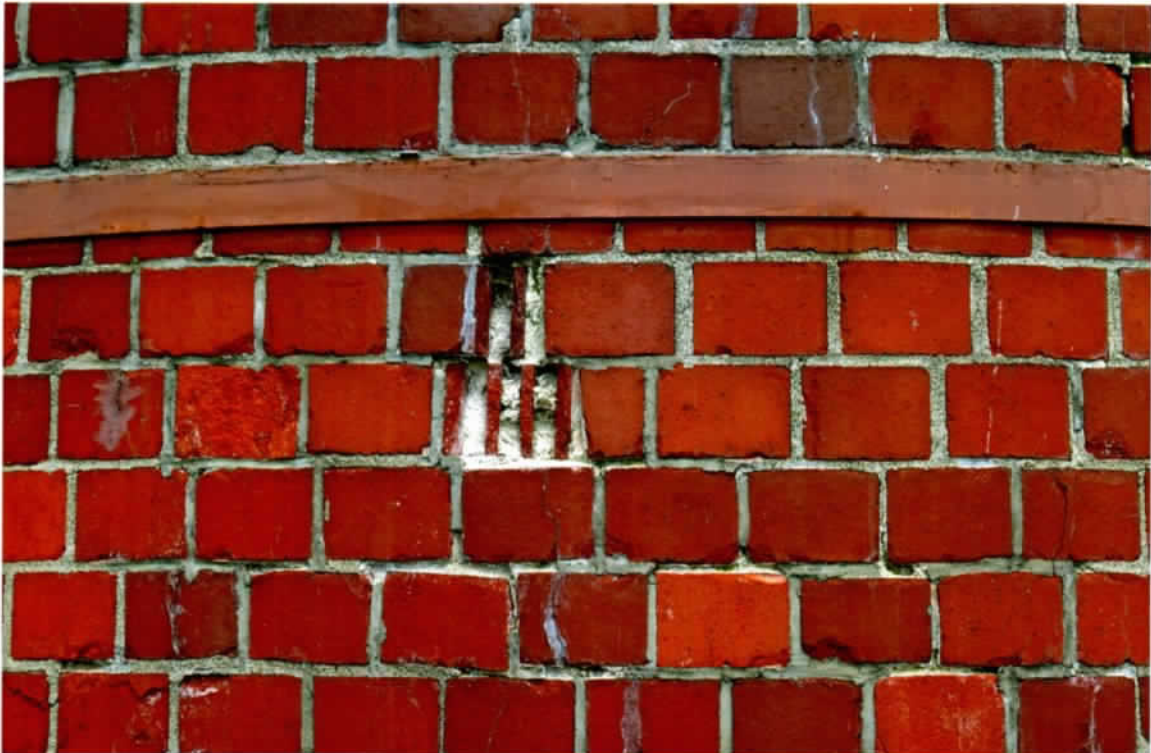
Photo 44. Close-up of the spalled brick faces below the 57'-7" level band, south side.

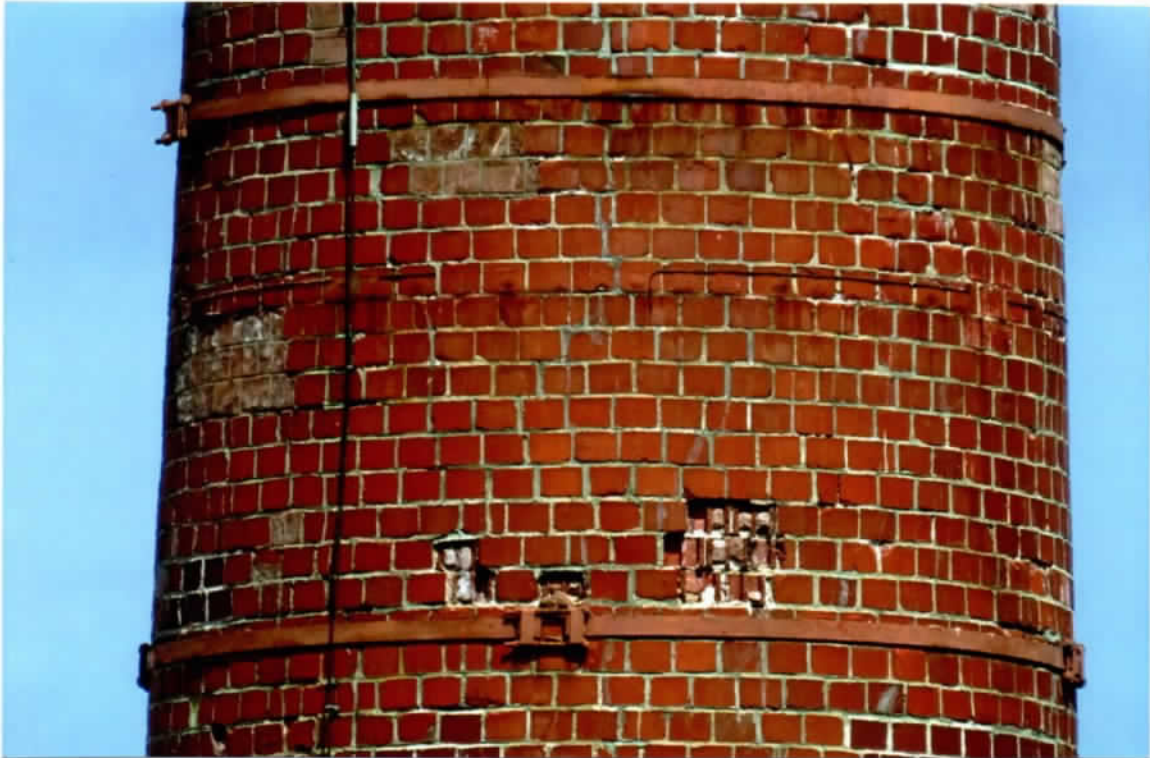
Photo 45. Poor exterior condition of the south side between the 49' and 41' levels. Note the numerous spalled and eroded brick faces.

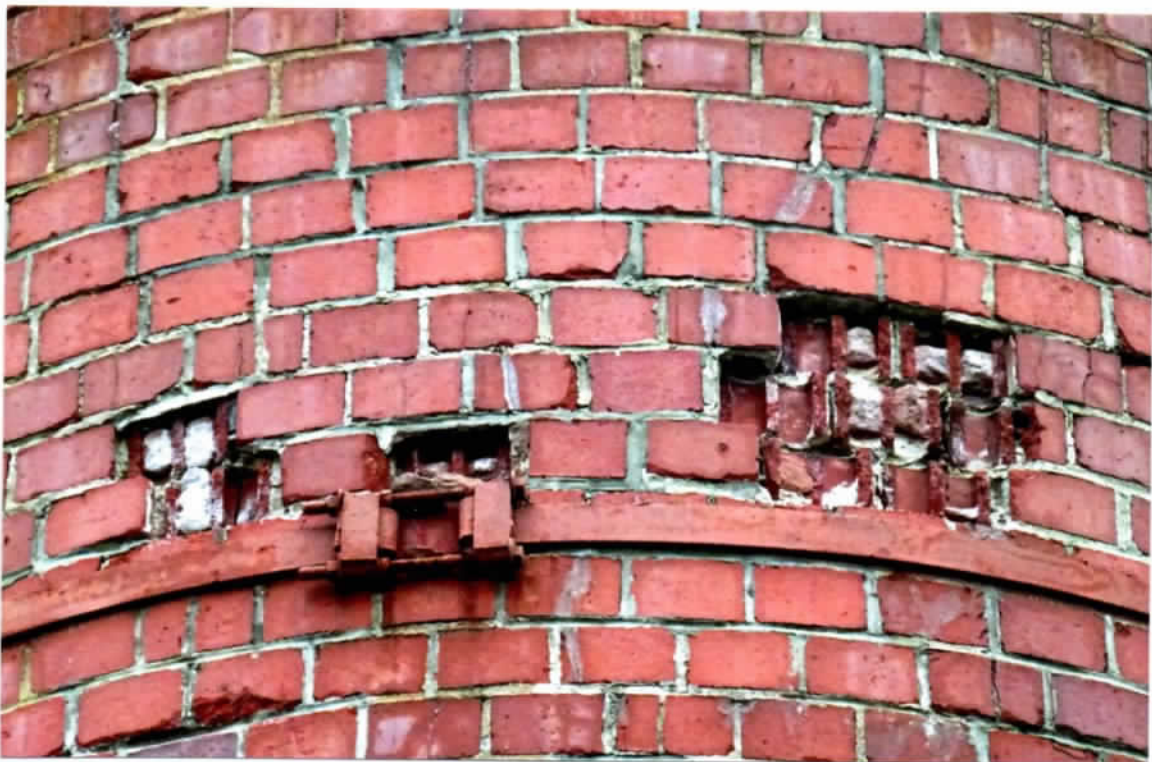
Photo 46. Close-up of the spalled brick faces above the 41'-11" level band, south side.

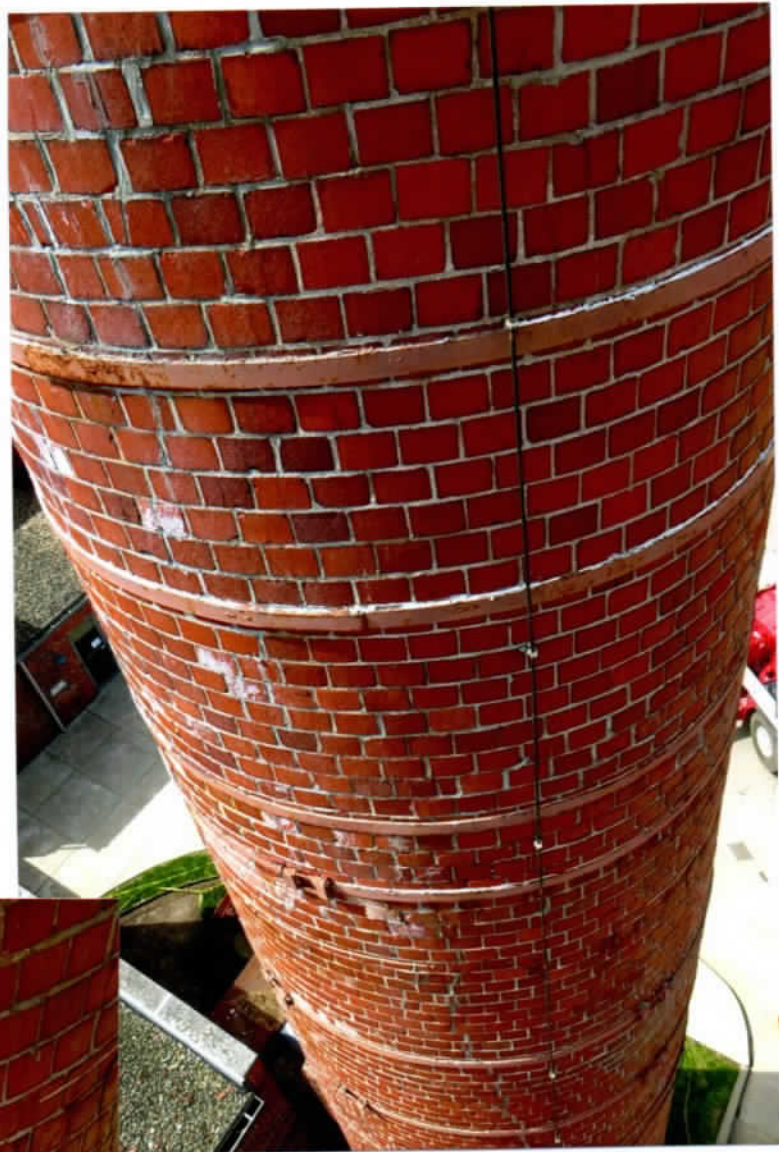
Photo 47.

Fair exterior condition of the northeast side between the 60' and 40' levels. No significant concerns were seen in this region. The download cable and bands were secure.

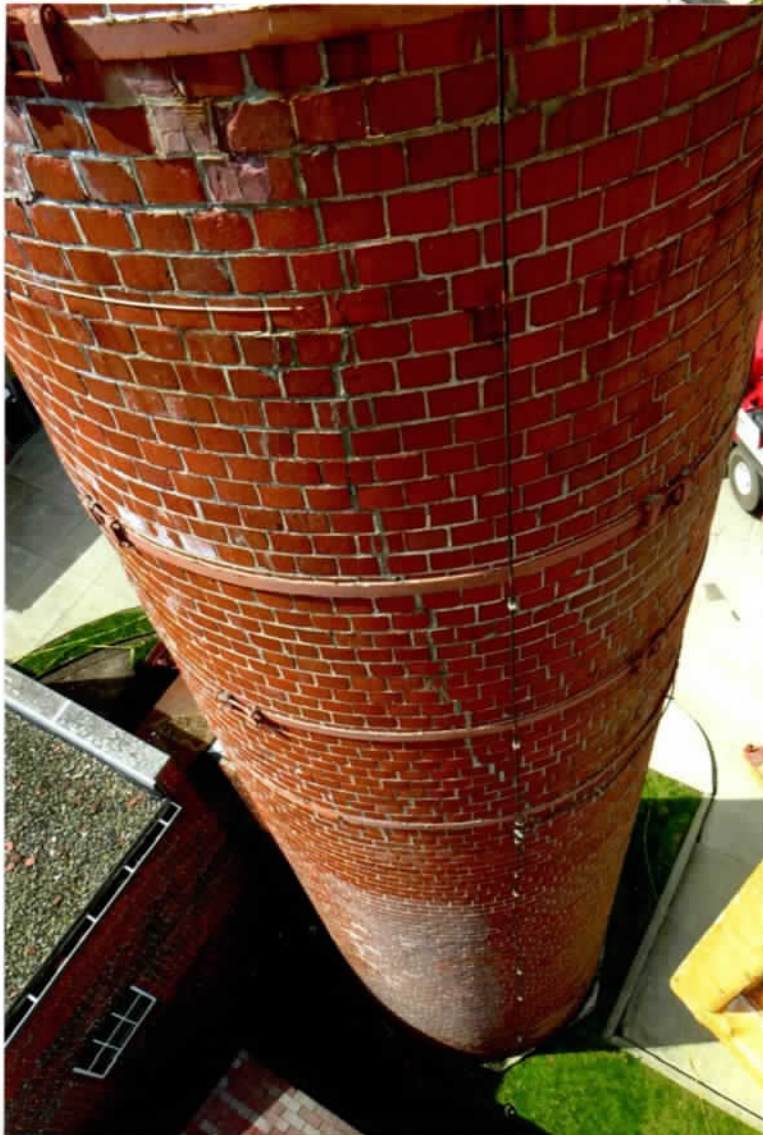
Photo 48.

Fair exterior condition of the northeast side between the 40' and 20' levels. No significant concerns were seen in this region. The download cable and bands were secure.

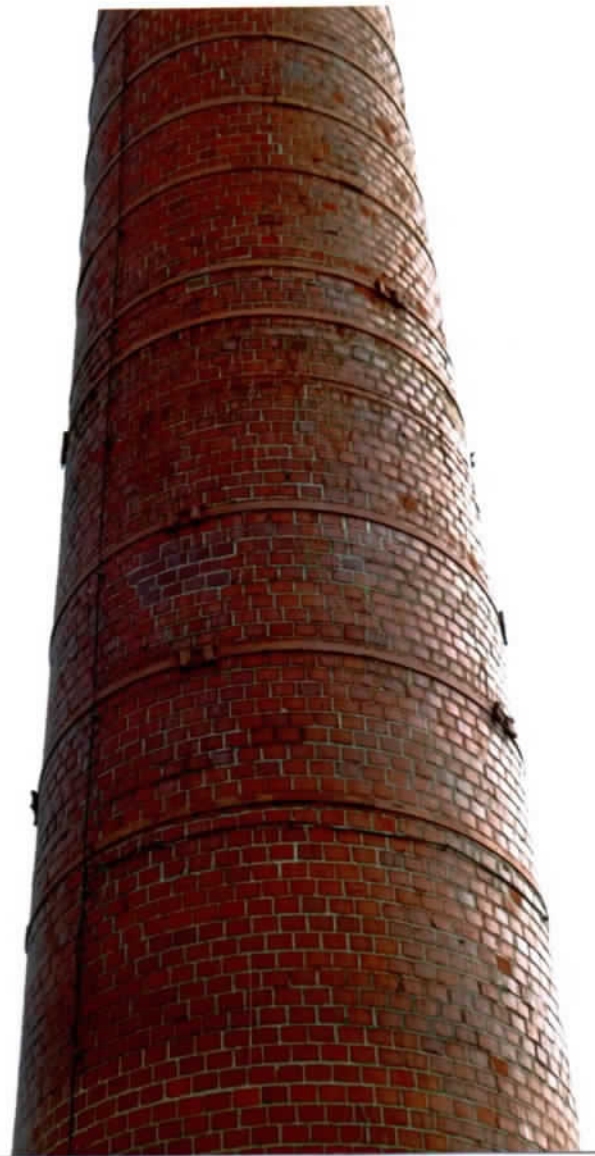
Photo 49.

Fair exterior condition of the north side between the 60' and 30' levels. No significant concerns were seen in this region. The download cables and bands were secure.

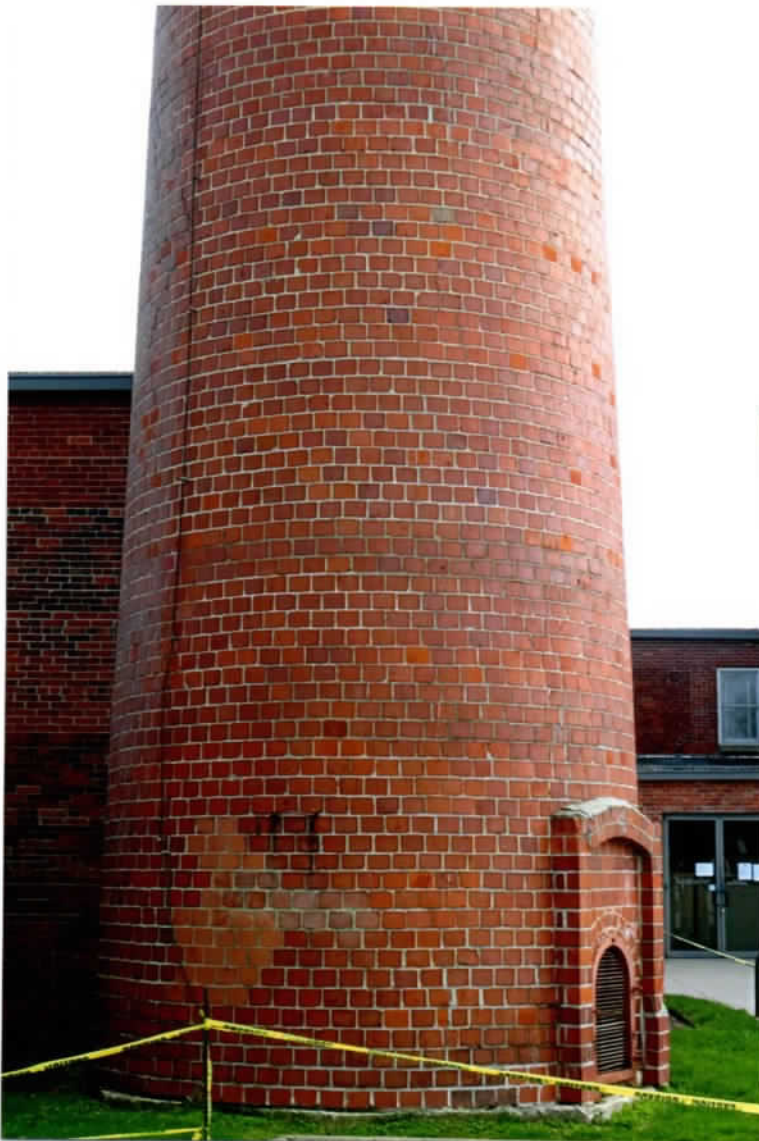
Photo 50.

Fair exterior condition of the lower 25' (north side). No significant concerns were seen in this region. The download cable appeared properly grounded at grade.
