**Bloomington Historic Preservation Commission, Zoom Virtual
Meeting, Thursday June 11, 2020, 5:00 P.M. AGENDA**

C. Johnson Creamery Stack Inspection Report

On April 6, 2020, a representative from R+P Industrial Chimney Company performed an inspection of the Johnson's Creamery chimney at 400 West 7th Street in Bloomington, Indiana. The purpose of the inspection was to examine the condition of the chimney and determine if any immediate maintenance work was required to bring it up to sound capacity. The chimney possessed a noticeable lean of the upper elevations and had not been thoroughly inspected for several years.

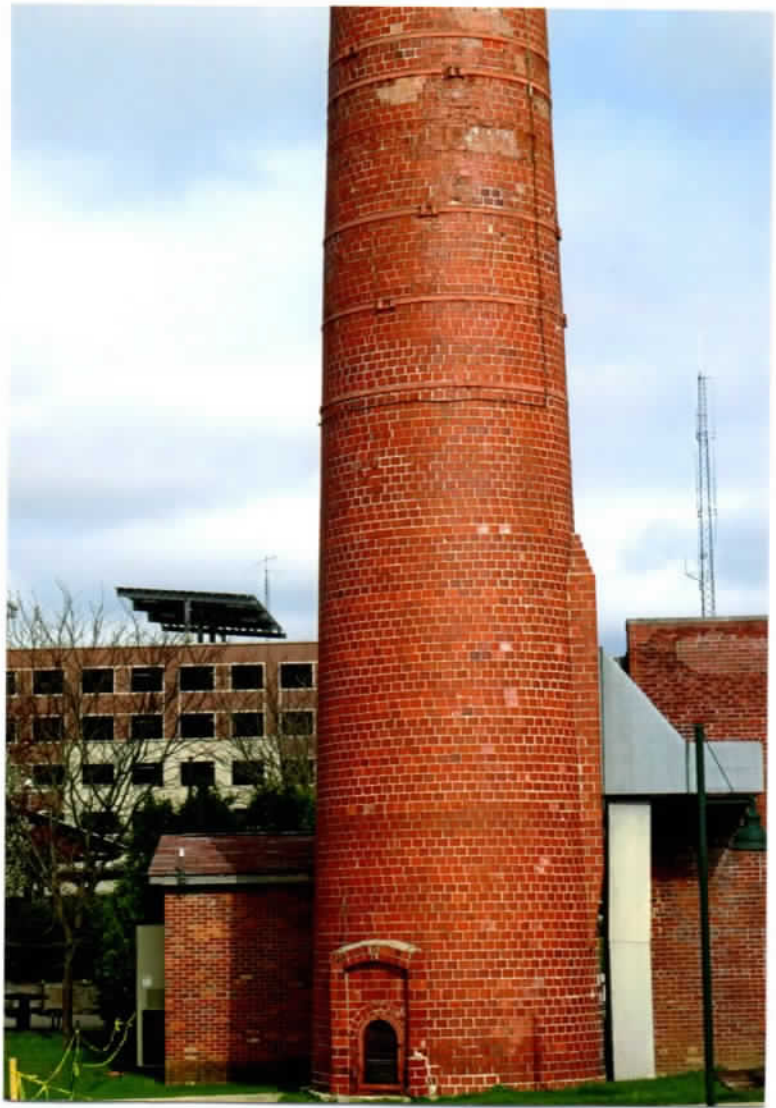
Photo 51.

Fair exterior condition of the lower 50' (west side). A few local areas of eroded bricks and deteriorated mortar existed, but no areas warranted immediate attention. The downlead cable and bands were secure.

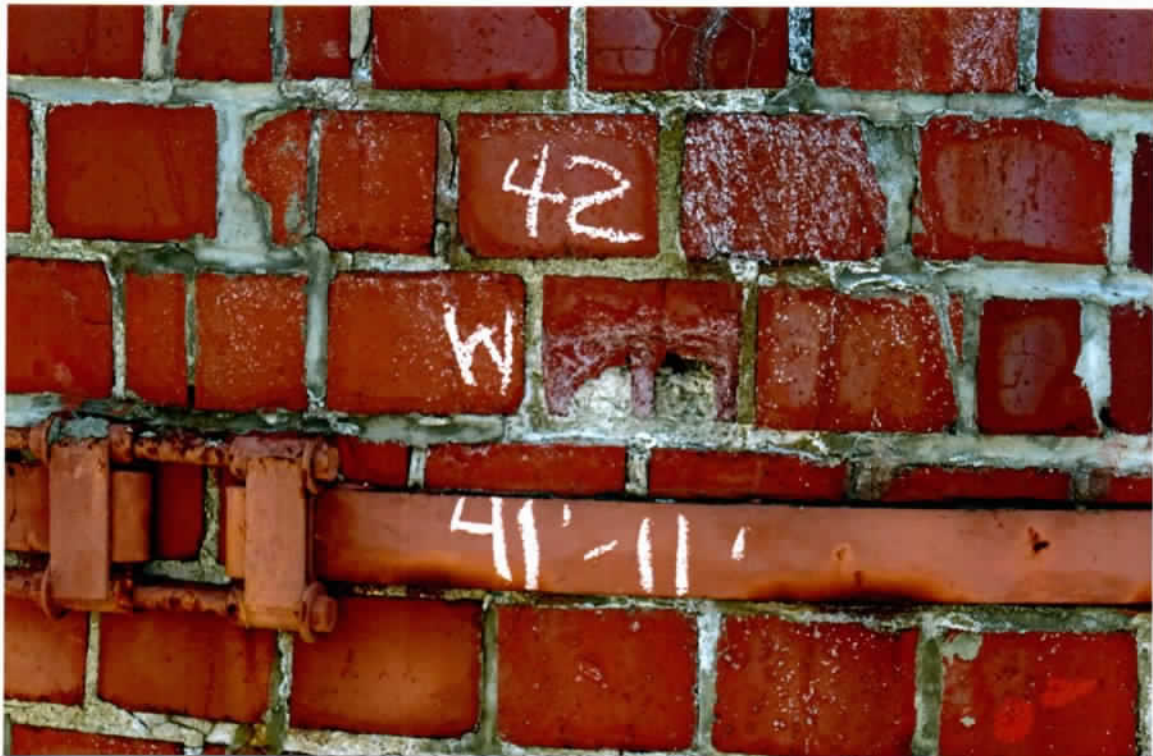
Photo 52. Close-up of the spalled brick face above the 41'-11" level band, west side.

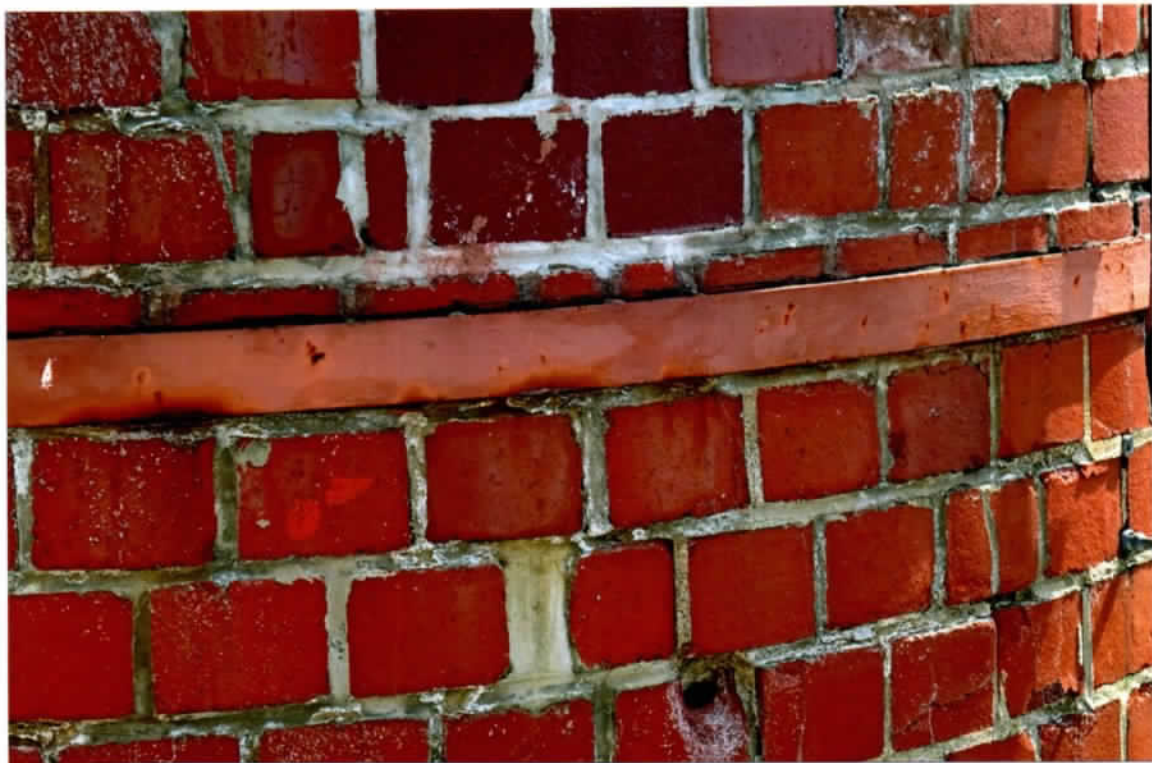
Photo 53. Close-up of the spalled brick face below the 41'-11" level band, west side.

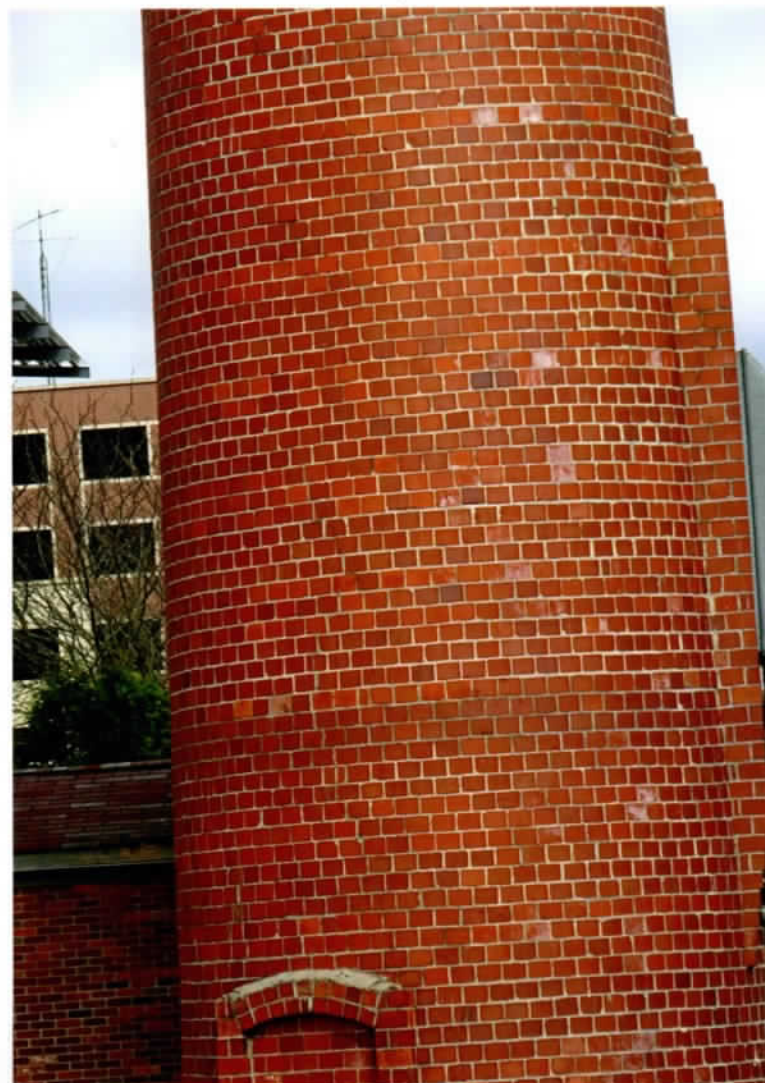
Photo 54.
Overall good condition of the west side
between the 30' and 5' levels. No areas of
concern were identified.

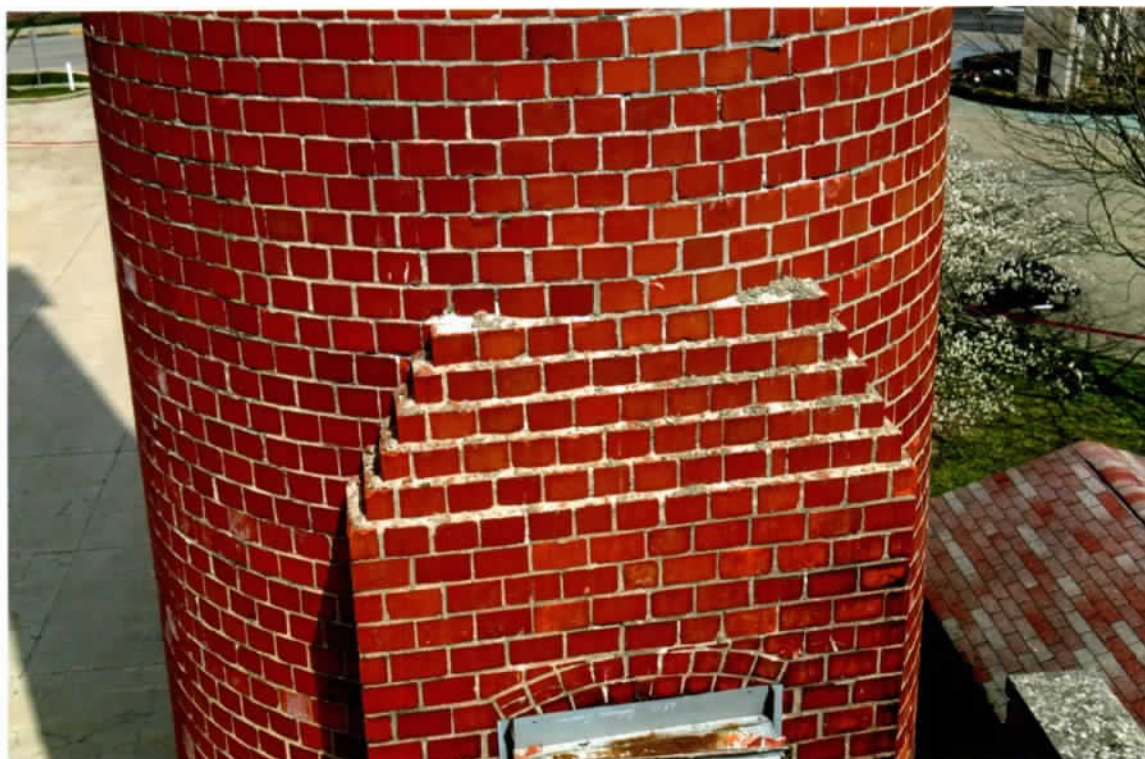
Photo 55. Good condition of the corbelled courses above the extended wall surrounding the original breeching duct opening (south side between the 30' and 20' levels).

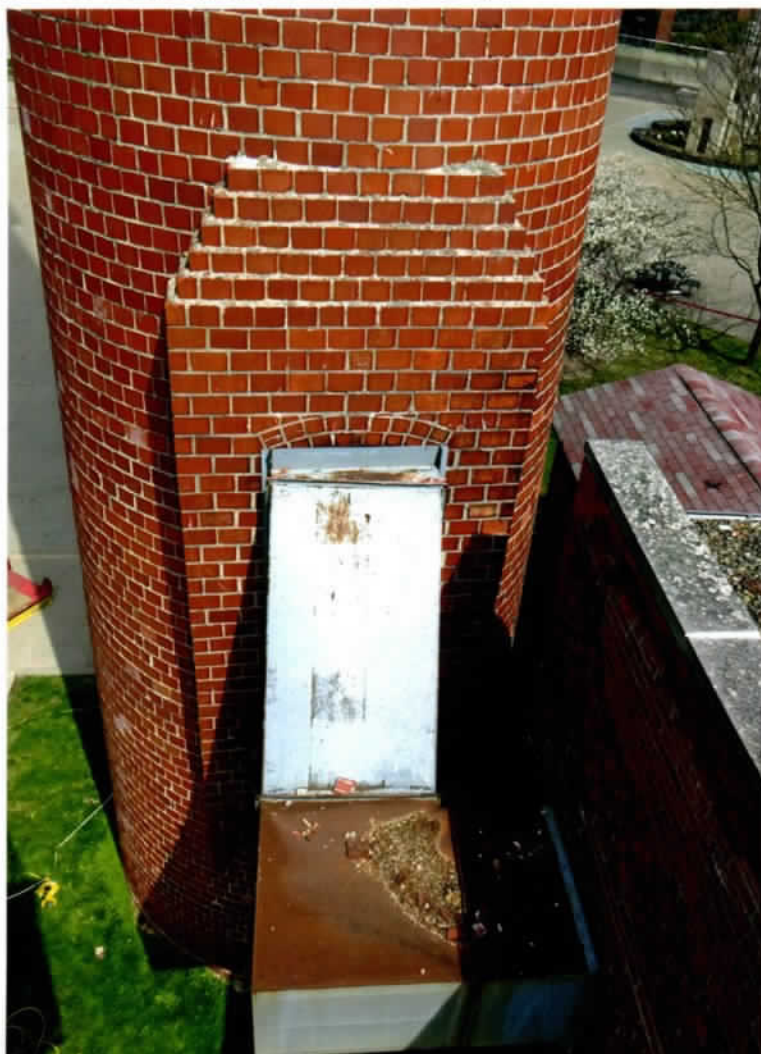
Photo 56.
Good condition of the extended wall surrounding the original breeching duct opening (lower south side). No concerns were identified along the entering duct.

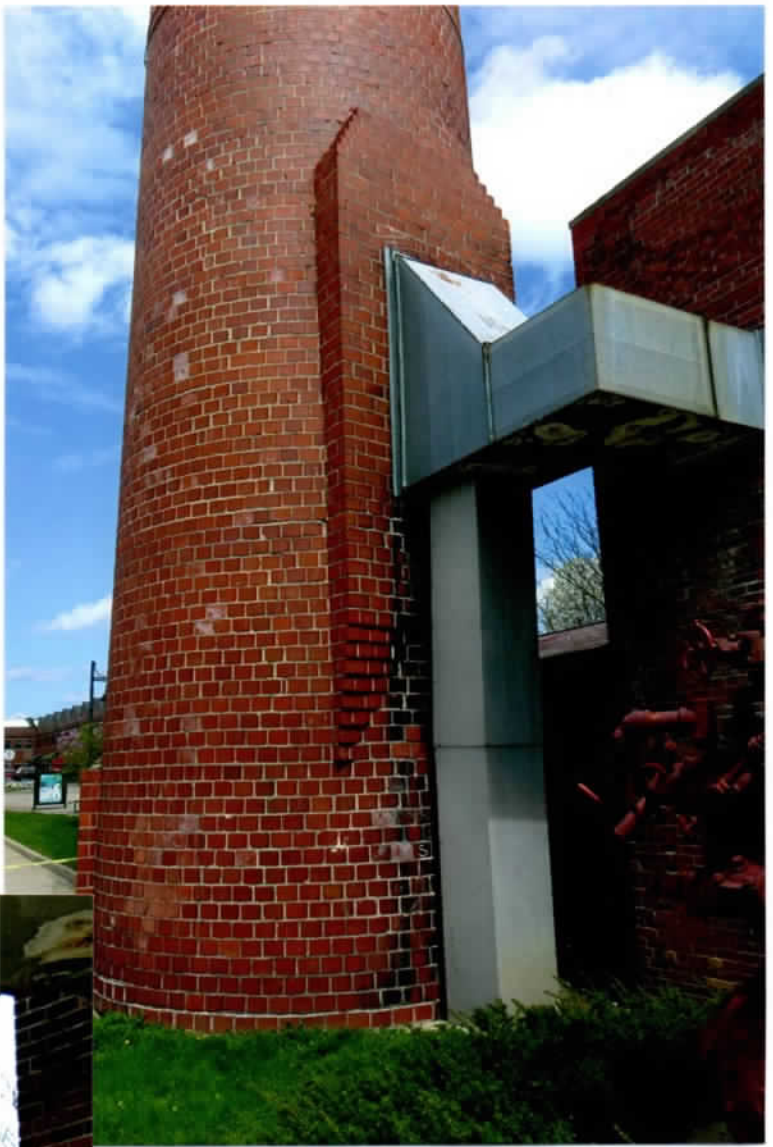
Photo 57.

Good condition of the extended wall surrounding the original breeching duct opening (lower south side). No concerns were identified along the entering horizontal duct or vertical shaft containing coaxial cables servicing the cellular antenna.

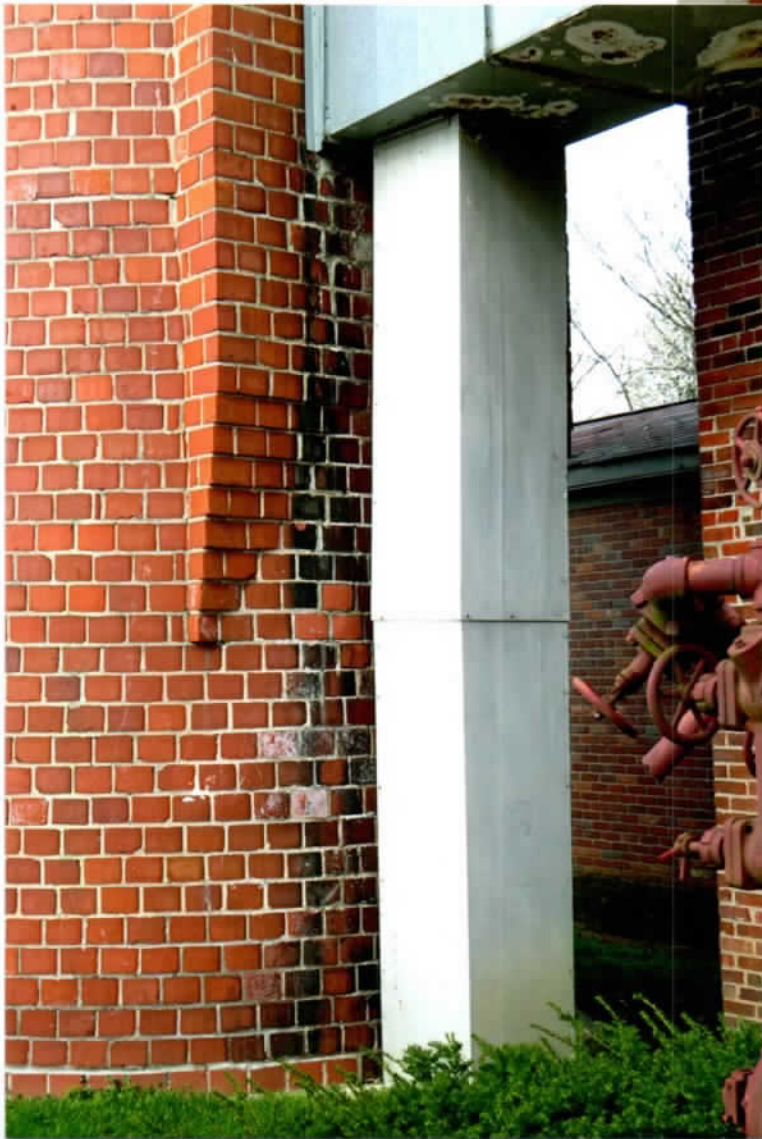
Photo 58.

Good condition of the $\pm 2'$ square vertical enclosure containing coaxial cables servicing the cellular antenna. Note only staining on the brick chimney from past leakage at the duct sill.

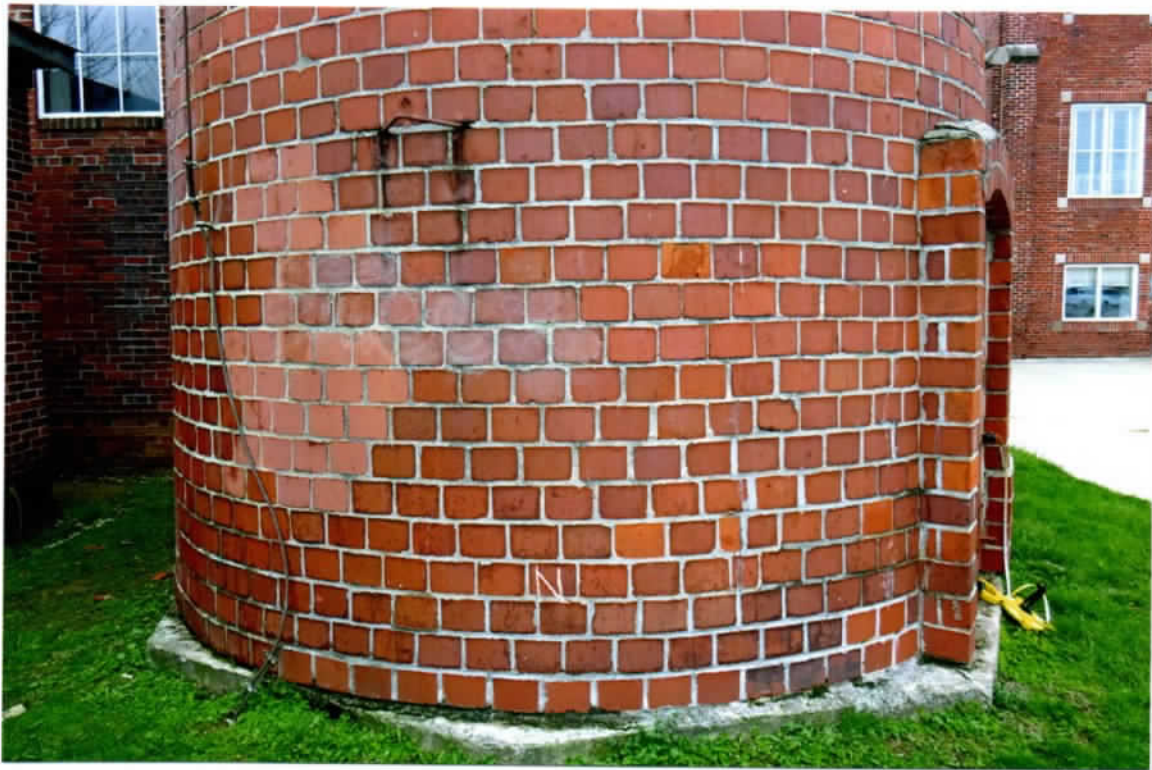
Photo 59. Good exterior condition of the lower north side at grade. The concrete foundation below the brick chimney was slightly eroded.

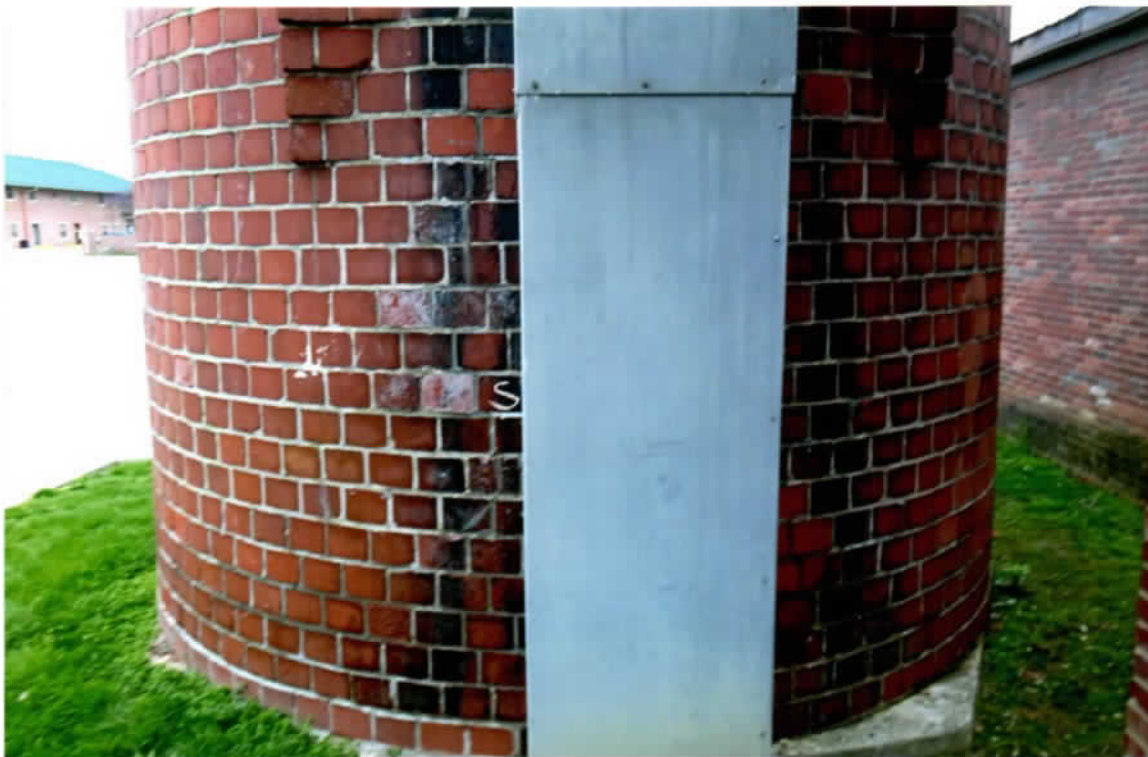
Photo 60. Good exterior condition of the lower south side at grade. Note only staining on the brick chimney from past leakage at the duct sill.

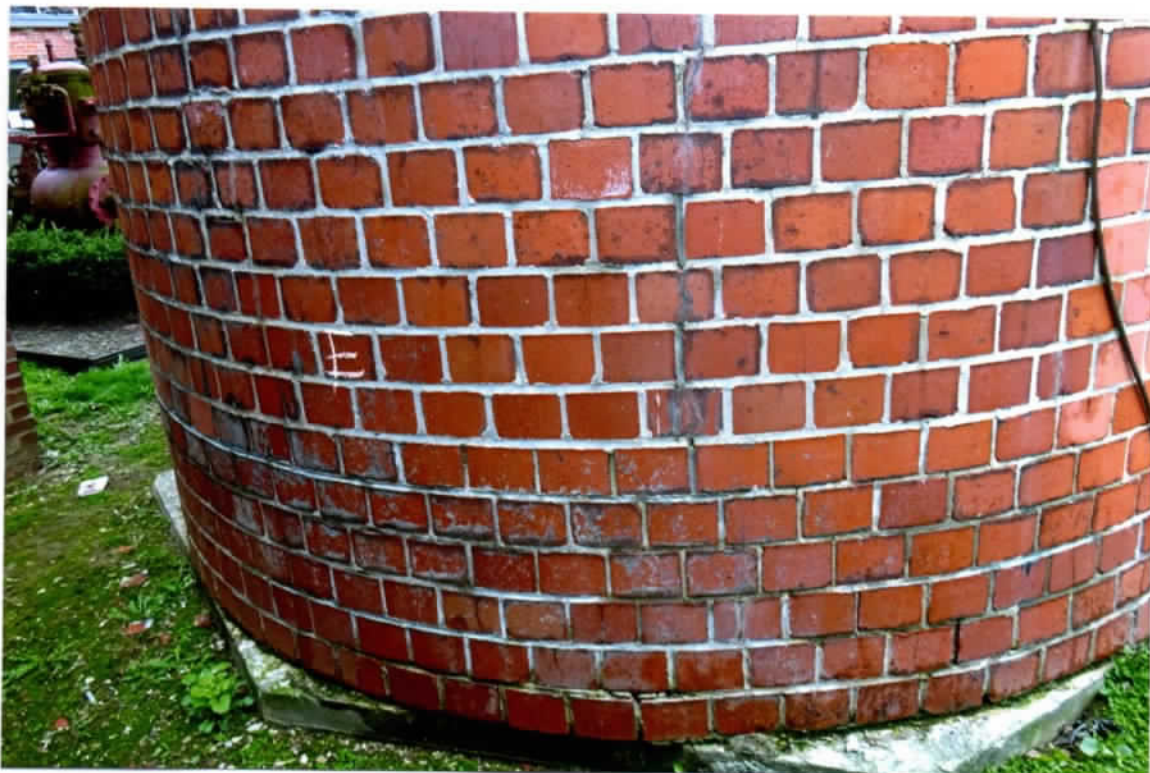
Photo 61. Good exterior condition of the lower east side at grade. The brick chimney overhung the concrete foundation by several inches in this region.

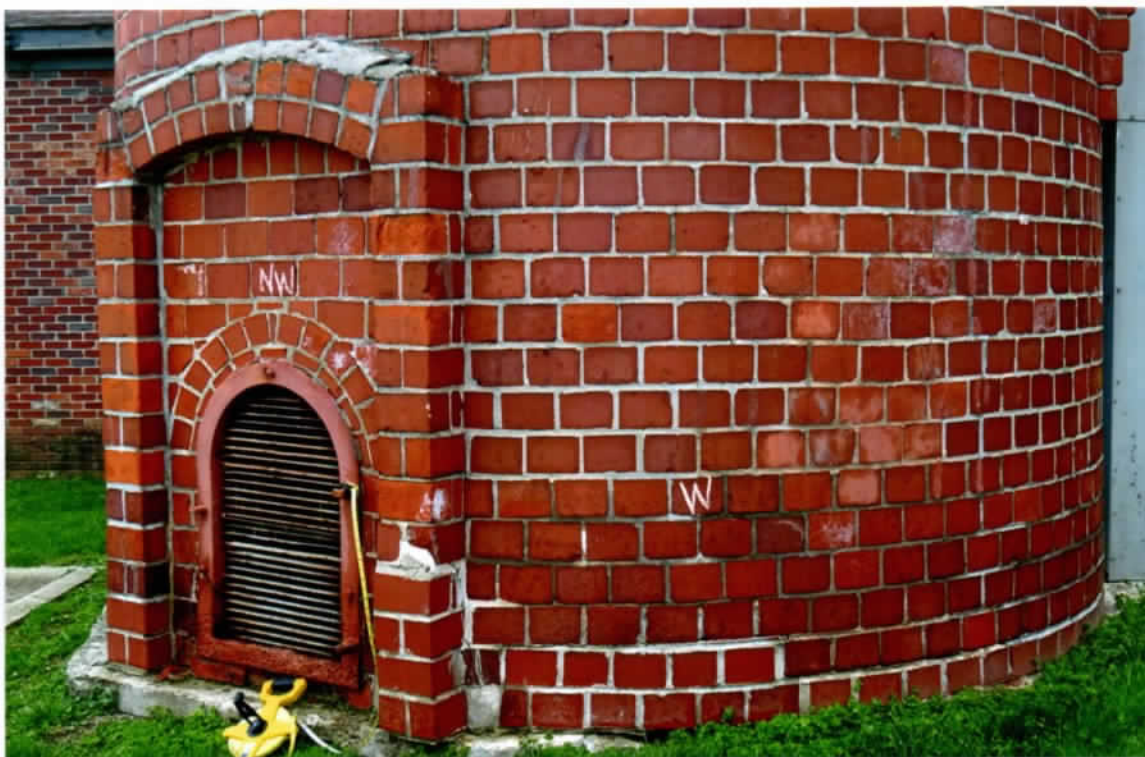
Photo 62. Good exterior condition of the lower west side at grade. The concrete foundation below the brick chimney was slightly eroded.

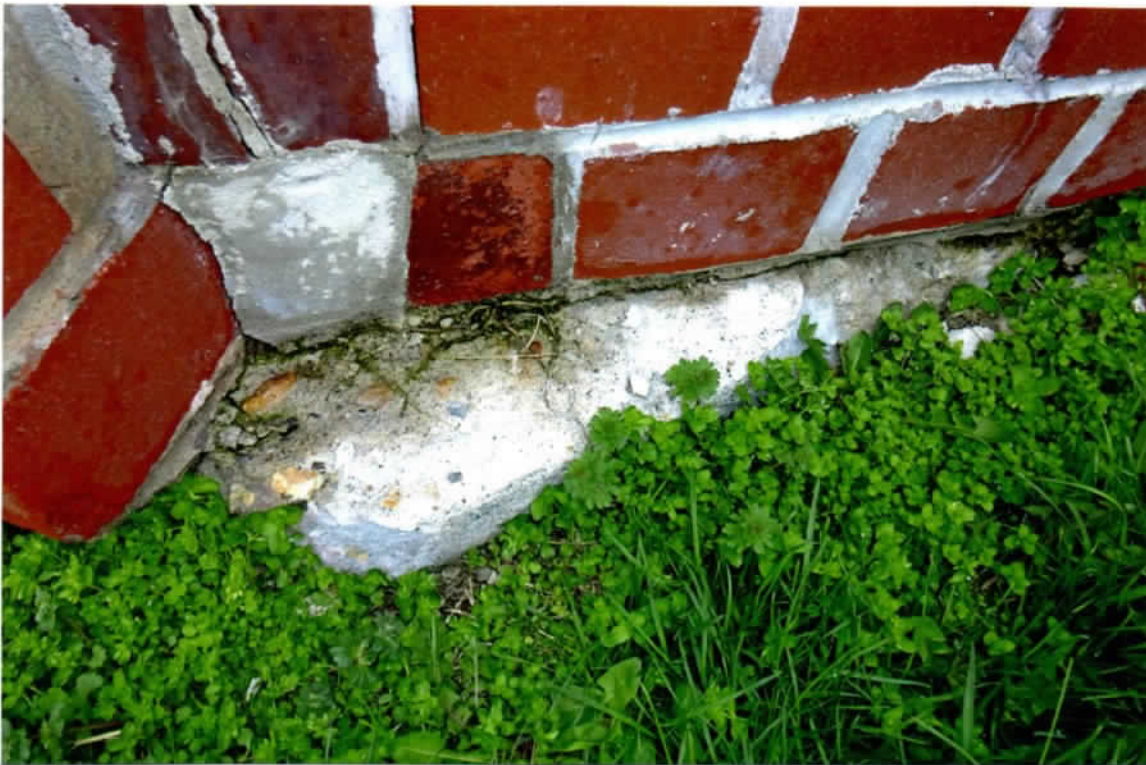
Upper surfaces of the concrete foundation were eroded on the west and north sides. The masonry wall did not fully bear on the concrete along the east side, but the concrete in this region remained in good condition. Photos 52 – 65 show the projecting foundation.

Photo 63. Close-up of the eroded concrete along the top of the foundation (west side).

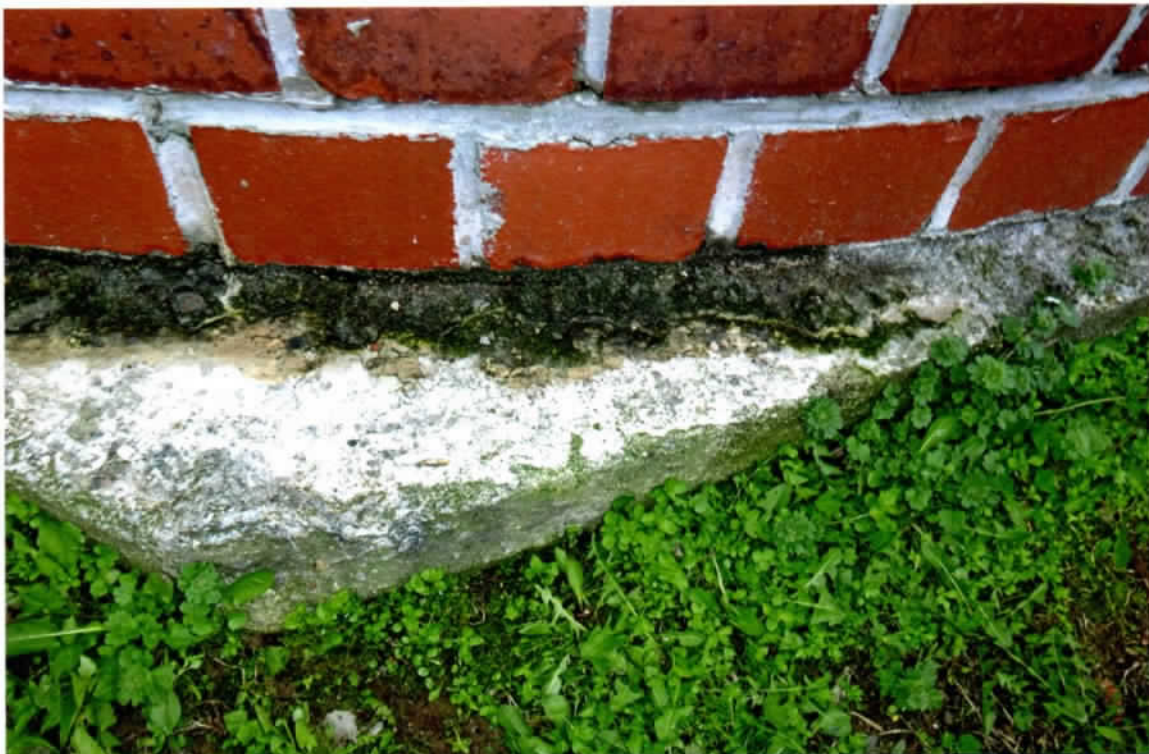
Photo 64. Close-up of the eroded concrete along the top of the foundation (north side).

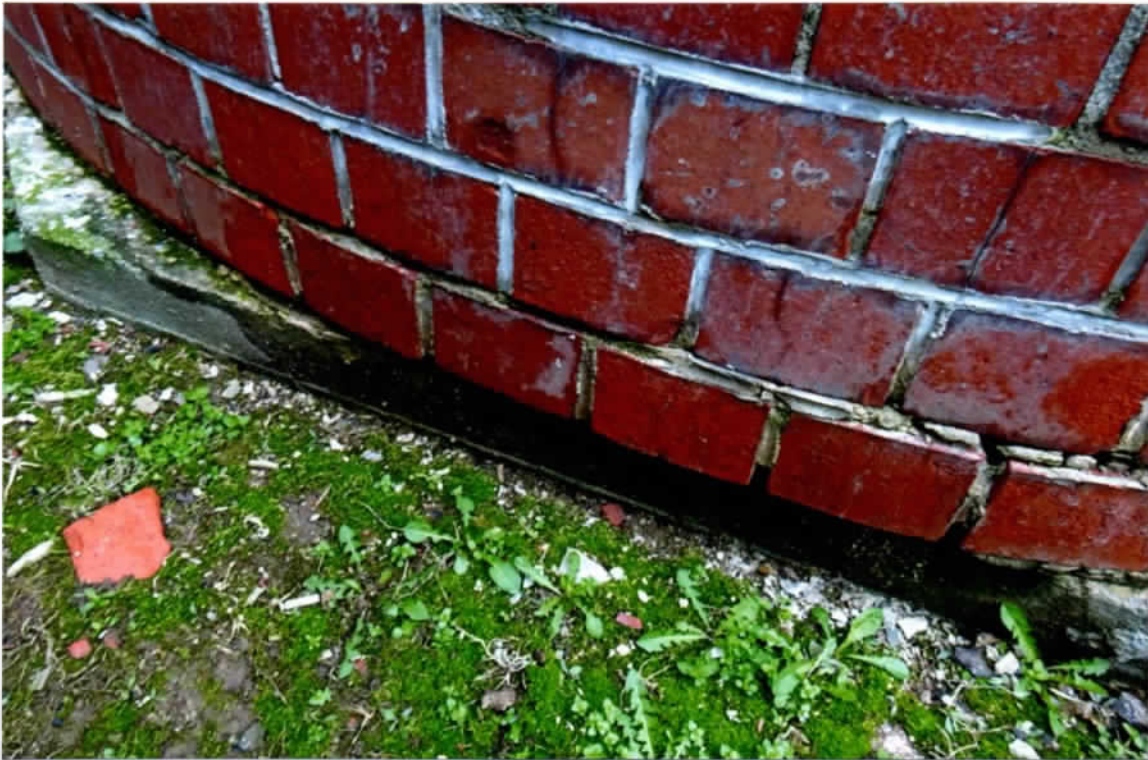
Photo 65. Close-up of the brick chimney not bearing on the concrete foundation (east side). No concerns were seen with the concrete directly below the brick wall in this region.

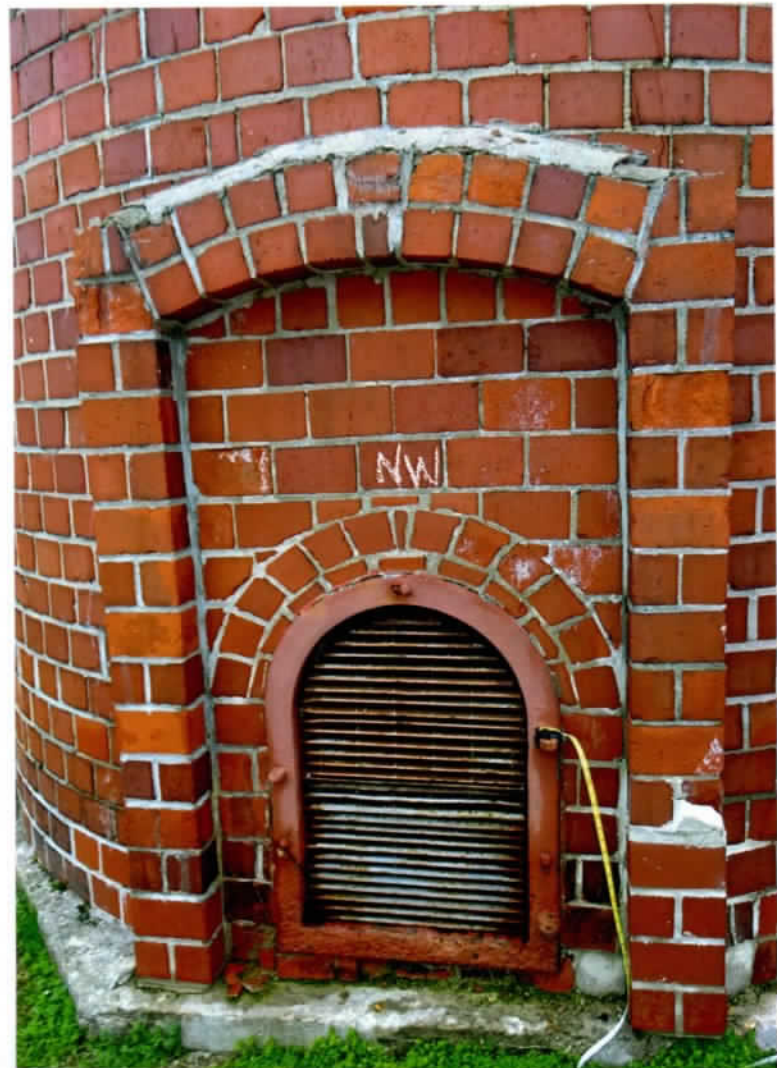
Photo 66.
Overall good condition of the extended wall and closure wall at the original construction and cleanout opening. The steel grate was secured to the original cleanout door frame.

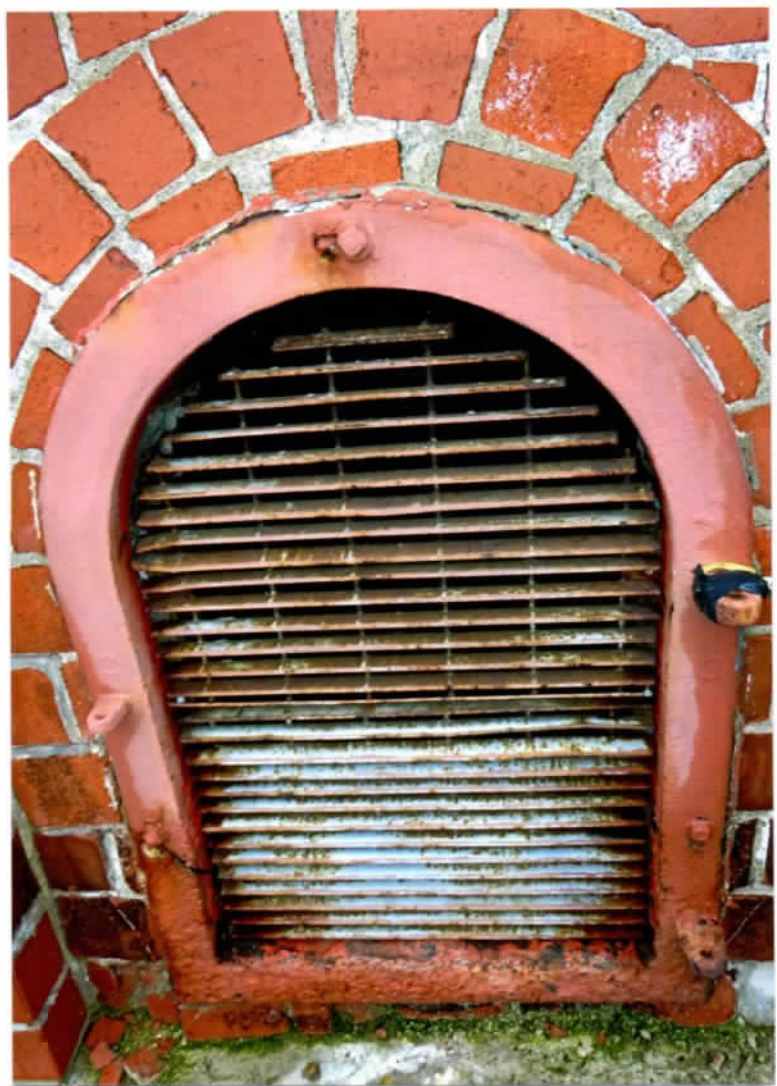
Photo 67.

The original cast iron cleanout door at the bottom of the northeast side had been replaced with a section of steel grating firmly attached to the door frame. The sill region of the frame was eroded from past leakage, but the frame was secure. The brickwork surrounding the frame filling the original construction opening was in good condition. Photos 66 – 67 show the cleanout opening and surrounding wall.

Close-up of the section of steel grating secured within original cleanout door frame (base of northwest side). Brick faces along the sill of the frame were eroded.

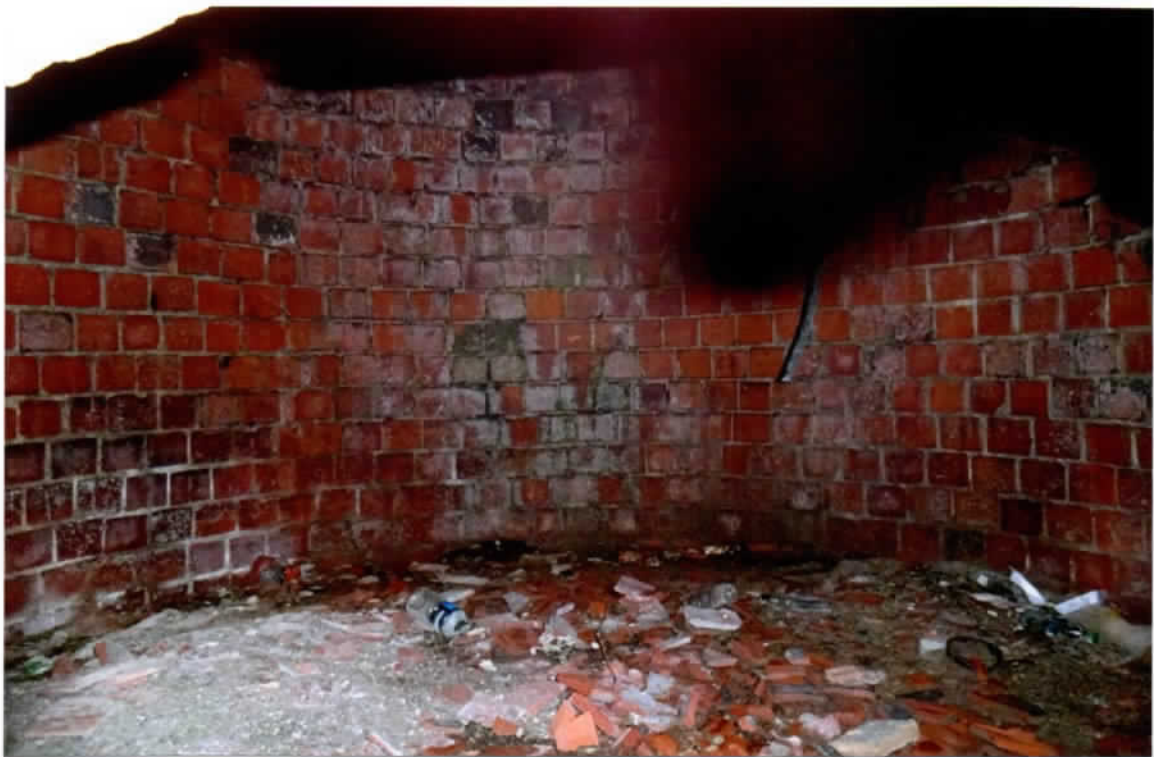
Photo 68. Fair interior condition of the lower brick wall (east and southeast sides). No immediate concerns were seen throughout the lower elevations of the outer wall.

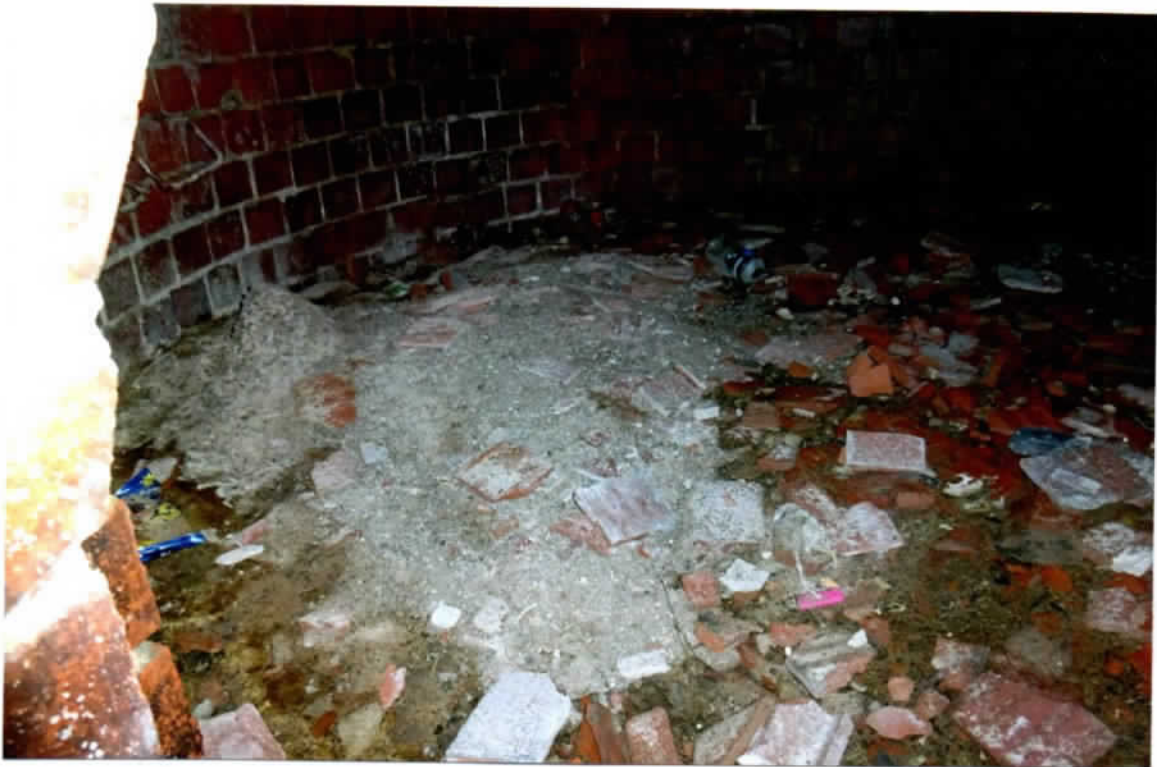
Photo 69. Approximately 8" of debris and brick faces in the chimney base near grade (north side).
Note the numerous brick faces in the debris.
