PUBLIC HEARING

BOARD OF HOUSING QUALITY APPEALS

JUNE 17, 2025 4:15 P.M.

**Woodland Springs
Exterior Stairs Buildings A through G
April 22-23, 2025**

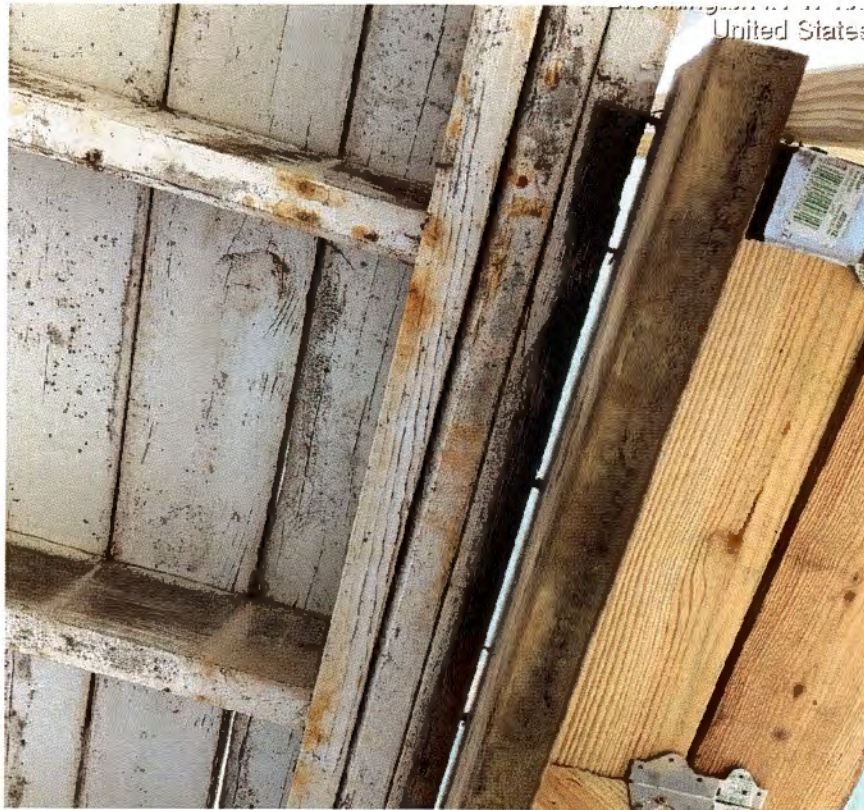
Example of stairs pulling away from upper level walkway

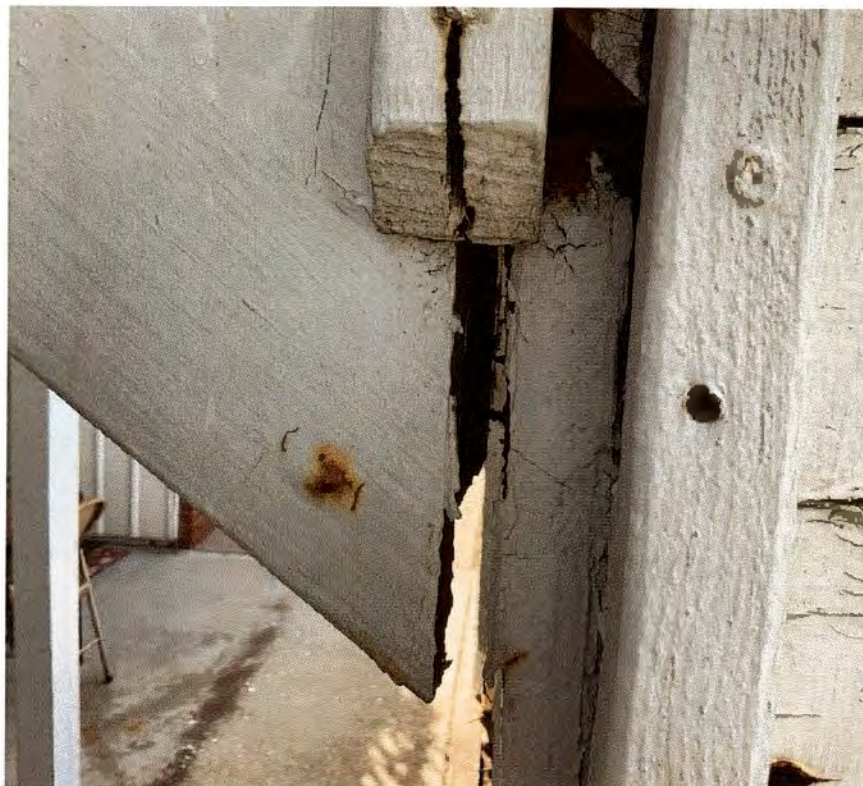
Example of stairs pulling away from upper level walkway

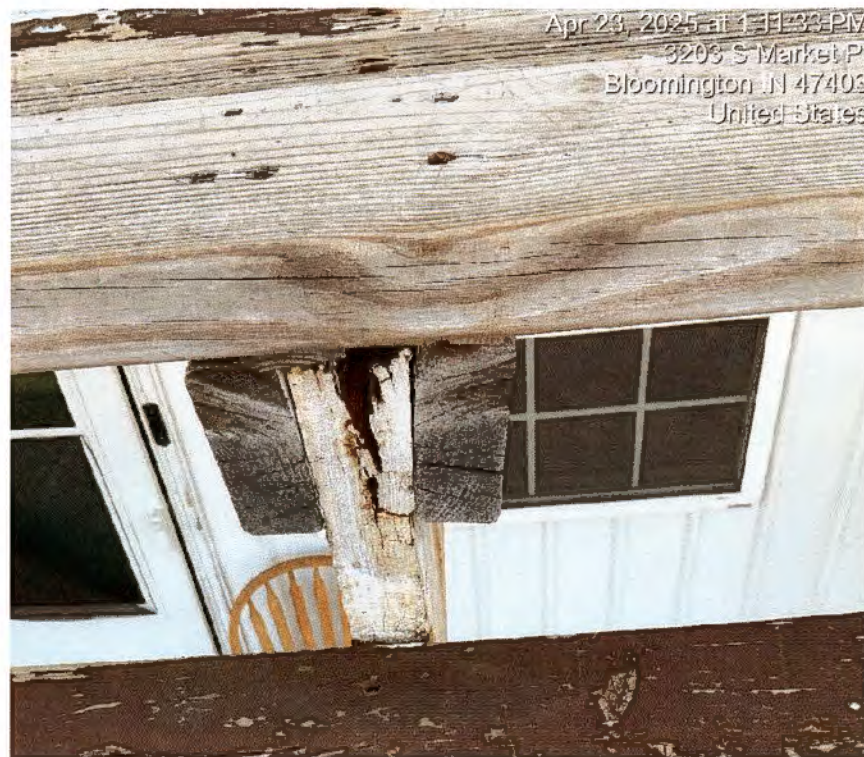
Example of deteriorated stringer

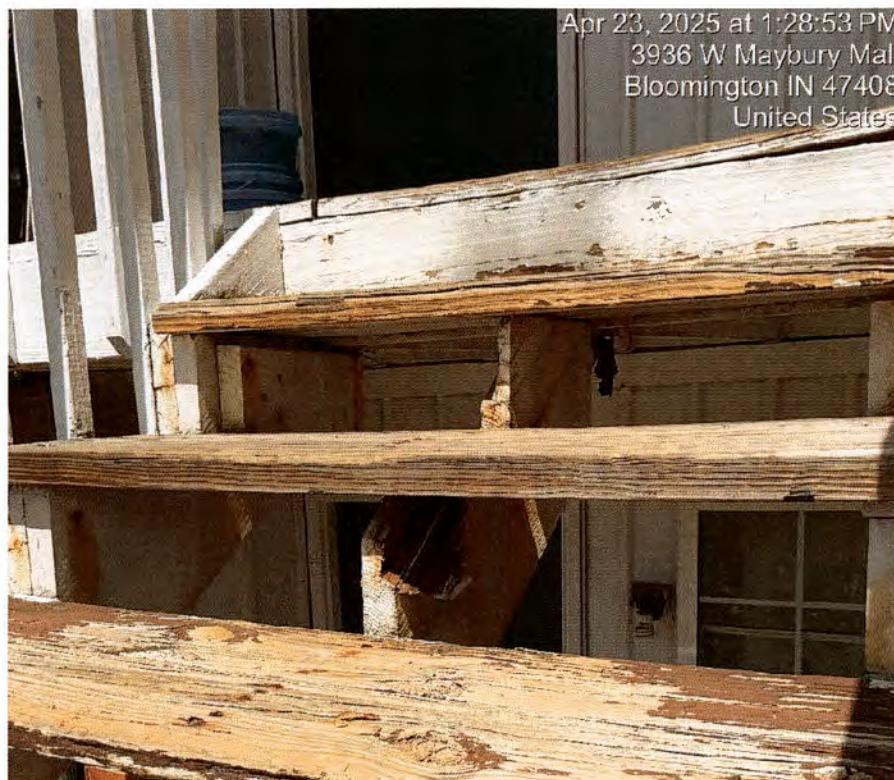
Example of deteriorated stringer

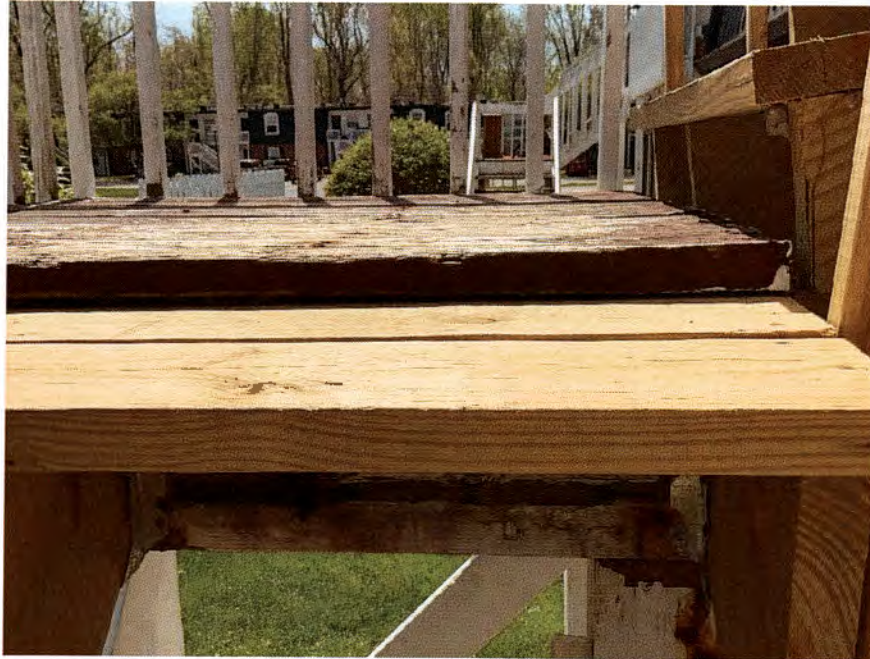
Example of trip hazard

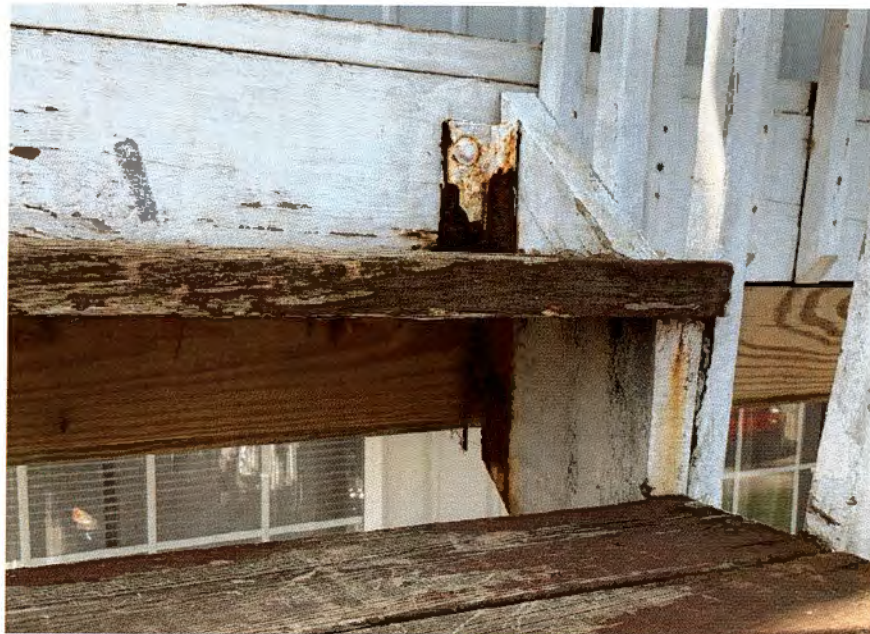
Example of deteriorated brack

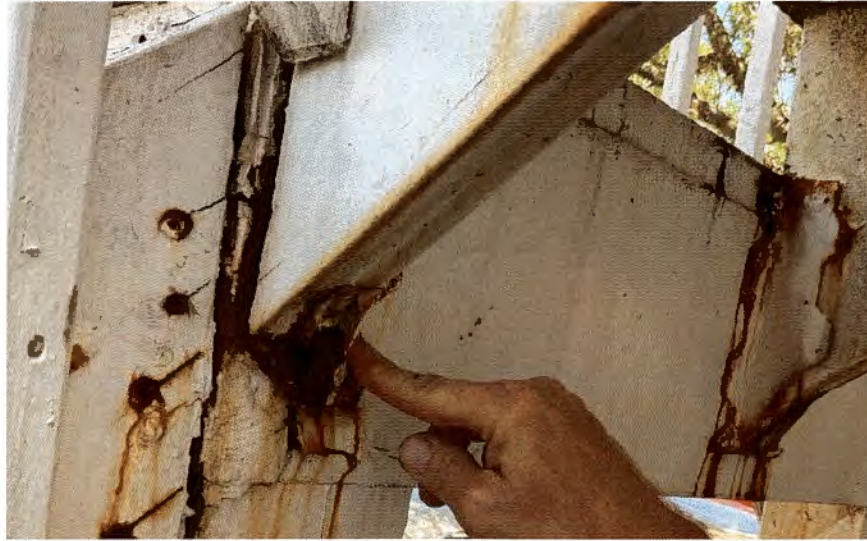
Example of deteriorated joist hanger

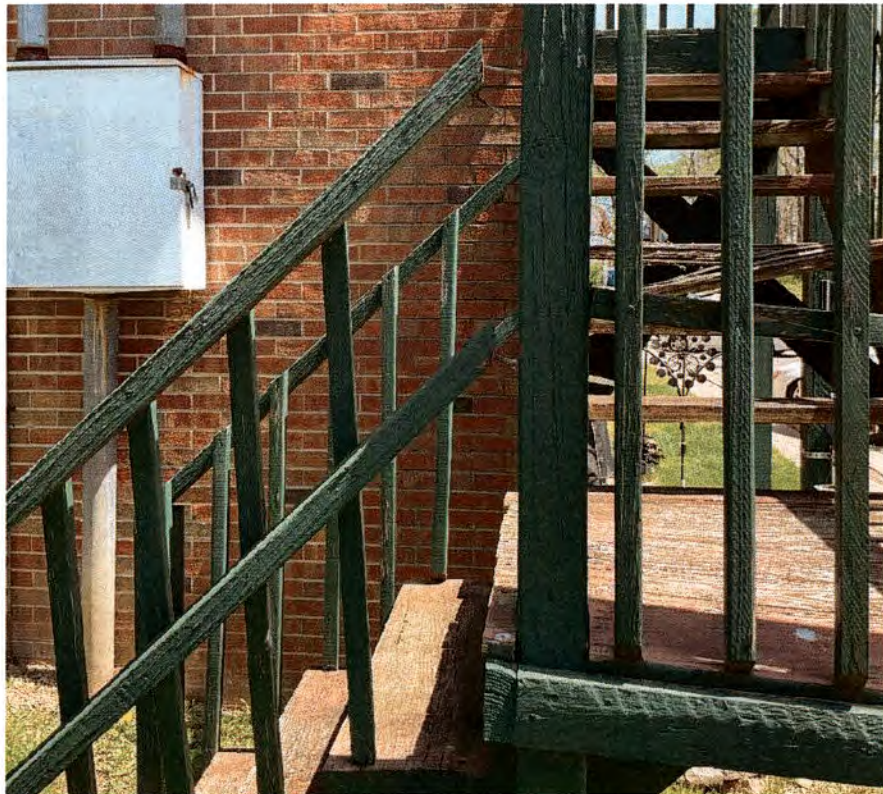
Example of loose handrail and missing spindles

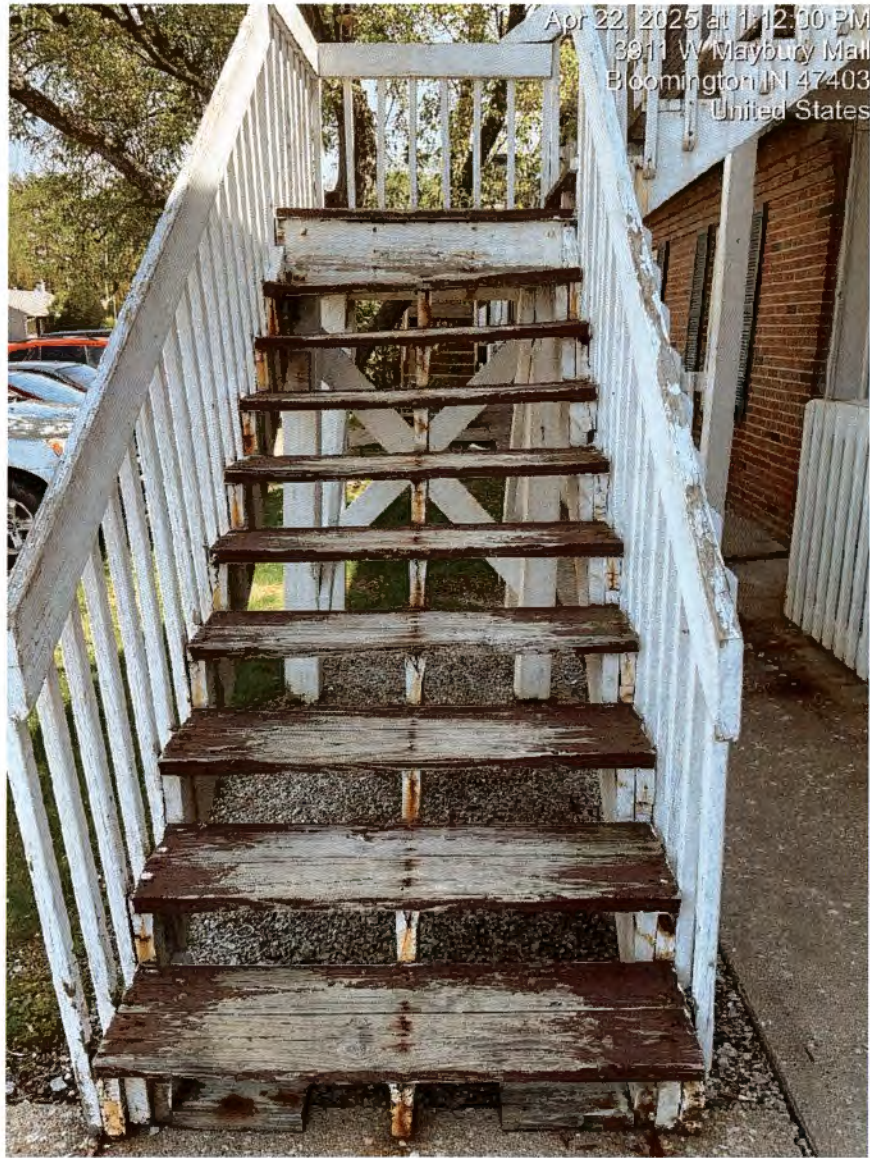
Example of leaning/listing stair

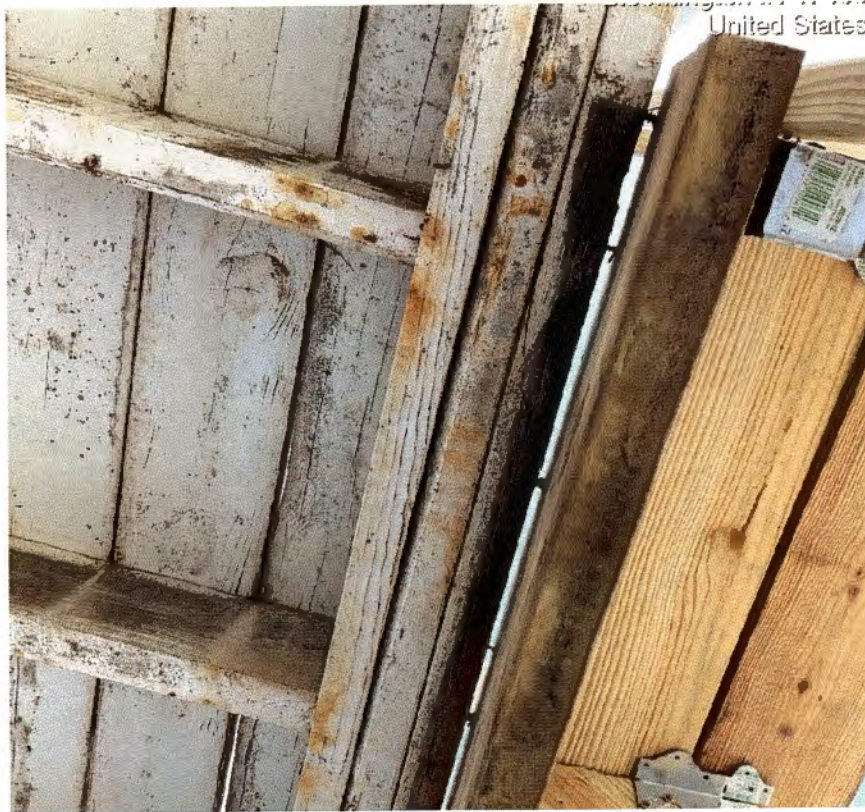
Example of stairs pulling away from upper level walkway

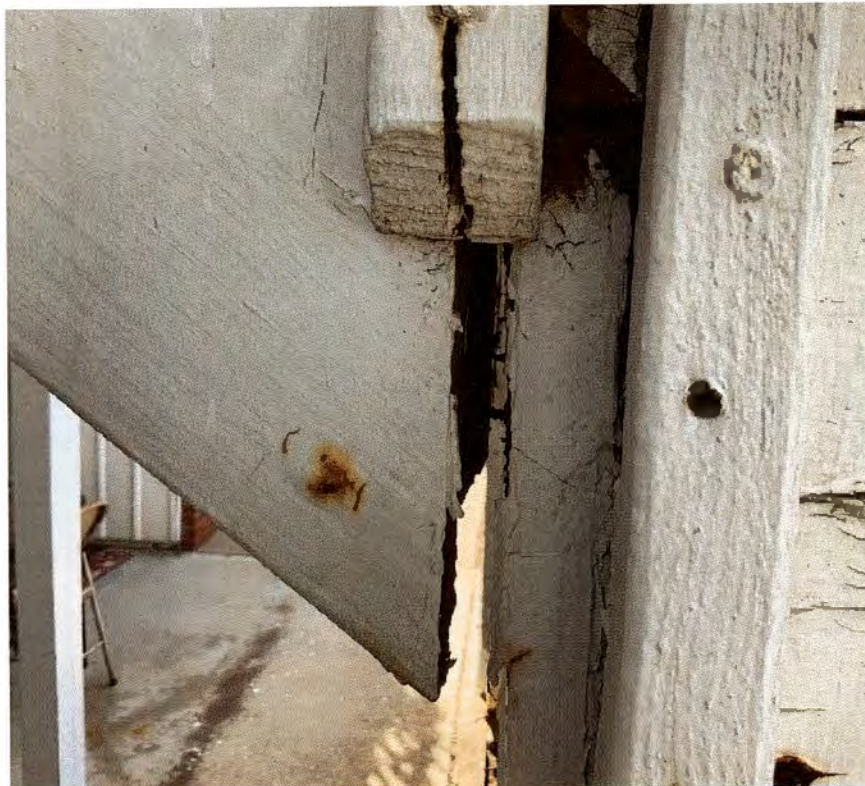
Example of stairs pulling away from upper level walkway

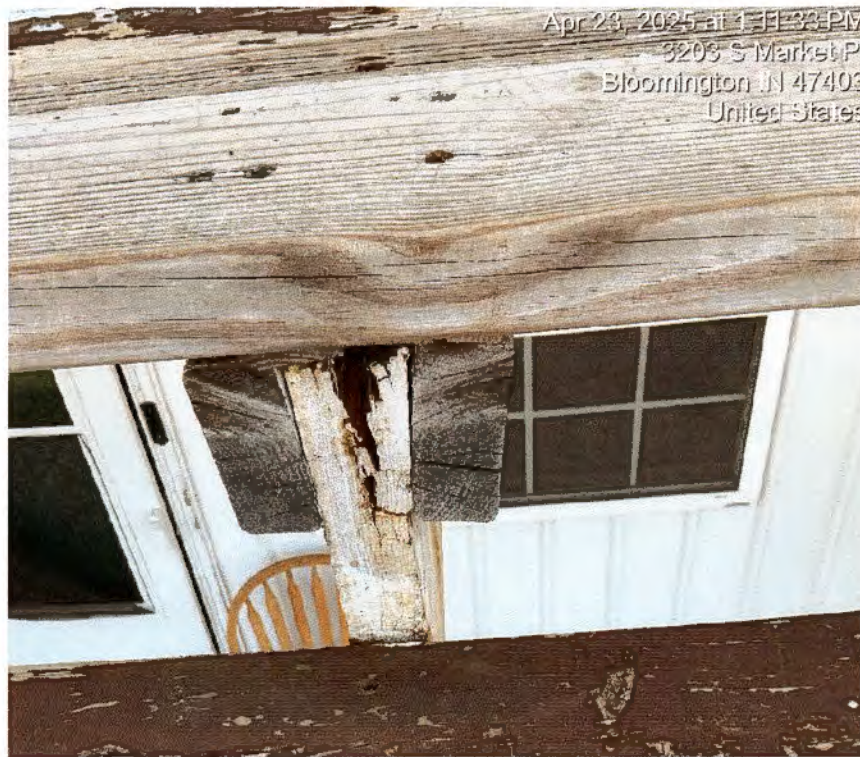
Example of deteriorated stringer

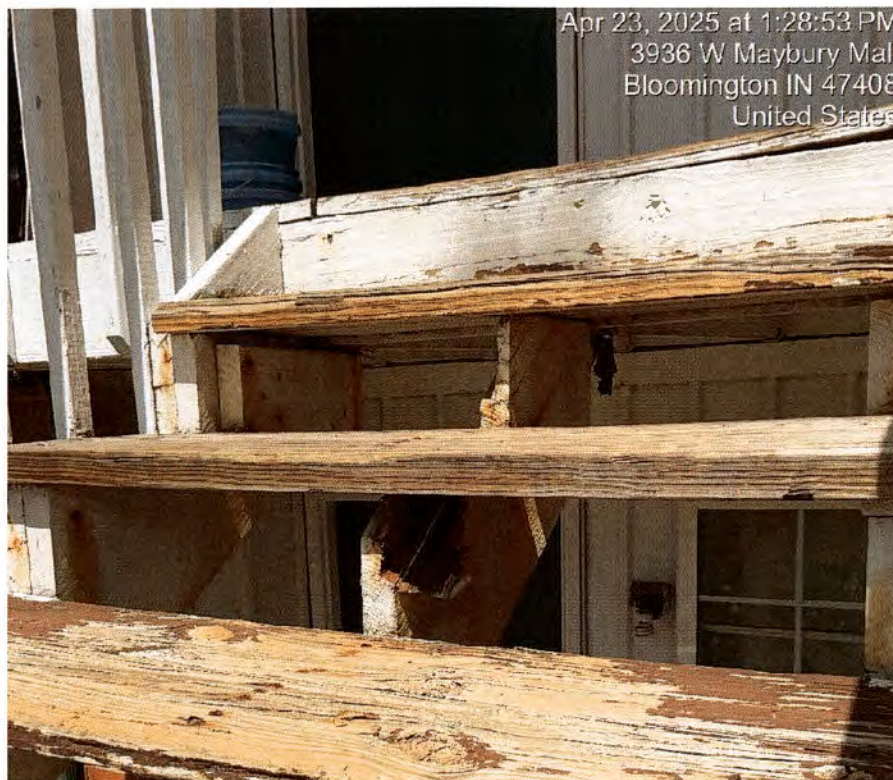
Example of deteriorated stringer

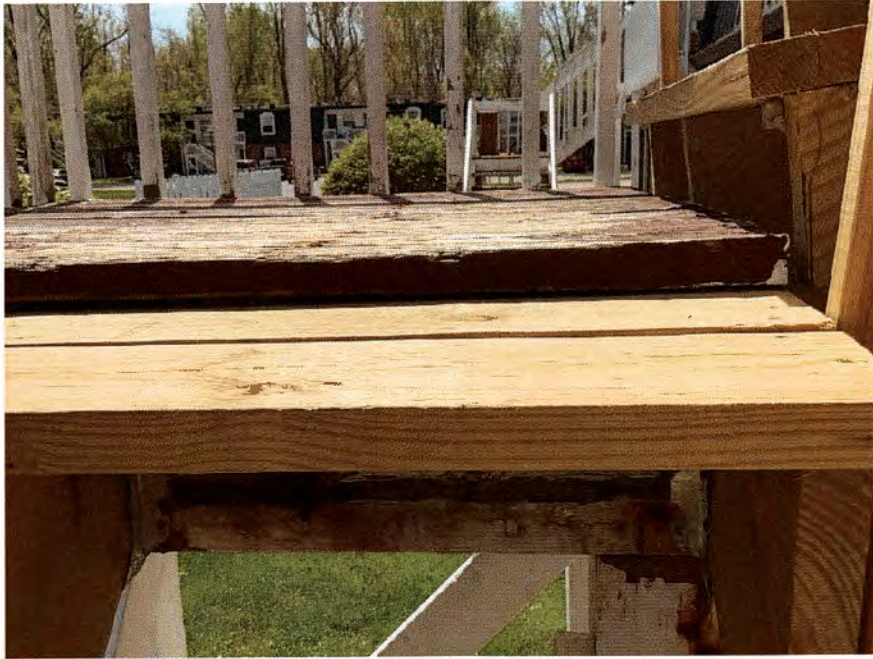
Example of trip hazard

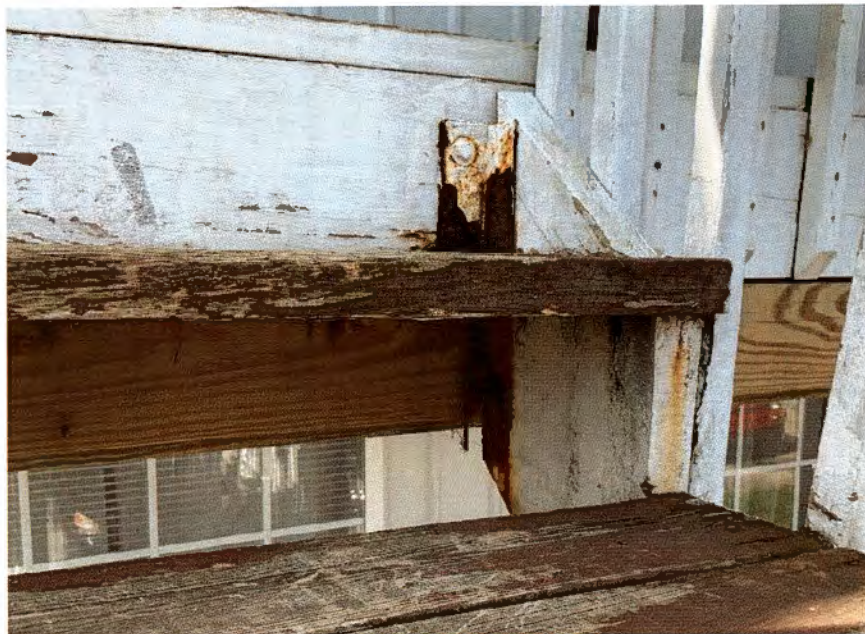
Example of deteriorated brack

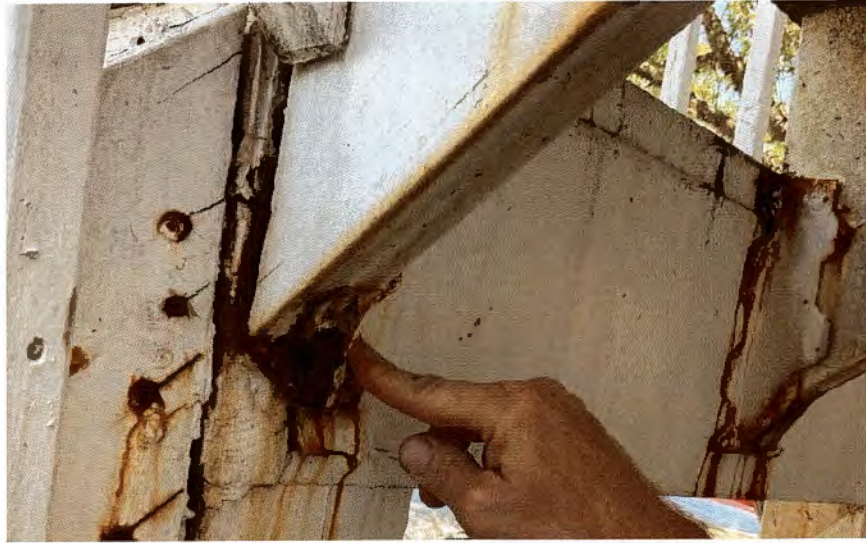
Example of deteriorated joist hanger

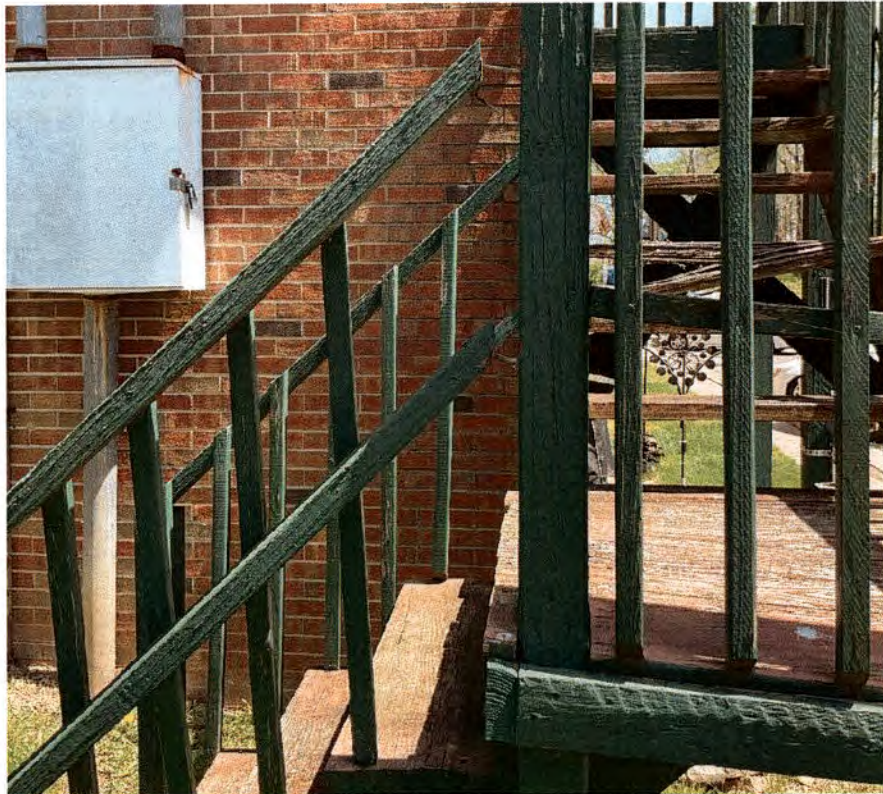
Example of loose handrail and missing spindles

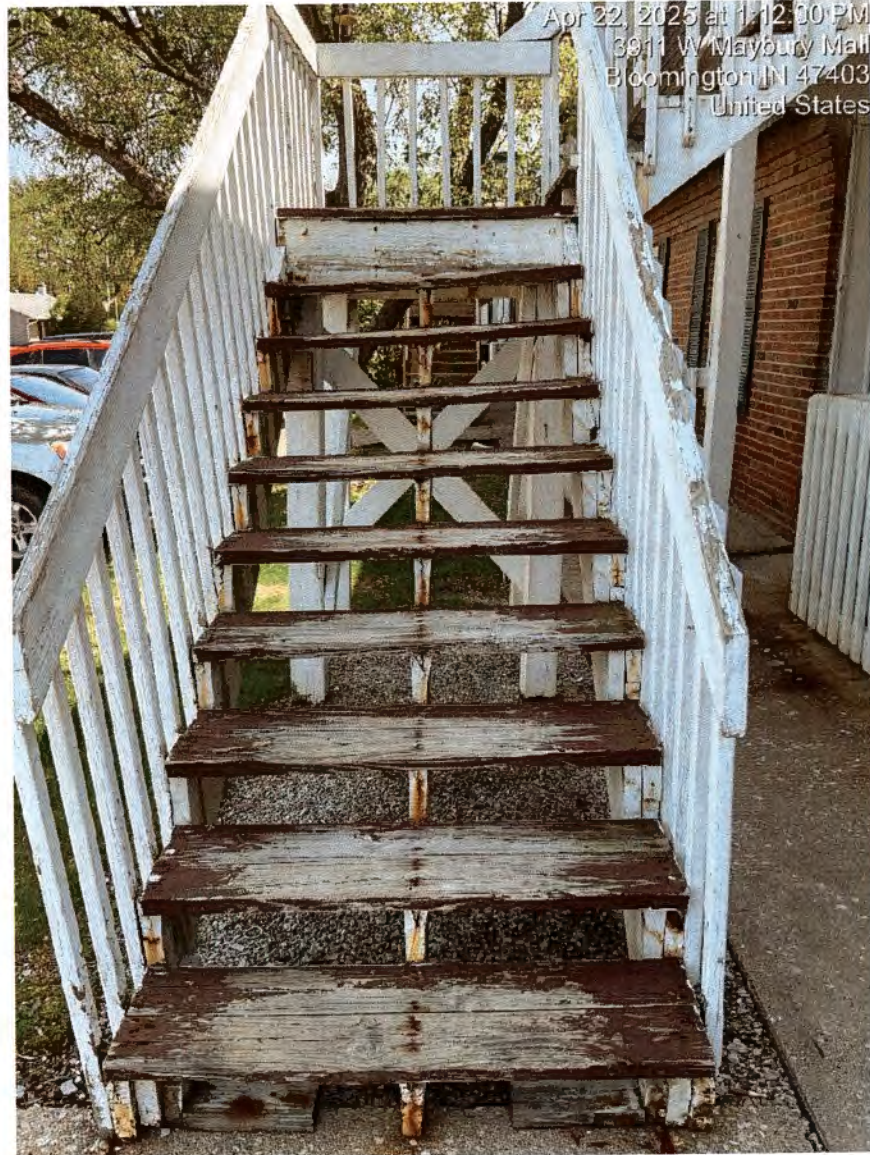
Example of leaning/listing stair
