PUBLIC HEARING

BOARD OF HOUSING QUALITY APPEALS

AUGUST 19, 2025 4:15 P.M.

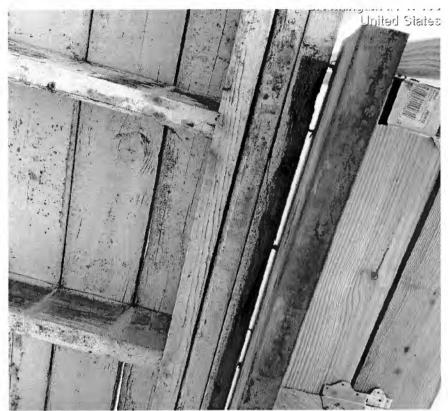
Example of stairs pulling away from upper level walkway

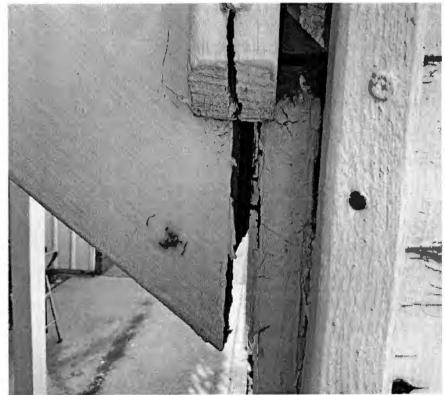
Example of stairs pulling away from upper level walkway

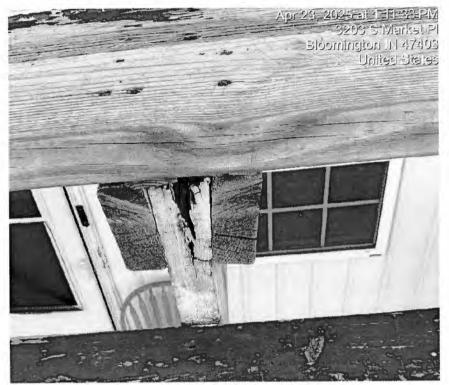
Example of deteriorated stringer

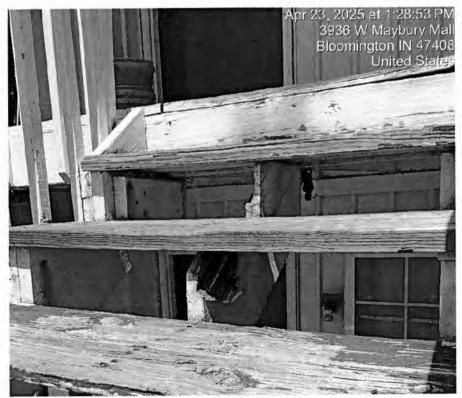
Example of deteriorated stringer

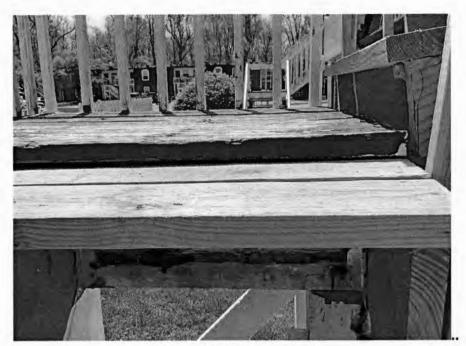
Example of trip hazard

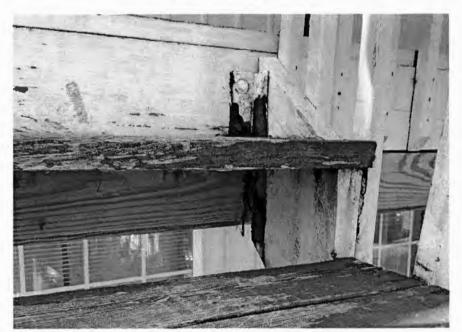
Example of deteriorated brack

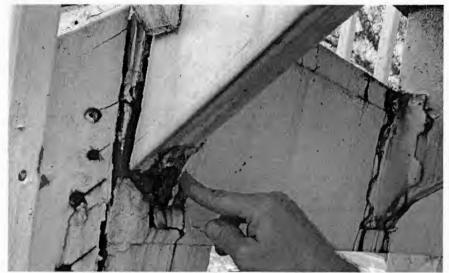
Example of deteriorated joist hanger

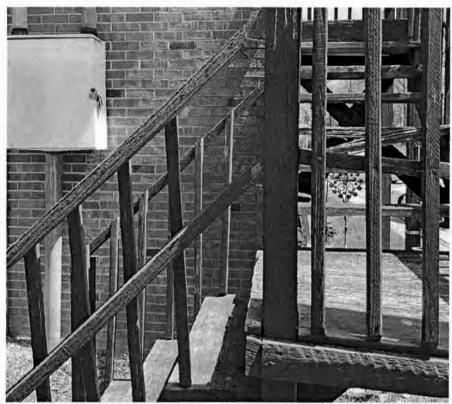
Example of loose handrail and missing spindles

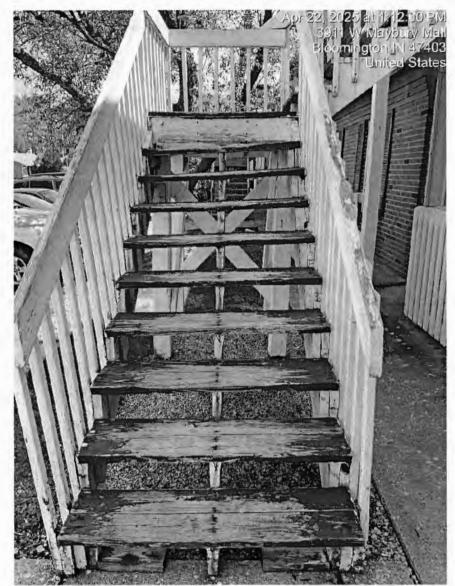
Example of leaning/listing stair

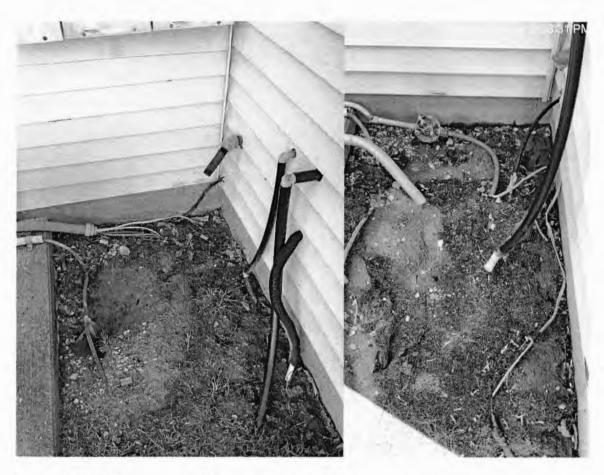
Building 2951 Open Junction Box, exposed wires, disconnected wire, etc.

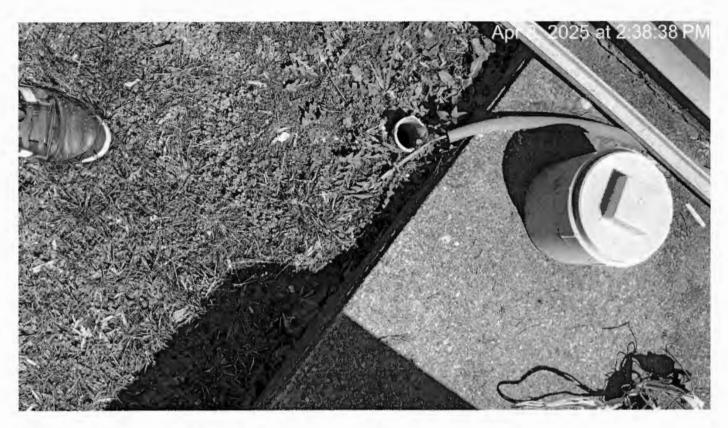
Bldg 2951 UG feed wire not properly buried.

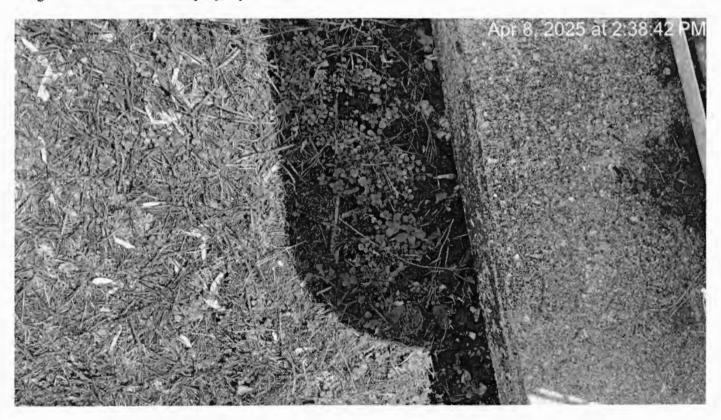
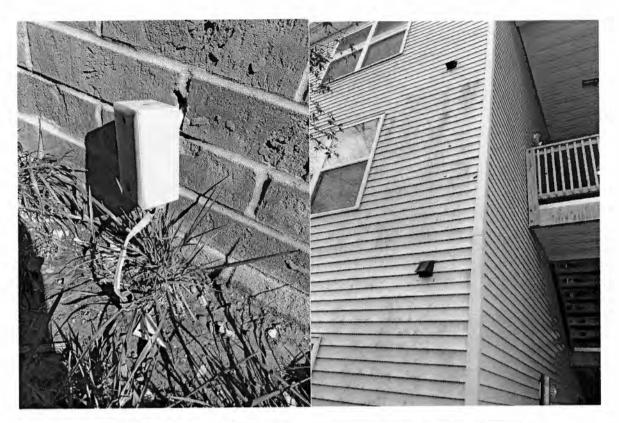
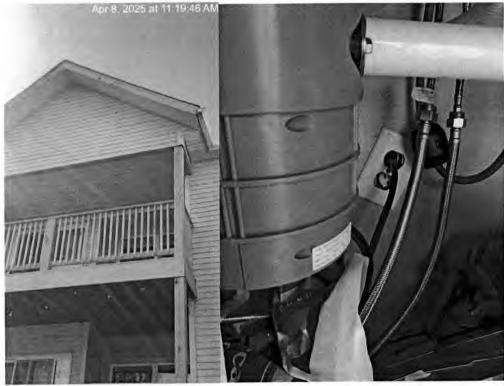
Building 2931: Top left - loose junction box, no conduit. Top right - Some of the damage siding. There was also missing siding (no picture). Bottom left - Missing metal fascia.

Bottom Right - example of set back outlets under sink cabinets.
