4th Street Parking Garage

Structural Condition Assessment Report

City of Bloomington

May 25, 2018

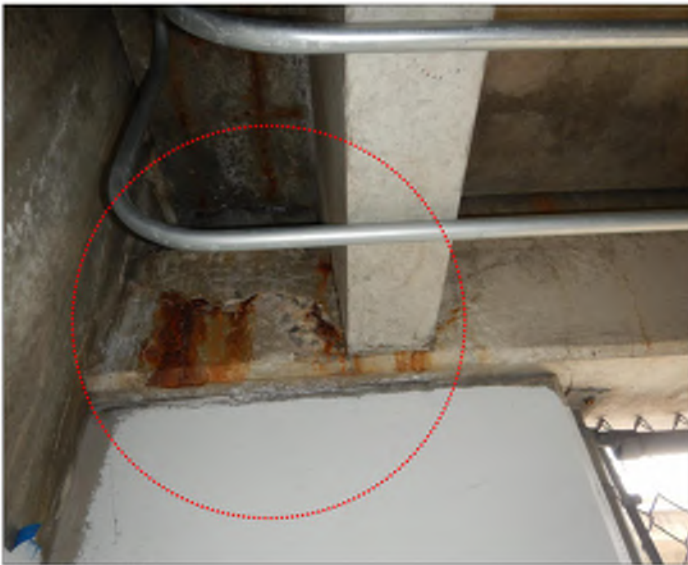
REPAIR ID - 01

REPAIR ID:	DETERIORATION DESCRIPTION:	QUANTITY:	PROPOSED REPAIR:	IMPACTED ELEMENT:	PRIORITY LEVEL:	REPRESENTATIVE PHOTO:
1	Beam underside delamination	5 EA	Partial Depth Patch w/ shoring during repair	Ledger Beams	HIGH

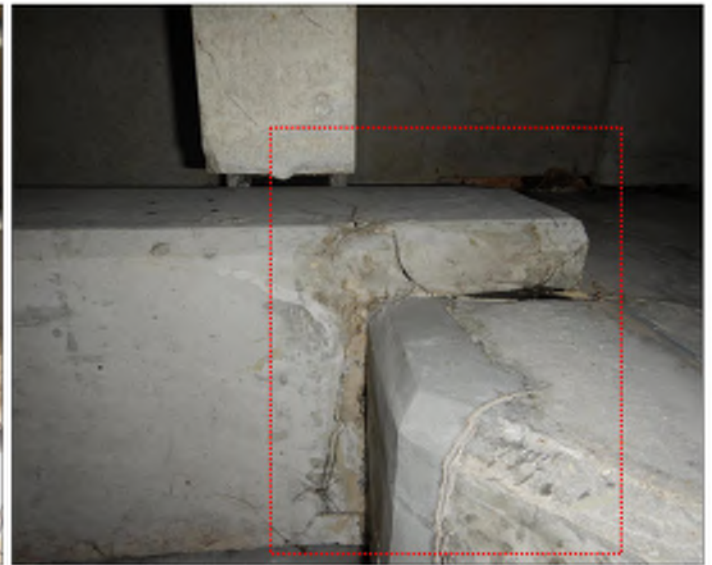
REPAIR ID - 02A

2A	Beam bearing	5 EA	Partial Depth Patch w/ shoring during repair	Ledger Beams	HIGH

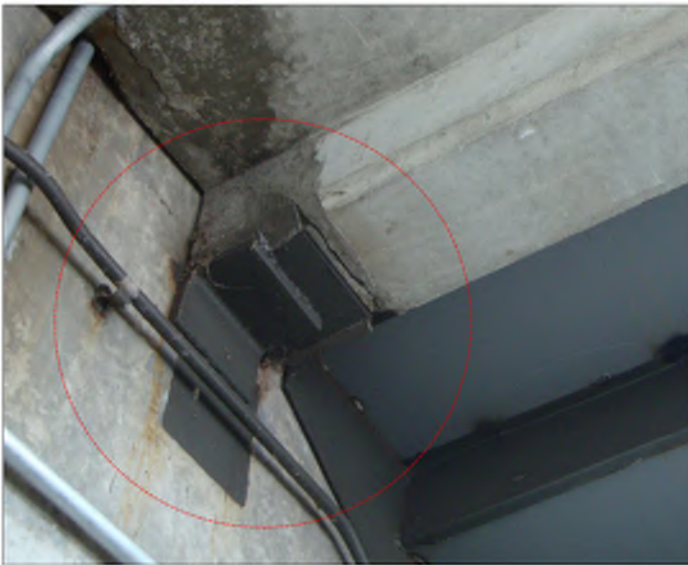
REPAIR ID - 02B

2B	Beam bearing	4 EA	Partial Depth Patch w/ shoring during repair	Stair Towers	HIGH

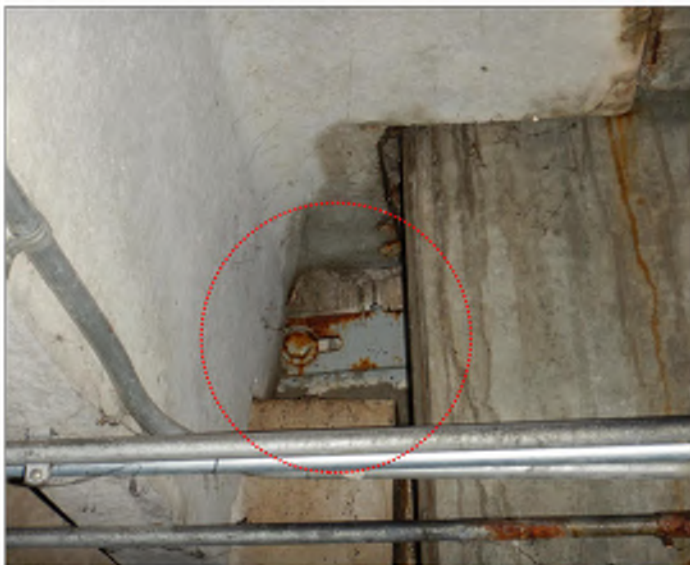
REPAIR ID - 05A

REPAIR ID:	DETERIORATION DESCRIPTION:	QUANTITY:	PROPOSED REPAIR:	IMPACTED ELEMENT:	PRIORITY LEVEL:	REPRESENTATIVE PHOTO:
3A	Exposed, corroded steel with spalled concrete on beam underside	218 LF	Clean and Coat	Ledger Beams	HIGH	 
3B	Exposed, corroded steel with spalled concrete on beams tops	107 LF	Clean and Coat	Ledger Beams	LOW	 
3C	Exposed, corroded steel with deteriorated concrete	205 LF	Clean and Coat	Double Tees Pedestrian Walkway (slab underside)	MED	 
3D	Exposed, corroded steel with deteriorated concrete	21 LF	Clean and Coat	Columns	MED	 
3E	Exposed, corroded steel with deteriorated concrete	13 LF	Clean and Coat	Wall Panels	LOW	 
3F	Exposed, corroded steel with deteriorated concrete	21 LF	Clean and Coat	Stair Towers	MED	 
4	Vertical cracks in walls	46 LF	Chemical Grout Injection	Retaining Walls Stair Towers	LOW	 
5A	Corroded steel plates and/or bolts	44 EA	Clean and Paint	Ledger Beams	MED

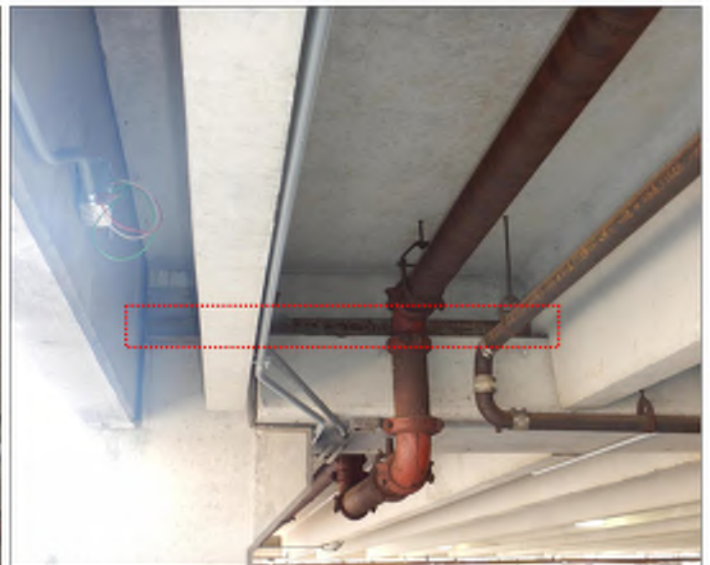
REPAIR ID - 05B

5B	Corroded steel angles	12 EA	Clean and Paint	Double Tees	HIGH	 
5C	Corroded steel plates	10 EA	Clean and Paint	Columns	MED

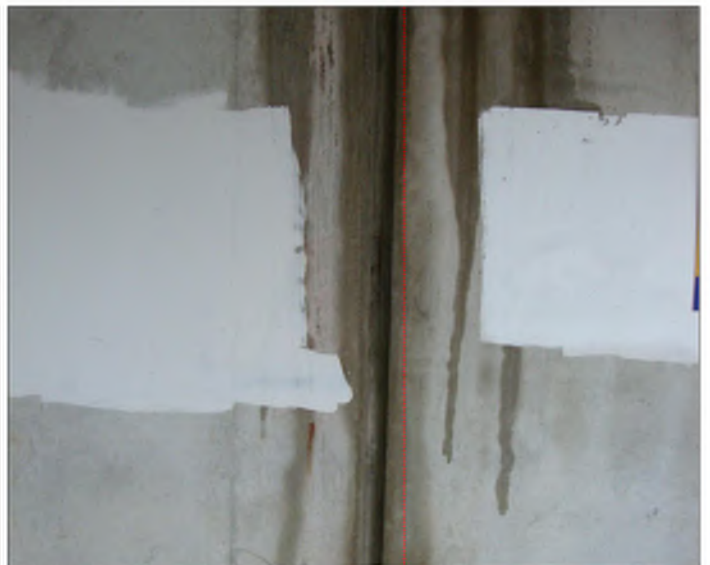
REPAIR ID - 09A

REPAIR ID:	DETERIORATION DESCRIPTION:	QUANTITY:	PROPOSED REPAIR:	IMPACTED ELEMENT:	PRIORITY LEVEL:	REPRESENTATIVE PHOTO:
9A	Deteriorated vertical joint material between elements (on top side of deck)	497 LF	Replace vertical joint sealant	Columns Wall Panels Ledger Beams Stair Towers	MED

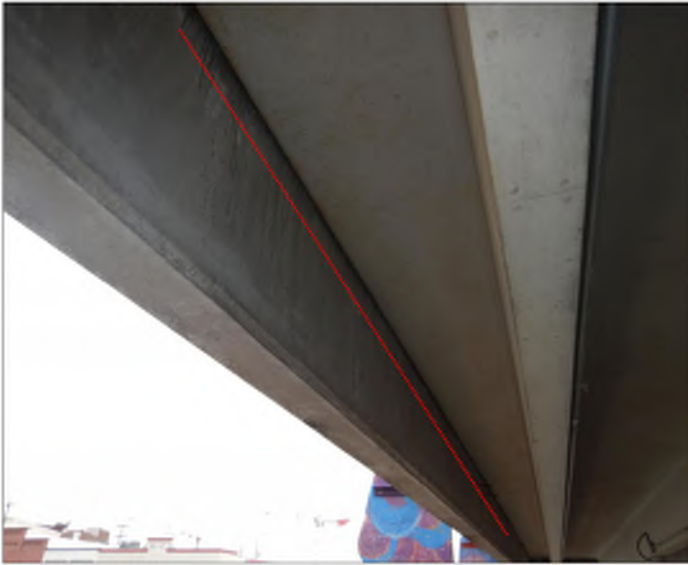
REPAIR ID - 09B

9B	Deteriorated perimeter cove joint material (on top side of deck)	4,737 LF	Replace cove joint sealant	Ledger Beams Wall Panels Columns Decks	MED

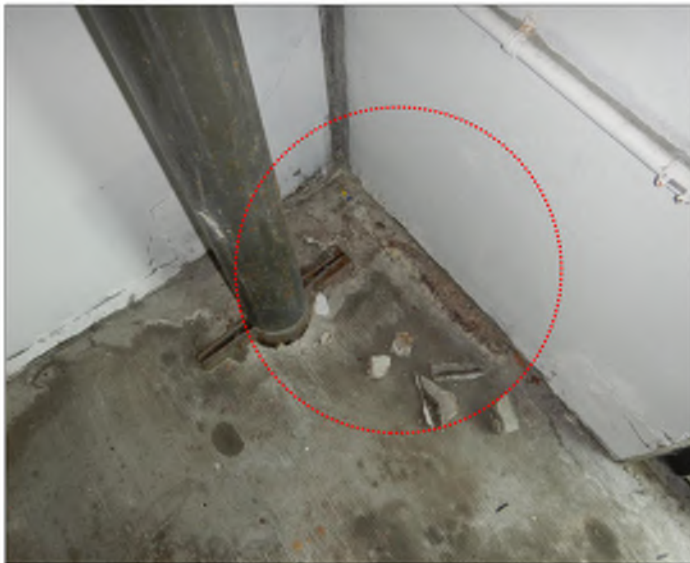
REPAIR ID - 10G

REPAIR ID:	DETERIORATION DESCRIPTION:	QUANTITY:	PROPOSED REPAIR:	IMPACTED ELEMENT:	PRIORITY LEVEL:	REPRESENTATIVE PHOTO:
10G	Concrete delamination on stair walls and landings	167 SF	Partial Depth Patch	Stair Towers	HIGH

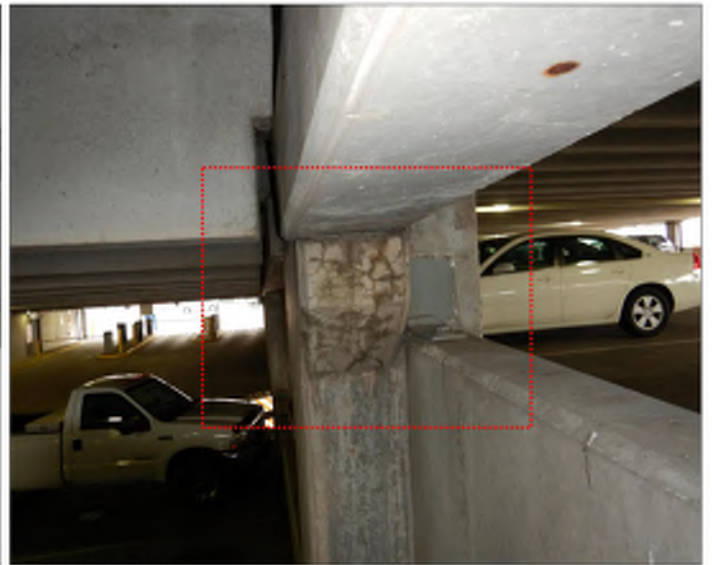
REPAIR ID - 12A

12A	Excessive water Leaking through column corbel	3 SF	Apply Silane Sealer	Columns	MED

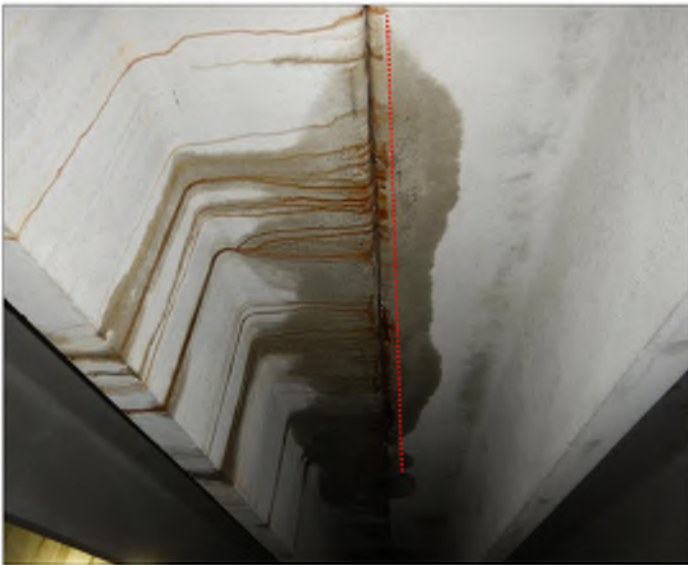
REPAIR ID - 12B

12B	Excessive water Leaking through deteriorated double tee flange	315 SF	Apply Silane Sealer	Double Tees	MED

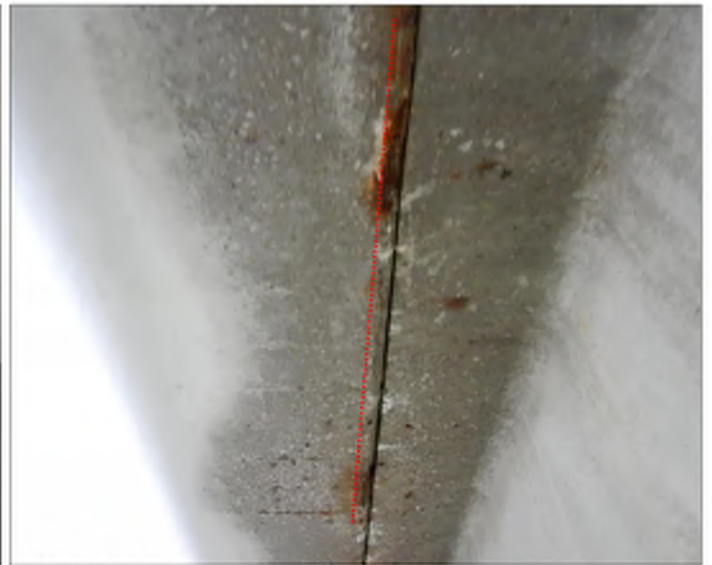
REPAIR ID - 13

13	Corroded shear transfer plate and corroded supplemental steel	55 EA	Clean and Coat (concrete demo required to inspect supplemental steel)	Double Tee	HIGH

14. Corroded shear transfer plate and corroded supplemental steel – double tees Clean and coat, minor demo required for embedded steel inspection	HIGH	55	EA	\$250.00	\$13,750.00

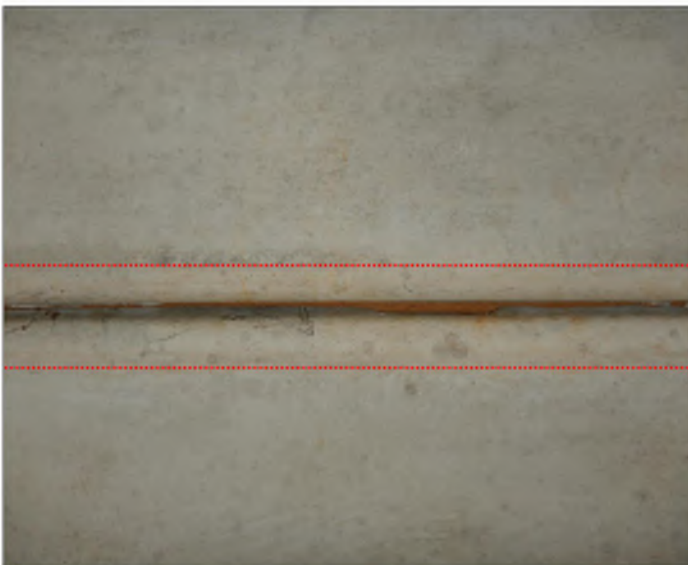
REPAIR ID - 14

14	Broken shear transfer plate	8 EA	Shear Transfer Plate Replacement with "Sandwich Plates"	Double Tee	HIGH

15. Broken shear transfer plate – double tees Shear transfer plate replacement with "sandwich plates"	HIGH	8	EA	\$500.00	\$4,000.00
16. Deck topping slab cracks – upper levels: 3 (west) and 4 Rout cracks and seal with joint sealant	HIGH	1,437	LF	\$5.00	\$7,185.00

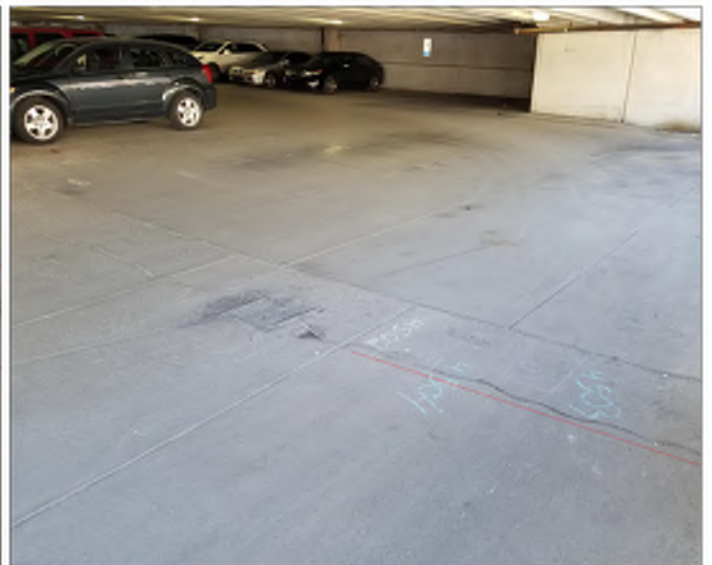
REPAIR ID - 15A

15A	Deck topping slab cracks on lower levels (interior)	2,339 LF	Rout cracks and Seal with Joint Sealant	Decks	MED

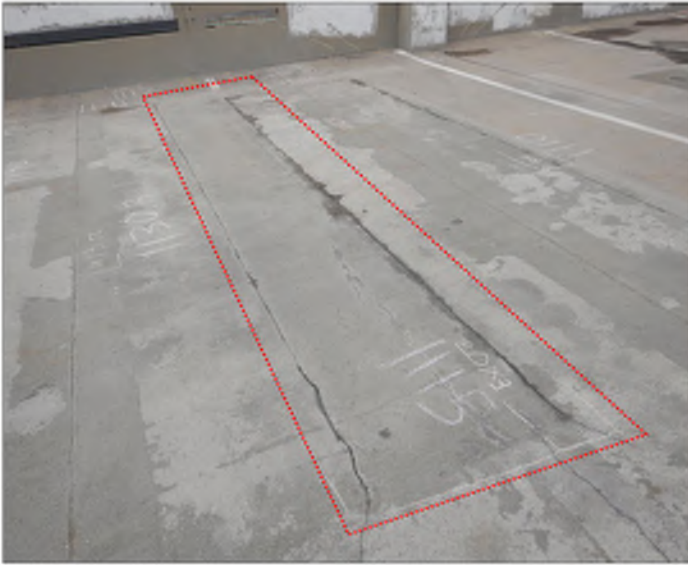
REPAIR ID - 15B

REPAIR ID:	DETERIORATION DESCRIPTION:	QUANTITY:	PROPOSED REPAIR:	IMPACTED ELEMENT:	PRIORITY LEVEL:	REPRESENTATIVE PHOTO:
15B	Deck topping slab cracks on upper levels (exterior)	1,437 LF	Rout cracks and Seal with Joint Sealant	Decks	HIGH	 
15C	Landing topping slab cracks on stair landings	18 LF	Rout cracks and Seal with Joint Sealant	Stair Towers	HIGH	 
16	Missing handrail post cap	3 EA	Replace Handrail Post Cap	Stair Towers	HIGH	 
17	Landing topping slab pour stop delamination	3 EA	Replace Landing Pour Stop (re-pour)	Stair Towers	MED	 
18	Handrail post section loss	12 EA	Supplemental Handrail Post Steel	Stair Towers	MED	 
19	Stair tread nosing section loss	47 EA	Stair Tread Nosing Repair	Stair Towers	HIGH	 
20	Stair tread section loss due severe corrosion	30 EA	Tread Strengthening	Stair Towers	HIGH	 
21	Deck topping slab deficiency on lower levels (interior)	64,604 SF	Waterproofing <u>Option A:</u> Apply Urethane Traffic Coating System	Decks	MED	See Appendix A

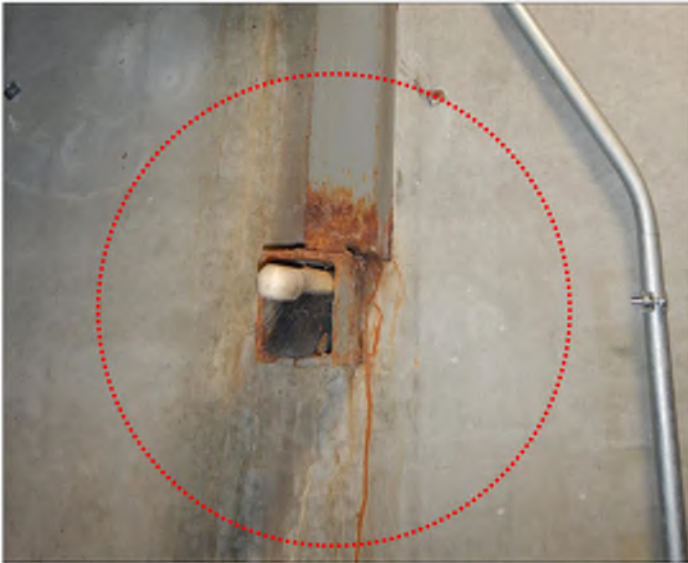
REPAIR ID - 24

24	Corroded embedded steel at bearing	4 EA	Provide additional bearing support	Panels	HIGH

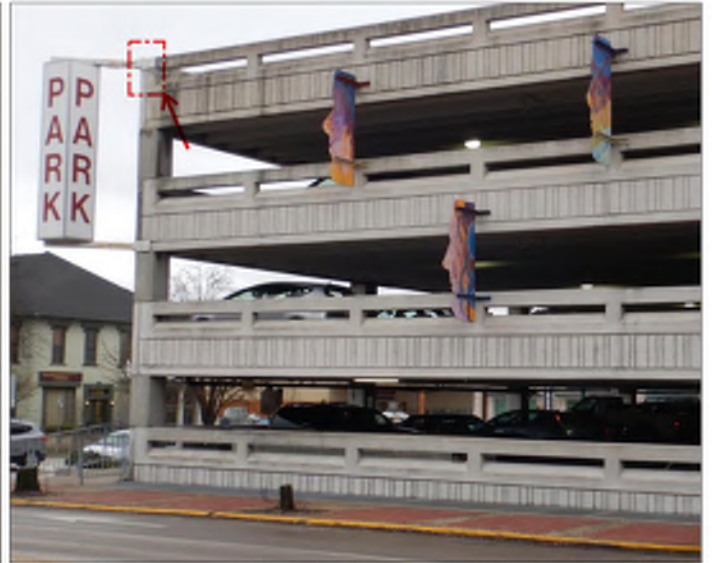
REPAIR ID - 25

25	Inadequate top garage sign connection	1 EA	Provide additional support	Exterior	HIGH

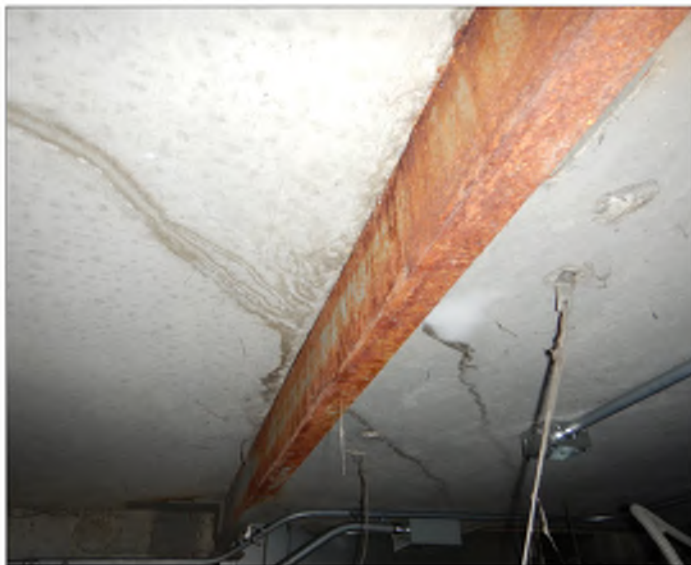
REPAIR ID - 28

28	Severe staircase steel corrosion (stair tower #1)	-	Clean and paint	Stair Towers	HIGH

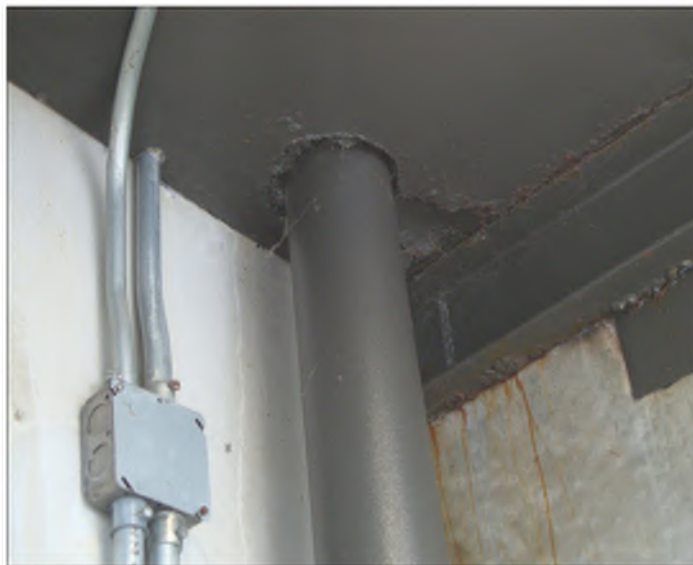
REPAIR ID - 29

29	Severe staircase steel corrosion (stair tower #3)	-	Clean and paint	Stair Towers	MED

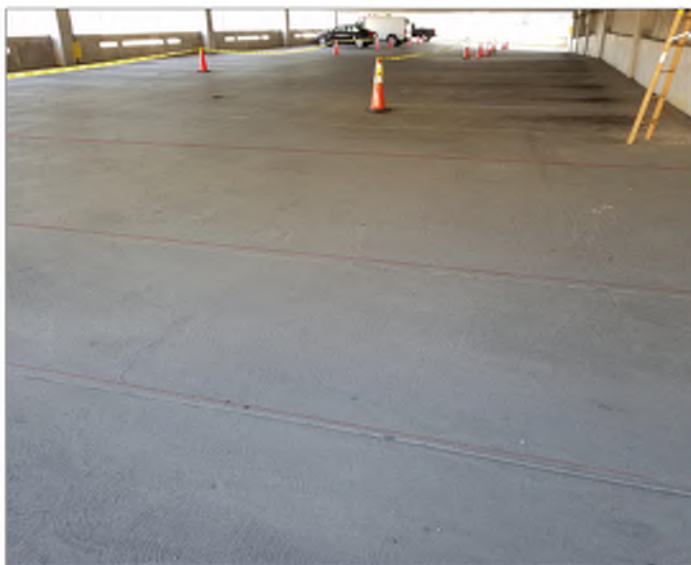
REPAIR ID - 9C

9C	Weathered control joints on deck topping slab	11,646 LF	Replace control joint sealant	Decks	HIGH
