# **ARSEE ENGINEERS, INC.**

**CLIENT ORIENTED — BY DESIGN**

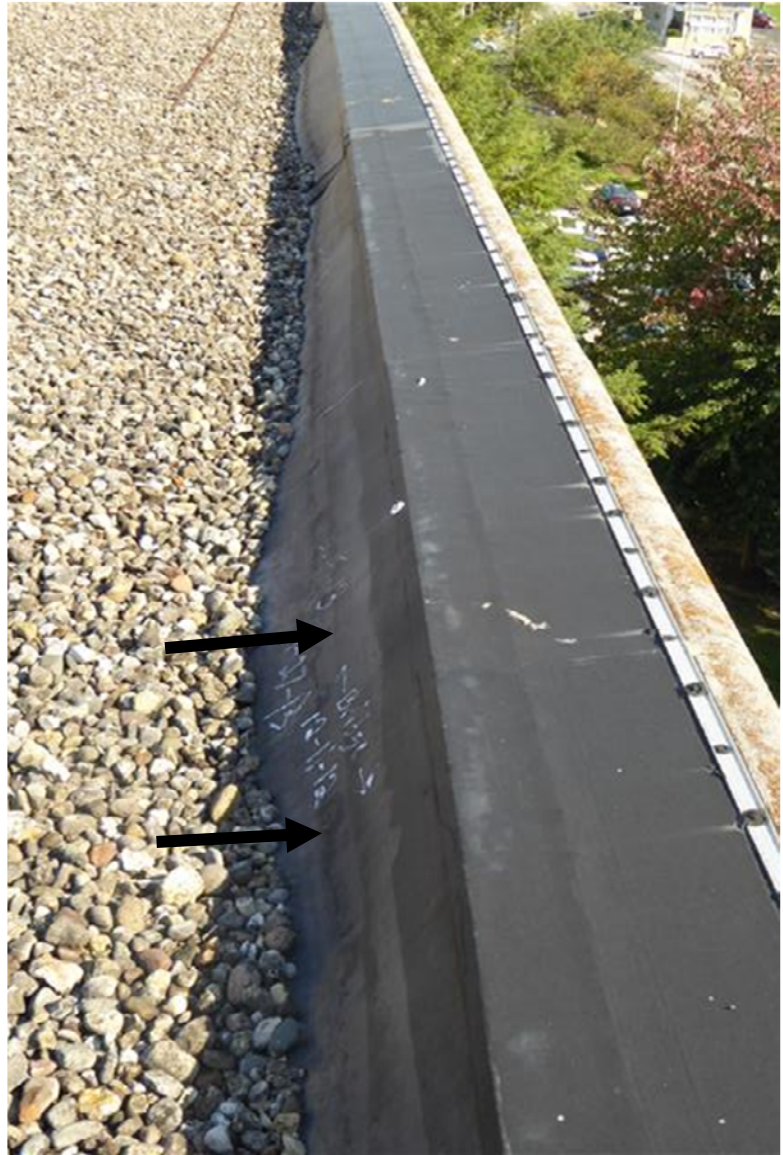
The membrane shrinks and pulls away from the coping. This is referred to as “tenting”.

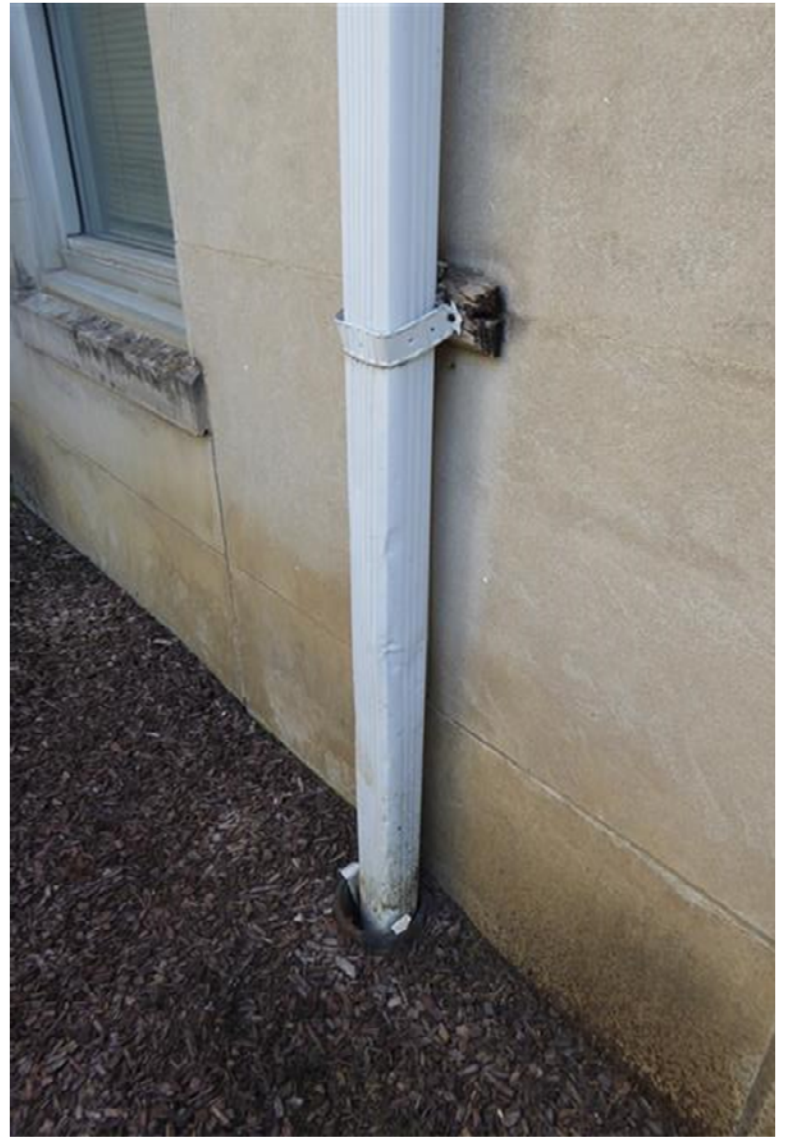
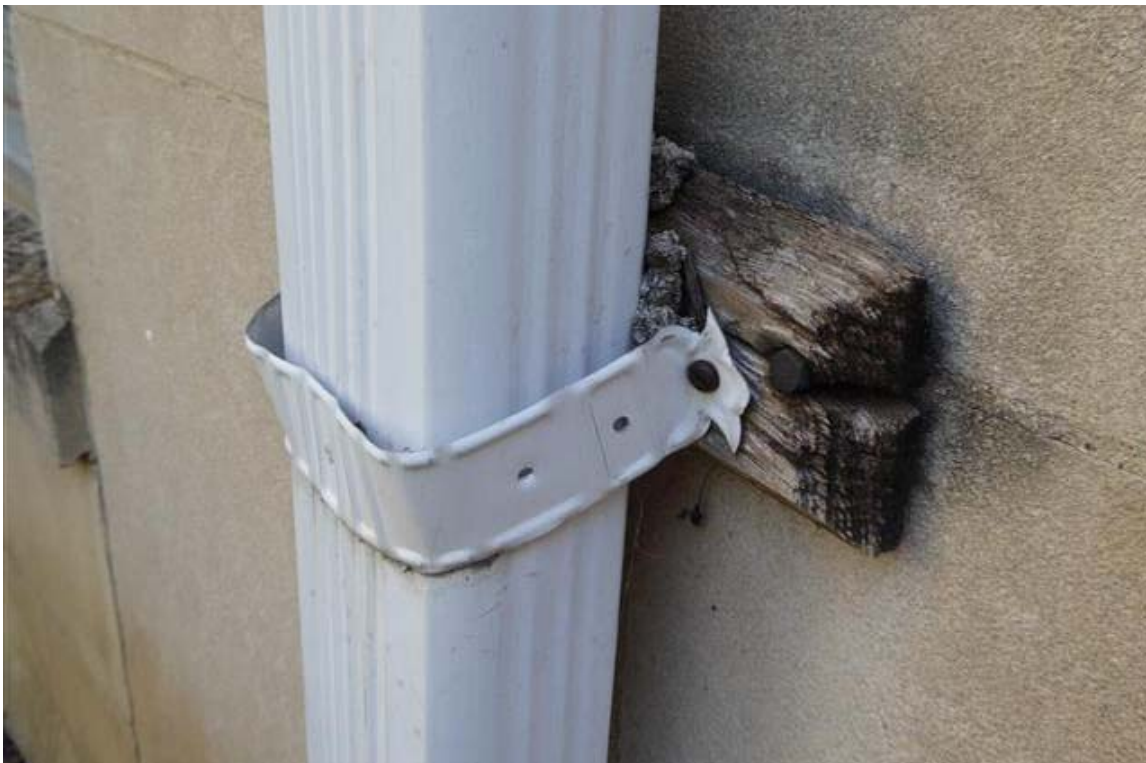
Downspouts feed into cast iron leaders.

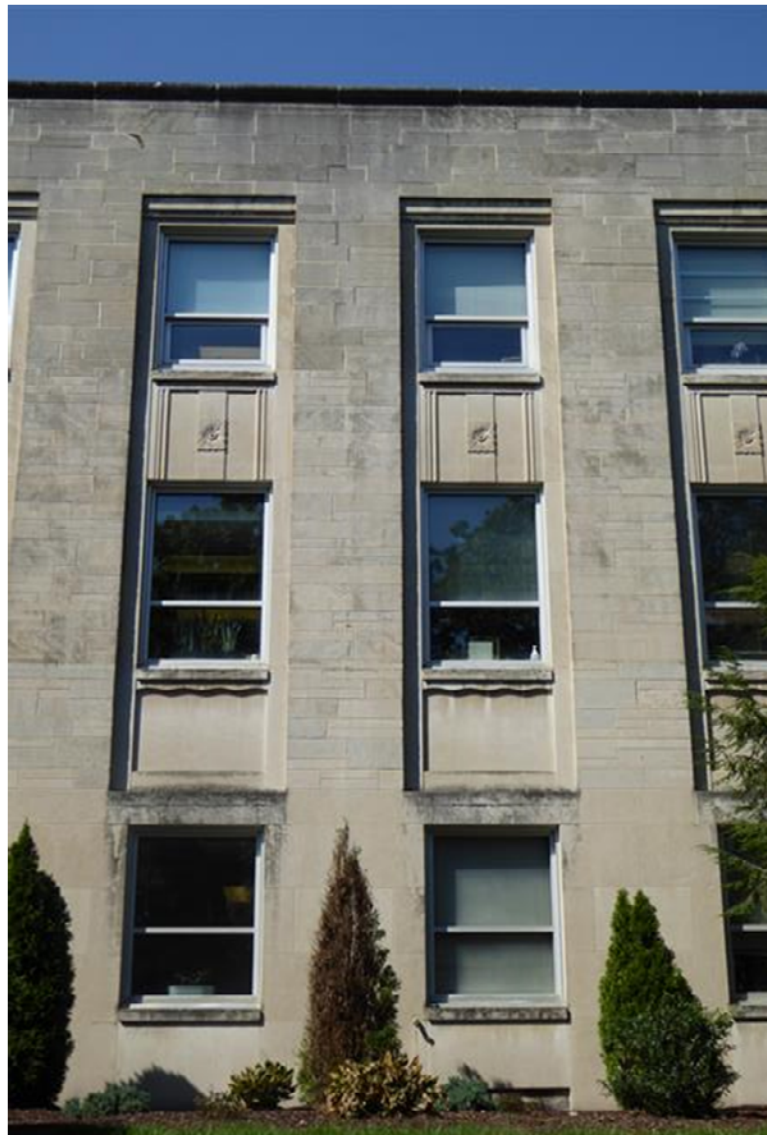
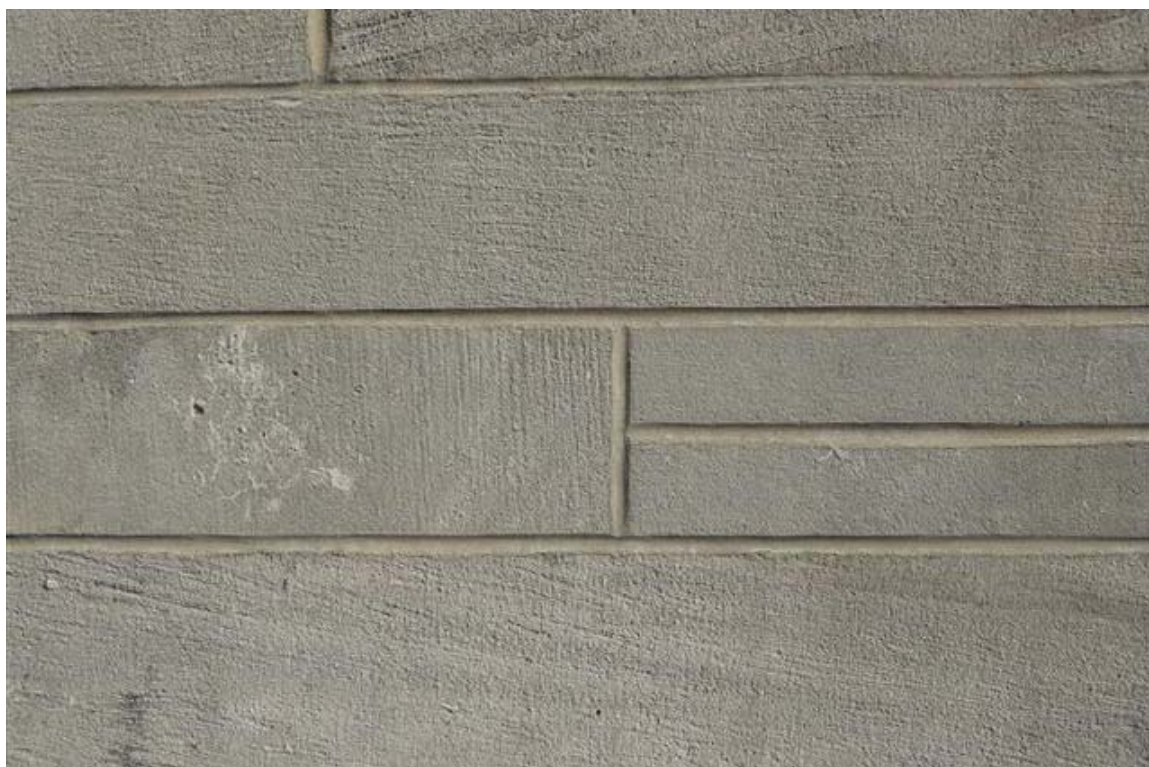
The façade is a combination of random ashlar and cut limestone. The stone itself is holding up well.

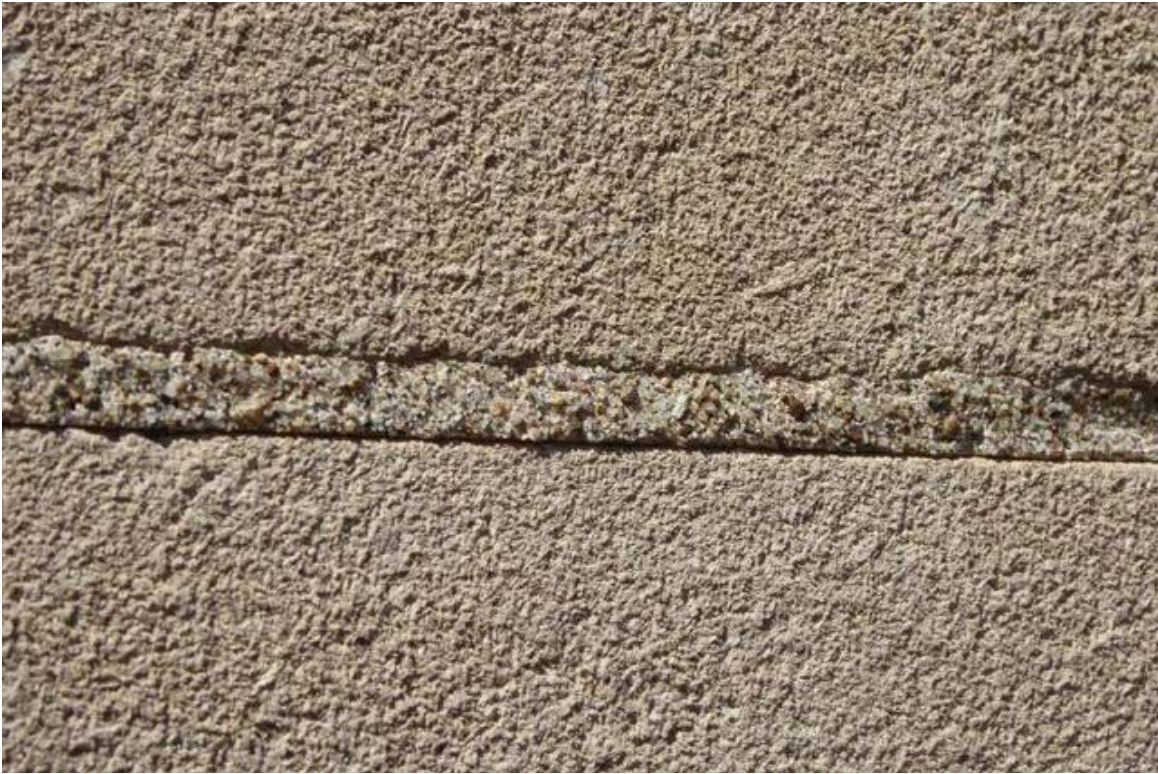
Photo 25 A few of the joints were struck flush and are more prone to moisture infiltration.

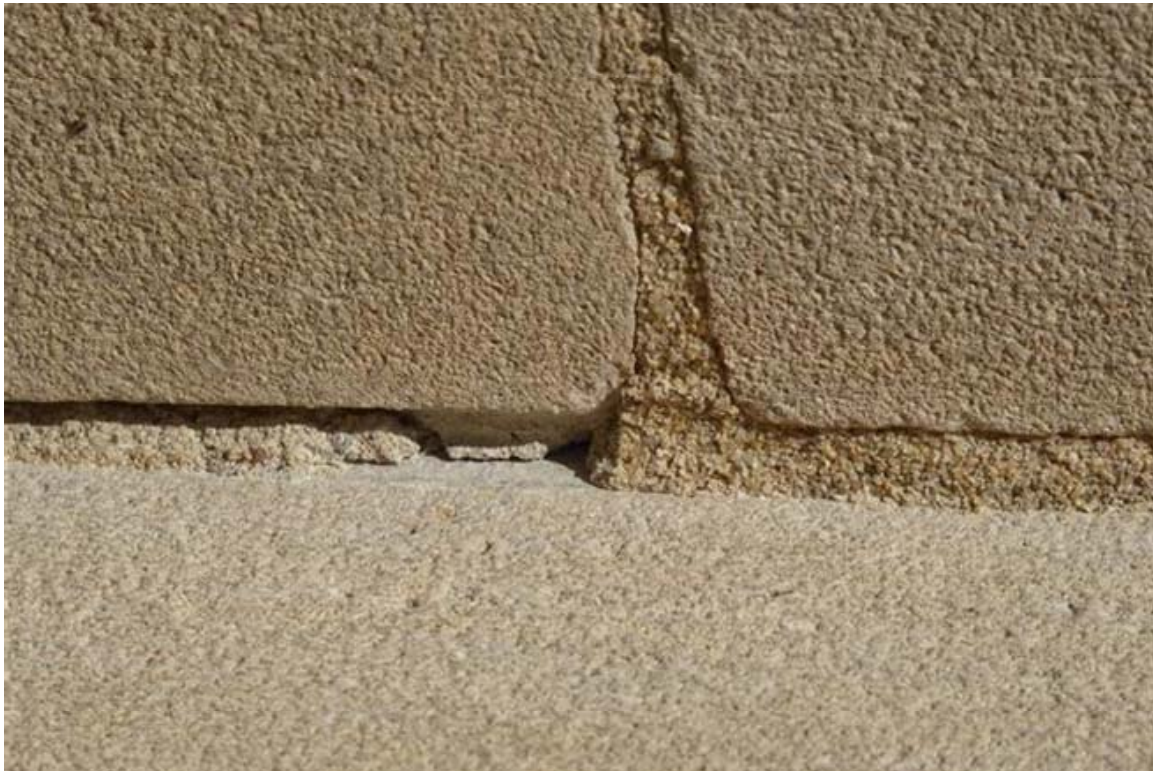
Photo 26 More recent tuckpointing has been thin and tends to crack and fall back out of the joint.

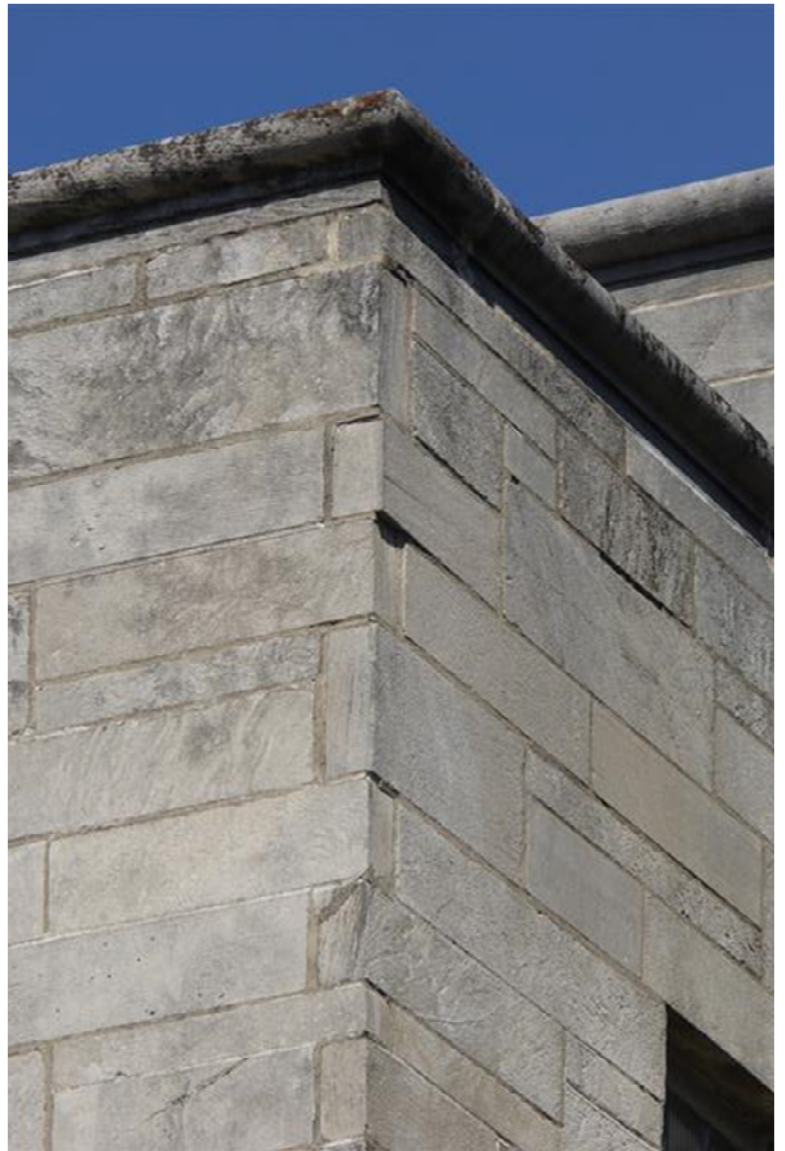
Joints near the top of the wall are wet most often. These need to be repointed.

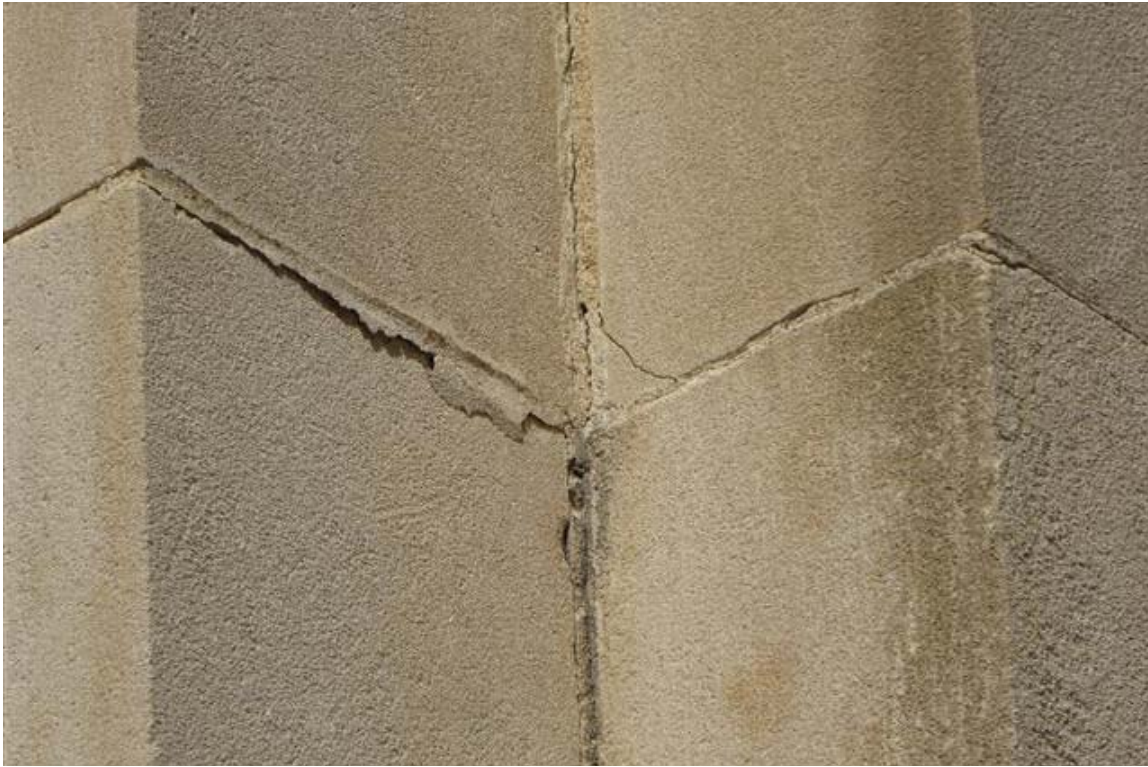
Similar condition on top of the south stairwell.

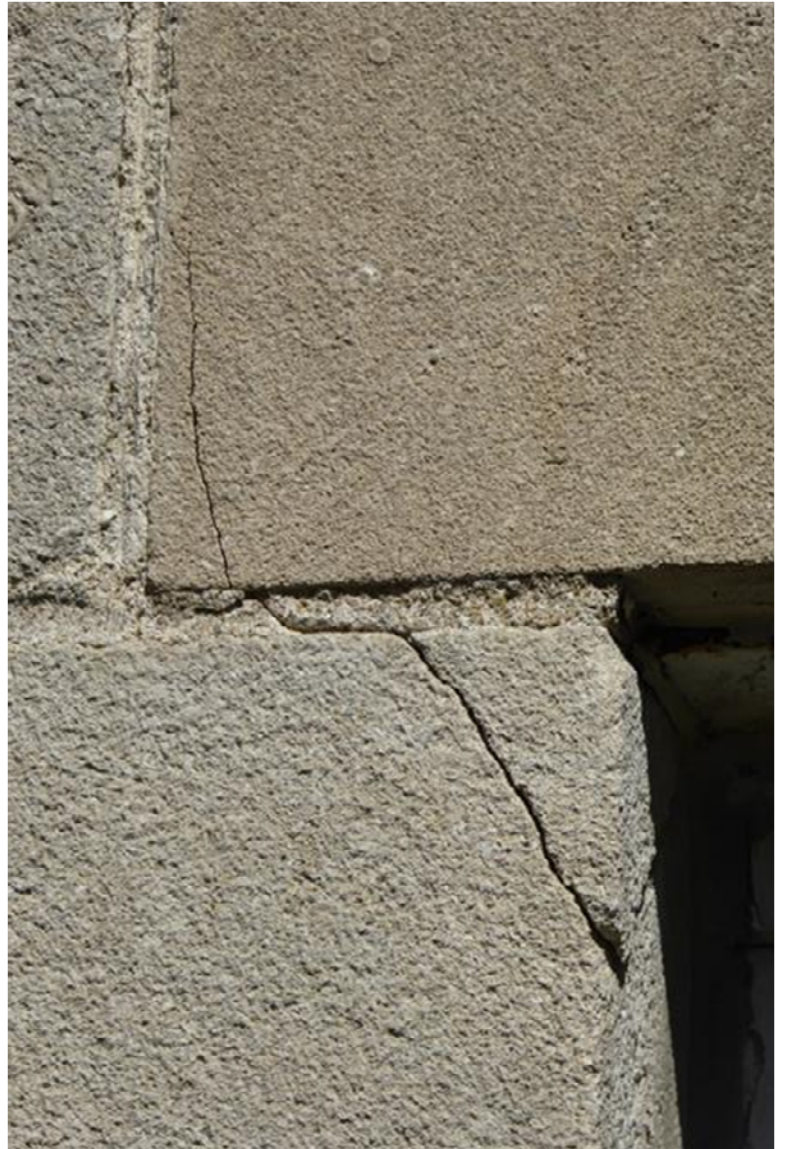
Cracking and spalling occur where tuckpointing mortar was too hard.

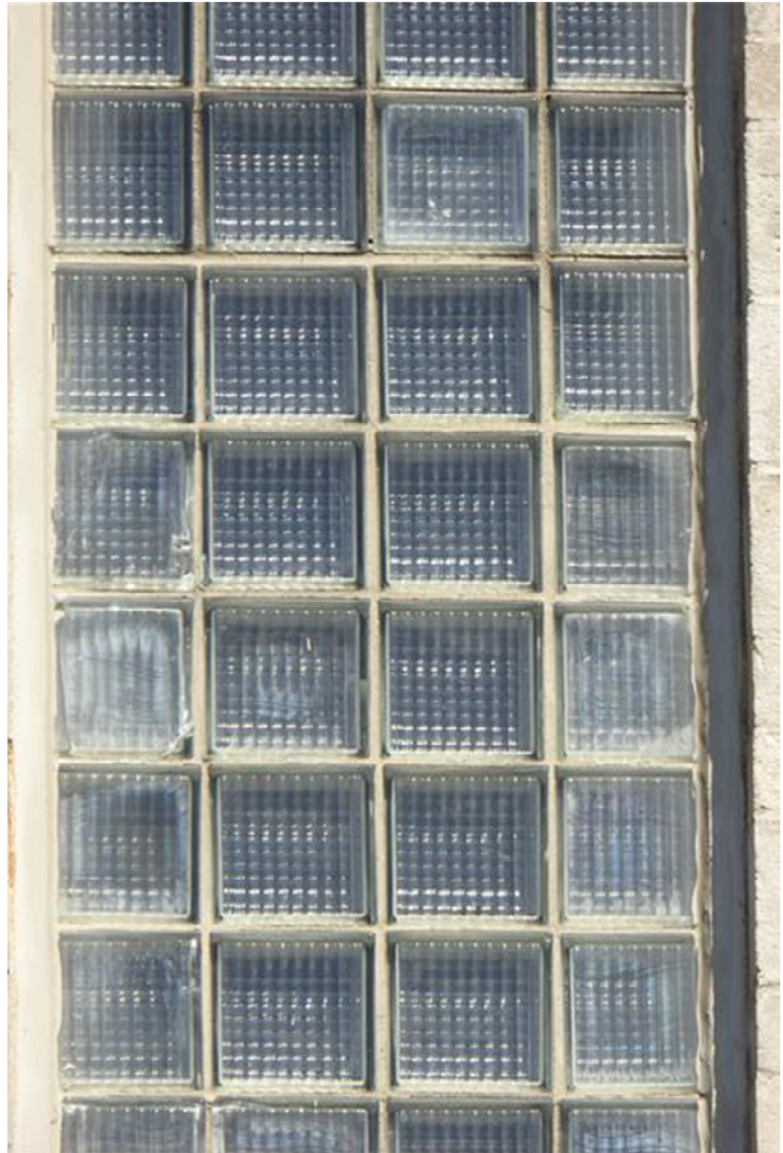
The glass block are generally in good condition and the mortar joints appear to be solid.

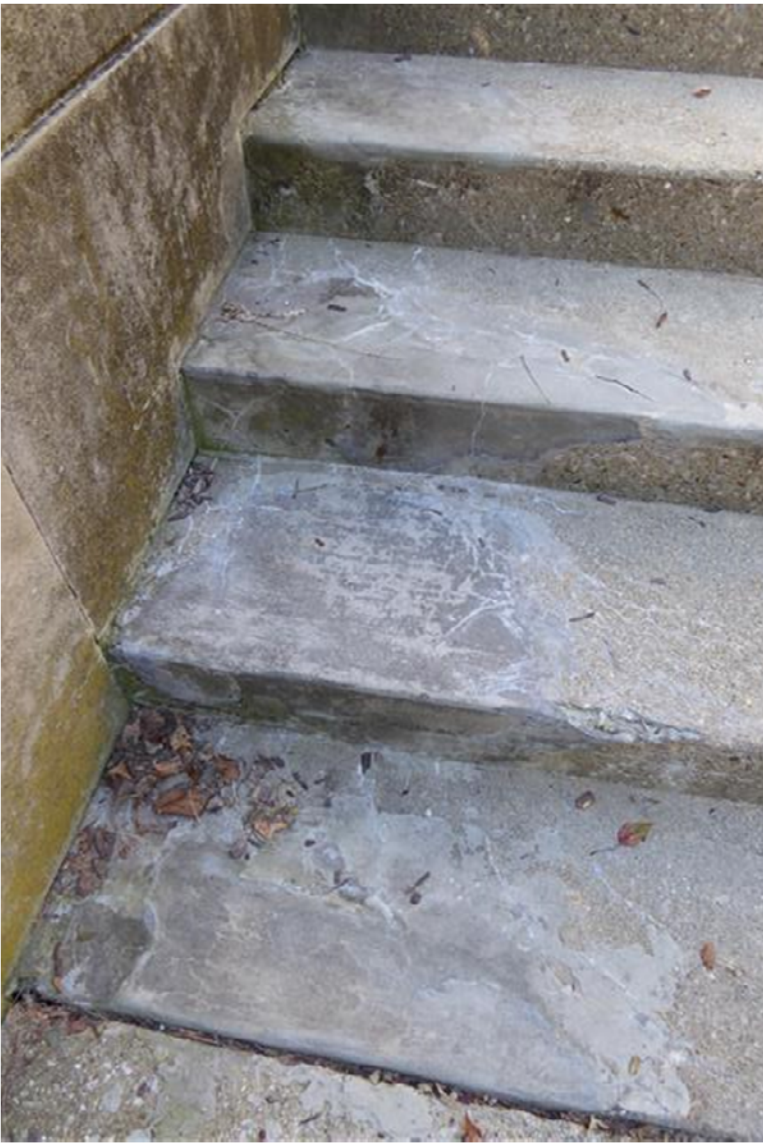
Photo 40 As are the steps into the main entrance.

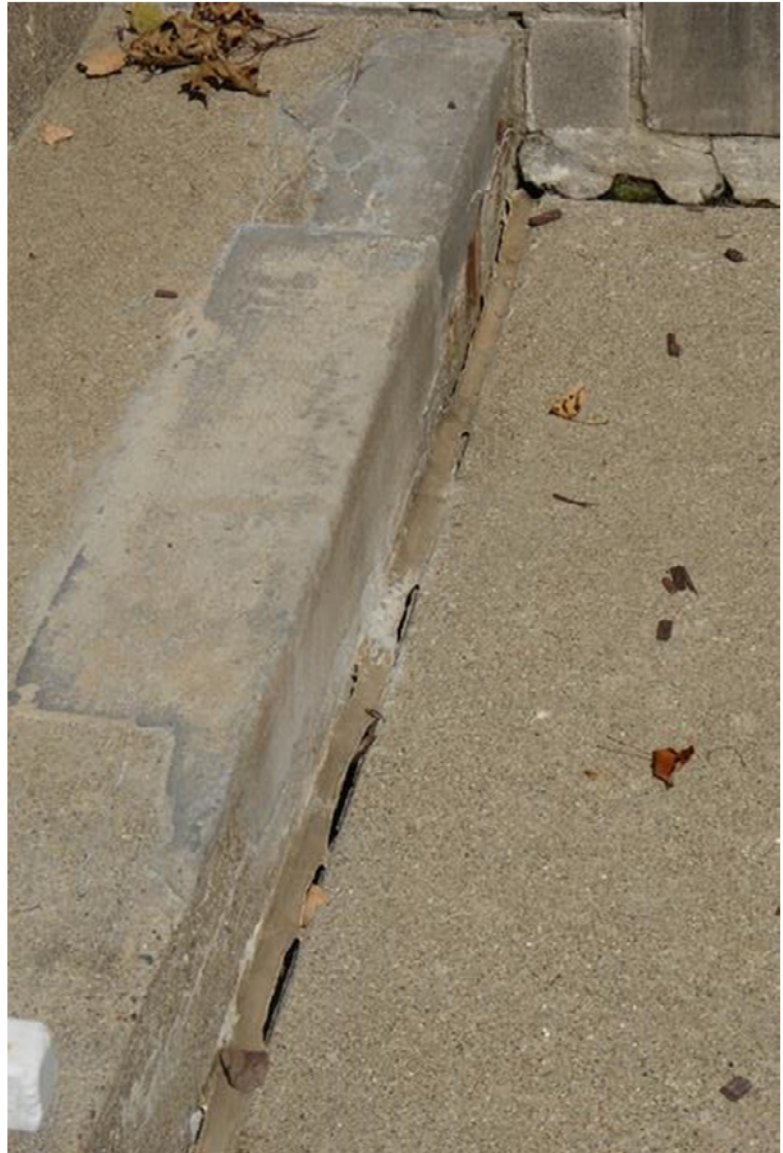
The concrete steps are beginning to deteriorate.

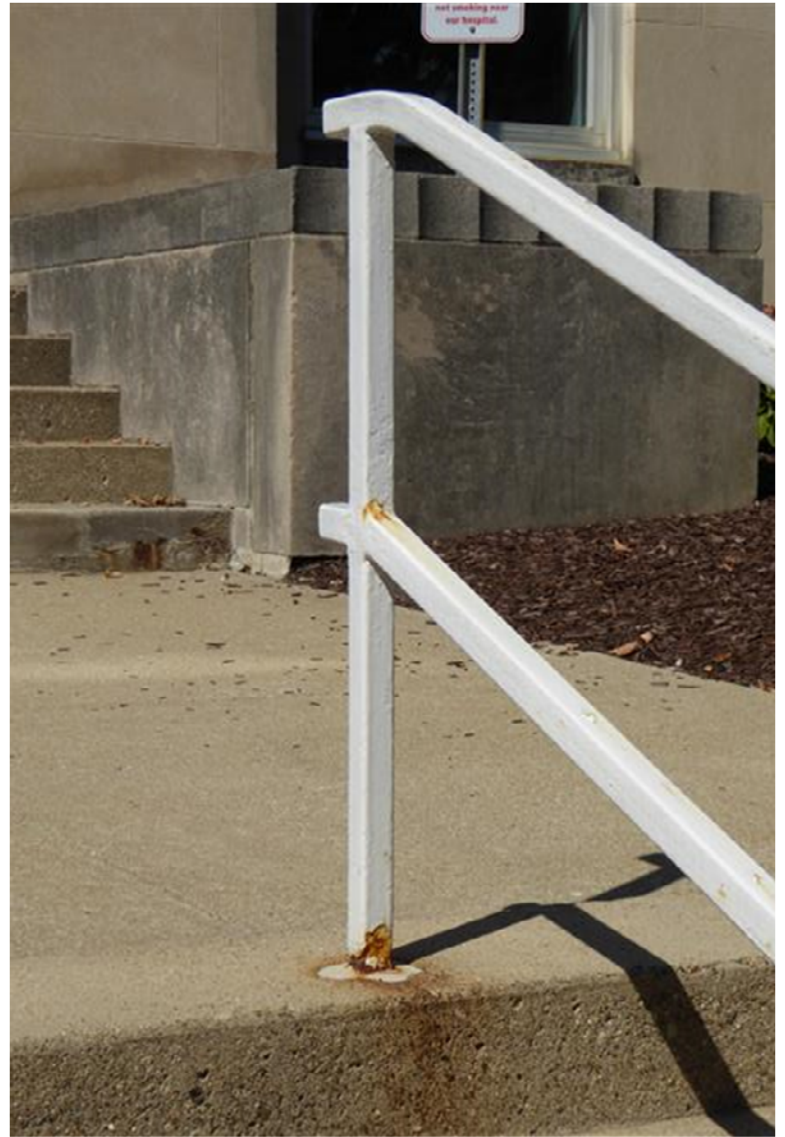
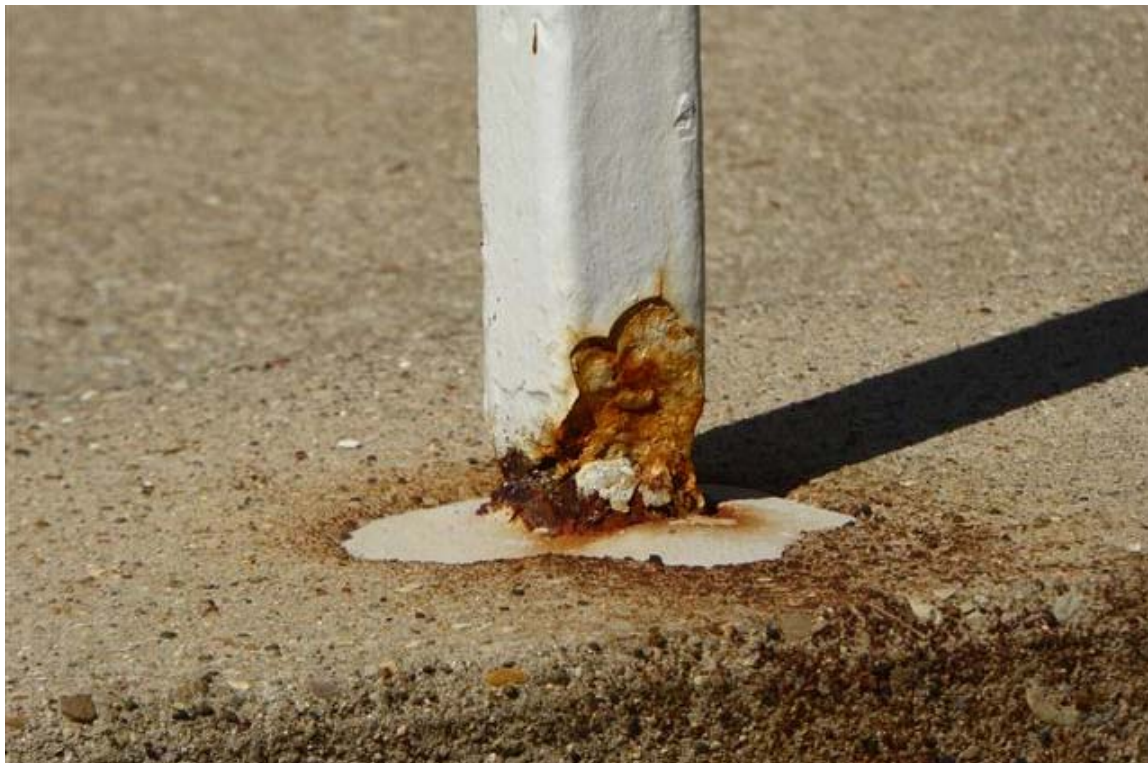
The hand railings do not meet current code requirements...

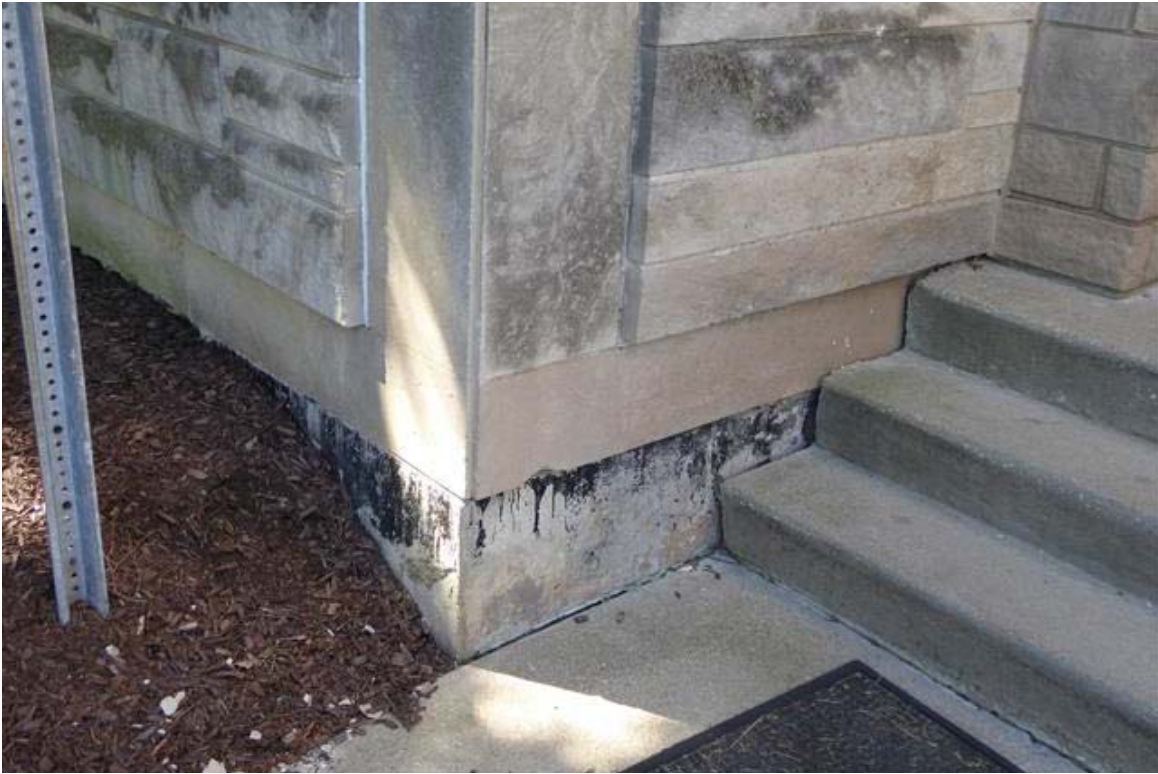
Photo 45 The perimeter basement walls are made of poured concrete.

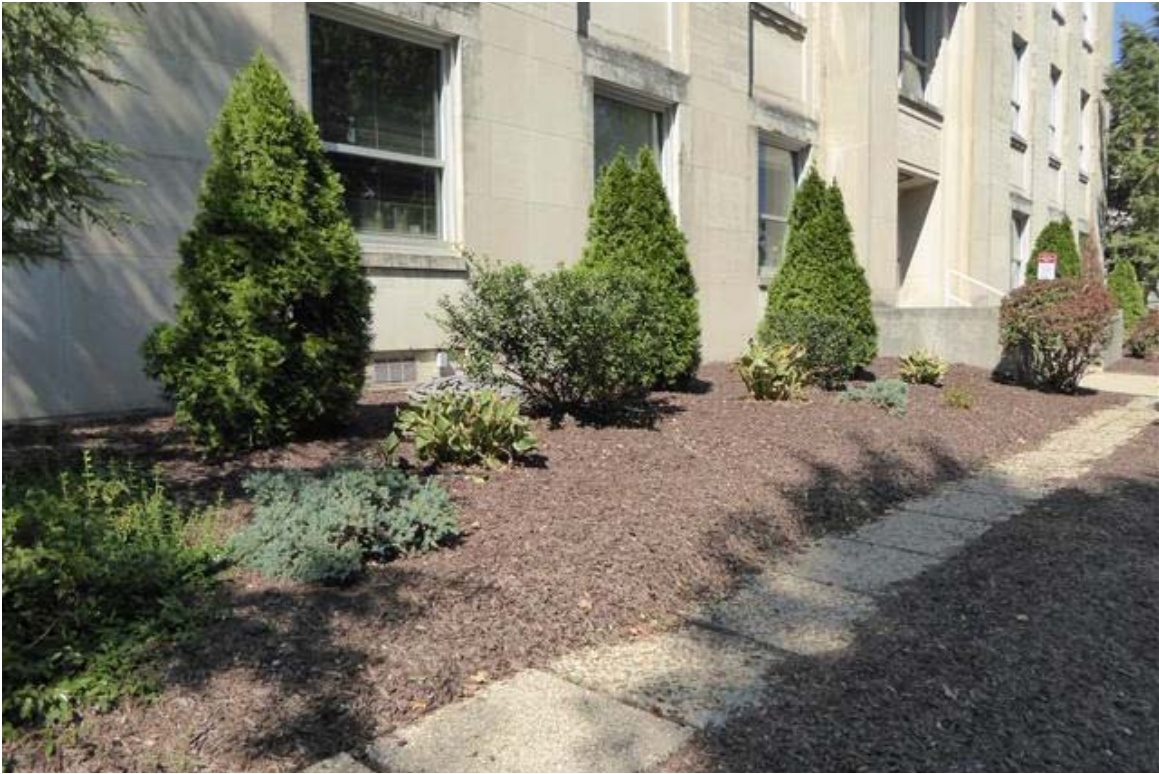
Photo 47 Plantings and landscaping beds...

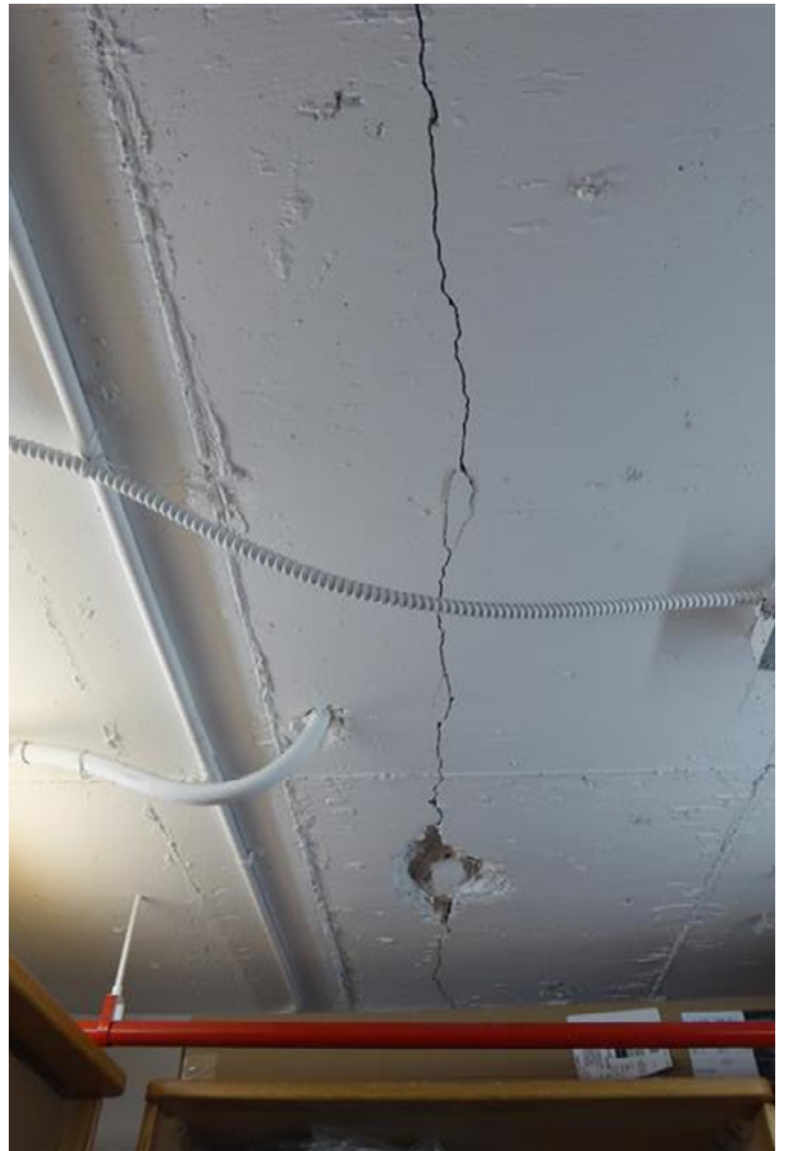
The first floor level is composed of a reinforced concrete slab which is supported by conventional beams and columns.

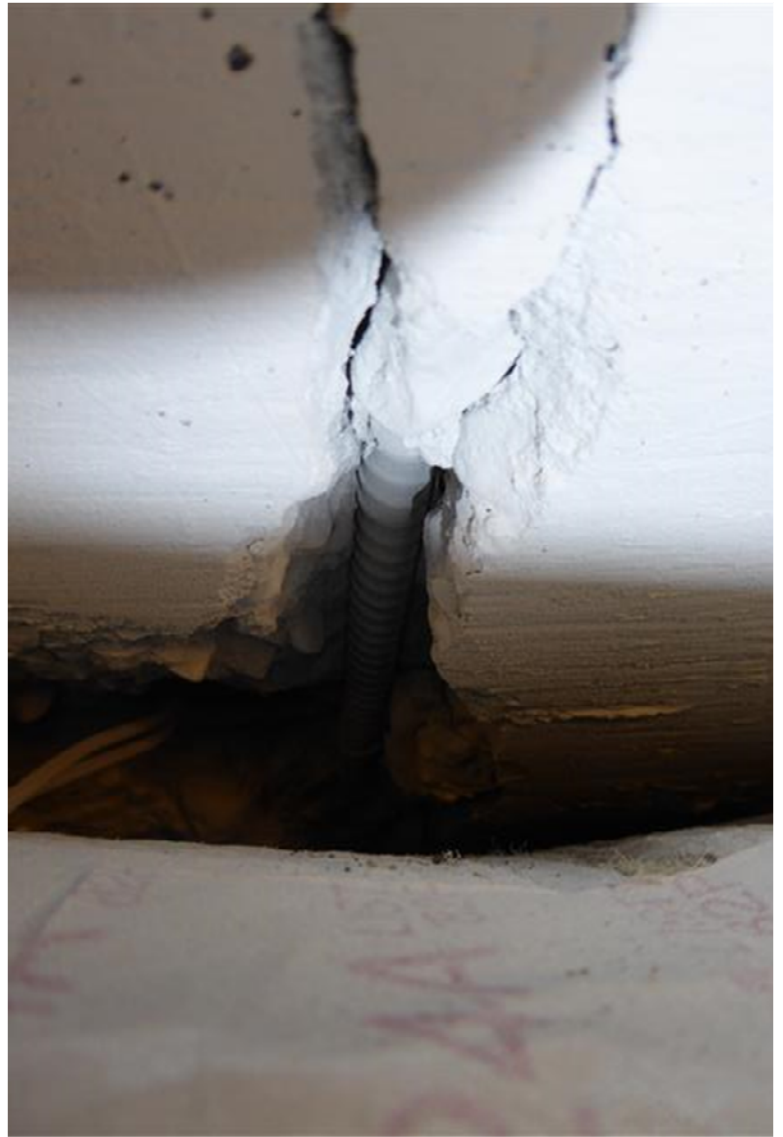
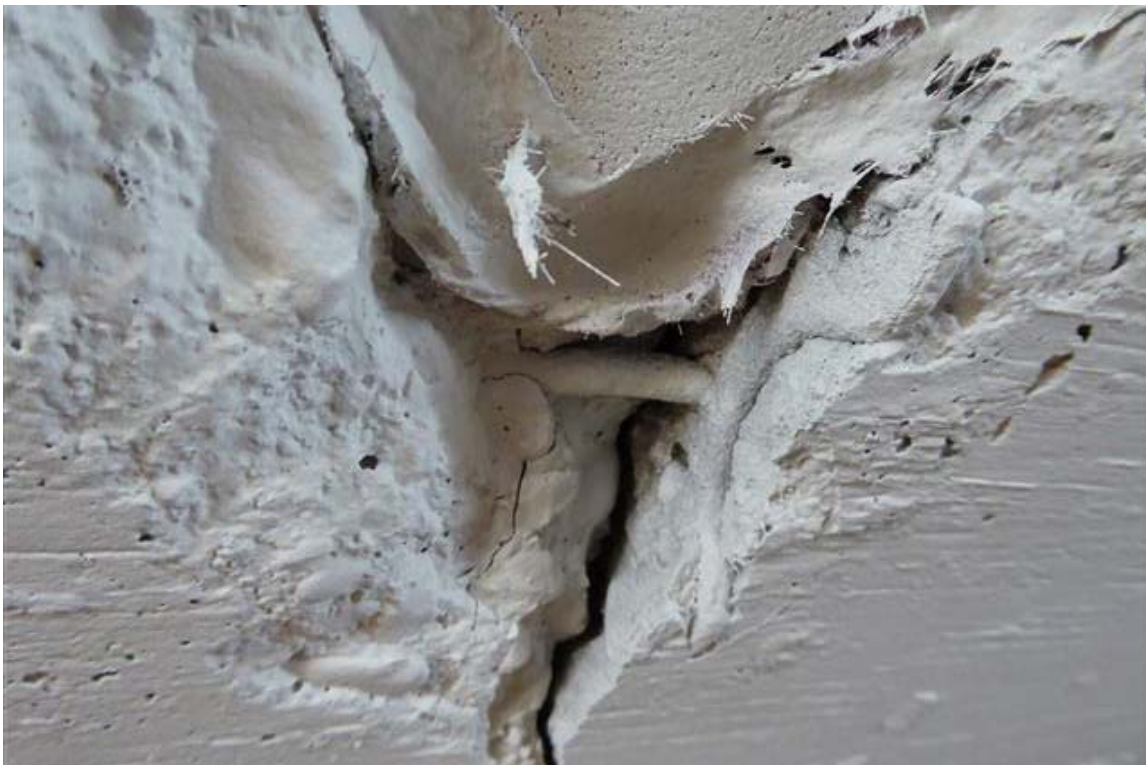
Photo 51  
Close up view of the conduit.

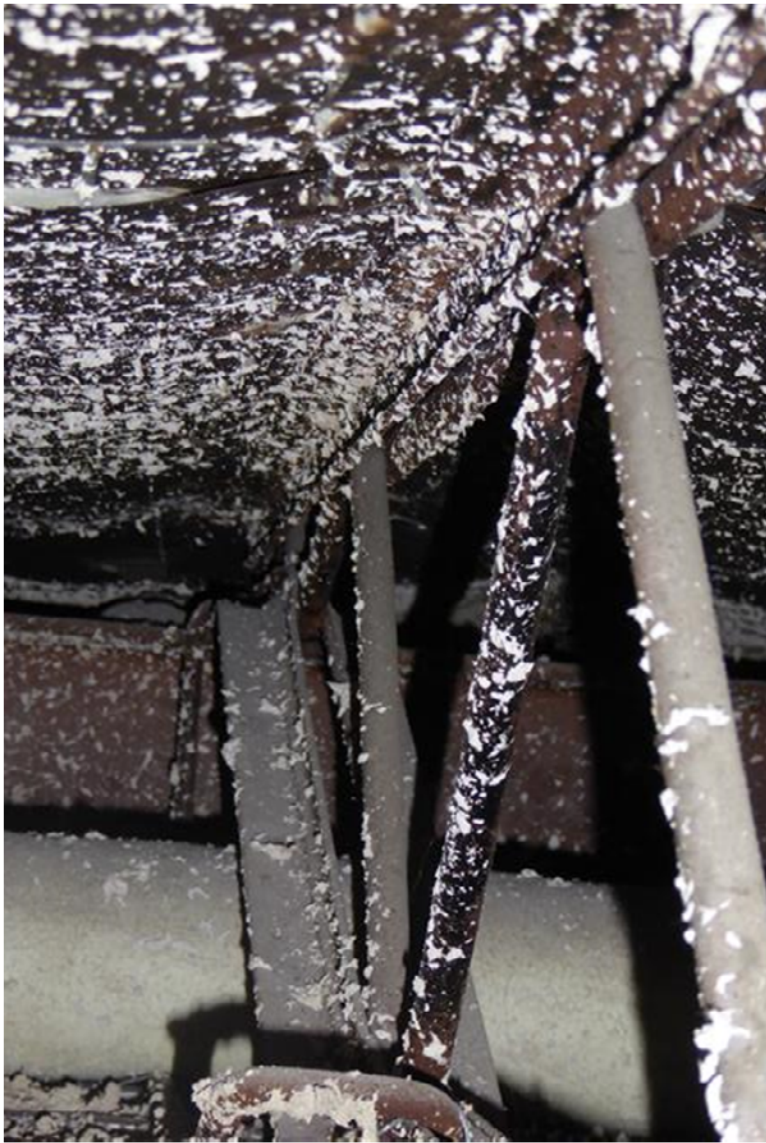
Steel bar joists support the roof slab. The roof slab is concrete which was supported in place with wire reinforced kraft paper.

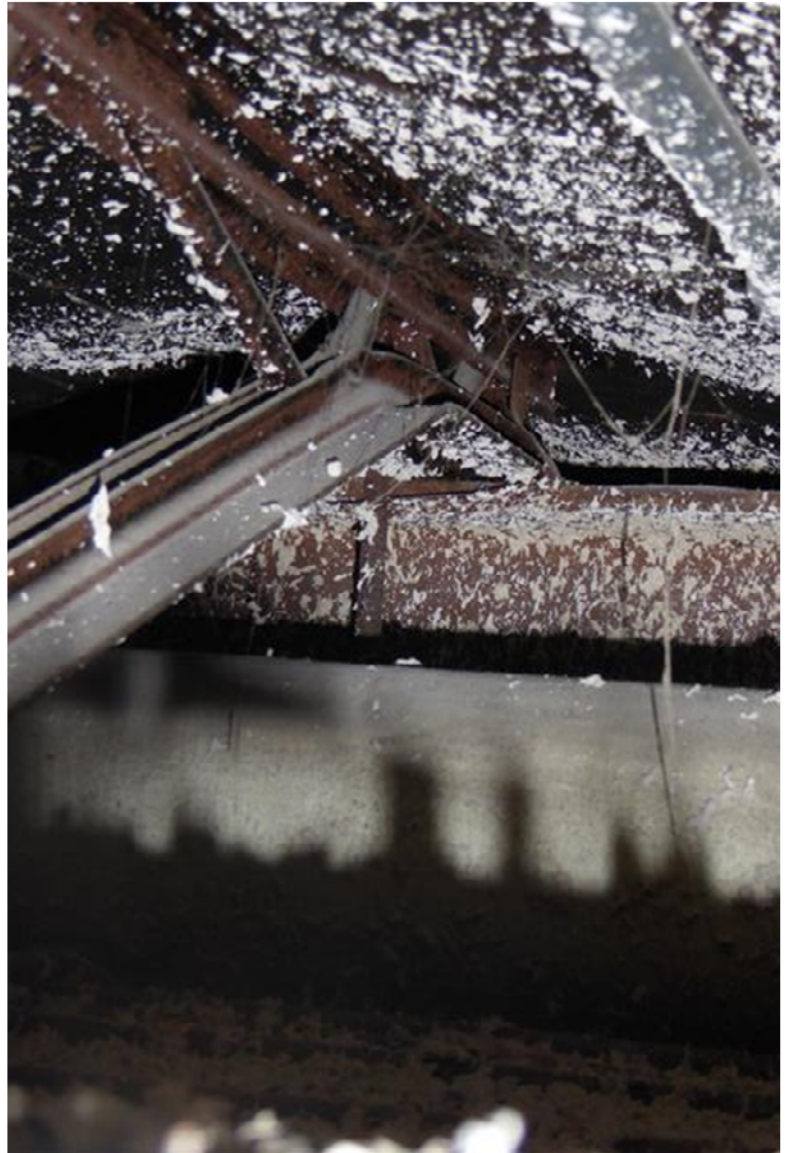
Similar construction was found supporting the second floor slab.

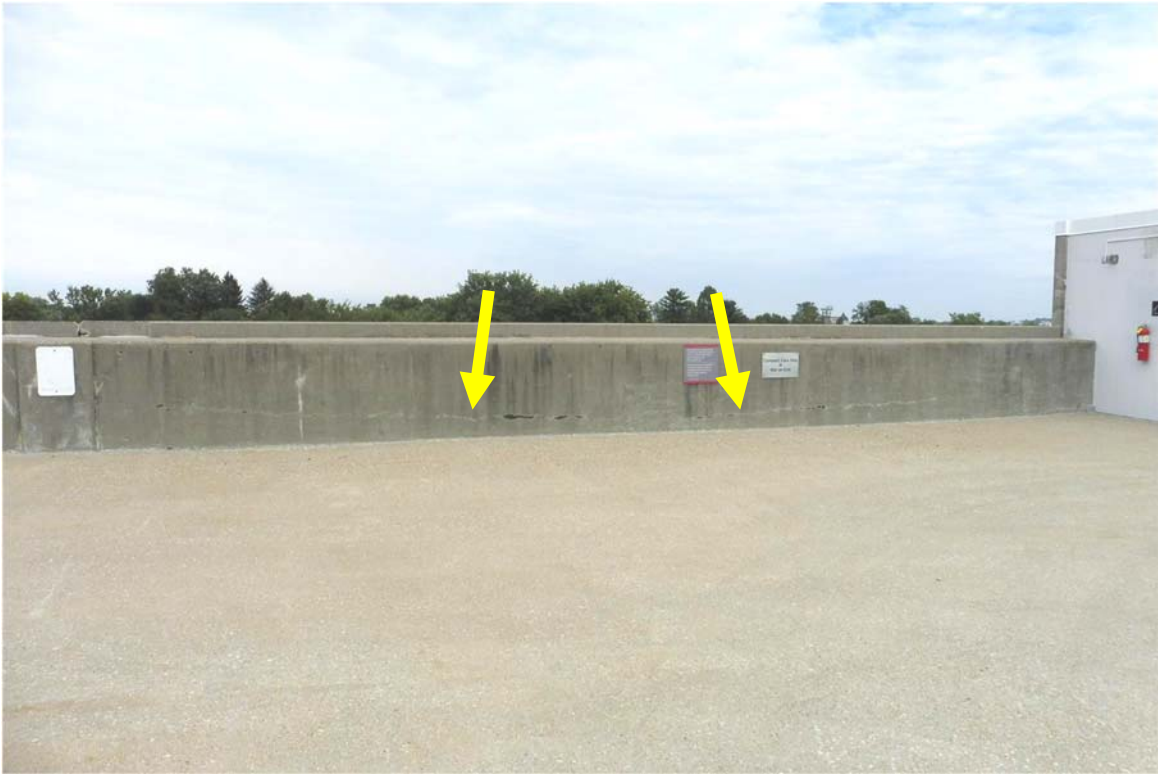
Photo 63 Post-tensioned beam along the north elevation at the roof deck has a crack that appears to follow the drape of the post-tensioning tendons. Grease is leaching from the crack near midspan, meaning that the sheathing has failed possibly due to moisture entering the unbonded tendons.

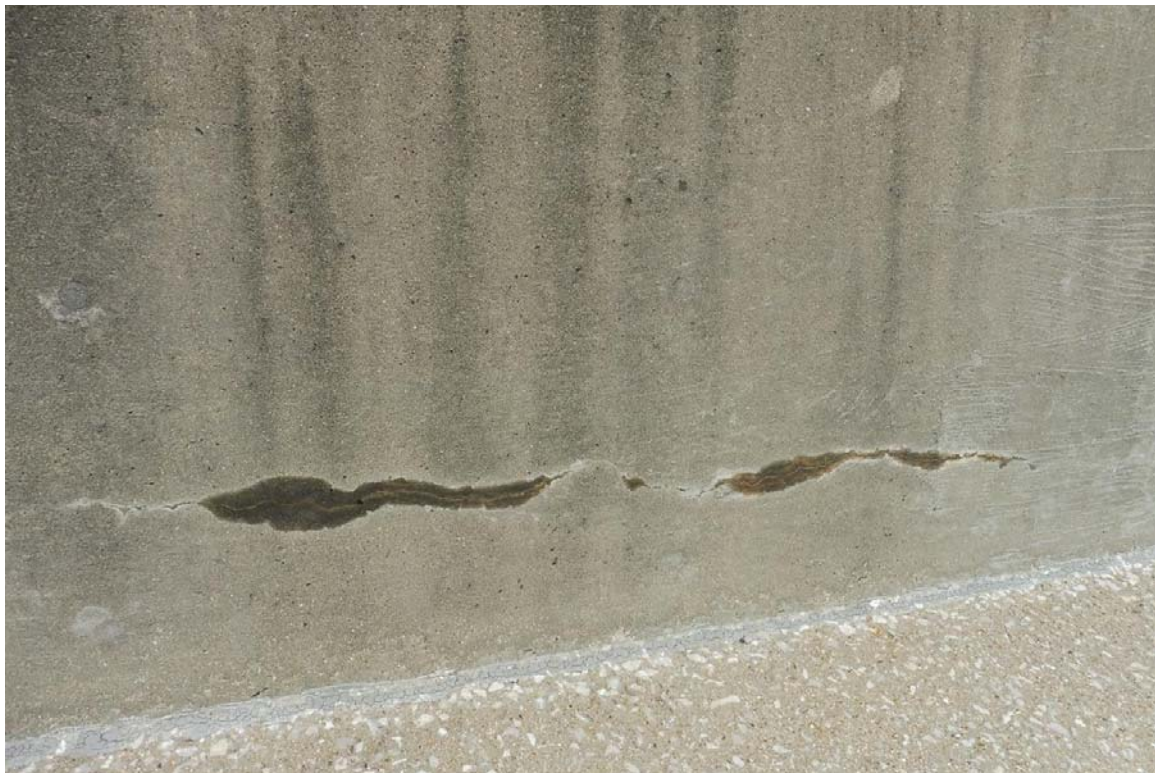
Photo 64 Close-up view of Photo 5.

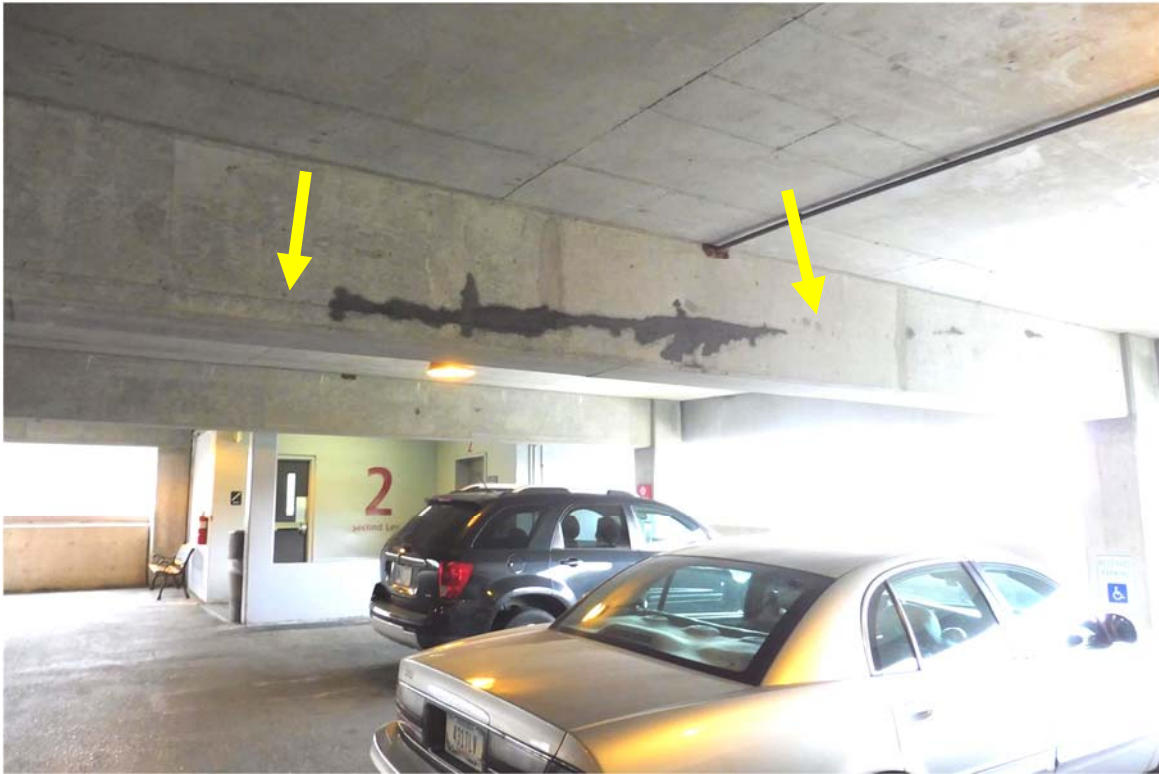
Photo 65 Level 3 beam seen from standing on Level 2 where grease from the tendons has leached out of the crack in the face of the beam.
