# **ARSEE ENGINEERS, INC.**

**CLIENT ORIENTED — BY DESIGN**

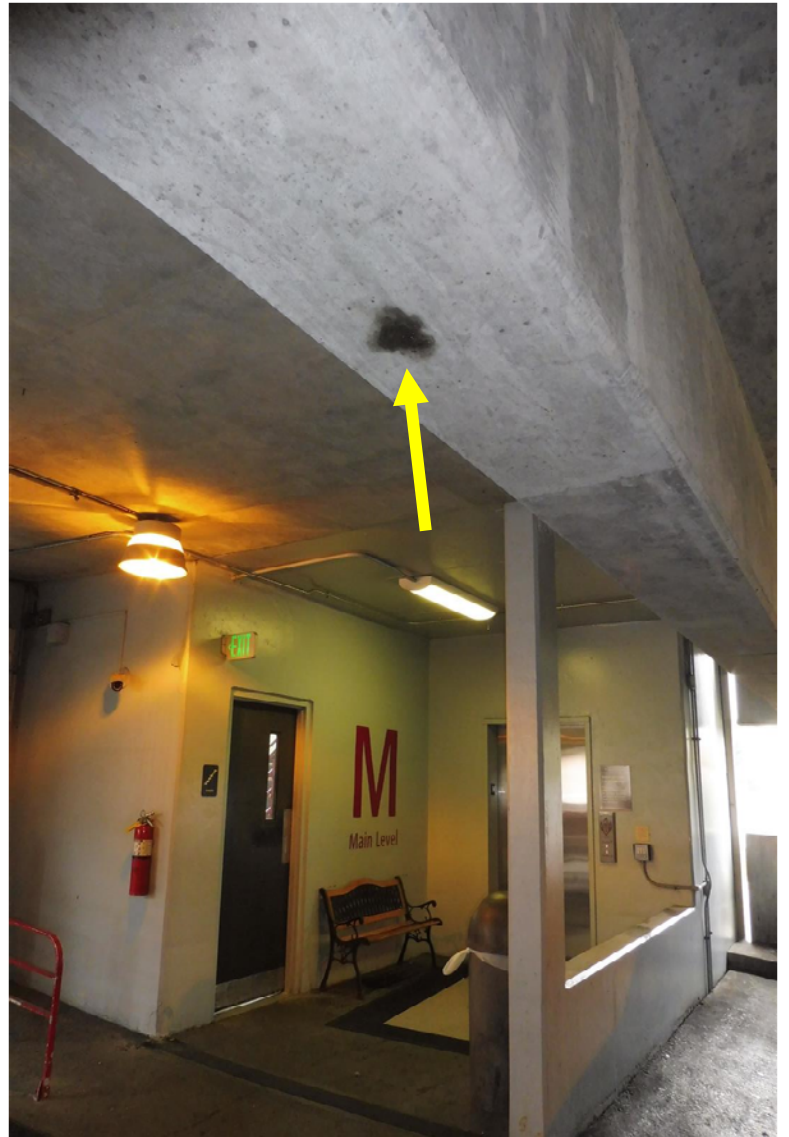
Examples of two additional beam locations where grease staining...

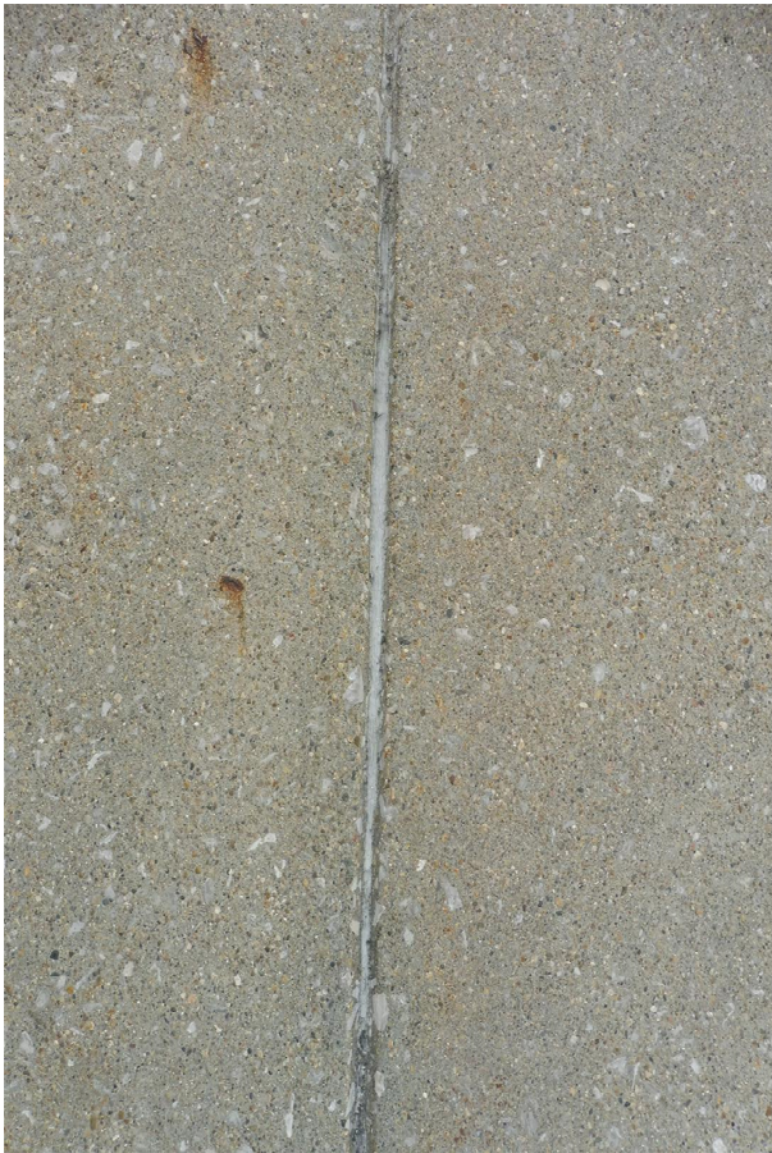
...was observed during the assessment.

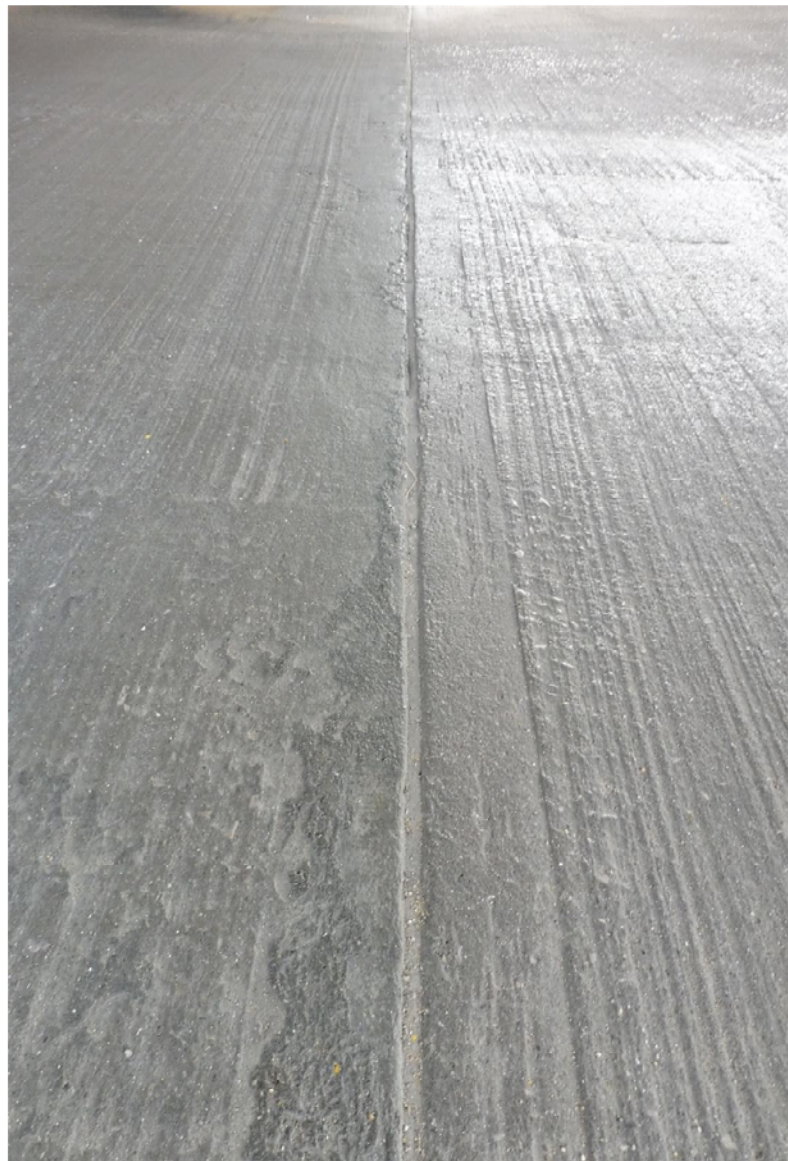
Horizontal sealant joints in the garage are limited to the floor slab pour strip as seen here and...

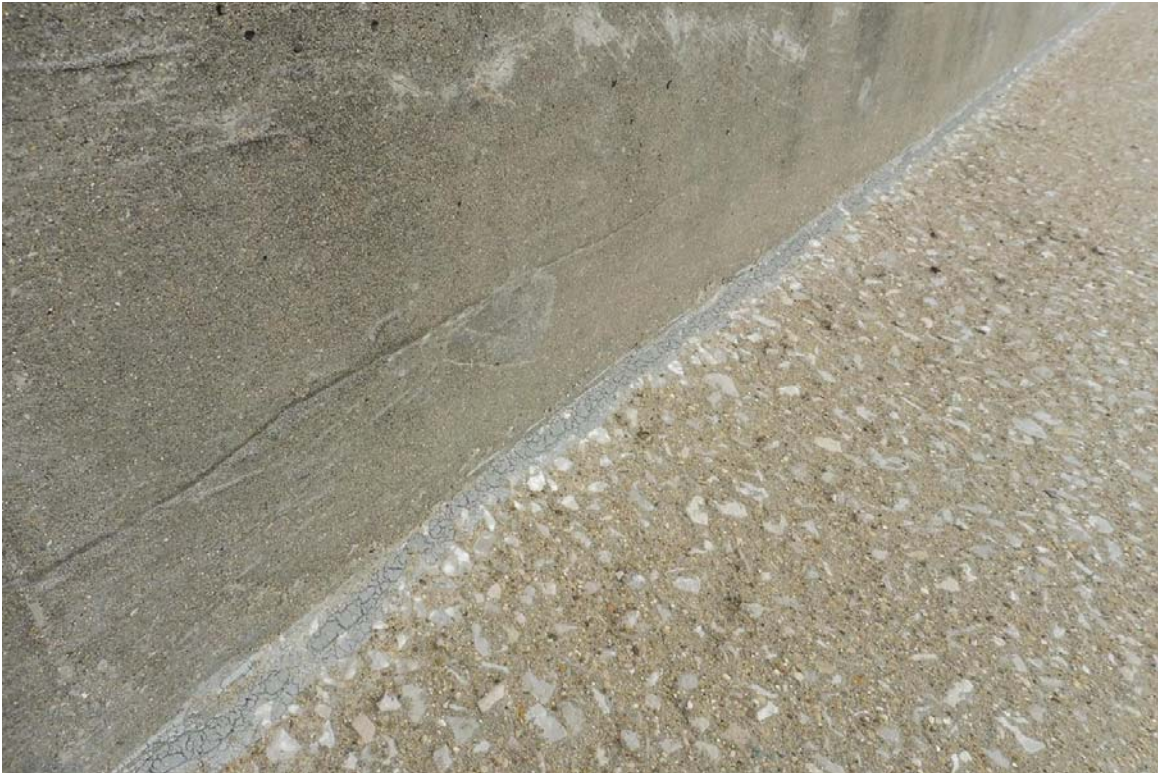
Photo 71 The perimeter sealant joints, however, are in fair to poor condition as many have failed such as the joint seen here on the roof level.

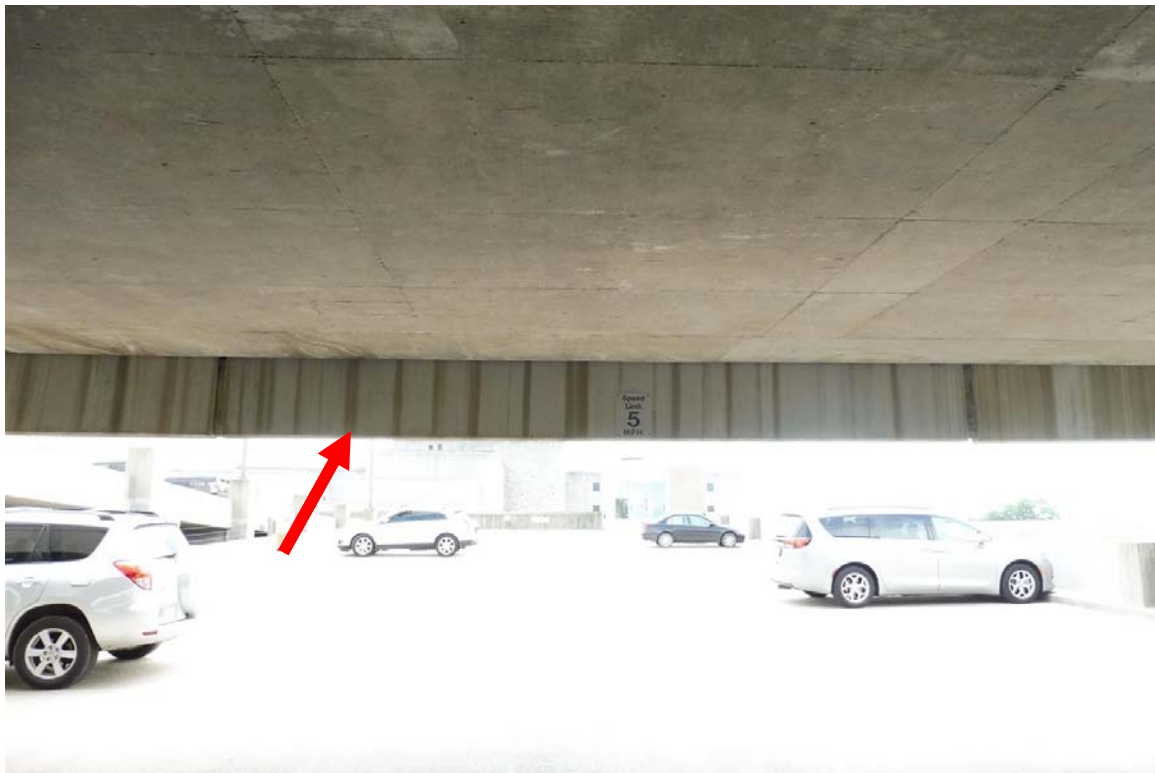
Photo 72 Staining on the back face of the edge spandrel is the result of water migration through the failed perimeter sealant joint above on the roof level.

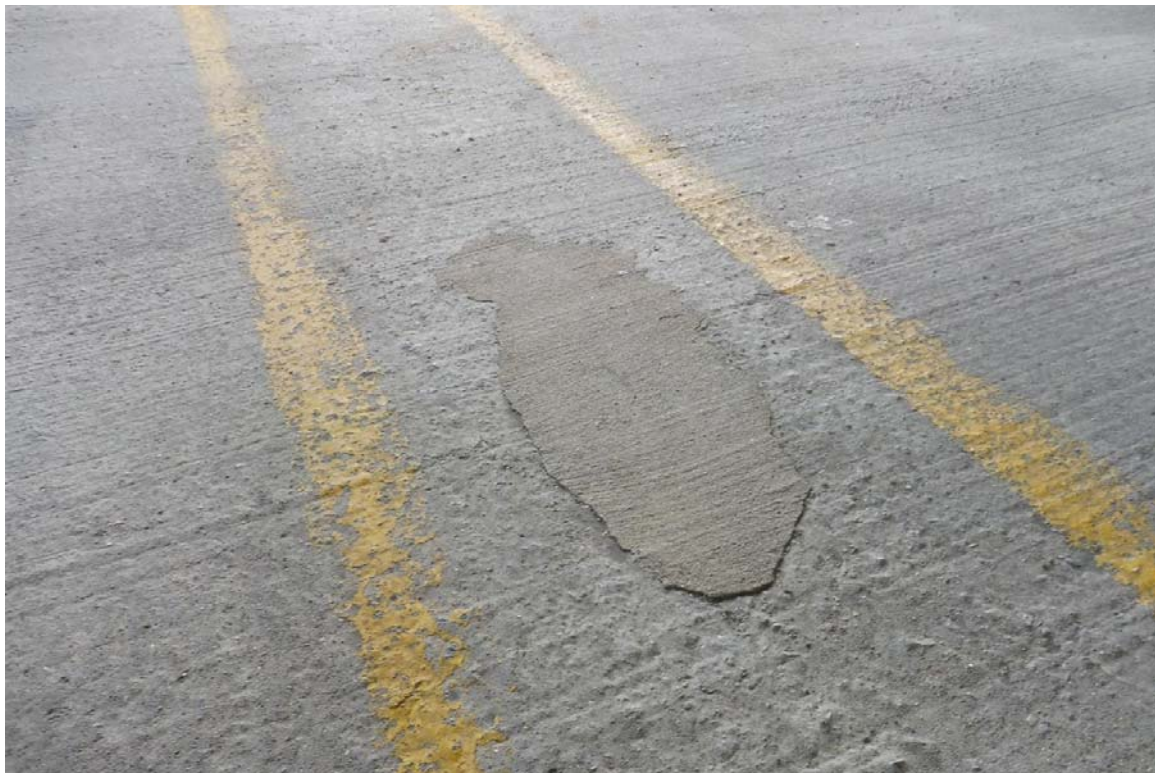
Photo 74 The floor slabs are in good condition while few existing patches were observed. The existing patch seen here was unsound and should be repaired.

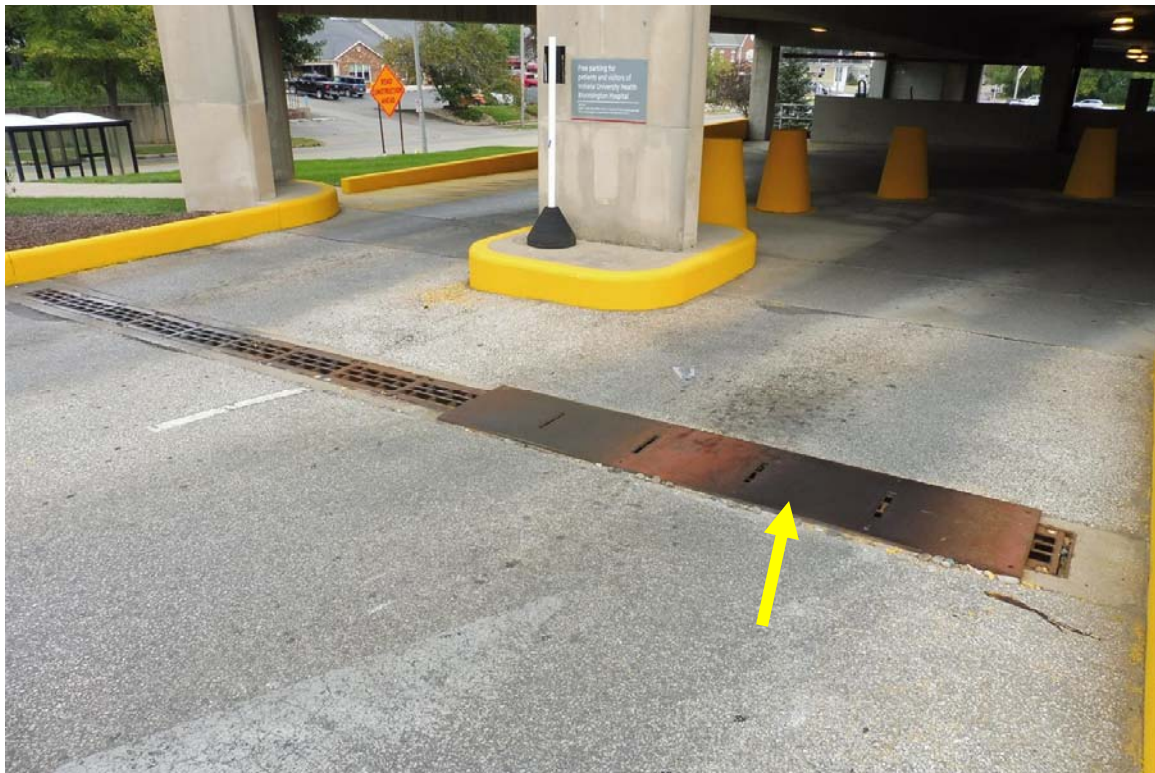
Photo 78 Steel road plate installed over the trench drain at the main entrance. The plate was loose and needs to be re-anchored. The condition of the trench drain below the road plate was not visible.

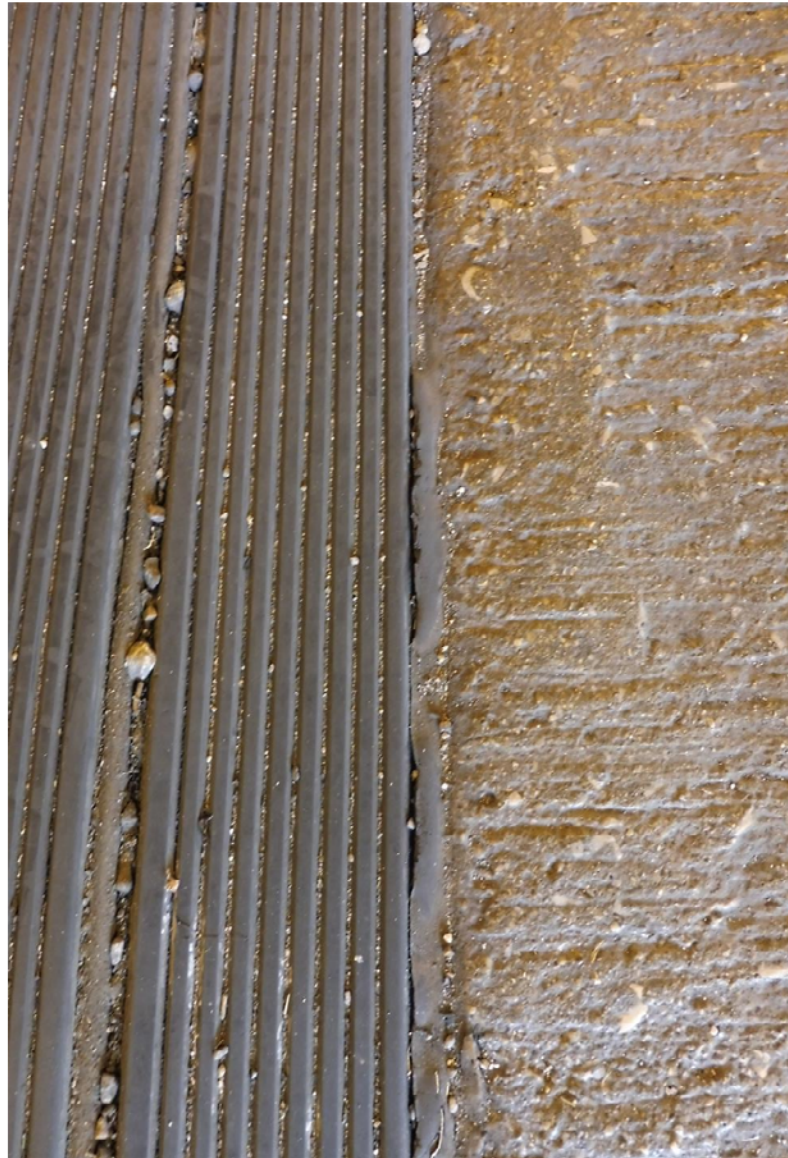
The only expansion joint in the garage exists at the transition between the post-tensioned deck and the slab-on-grade.

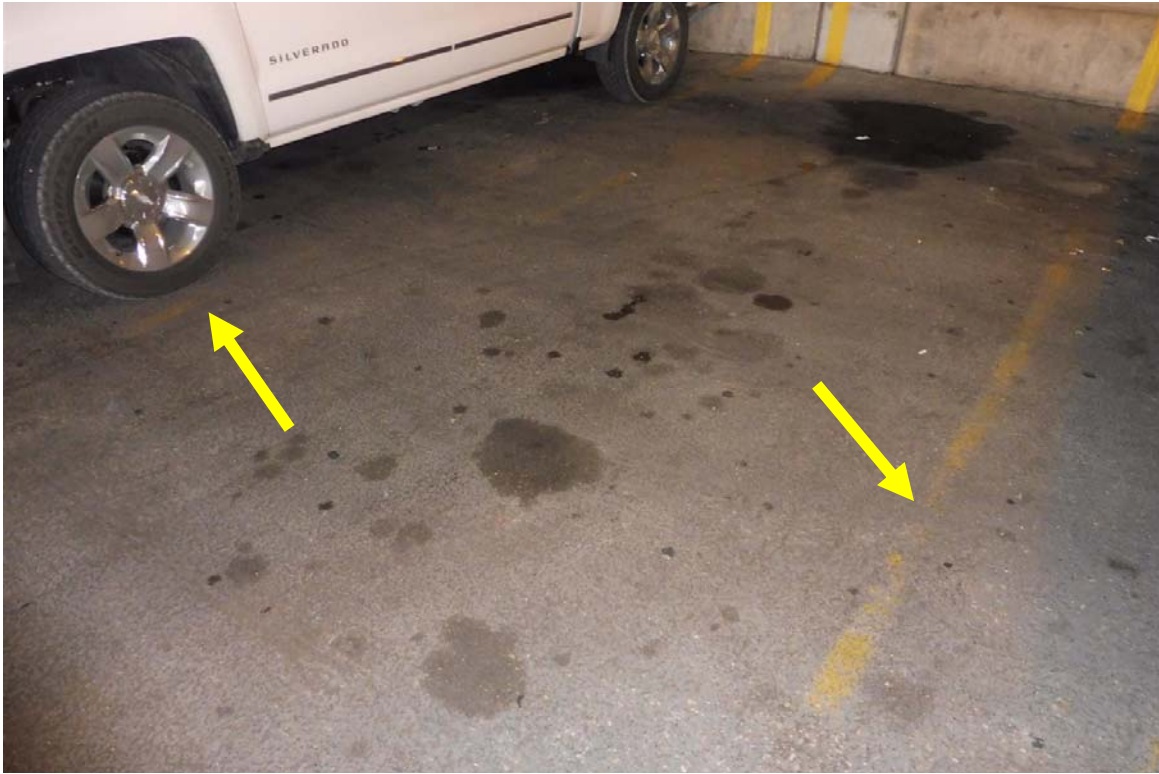
Photo 81 The striping paint throughout the garage should be reinstalled as many of the parking stall lines have faded/worn away.

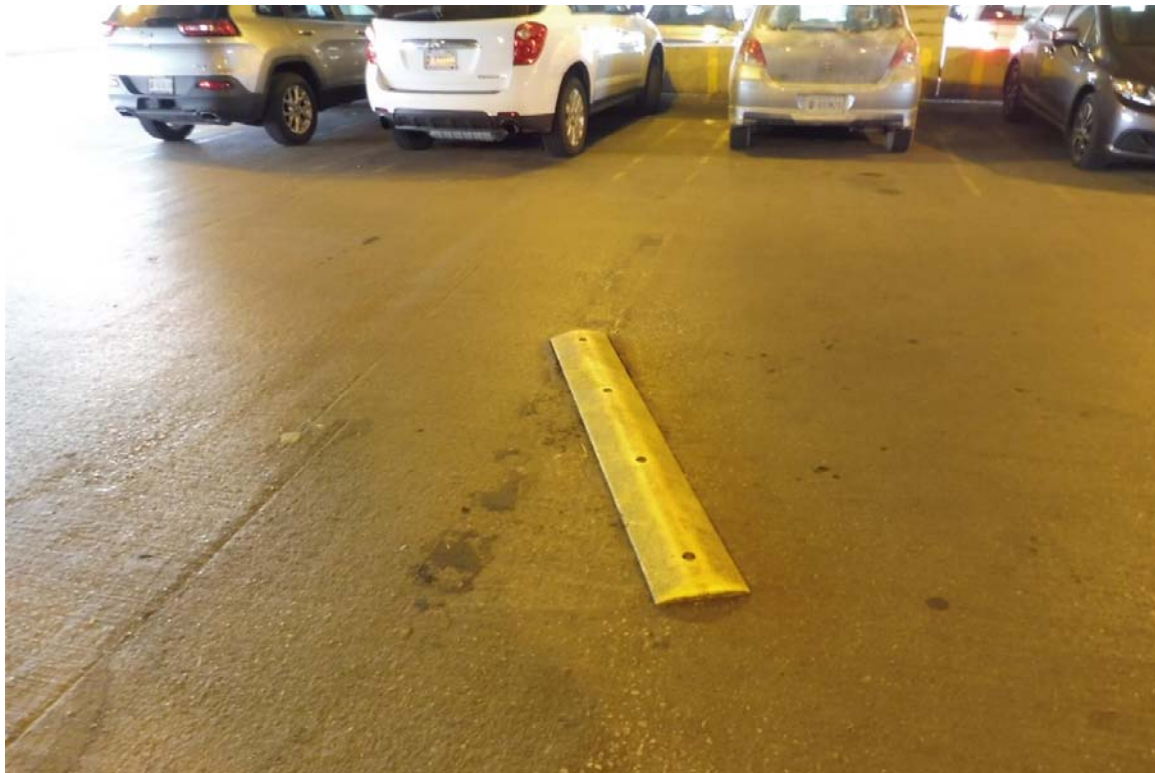
Photo 82 Speed bump devices have been installed. Several were missing and others were loose as seen here.

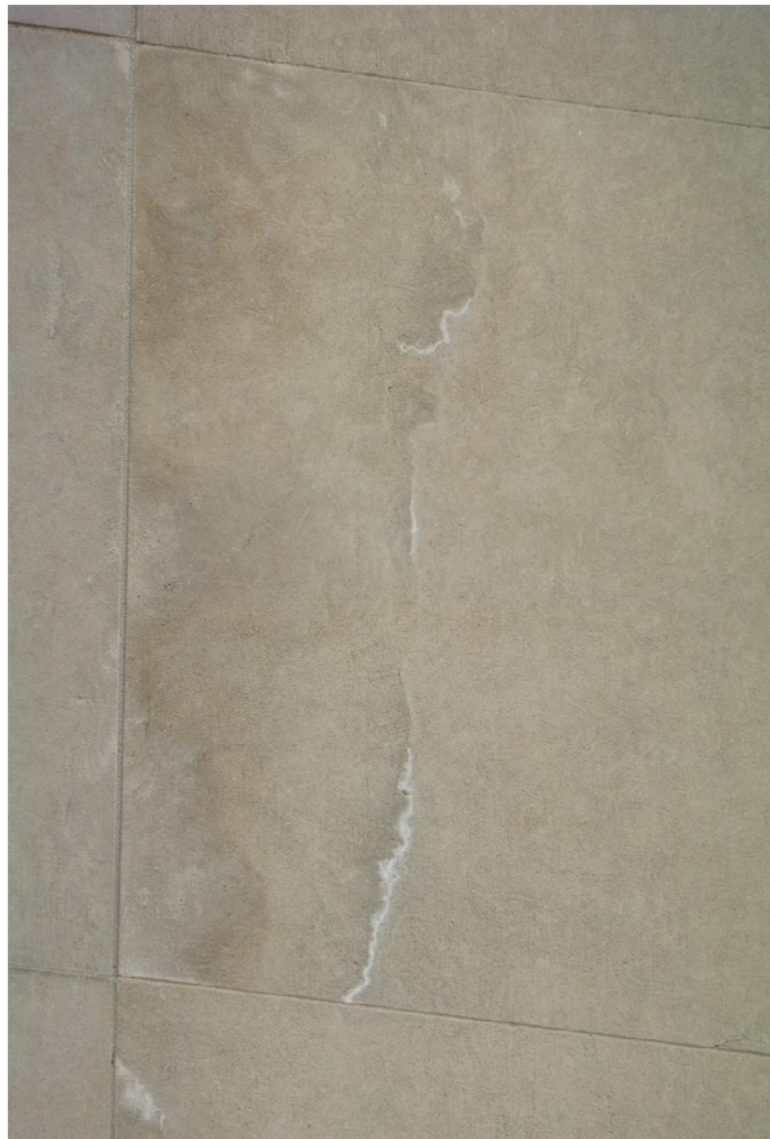
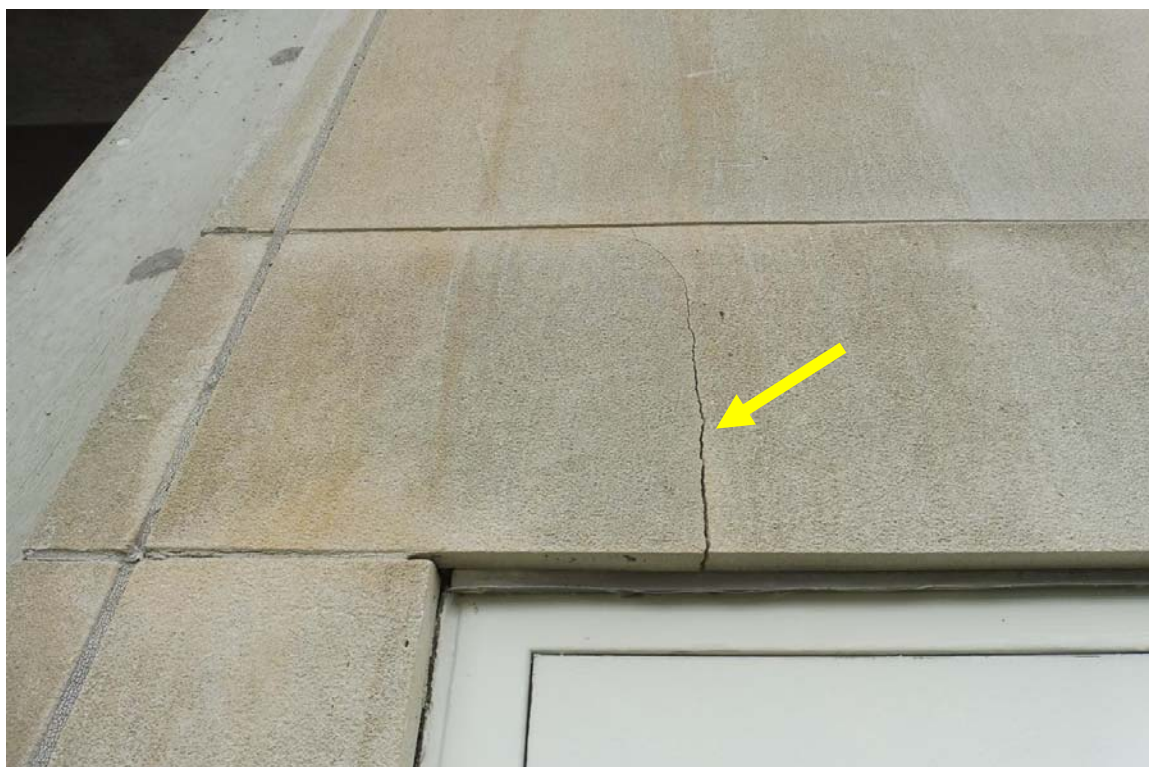
Moisture has migrated through the limestone panel on the stair tower, leaving behind deposits of white staining called efflorescence.

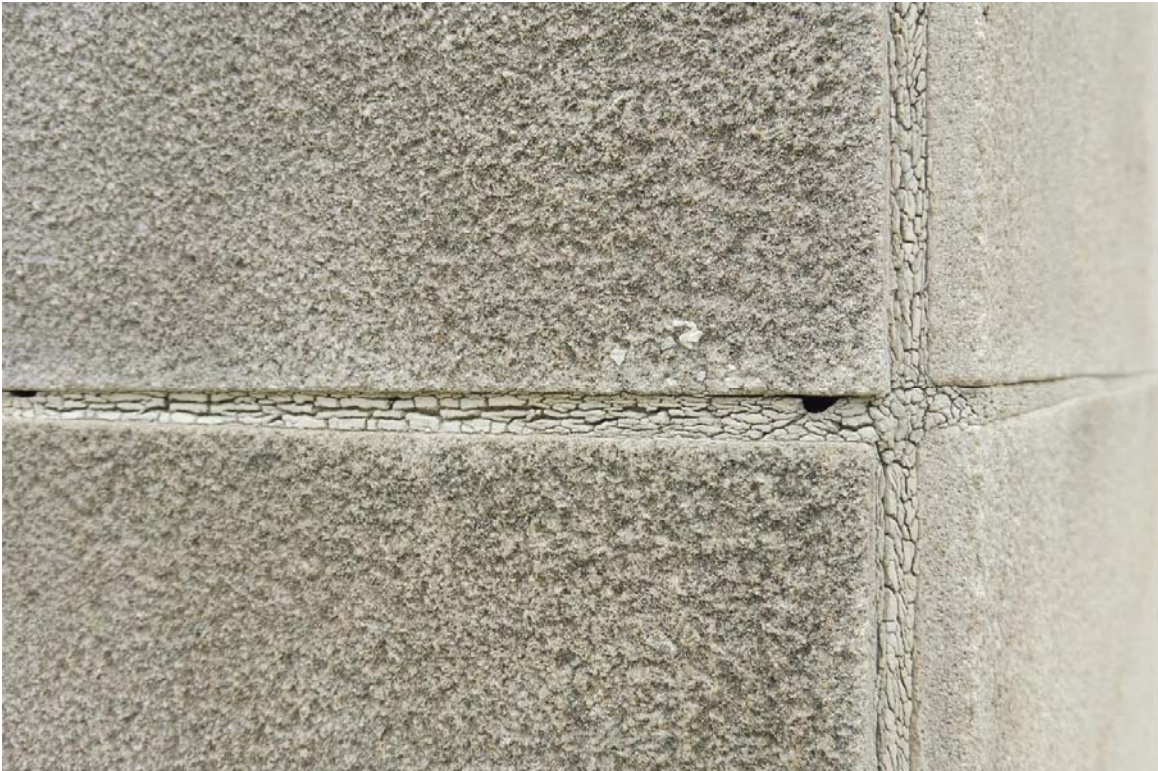
Photo 85 Sealant joints within the limestone panels on the garage...

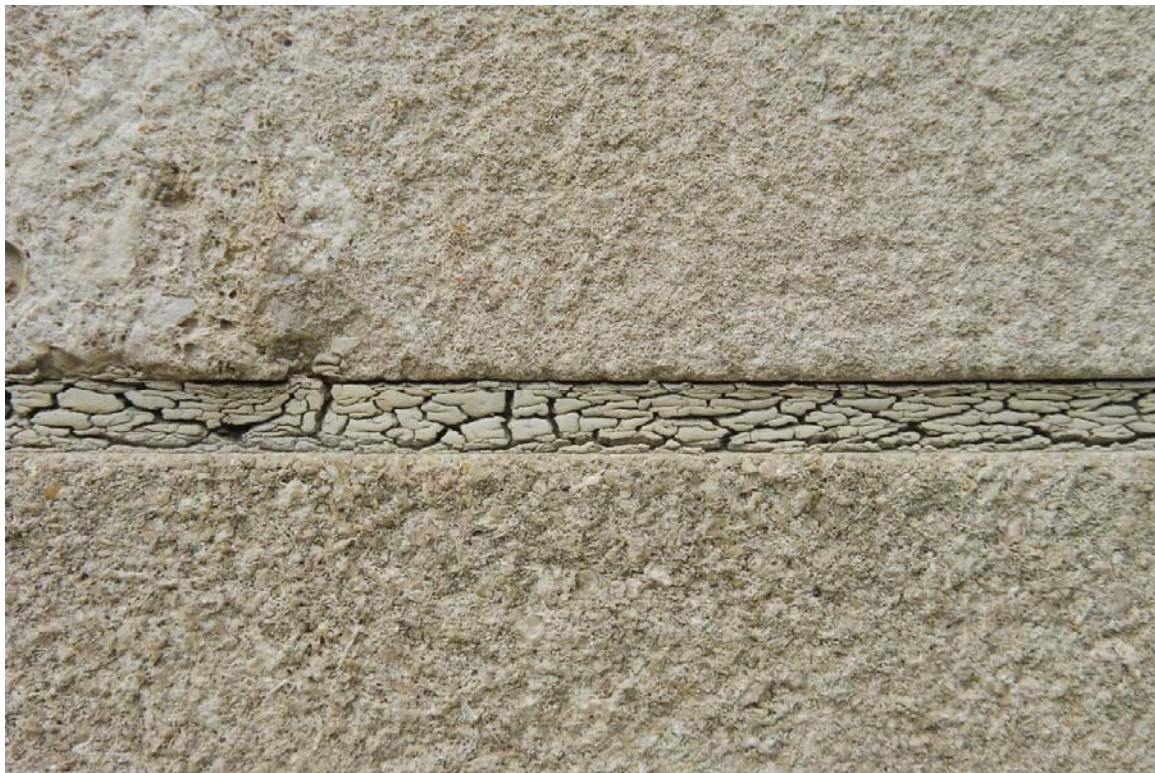
Photo 86 ...have reached their useful service life and should be replaced.

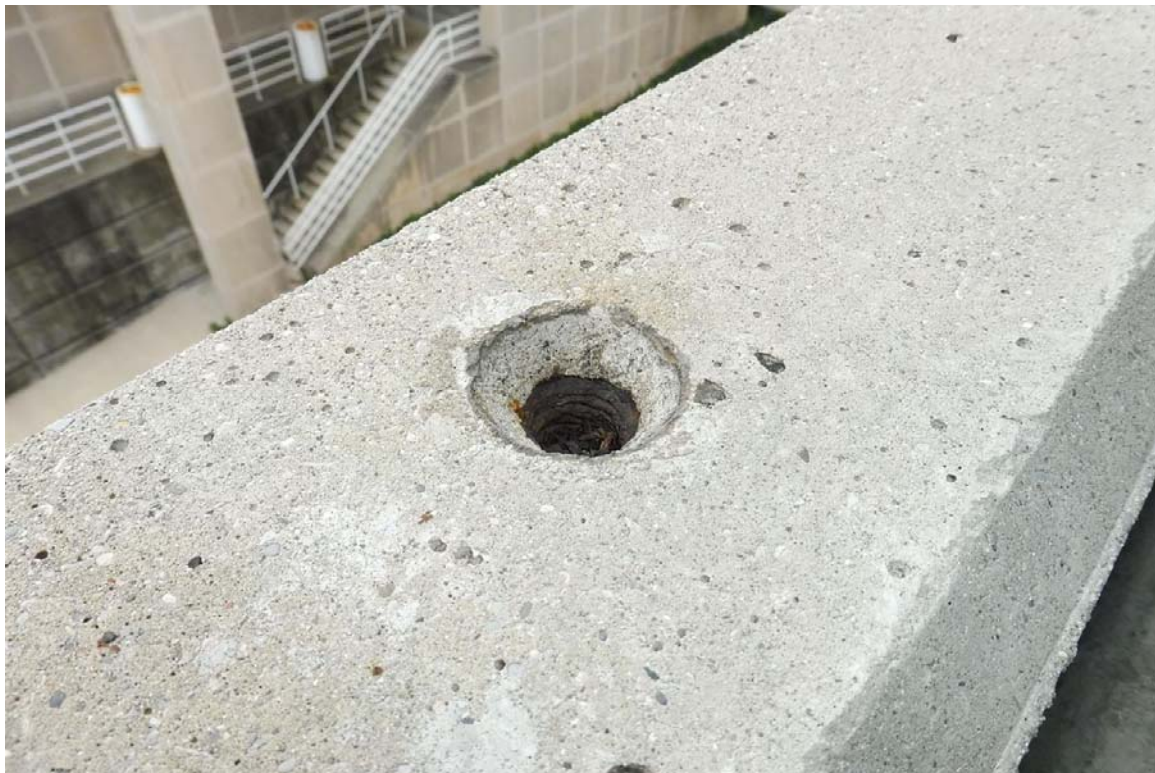
Photo 88 ...should be cleaned and filled with non-shrink grout to keep the metal insert embedment from corroding.

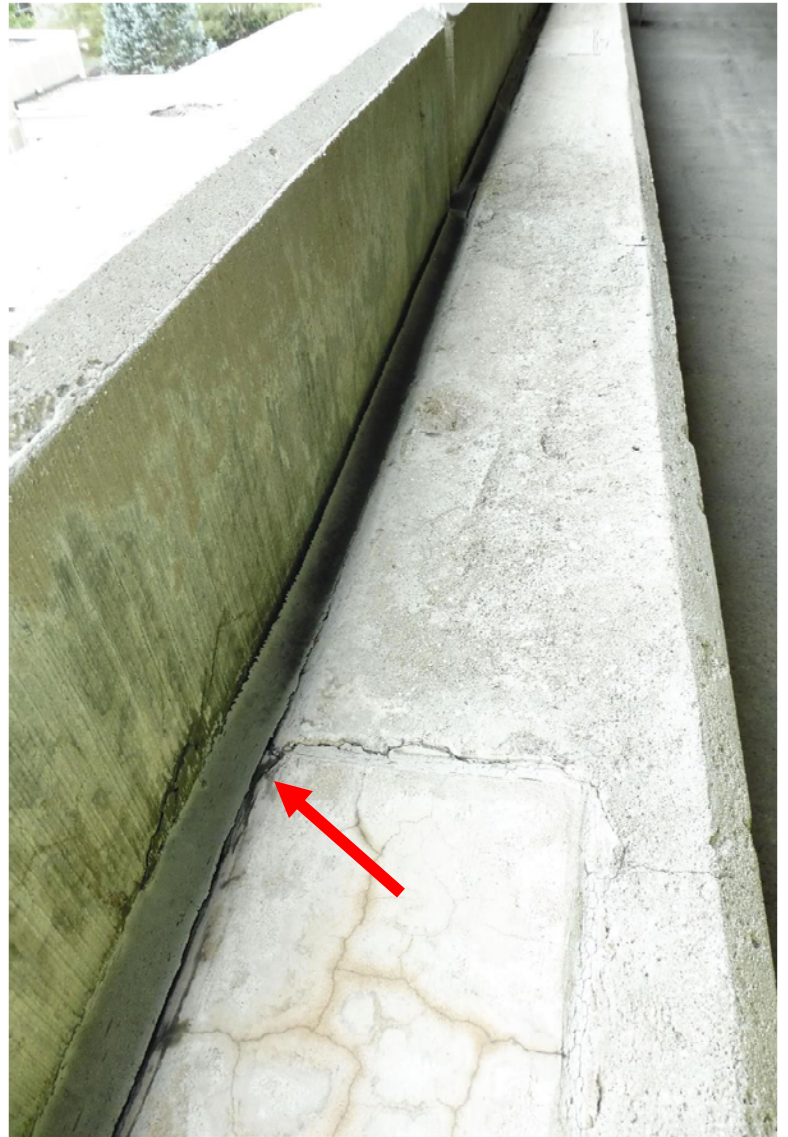
Existing sealant joints between the façade spandrels and the garage structure have failed in many locations. The premold type membrane installed over the connections were also failed at some locations.

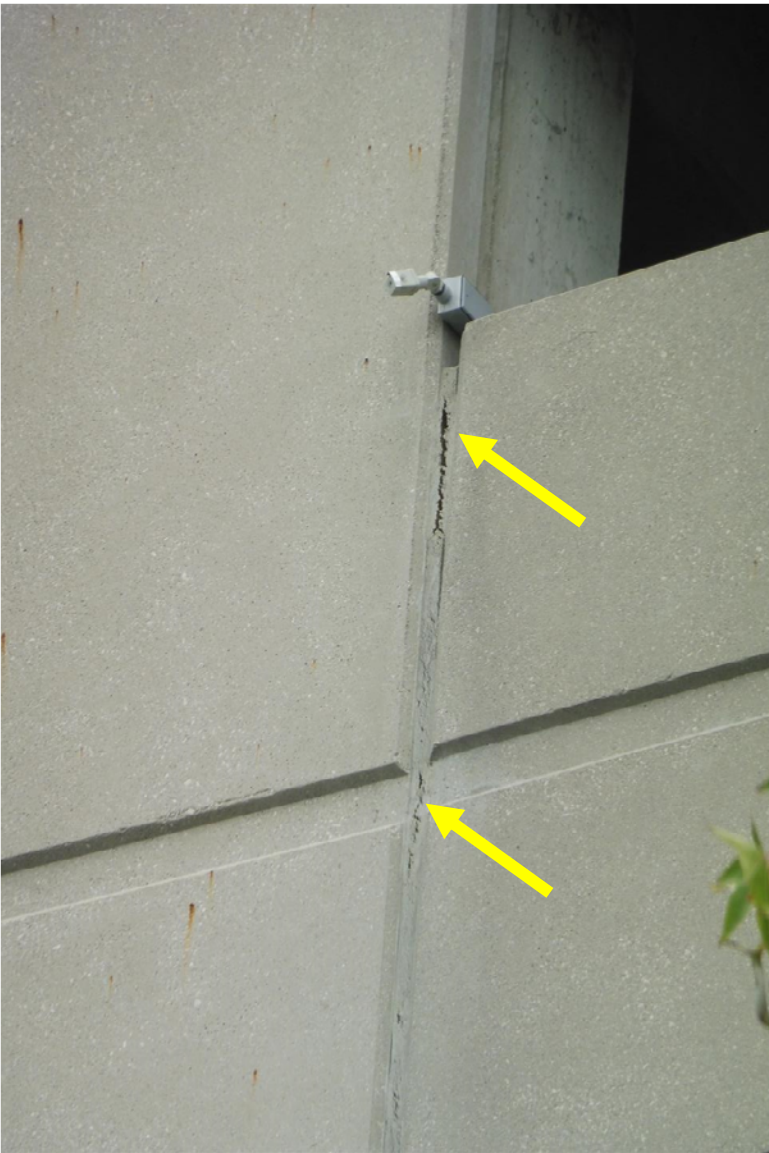
The sealant joints throughout the precast façade...

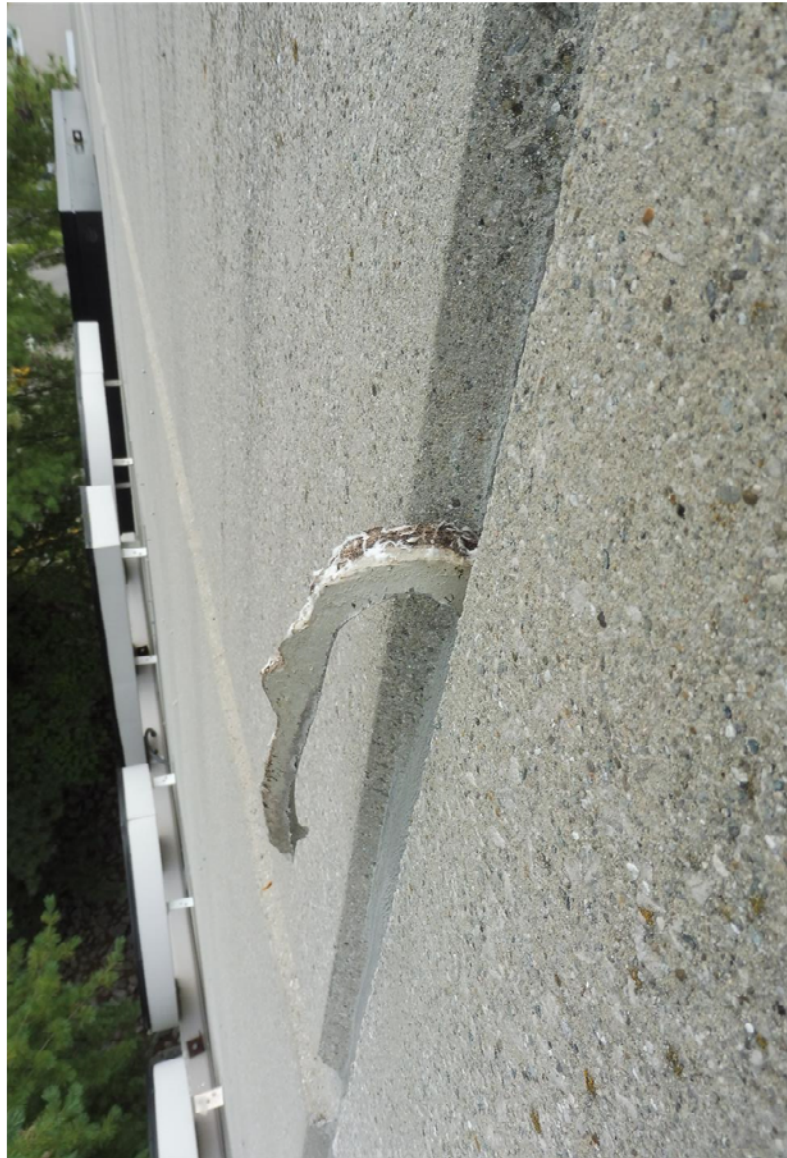
...have failed in most locations and need to be replaced.

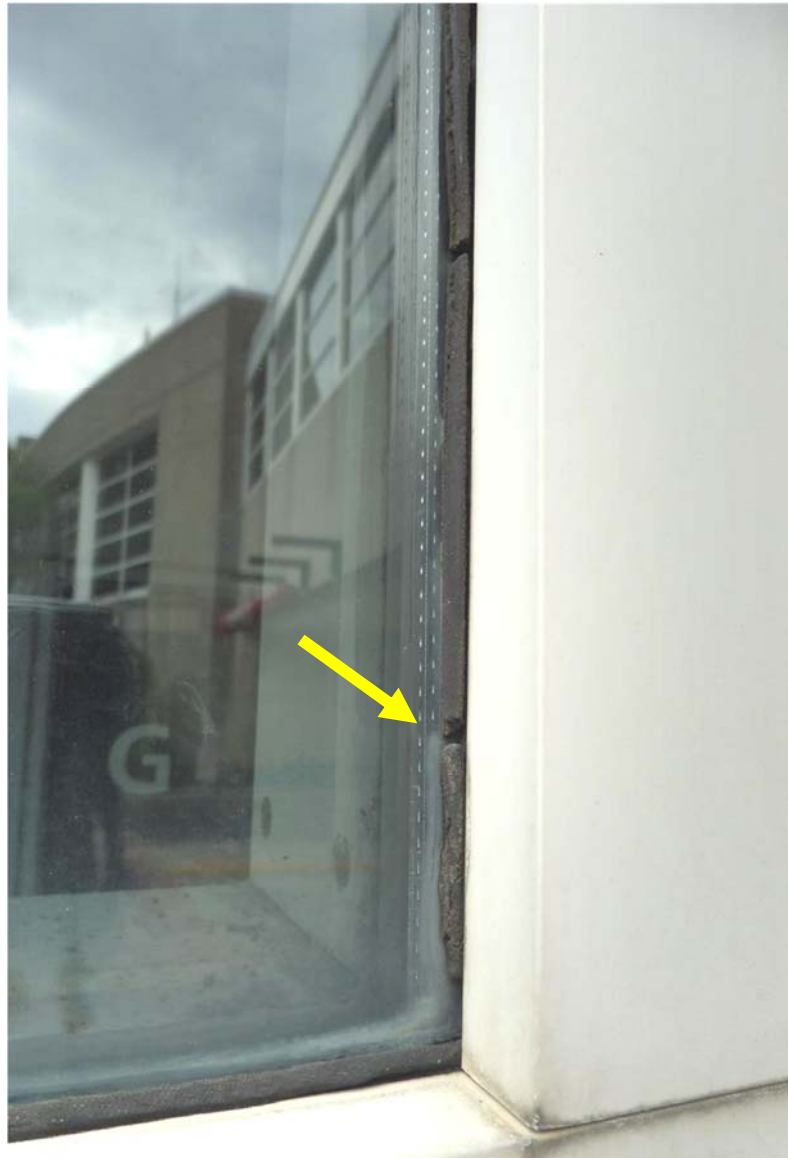
Sealant joints between the limestone and curtain wall system have failed in multiple areas.

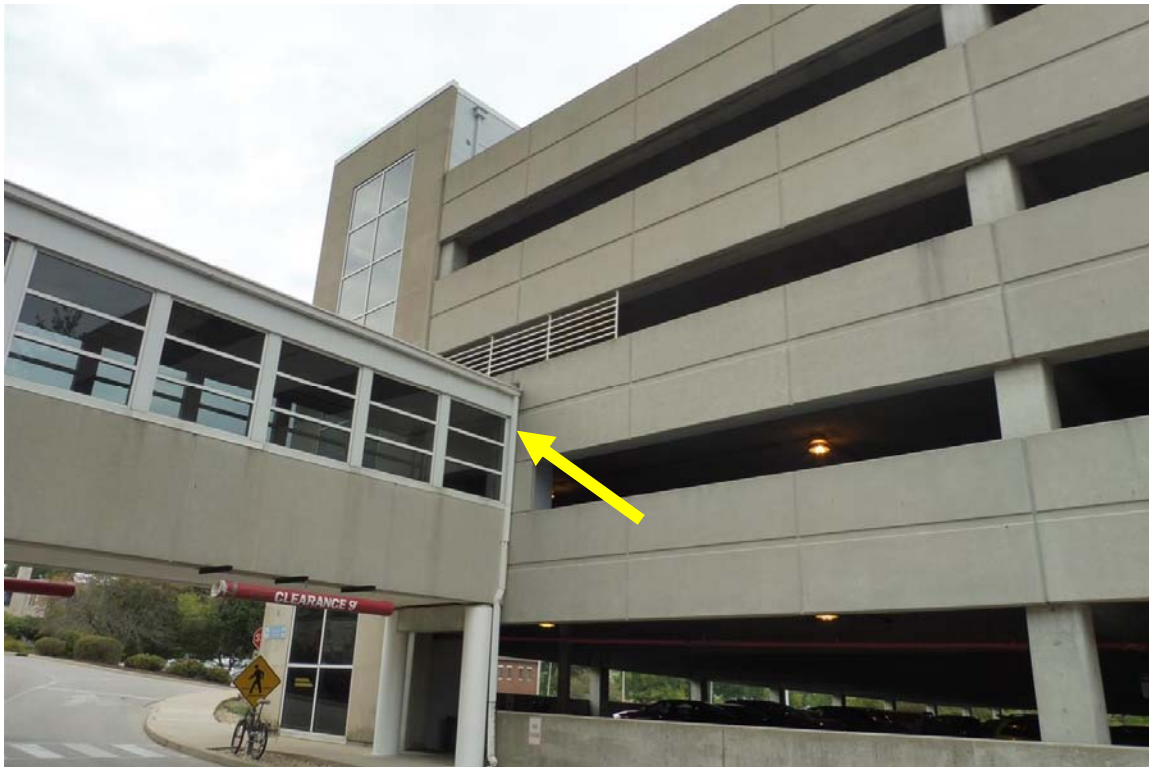
Gaskets in the curtain wall system have shrunk and many have failed. They should be removed and either replaced with new gasket material or wet sealed with liquid sealant.

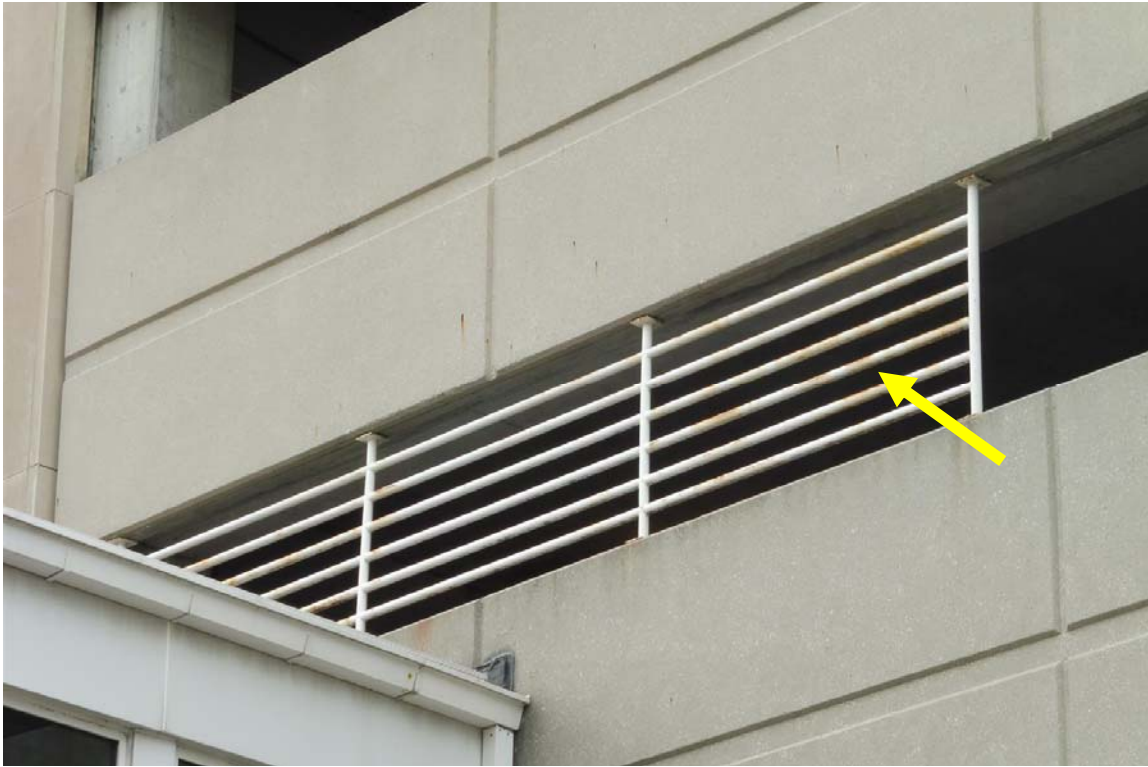
...rework of the existing precast spandrel will be necessary to create a Code compliant guardrail.

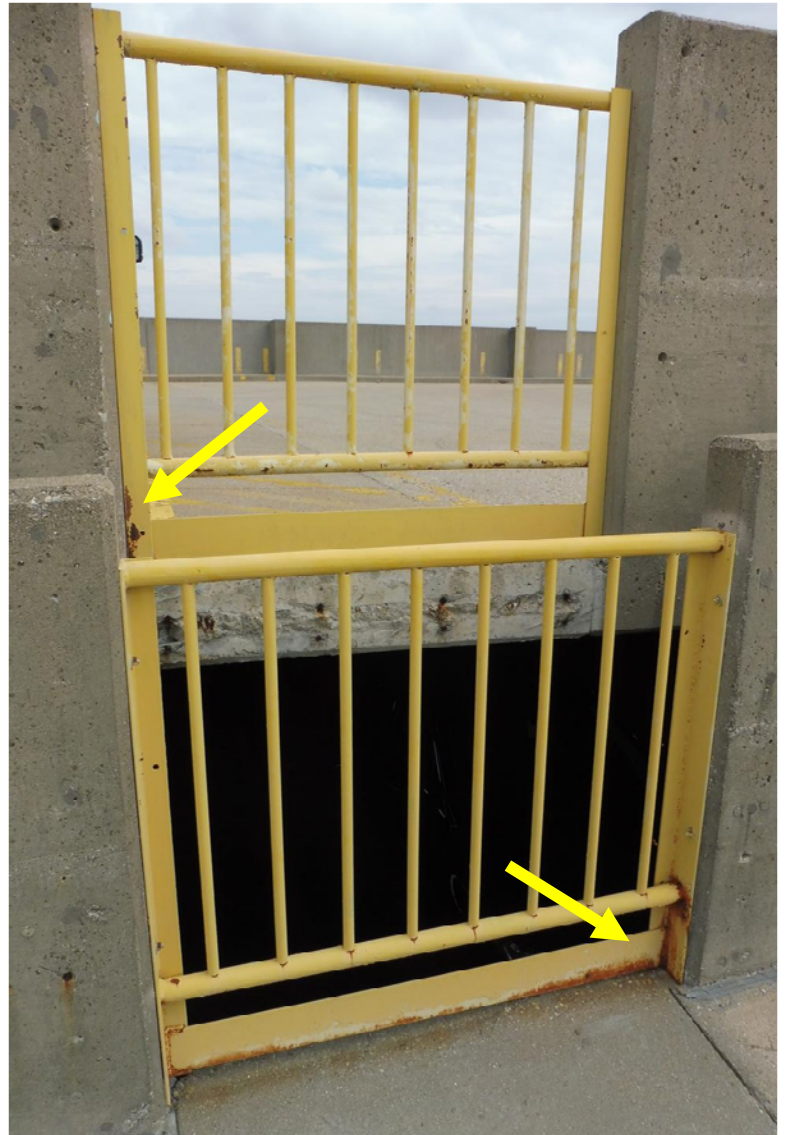
Miscellaneous steel throughout the garage has rusted...

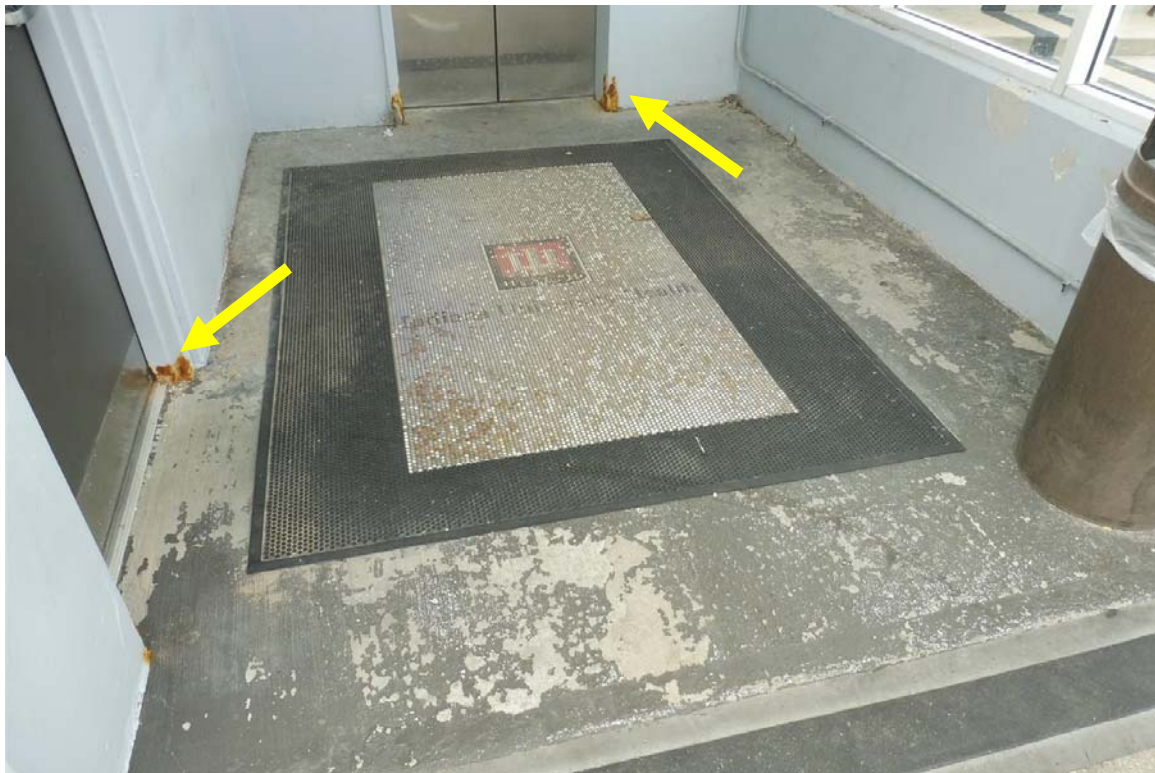
Photo 100 The existing floor coating throughout the stair/elevator tower has failed. Corrosion of the door frames both to the stair and the elevator were observed on each level.

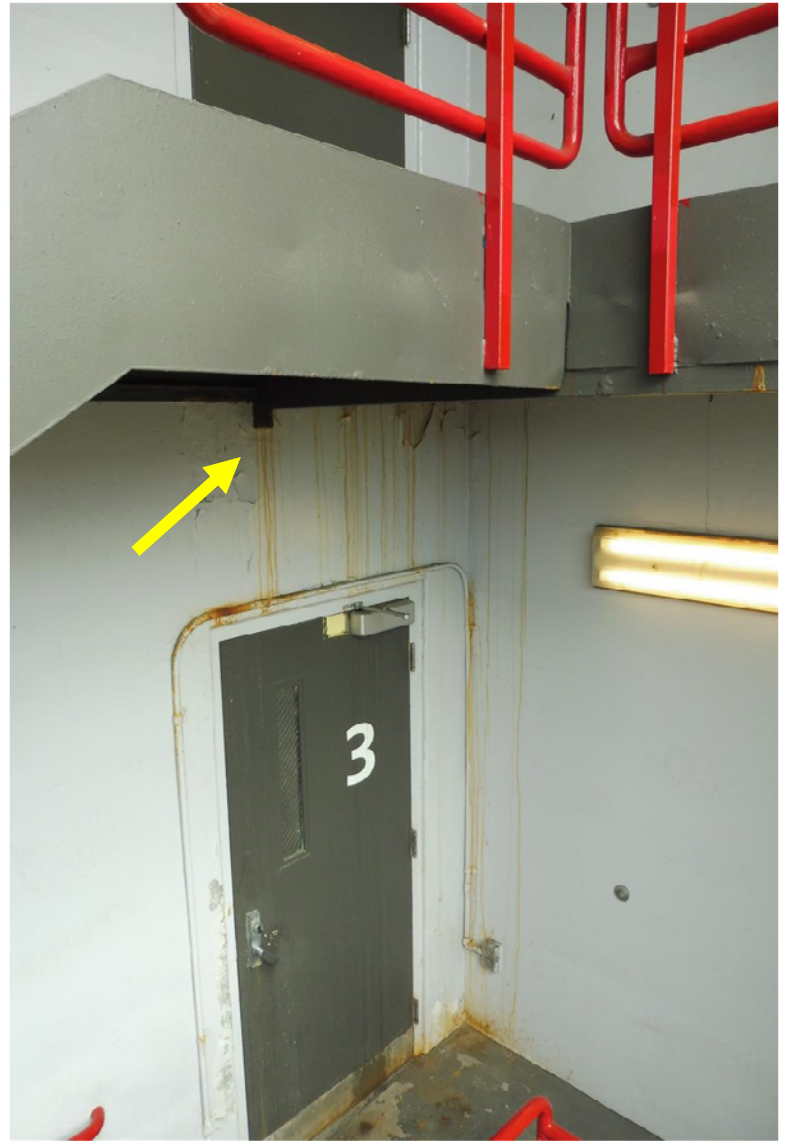
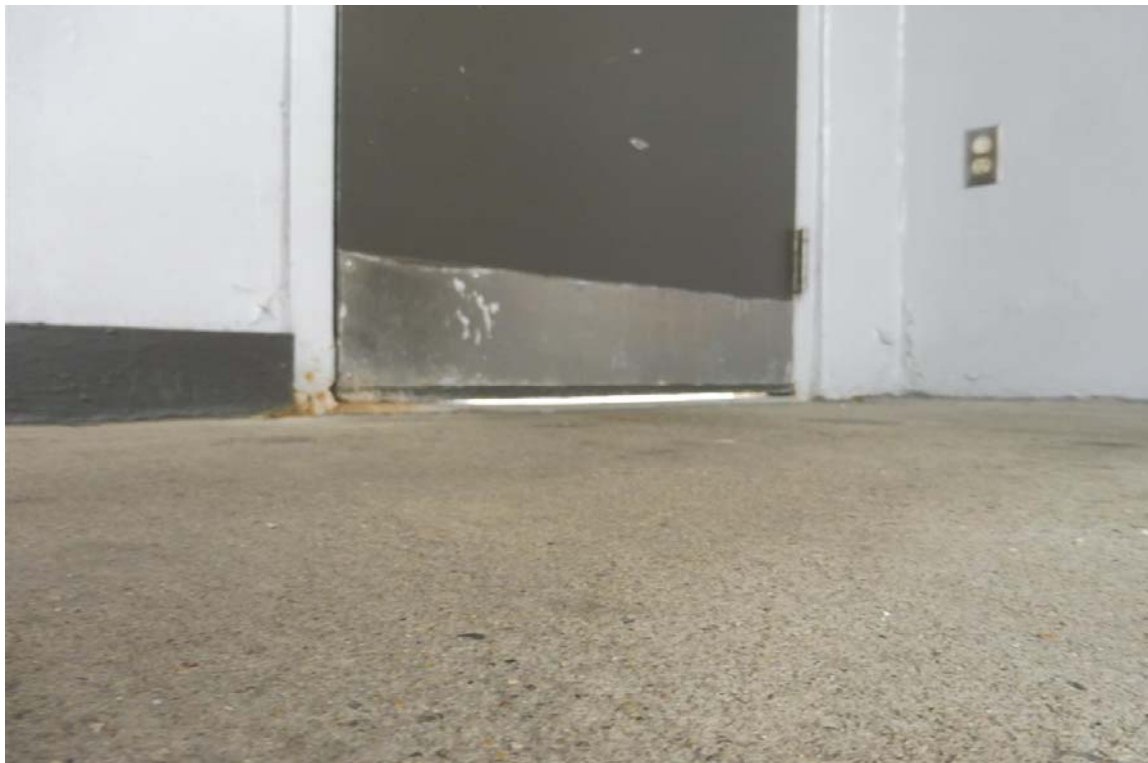
Water infiltration has caused corrosion of the steel stair structure and failure of the coating on the concrete walls inside the stair.
