# **ARSEE ENGINEERS, INC.**

**CLIENT ORIENTED — BY DESIGN**

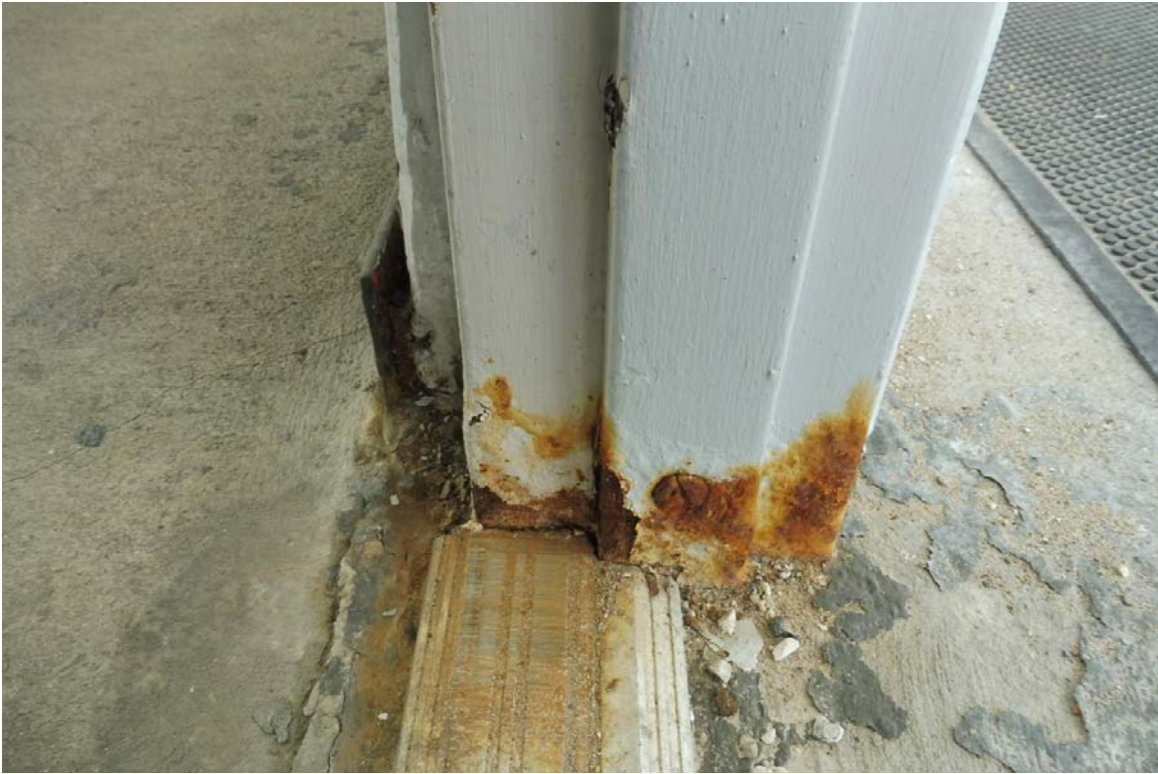
Photo 103 Corrosion at the bottom of the door frames...

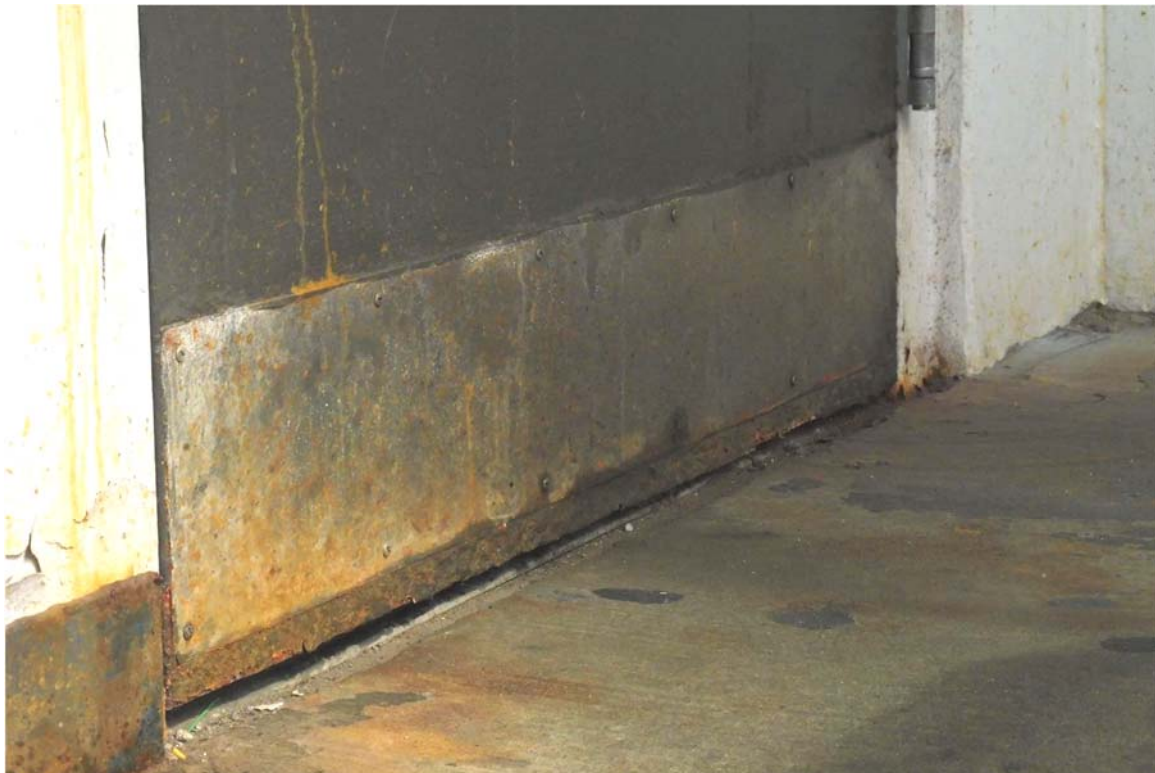
Photo 104 ...as well as the hollow metal doors was observed on each level of the southwest stair. Regular maintenance of the coatings on the doors and frames will help minimize the corrosion levels.

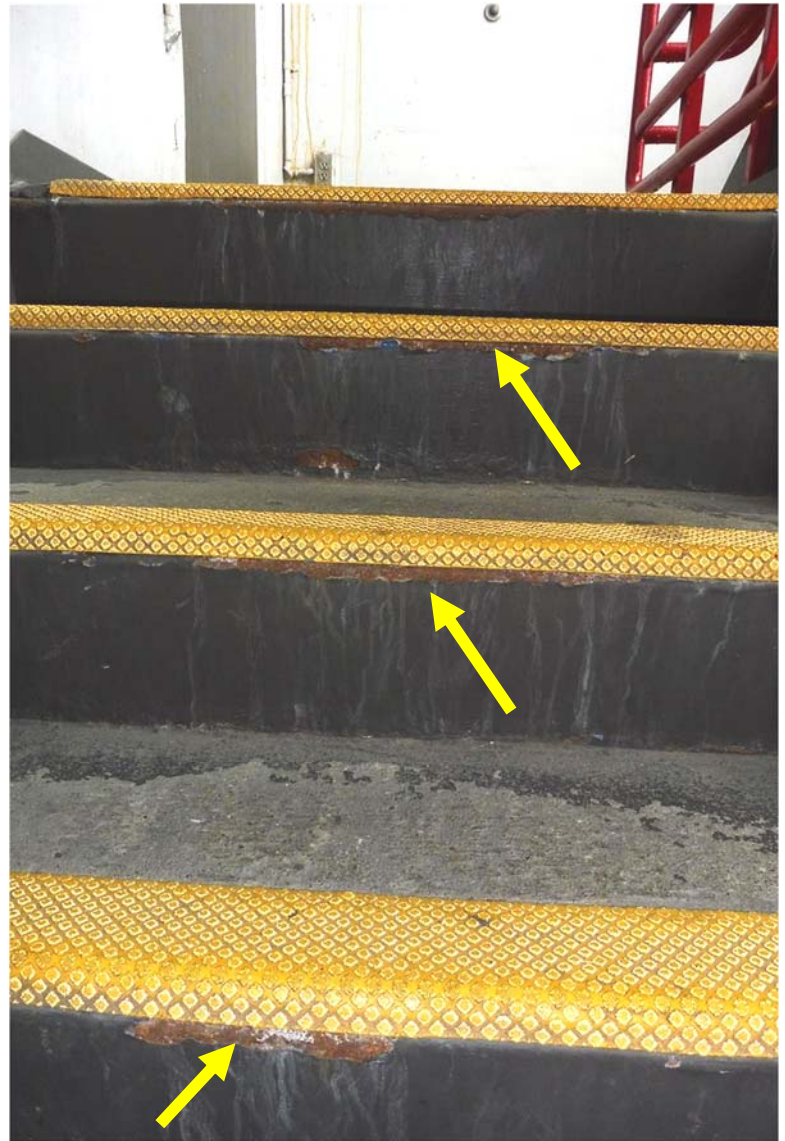
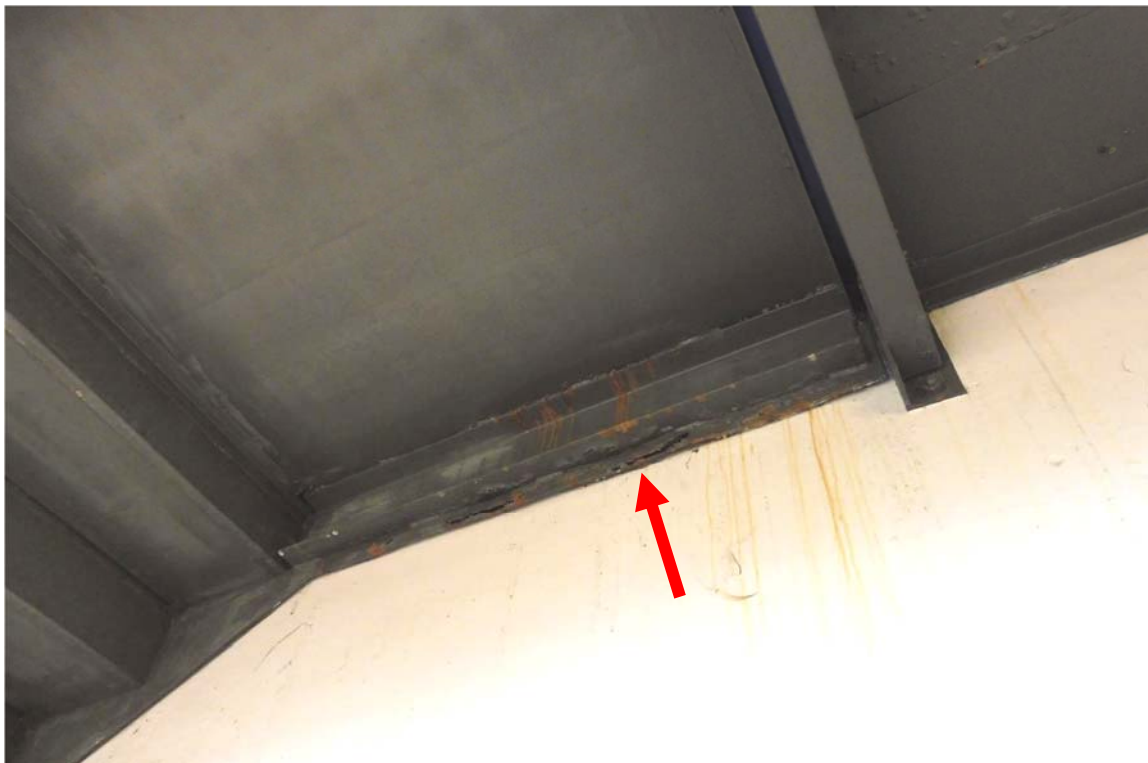
Moisture in the stair tower has also led to corrosion of some of the metal risers in the metal pan stairs...

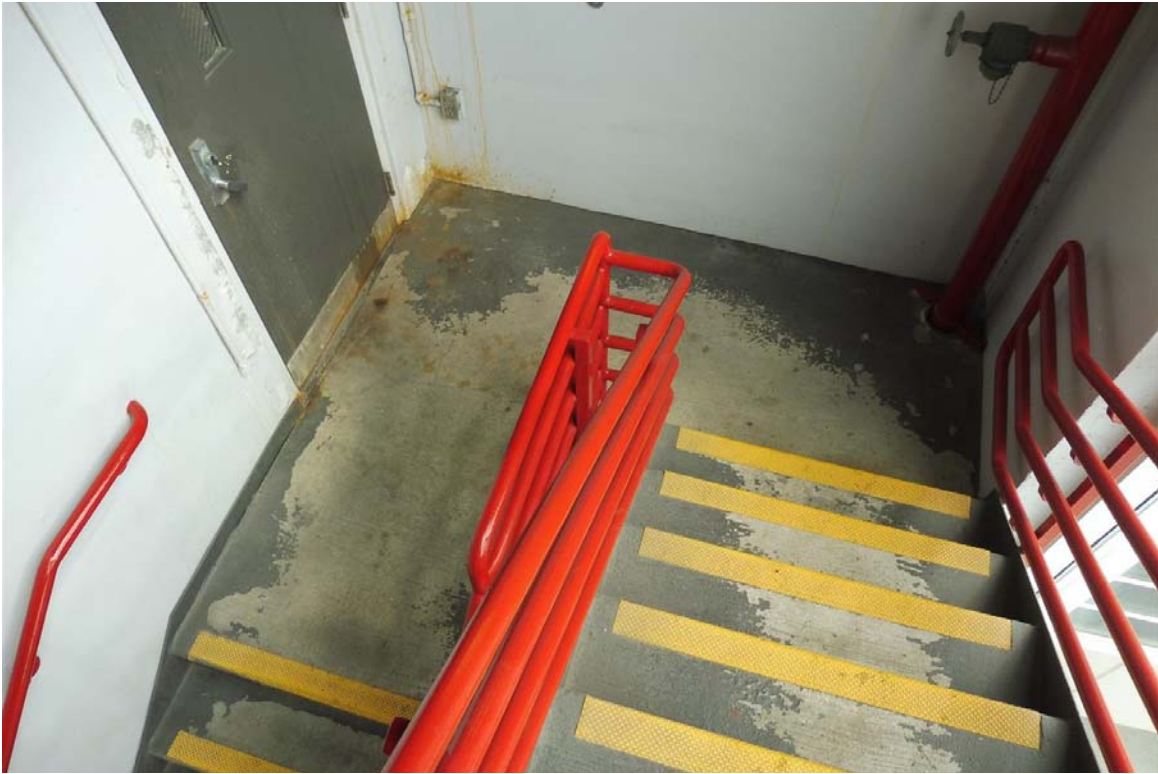
Photo 107 View of the failed floor coating that was previously applied to the treads and landings. We suggest replacement of the coating system to increase the protection of the metal pan stair structure below the concrete landings and treads.

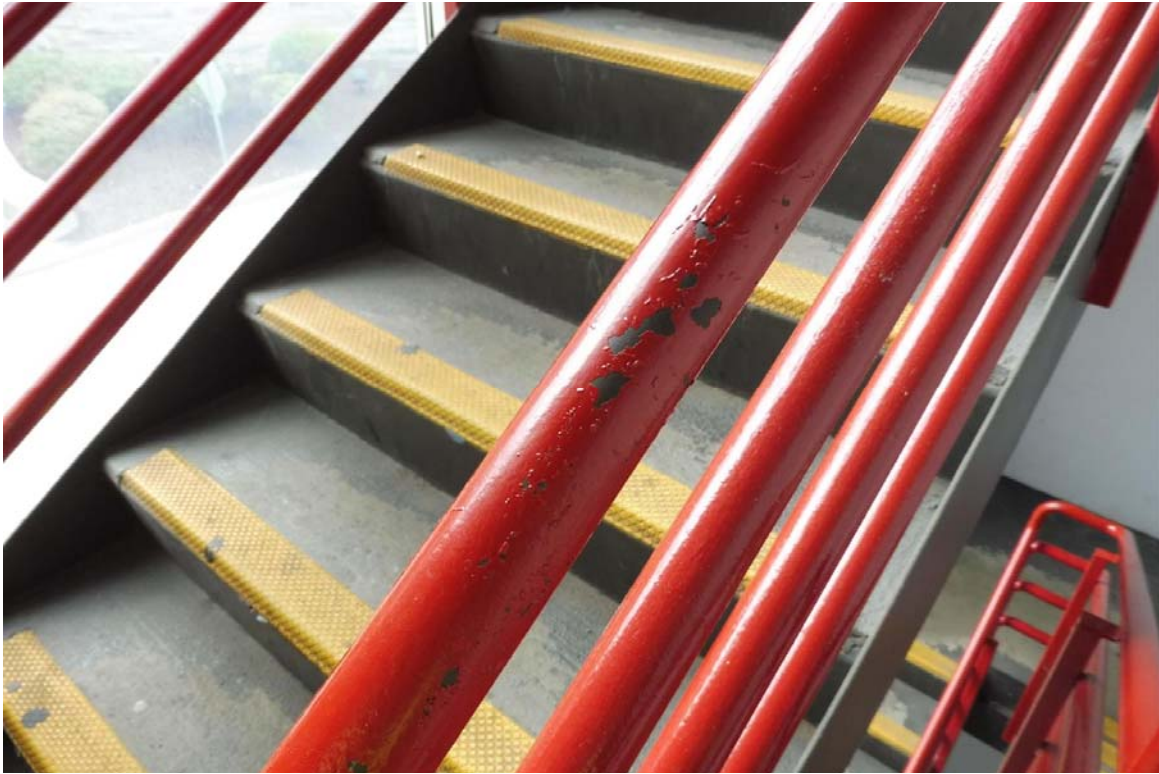
Photo 109 The paint system on the handrails was generally in good condition with few areas as seen here where the coating is starting to fail.

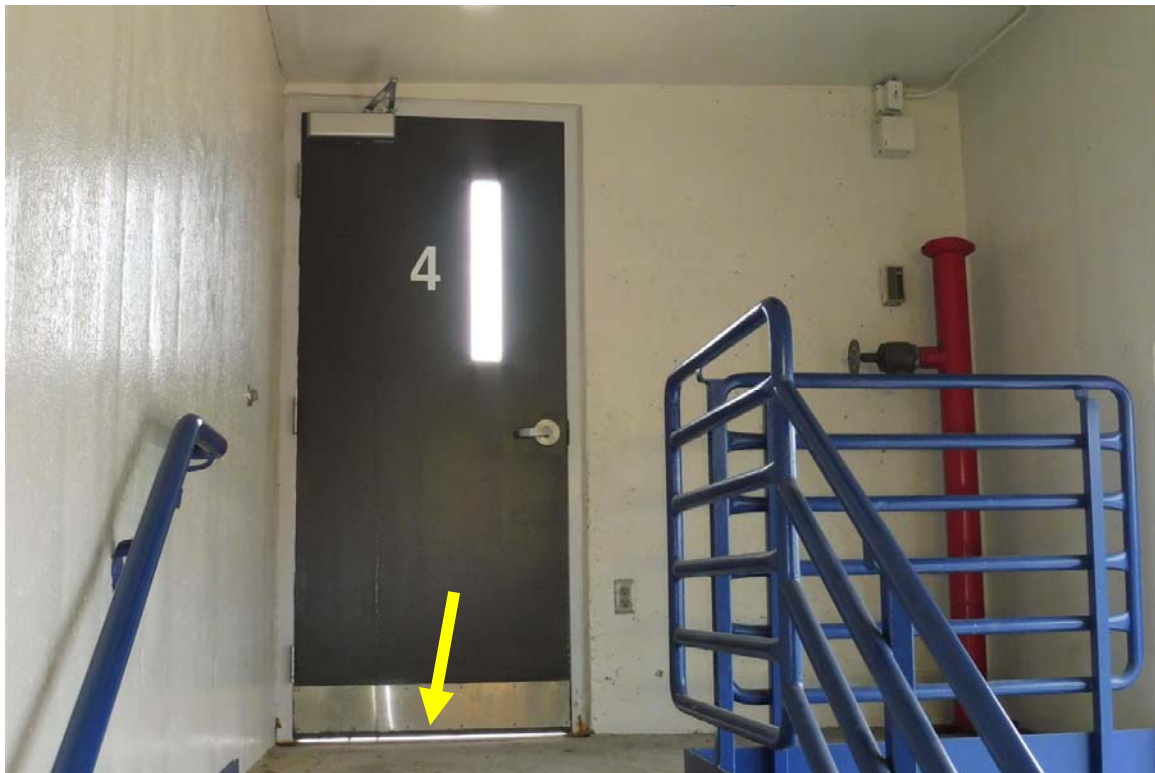
Photo 112 Similar to the southwest stair, moisture has been infiltrating the northeast tower via the gap below the roof level door. Damage caused by the water can be seen in the following photos.

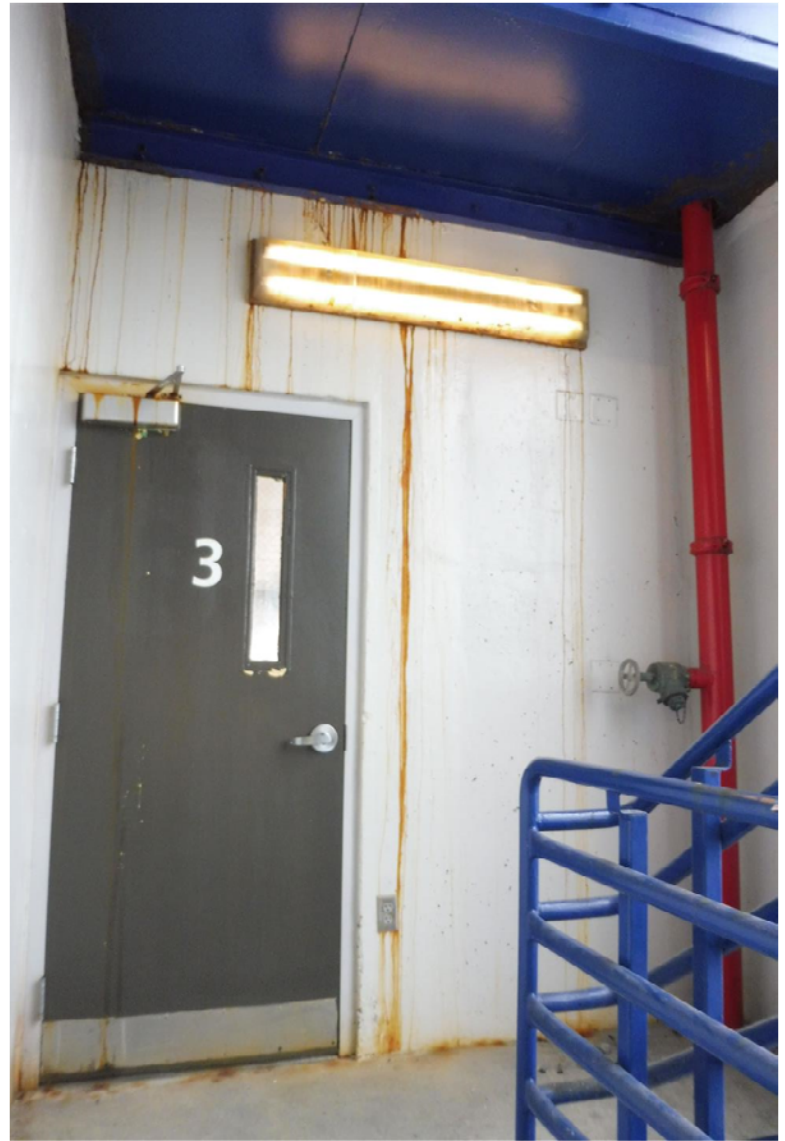
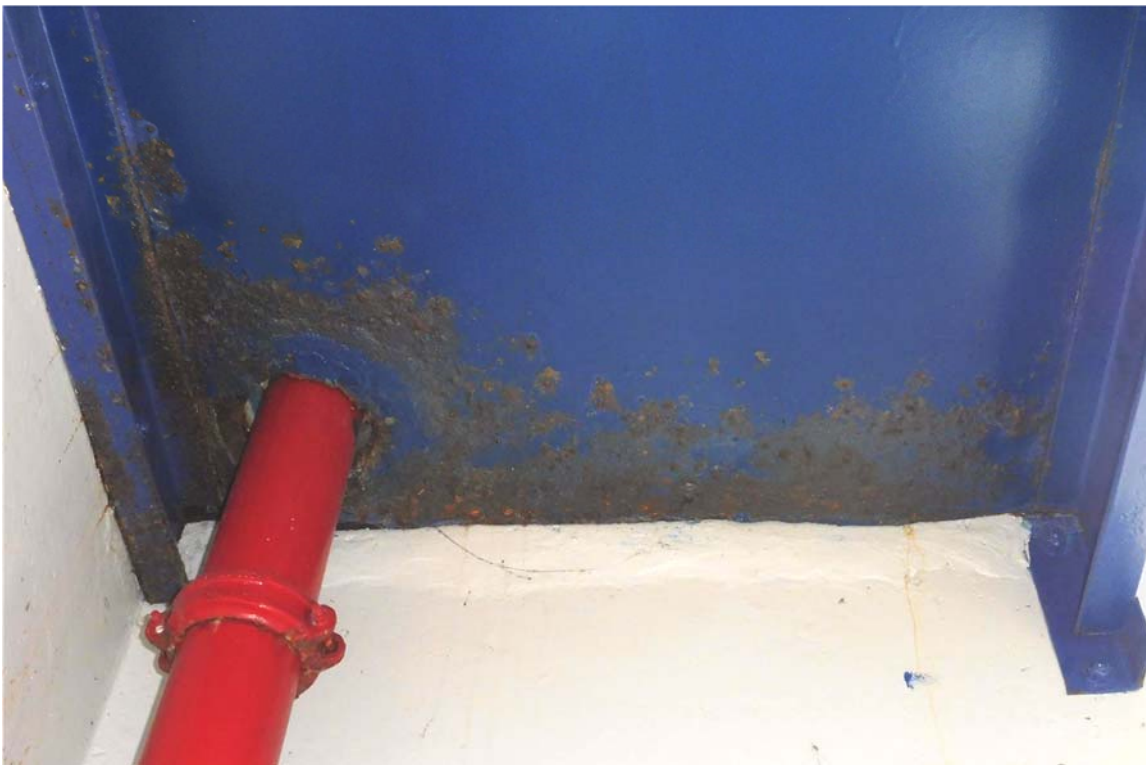
View below the roof level door where significant rust streaks down the wall and failed wall coatings are the result of the water infiltration below the door above.

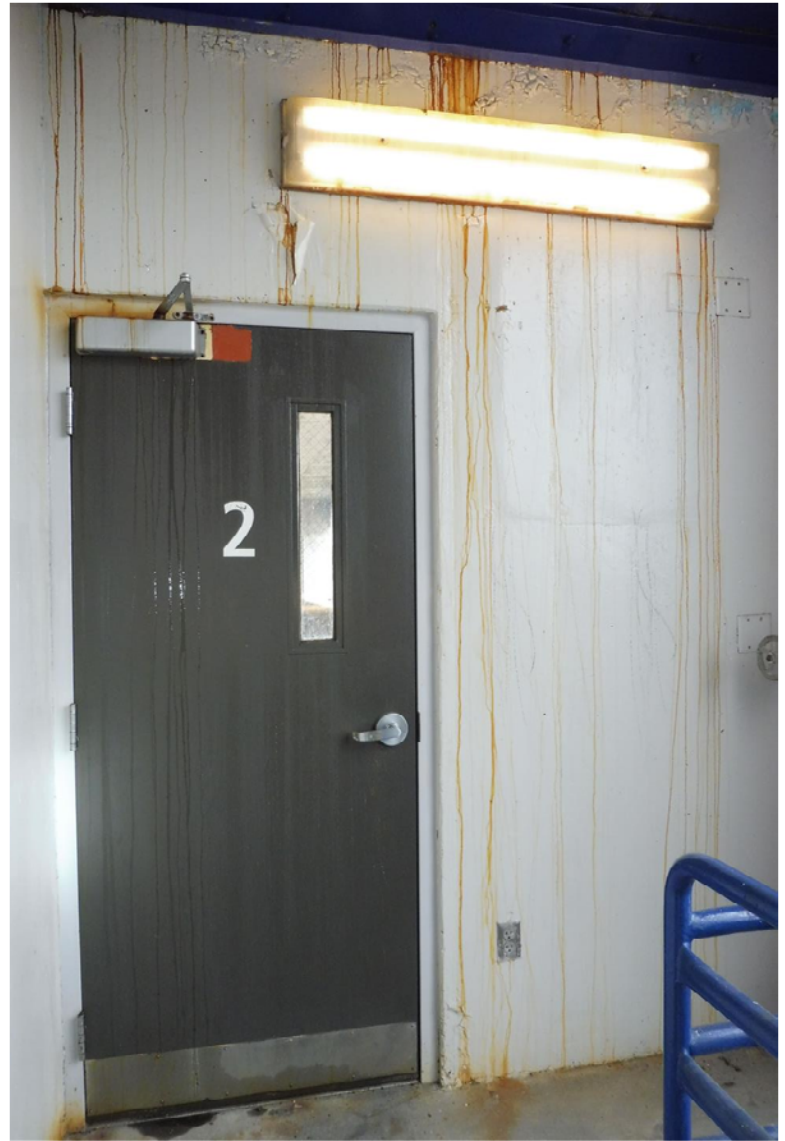
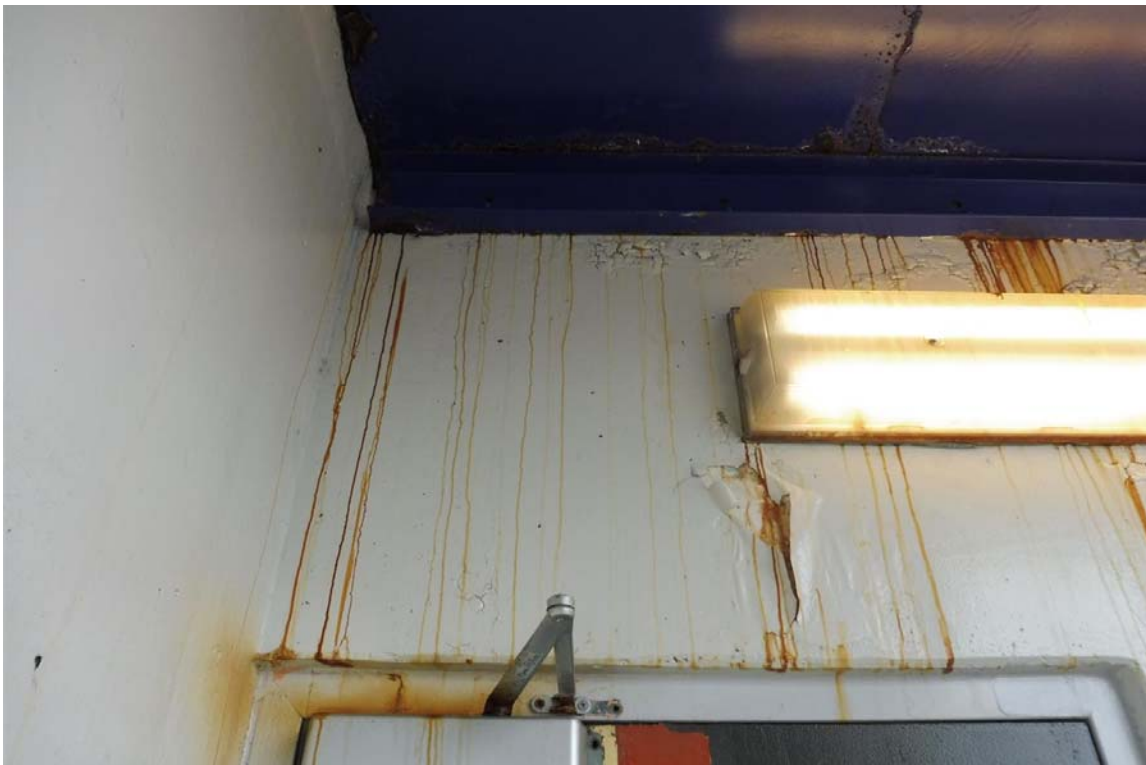
Corrosion of the metal pan stair structure and failure of the wall coatings continued below Level 2.

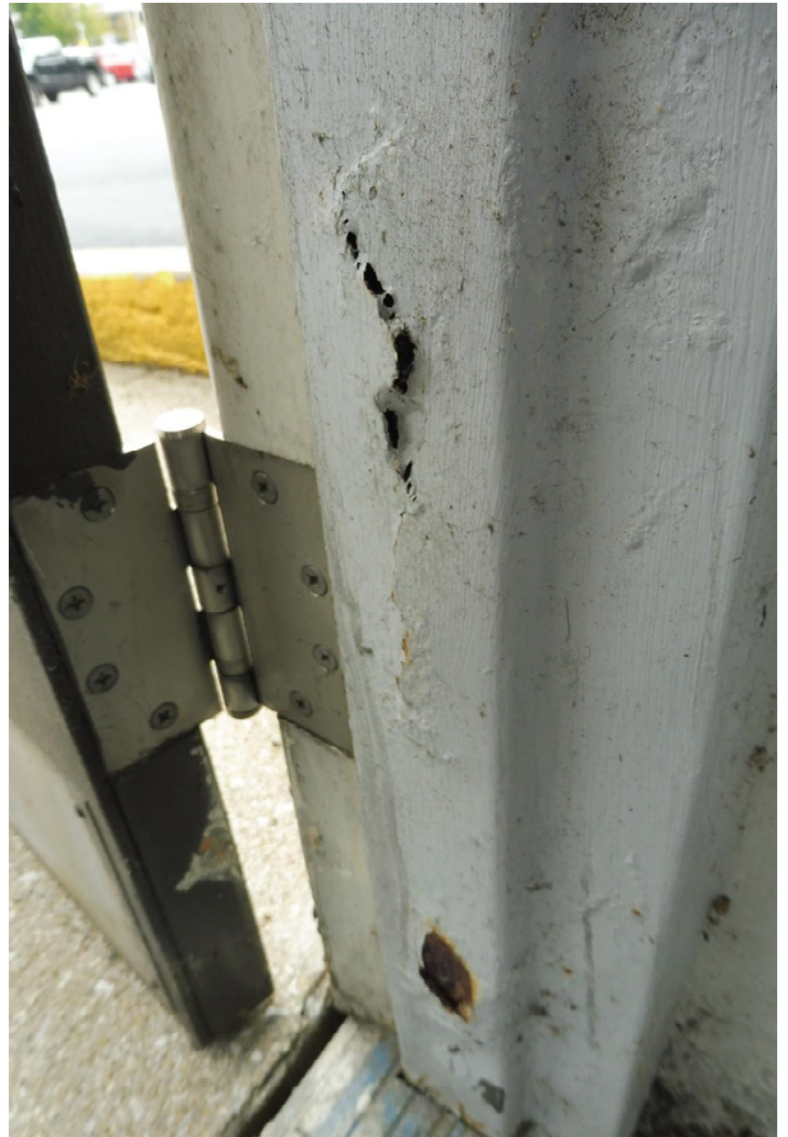
The paint on the handrails and stair structure below Level 2 was in better condition, but rust was observed on the undersides of some of the handrails as seen here.

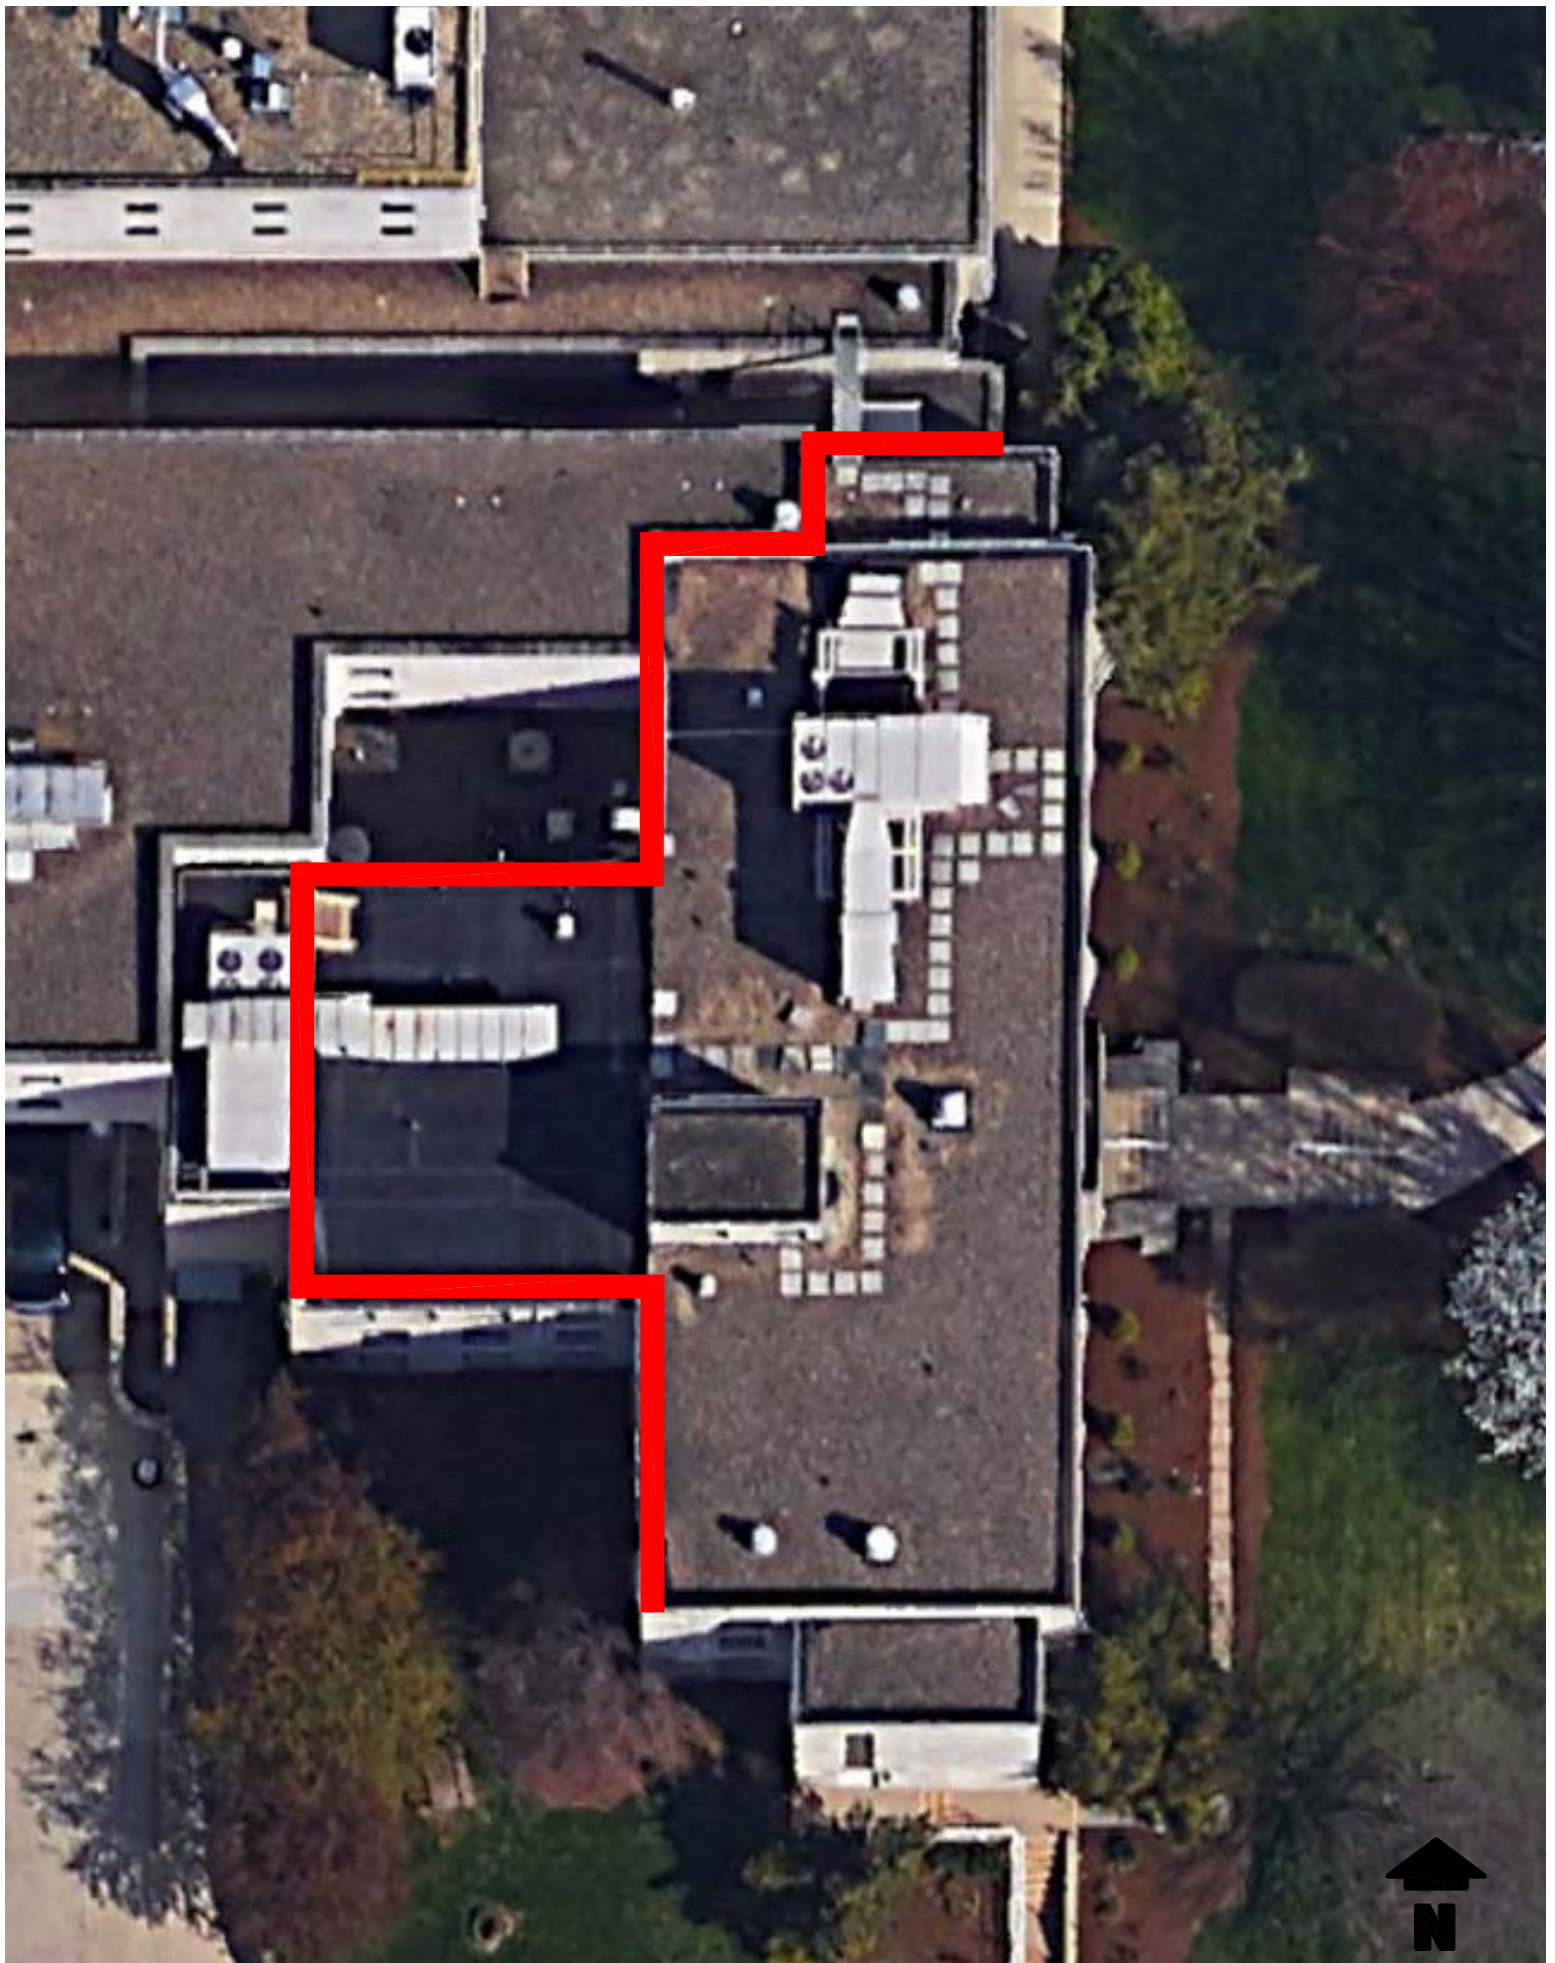
Moisture has entered and froze within the grade level door frame on the northeast stair, causing the steel frame to split.

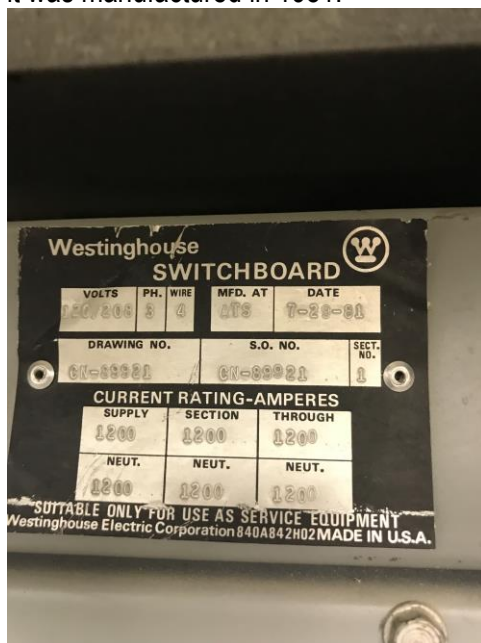
## **I Physical Description/Existing Conditions** *(continued)*

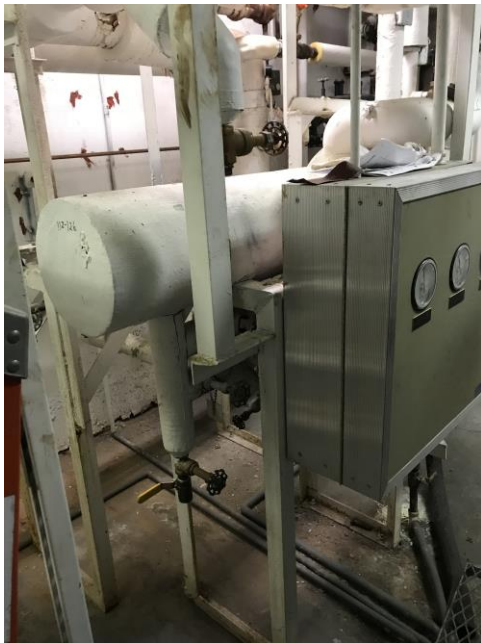
Steam-to-Hot Water Heat exchanger

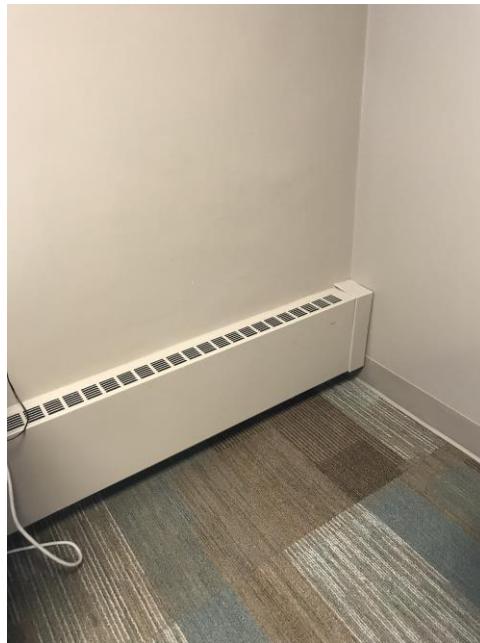
Perimeter hot water heater

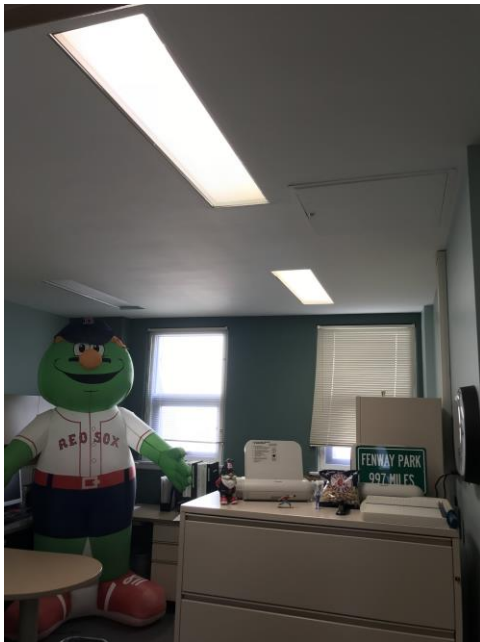
Typical 1x4 troffers on the 3<sup>rd</sup> floor

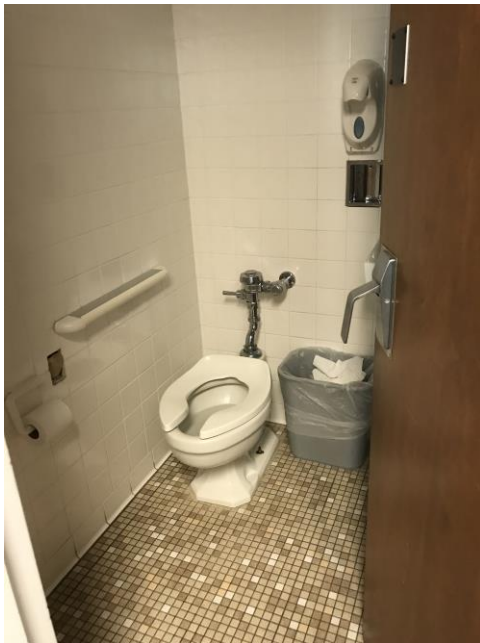
Typical water closet

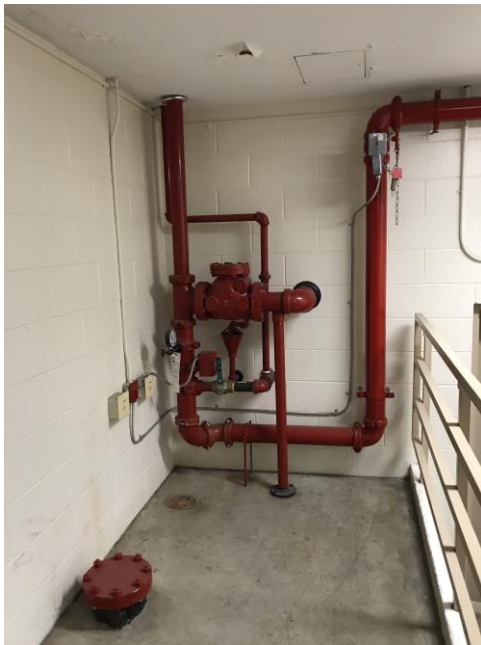
Fire riser with abandoned source line in the foreground

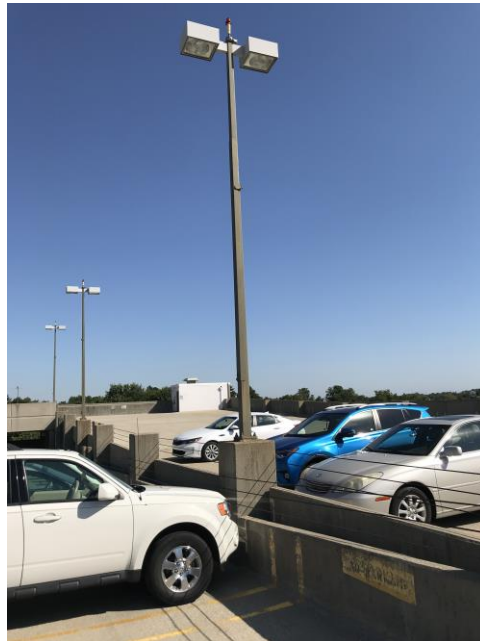
Pole-mounted fixtures on the roof
