# **ARSEE ENGINEERS, INC.**

IU Health Facility Assessment  
Bloomington, Indiana  
for

RE: IU Health Facility Assessment  
Bloomington, Indiana

## **EXECUTIVE SUMMARY**

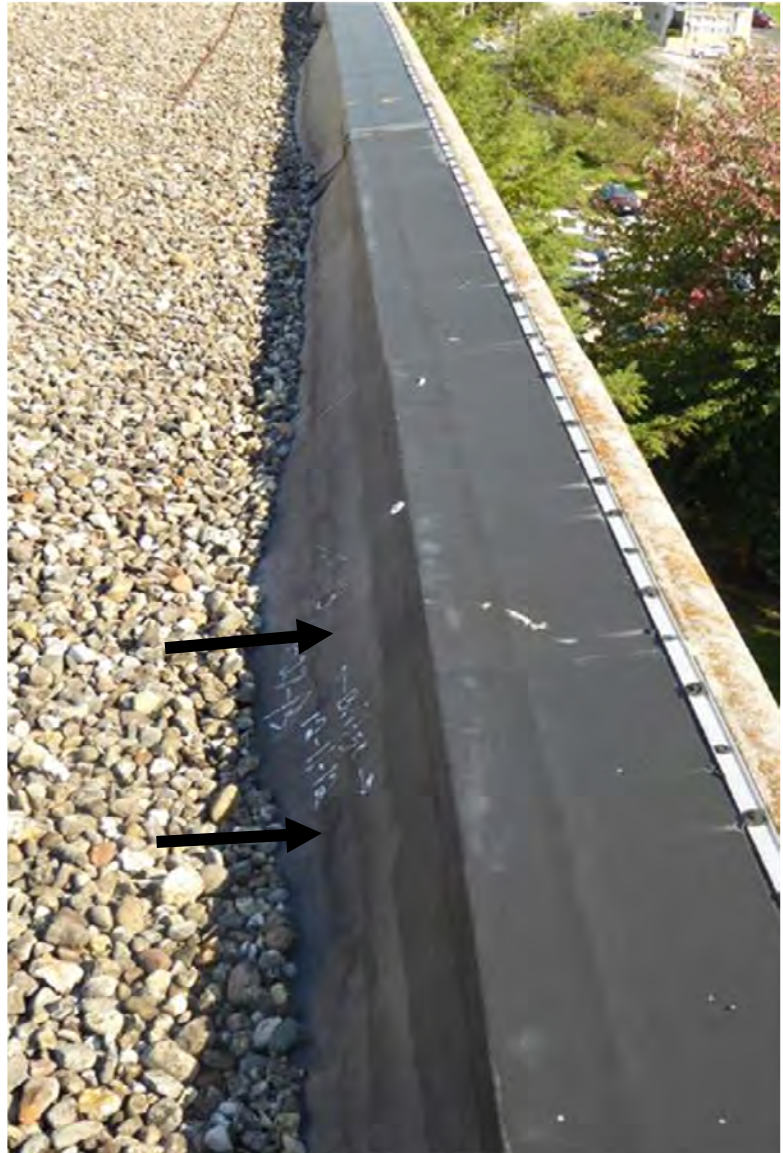
Photo 16

Tensile stresses in the membrane will eventually lead to tears in the membrane or adhesion failures with the flashings.

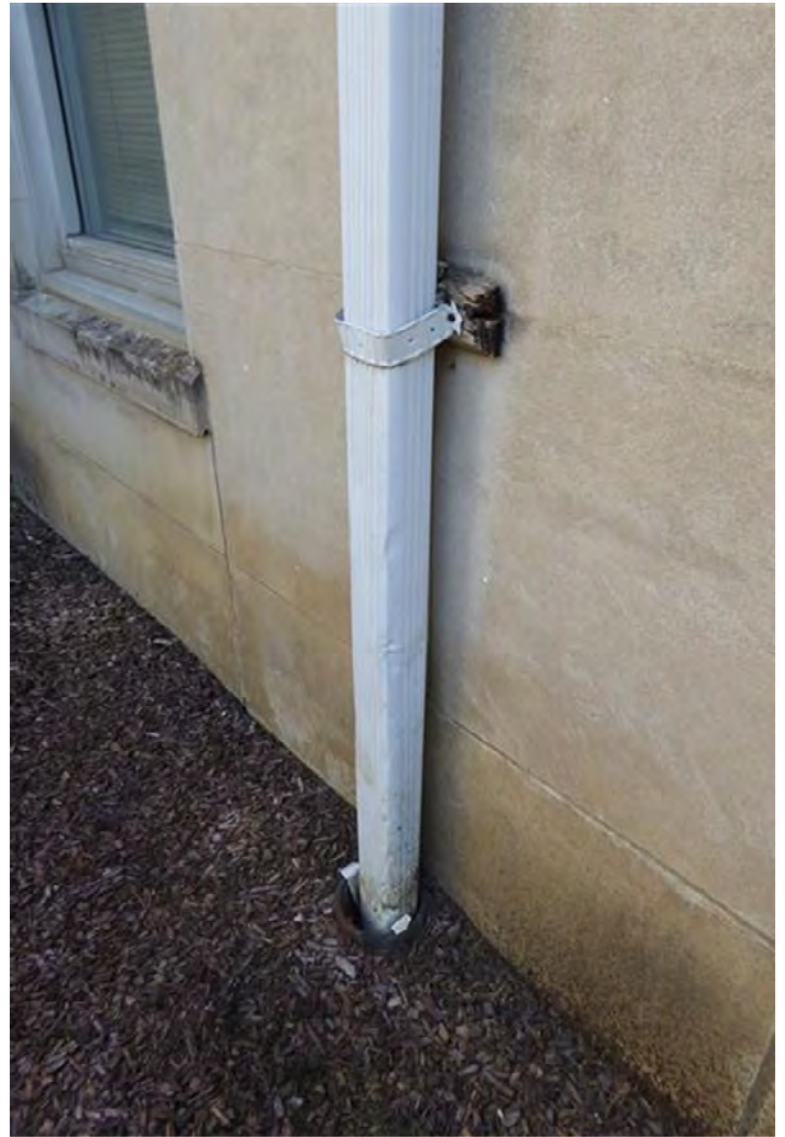
Photo 22

One of the original downspout connections. The downspouts have been replaced with residential style units.

Each of the flat roofs is sloped to drain to a series of sheet metal gutters and downspouts as shown in Photos 19 through 22. Some of these elements have been replaced with cheaper residential style units. Original components are worn and showing their age. These should be replaced with new painted galvanized steel units to conform with the original design intent.

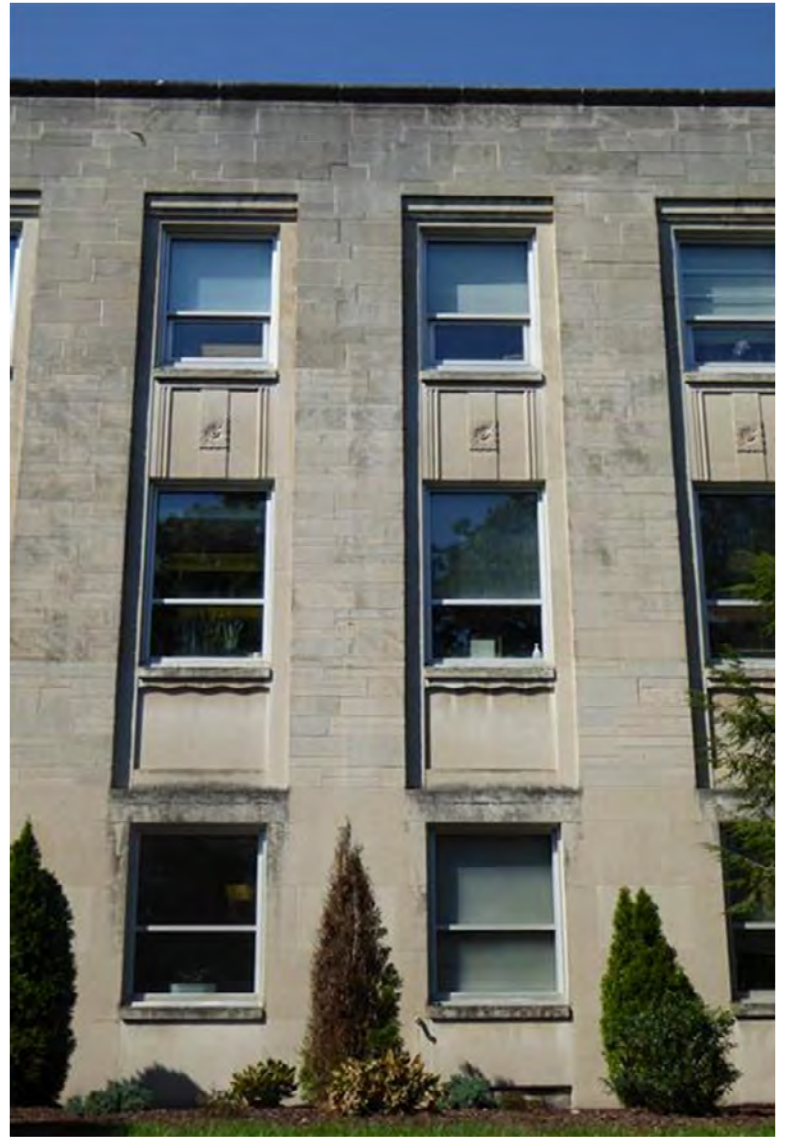
Photo 24

Mortar joints are tooled to a concave profile and are generally in good condition.

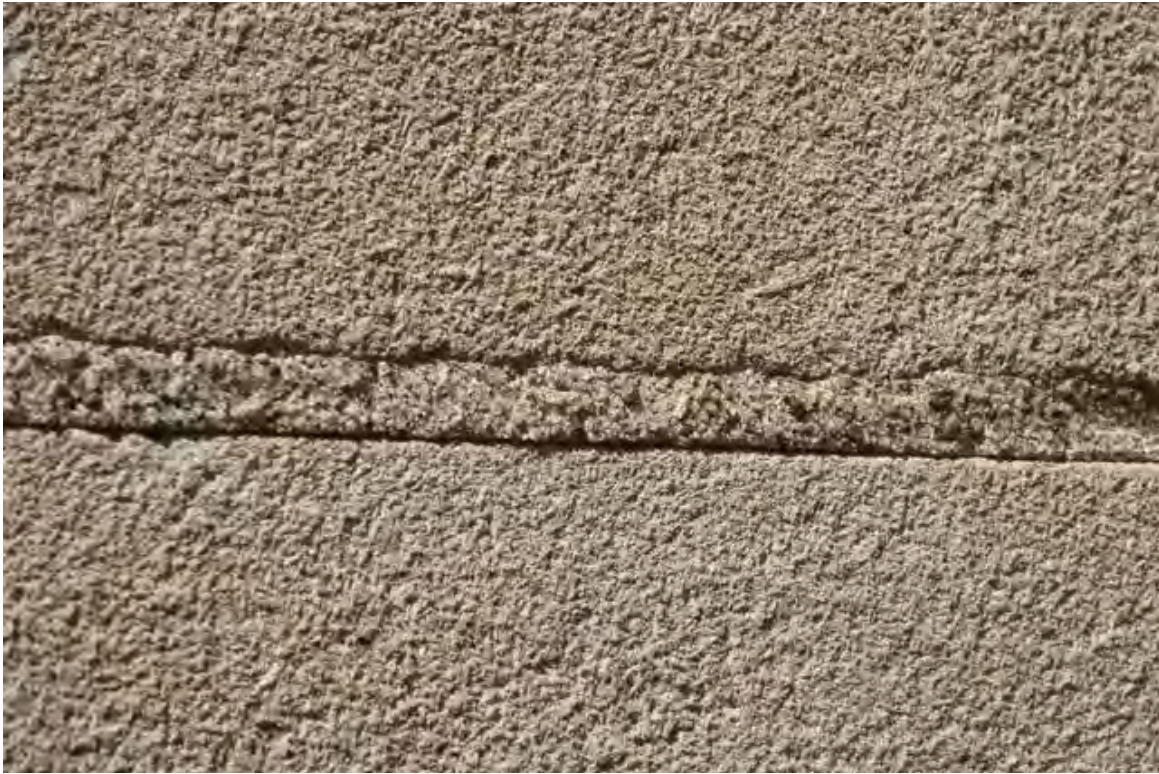
Photo 25 A few of the joints were struck flush and are more prone to moisture infiltration.

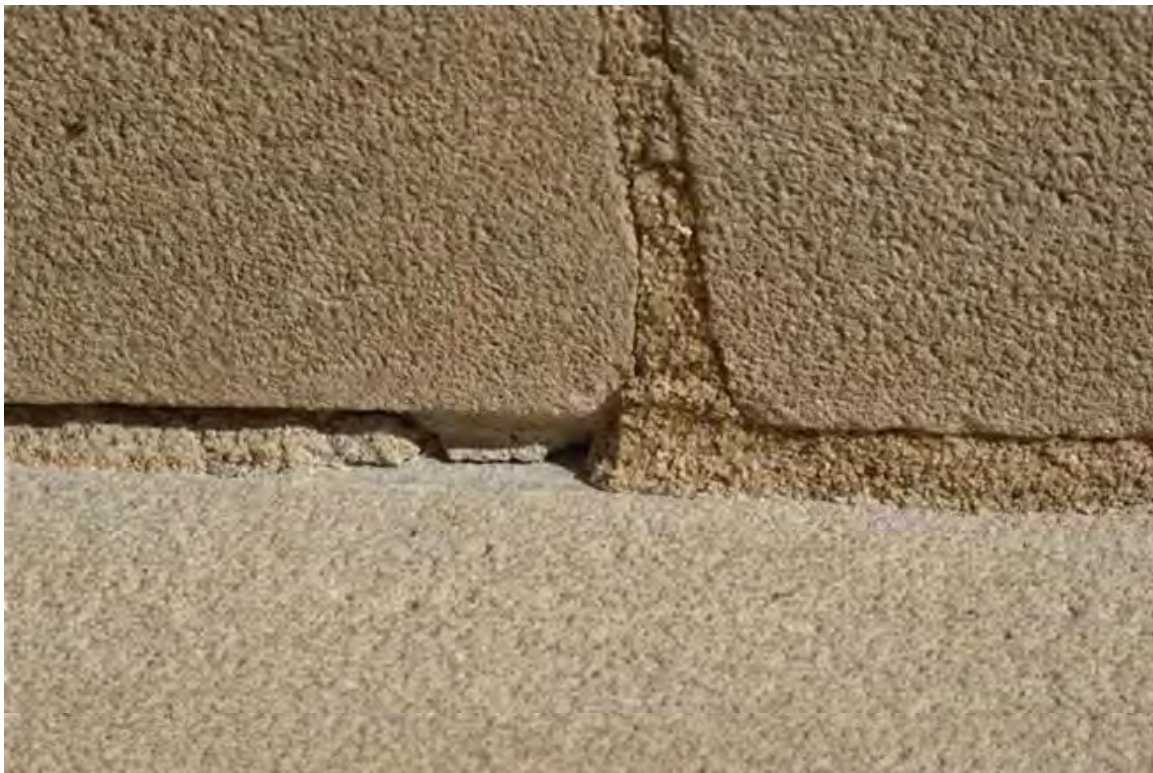
Photo 26 More recent tuckpointing has been thin and tends to crack and fall back out of the joint.

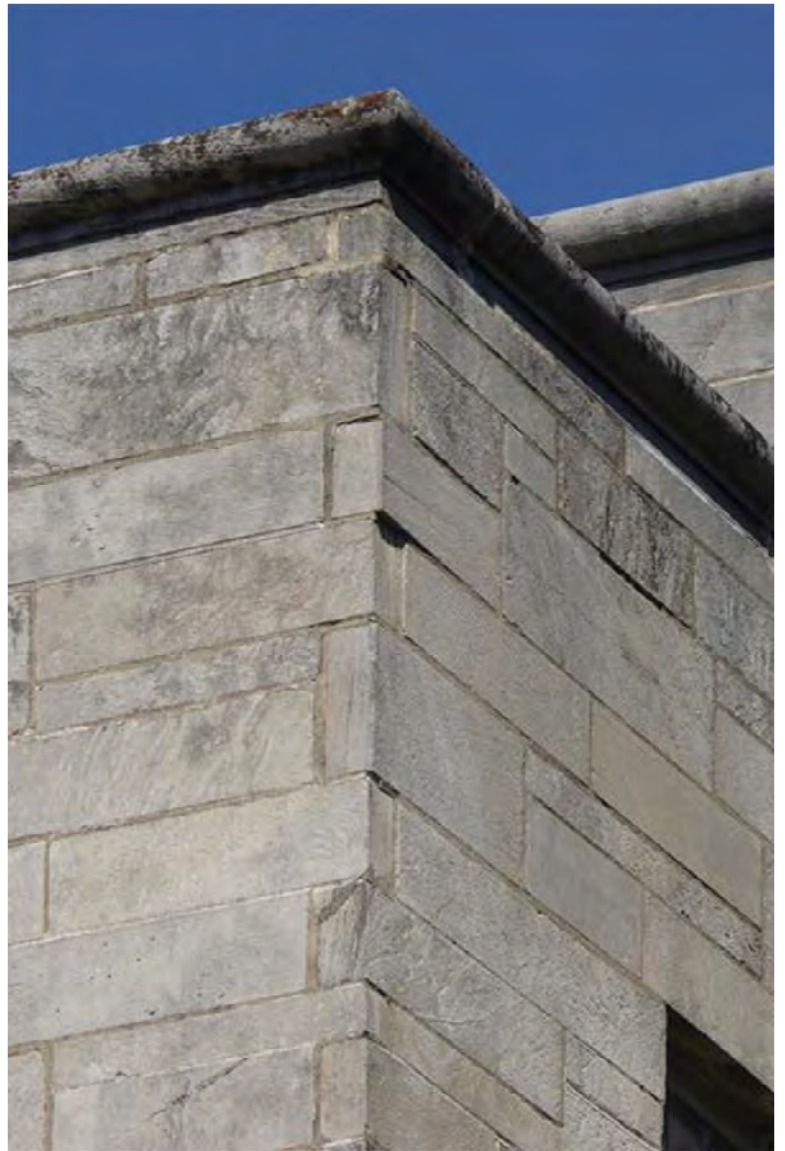
Photo 28

Similar condition on top of the south stairwell.

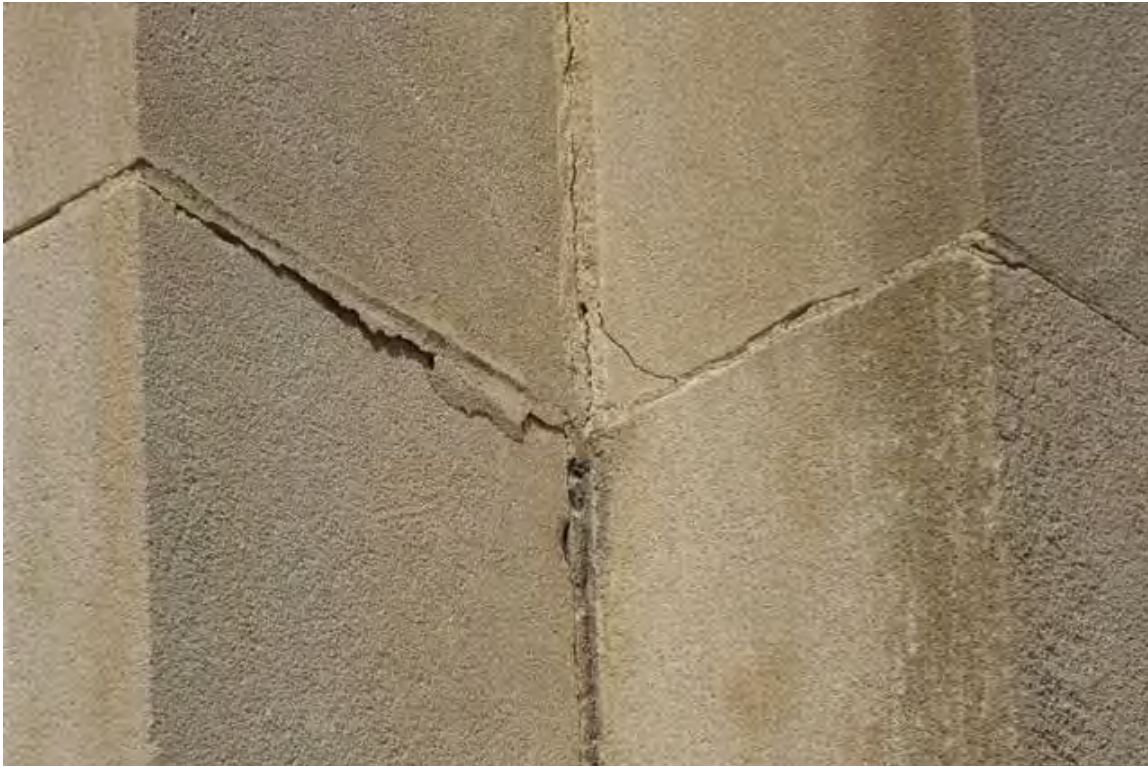
Photo 29

Cracking and spalling occur where tuckpointing mortar was too hard.

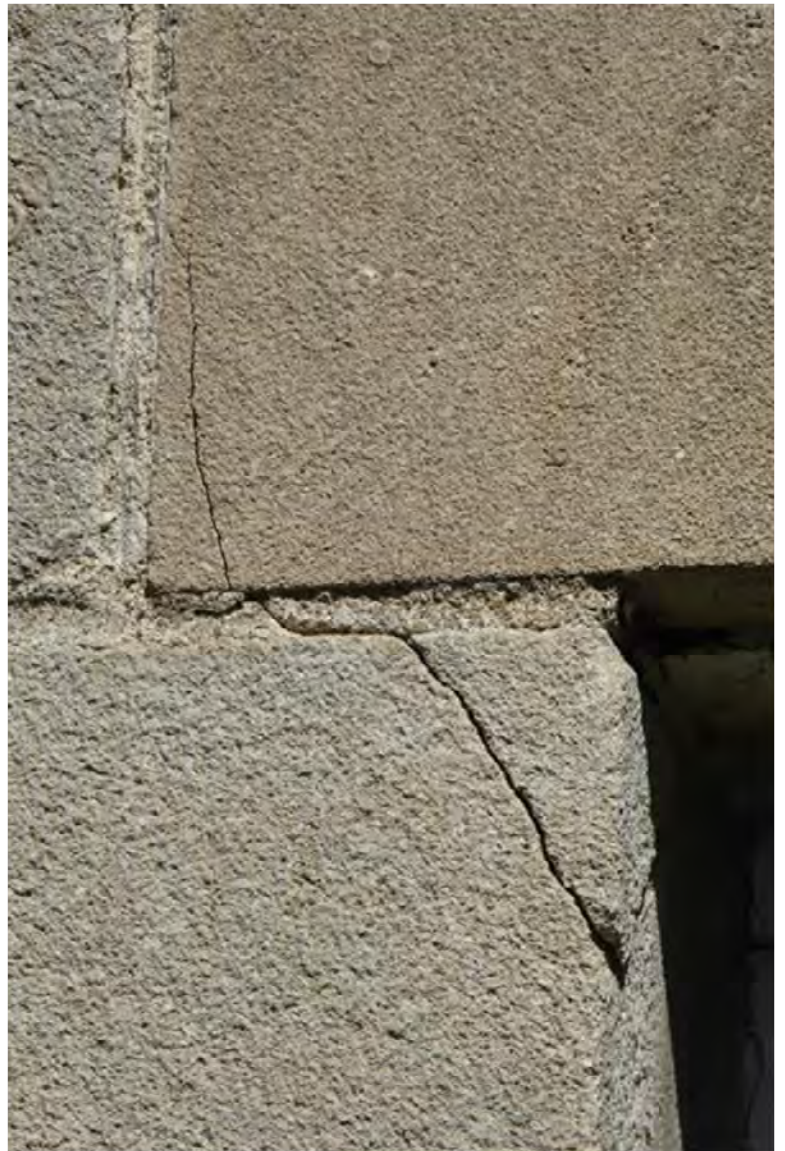
Photo 30

Closer view of cracking at the end of a window lintel.

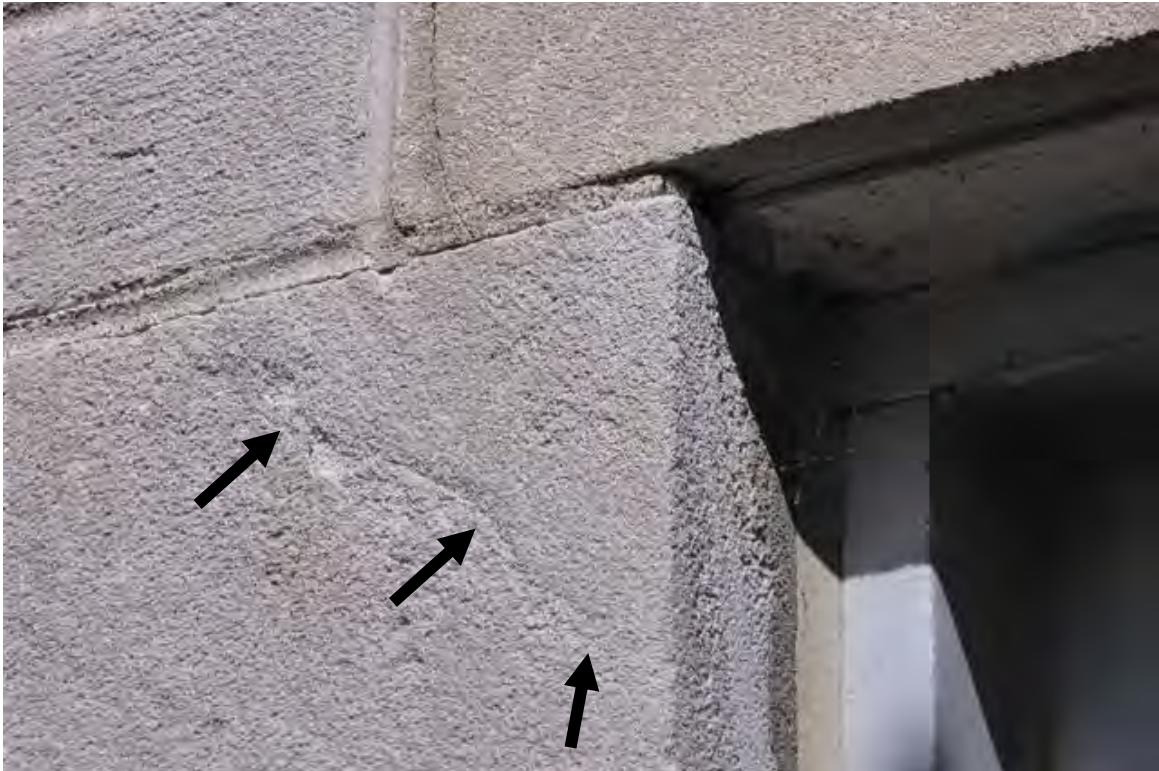
Photo 31 A cementitious patch was installed at a previous spall.

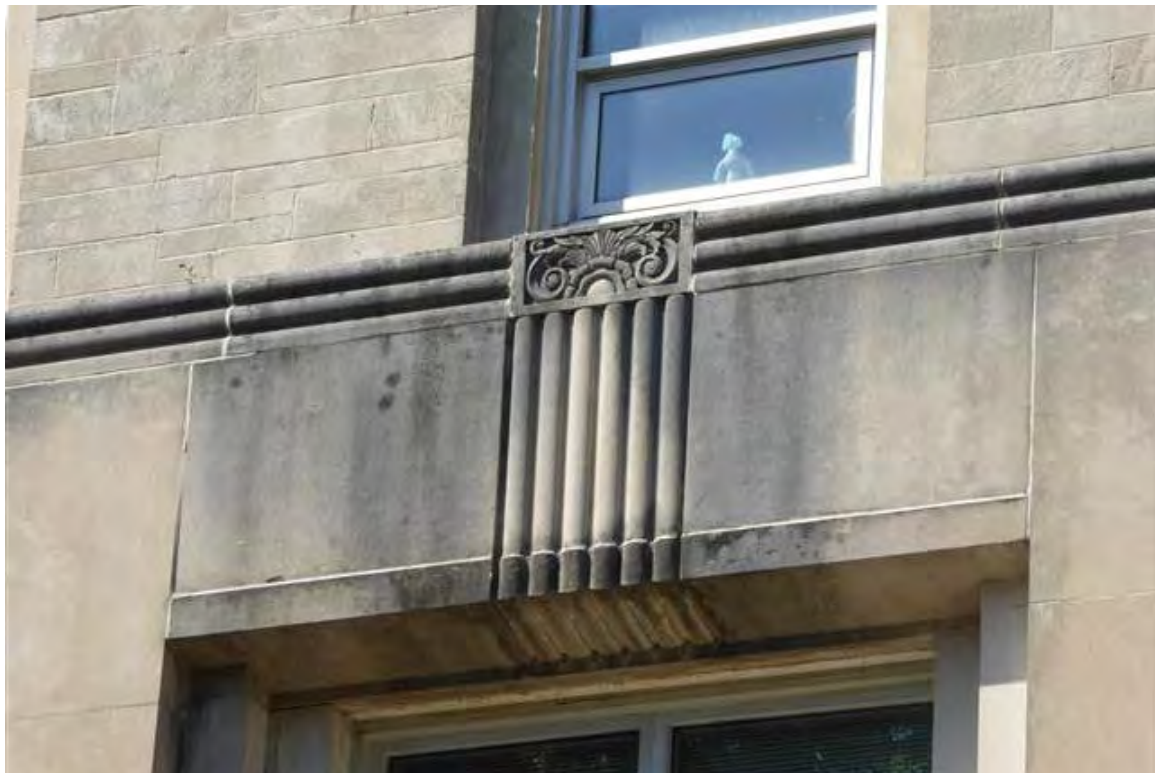
Photo 32 Organic material grows on the face of the protrusion over the east entrance.

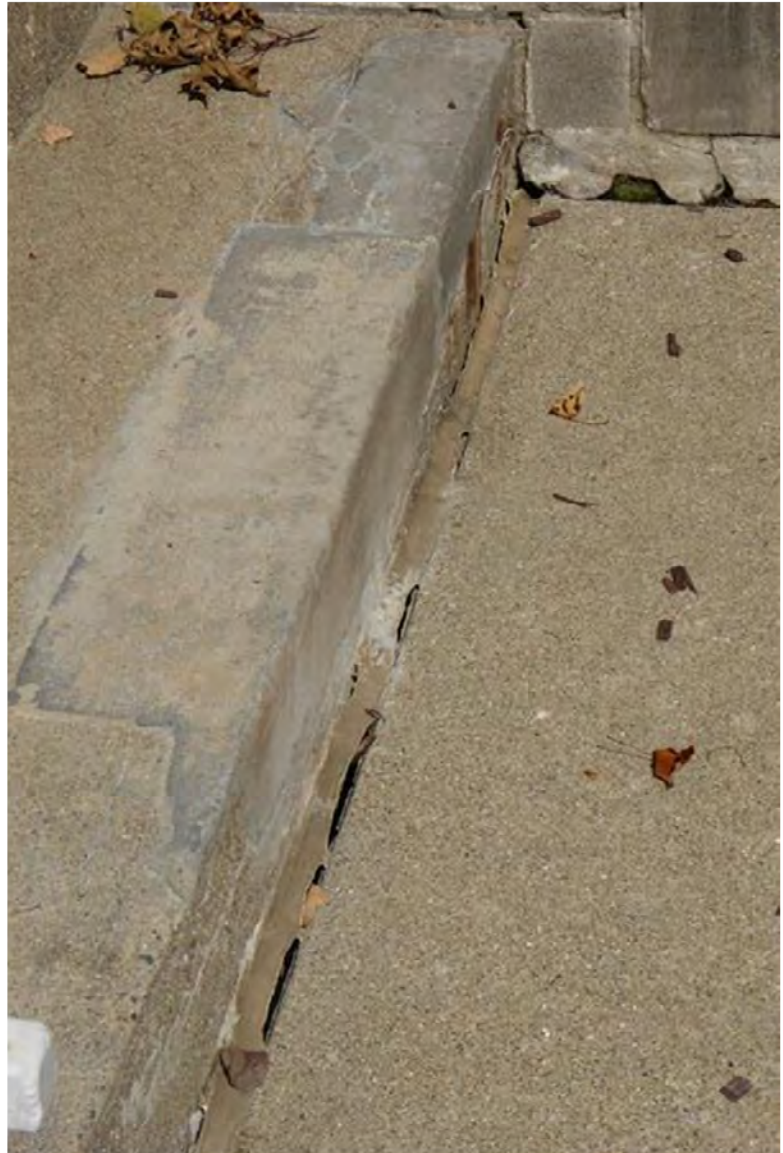
Photo 42

Previous cementitious patches in some of the steps and failed caulking.

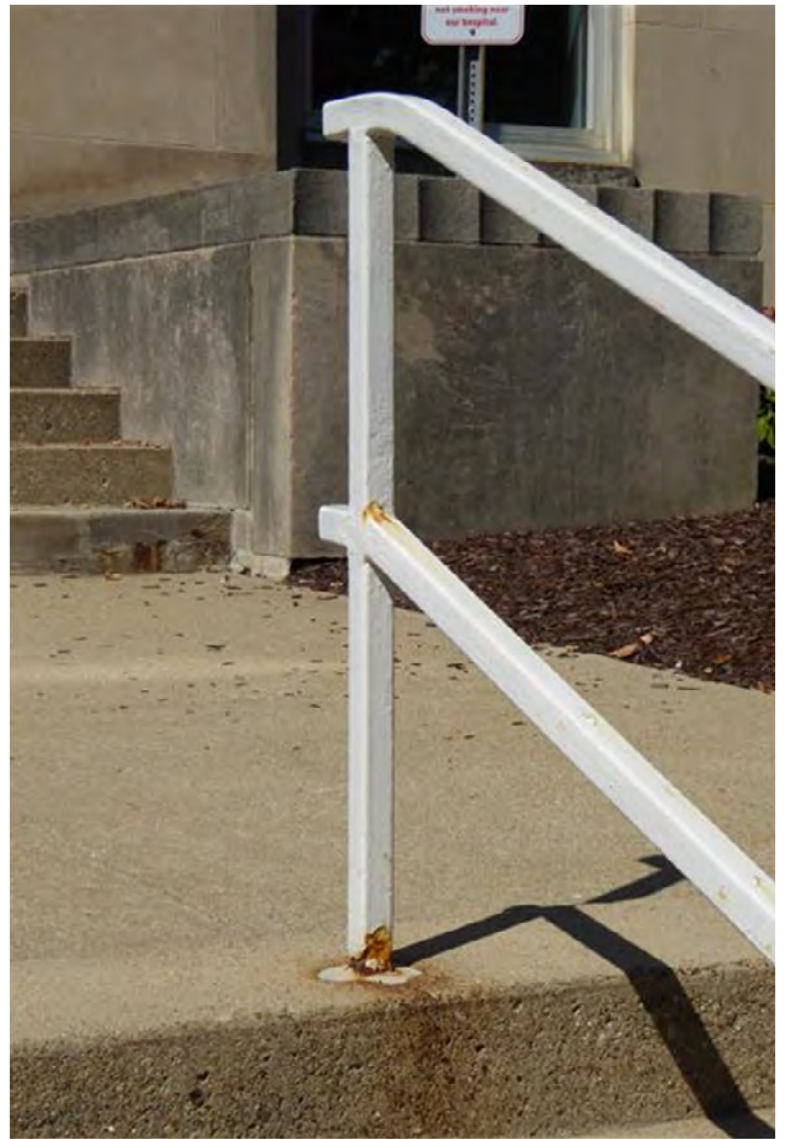
Photo 44

The hand railings do not meet current code requirements...

...and are severely corroded at the base of the posts.

The main entrance is on the east elevation of the building. A concrete walkway with steps extends down to South Rogers Street. The majority of this walkway will probably be redesigned so we have assumed that only the stairs, landings and limestone cheek walls shown in Photos 39 through 44 will remain part of the salvaged building. The limestone needs to be cleaned and repointed. Other repairs are minimal. The concrete steps are deteriorating due to freeze/thaw damage. We have included repairs to address cracking and spalling and installation of a traffic coating to protect the concrete from further deterioration. Finally, the handrails do not meet code and are generally in poor condition. We have included monies for new stainless steel handrails.

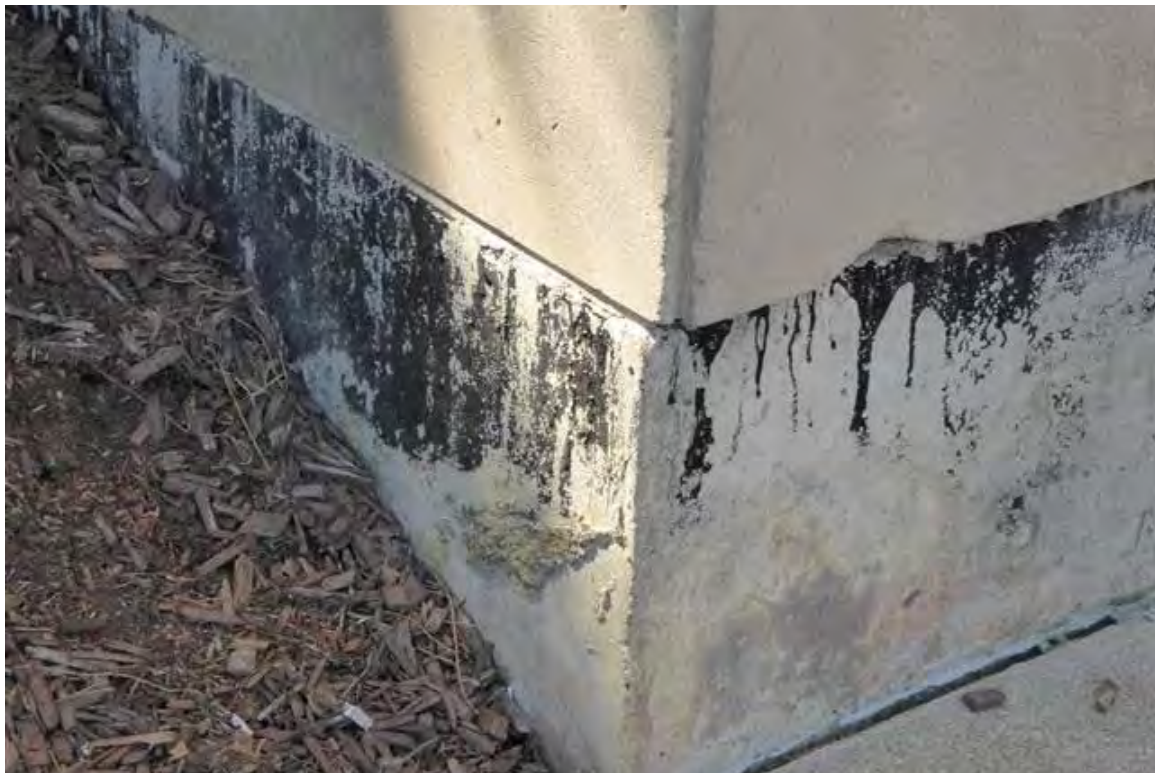
Staff did report evidence of water leaks into the basement along the east elevation of the building. Photos 45 through 48 show that the concrete basement wall was originally coated with a bitumen based waterproofing which has deteriorated badly. Planting beds extend up onto the face of the limestone masonry. As these absorb and retain moisture, they serve as reservoirs for water to migrate through cracks and joints into the building. Re-landscaping and lowering grade will help but may not solve all of the leaks. The most effective way to prevent further leaks is to excavate and expose the wall, install new waterproofing and perimeter drainage and re-landscape. However, without knowing the eventual use of the building/basement this cost may not be justified. We have included a separate line item on the cost estimate so this can be evaluated further.

Photo 46 The original bitumen based waterproofing has deteriorated badly.

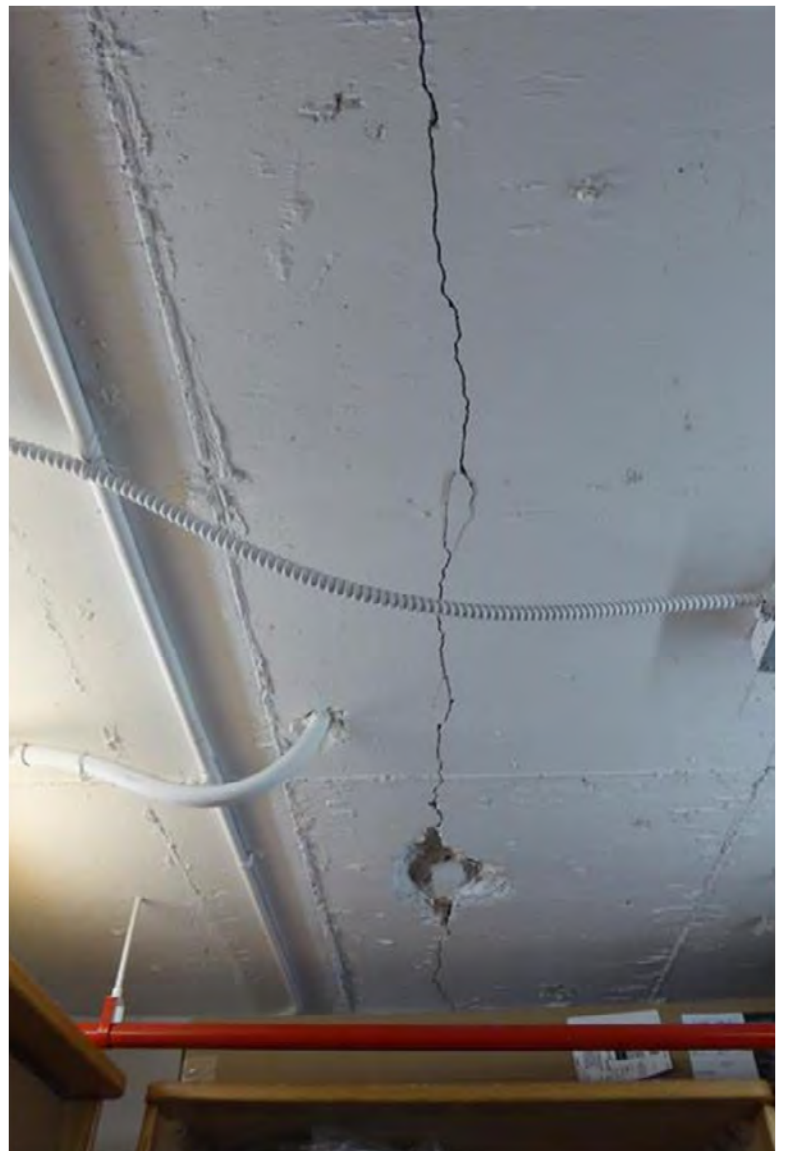
Photo 50

There was virtually no sign of distress in the concrete. This crack occurs where an aluminum conduit was run through the slab.

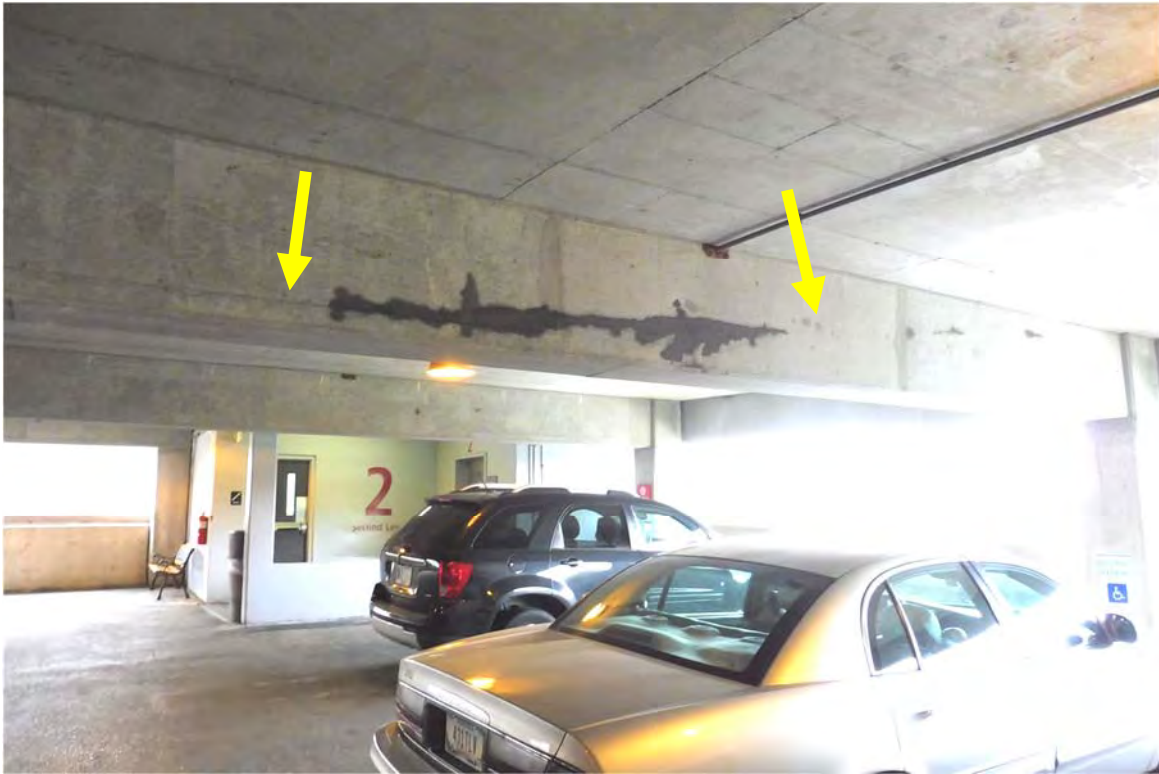
Photo 65 Level 3 beam seen from standing on Level 2 where grease from the tendons has leached out of the crack in the face of the beam.

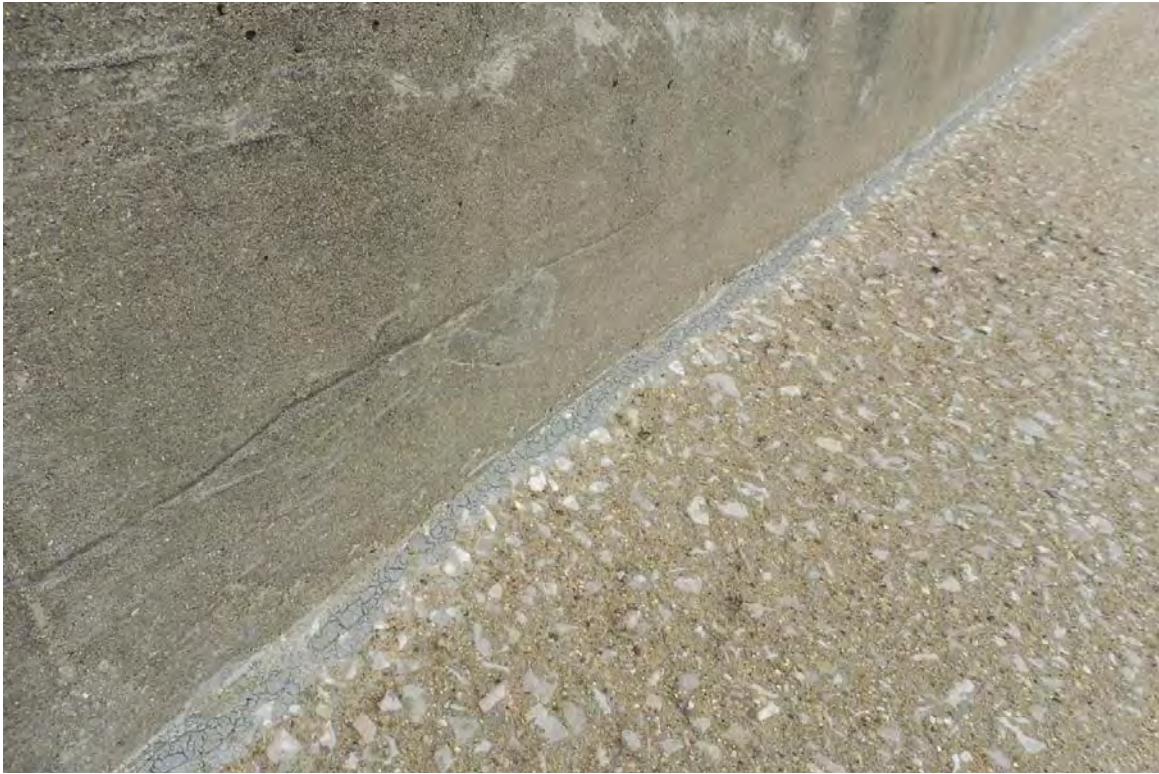
The concrete slab was constructed in two halves in the north-south direction with a pour strip across the middle of the garage. During construction, the contractor stressed the two halves of the slab at the pour strip location. Then the pour strip would have been placed with concrete to connect the two halves. Those pour strips are visible and contain sealant joints along the perimeter and at the control joints parallel to the width. The sealant in those joints is in fair condition as seen in Photo 69. The construction joint between ramps was located at the north turn lane and has been sealed as shown in Photo 70. Maintenance of those sealant joints is critical in minimizing water migration into the slab, which can result in corrosion of the reinforcing steel, including post-tensioned tendon end anchors that are located immediately adjacent to the pour strip joints. Perimeter sealant joints between the slab and the bumper walls on the roof level have generally failed and water has leaked through as evidenced by the staining below on the face of the spandrel panels. Those conditions are illustrated in Photos 71 and 72.

Photo 71 The perimeter sealant joints, however, are in fair to poor condition as many have failed such as the joint seen here on the roof level.

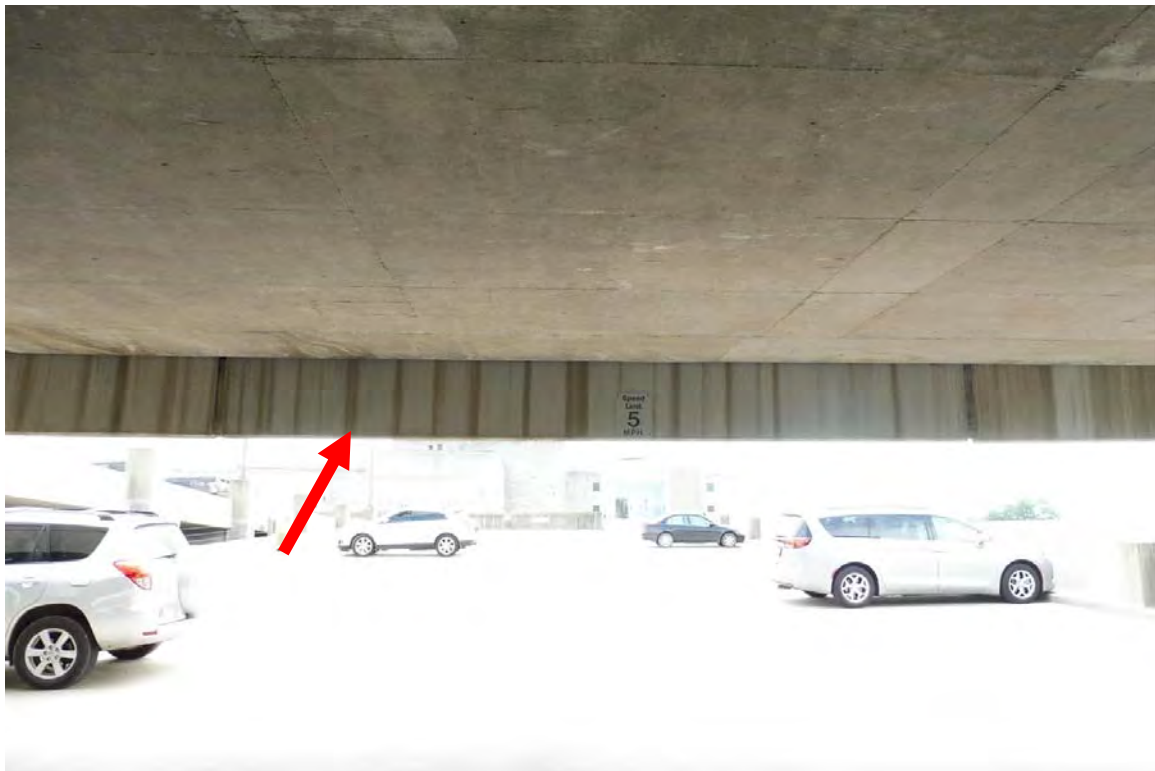
Photo 72 Staining on the back face of the edge spandrel is the result of water migration through the failed perimeter sealant joint above on the roof level.

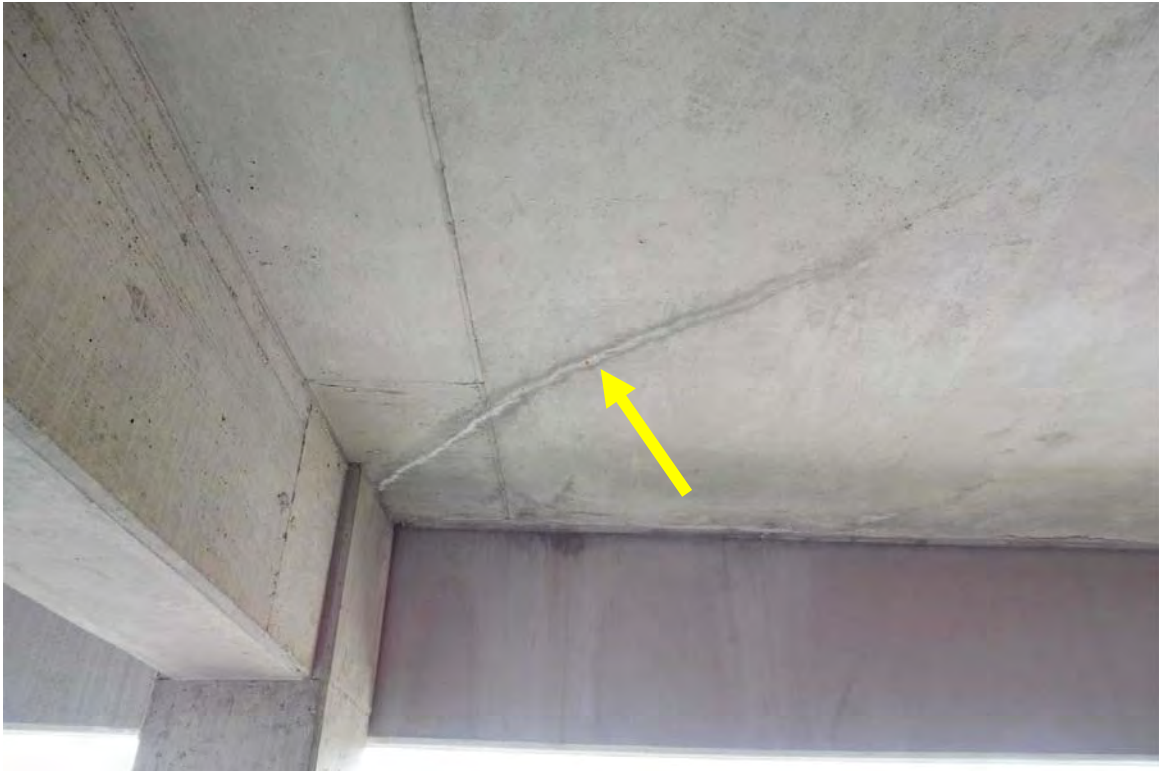
Photo 73 Cracks on the underside of the post-tensioned floor slabs existed in localized areas. The white staining seen along the crack is the result of calcium deposits on the surface from water migration through the crack.

Diagonal cracks on the underside of the post-tensioned slab were visible at select locations as shown in Photo 73. The white staining along the cracks suggests that water has migrated through the slab. We recommend injecting the cracks with a hydrophobic resin that will minimize the water migration.

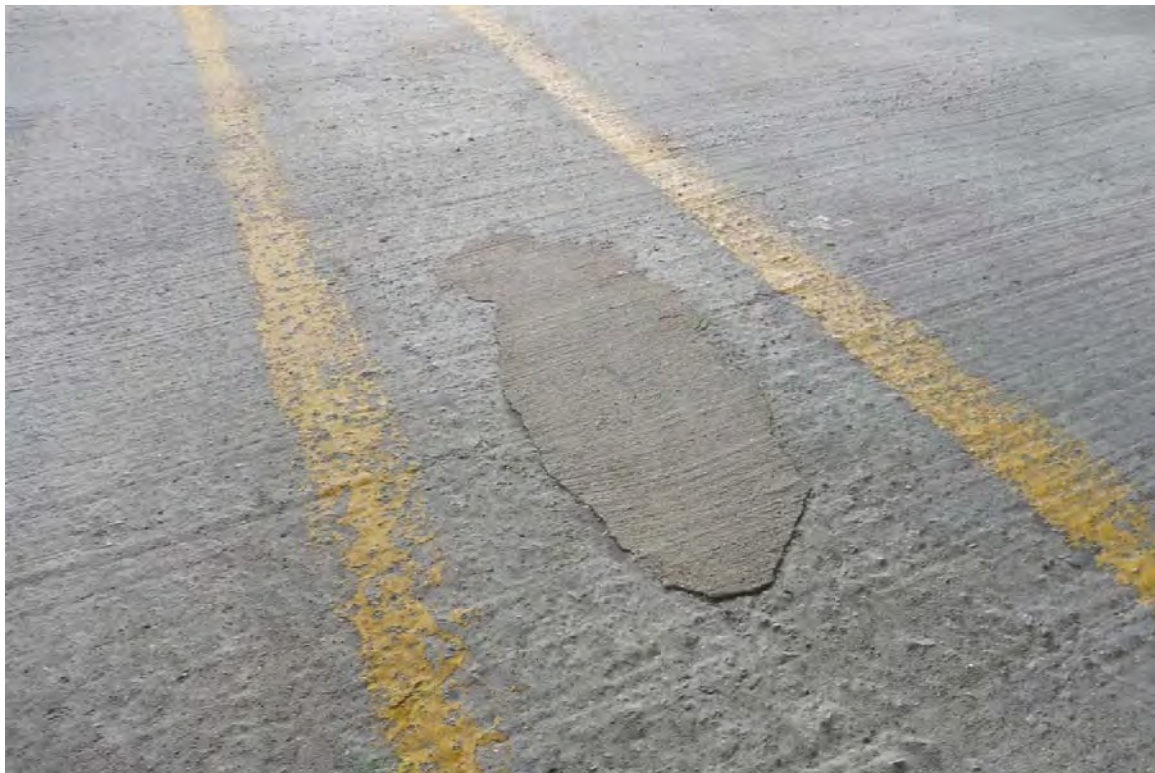
Photo 74 The floor slabs are in good condition while few existing patches were observed. The existing patch seen here was unsound and should be repaired.

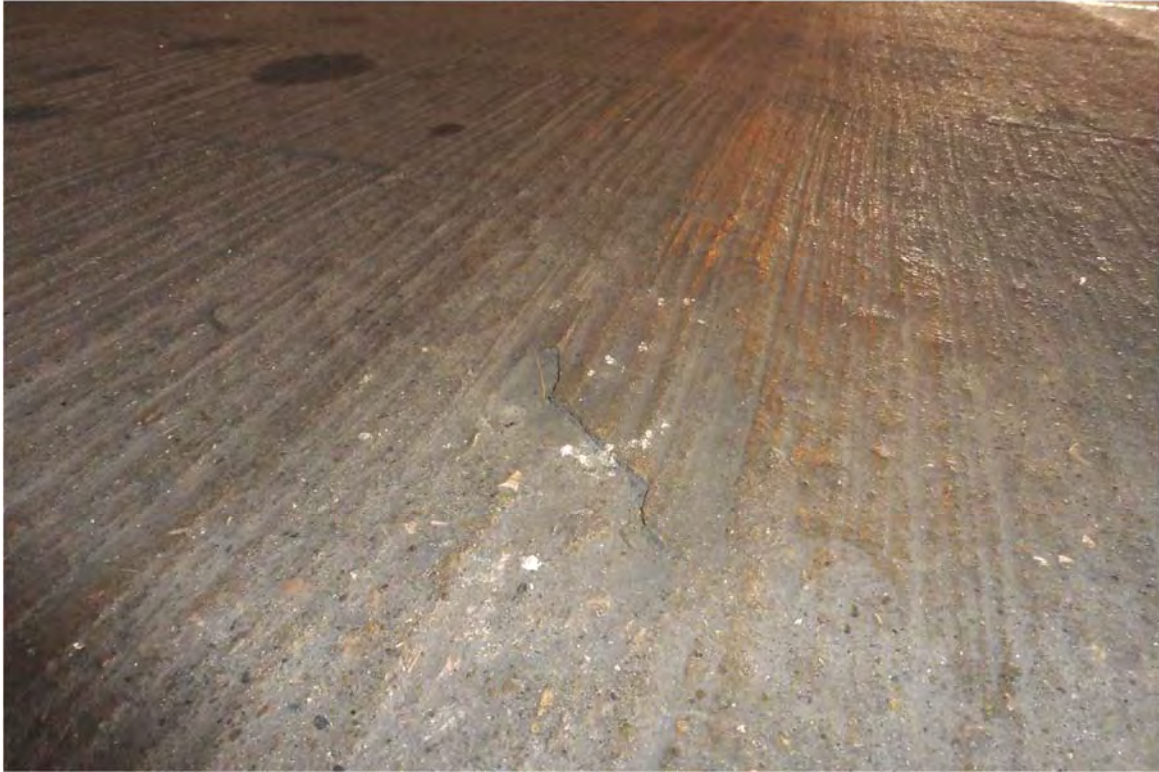
Photo 75 Slab scaling of the top surface was noted at some locations, generally on the lower levels where the volume of vehicles is typically higher.

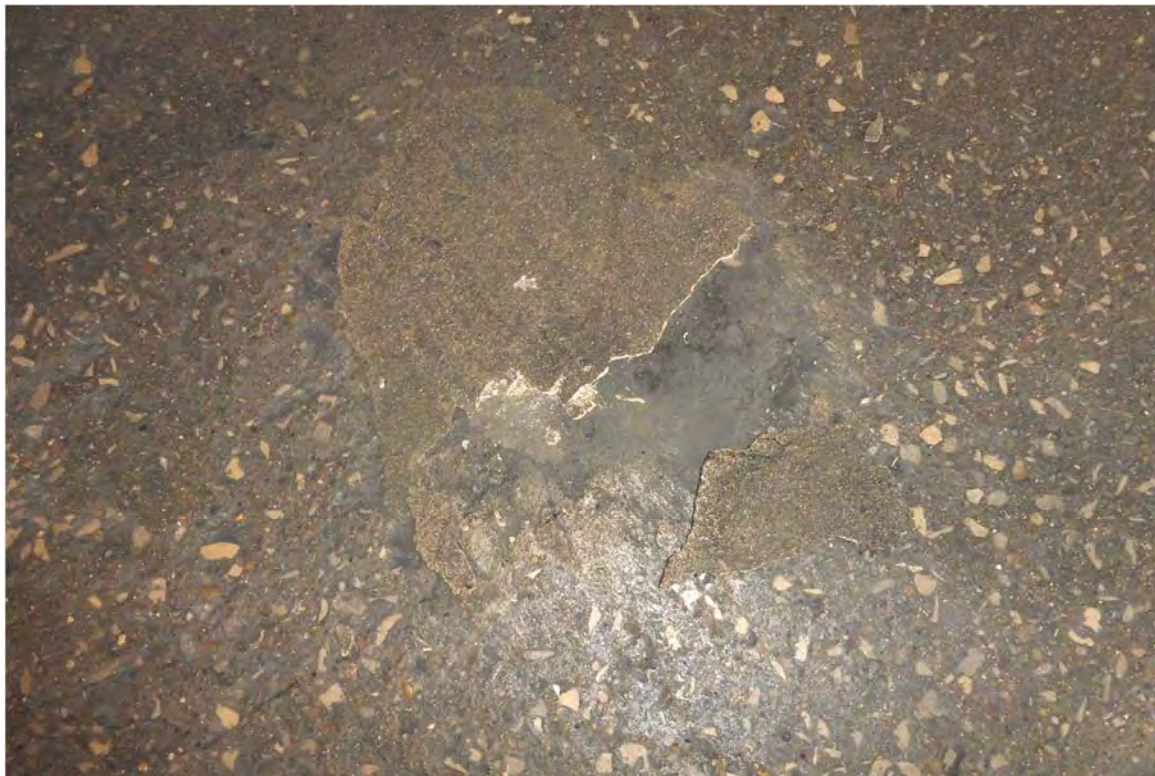
Photo 76 Another example of surface scaling that was observed.

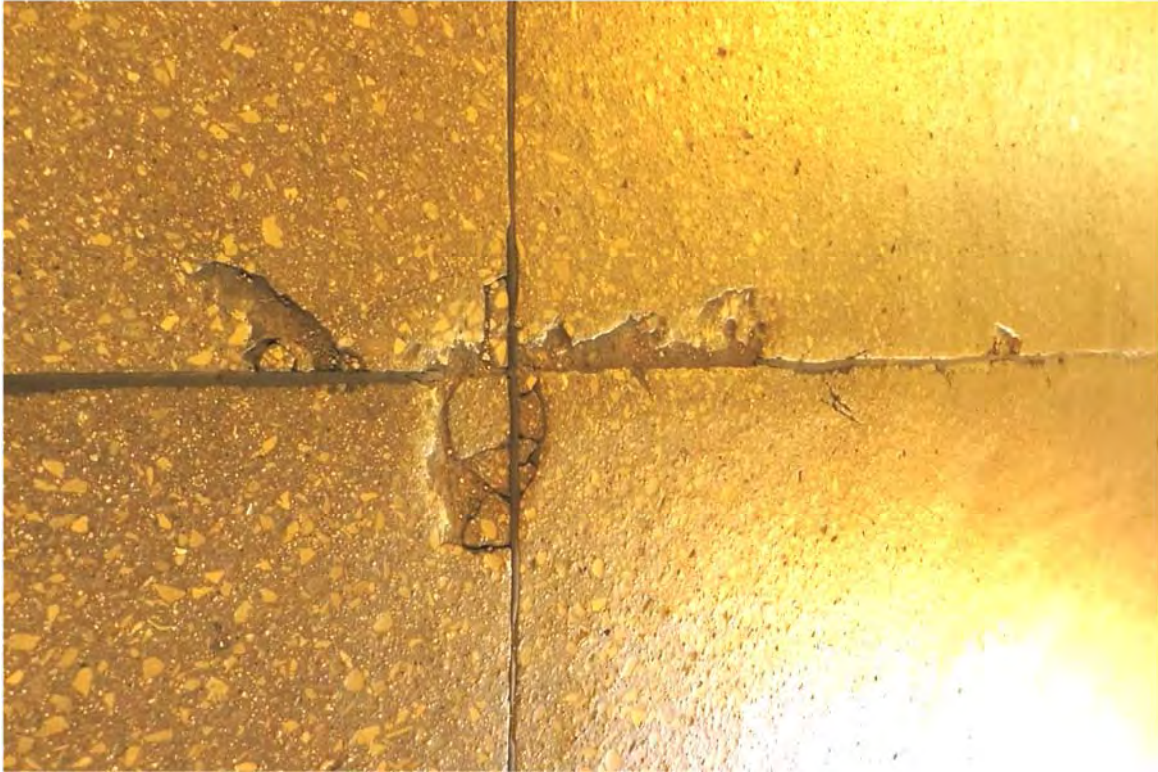
Photo 77 Small spalls in the slab-on-grade at the sawcut control joints should be patched to keep from enlarging with time.

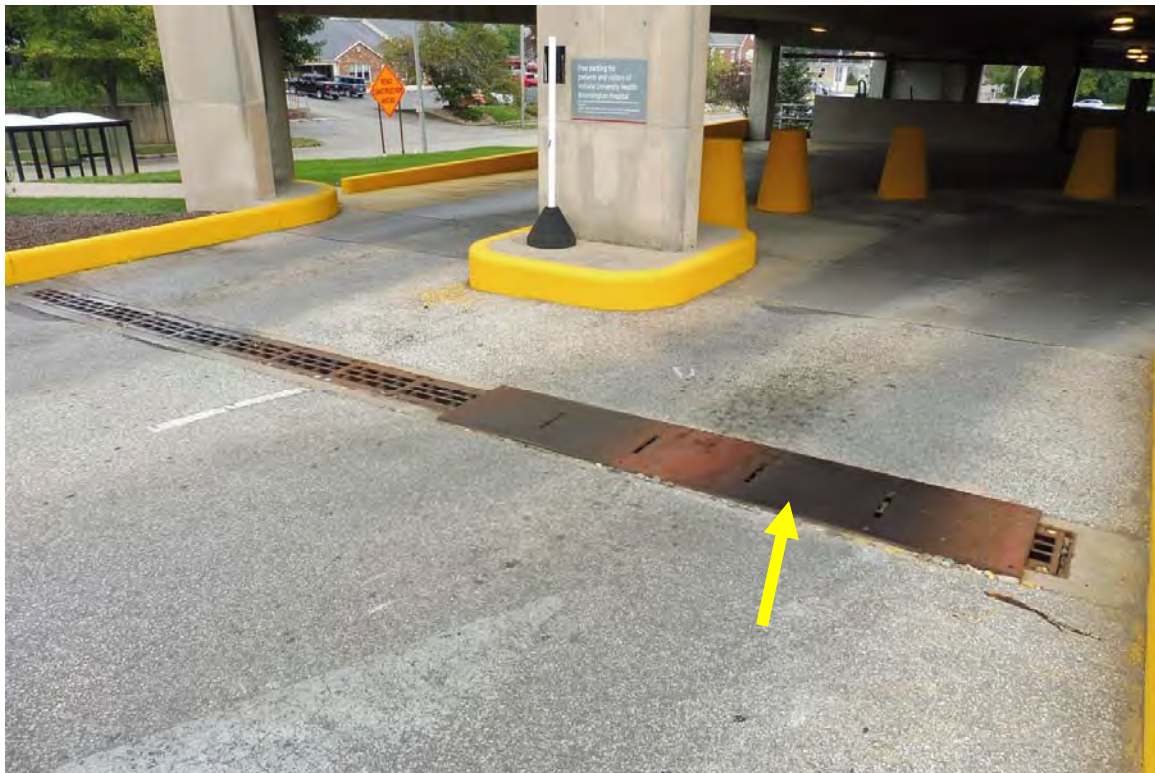
Photo 78 Steel road plate installed over the trench drain at the main entrance. The plate was loose and needs to be re-anchored. The condition of the trench drain below the road plate was not visible.

grade joints as shown in Photo 77 and should be repaired before they become larger. Cracks in the lower level slab-on-grade should be routed and sealed to prevent water from infill. The trench drain at the garage entrance could only be partially viewed due to the steel road plate covering half of the drain as shown in Photo 78. The road plate was loose and should be temporarily re-anchored until the trench drain can be properly repaired.
