# **ARSEE ENGINEERS, INC.**

IU Health Facility Assessment  
Bloomington, Indiana  
for

RE: IU Health Facility Assessment  
Bloomington, Indiana

## **EXECUTIVE SUMMARY**

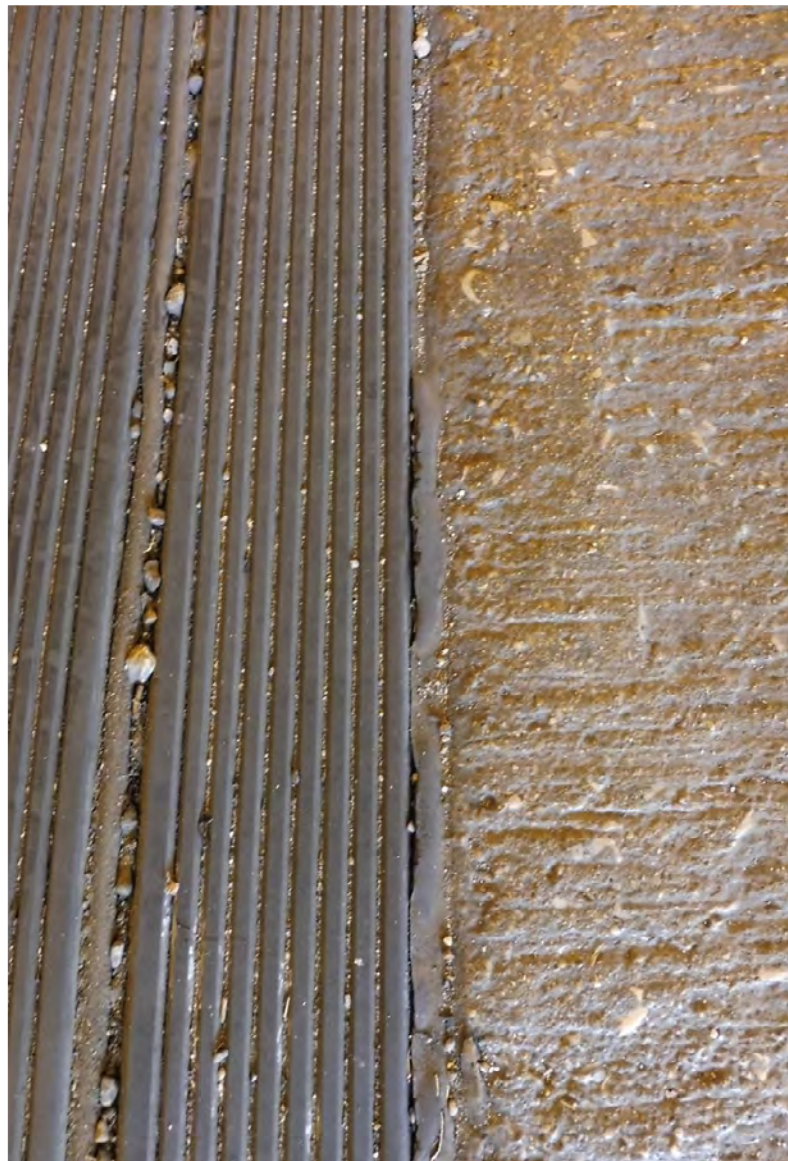
Photo 80

The joint is in fairly good condition, but the perimeter sealant has failed in multiple locations and should be replaced.

The winged expansion joint installed at the transition between the slab-on-grade and the post-tensioned slab was in good condition. The sealant joints along the perimeter of the winged joint, however, have adhesively failed in multiple areas as shown in Photos 79 and 80. That sealant should be replaced to maintain a watertight perimeter along the winged joint. If left untreated, moisture can infiltrate the perimeter and damage the joint and adjacent concrete.

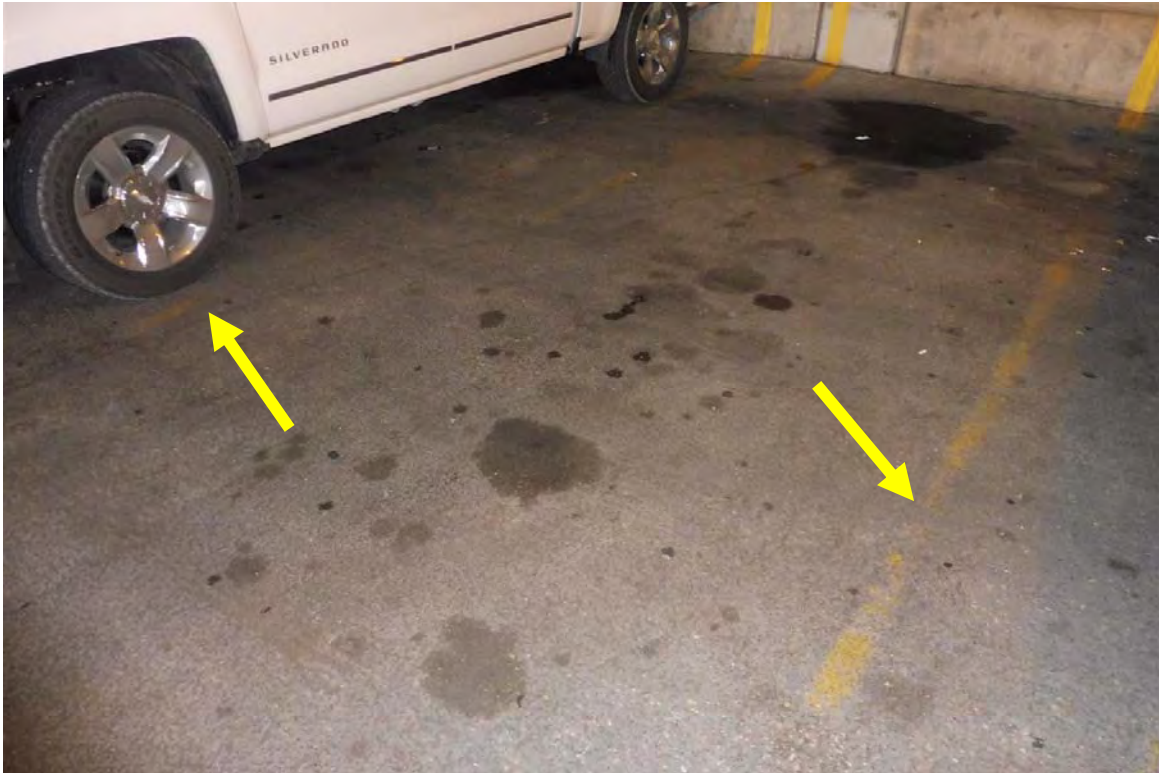
Photo 81 The striping paint throughout the garage should be reinstalled as many of the parking stall lines have faded/worn away.

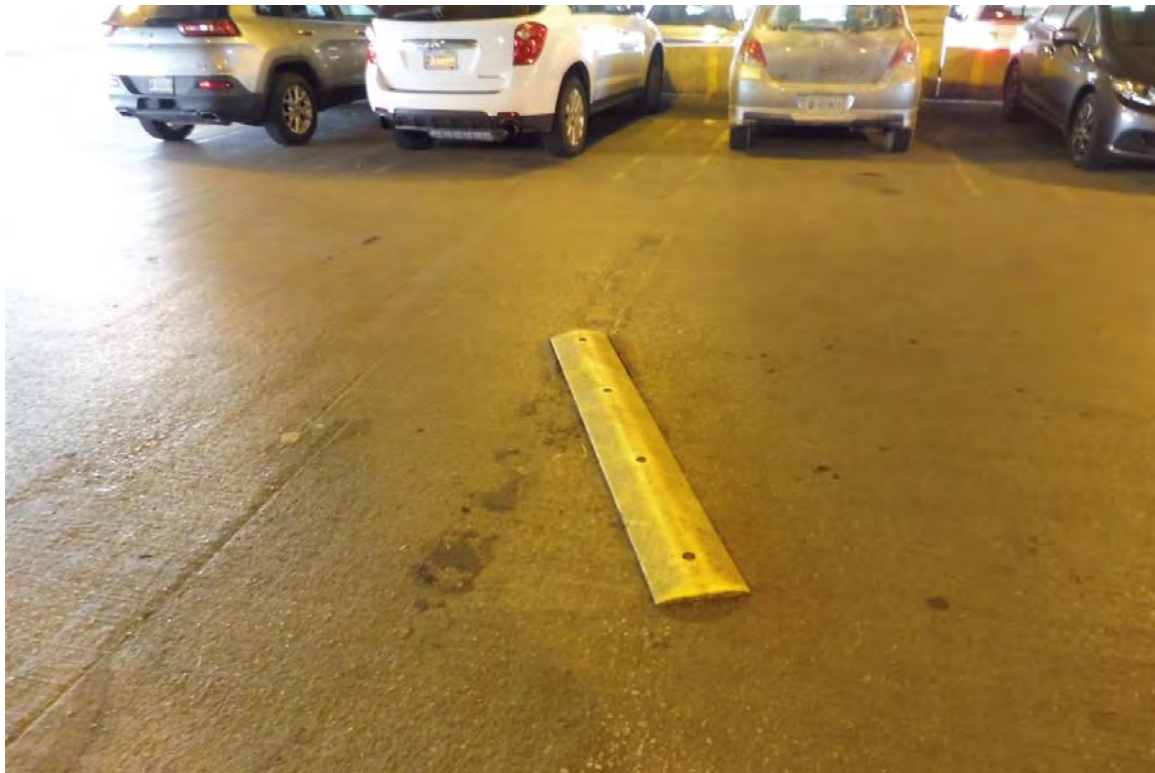
Photo 82 Speed bump devices have been installed. Several were missing and others were loose as seen here.

Other slab conditions that were noted include fading of the parking stall striping paint as shown in Photo 81. Also, loose and missing speed bump devices were documented on several of the levels. An example of one of the loose speed bumps is shown in Photo 82. Some of the missing speed bumps were found against the bumper walls behind the parking stalls.

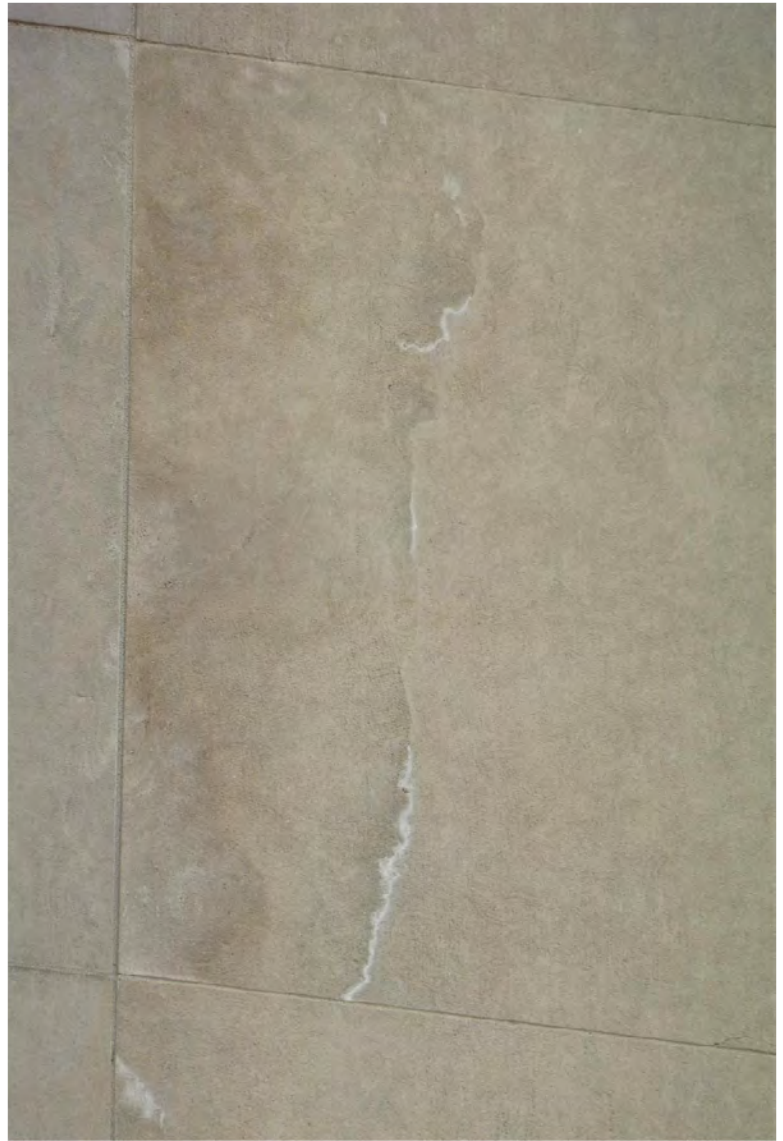
Photo 84

Cracked limestone panel over the northeast stair grade level entrance.

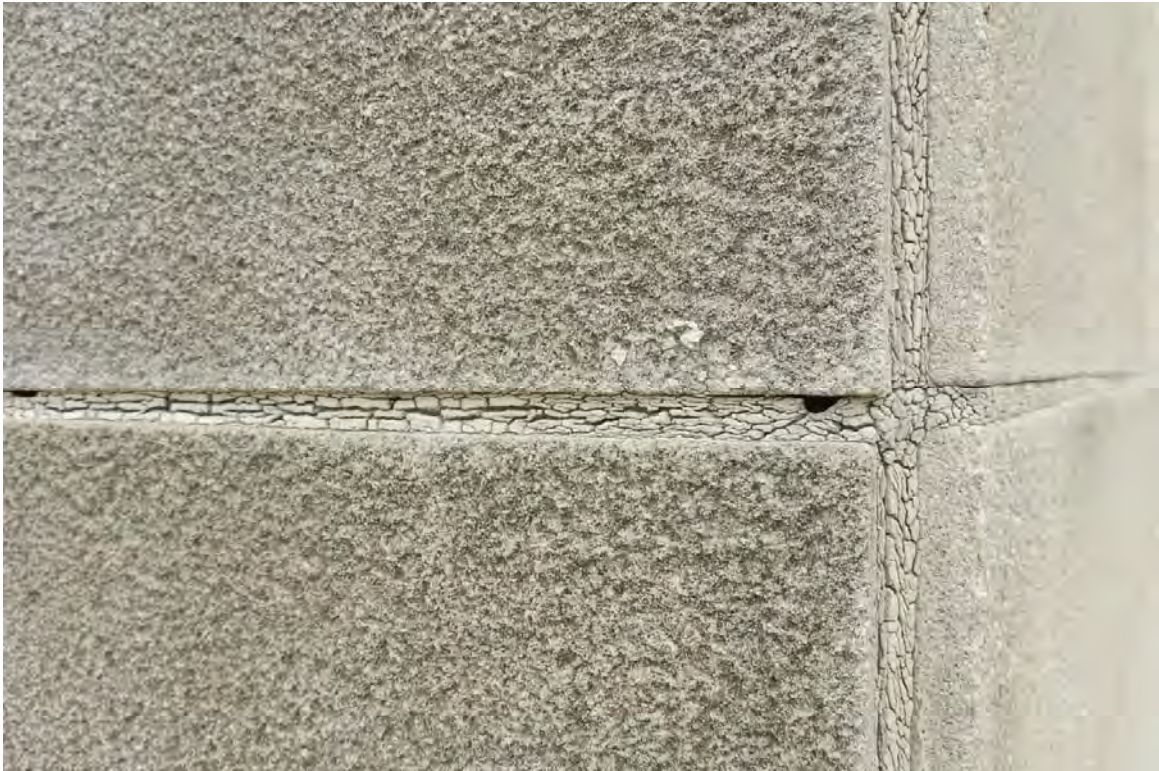
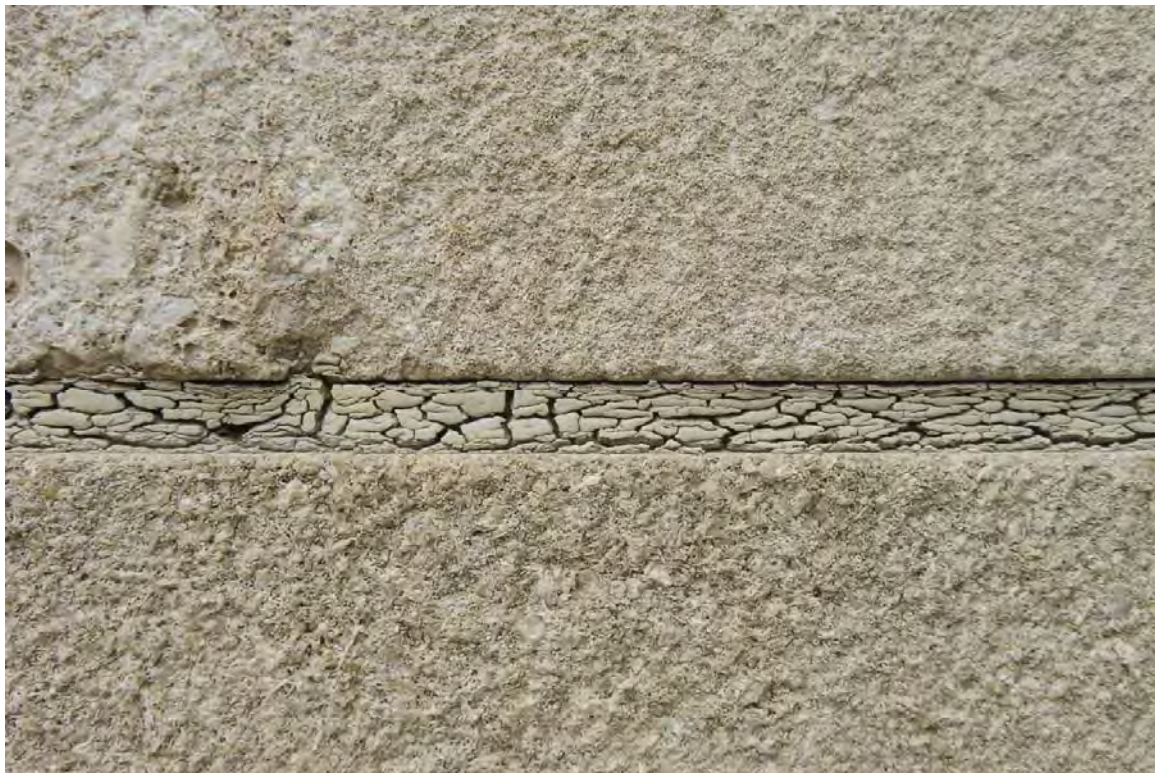
Photo 85 Sealant joints within the limestone panels on the garage...

Photo 86 ...have reached their useful service life and should be replaced.

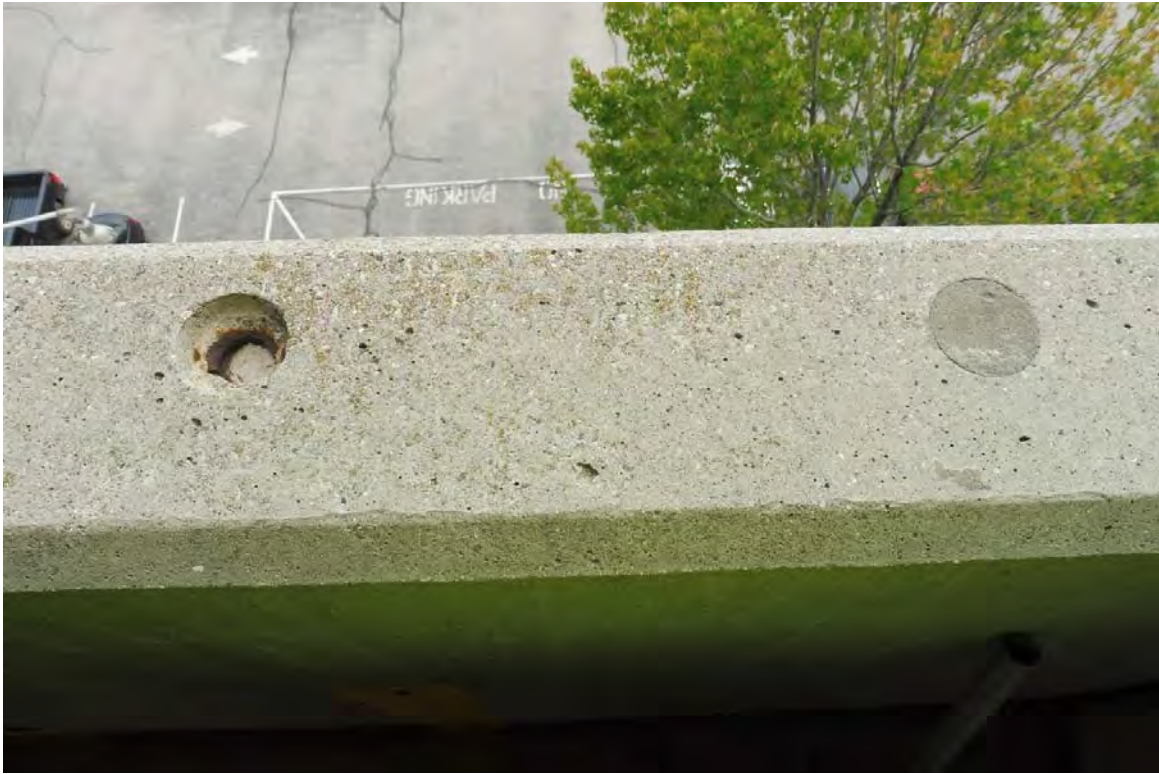
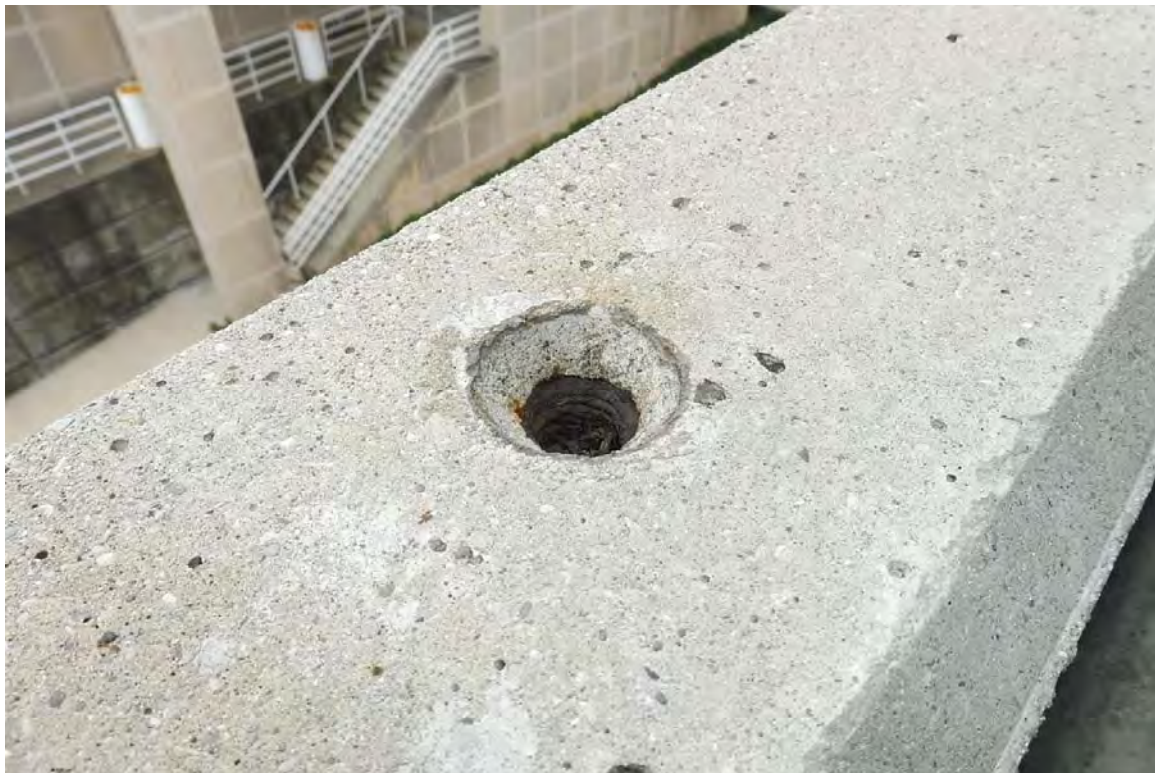
Photo 87 Missing grout pockets at the lift insert holes on the skyward face of the façade panels...

Photo 88 ...should be cleaned and filled with non-shrink grout to keep the metal insert embedment from corroding.

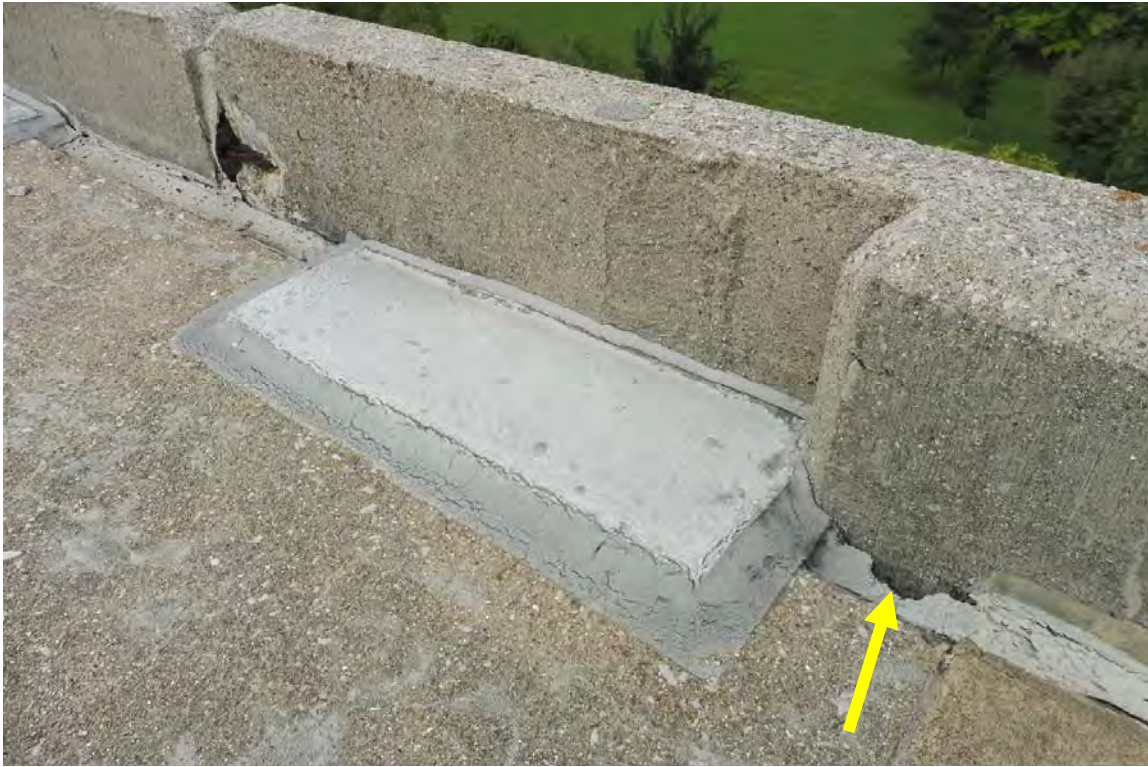
Photo 89

Existing sealant joints between the façade spandrels and the garage structure have failed in many locations. The premold type membrane installed over the connections were also failed at some locations.

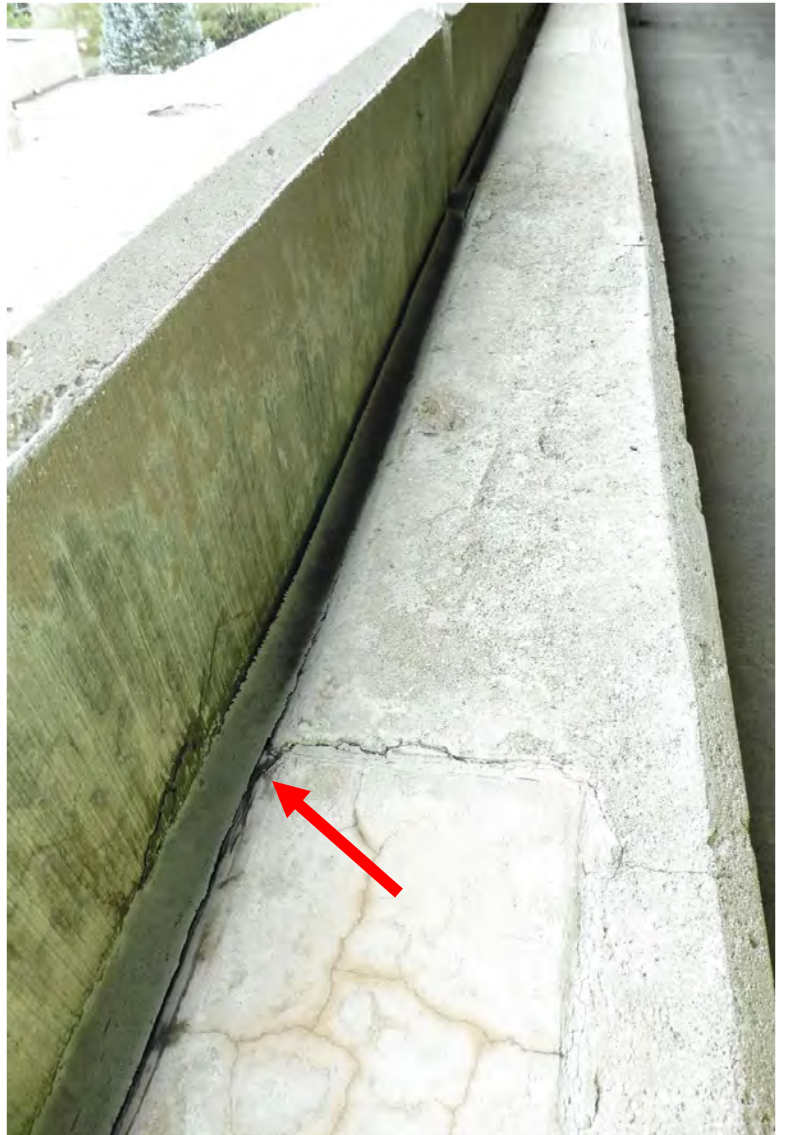
Photo 90

Another example of failed sealant between the façade spandrels and the garage structure. These joints are important to help keep water from migrating into precast connections and post-tensioned tendon anchor blockouts in the beams and columns.

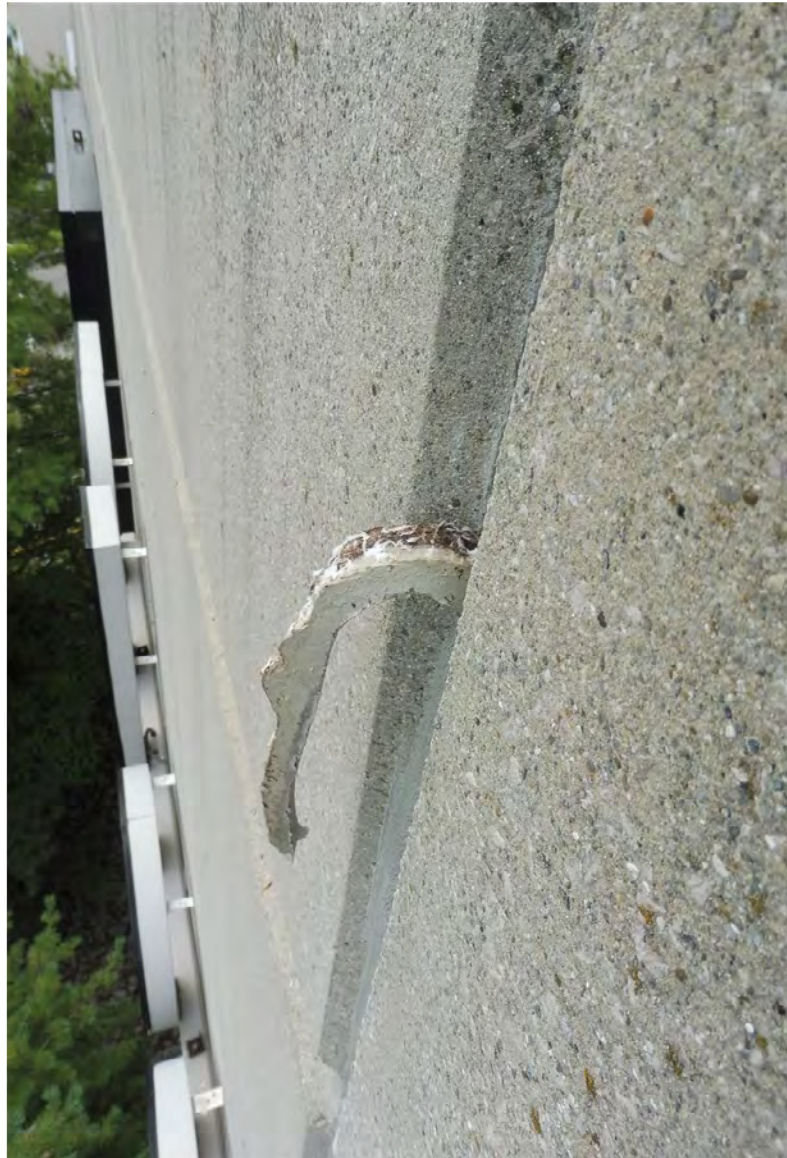
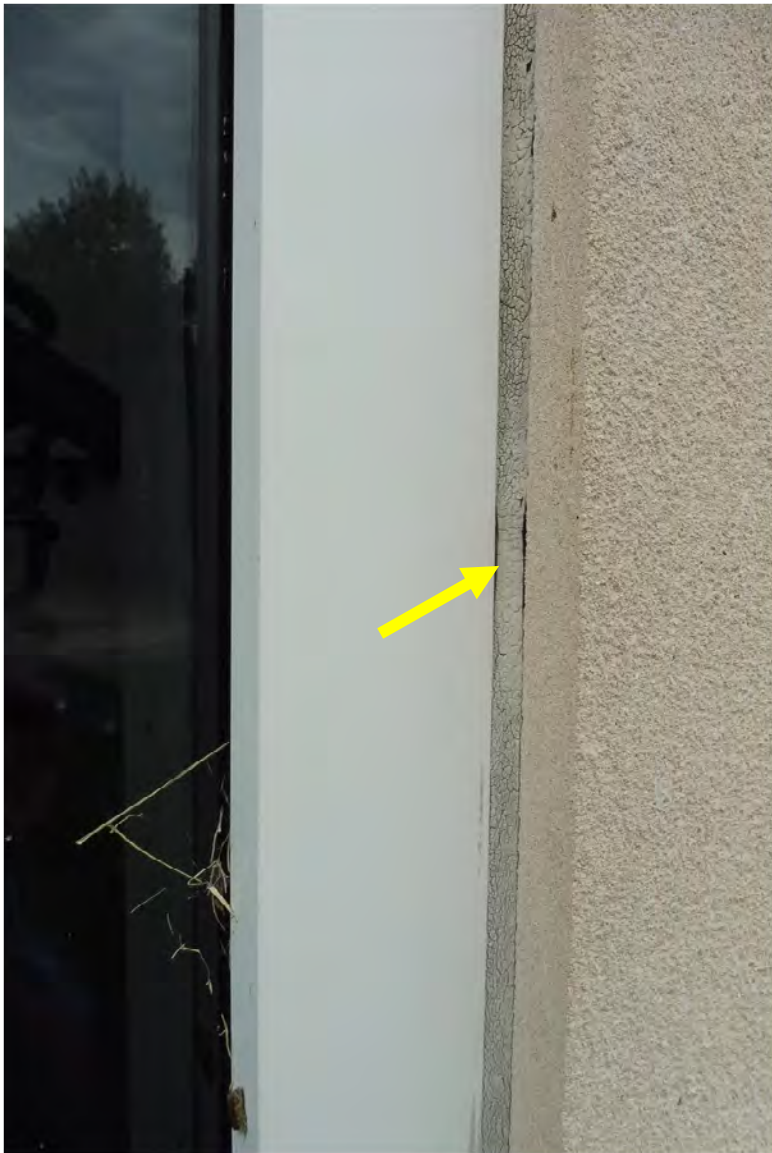
The sealant joints throughout the precast façade...

...have failed in most locations and need to be replaced.

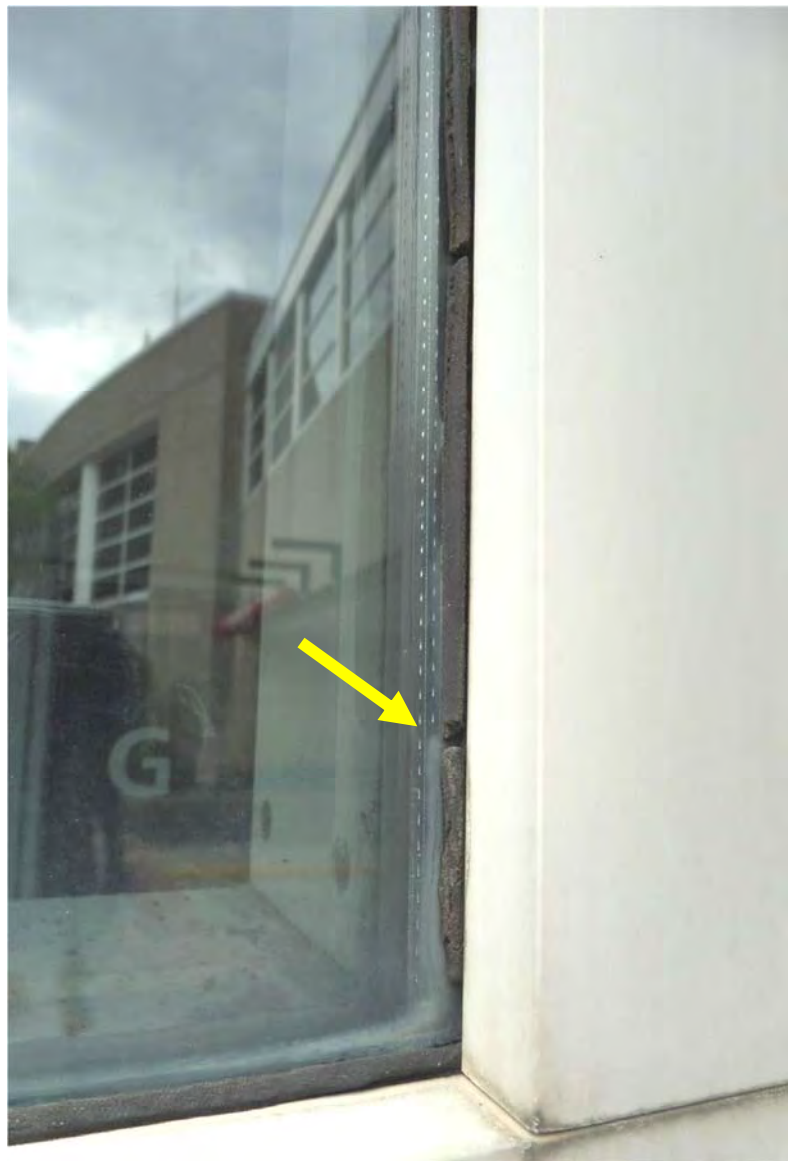
Photo 94

Gaskets in the curtain wall system have shrunk and many have failed. They should be removed and either replaced with new gasket material or wet sealed with liquid sealant.

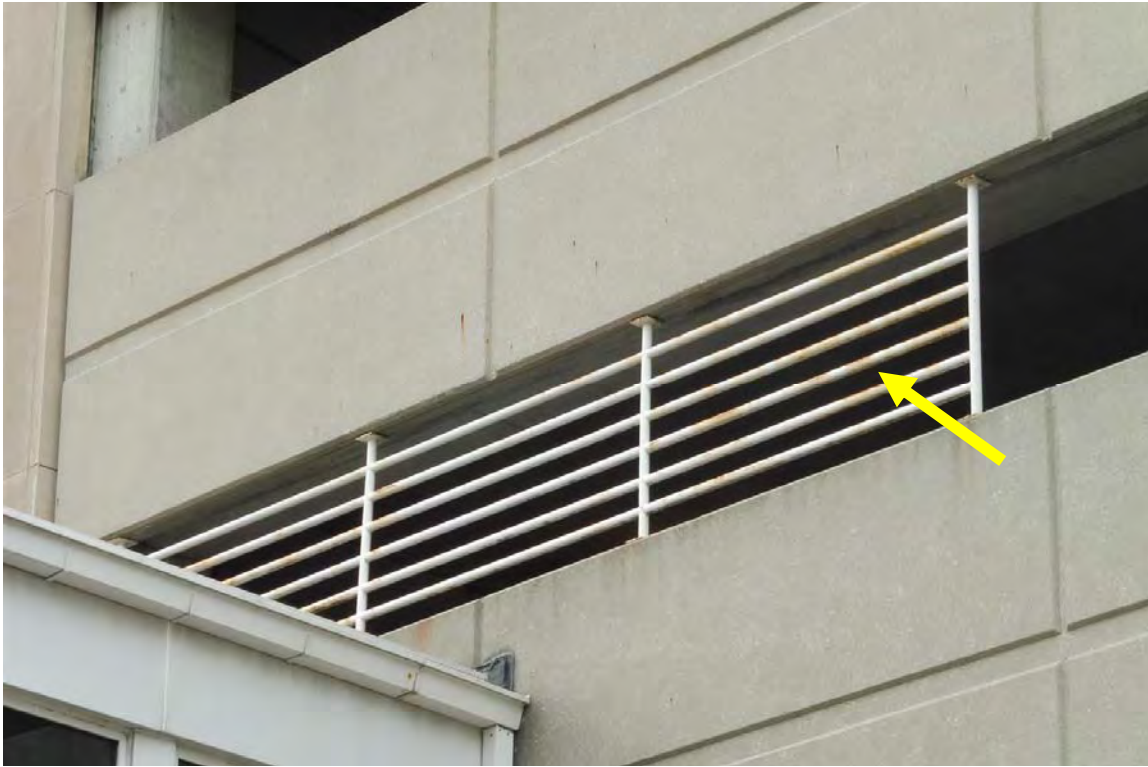
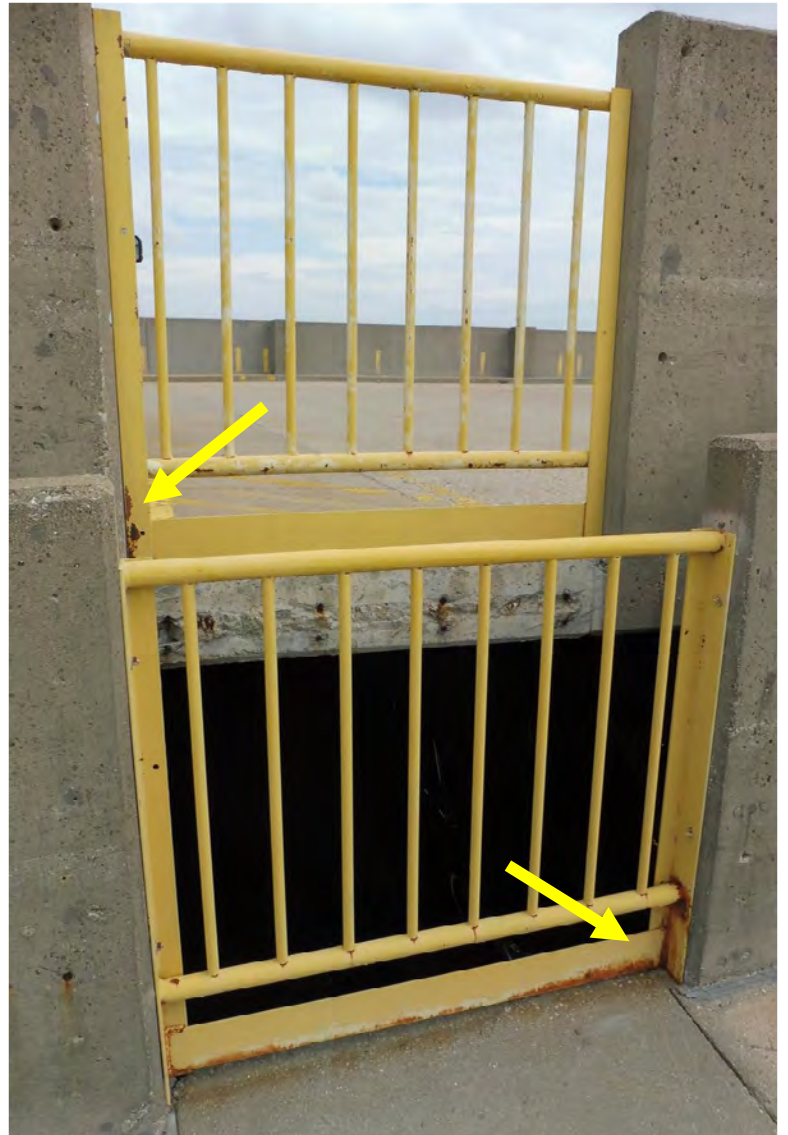
Miscellaneous steel throughout the garage has been coated, but those coatings have started to break down and corrosion of the underlying steel substrate has commenced. Photos 97 and 98 show examples of the corrosion that has formed in areas where the existing coatings have failed.

Miscellaneous steel throughout the garage has rusted...

...and needs to be cleaned and coated with a durable coating system.

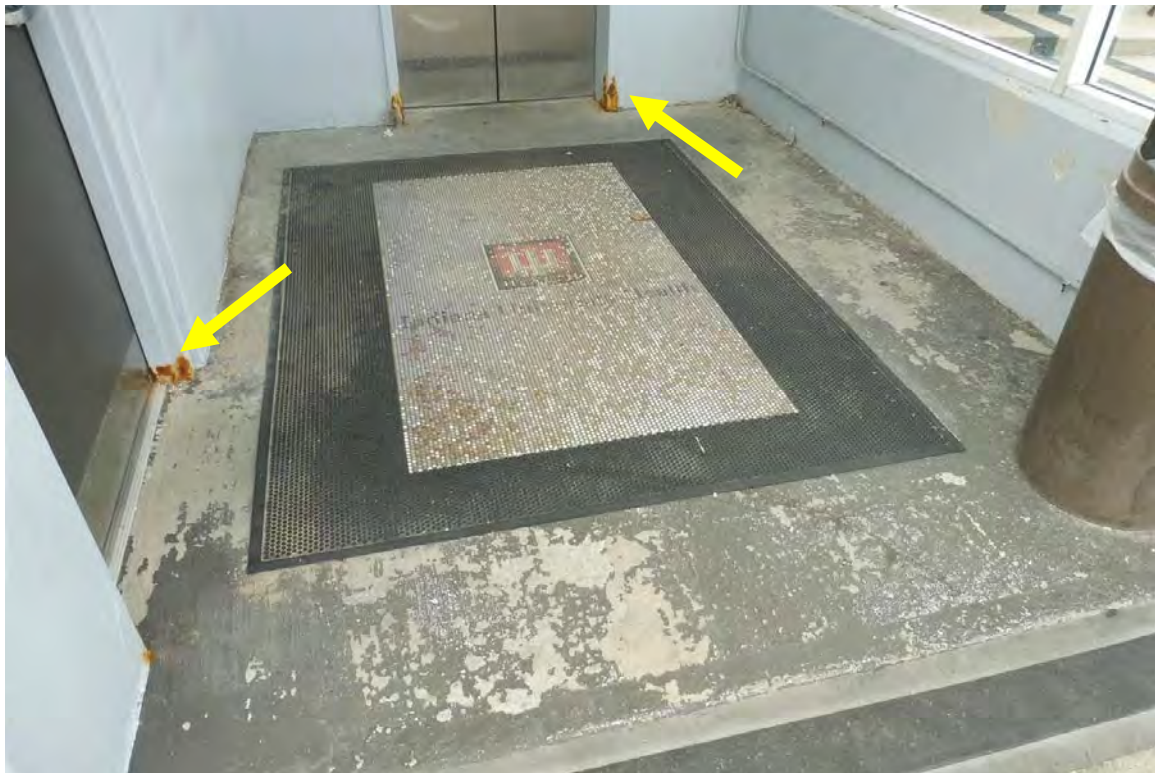
Photo 100 The existing floor coating throughout the stair/elevator tower has failed. Corrosion of the door frames both to the stair and the elevator were observed on each level.

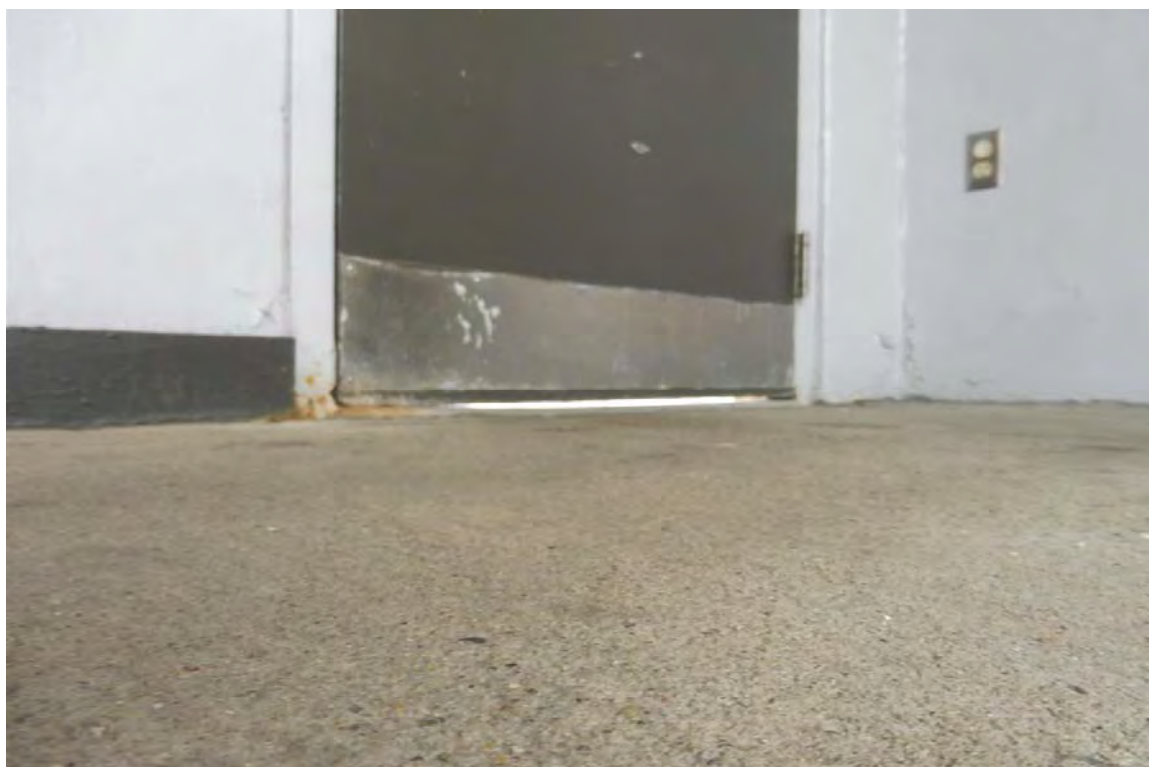
Photo 102

With no evidence of water infiltration from the roof above, it appears the water is entering the stair through the gap below the roof level door. We suggest a door sweep be installed to help minimize the water travel underneath the door.

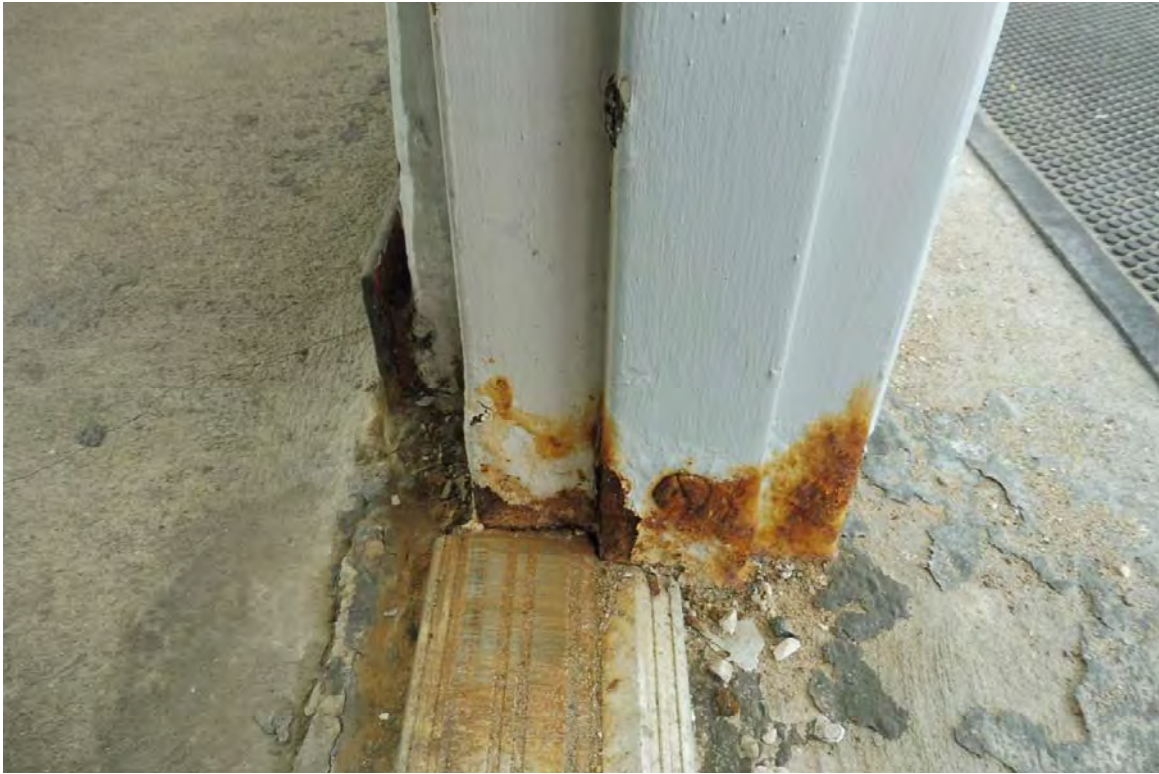
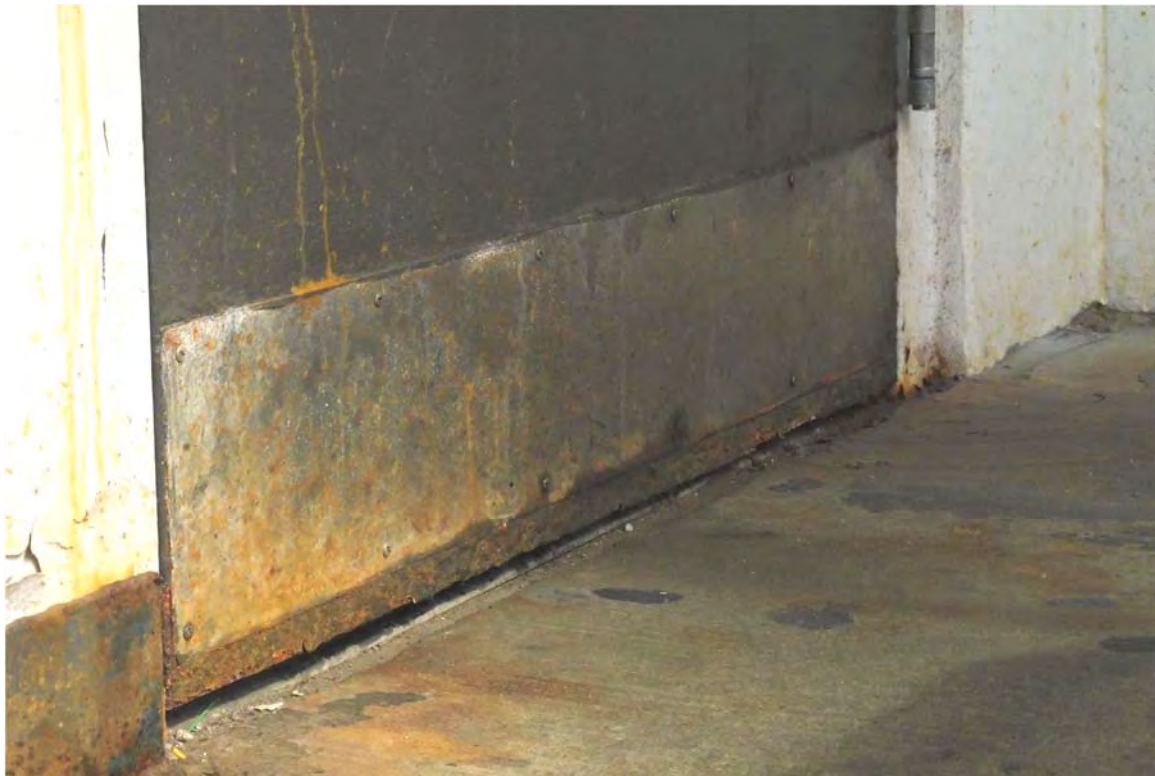
Photo 103 Corrosion at the bottom of the door frames...

Photo 104 ...as well as the hollow metal doors was observed on each level of the southwest stair. Regular maintenance of the coatings on the doors and frames will help minimize the corrosion levels.

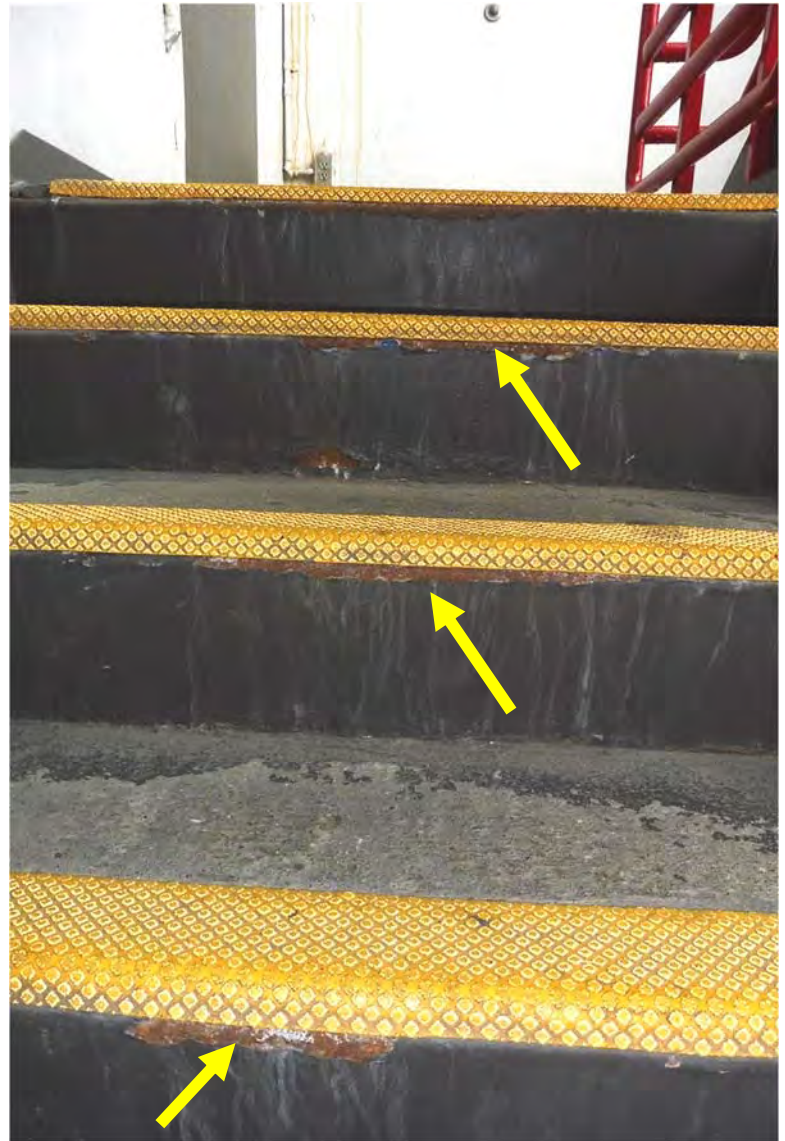
Photo 106

Moisture in the stair tower has also led to corrosion of some of the metal risers in the metal pan stairs...

...as well as localized areas of the metal pan stair structure itself.

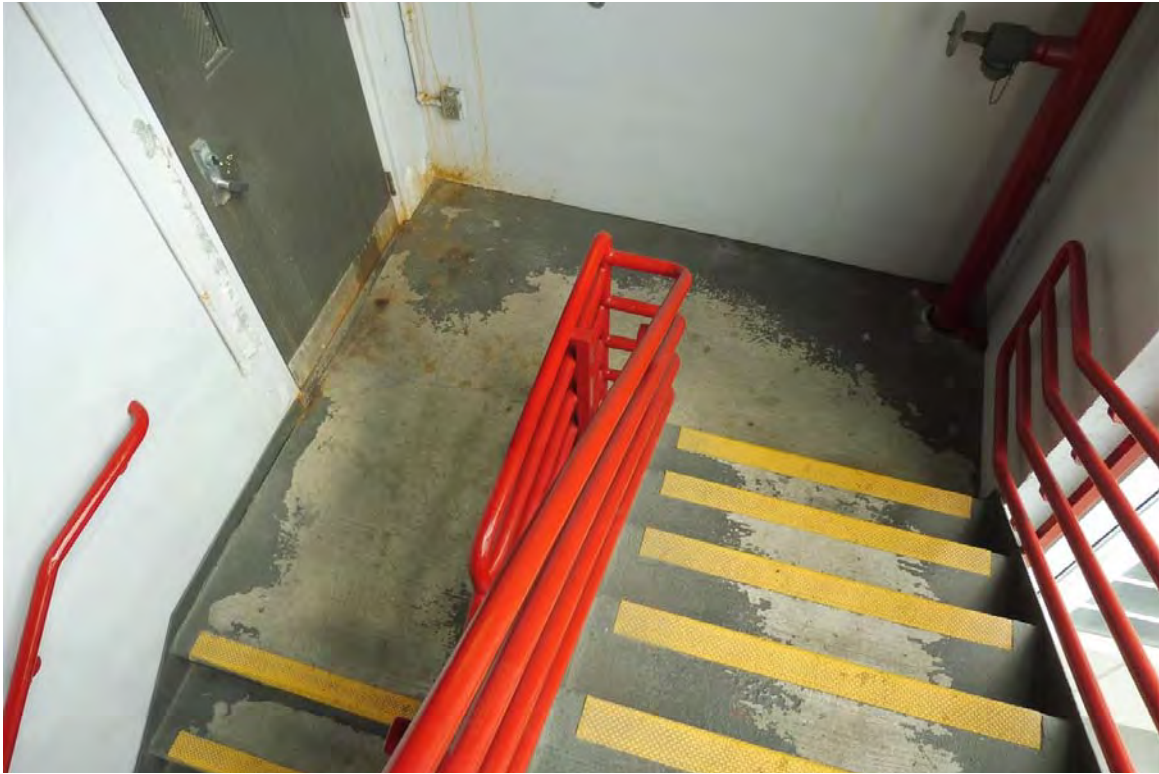
The floor coating applied to the landings and treads has failed as seen in Photo 107. Similarly, water infiltration in the stairwell has caused the wall coatings to peel and bubble in multiple areas as shown in Photo 108. Garage stairwells that do not have controlled fan systems tend to have higher humidity conditions. An increase in air movement and better control of thermal conditions within the tower can help minimize the amount of ambient moisture present. A reduction in relative humidity would be beneficial for all the coated surfaces.

Photo 107 View of the failed floor coating that was previously applied to the treads and landings. We suggest replacement of the coating system to increase the protection of the metal pan stair structure below the concrete landings and treads.

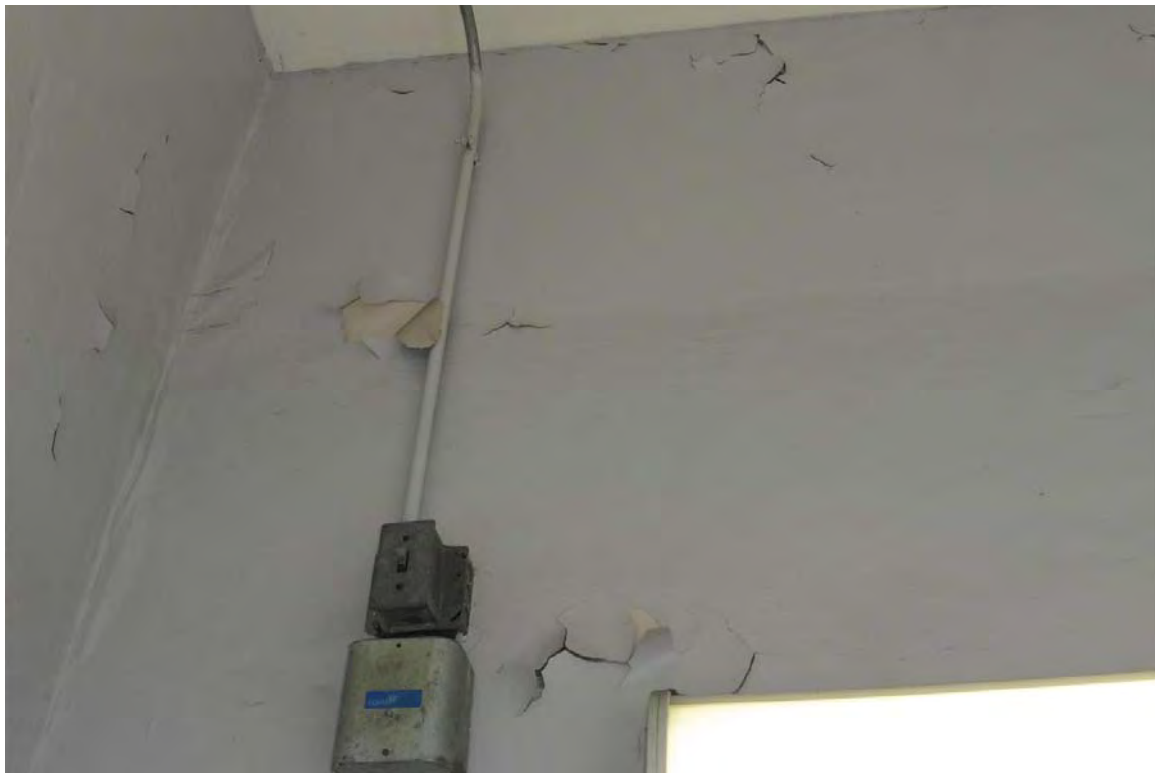
Photo 108 Example of the peeling and failed coating on the concrete walls within the southwest stair.

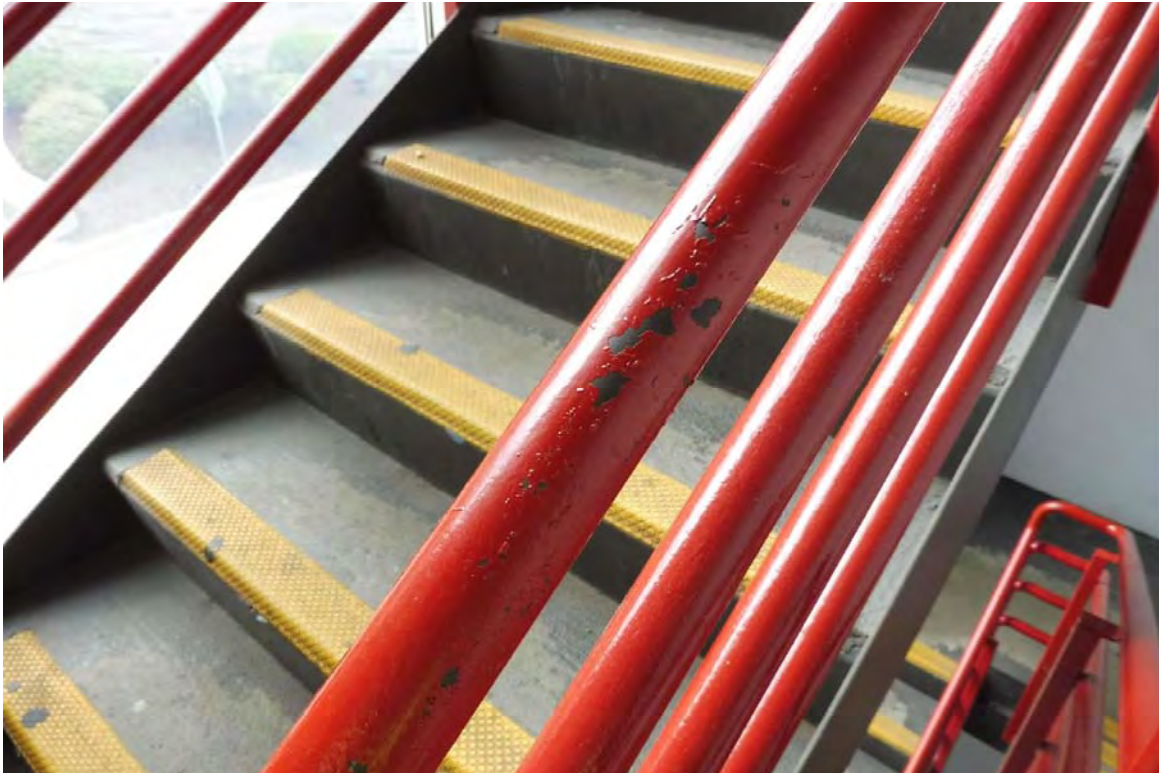
Photo 109 The paint system on the handrails was generally in good condition with few areas as seen here where the coating is starting to fail.

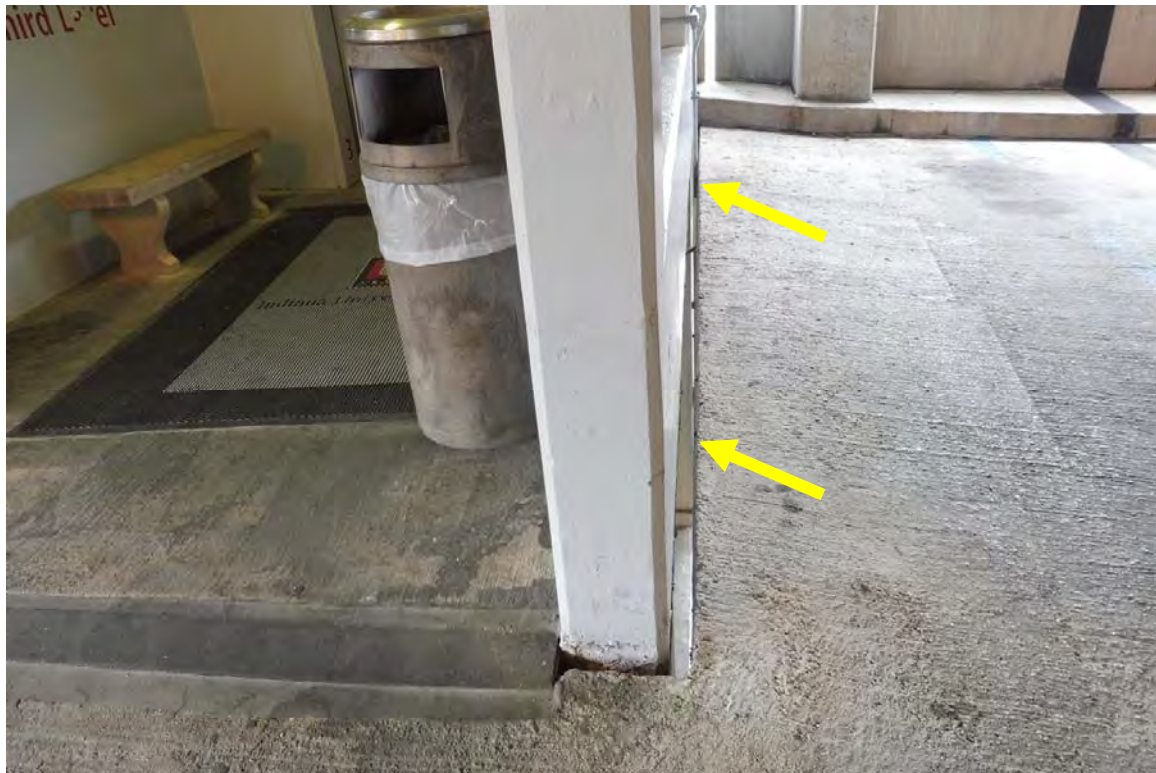
Photo 110 The expansion joint between the southwest stair/elevator tower and the garage floor slab is open at Levels 2 and 3. We would suggest an expansion joint be installed to seal the gap.
