# **ARSEE ENGINEERS, INC.**

IU Health Facility Assessment  
Bloomington, Indiana  
for

RE: IU Health Facility Assessment  
Bloomington, Indiana

## **EXECUTIVE SUMMARY**

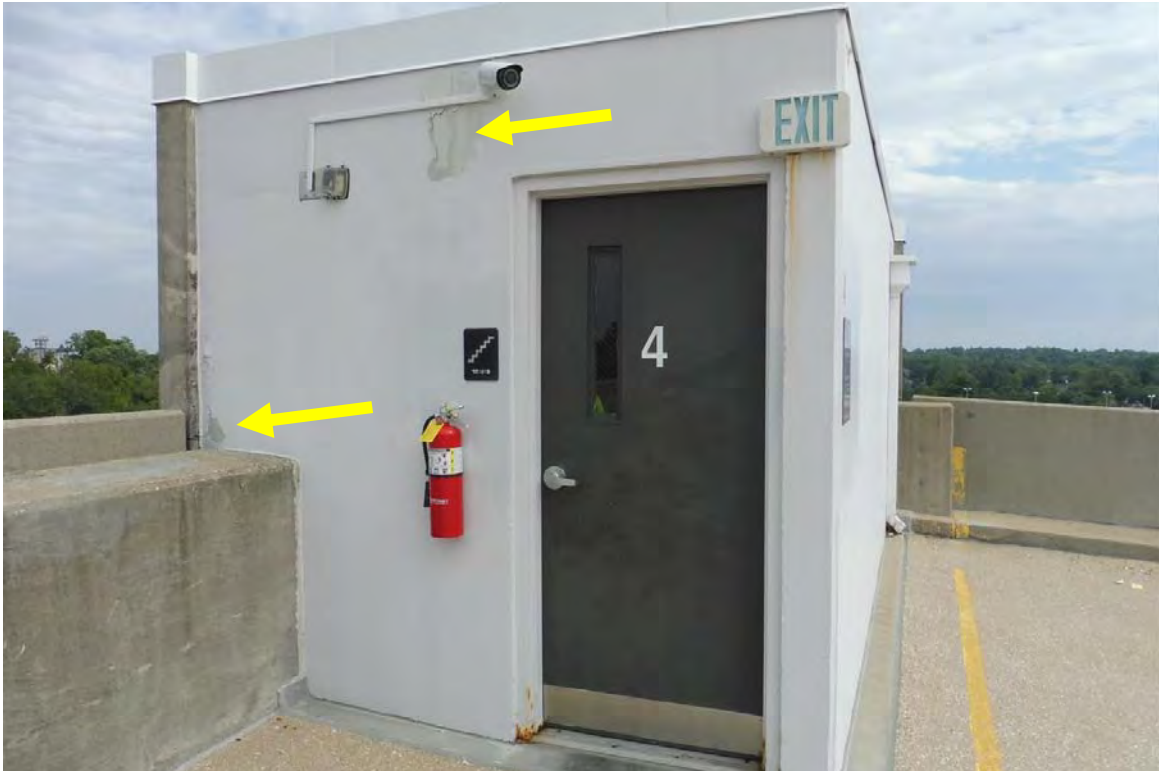
Photo 111 Northeast stair tower at the roof level. The coating on the concrete walls has failed in multiple areas on the outside of the stair tower.

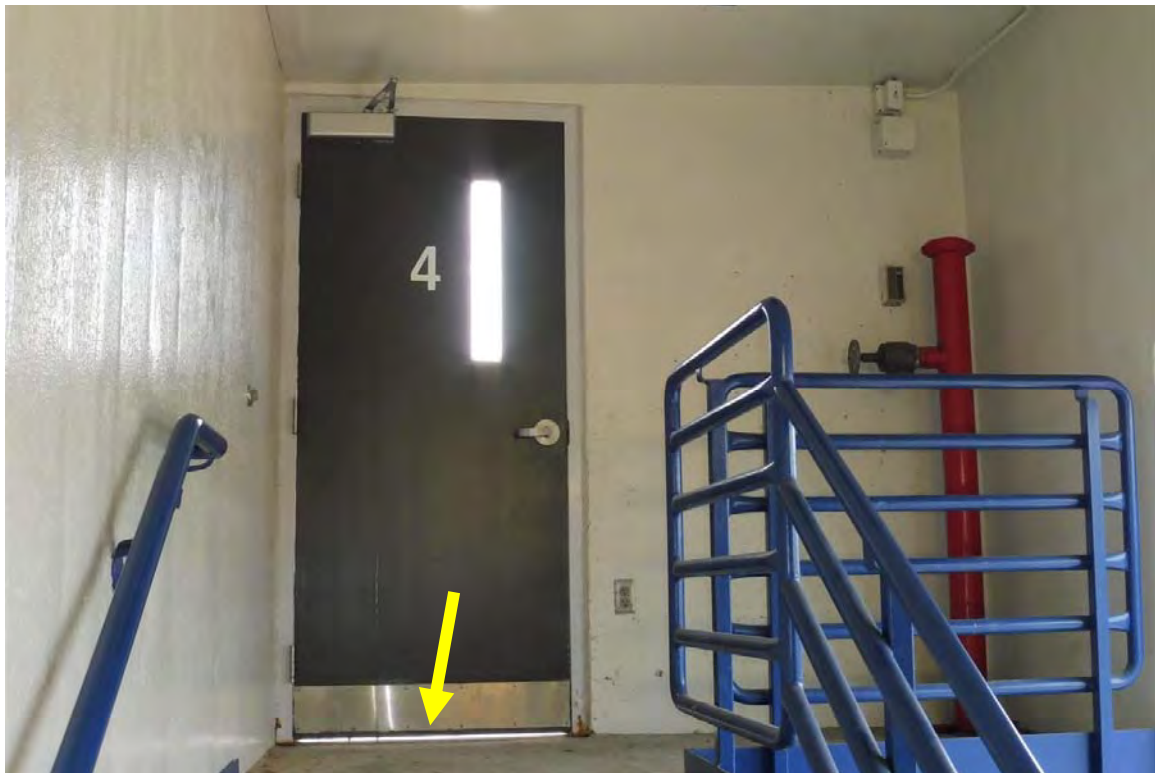
Photo 112 Similar to the southwest stair, moisture has been infiltrating the northeast tower via the gap below the roof level door. Damage caused by the water can be seen in the following photos.

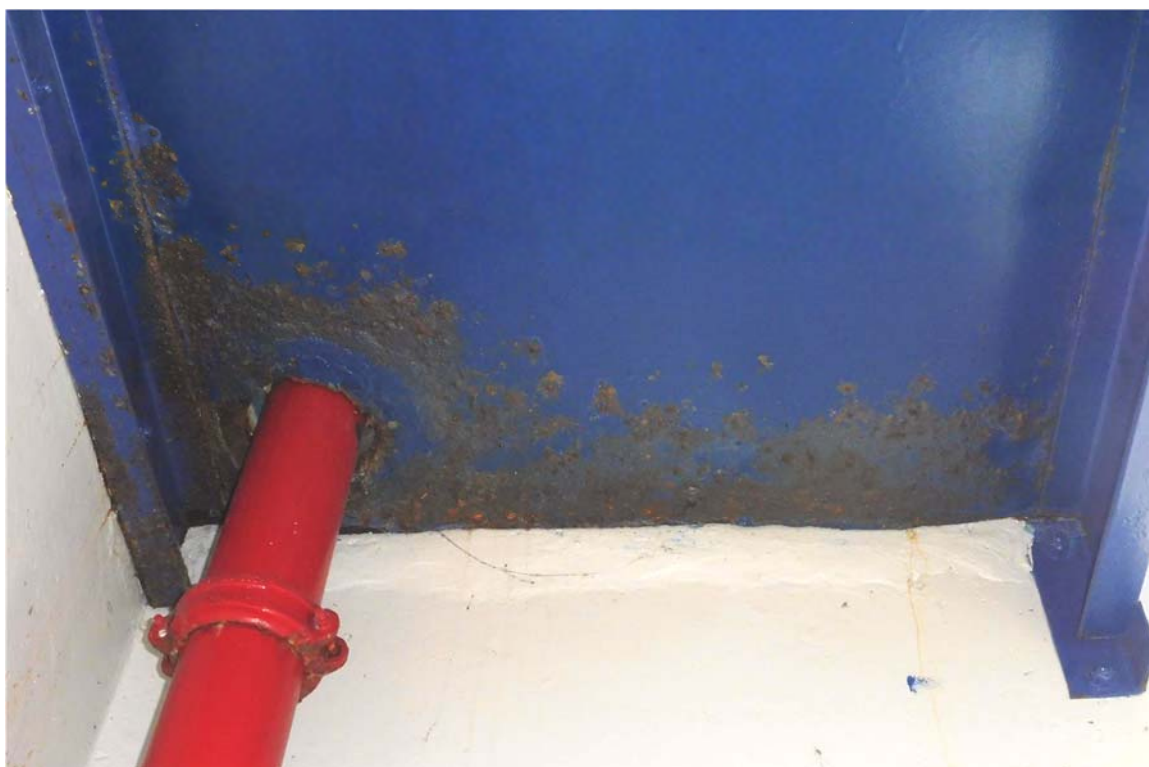
Photo 114

Corrosion of the roof level landing metal pan. The perimeter channel is also corroded as a result of the water infiltration.

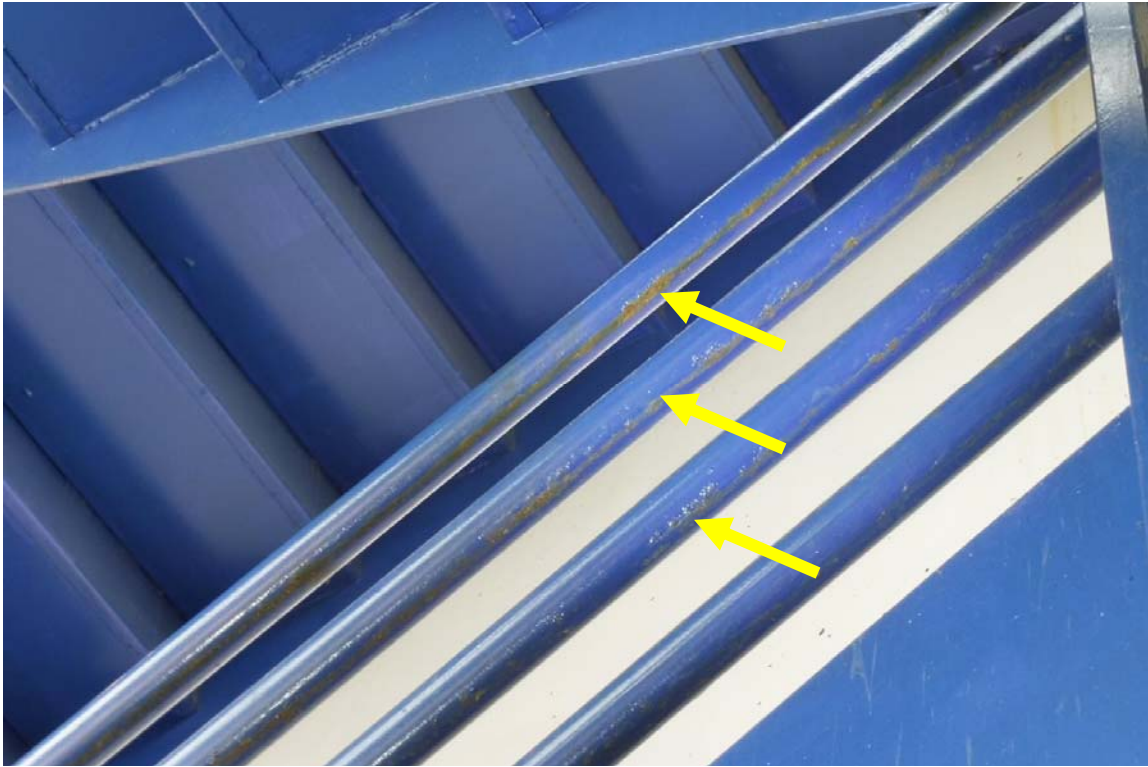
Photo 117

The paint on the handrails and stair structure below Level 2 was in better condition, but rust was observed on the undersides of some of the handrails as seen here.

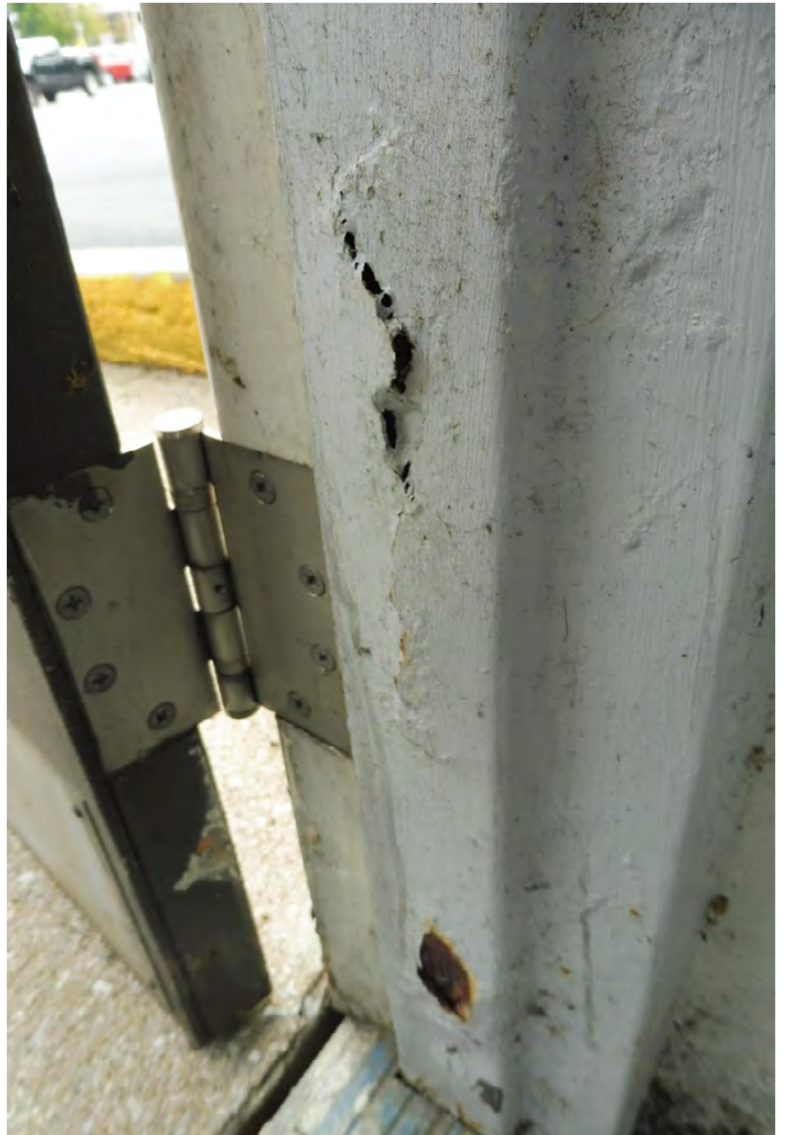
Photo 118

Moisture has entered and froze within the grade level door frame on the northeast stair, causing the steel frame to split.
