# Q-Care Roof System Assessment

**Customer:** City of Bloomington Department of Public Works

**Jobsite:** John Waldron Arts Center (Bloomington)

**Inspection Number:** INS-88

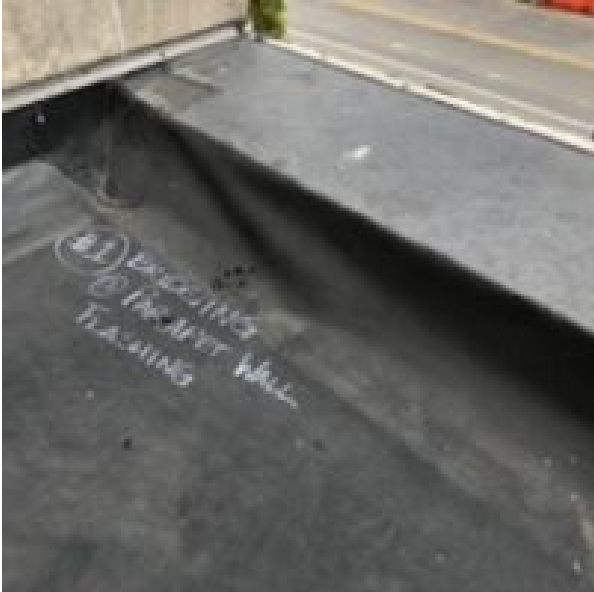
<p><b>Deficiency Number:</b> 17734</p> <p><b>Photo Type:</b> Problem</p> <p><b>Category:</b> Wall or Base Flashing</p> <p><b>Deficiency:</b> Loose Base Tie-in of Base Flashings</p> <p><b>Unit:</b> sf</p> <p><b>Quantity:</b> 15</p> <p><b>Inspected By:</b> Justus King</p> <p><b>Note:</b> Loose/unadhered wall flashing membrane identified. The wall flashings are installed to prevent moisture from damaging the wall substrate and to protect the roof system from water intrusion at the roof/wall transition. Cut open all affected areas of parapet wall. Readhere existing membrane to the substrate, making sure to properly repair any areas of base tie in that are affected. Repair cuts in parapet wall membrane per industry standards.</p> <p><b>Recommendation:</b> Repair</p>

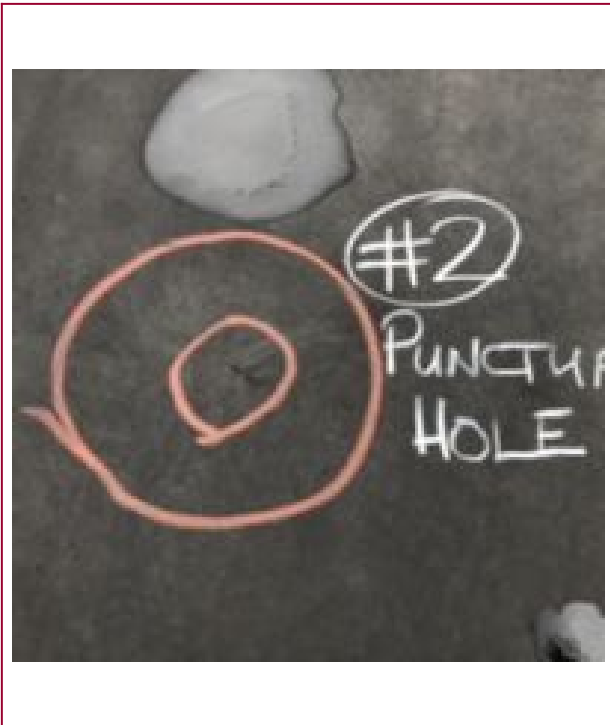
**Deficiency Number:** 17735

**Deficiency:** Holes or Punctures

**Quantity:** 6

**Note:** Puncture hole identified. Puncture holes in roof/flashing membranes allow for water intrusion into the roof system usually resulting in leak activity. Install a permanent repair patch to the deficiency using similar materials per industry standards.

**Recommendation:** Repair

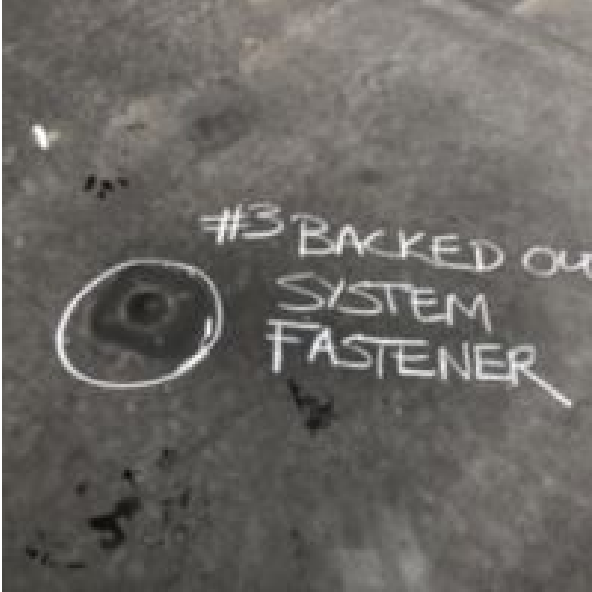
**Deficiency Number:** 17736

**Deficiency:** Fastener Loose/Missing

**Quantity:** 1

**Note:** Loose/backed out roof system fastener identified. Roof system fasteners hold the roof insulation and/or the roof membrane intact to the substrate. Fasteners can back out because of building movement or expansion/contraction of the roof system caused by hot/cold temperatures. They may also back out from improper installation practices. Open roof membrane in the affected areas. Reset existing/replace damaged fastener and repair membrane w/similar material per industry standards.

**Recommendation:** Repair

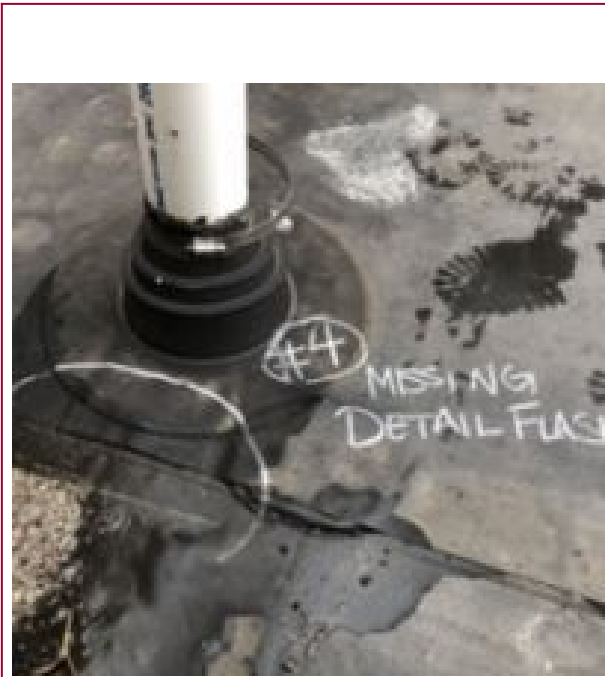
**Deficiency Number:** 17737

**Deficiency:** Improper Patch

**Note:** Missing detail flashing identified. Detail flashings are responsible for keeping moisture from intruding into the roof system at all roof penetrations, perimeter wall transition intersections, etc. Remove all loose/failed flashing material and install new flashing using similar materials per industry standard.

**Recommendation:** Repair

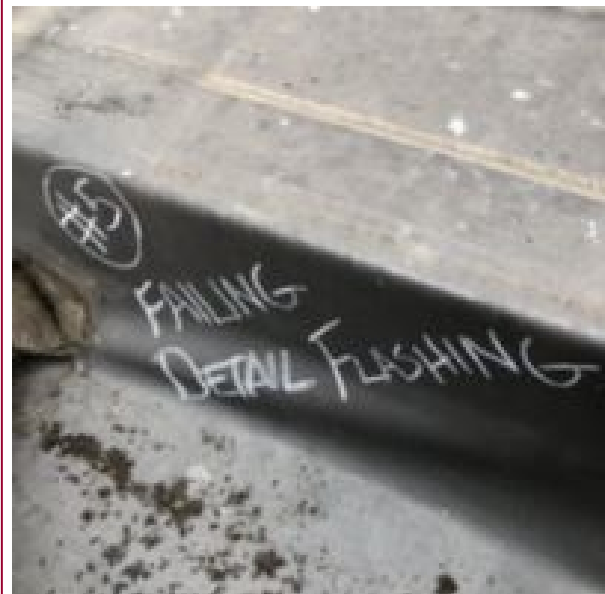
**Deficiency Number:** 17738

**Deficiency:** Hole/Opening in Patch

**Note:** Missing detail flashing identified. Detail flashings are responsible for keeping moisture from intruding into the roof system at all roof penetrations, perimeter wall transition intersections, etc. Remove all loose/failed flashing material and install new flashing using similar materials per industry standard.

**Recommendation:** Repair

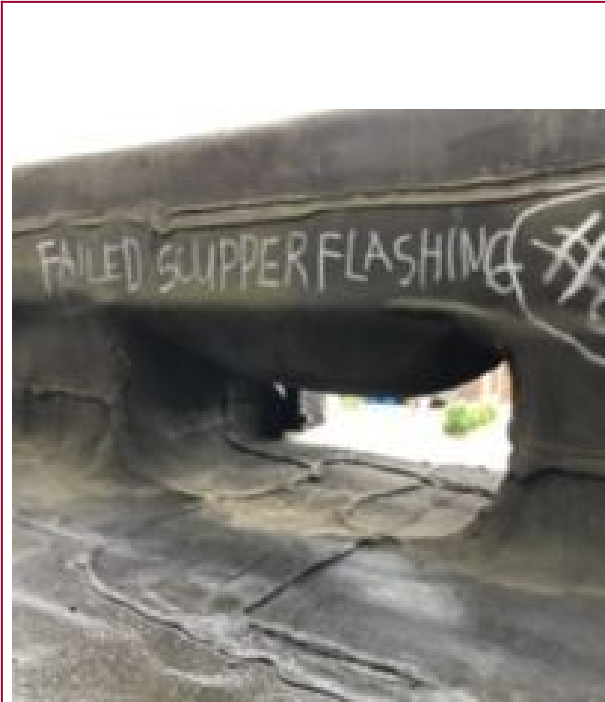
**Deficiency Number:** 17740

**Deficiency:** Hole/Tear in Membrane at Drain or Scupper

**Quantity:** 4

**Note:** Failed scupper flashing identified. Through wall scupper drains are designed to allow water to run off of the roof surface. Their penetration point in a parapet wall must be properly flashed to prevent water intrusion at that parapet wall. Remove all loose/failed flashing material from affected area. Install new flashing pieces to affected area per industry standards.

**Recommendation:** Repair

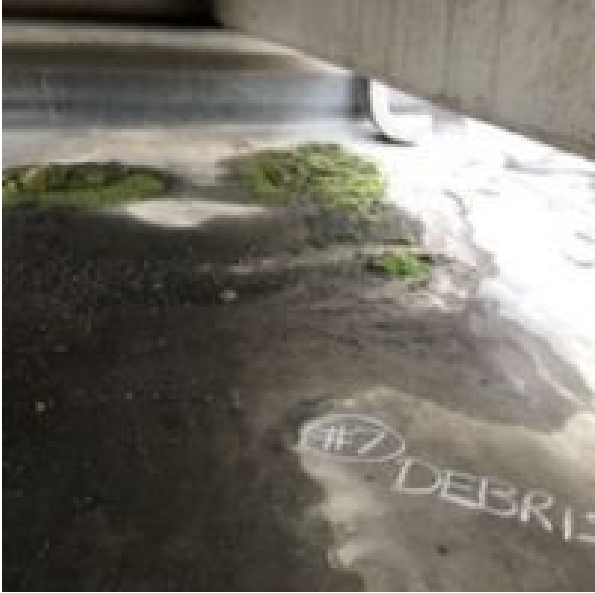
<b>Deficiency Number:</b> 17741
	<b>Photo Type:</b> Problem
	<b>Category:</b> Debris or Vegetation
	<b>Deficiency:</b> Heavy Debris
	<b>Unit:</b> Area
	<b>Quantity:</b> 1
	<b>Inspected By:</b> Justus King
<b>Note:</b> Collected debris identified on roof surface or in guttering. Loose debris can impede water run off in drainage sump areas and guttering. Additionally it can clog roof drain pipe, scupper and downspout outlet openings. Remove loose debris from roof surface and haul away.	
<b>Recommendation:</b> Repair

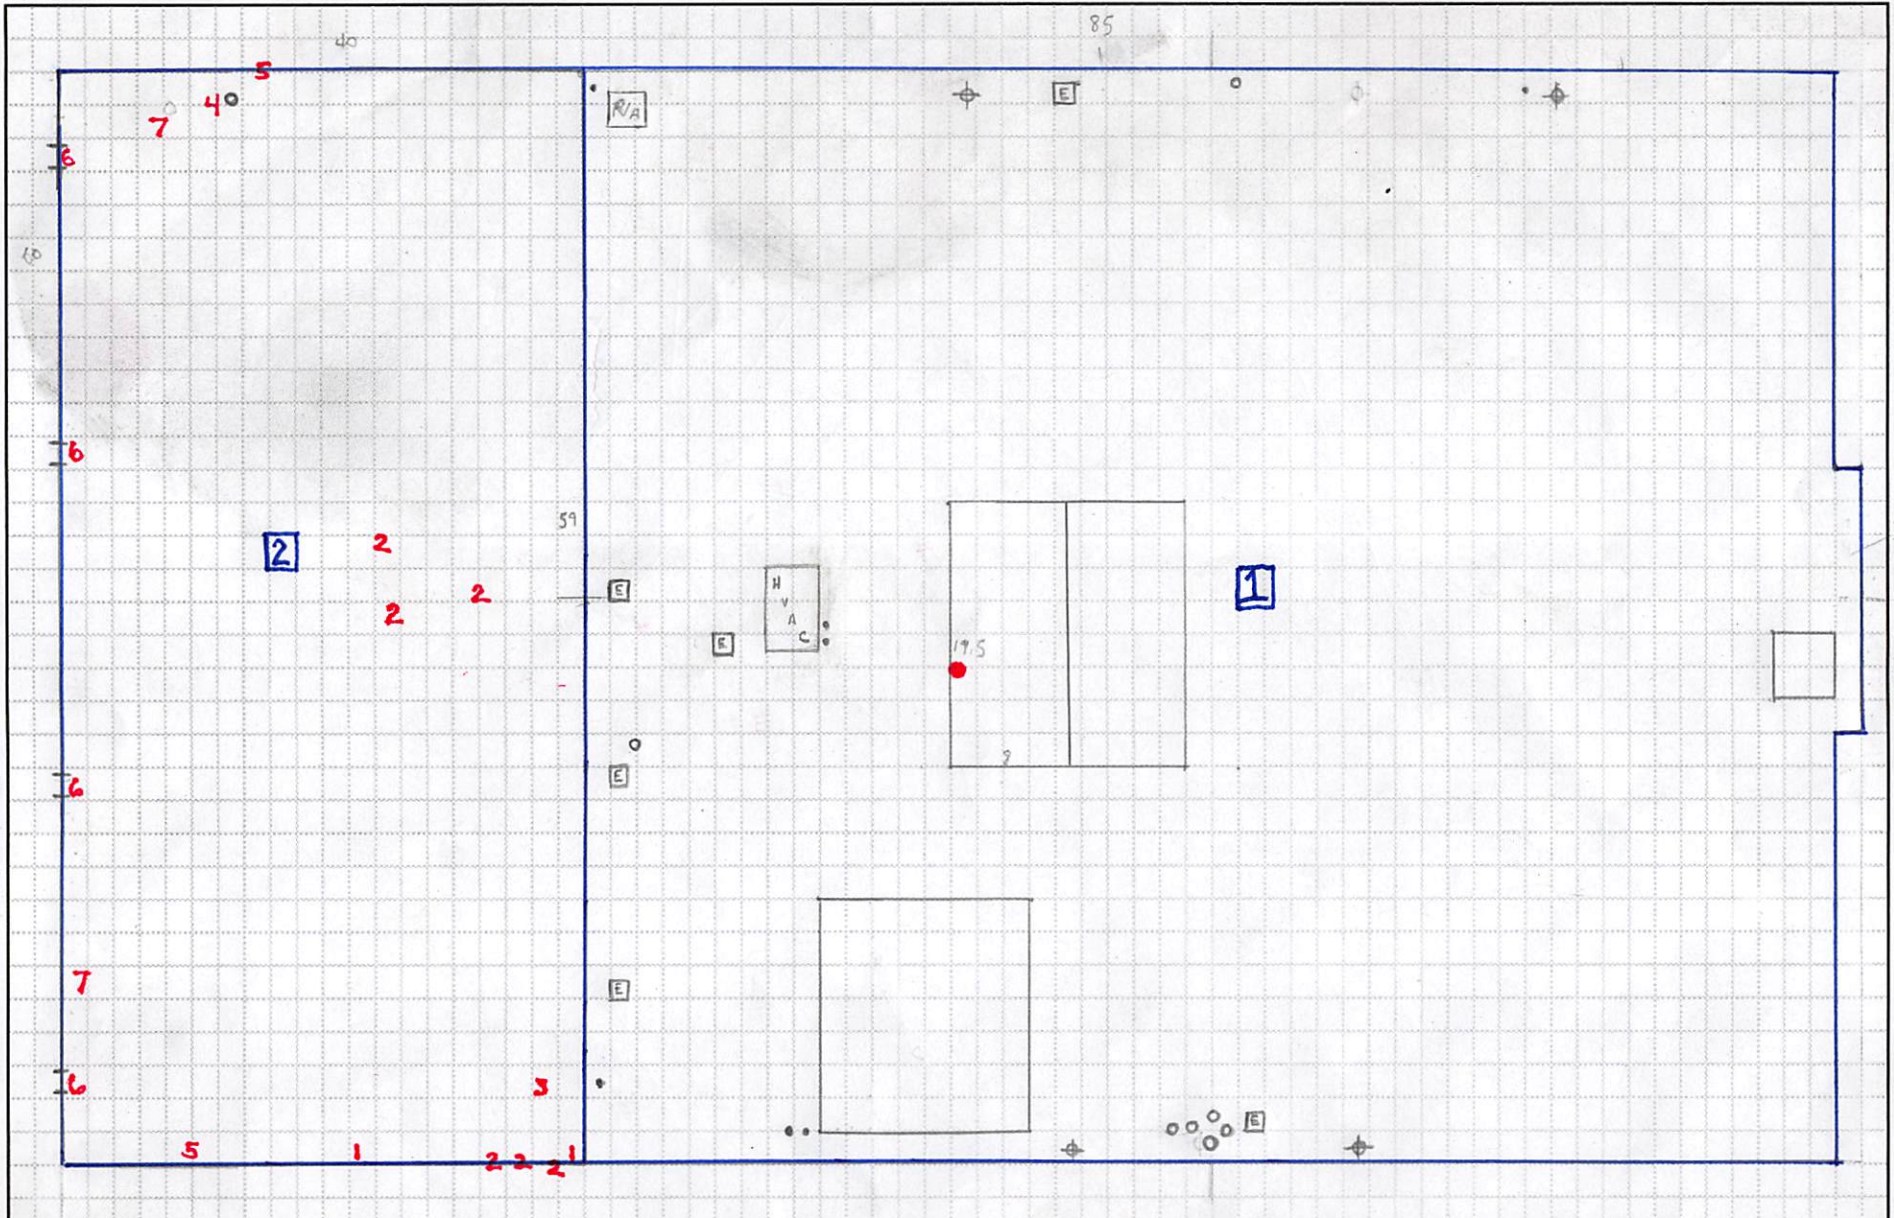
Building Name JOHN WALDRON ART CENTER (122 S. WALNUT ST. BLOOMINGTON)

SECTION: 1  
 AREA: 5,134(SF)  
 ROOF TYPE: CARLISLE TPO  
 CONDITION: EXCELLENT  
 DEFICIENCIES: NONE

SECTION: 2  
 AREA: 2,400(SF)  
 ROOF TYPE: EPDM (F/A)  
 CONDITION: FAIR  
 DEFICIENCIES: MINOR
