July 21, 2020

Re: Facility Assessment-122 South Walnut St.

Howard Douglas Bruce
President-Architect
Tabor/Bruce Architecture & Design, Inc.

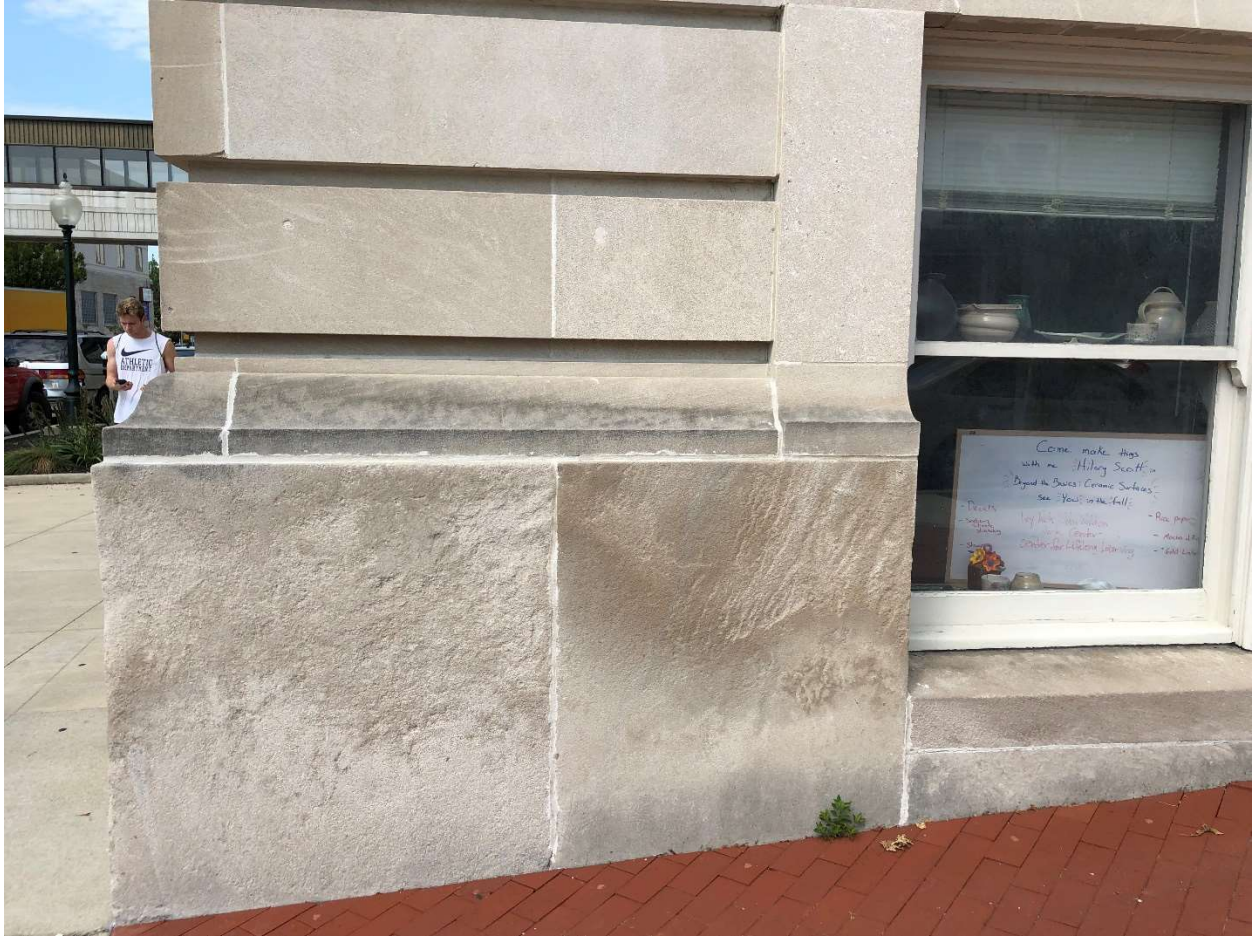
While the building has been well maintained, the building envelope requires maintenance. The work has begun in some areas along the South and East facades for tuckpointing masonry where damaged and missing. The exterior has numerous places where spalling of the limestone has occurred because of past cleaning, age, and salts from sidewalk and street treatments. See attached PDF sheets for repairs. Many areas have damaged stone from rusting of limestone anchoring systems and improper items drilled into the stone. Needed areas to be addressed are the North and west facades. A few areas have no grout within the limestone joints and need repaired to limit future damage and water intrusion. The steel exit stair from the third floor needs sanded-welds or bolted connections checked, and primed and painted. It shows signs of rust that should be striped before rust through conditions occur.

Exterior Limestone spalling

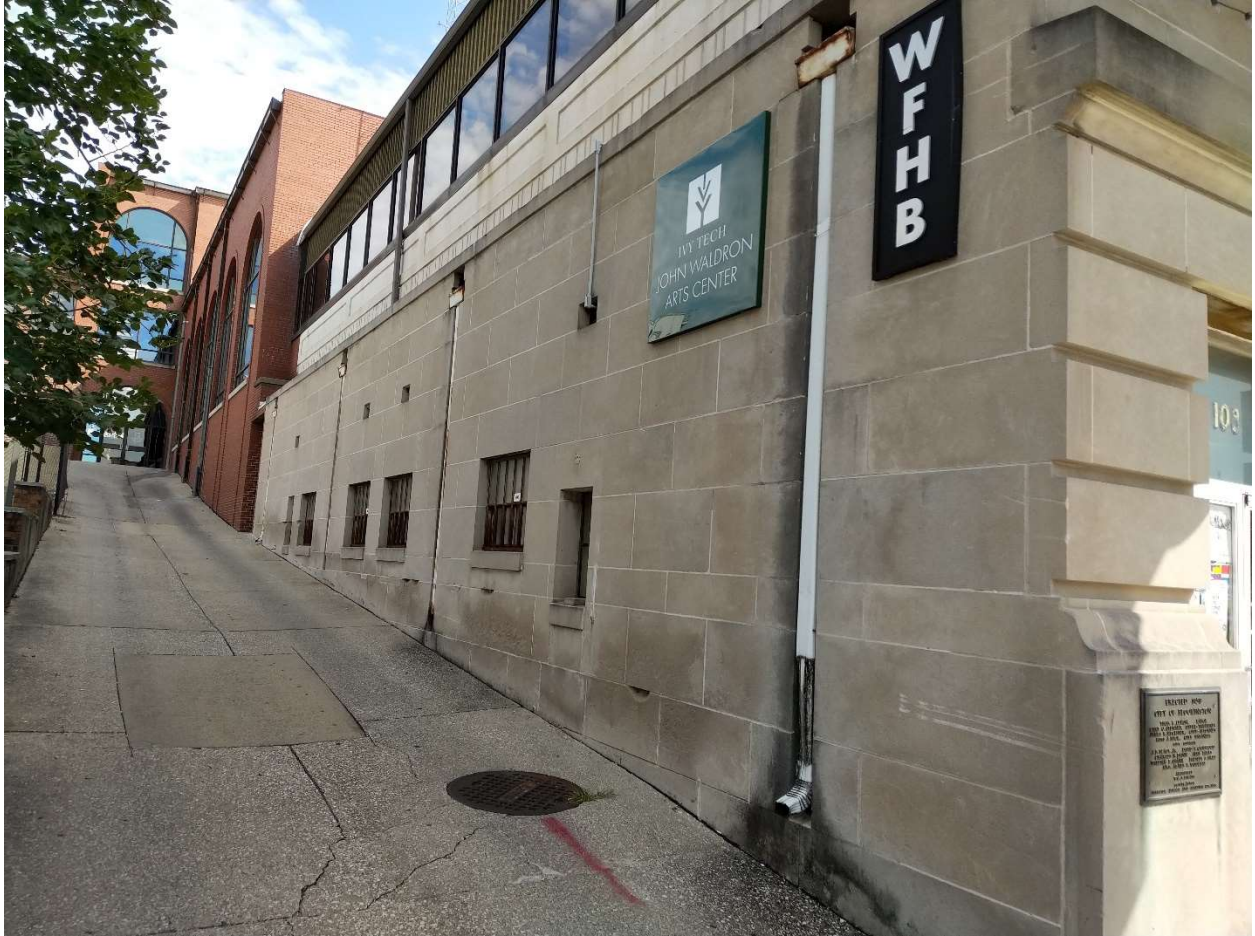
West alley exterior with issues in spalling, cracking, and drains.

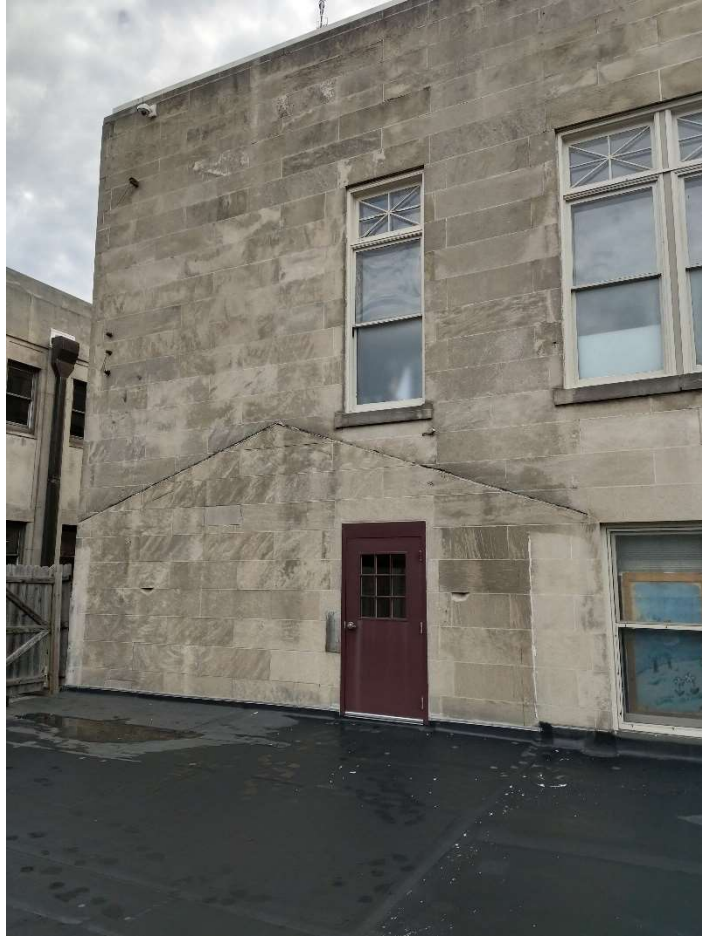
Upper west elevation at roof with masonry issues.

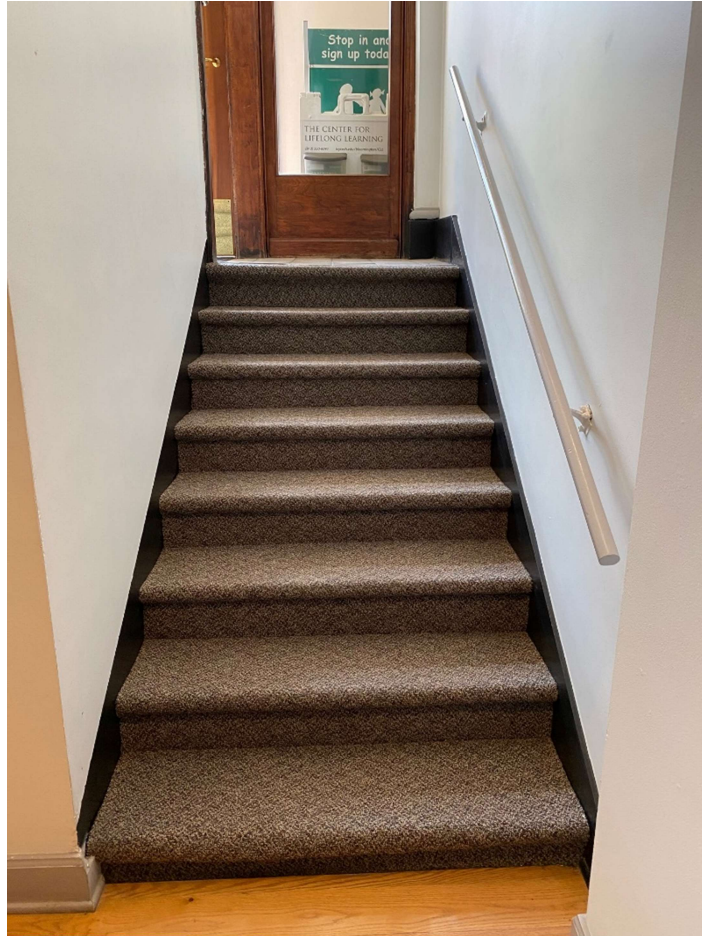
Handrails on stairs are not on both sides of the stairs nor do they return to the wall as required by the building code and present a hazard. The exterior wooden exit stair has rusted fasteners as well as loose railings and should be replaced. It has weathered extensively. The door to the west lower roof has had some renovation work started but not completed and should be finished. It may have had water intrusion, so flashings and sealants may be required before gypsum board is completed. It needs a new door threshold as well.

Typical stair railing-doesn't return to wall and not on both sides of stair

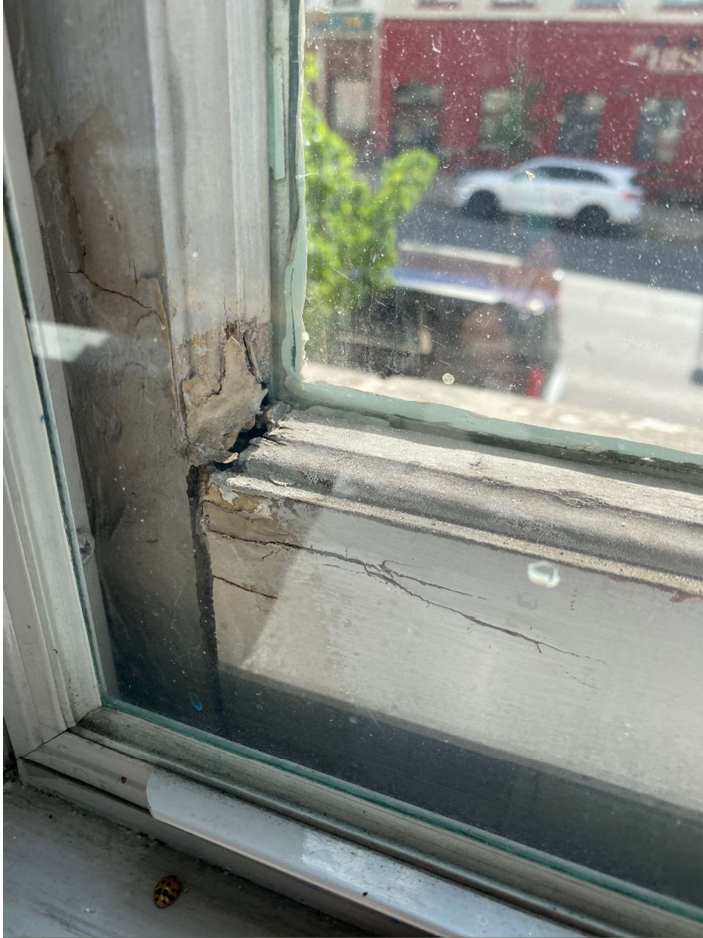
A few wood windows along the south and east facades have rotted and need rebuilt. (Window replacement in an historic building at this level is discouraged).

Second floor East window deterioration

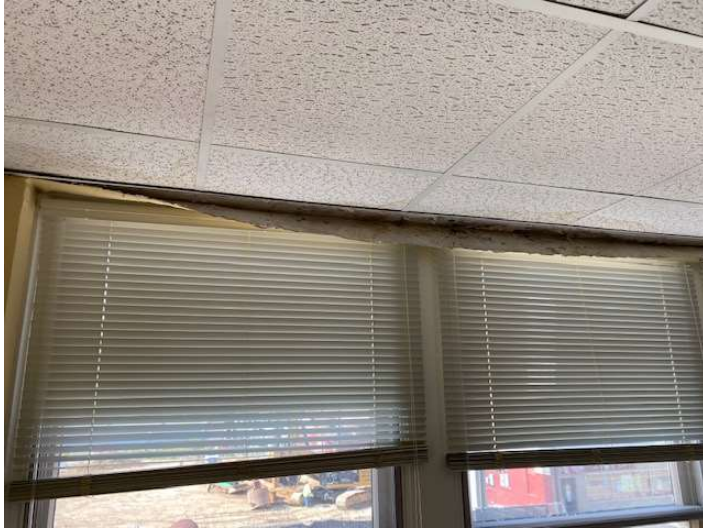
Second floor SW office window moisture issues

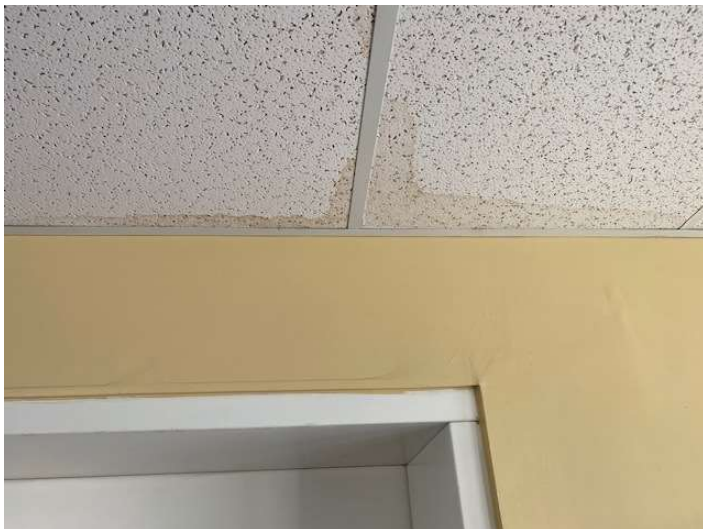
Some staining of ceiling tiles in South West office. Tiles are in the office and along an exterior wall and where the elevator tower is located.

SW Office ceiling tile staining

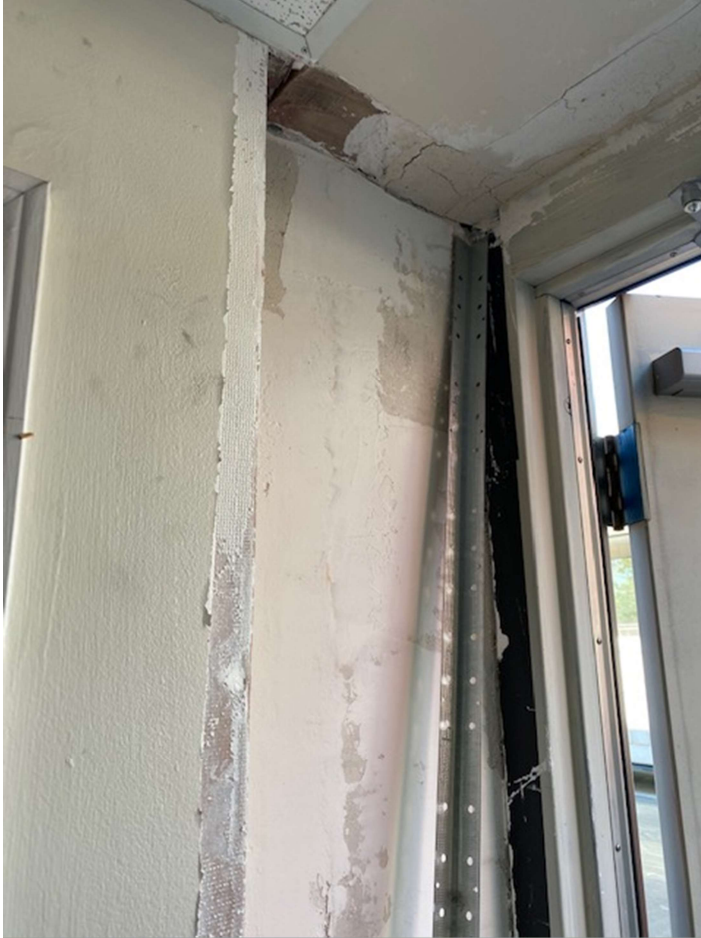
Third floor office door to low west roof area access

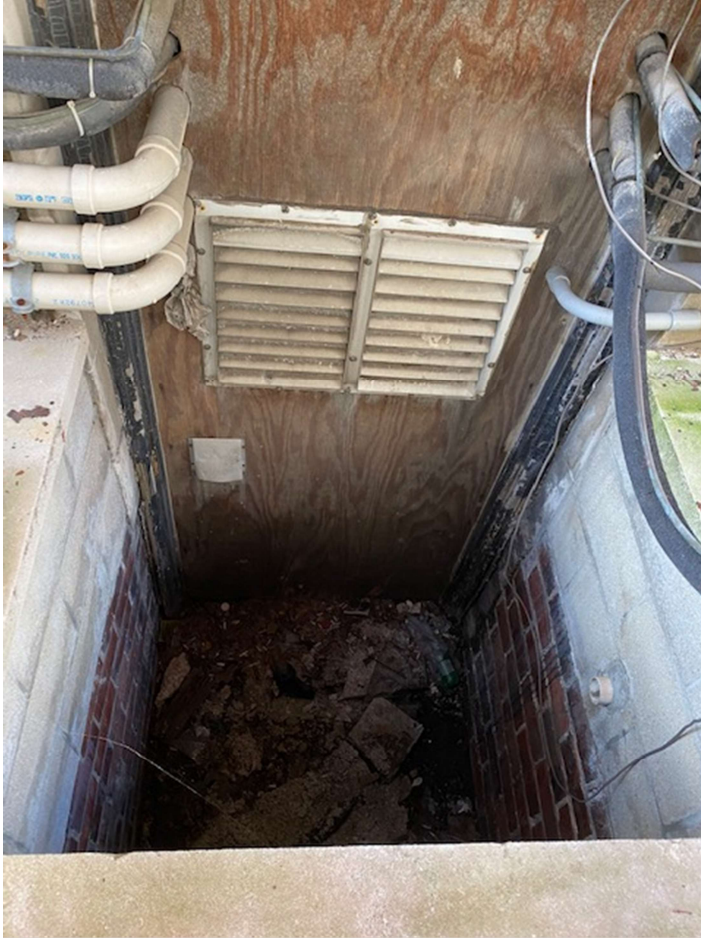
North Exterior mechanical room air intake well

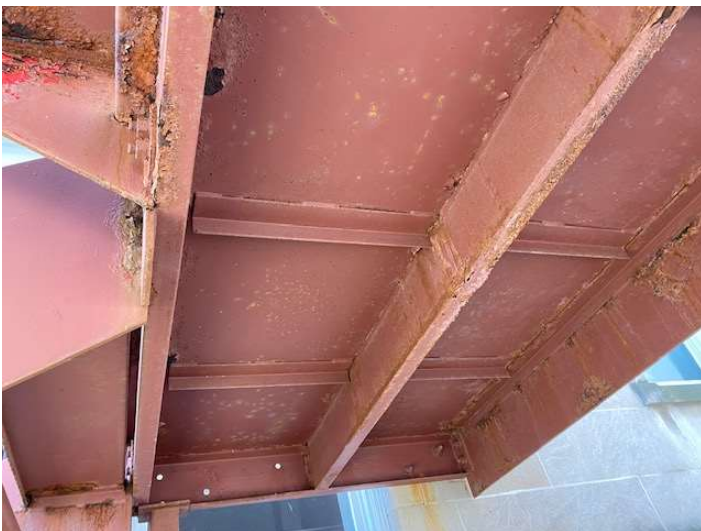
North exterior exit stair deterioration

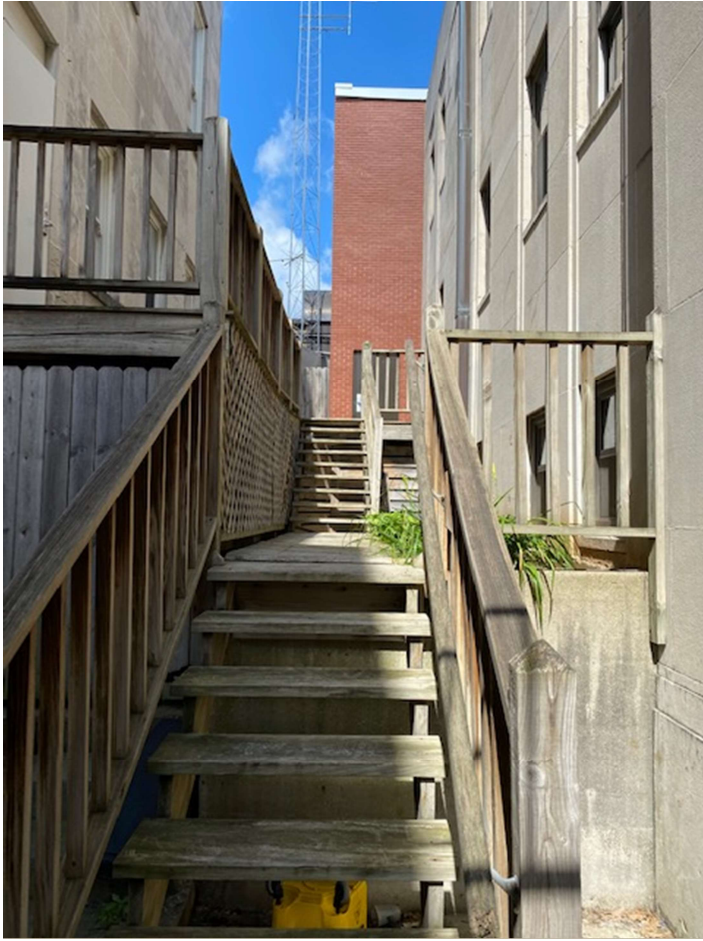
North exterior wood exit stair

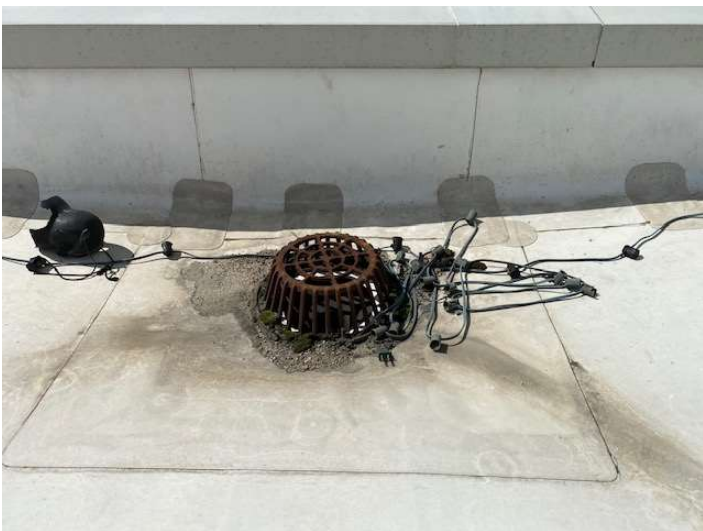
Some ponding of the roof membrane was visible at the location of roof equipment curbs, indicating low spots and lack of some water drainage. The roof drains on the main structure roof did need cleared and should be better maintained.

Main roof-roof drain debris

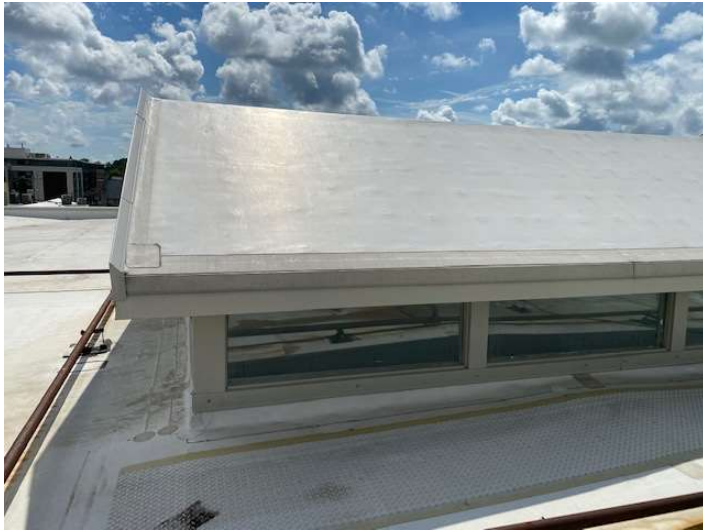
Skylight exterior framing

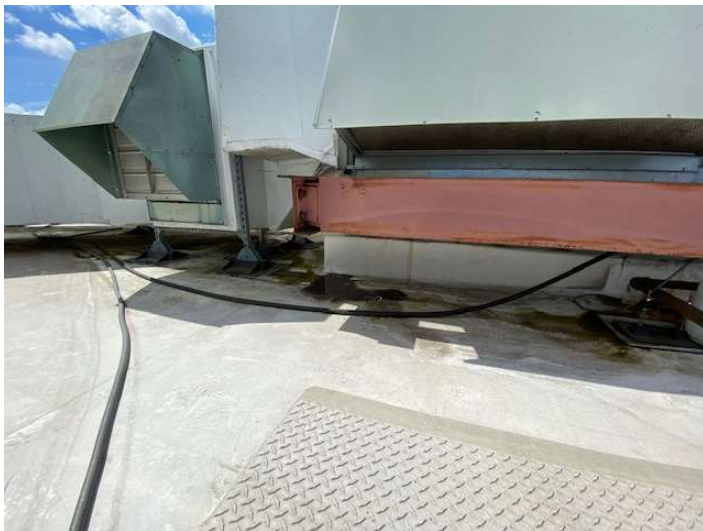
There were no identified deficiencies on the interior of the building that were noticed. On the roof, there was some light ponding at some of the rooftop RTU units are located, possibly from condensation drains. Both roofs were intact and showed no visible issues.

Main roof mechanical equipment condensation water ponding

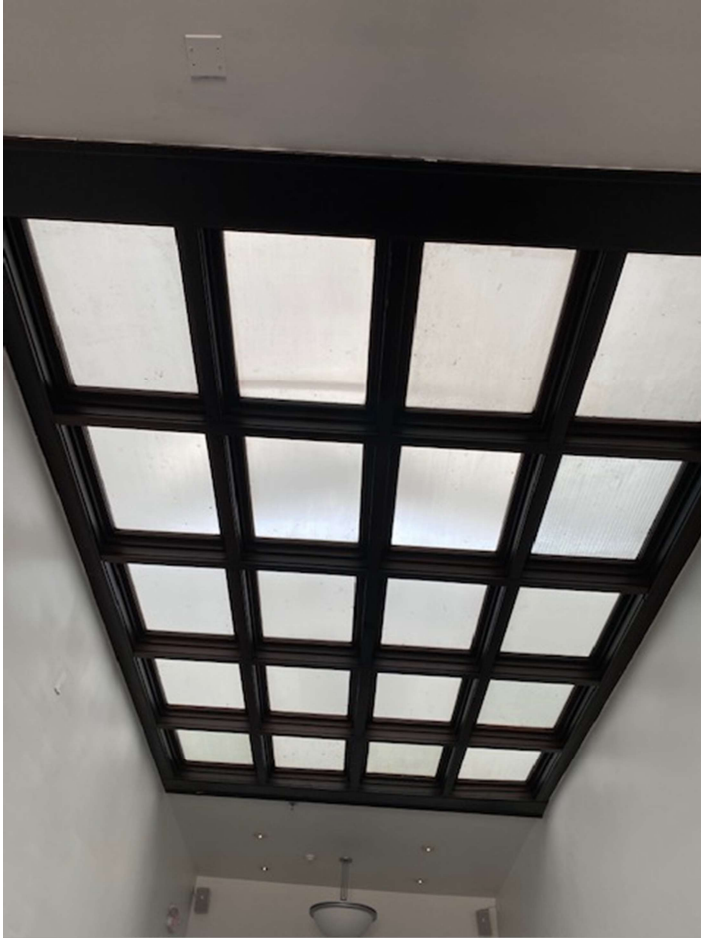
Interior roof skylight

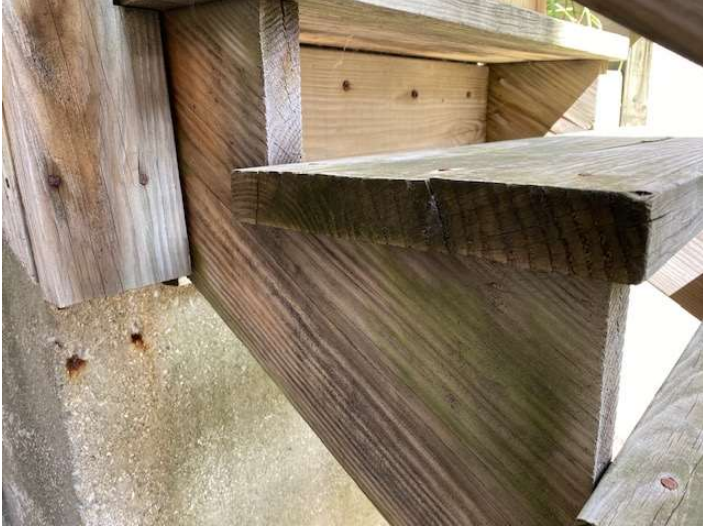
North wood exit stair rusted support fasteners

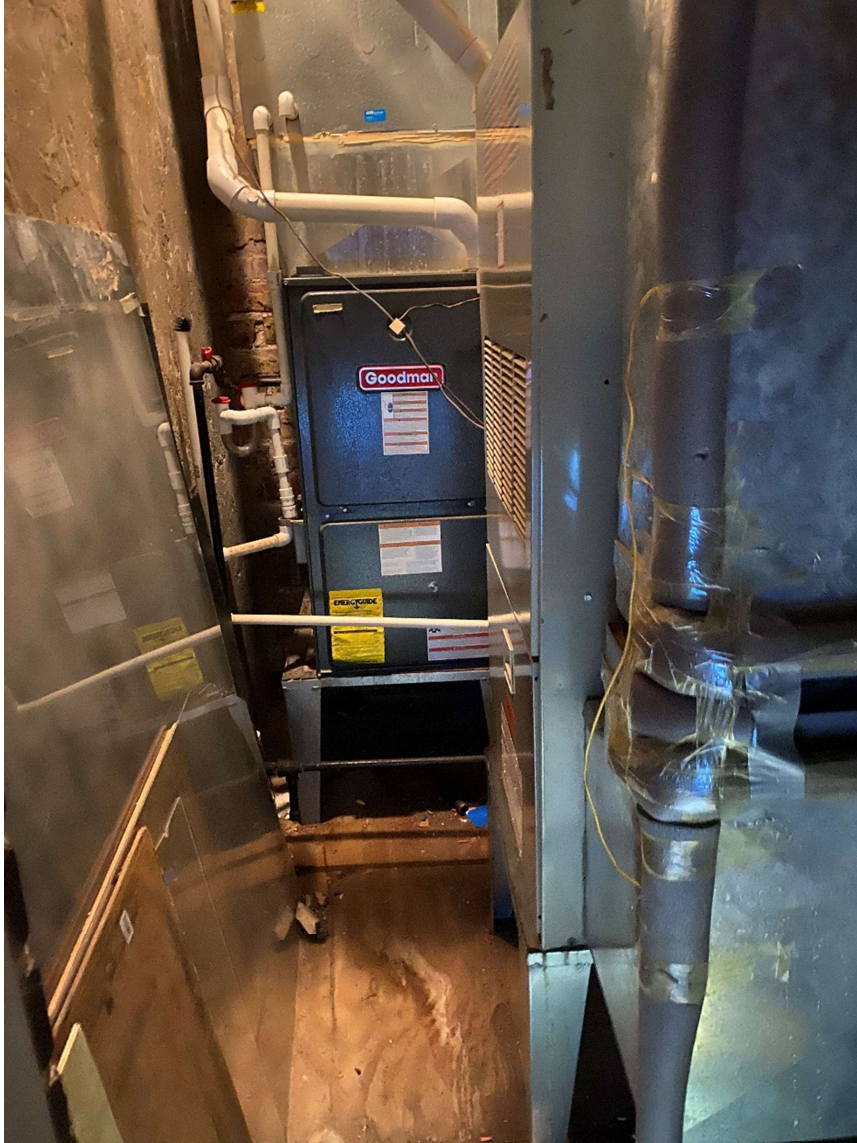
Most of the furnaces and five (5) of the ACCU's are well past their expected useable lifetime and need to be replaced right away. Some of the ACCU's are literally falling apart and must be replaced right away. The RTU's appear to be in good condition and replacement could be several years into the future.

Two furnaces at first floor performance space

- H1.1 Replace all failing (or failed) ACCU's.
- H1.2 Replace all vintage 1992 furnaces.
- H1.3 Add mechanical ventilation to all areas served by the split-systems. This can be in two (2) different ways:

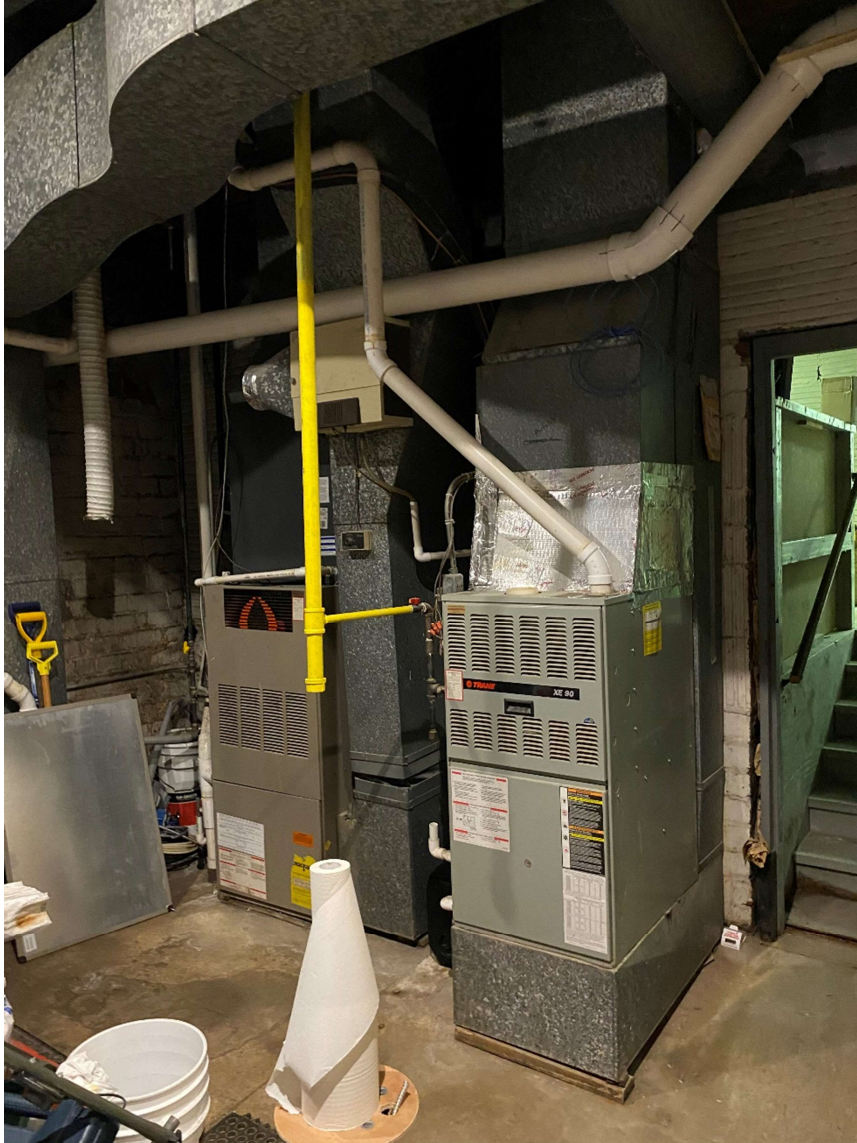
Mechanical room furnace

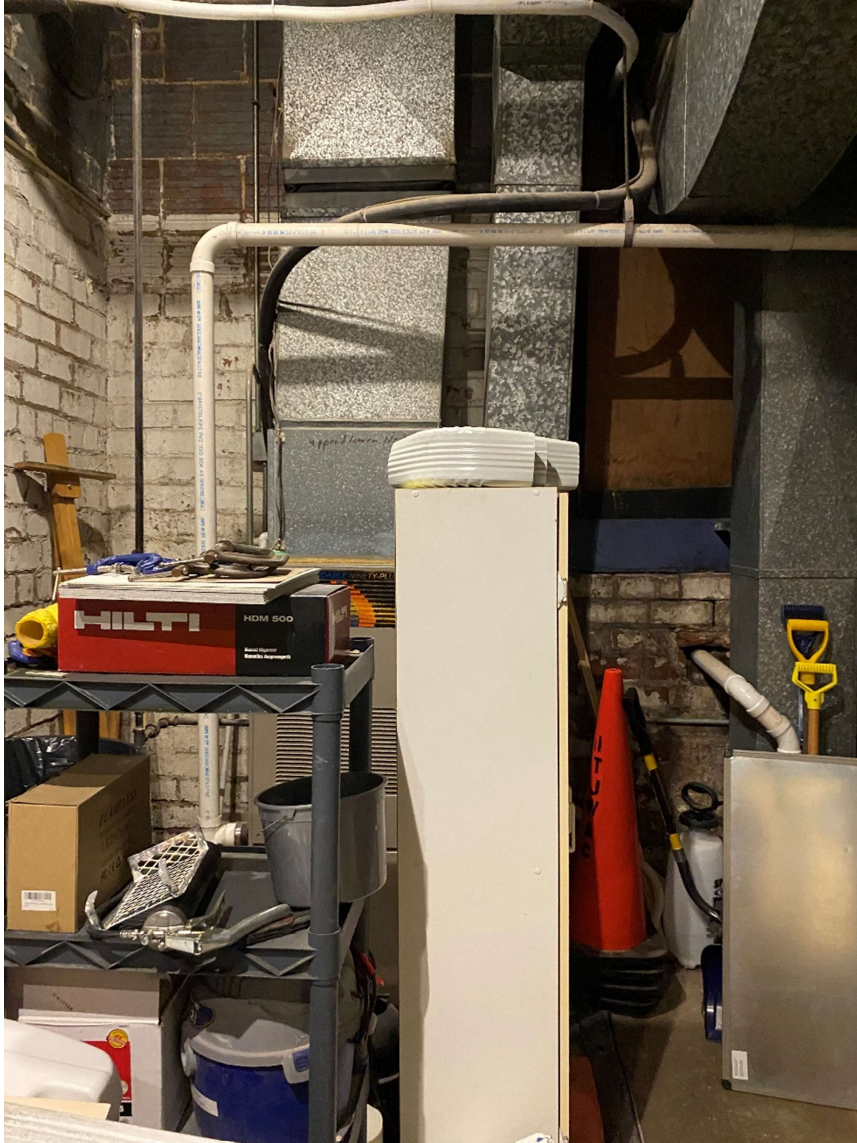
Mechanical room furnace

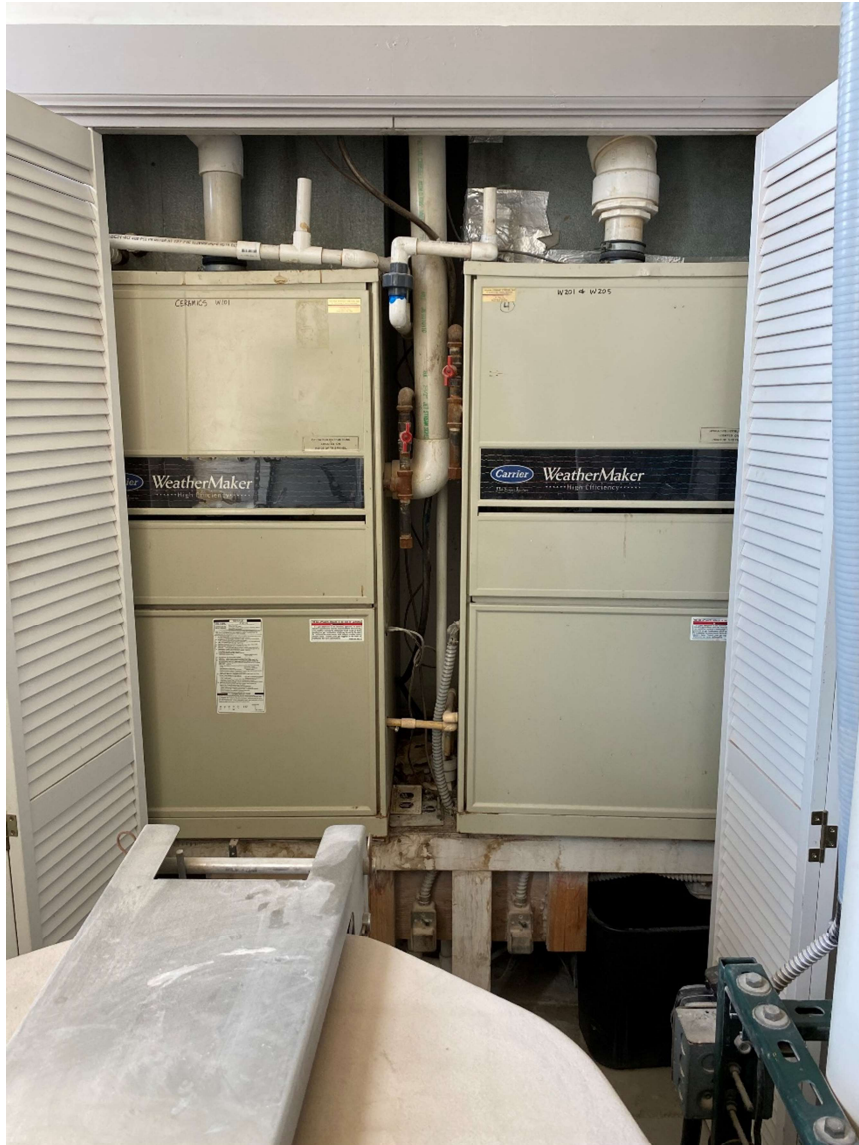
Furnace at first floor kiln room

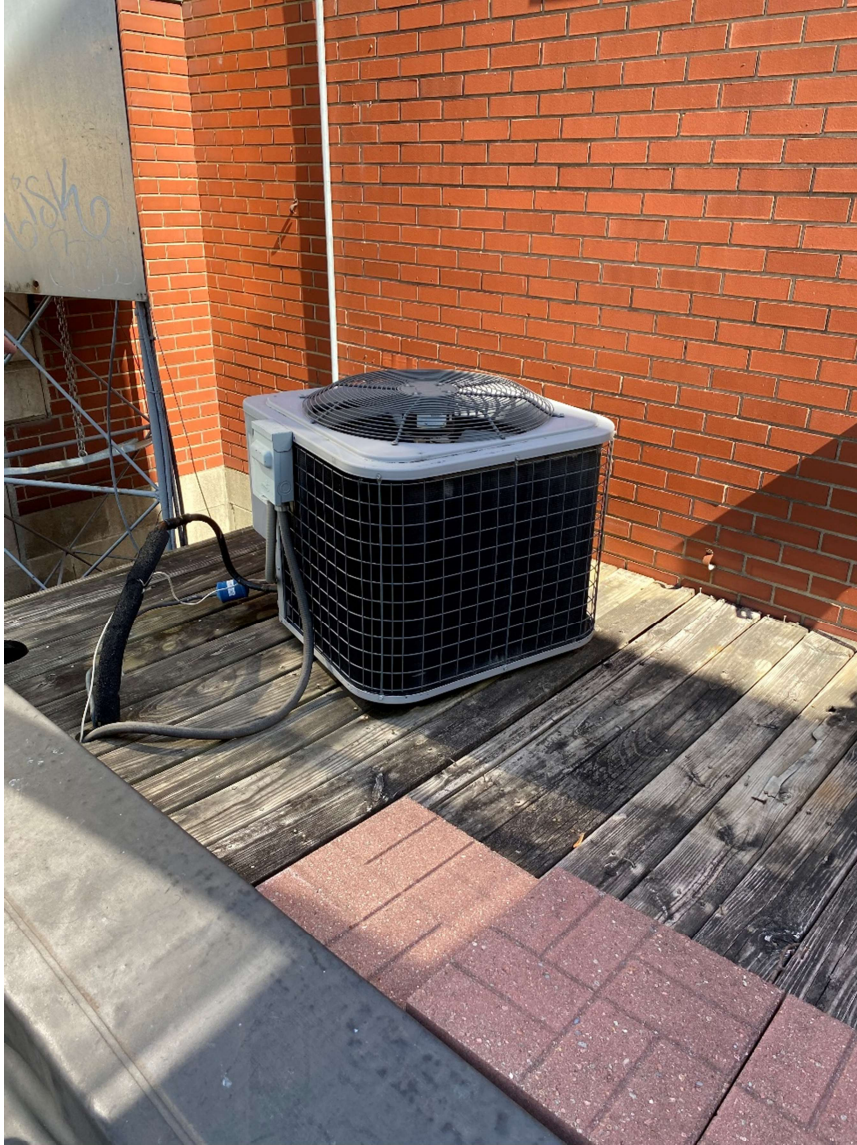
ACCU unit possible serving WFHB

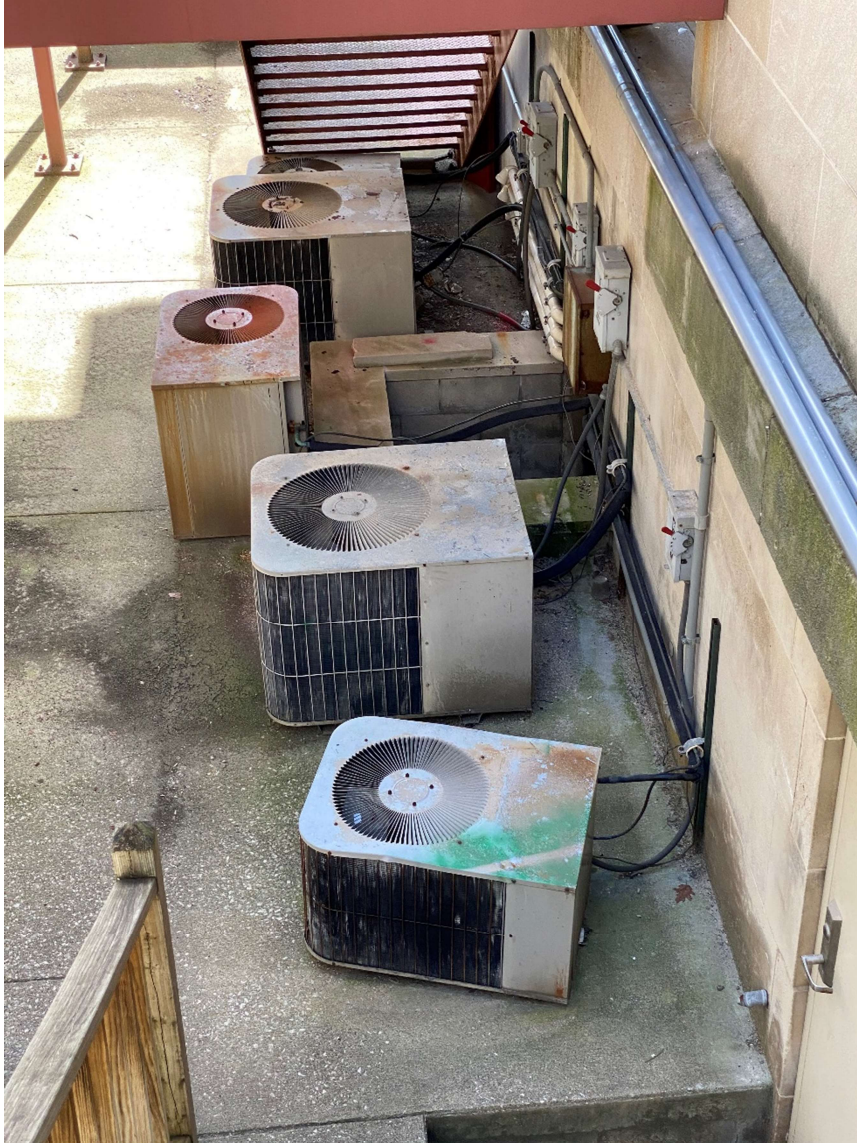
Old ACCU units at north exitway/alley enclosure

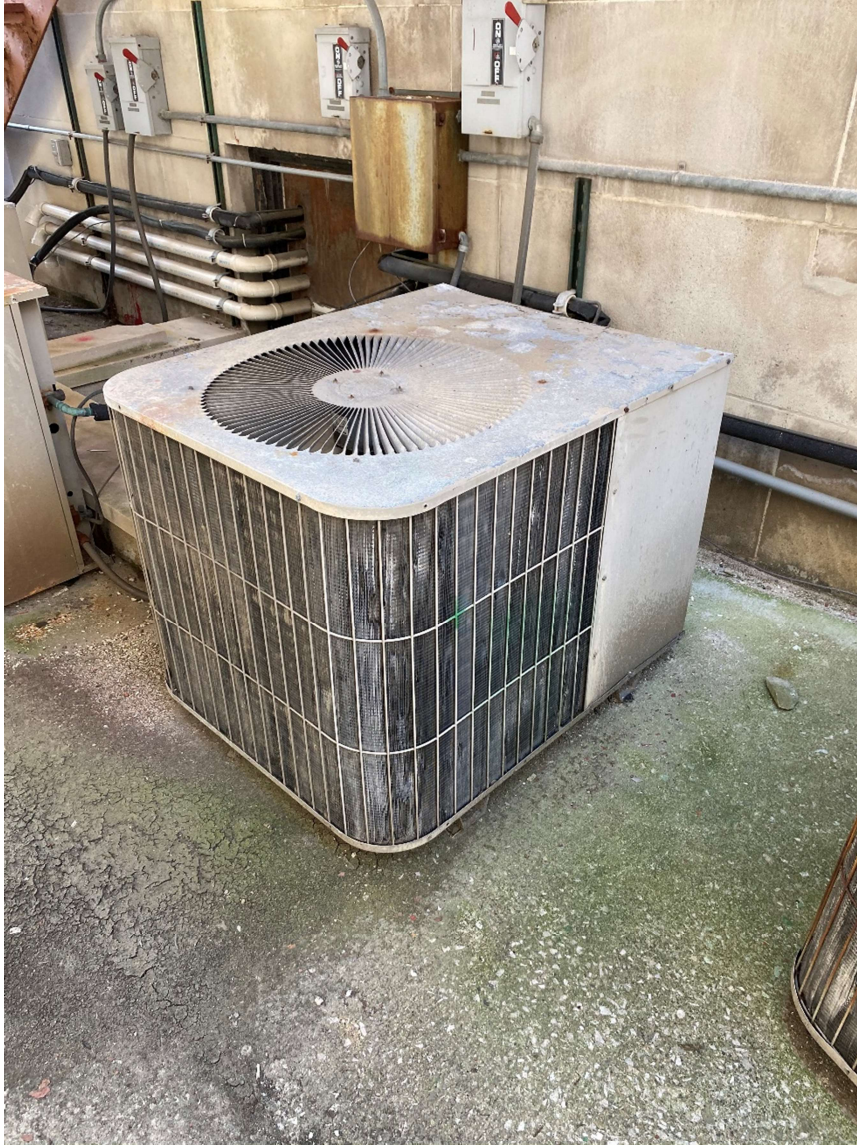
Failing ACCU in north alley/exit enclosure
