BHPC MEETING PACKET

Amended January 27, 2022

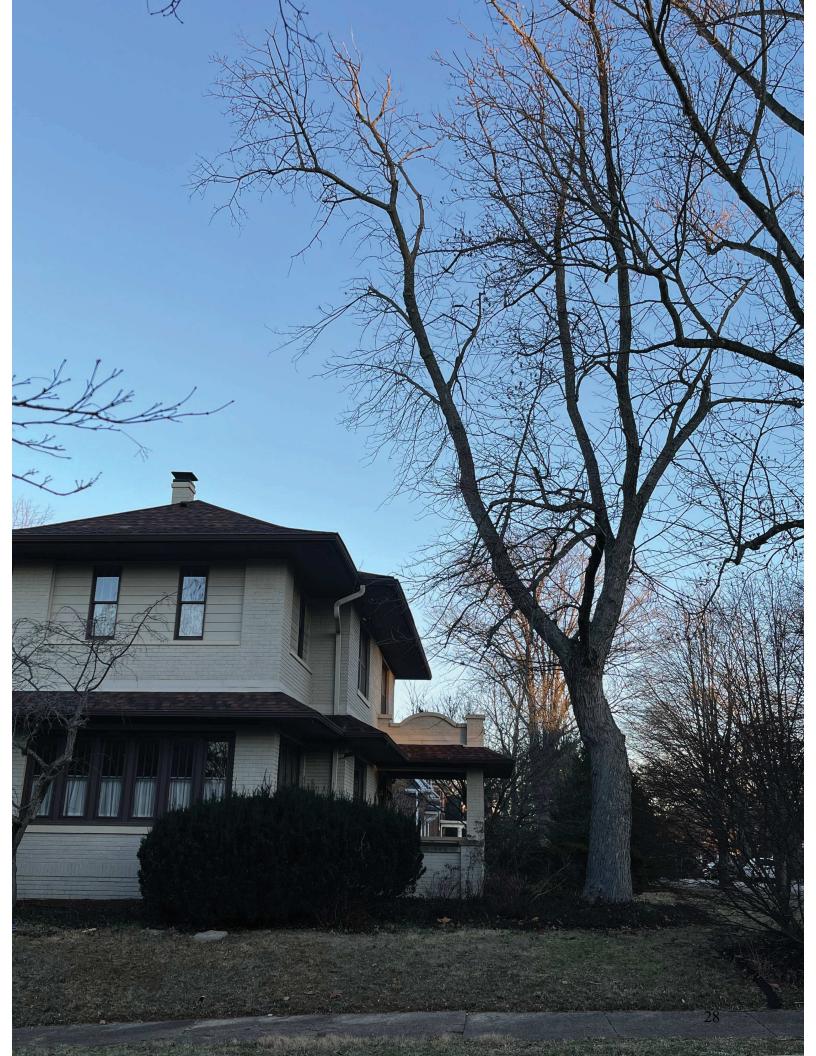
STAFF RECOMMENDATIONS	Address:	2001 E Hillside Dr., Lot 8
COA 22-03	Petitioner:	Jacob Bower-Bir
	Parcel:	53-08-03-300-001.000-009
RATING: NOTABLE	Survey:	C. 1842, Federal Style, I-House

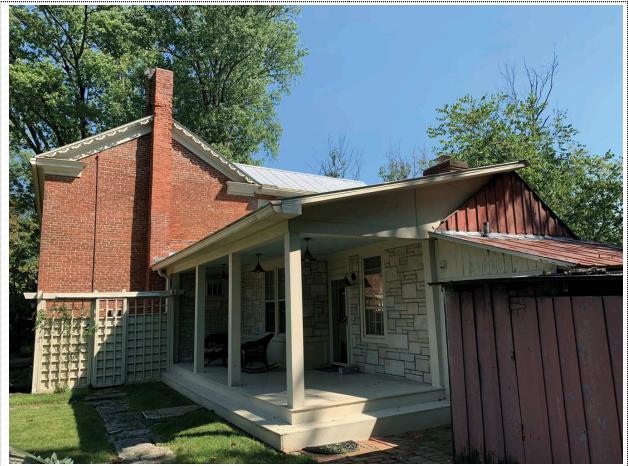
Background:	The Reverend James Faris House Historic District
Request:	Partial demolition, stabilization of foundation, and new construction.
Guidelines:	The Secretary of the Interior's Standards for the Treatment of Historic Properties

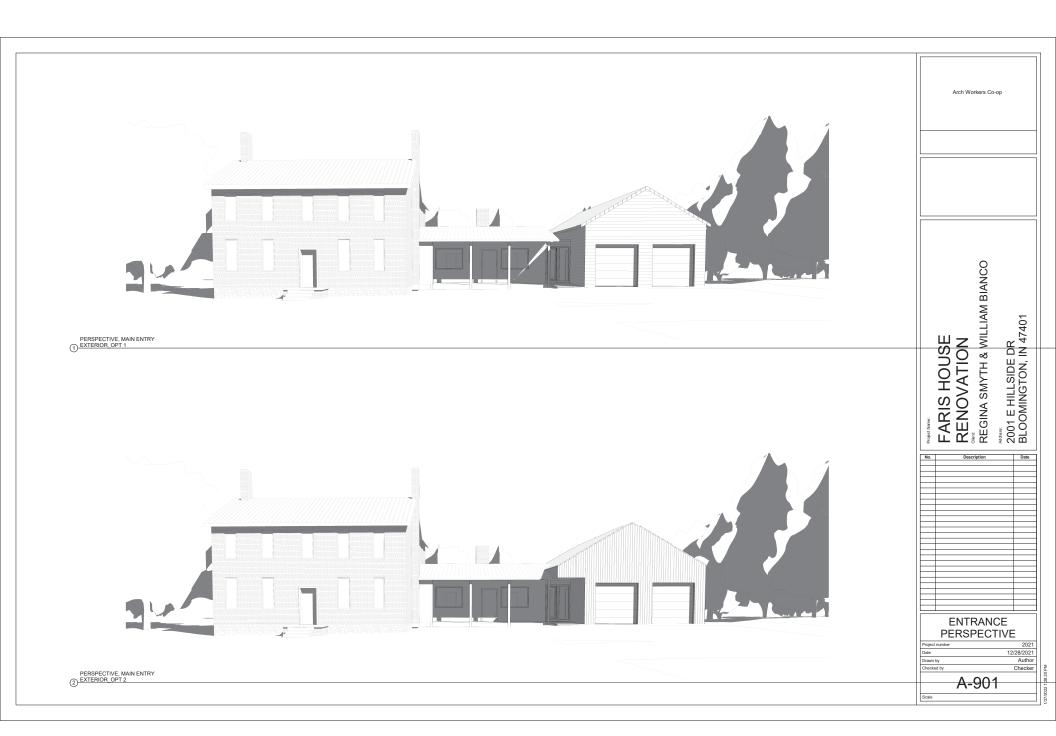
The petitioner revised the addition design to incorporate the feedback received from the HPC on the Jan. 13, 2022 meeting. The proposed garage has been set back, option 1 reflects a smaller roof proportion but option 2 provides a roofed entrance to the extension.

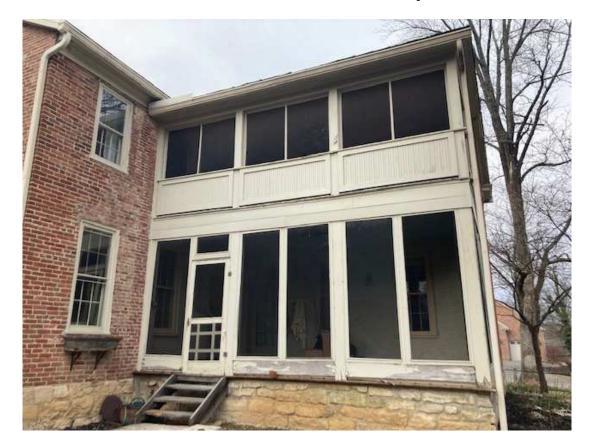
Repair history demonstrates widespread problems with existing foundation

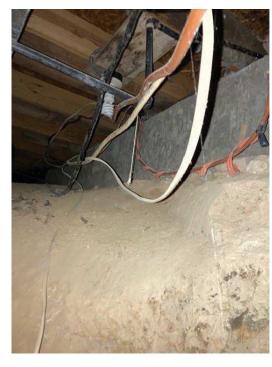
Old foundation repair under I-wing (completed by unknown previous owner)

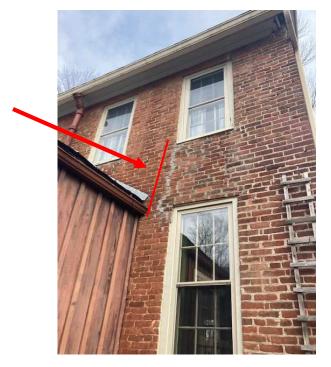
2013 repair to support I-wing (installed 5 helical piers, additional jacks under porch)

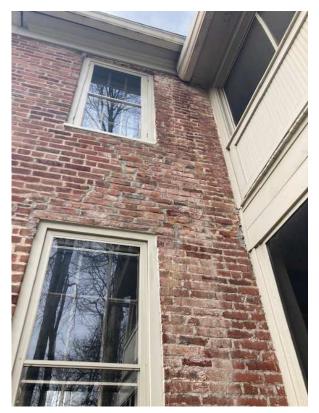
Porch problem 2: lack of footer is causing movement and stressing other parts of house

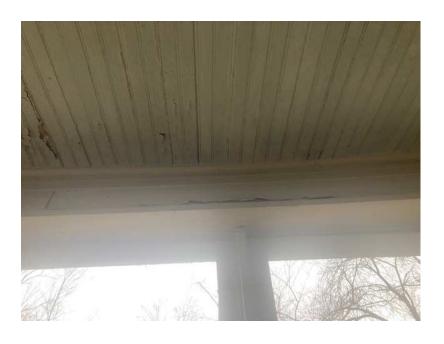
Interior view of bent support beam. Multiple contractors advised that replacement not feasible

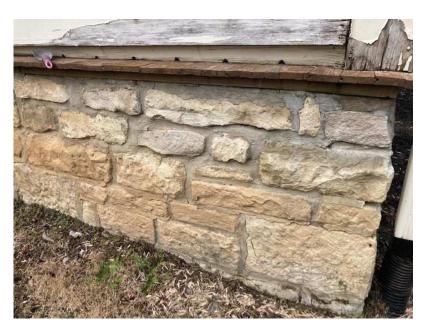
Stone pointing shows evidence of multiple repairs and cracking

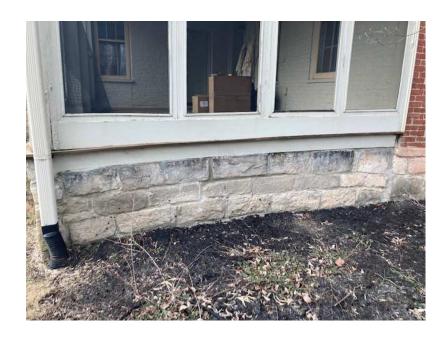
Side view showing bending of foundation stones and beam supporting porch.

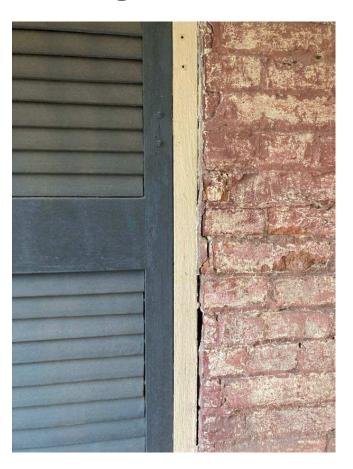
Cracking in stairwell, twisting window frames

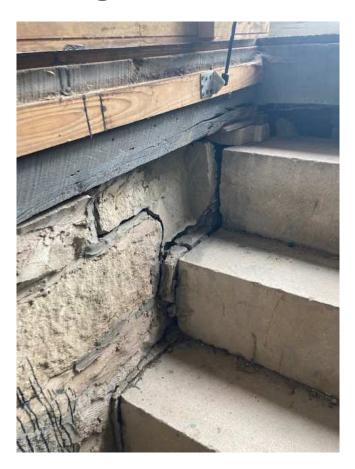
Strategies for addressing porch issues

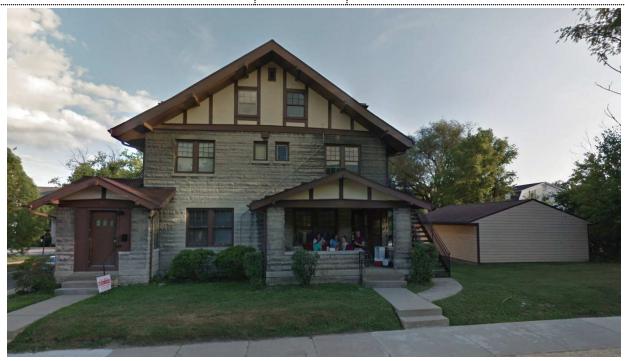
Background:	University Courts Historic District, Garage was added	
	in 2006:	
	2006-03-01 New Construction - Complete Structure	
	\$32,600 (Source: Elevate)	
Request:	Full demolition of the garage.	
Guidelines:	University Courts Historic District Guidelines

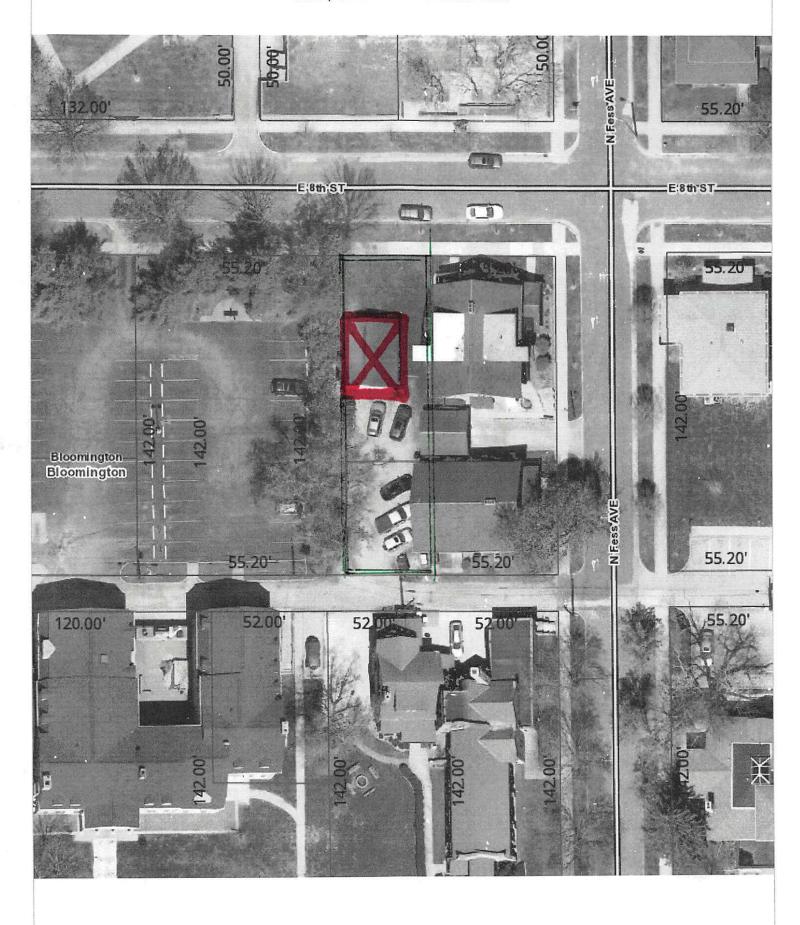
Google Maps 622 E 8th St

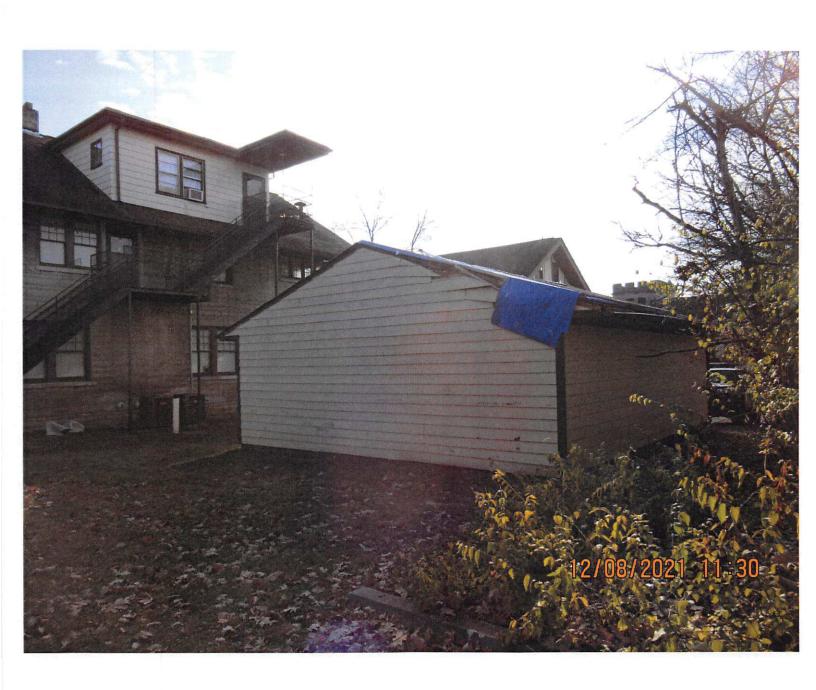
STAFF RECOMMENDATIONS	Address:	731 W 3rd St.
COA 22-06	Petitioner:	Doug Wissing
	Parcel:	53-08-05-107-009.000-009
RATING: NOTABLE	Survey:	c. 1900, T-Plan Cottage

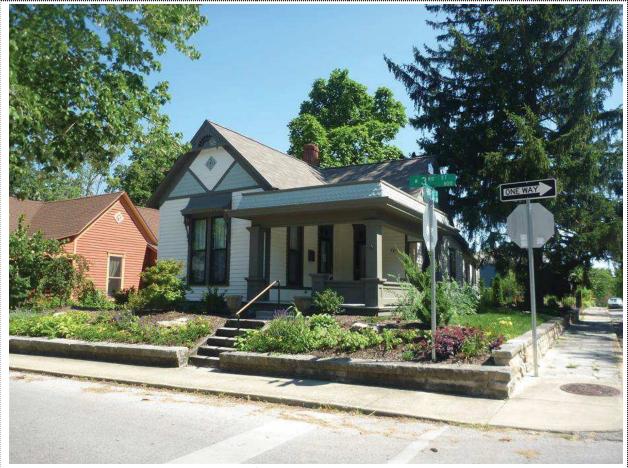
Background:	Greater Prospect Hill Historic District
Request:	Add a half story with dormers to the garage.
Guidelines:	Greater Prospect Hill Historic District Guidelines

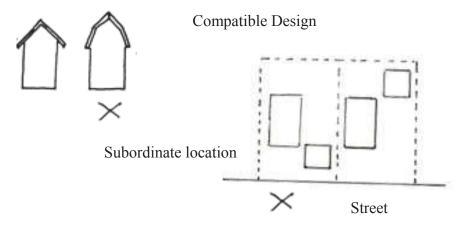
<u>Definition</u>: Any structure secondary to the principal building on the lot and greater than 80 square feet in size is subject to the following guidelines:

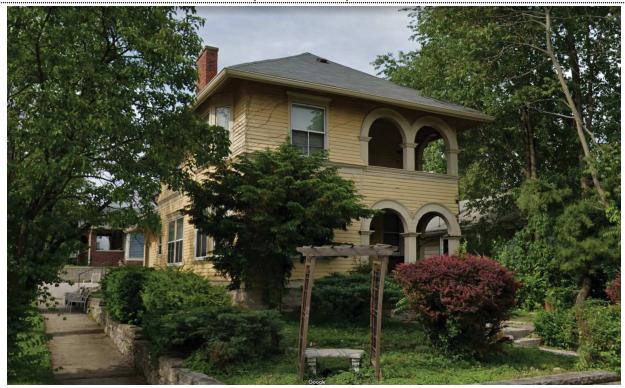
Background:	Henley House Historic District
Request:	Window replacement
	The Secretary of the Interior's Standards for the
	Treatment of Historic Properties

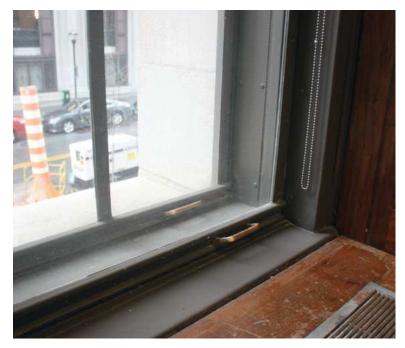
[18] The historic metal storm windows in this 1920s office building were retained and repaired during the rehabilitation project.

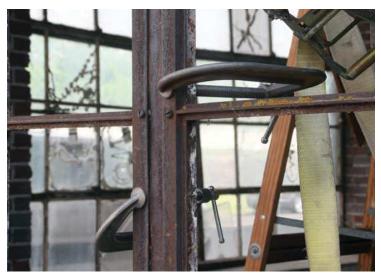
[20 a-d] The original steel windows in this industrial building were successfully repaired as part of the rehabilitation project (left).

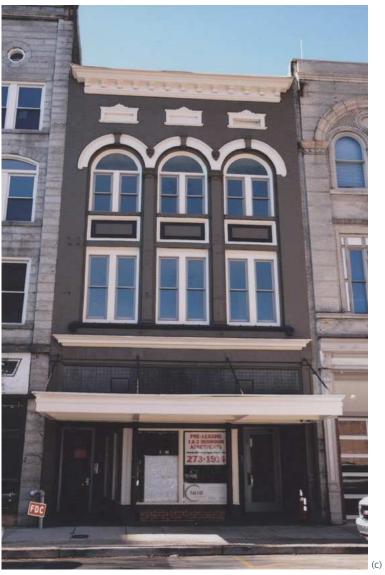
[22] **Not Recommended:** (a-b) The original wood windows in this late-19th-century building, which were highly decorative, could likely have been repaired and retained. (c) Instead, they were replaced with new windows that do not match the detailing of the historic windows and, therefore, do not meet the Standards (above).

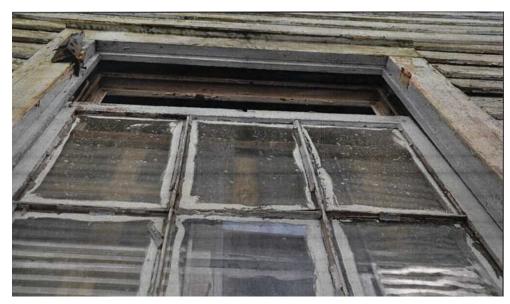
[23] (a)This deteriorated historic wood window was repaired and retained (b) in this rehabilitation project.

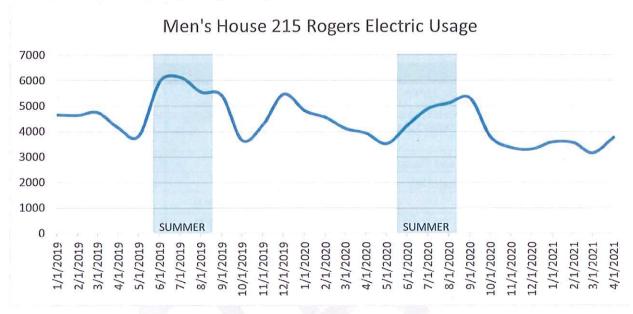
The Women's House consumed 147 kWh of energy on average per day and the cost for that energy averaged \$.13 per kWh. The chart below demonstrates the energy (kWh) consumed June 2019 – April 2021. The highest energy usage correlates with the summer months, when air conditioning is being used.

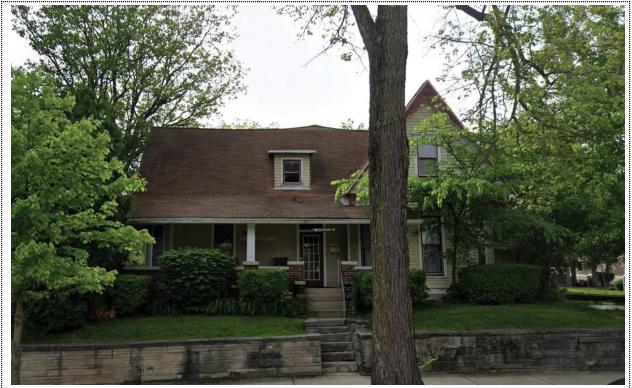
Background:	Near West Side Conservation District
Request:	Window replacement
Guidelines:	Near West Side Conservation District Guidelines

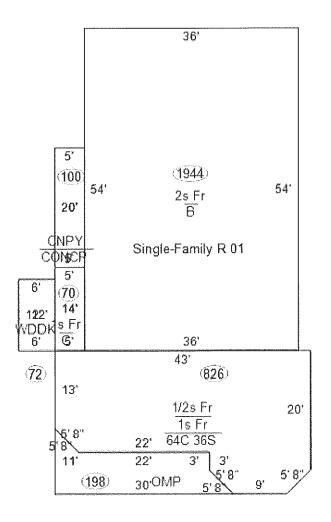
STAFF RECOMMENDATIONS	11441 0550	500 W 7th St.
COA 22-09	•	Glenda Murray
	•	53-05-32-403-068.000-005
		c. 2010

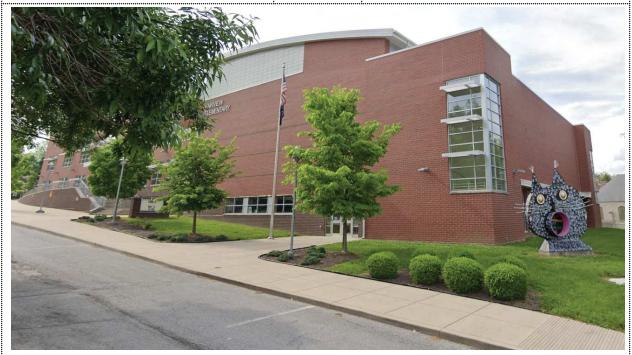
Background:	Near West Side Conservation District
Request:	Yard canopy in school yard
Guidelines:	Near West Side Conservation District Guidelines

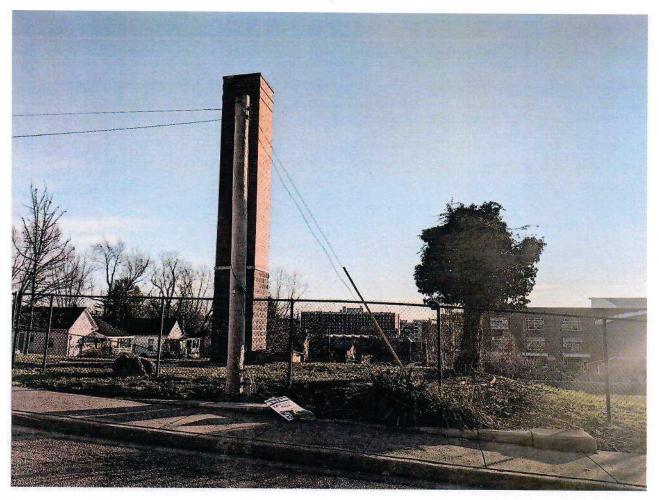
View from Fairview Street looking east to Fairview School in the right of the photo. The new outdoor classroom will be a shade canopy located five feet south of the swift tower (constructed in 2010) and five feet inside the school fence. The tall tree stump with vines, which looks like a lollipop tree, will be removed.

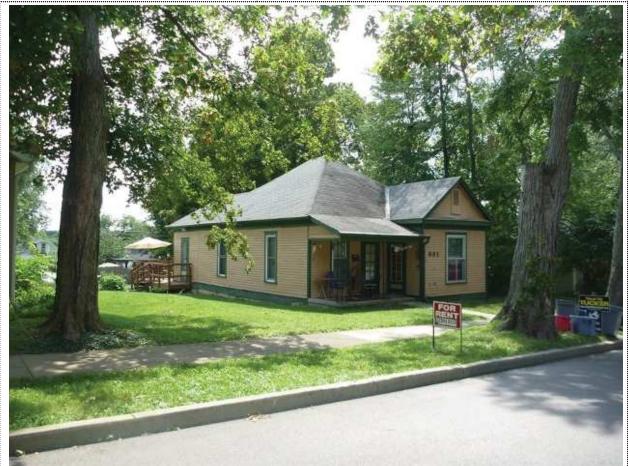
Background:	Greater Prospect Hill Historic District
Request:	Room addition and deck on the rear of the house.
Guidelines:	Greater Prospect Hill Historic District Guidelines

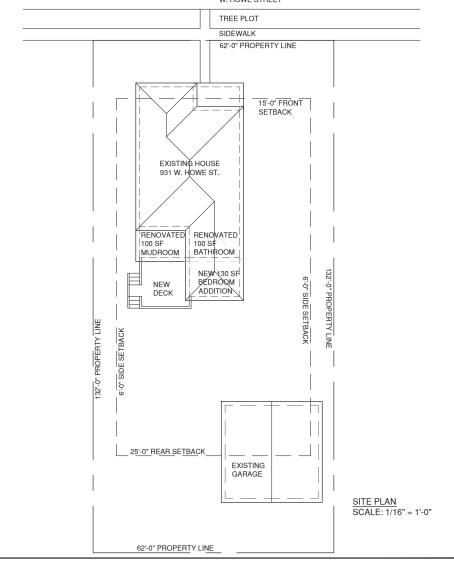
- DIMENSIONS ON FLOOR PLANS ARE MEASURED FROM FACE OF STUD TO FACE OF STUD.
- G. PROVIDE WOOD BLOCKING IN WALLS AS REQUIRED BEHIND ALL CASEWORK.
- REFER FIRST TO DRAWINGS AND ON-SITE RED BINDER FOR ANSWERS TO ANY QUESTIONS ABOUT DESIGN/DETAILS. CONTACT DESIGNER/PROJECT MANAGER IF FURTHER INFORMATION IS REQUIRED.

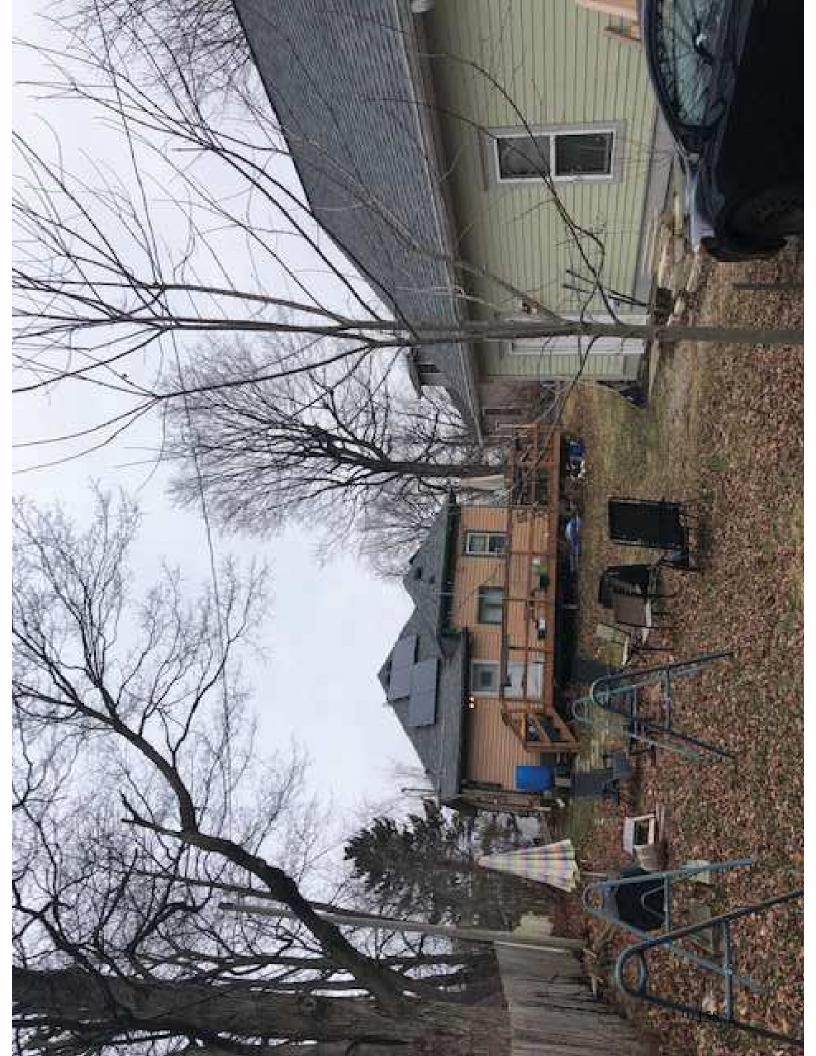
STAFF RECOMMENDATION	Address:	311 W 7th St.
DD 22-07	Petitioner:	Henry Hoover
Start Date: January 12, 2022	Parcel:	53-05-33-310-372.000-005
RATING: NOTABLE	Survey:	c. 1913, 20th Century Industrial

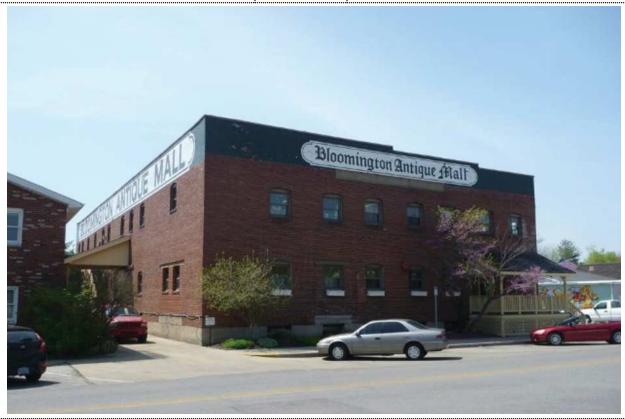
Background:	The Bloomington Antique Mall, Historically known as	
	the "Bloomington Wholesale Grocery Company"	
	amongst other names, is located within the Near West	
	Side Historic District.	
Request:	Partial demo of wood ramp.	
Guidelines:	According to the demolition delay ordinance, BHPC	
	has 90 days to review the demolition permit application	
	from the time it is forwarded to the Commission for	
	review.

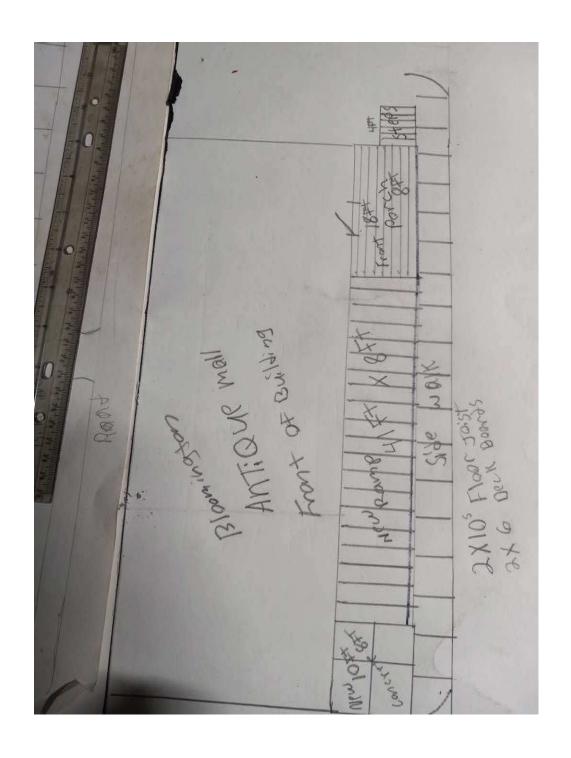
Description: Bloomington Wholesale Food 311 West 7th (photo 3)

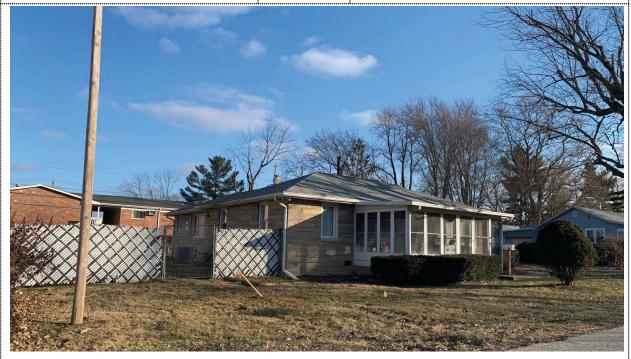
Background:	One of six structures along 19th St. slated for demolition and located near the Indiana Memorial Stadium.
Request:	Full Demolition
Guidelines:	According to the demolition delay ordinance, BHPC has 90 days to review the demolition permit application from the time it is forwarded to the Commission for review.

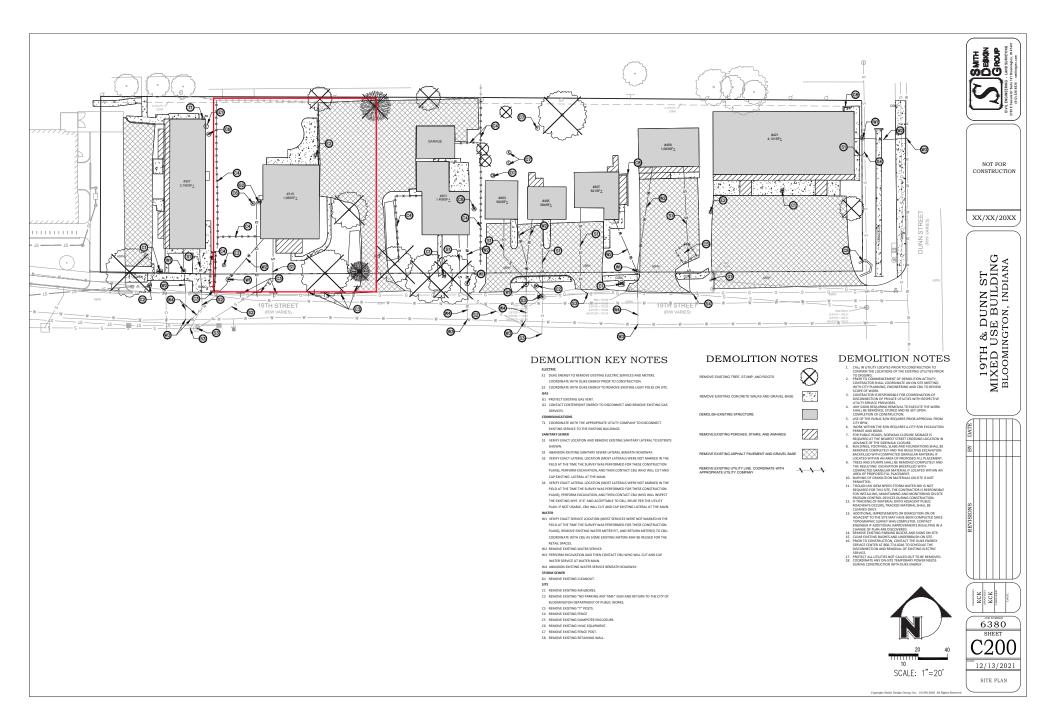
STAFF REC	COMMENDATIONS	Address:	401 E 19th St
DD 22-02		Petitioner:	Ryan Strauser, Strauser
			Construction Co., Inc.
Start Date:	December 22, 2021	Parcel:	53-05-28-300-073.000-005
RATING:	Contributing	Survey:	c. 1950-52, Ranch
