BLOOMINGTON TRAFFIC COMMISSION
AGENDA
April 22, 2015
5:30 P.M. – COUNCIL CHAMBERS

**City of Bloomington Traffic Commission Minutes
February 25, 2015 in the Council Chambers, City Hall**

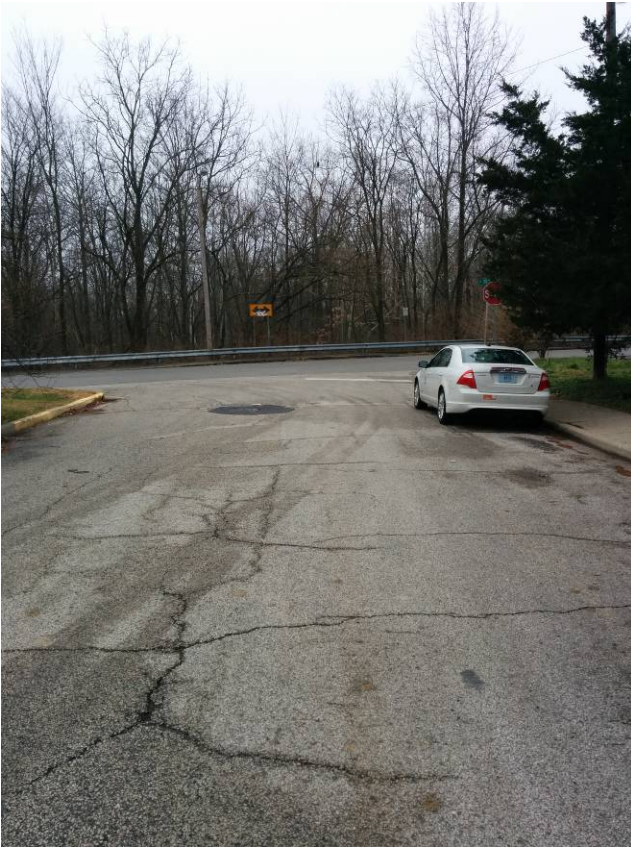
Monroe Street looking south towards 10th Street (~30 feet wide)

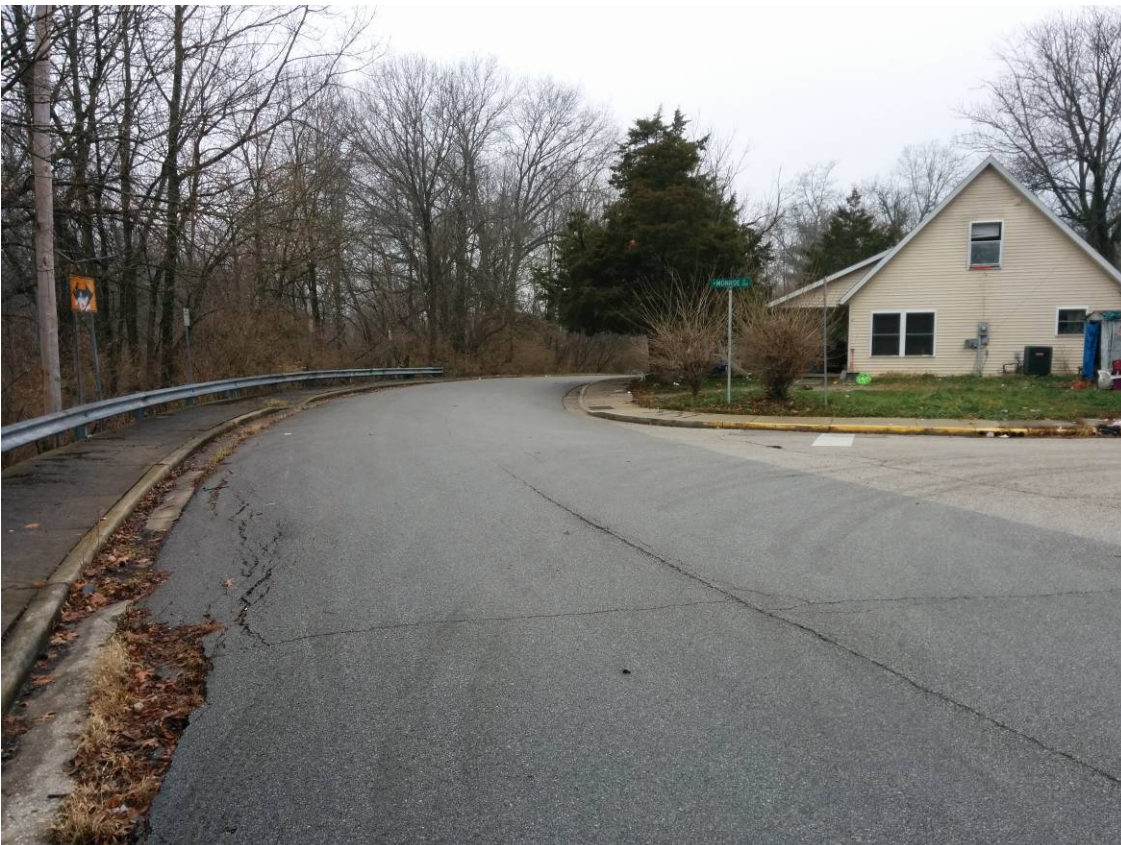
10th Street looking west towards Monroe Street (~25 feet wide)

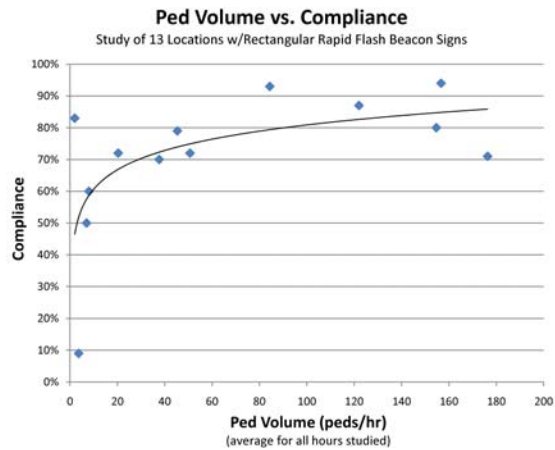
The City of Boulder has evaluated crosswalk enhancements at uncontrolled crossing locations over the years and has determined that there is a clear relationship between driver compliance (yielding) and the pedestrian and/or bicycle crossing volume. Data collected at Boulder crosswalks where rectangular rapid flash beacon signs (RRFB) or State Law-Yield signs were installed shows that driver compliance typically increases with higher crossing volumes. It is theorized that the primary reason for this relationship is that drivers tend to ignore enhanced crossing treatments over time at locations where they infrequently see pedestrians crossing. The following graphs illustrate this relationship:

The above data also illustrates that, below roughly 20 pedestrians per hour, driver compliance decreases significantly. Thus, the base threshold for consideration of an enhanced crossing treatment at an uncontrolled location is 20 pedestrians per hour. This threshold is consistent with recent national guidance and policies adopted by other states and cities, as determined through literature research.

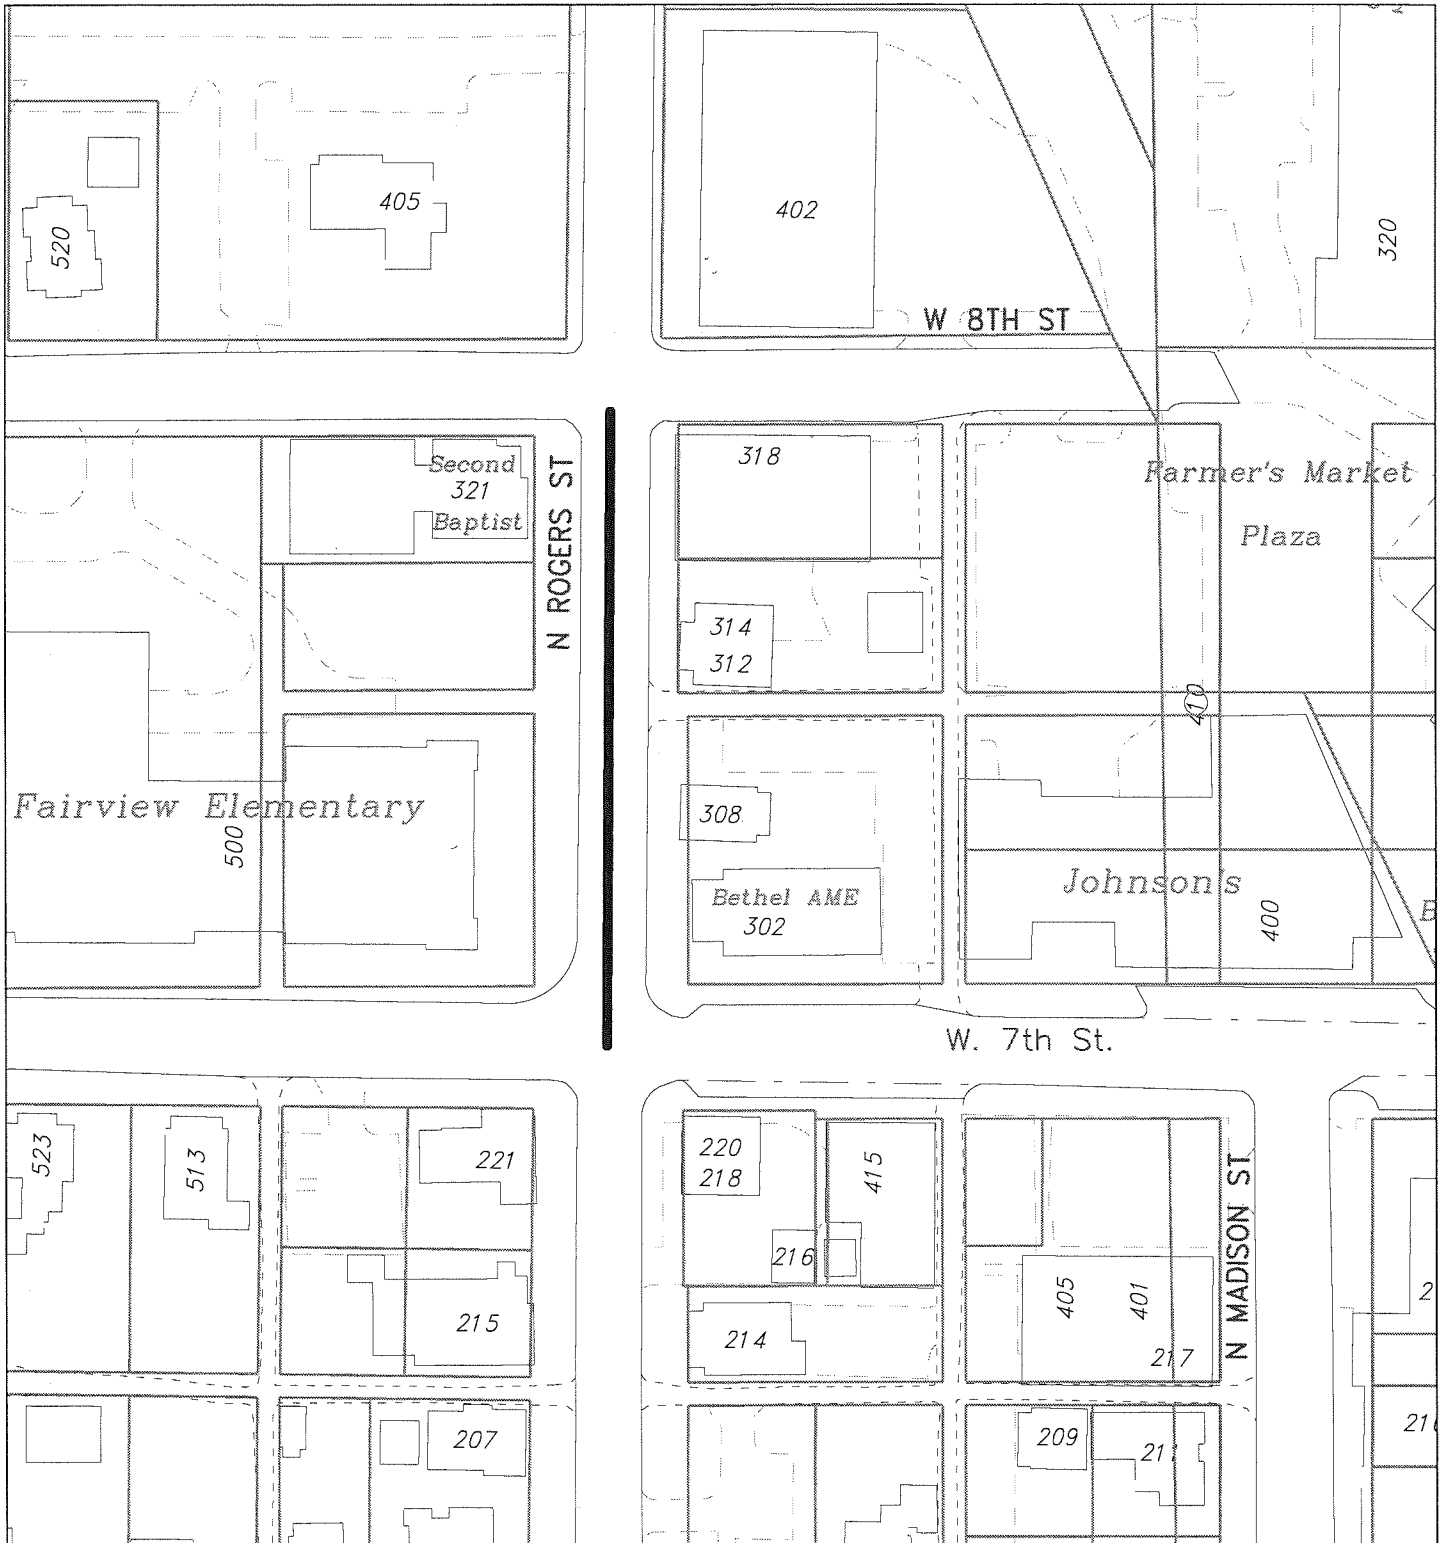
N. Rogers Street – Proposed School Speed Zone (Fairview Elementary School)

Scale: 1" = 100'

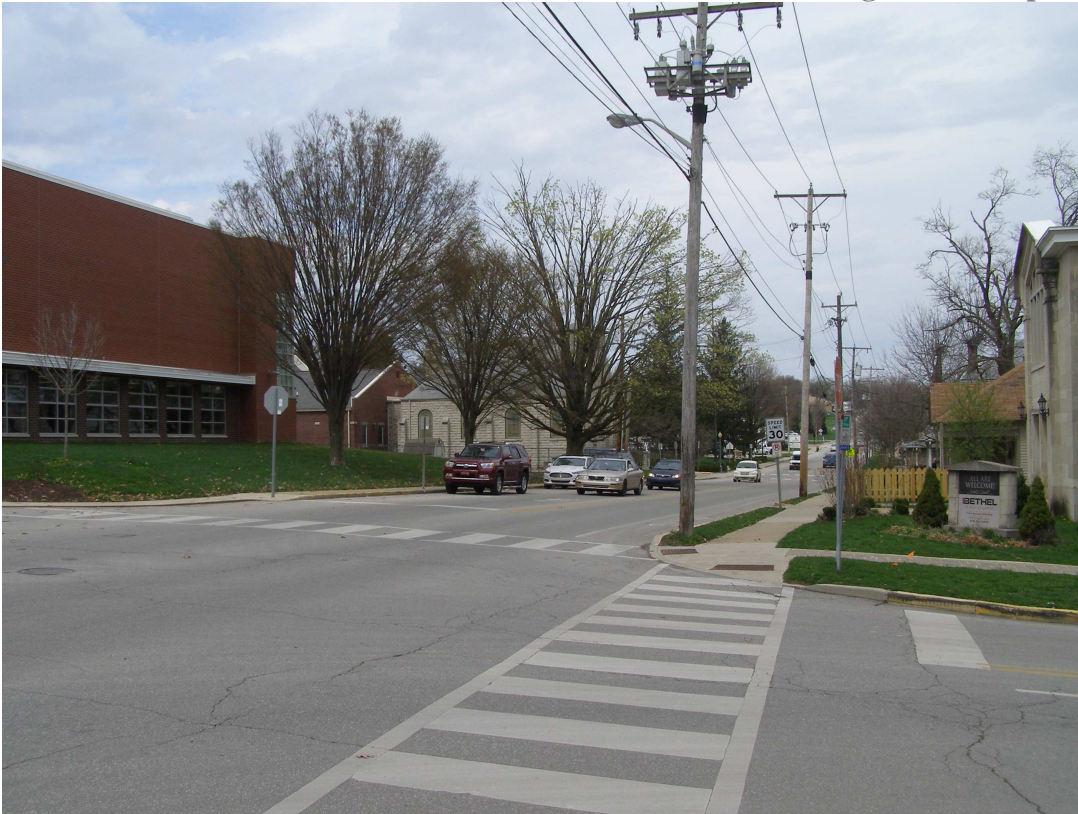
N. Rogers Street (~35') looking northbound at Fairview Elementary School/W. 7th Street.

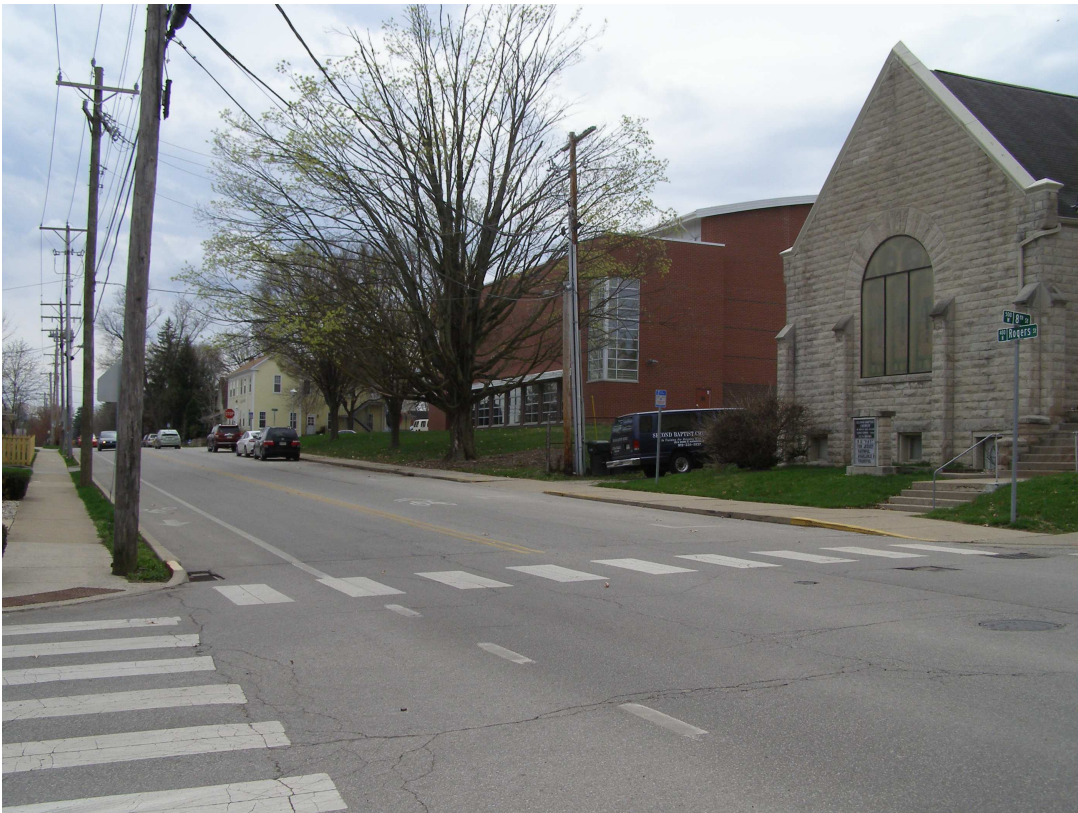
N. Rogers Street (~35') looking southbound at intersection with W. 8th Street.

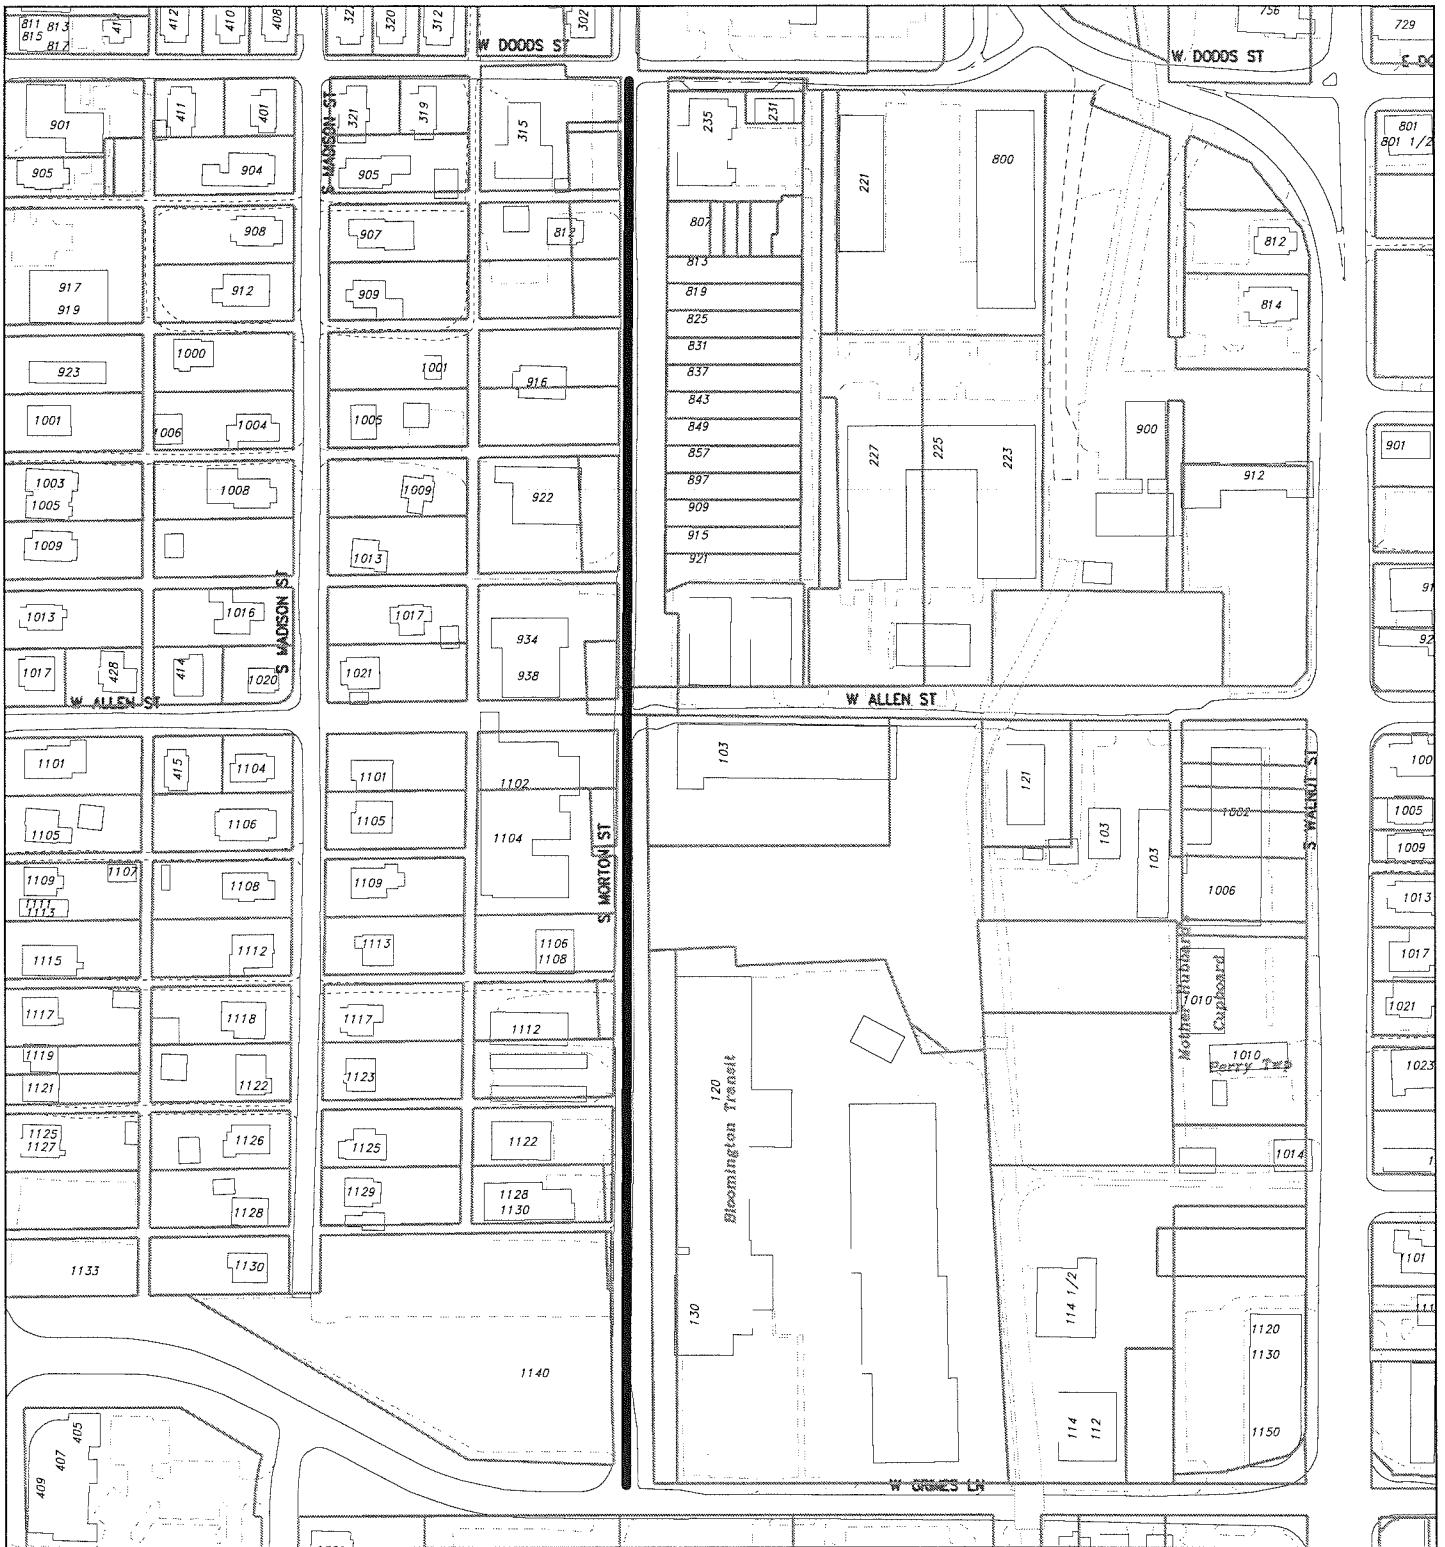
Add additional on-street parking along S. Morton Street
 Convert S. Morton Street to a one-way street configuration

Scale: 1" = 200'

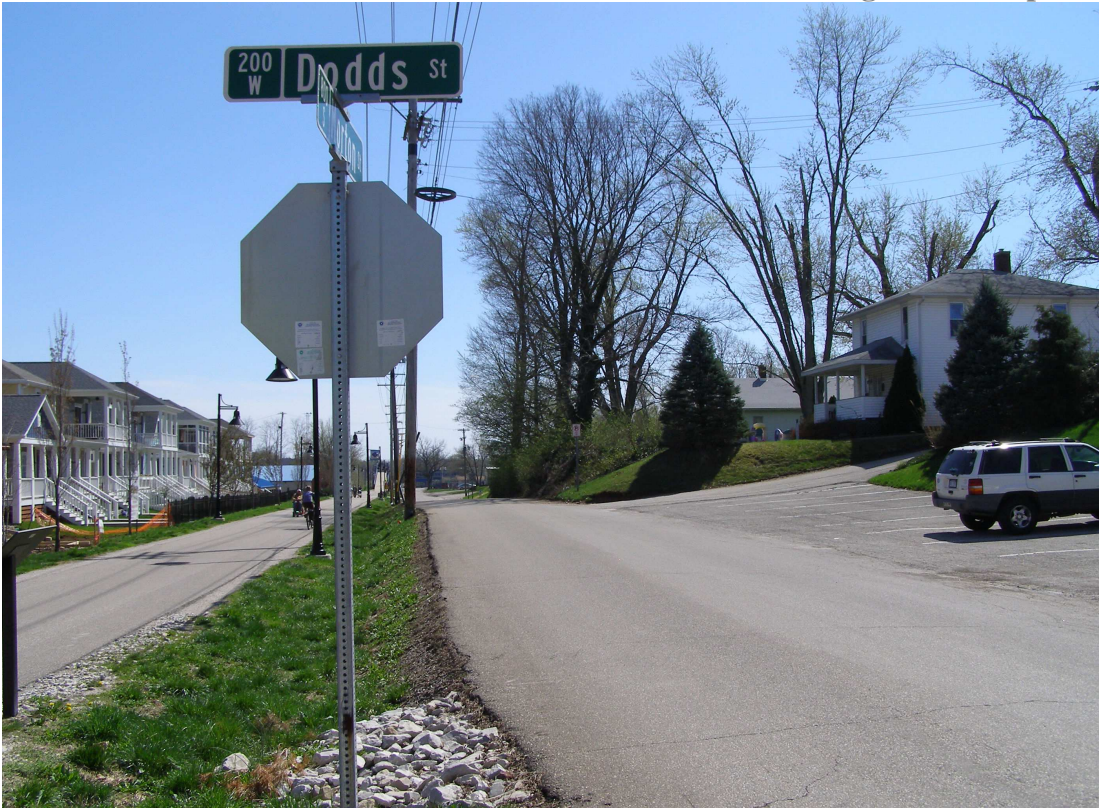
S. Morton Street looking south at intersection with W. Dodds Street (~20 feet).

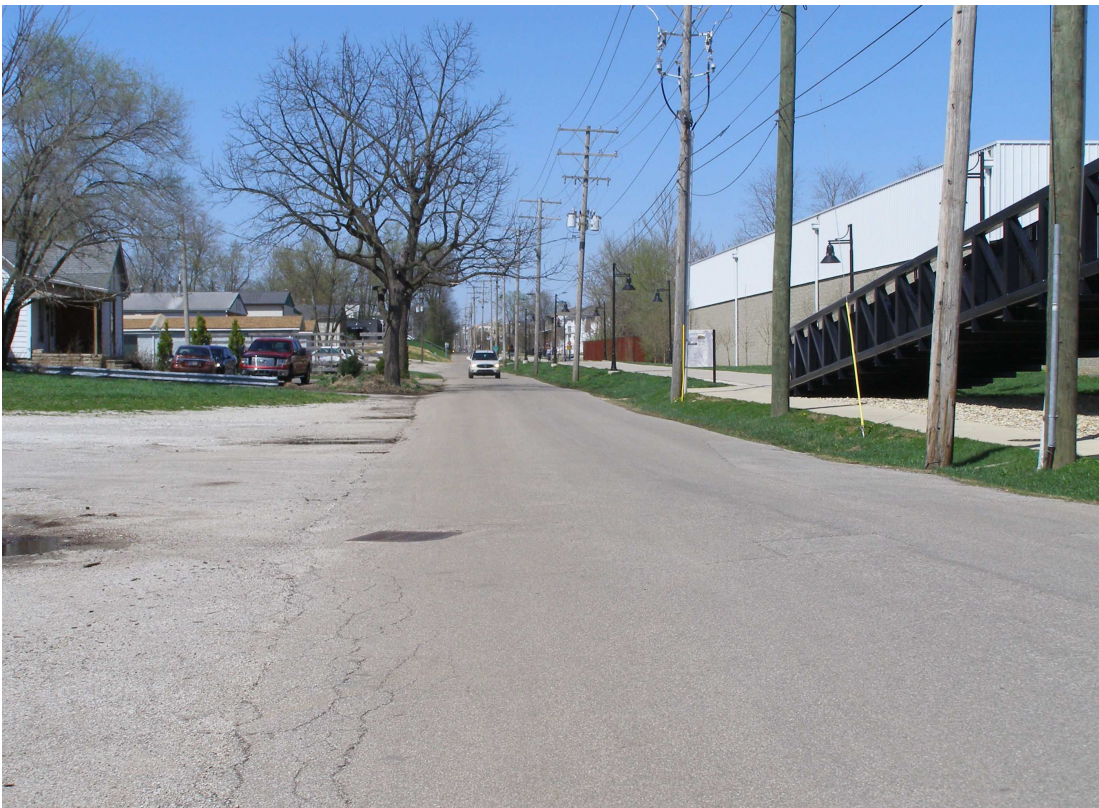
S. Morton Street looking south at intersection with W. Grimes Lane (~20 feet).

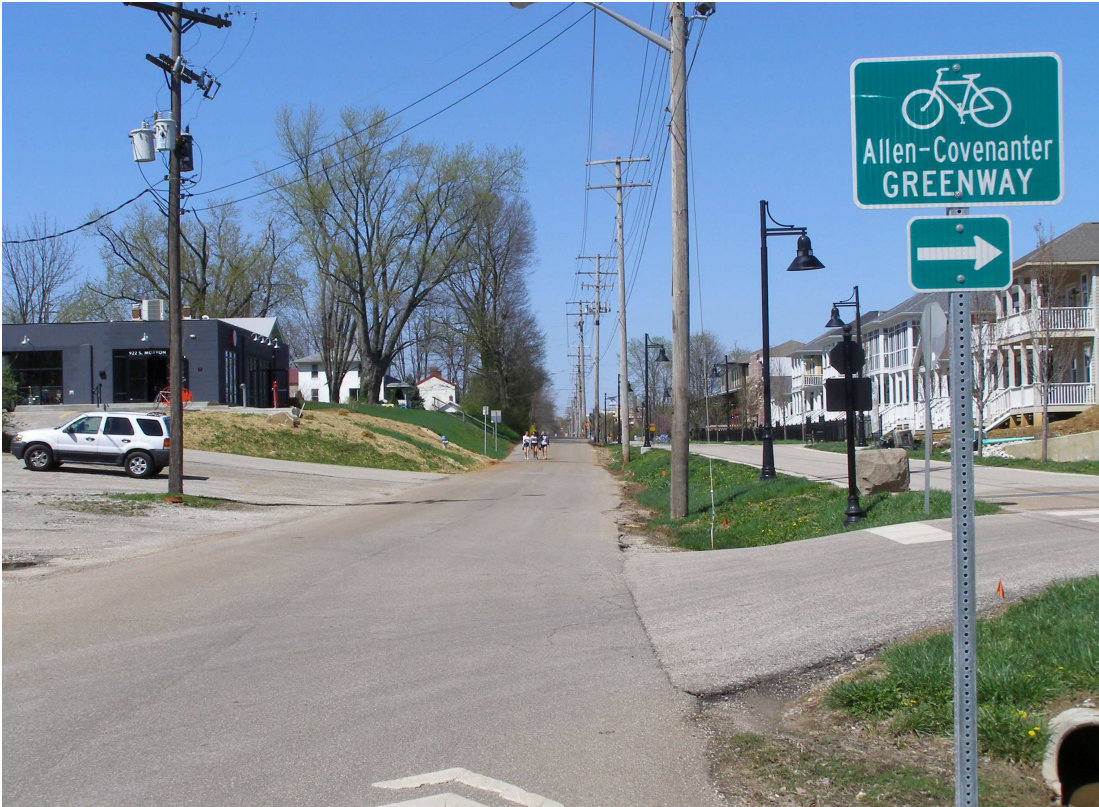
S. Morton Street looking south at intersection with W. Allen Street (~20 feet).
