# **Fairview Historic District Design Guidelines**

FAIRVIEW LOCAL HISTORIC DISTRICT

BLOOMINGTON HISTORIC PRESERVATION

October, 2002

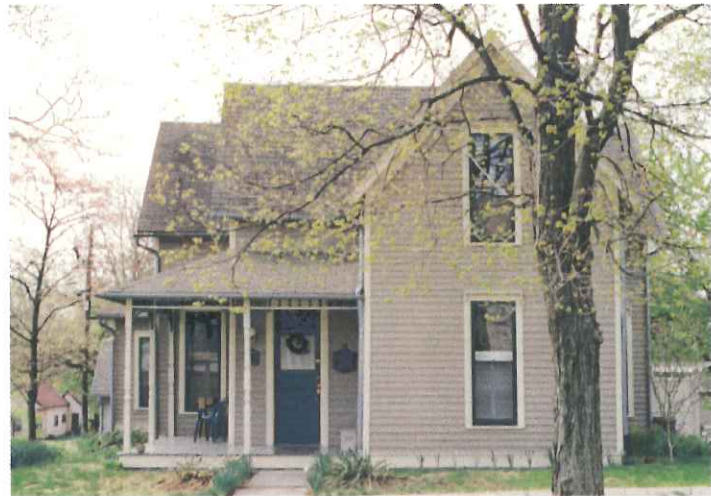
## *Griffin House - 621 West Seventh*

This Queen Anne style home was built in the 1890's by Lafayette Mayfield. The Griffin Family, owners of Quality Hardware Store, occupied it for 44 years. Mrs. Griffin was a founding member of the Fairview PTA. Mary Ellen Farmer, a daughter of the Griffins, was able to provide a c. 1920 photograph of the porch, on which the design for the restoration was based. She remembers when the land extended along "Fairview," which exists only as an unpaved alley to 6th Street, and when the family built the small bungalow for her grandmother that is now 208 North Fairview. When the Griffin House was restored in 1990, the owners discovered a trailer that had been walled into the house as an addition. This was a Bloomington Restorations, Inc. revolving loan project and one of the most dramatic restorations that BRI ever attempted.

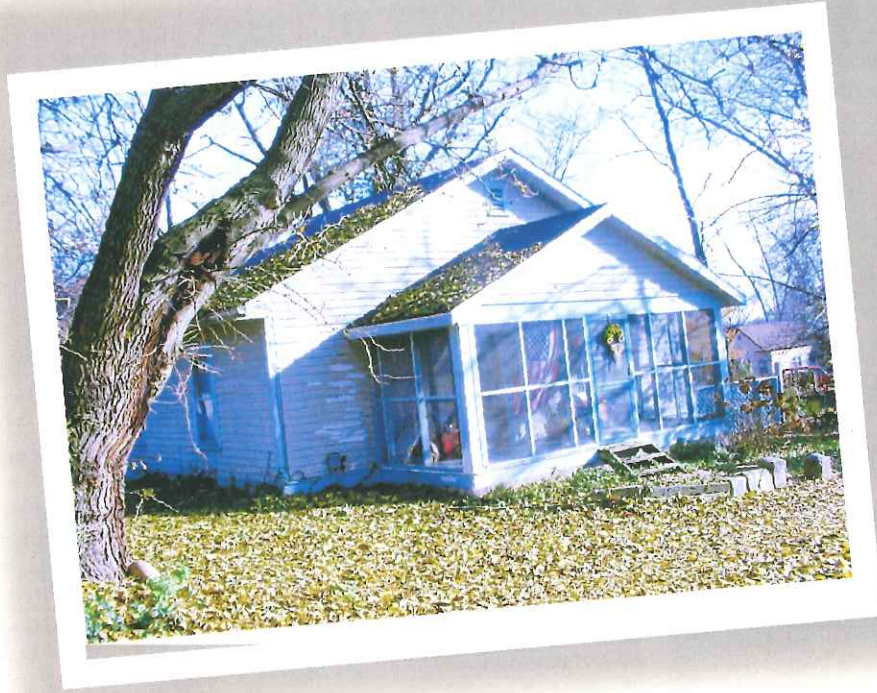
## *208 North Fairview*

This small vernacular bungalow located on the alley between Sixth and Seventh Streets, and was built some time before 1930. At this location, "Fairview Street" is a 12' alley but still maintains its name. The Griffin family built this cottage for an elderly relative, and located it on the rear of their lot.

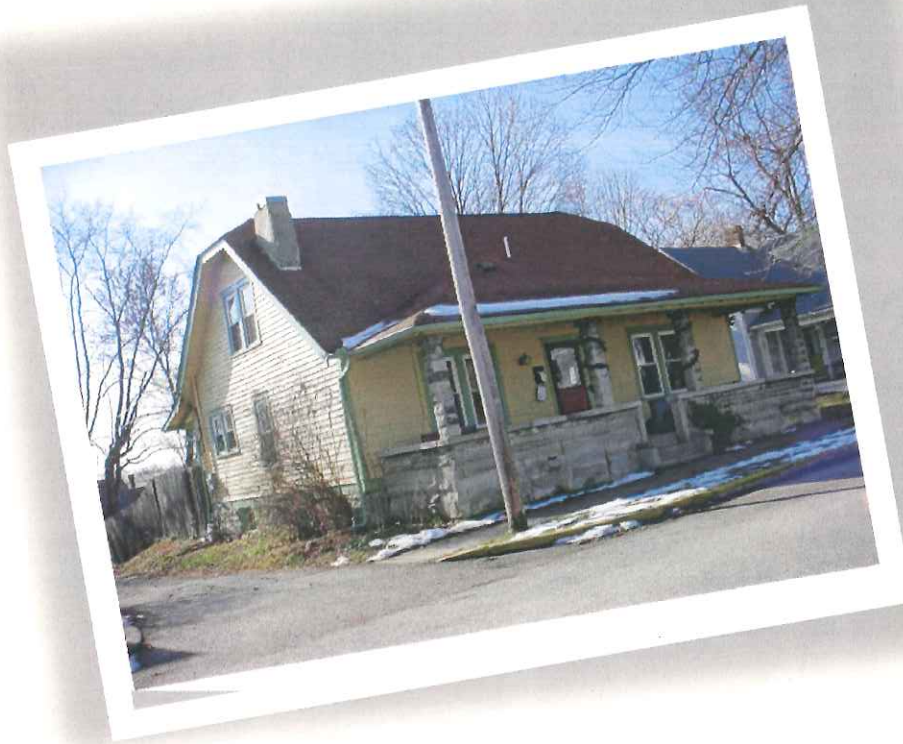
### *625 West Seventh Street*

A modest story and a half bungalow, this property has an unusual jerkin head roof treatment, or clipped gables. The large rock-faced limestone porch is characteristic of an area where stone was readily available for even the smallest houses. Historically this was the residence of an African American family. William C. Mathews was a janitor at the county courthouse. Other members worked variously as factory hands and chauffeurs. The Mathews family lived there for 25 years. In 1940, Morris Thorpe resided at this address. While many African American families have left the neighborhood, many members of Thorpe's extended family still live in the Near West Side.

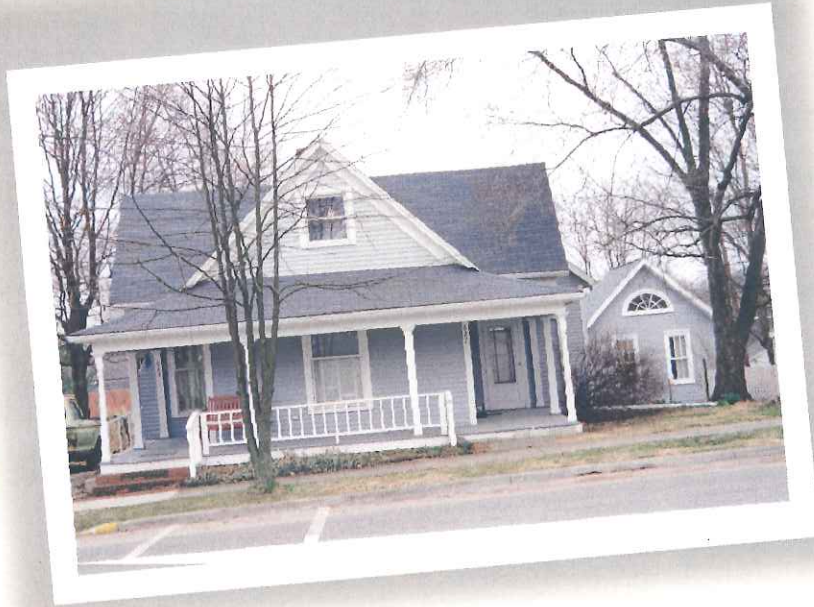
### *627 West Seventh Street*

One of the earliest houses in the district, the home at 627 was occupied by the Thornton family for nearly 50 years. During renovation, log beams were discovered in the foundation. Log sills are present in many houses in the neighborhood. This led the current residents to believe it is an early construction. Sanborn fire insurance maps show that this particular building appears between 1898 and 1907. A letter carrier named Munson lived here from 1909-1930. According to a newspaper article of the time, it was in his home, in 1921, that the Board of Fairview Methodist Church met to discuss the construction of a temporary Tabernacle following the terrible fire on Christmas Eve that entirely destroyed the church. The Thornton family lived in the neighborhood at various addresses including 622 West Sixth.

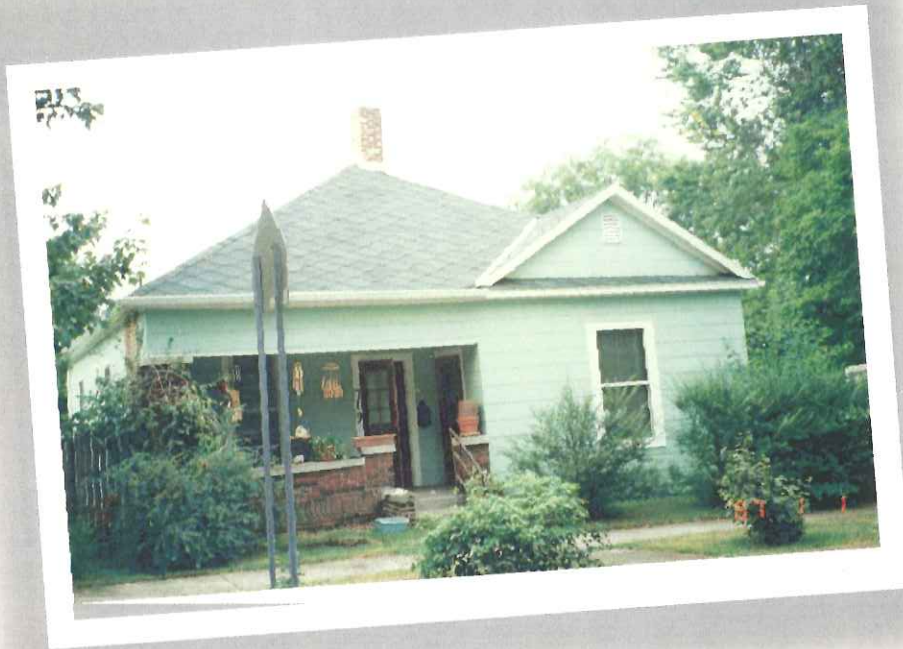
### *719 West Seventh Street*

This property is a pyramidal roof cottage with a pedimented gable, one of the most prevalent forms in the Near West Side. Its most famous occupant was L. E. Dyer, long time principal of Fairview grade school, for whom the Dyer School was named. Mrs. Dyer taught at Fairview School for many years as well. The footprint of the house has remained the same since 1898. Evidence of a small garage or barn-like storage structure remains on the southwest corner of the lot. The earliest documented owner was a barber named L.M. Hanna.

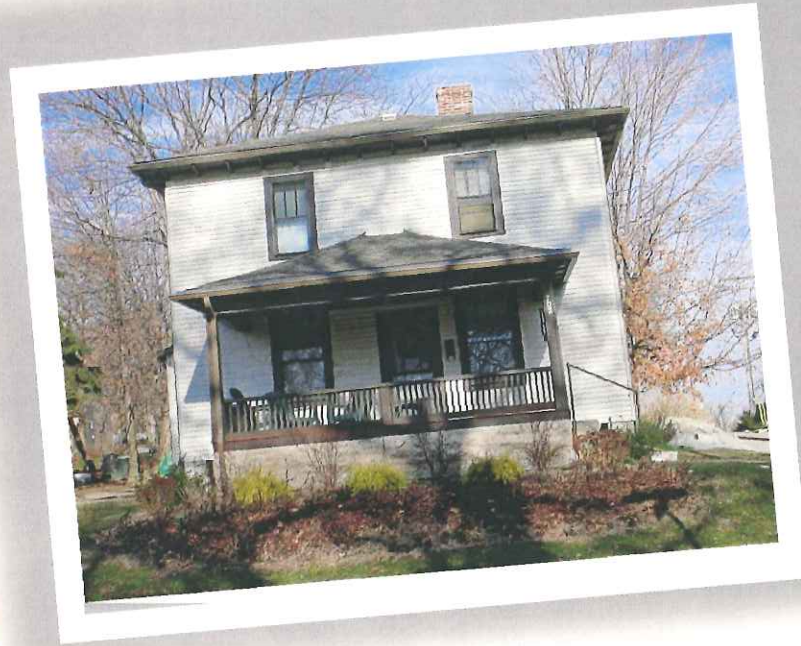
### *702 West Seventh Street*

This house is the most recent residence built in the district. Constructed in 1923, it replaced an existing house which was moved from Seventh Street a few dozen feet to the north to have a Fairview address. That house, at 309 North Fairview, still stands. The house at 702 is a splendid example of the four square form. Affectionately nicknamed the "wife killer," the four square was relatively affordable and doubled the square footage of the familiar bungalow, but was reputed to be a cleaning nightmare. This is a nice example of a four square with a wooden porch rather than the more common brick porch and console type modillions supporting the eaves. Placed on an embankment at the high point of Fairview Hill, the house to the front door is laid with limestone slabs and massive steps.

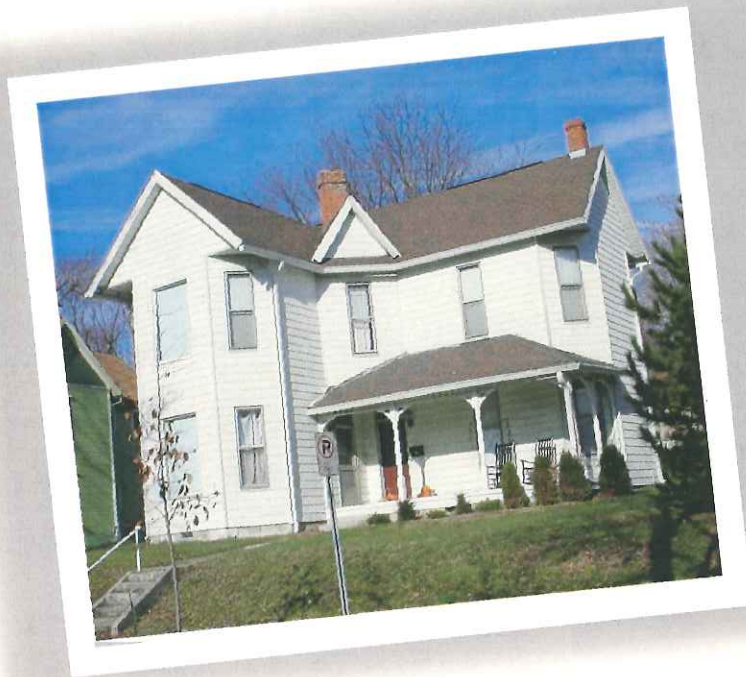
## *708 West Seventh Street*

This two story gabled-ell is a near twin to 714 West 7th Street. It differs in the addition of a second floor gable within the crook of the ell. Both wings of the house having chamfered corners. The house was substantially improved in 2000 , although its exterior is not completely restored. The carpentry work on the porch was restored, using existing templates. The Brown family lived here from 1900-1940. Earl Brown was a teacher. Boarders were taken in from time to time.

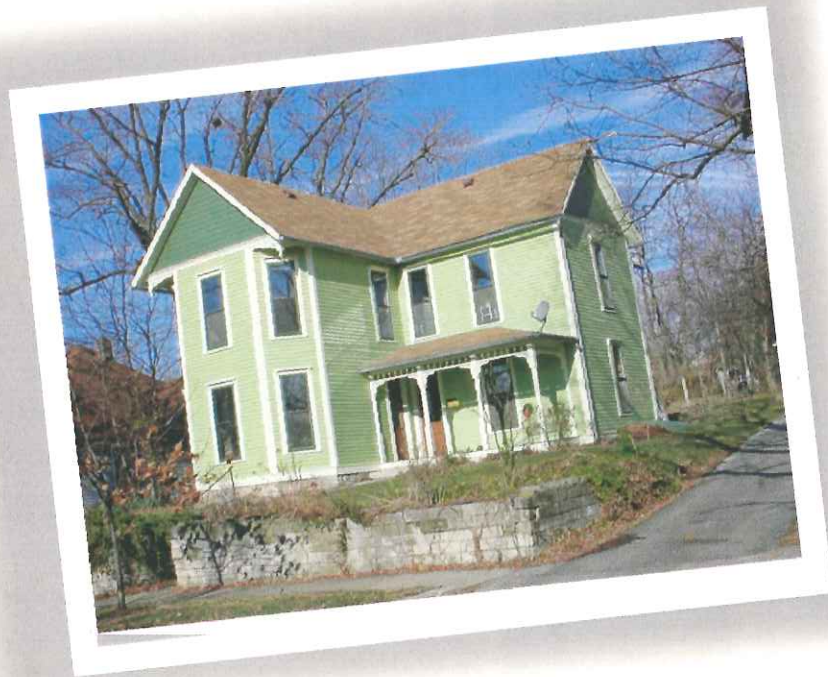
### *714 West Seventh Street*

Known as the Flanigan House, this substantial Queen Anne was restored with BRI Guaranteed Loan Funds in 1985. A near twin to the 2 story gabled-ell at 708, it was owned by Rev. Adamson, minister of the Church of Christ. In the 1930's was occupied by the Ringlette Shop, one of the many beauty shops located in the Near West Side. One of the first listed occupants, in 1900 was J.W. Faris, of the grocery family. This house shows Queen Anne detailing in its shingling and its scrollwork details rival anything on the grand Victorian houses North Washington Street.

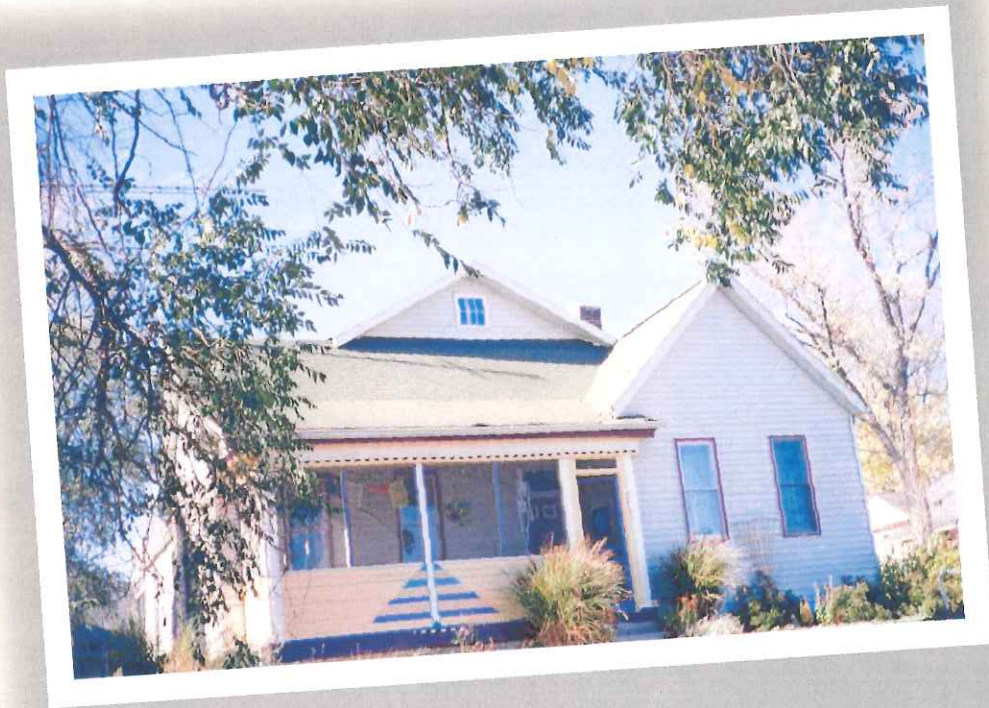
### *319 North Fairview*

This gabled-ell was built in 1880's and originally located across Fairview down the hill facing onto West 8th next to the former Fairview United Methodist Church. That church burned in the Christmas fire in 1921. After the fire, the house was pulled, using mules and rollers, to its present location. When the current owners were removing the old siding from the house in 1994, they discovered scorch marks from the church fire indicating that it had once been located across the street adjacent to the old church site

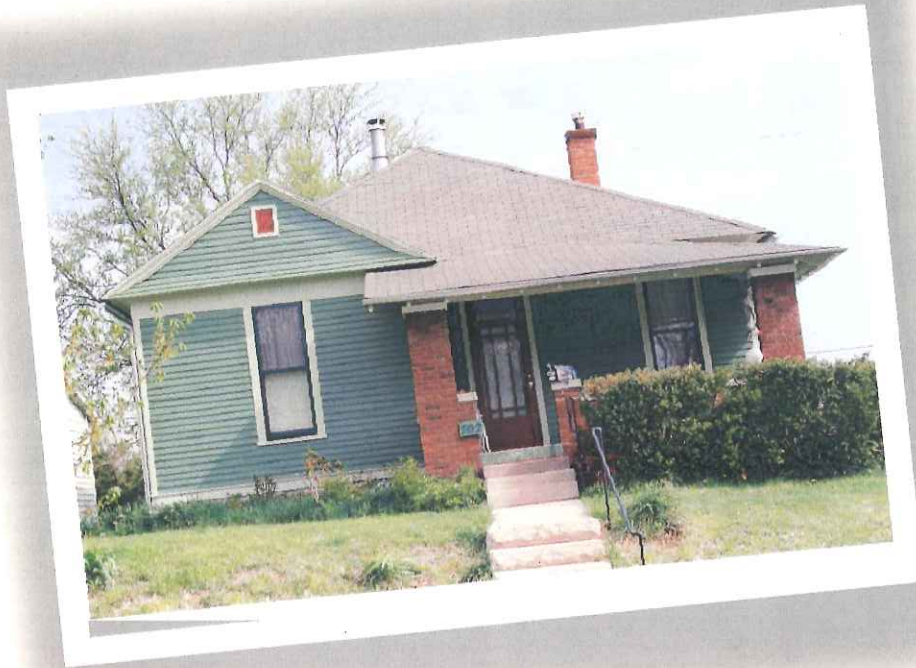
### *702 West Eighth Street*

This pyramidal cottage was built in 1908. It features a distinctive pedimented gable with a bell cast skirt. The house retains its original windows and transoms. The first owner of the house was W.H. Thrasher who worked as a butcher in the grocery store of W.A. Tarkington, at 423 West 6th Street. He later went on to operate the Monon Restaurant at 700 East Atwater. From 1929, a Thomas Farr lived in the house. He was listed for many years as a railroad worker on the Monon line. Later, he worked at the Wiles Drug Store. Like the Griffin -Thornton family on Seventh and Sixth Streets, members of the Farr family lived at several locations in the neighborhood.

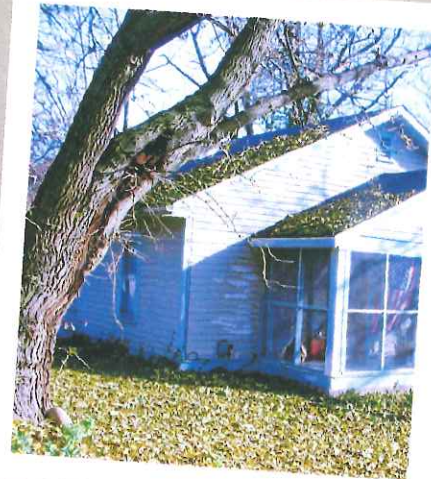
*Inappropriate*

*Avoid removal of mature trees that contribute to the overall neighborhood canopy.*

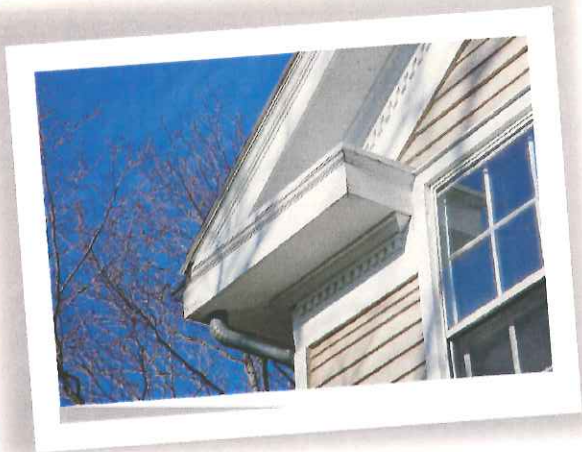
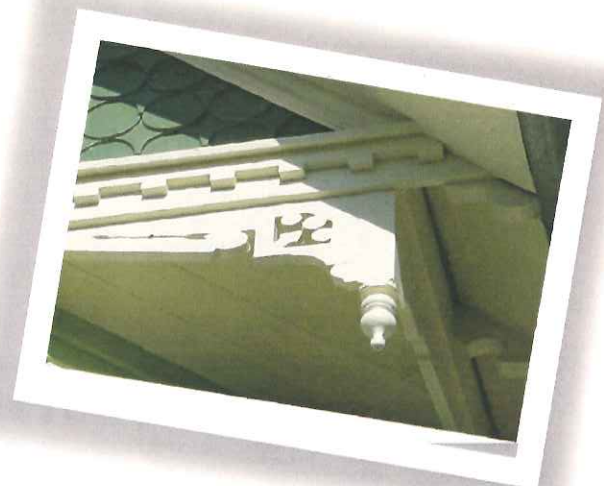
#### *Inappropriate*

*Avoid application of siding materials not consistent with the character or style of the building, or materials that were unavailable at the time the building was constructed.*

*Artificial sidings such as artificial stone or brick, asphalt shingle and brick, plywood, particle board, hard board and aluminum or vinyl siding have been documented to cause and cover up serious, costly and often irreparable damage to buildings. (See also synthetic siding, page 29.)*

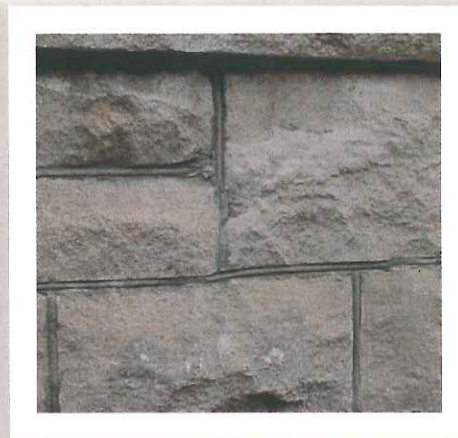
*Do not use electric saws to remove mortar during tuckpointing; this method can damage surrounding masonry surfaces and change the joint size. Avoid unnecessary tuckpointing.*

*Do not tuckpoint masonry using a mortar of high Portland Cement content; this mortar often creates a bond stronger than the building material itself. Damage resulting from the differing porosity and expansion rates of the material and mortar can lead to expensive replacement of the masonry units, such as brick or stone block.*

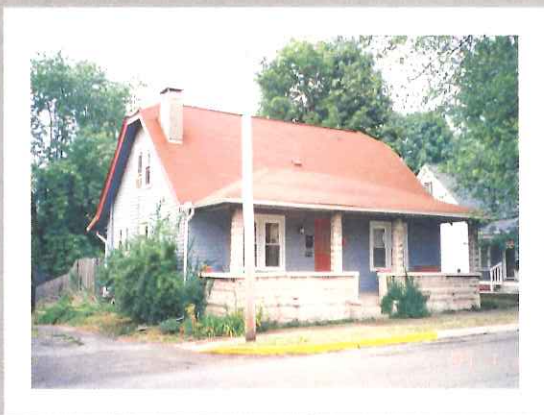
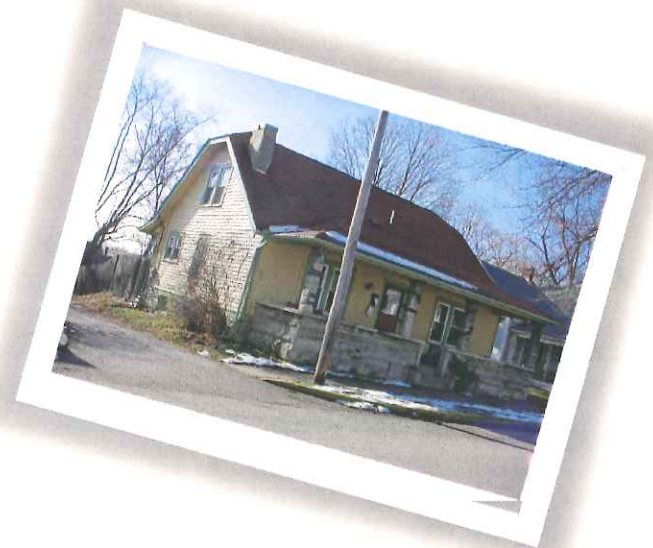
### *Inappropriate*

*Avoid painting masonry surfaces such as limestone and most brick surfaces.*

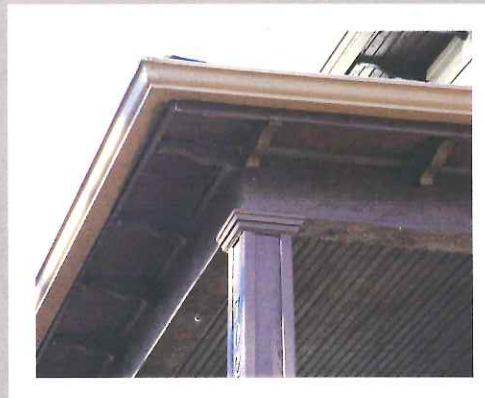
#### *Inappropriate*

*Avoid removal or change of character-defining architectural features, materials, or detailing. Also avoid addition of incompatible materials or architectural features foreign to the original structure or building style.*

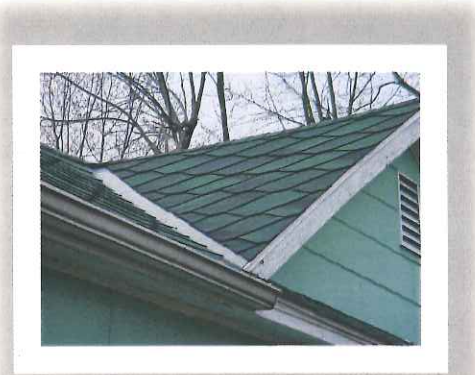
*Roofing materials such as roll roofing, plastic, or tarpaper are inappropriate permanent coverings.*

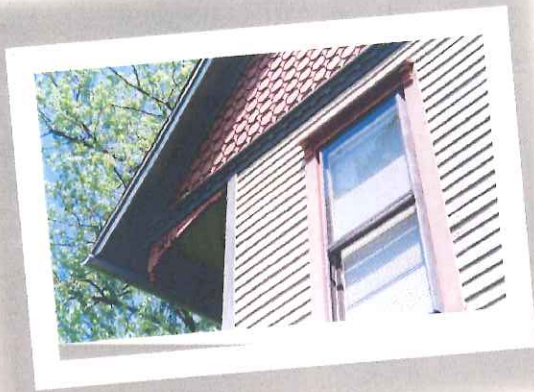
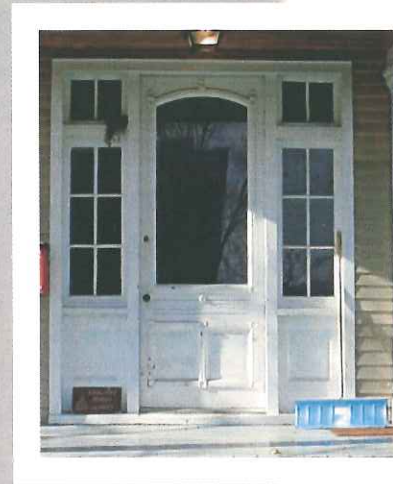
### Appropriate

Original windows and doors and their characteristic elements including sashes, lintels, sills, shutters, transoms, pediments, molding, hardware, muntins, and decorative glass should be retained and repaired rather than replaced. If original windows and doors are deteriorated beyond repair, replacements should duplicate the original in size and scale. Design, material, color, and texture should be duplicated as faithfully as possible.

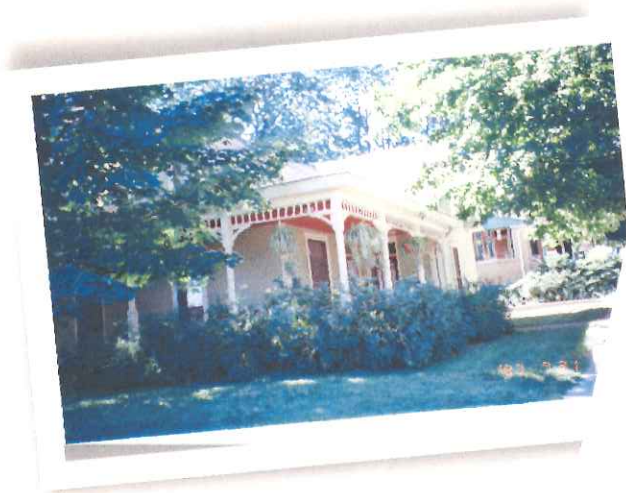
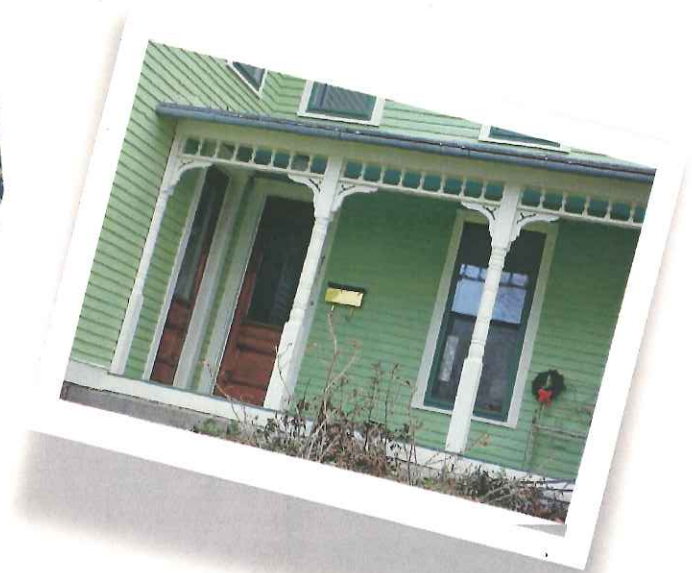
#### Inappropriate

*It is inappropriate to alter details that help define the character and construction of the porch and the overall style and historical development of the building.*

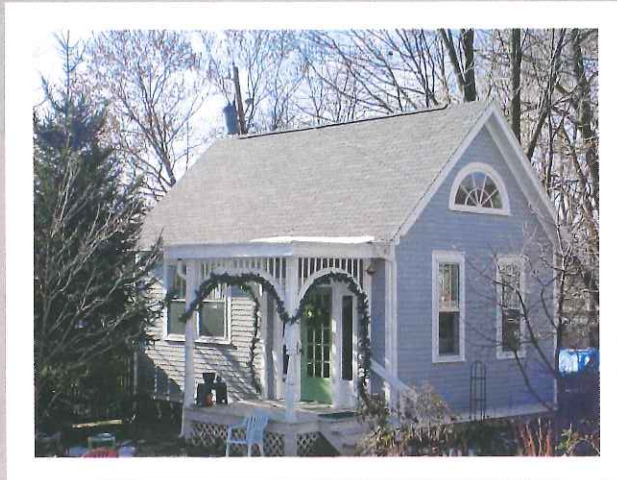
This new construction of an artist's studio was approved by the historic commission in 2000.
