**PROSPECT HILL LOCAL HISTORIC DISTRICT**  
**BLOOMINGTON HISTORIC PRESERVATION COMMISSION**

**BOOK OF GUIDELINES**

# Prospect Hill Historic District

**Prepared by the Study Committee  
of the Prospect Hill Local Historic District  
and the City of Bloomington**

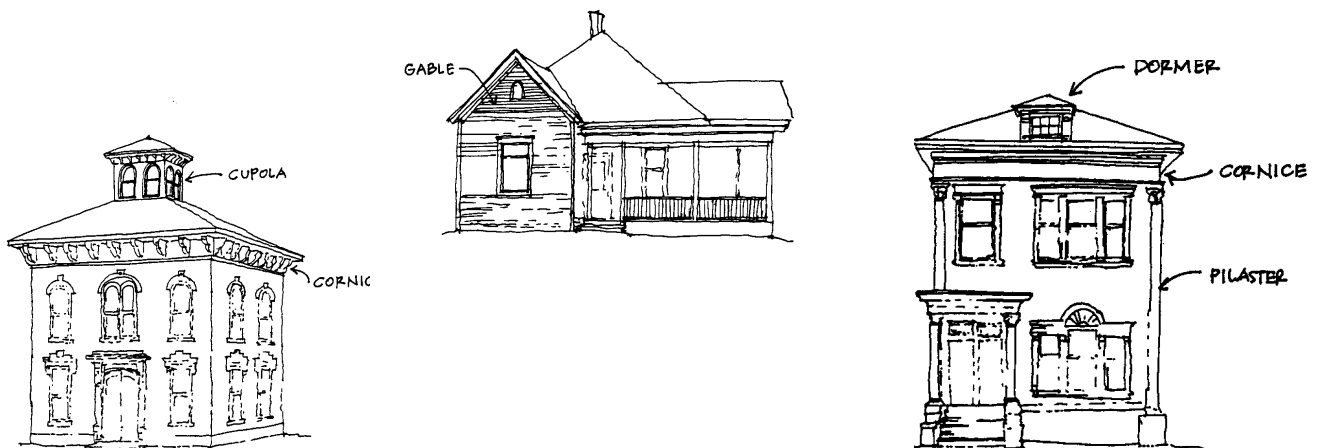
Retain the roof's original shape, materials, architectural features, and detailing such as brackets, chimneys, **cornices**, cupolas, **dormer windows**, gable end shingles, and weather vanes. Maintain and repair as needed all decorative elements found on the **gable ends of the roof**. If these elements must be replaced, they should imitate original design patterns. Maintain flashing, valleys, and other water repellent devices to prevent water infiltration into the building envelope.

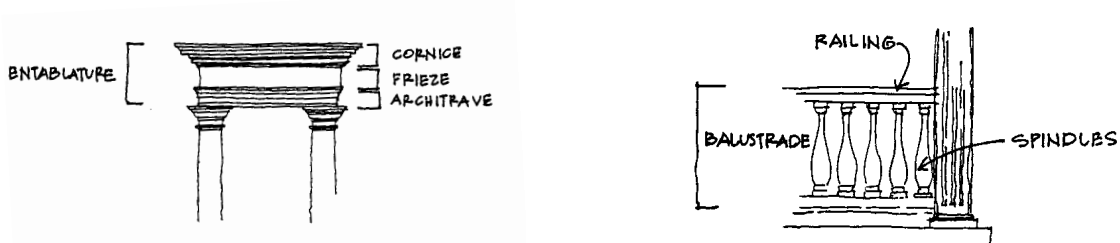
Retain existing original porch features and details. Repair missing or deteriorated elements or replace them with elements that duplicate the originals in design and materials. Paint new porch work.
