Griffy Lake
Aquatic Vegetation Management Plan
2017-2021
Monroe County, Indiana
February 21, 2017

Prepared for:
City of Bloomington Parks & Recreation
401 N. Morton St. Suite 250
Bloomington, IN 47402

Prepared by:
**AQUATIC
CONTROL**
Est. 1966
PO Box 100
Seymour, Indiana 47274

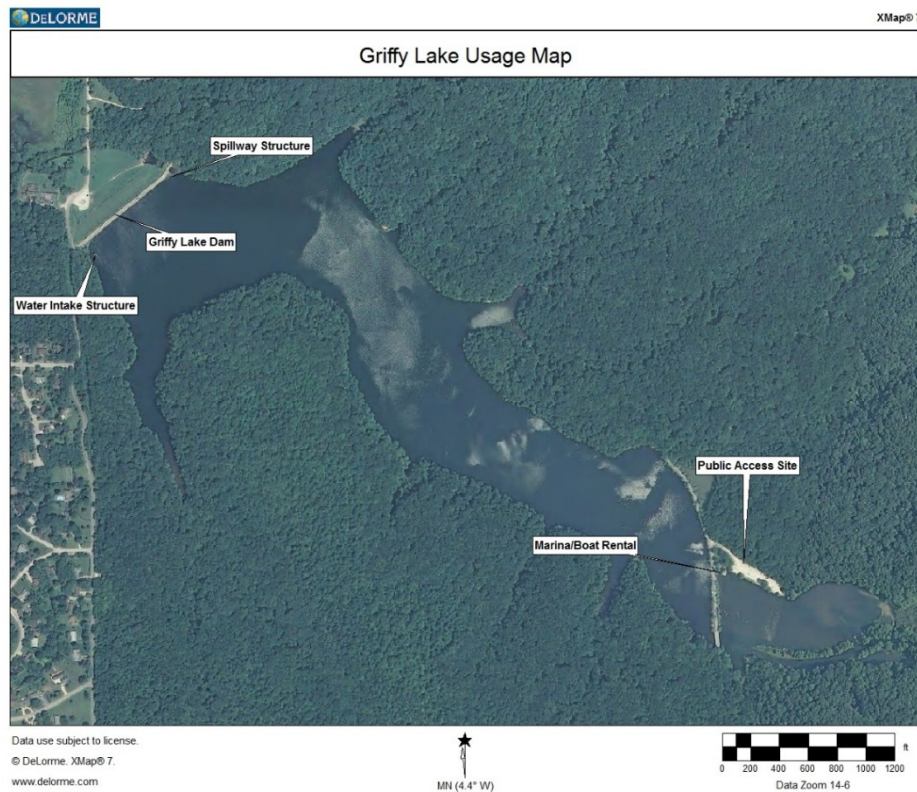
Figure 2. Griffy Lake usage map.

Griffy Lake and the immediate surroundings are owned by the city of Bloomington and managed by the Bloomington Parks and Recreation department. There are no permanent dwellings on the shoreline of Griffy Lake. Griffy Lake attracts numerous visitors from the Bloomington area. It is a very popular place for boating, fishing, picnicking, hiking, and environmental education. Public access, in the form of a boat ramp, is located in the southeast corner or upper end of the lake (Figure 2). This access site is managed by

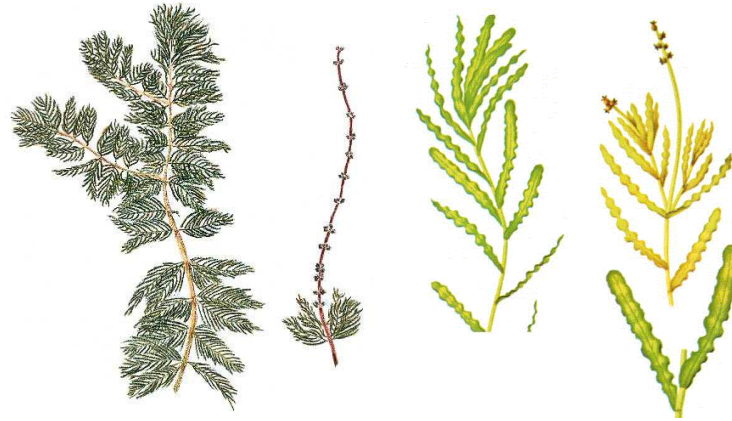
Figure 3. Illustrations Eurasian watermilfoil (left), and curly-leaf pondweed (right) (Illustrations provided by Applied Biochemist).

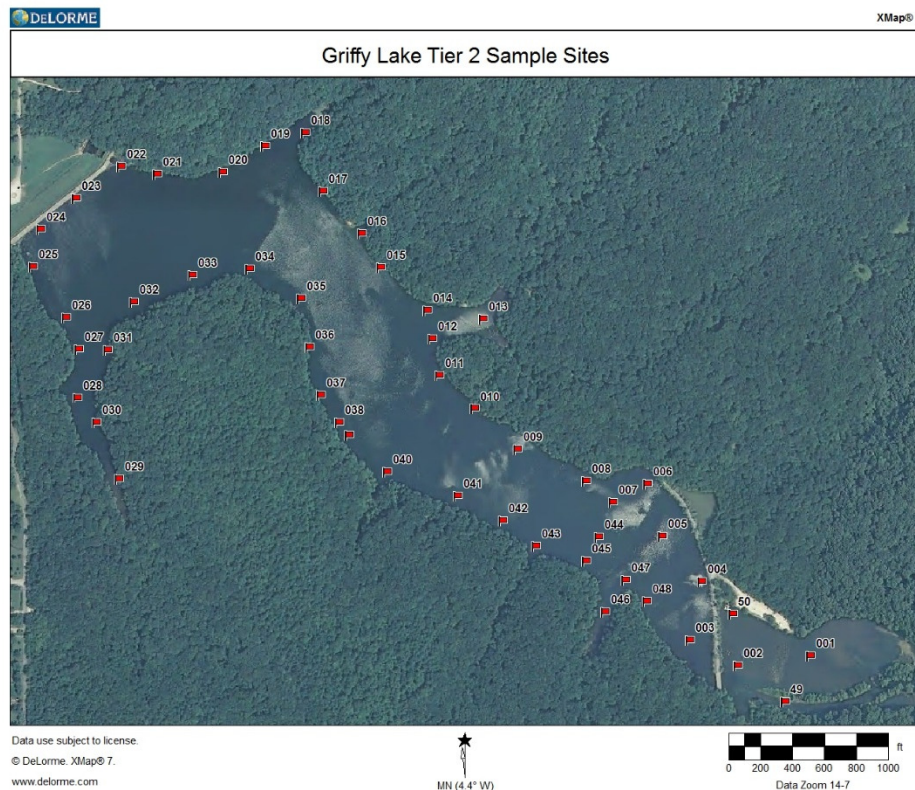
Figure 4. Tier II sample sites.

Sample sites are selected based on a stratified random methodology. Once a site is reached the boat was slowed to a stop. A depth measurement was taken by dropping a two-headed standard sampling rake that was attached to a rope marked off in 1-foot increments. An additional ten feet of rope was released and the boat was reversed at minimum operating speed for a distance of ten feet. Once the rake is retrieved the individual plant abundance on the rake is scored with either a 0 (no plants retrieved), 1 (1-20% of rake teeth filled), 3 (21-99% of rake teeth filled), or 5 (100% of rake teeth filled) (IDNR 2014). Fifty sample sites were surveyed on Griffy Lake (Figure 4).

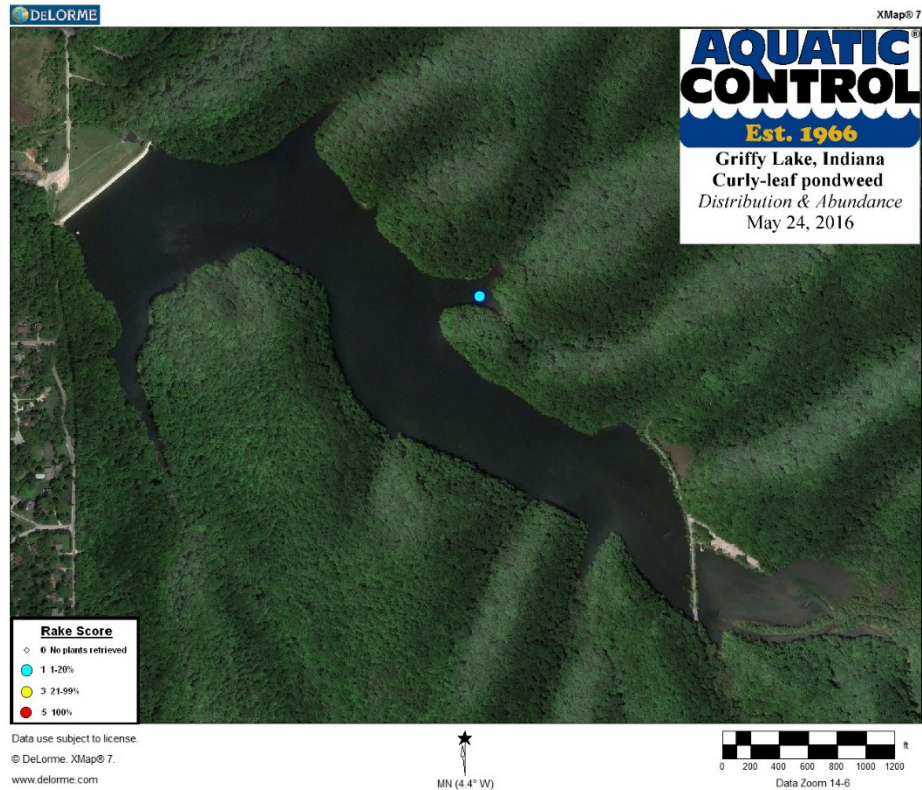
Figure 8. Tier 2 sample sites where curly-leaf pondweed was collected, May 24, 2016.
