COLLEGE MALL PEDESTRIAN ACCESSIBILITY STUDY

**A REPORT BY THE CITY OF BLOOMINGTON
PLANNING DEPARTMENT**

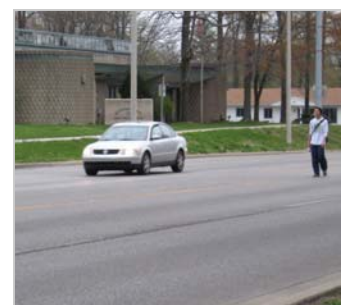
A pedestrian crosses 3rd St. at an unmarked crossing.

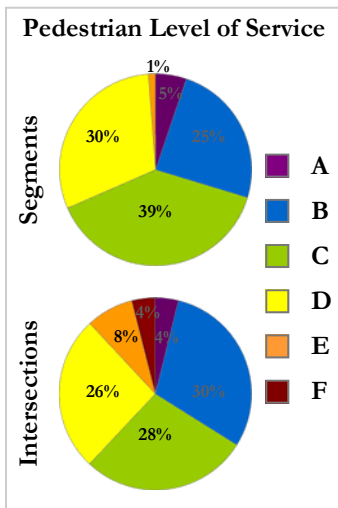
Results from Pedestrian Level of Service analysis.

To bring together the various components of the inventory, a pedestrian level of service analysis was conducted. This methodology incorporates pedestrian infrastructure, traffic volumes, and speed, providing an overall measure of the comfort and perceived safety of the walking environment. This analysis revealed that more than 30% of the pedestrian environment fall into the “A” and “B” categories, which is comfortable for almost all pedestrians. Unfortunately, an almost equal portion was determined to fall in the “D”, “E”, and “F” categories, which most pedestrians would find to be uncomfortable, if not a thorough deterrent from walking.

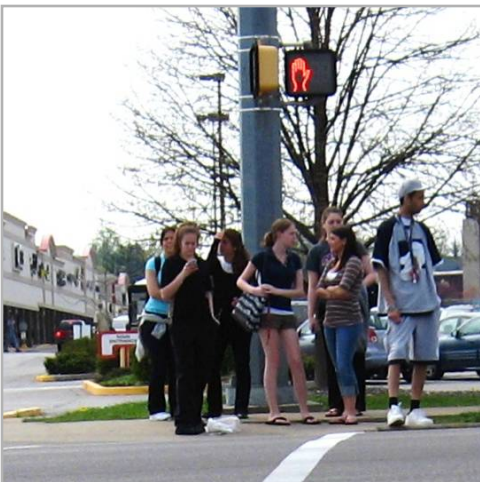
Pedestrians wait to cross College Mall Rd. at Eastland Plaza Dr.

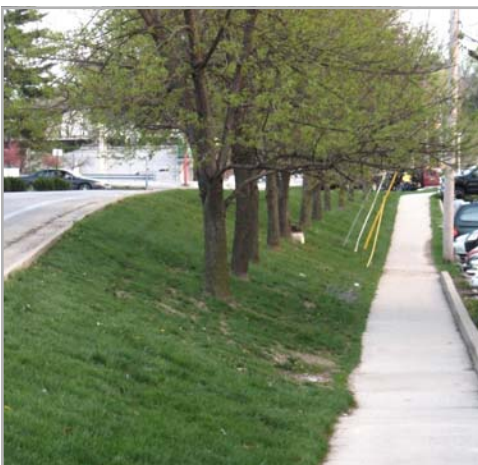
This sidewalk along Kingston Dr. is separated horizontally and vertically from traffic, while street trees establish a buffer and provide shade. Together these design elements create a comfortable walking environment.

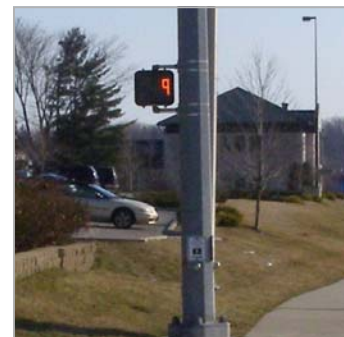
Pedestrian signals with countdown timers, as here at 2nd St. & College Mall Rd., provide valuable information for pedestrians and motorists .

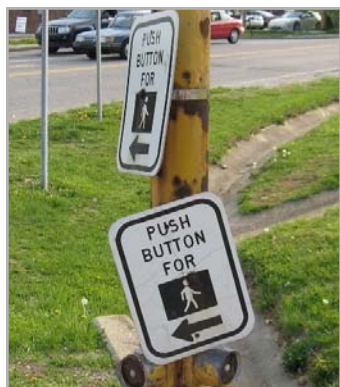
Push buttons at 10th St. & the Bypass

Pedestrian push buttons are a common feature at signalized intersections in the College Mall area. While push buttons allow for greater flexibility in signal timing, they can contribute to confusion and frustration amongst pedestrians, and the benefits to motorists are negligible in some situations. In particular, push buttons are sometimes installed in such a way as to require their use when the pedestrian signal should automatically follow the traffic signal cycle. WALK signals should be displayed for a given crossing when the parallel street has a green light, unless doing so would cause a significant delay to vehicular traffic.

Twenty-six crossings in the College Mall area require the pedestrian to use the push button to receive a WALK signal, while another six feature the option of using them. Out of the 26 crossings that require the push button, eight are preliminarily judged to be inappropriate in that the WALK signal should come on automatically with a parallel green light (these are minor street crossings). An additional eight may also be inappropriate in light of high pedestrian volumes and/or insignificant benefits resulting from their use. The choice of whether and how to use push buttons should reflect policy tradeoffs related to vehicular traffic flow vis-à-vis pedestrian safety and convenience.

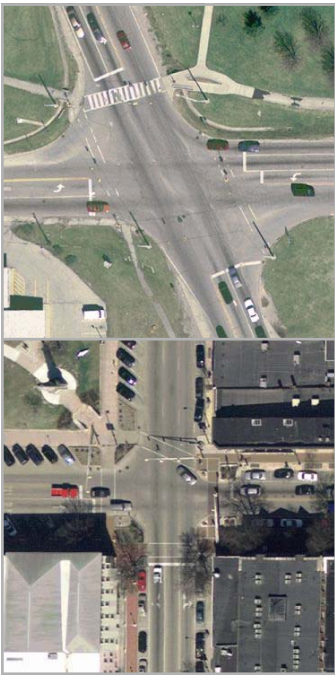
Aerial photos of 10th and the Bypass (top), compared to Kirkwood and Walnut (bottom) demonstrate longer crossing distances and wider curb radii. These features also contribute to a much larger intersection footprint. The photos are shown at the same scale.

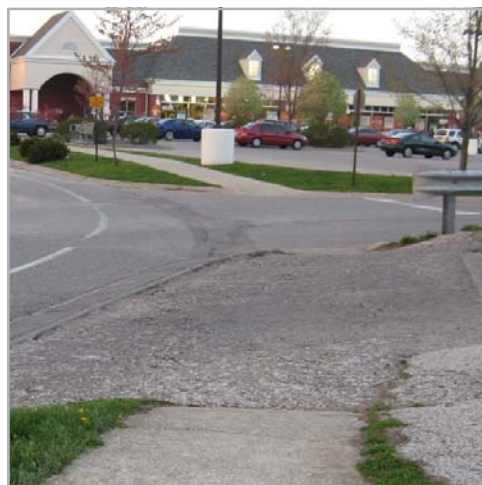
This series of driveway crossings along Kingston Dr. exhibits poor design. In particular, the sidewalk should continue through the crossings to indicate that the pedestrian has the right-of-way.

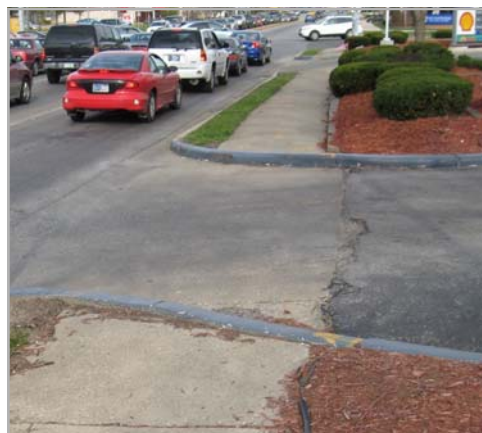
Curb ramps are needed at this driveway crossing along E. 3rd St.

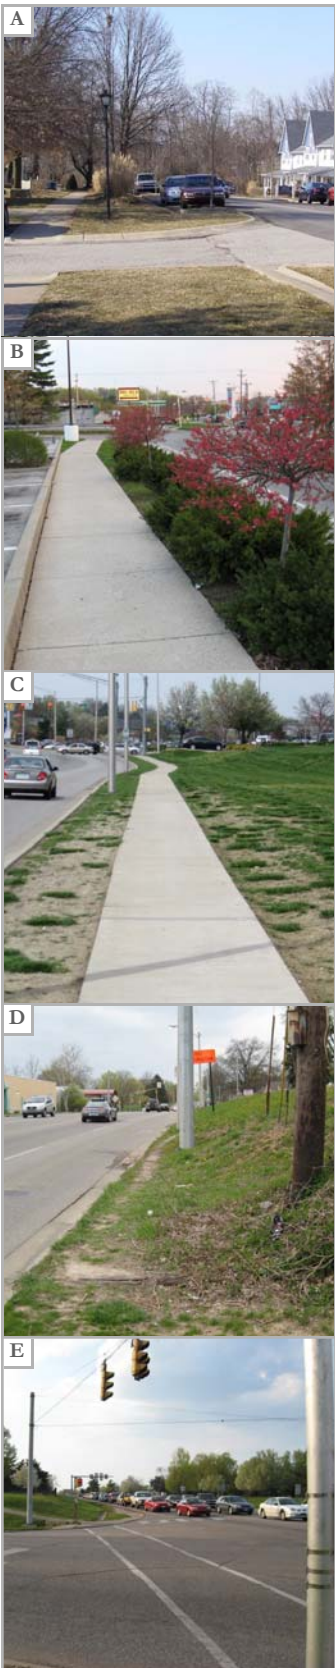
These examples range from Pedestrian Level of Service A (top) to Level of Service E (bottom).

Categories “E” and “F” are reserved for the least hospitable pedestrian environments. High-volume, high-speed roadways without sidewalks, and wide intersection crossings with little to no pedestrian accommodations are typical of these categories. While only one segment in the study area is rated as an “E”, four intersection crossings received the rating, and two crossings received the “F” rating. Each of these “E” and “F” ratings are for facilities under the jurisdiction of the Indiana Department of Transportation. Needless to say, these facilities serve as a deterrent to pedestrian travel.

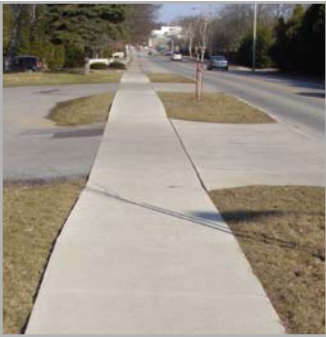
This sidewalk and driveway crossing are well-designed: the pedestrian clearly has the right-of-way, as the sidewalk is uninterrupted across the driveway.

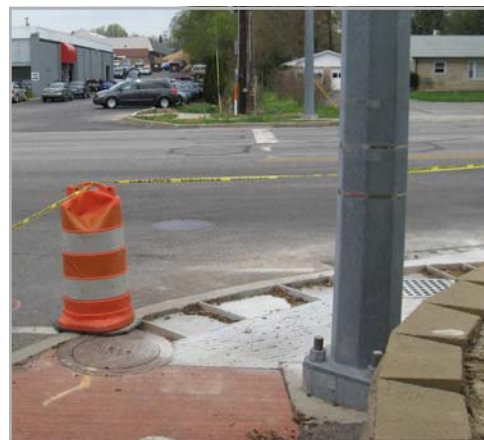
Curb ramp reconstruction at 3rd St. & Clarizz Blvd.

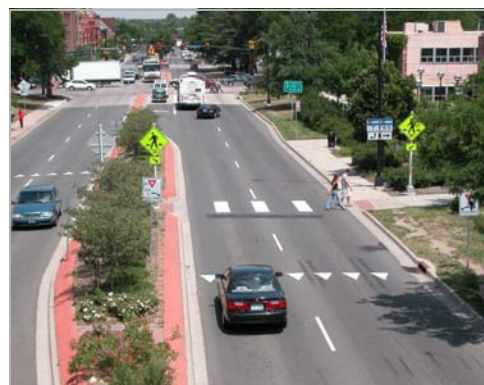
This crosswalk in Boulder, CO illustrates best practices for markings and signage at mid-block crosswalks.

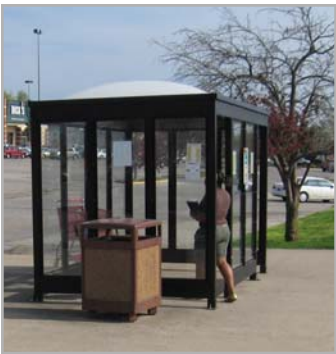
Bus shelters, such as this one on College Mall Rd. encourage transit usage.

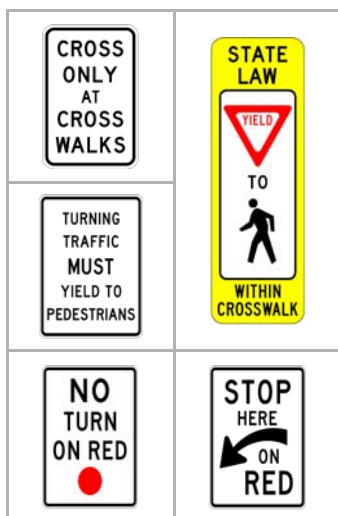
There are a variety of signs that can be used to improve interactions between motorists and pedestrians.

Strategically placed signs can reinforce safe interactions between motorists and pedestrians and notify users of existing laws. Signs should not be used, indiscriminately, however, as overuse may cause them to be ignored. Examples of relevant MUTCD-compliant signs are shown at right. The recommendations below include signage in a few cases, but many more opportunities exist for effective signage to be installed.

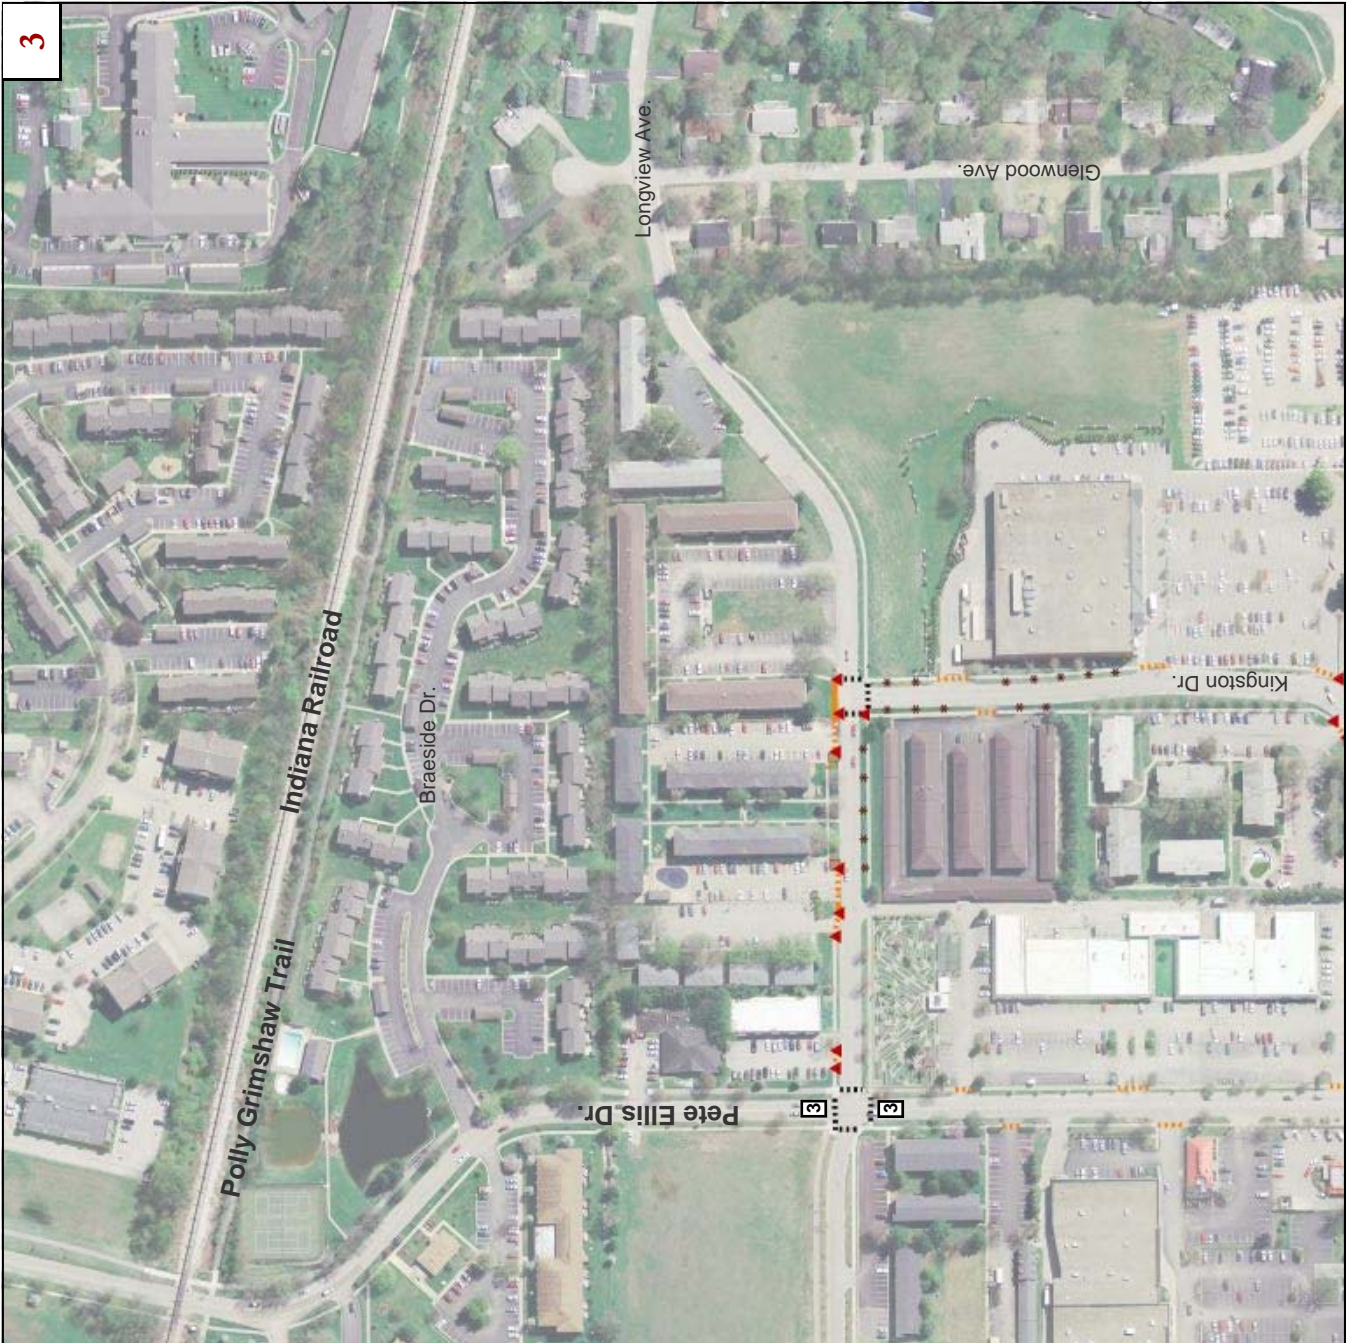
Figure 15 - Conceptual Recommendations (Section 3)

3 | New uncontrolled crossing

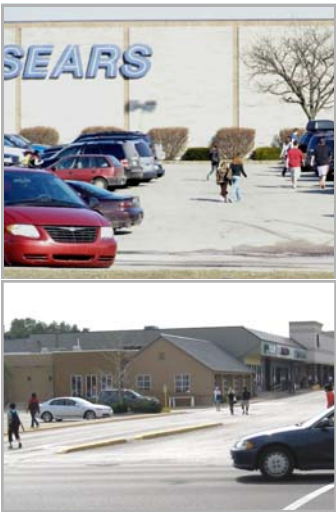
Pedestrians walk through the College Mall and Eastland Plaza parking lots after de-boarding at College Mall Rd. and Eastland Plaza Dr.

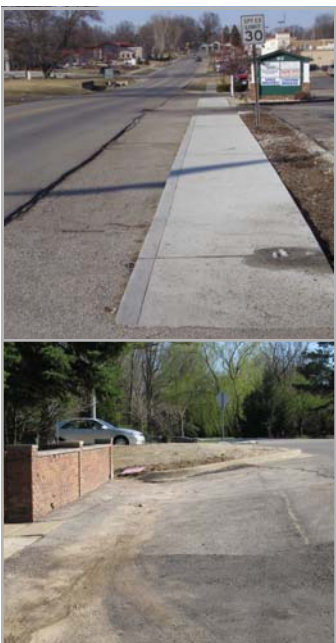
Incomplete sidewalk network along Woodscrest Dr.

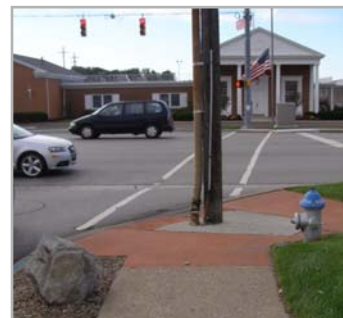
This curb ramp at 3rd & Pete Ellis was recently reconstructed, but the utility pole was not relocated.

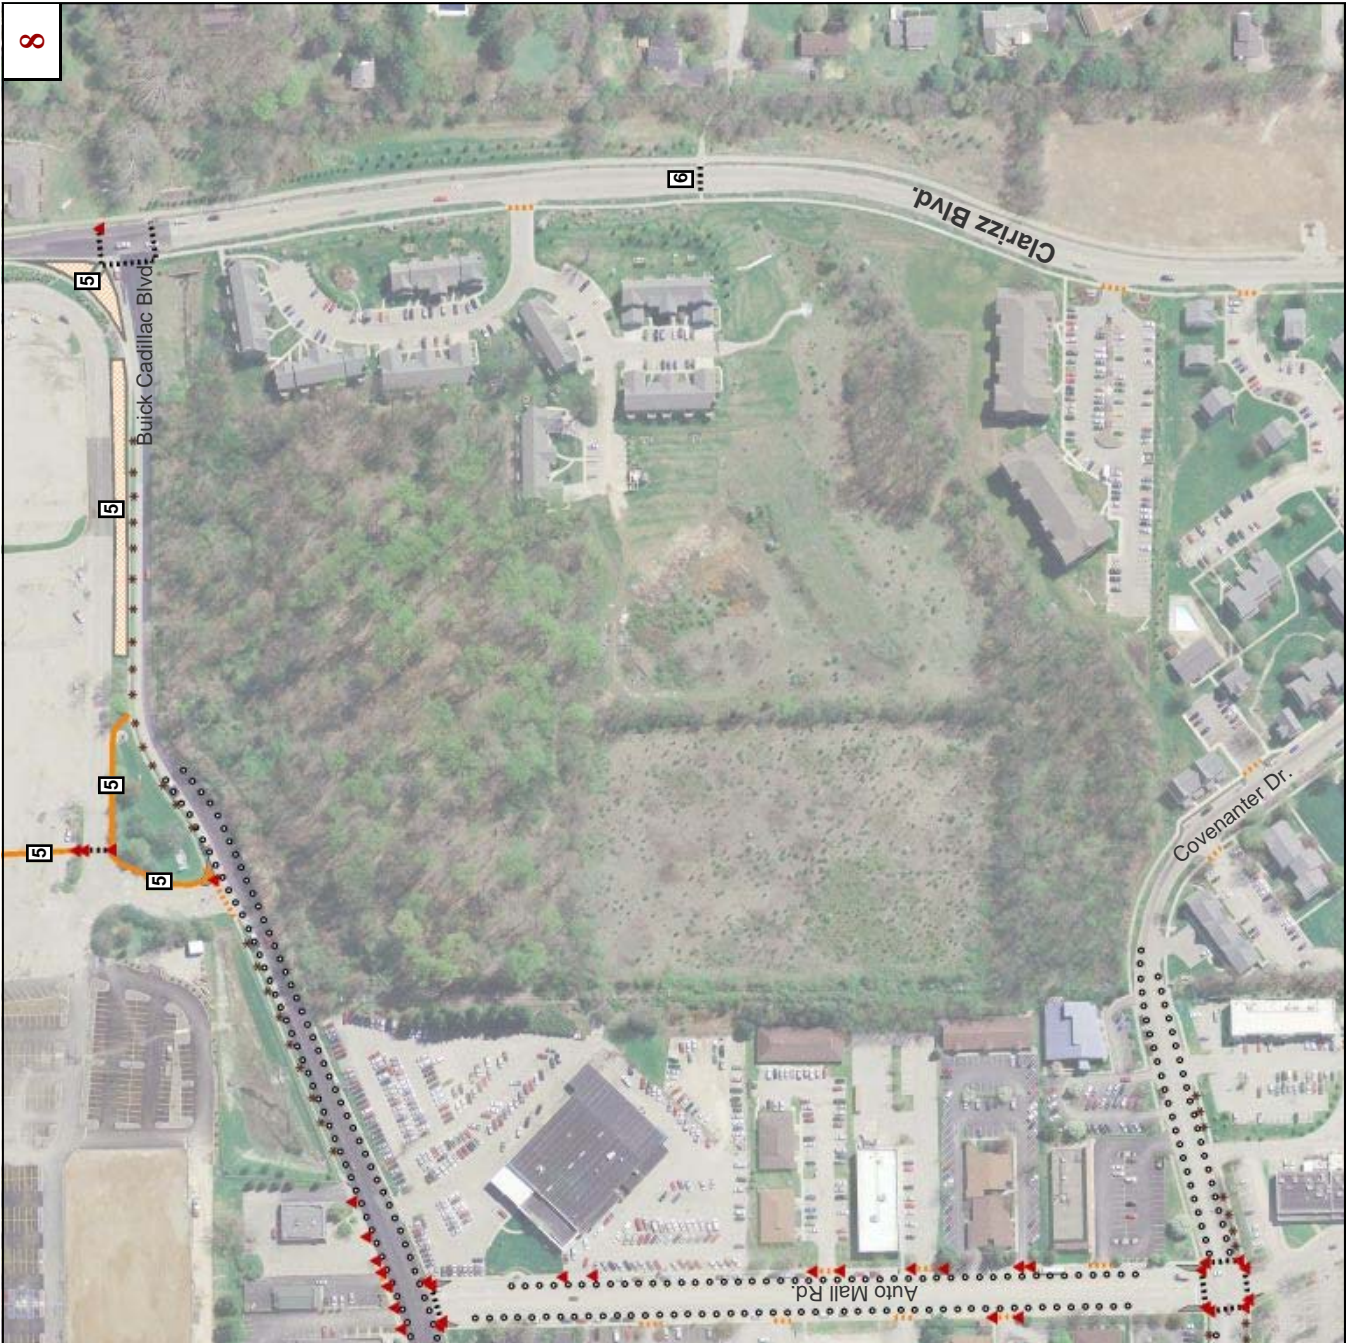
Figure 21 - Conceptual Recommendations (Section 8)

- 5 Public/private partnership
- 6 New midblock crossing
