Griffy Lake Nature Preserve Master Plan

Monroe County, Indiana

Summer 2008

GRIFFY LAKE NATURE PRESERVE MASTER PLAN UPDATE 2008 EXECUTIVE SUMMARY

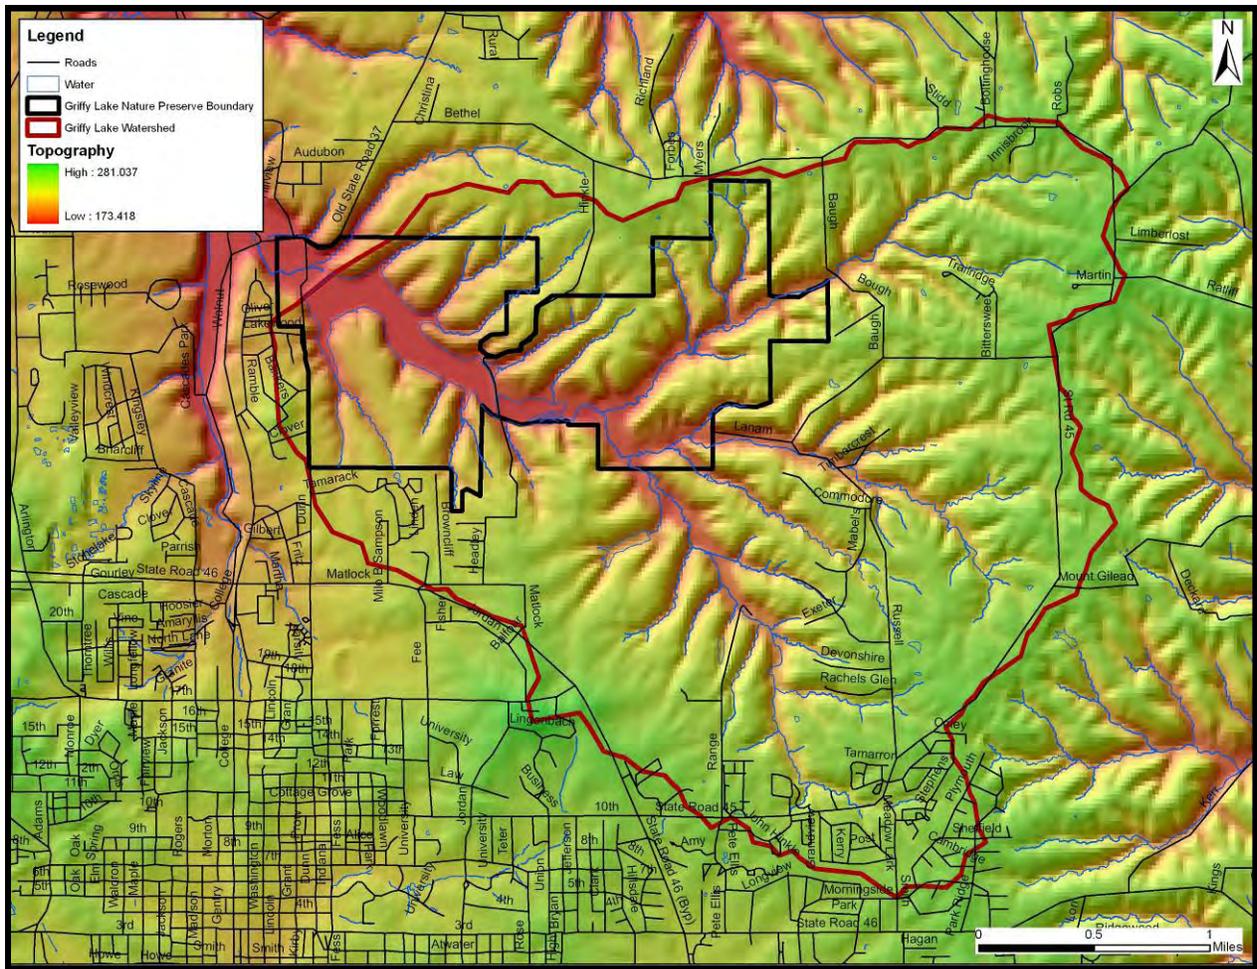
Figure 3. Topographical map of the Griffy Lake watershed.

The topography of the Griffy Lake watershed and the Griffy Lake Nature Preserve is typical of the area. The highest areas of the watershed lie along the watershed's headwaters reaching elevations greater than 800 feet above mean sea level. Griffy Lake, elevation 633 feet above mean sea level, is the lowest point in the watershed. Figure 3 presents a topographical relief map of the Griffy Lake watershed.

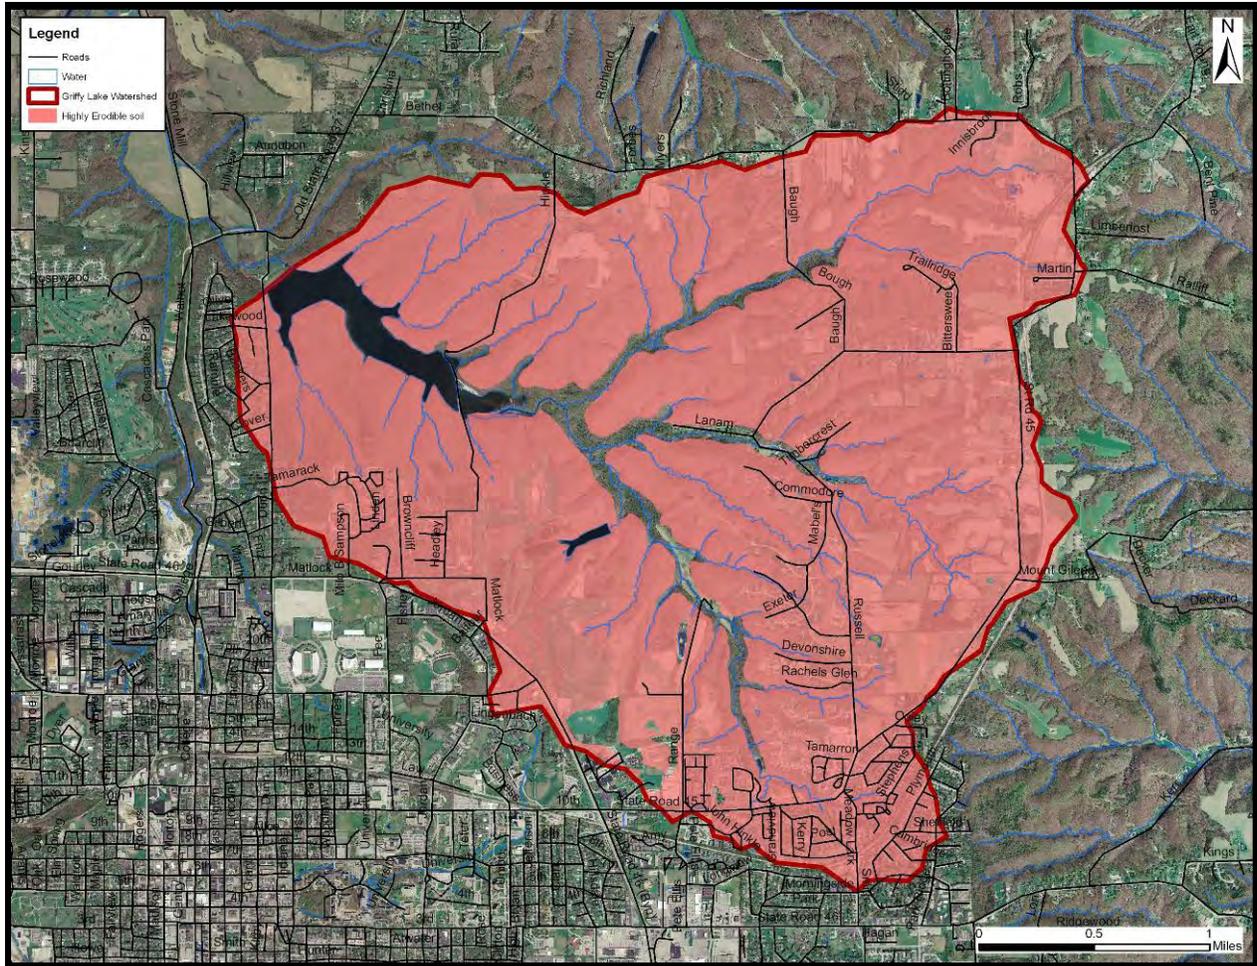
Figure 6. Soil erodibility (highly erodible and potentially highly erodible soils) within the Griffy Lake watershed.

As detailed by Jones et al. (1984), slope and the threat of erosion are the two greatest constraints placed on the Griffy Lake watershed and nature preserve. The best assessment for soil erosion concern relates to classification of soils by their erodibility. Specifically, soils are classified as highly erodible soils, potentially highly erodible soils, or neither. As implied by the name, highly erodible soils are the easiest to erode from the land surface. While potentially highly erodible soils (PHES) are also in danger of erosion, their potential is not as high as highly erodible soils (HES). As Figure 6 indicates, highly erodible soils cover a substantial portion (4750 acres or nearly 92%) of the Griffy Lake watershed. This acreage is spread throughout the watershed. Additionally, highly erodible soils cover nearly 78% of the Griffy Lake Nature Preserve. The highly erodible soils cover most areas of the watershed that are not covered by water or located within the wetland adjacent to Griffy Lake. Nearly the entire watershed is covered by highly erodible soils due to the thin nature of the soils present and the steep slopes located throughout the watershed and nature preserve. However, the highest concern for soil erosion is associated with the steep ravines located throughout the watershed and nature preserve and along the convex slopes adjacent to Griffy Lake's shoreline. These soils are typically Berks-Weikert and Caneyville silt loam soils. Specific erosion issues resulting from the prevalence of highly erodible soils within the nature preserve will be discussed in subsequent sections.

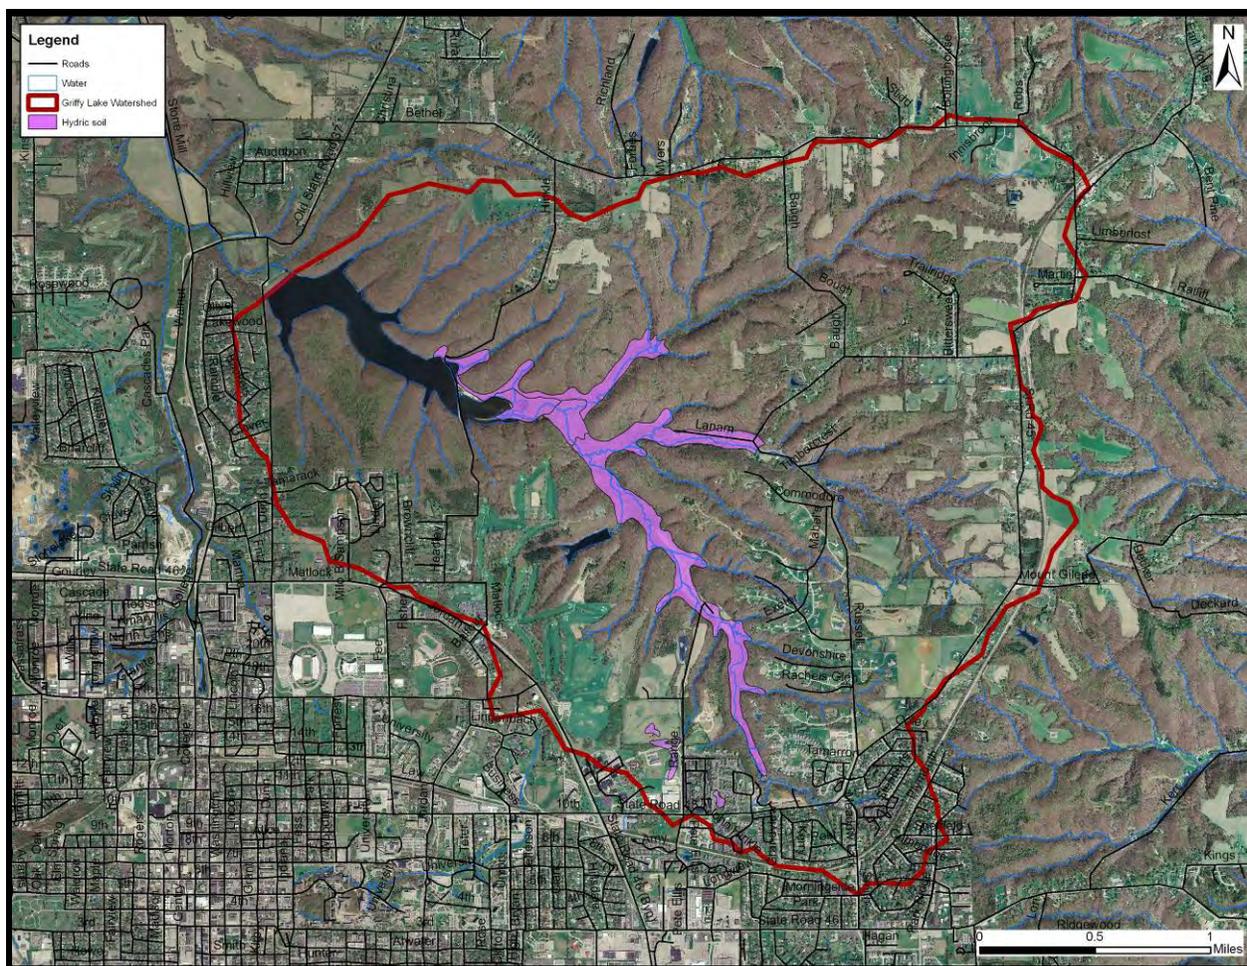
Figure 7. Hydric soils present within the Griffy Lake watershed.

A secondary concern for soils within the Griffy Lake watershed and thus the Griffy Lake Nature Preserve is the flooding or periodic inundation of the soils. Soils which formed under periodically flooded or wetland conditions are referred to as hydric soils. Figure 7 displays the limited distribution of hydric soils within the Griffy Lake watershed. Hydric soils cover approximately 10% of the Griffy Lake Nature Preserve but are present on less than 4% of the Griffy Lake watershed. Bonnie silt loam soils are found near the east end of the lake and are typically subjected to periodic inundation. This inundation typically occurs during the runoff season or from March to June and is exacerbated by the poor drainage present on these soils. Other floodplain soils, including Burnside silt loam, Haymond silt loam, and Wakeland silt loam soils, are subjected to inundation only during periodic high magnitude runoff events (50 to 75 year rain events).

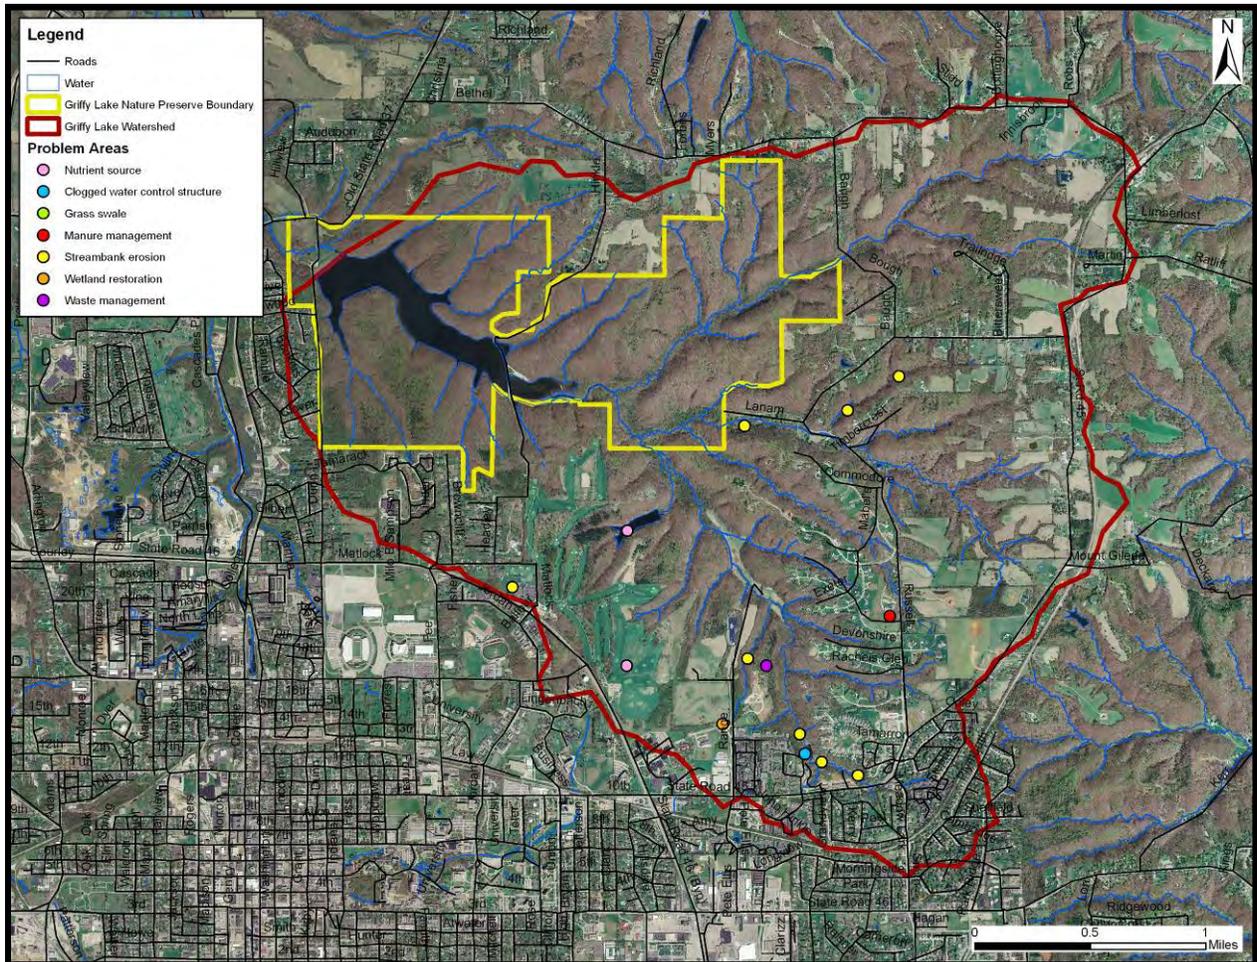
Figure 12. Water quality-based problem areas identified within the Griffy Lake watershed, March 2008.

There are numerous visual signs of these problems within the watershed. Some of these problems, observed during watershed reconnaissance, are shown in the map on Figure 12, and in the photographs following.

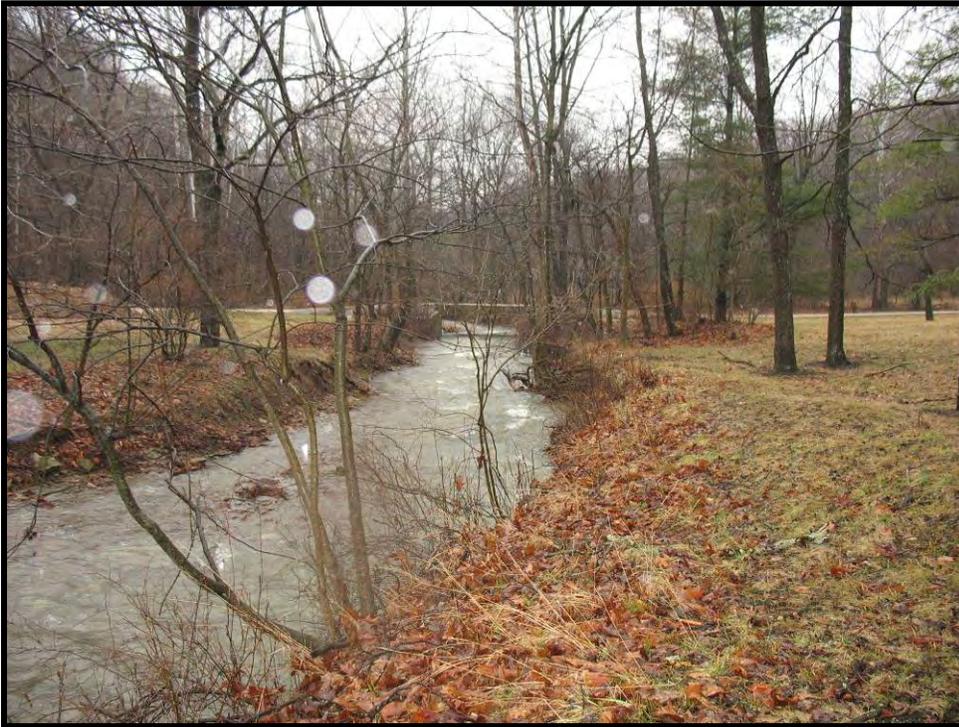
Figure 13. Streambed and bank erosion along Griffy Creek adjacent to Lanam Road.

Urban and suburban development replaces undisturbed land having higher water infiltration capacities with impervious surfaces (roofs, roads, parking lots, etc.) that allow no water infiltration. The result is an increase in runoff during storm events. The increased runoff may create erosion channels on the land and thereby increasing flow velocities of water in stream channels. The higher velocities contain more kinetic energy that erodes the bottom and sides of the existing stream channels. This eroded sediment, and nutrients and other materials, make their way down the channels to Griffy Lake. Representative problem areas related to streambed

and bank erosion are shown in Figures 13 and 14, while Figure 15 documents the impact of development within the watershed which results in reduced groundwater infiltration.

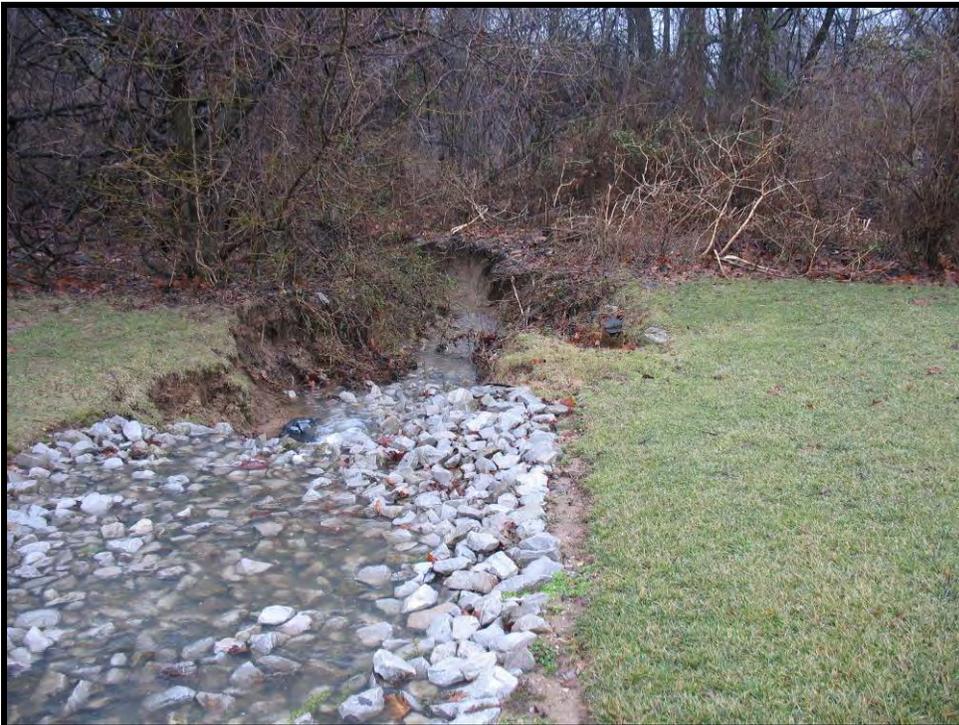
Figure 14. Runoff from the Indiana University (IU) Foundation drains via a rip-rap lined ditch but substantial erosion is apparent where the rip-rap ends.

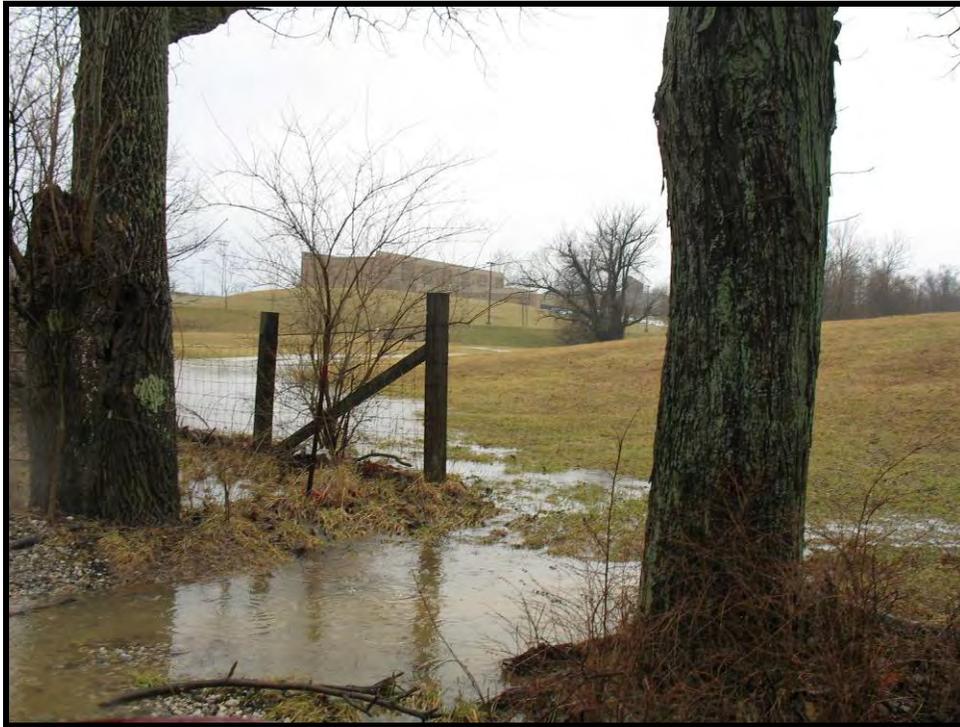
Figure 15. Runoff from the IU Motor Pool and Auxiliary Library Facility contribute to standing water along Range Road.

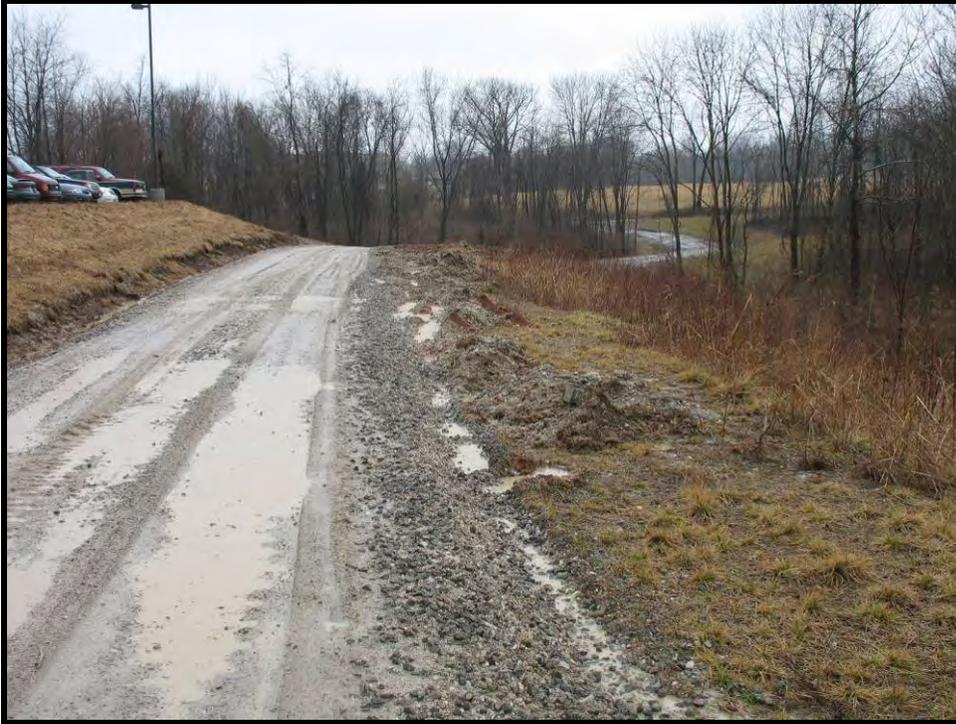
Figure 16. A gravel road to the storage area at the new IU Physical Plant building is unstable and erodes into Griffy Creek.

In order to prevent erosion, a stable vegetation cover should be reestablished following disturbances associated with new construction. Without a stable cover, precipitation and runoff cause soil erosion. Figures 16 to 18 illustrate examples of current development within the Griffy Lake watershed and the development's potential impact to Griffy Lake.

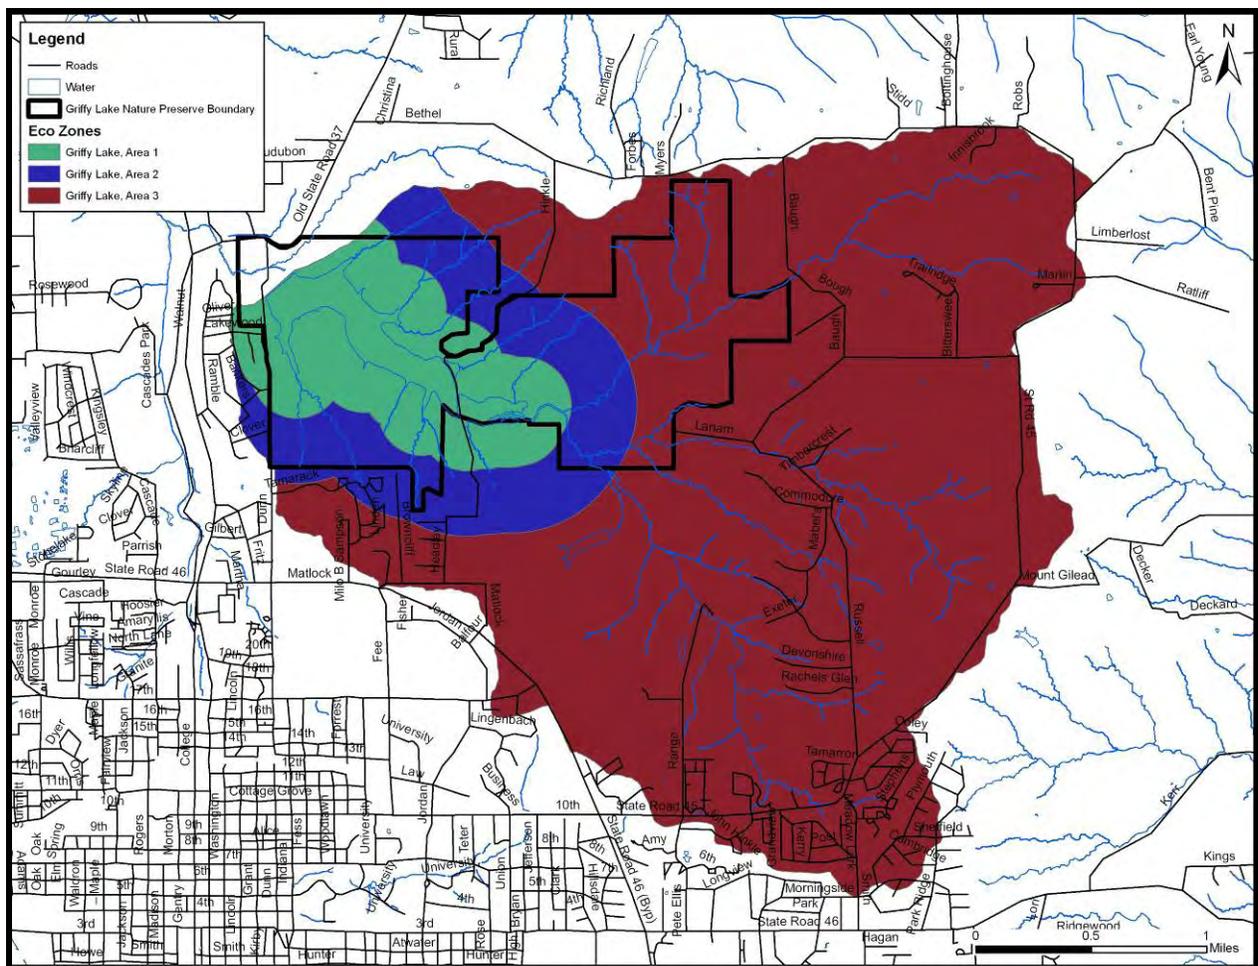
Figure 28. Environmental Constraints Overlay (ECO) within the Griffy Lake Nature Preserve and Griffy Lake watershed.

In addition to the zoning districts, the Monroe County also has an Environmental Constraints Overlay (ECO), which restricts building and development in specific areas around Griffy Lake and the Griffy Lake Nature Preserve (Table 2; Figure 28). The highest restrictions exist within areas immediately adjacent to Griffy Lake. These areas rate as Area 1 and require a minimum lot size of five acres with no more than 1 acre of development. Additionally, development cannot occur in areas with a 12% or greater slope. As one moves farther away from the lake, the restrictions lessen. However, development within the Griffy Lake watershed rates as Area 3 at a minimum. These restrictions require a minimum of a 2.5 acre lot size with no more than 1 acre of development. Additionally, development cannot occur in areas of 18% slope or greater.

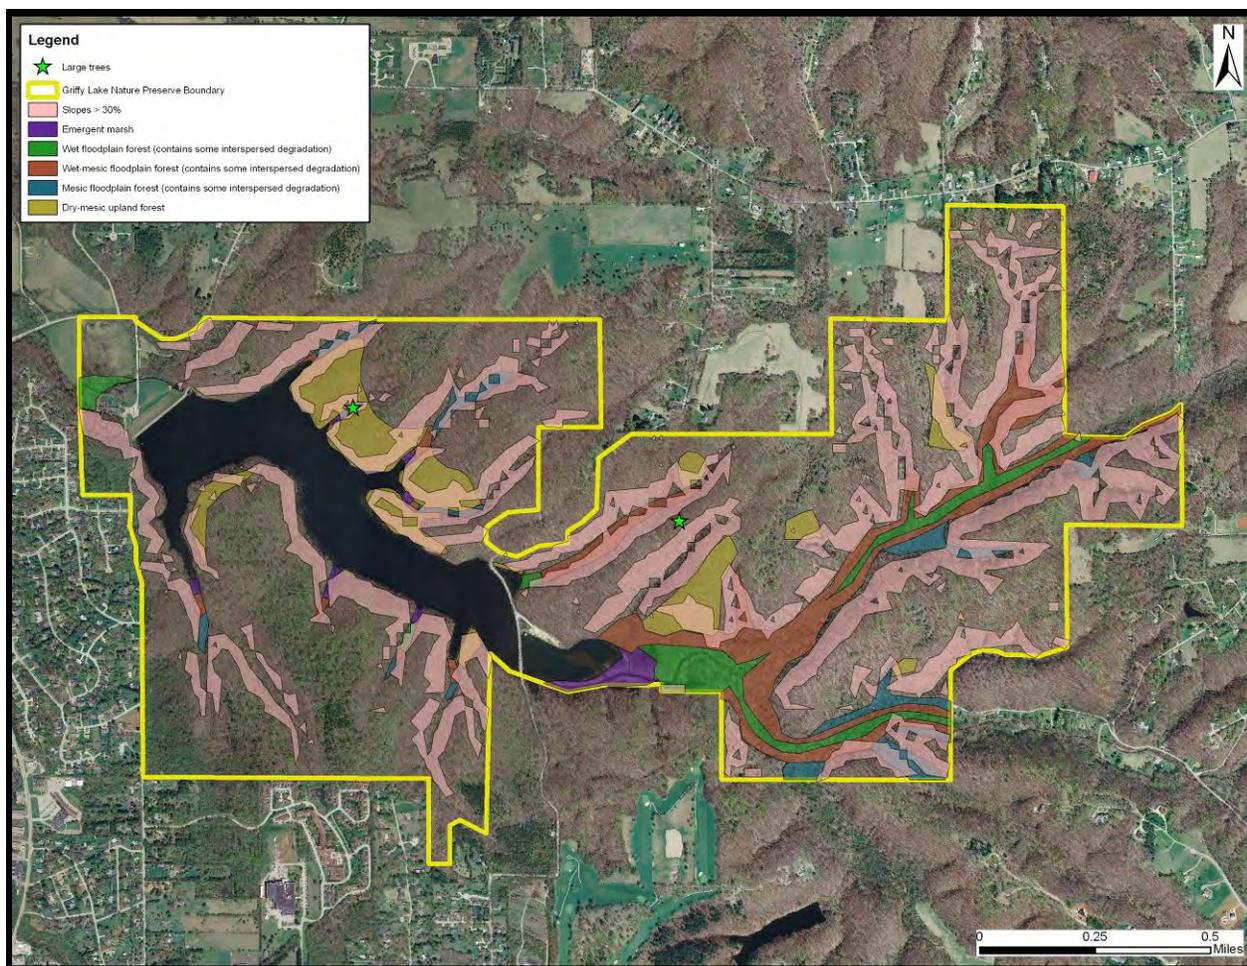
Figure 29. Sensitive Habitat Areas mapped in Griffy Lake Nature Preserve.

Several areas at the site have been identified as Sensitive Habitat Areas for various reasons. Sensitive Habitat Areas include slopes of greater than 30%, Emergent Marsh, Floodplain Forest (Wet, Wet-Mesic, and Mesic), and Dry-Mesic Upland Forest. In addition, two locations dominated by large (greater than 24 inches diameter at breast height) trees were also noted. Areas identified as Sensitive Habitat Areas are mapped in Figure 29.

Slopes of greater than 30% are found throughout the site and are mostly correlated with steep ravines leading into Griffy Creek and Griffy Lake. These slopes generally are comprised of Mesic Upland Forest and Dry-Mesic Upland Forest. In some places, the slopes consist of exposed bedrock with very little to no soil present. The steep slopes are considered Sensitive Habitat Areas because of their potential for further erosion. Where soil is shallow and bedrock is exposed, a unique community is created that often is comprised of uncommon and specialist plant species. It is recommended that these areas be avoided to the extent possible. Trails should be constructed away from the steep slopes, both for safety of hikers and to avoid destroying the sensitive habitat. If trails are constructed from the uplands to Griffy Creek or Griffy Lake, they should be constructed in areas where the slope is less than 30%.

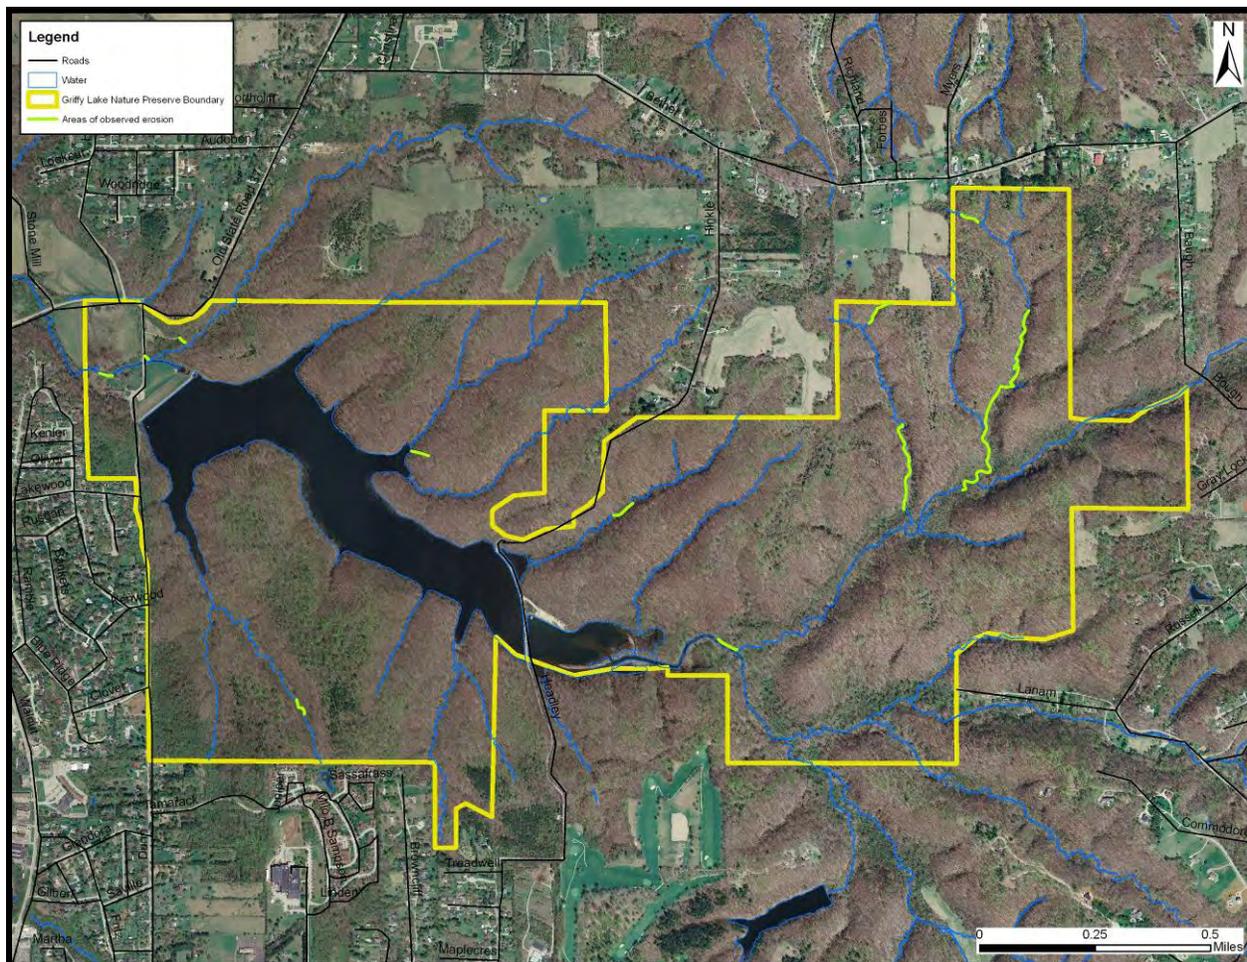
Figure 37. Streambed and bank erosion areas identified throughout Griffy Lake Nature Preserve, May and September 2007.

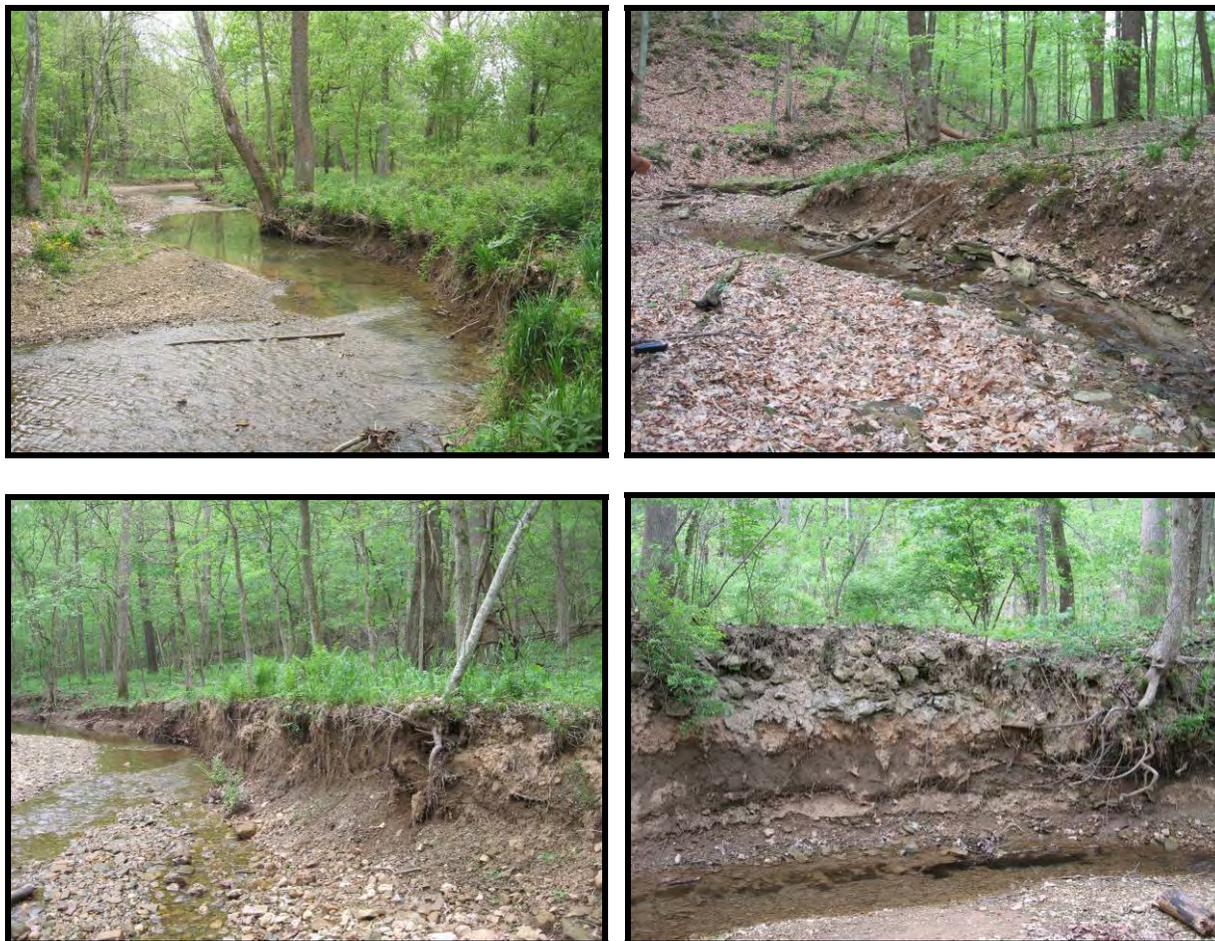
Figures 38 to 41. Streambank erosion occurring within tributaries to Griffy Lake on the Griffy Lake Nature Preserver, May and September, 2007.

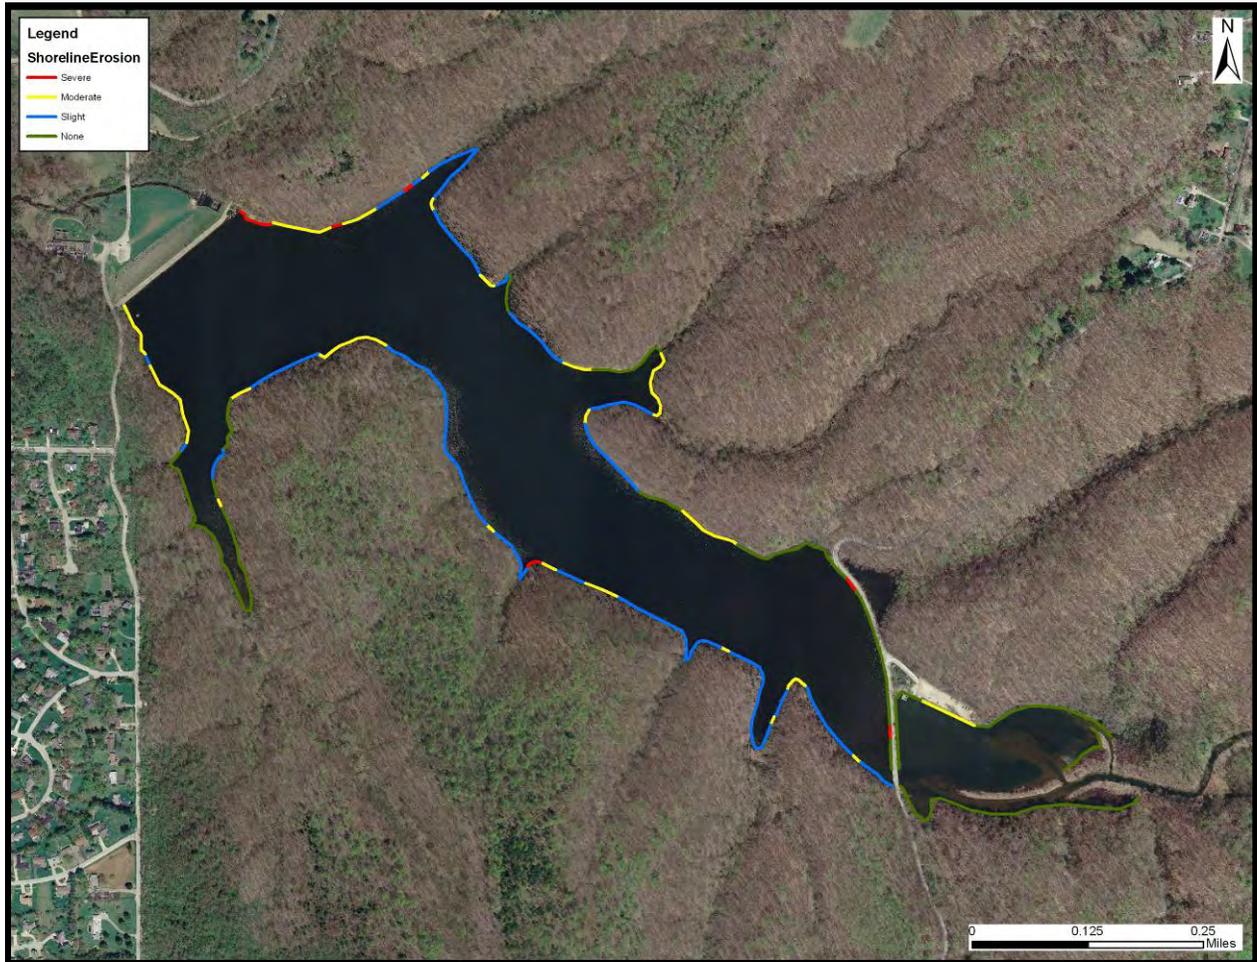
Figure 42. Shoreline erosion rating for the shoreline of Griffy Lake, October 2007.

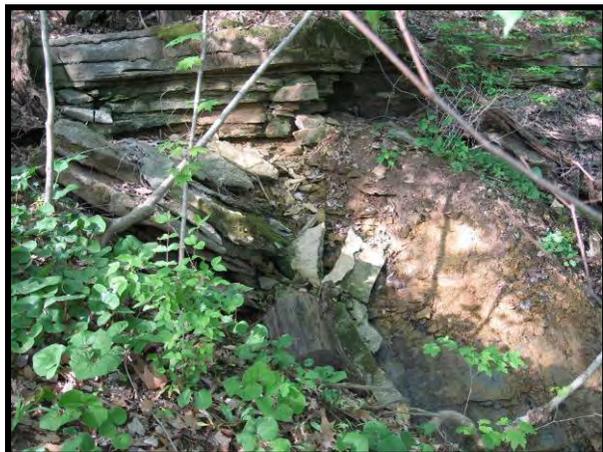
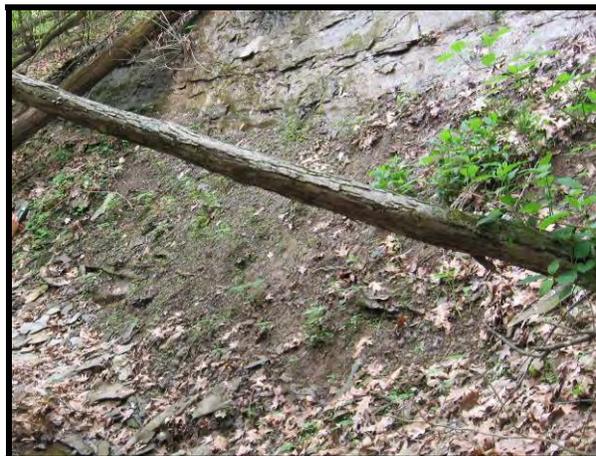
Figures 49 and 50. Sediment erosion areas identified within Griffy Lake Nature Preserve, May and September, 2007.

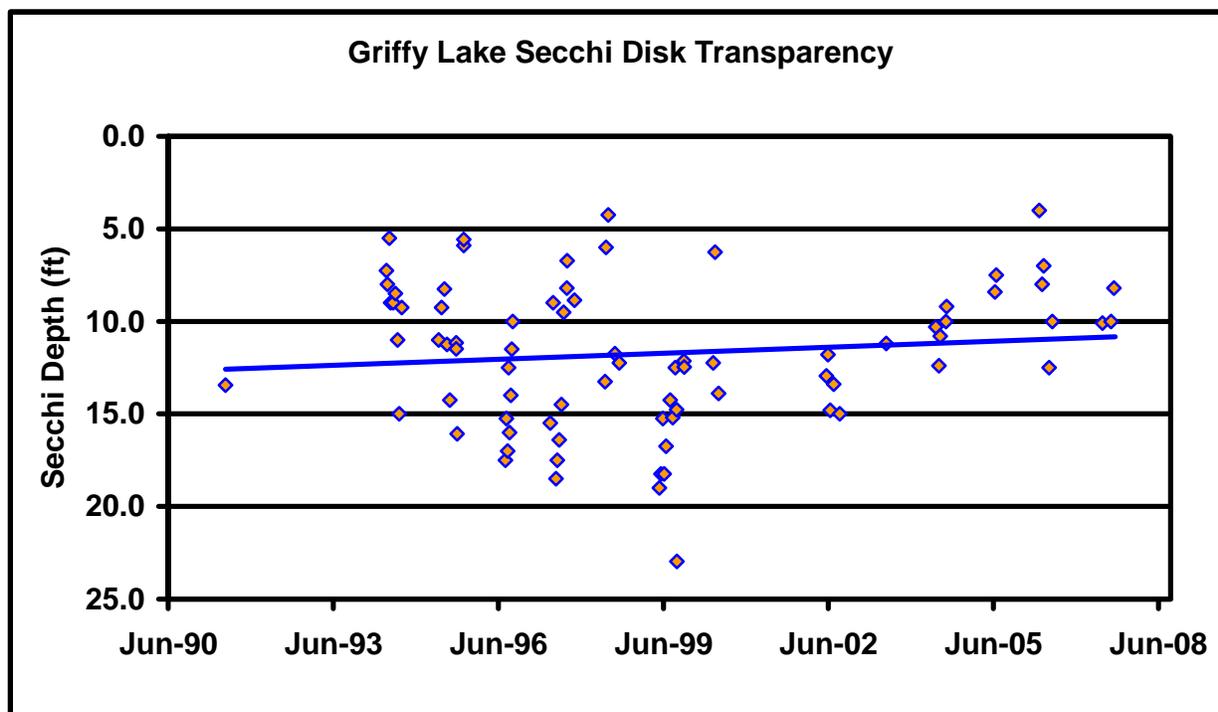
Figure 52. Historic Secchi disk transparency data for Griffy Lake.
 Source: CLP, 1991, 1997, 1999; Volunteer monitors 1994-2007; Aquatic Control, 2005-2008.

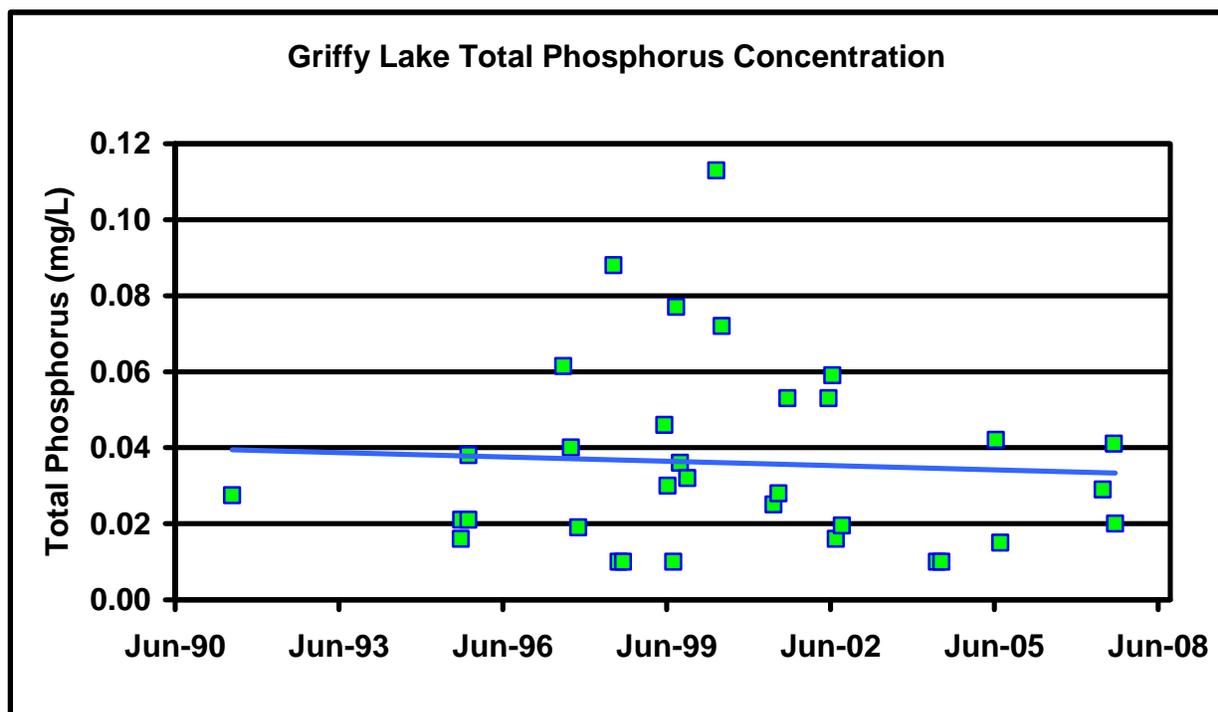
Figure 53. Historic total phosphorus concentrations measured in Griffy Lake.

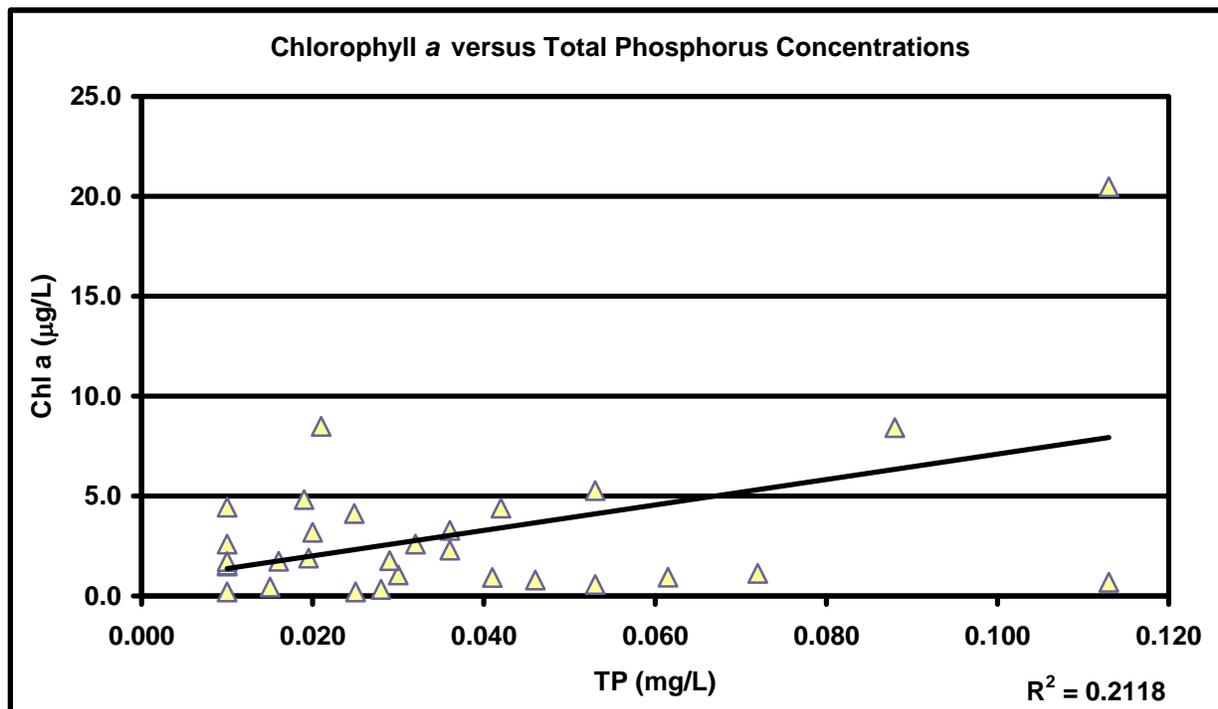
Figure 54. Total phosphorus and chlorophyll *a* concentrations measured in Griffy Lake, 1991 to 2007.

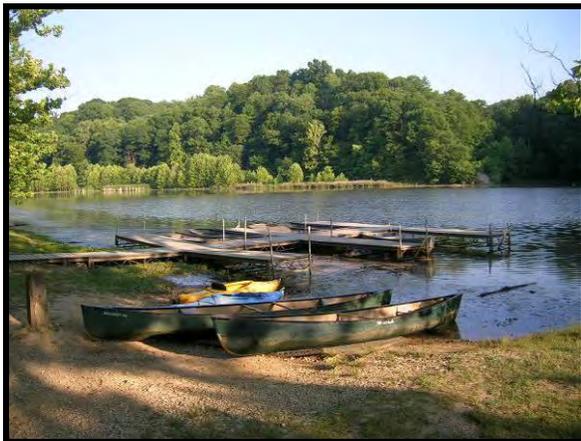
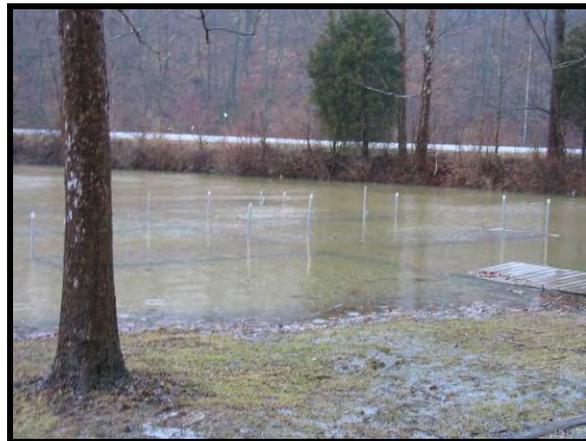
Figures 55 and 56. Docks adjacent to the boat ramp during typical conditions and during a 1.5-inch rain event, March 2008.

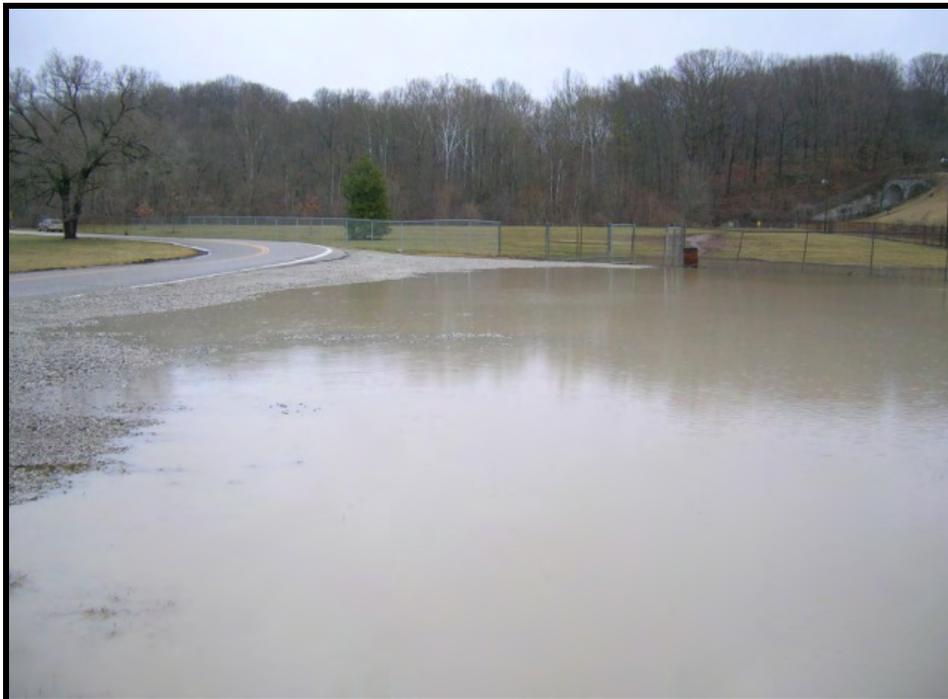
Figure 68. Flooding in dam parking lot, 2/1/08.

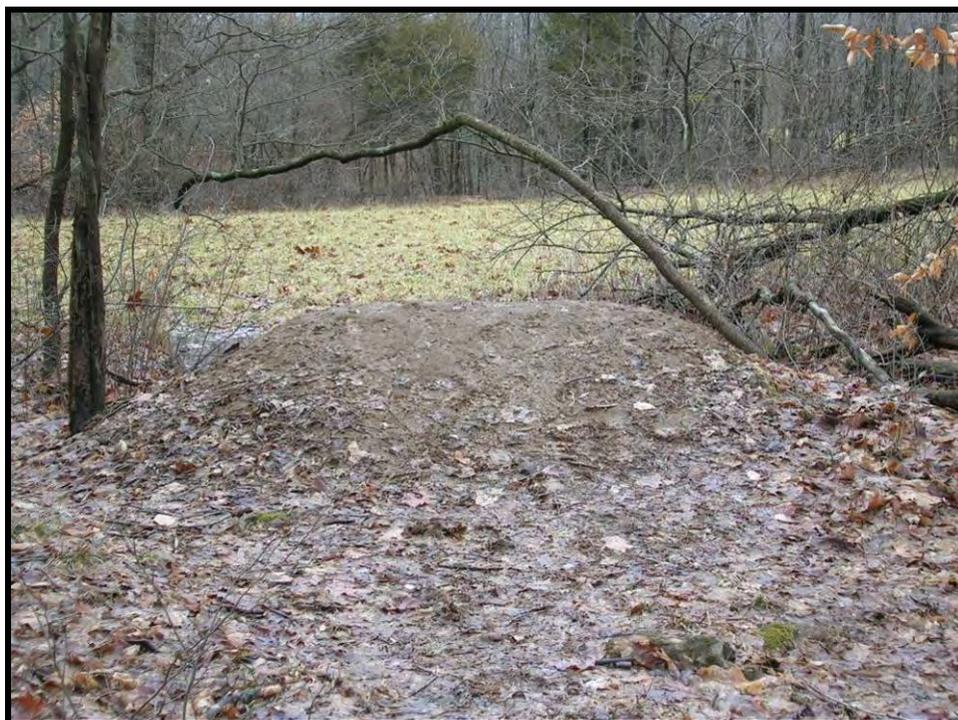
Figure 69. Dirt mound blocking off-road vehicle access to Griffy Lake Nature Preserve, north point Hiking Trail near the boathouse parking lot.

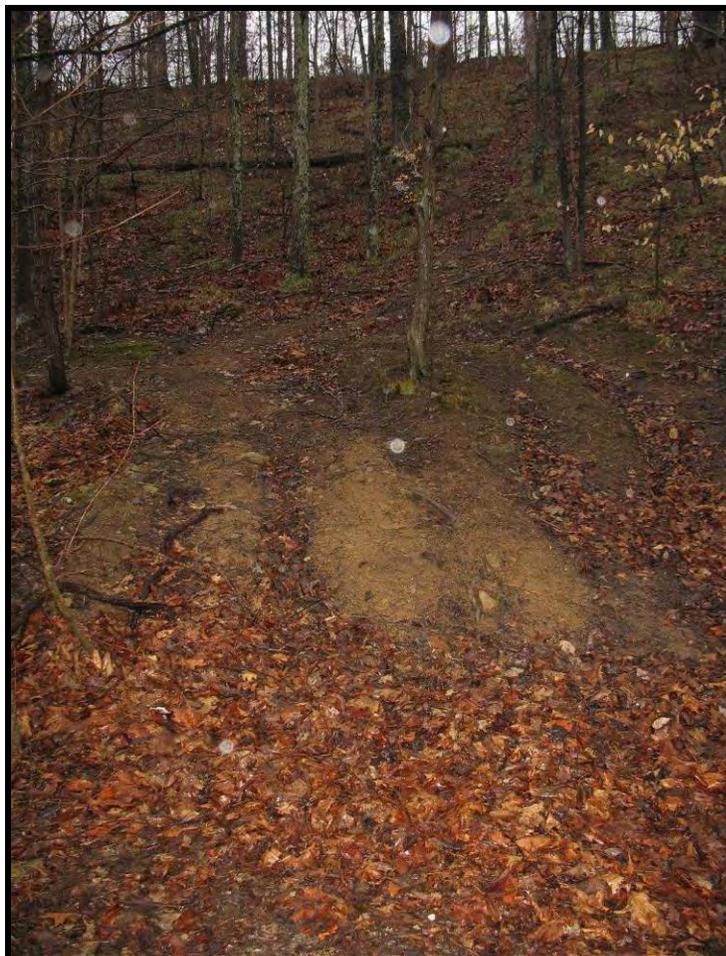
Figure 70. Evidence of ORV or other heavy access at hill adjacent to Lanam Road entrance to GLNP.

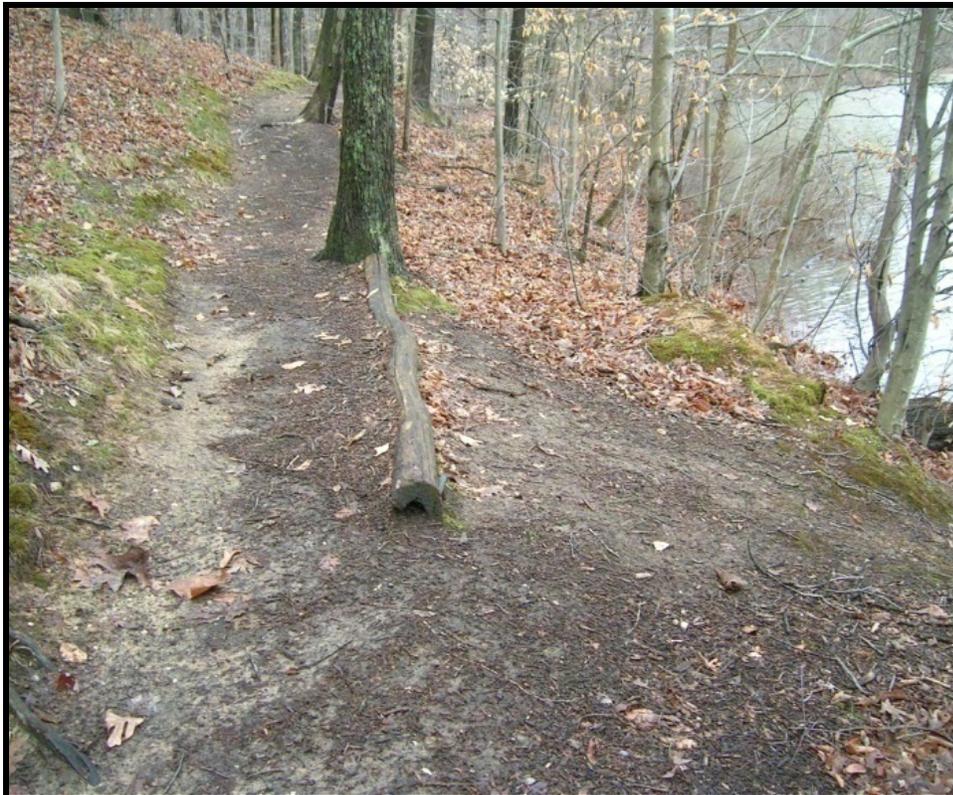
Figure 81. Logs installed to maintain downhill edge of trail.
