Griffy Lake Nature Preserve Master Plan

Monroe County, Indiana

Summer 2008

GRIFFY LAKE NATURE PRESERVE MASTER PLAN UPDATE 2008 EXECUTIVE SUMMARY

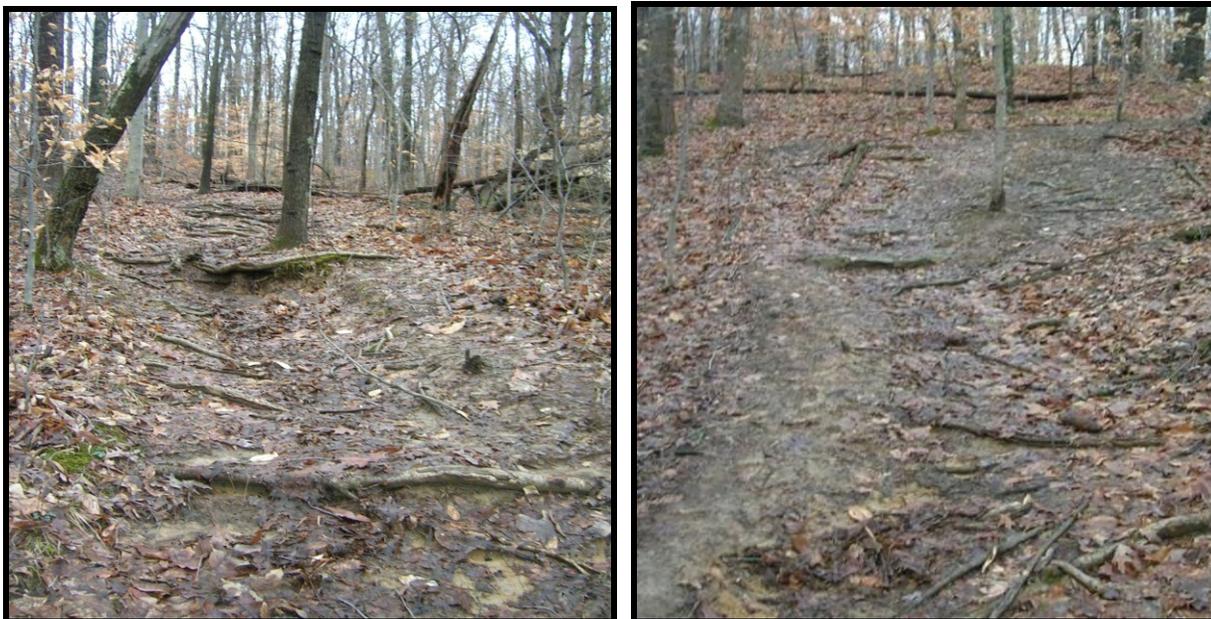
Figures 82 and 83. Steep grades on the Hiking Trail.

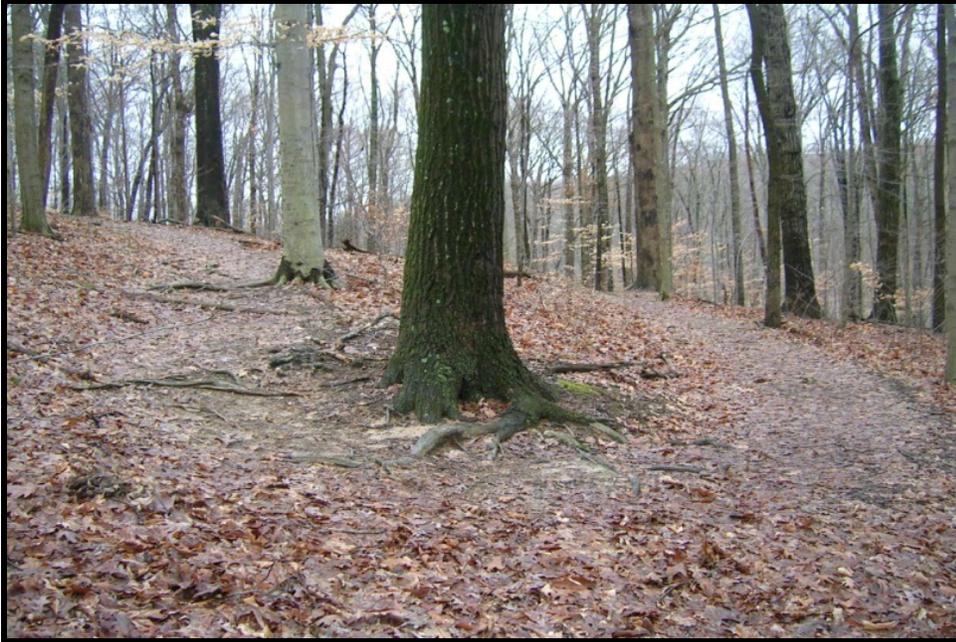
Figure 85. Grade reversal on Nature Trail.

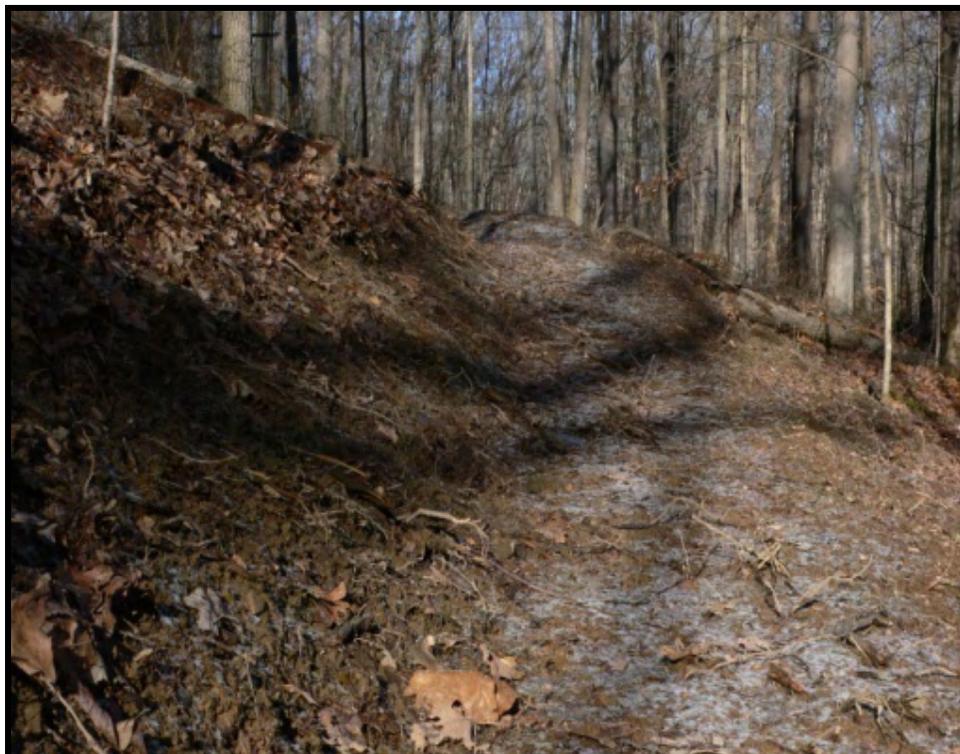
Figure 86. Out-sloping in Brown County State Park.

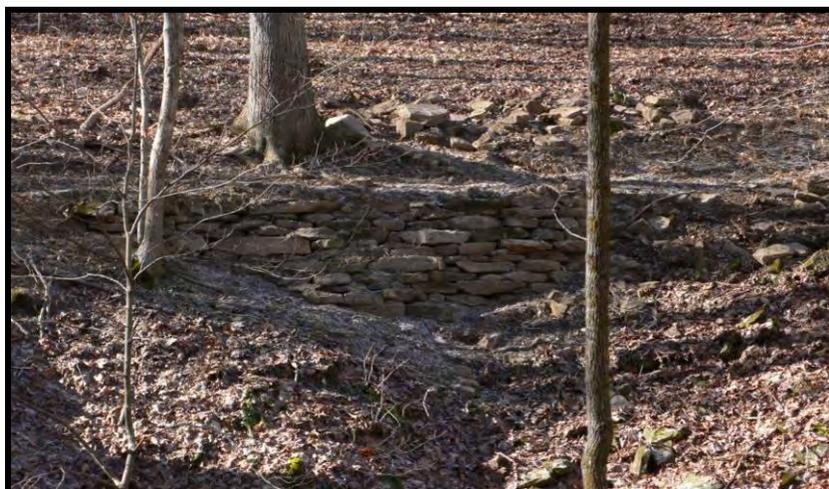
Figure 88. Retaining wall at Brown County State Park.
