**CITY OF BLOOMINGTON, COMMON COUNCIL
 JACK HOPKINS SOCIAL SERVICES FUNDING
 COMMITTEE
 2014 GRANT APPLICATION**

Prepared For:
Monroe County United Ministries

Prepared By:
Sherlock Homes Inspection Svc., Inc.

Report Number:
131014MF

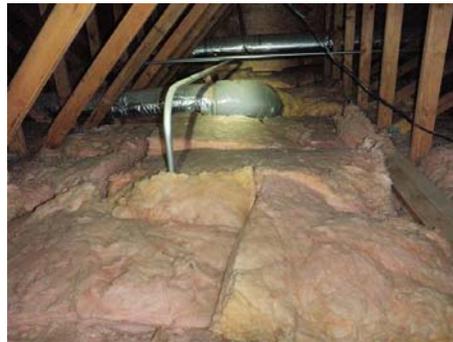
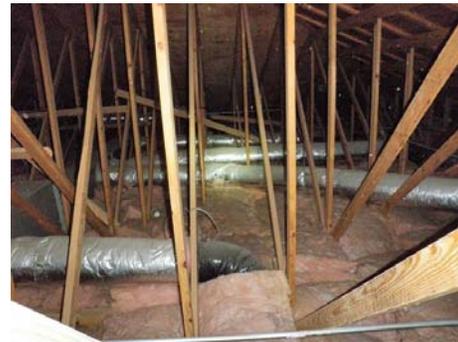
Area of missing insulation

- **Improve:** There is an inadequate amount of insulation in the attic. The lack of insulation will contribute to energy loss and comfort complaints. Insulation levels are specified by R-value. R-value is a measure of insulation's ability to resist heat flow. The higher the R-value, the better the thermal performance of the insulation. The recommended level for most attics is to insulate to R-38 or about 10 to 14 inches, depending on insulation type.

Location of condition: There are some areas of low insulation and a few spots where there is no insulation. First all air sealing should be completed and then more insulation added to the low spots at a minimum. Ideally the added insulation would also be mounded over the ductwork.

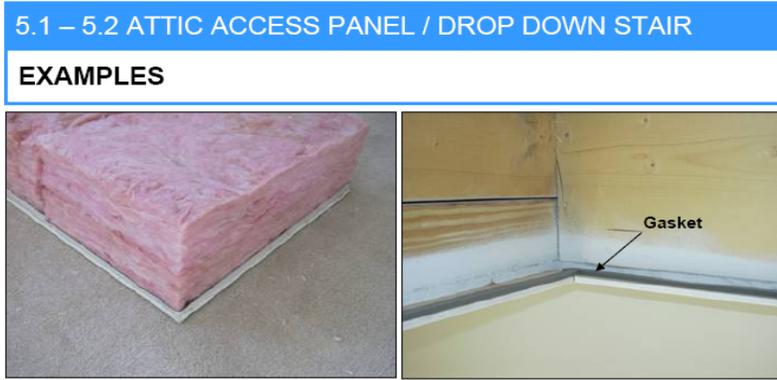
Figure 5.1.3 - Example of properly insulated attic hatch

- **Improve:** The attic access hatch is not properly insulated or air sealed. The hatch should be insulated to an R38, curbing installed around the opening to prevent insulation from falling into the living area, and the hatch lid should receive a gasket.

Location of condition: Three hatches.

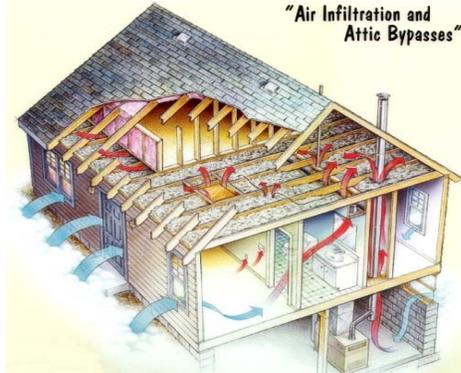
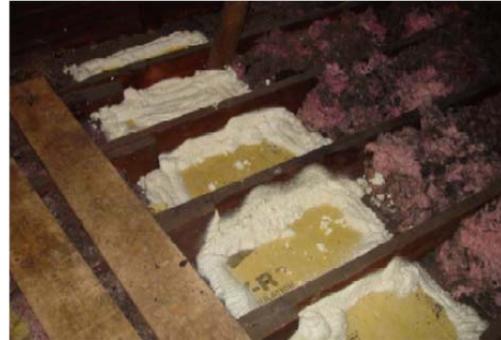
Example of sealing by passes

- **Improve:** There are air by-passes present between the attic and living space. Attic bypasses are hidden air passageways that lead from the heated space into the attic. Because warm air rises, it is continuously moving up these passageways and escaping into the attic during cold weather. These bypass leaks can cut the effectiveness of attic insulation by 30 to 70 percent. The by passes should be sealed with a rigid material to help prevent air flow.

Location of condition: Visible at the furnace piping penetrations.

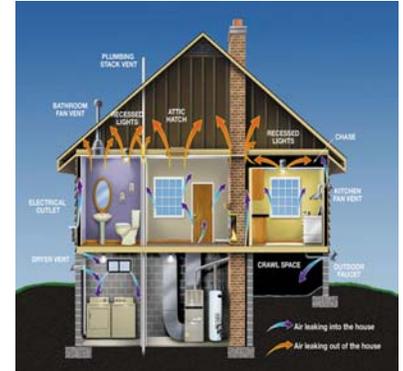
Table 2
Air Leakage & Pressure Differentials

Blower Door @ CFM50	Auditor	Cont Interim	Cont Final	Final Auditor
List:	26059		0	
Pressure Differentials @CFM50 Taken At	Auditor	Cont Interim	Cont Final	Final Auditor
Attic	NA			
Crawl	NA			
Knee Wall	NA			
Bulk head	NA			
Minimum Ventilation Rate	14,194		14,194	14,194
70 % MVR (lowest blower door reading can be)	9,936			
Opportunity for Improvement	16,123			
Contractors Final Improvement			16123	
Final Auditor Improvement				16123

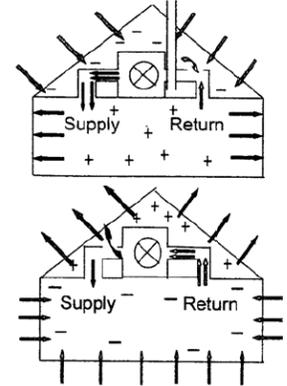
The U.S. Department of Energy determined that an average of 25% to 40% of heating and cooling energy is lost through duct system leakage. Duct leakage has a major impact on indoor air quality and energy efficiency. Return ductwork air leaks draw air into the house from crawlspaces, garages, and attics. This leakage can bring unconditioned air, dust, mold spores, insulation fibers and other contaminants into the building. Leaking supply ducts will tend to depressurize the home, drawing air from wherever is most accessible to try and balance the pressure. Often this air will come from interior walls, crawlspace, or even reversal of exhaust flues pulling combustion chemicals into the house.

Household depressurization can also pull combustion products such as carbon monoxide from furnaces, water heaters and fireplaces into the house, which can lead to polluted indoor air and potentially harmful health effects. In the case of your home, the furnace ducts including their connections to the registers) are leaking excessively. Delivery system repair and/or replacement will significantly improve both system performance and indoor air quality.
