**Bloomington Historic Preservation Commission, Zoom Virtual
Meeting, Thursday June 11, 2020, 5:00 P.M. AGENDA**

C. Johnson Creamery Stack Inspection Report

On April 6, 2020, a representative from R+P Industrial Chimney Company performed an inspection of the Johnson's Creamery chimney at 400 West 7th Street in Bloomington, Indiana. The purpose of the inspection was to examine the condition of the chimney and determine if any immediate maintenance work was required to bring it up to sound capacity. The chimney possessed a noticeable lean of the upper elevations and had not been thoroughly inspected for several years.

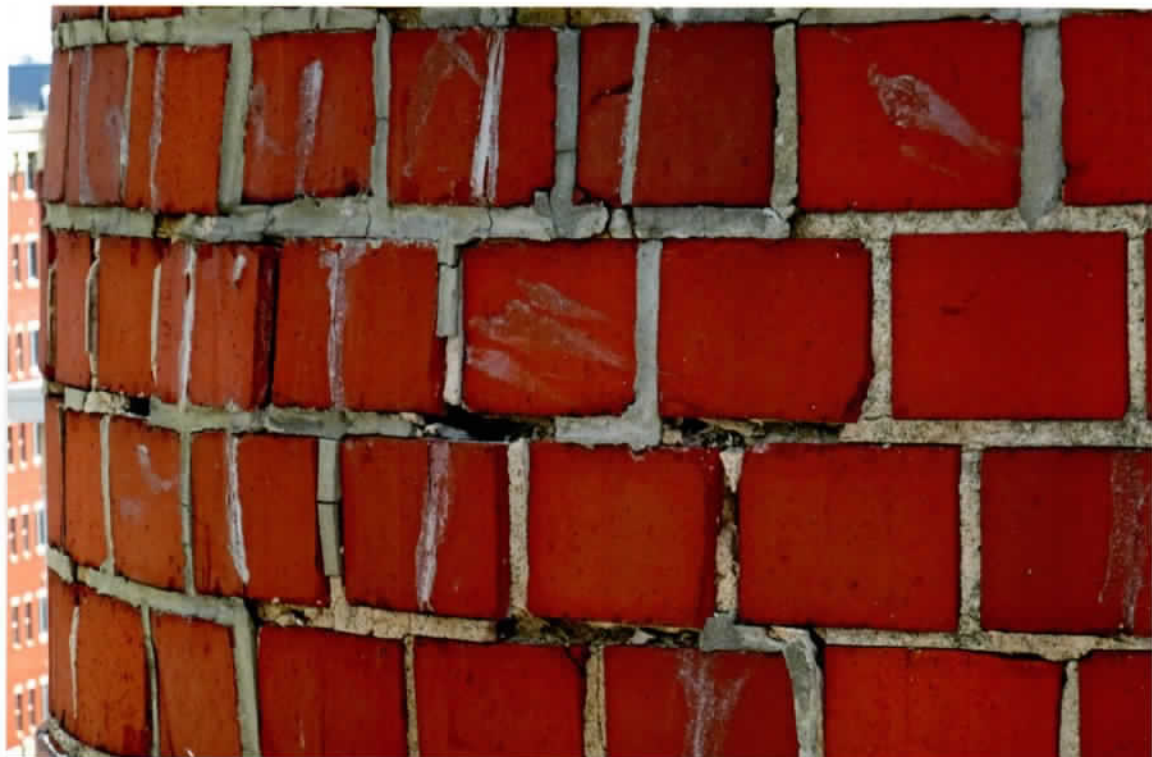
- 115'-0" to 40'-0" – The overall condition of this region was poor. Numerous spalled bricks, loose brick faces, bulged regions, dislodged mortar and cracked mortar were identified. The loose brick faces (Photos 31 and 39) were in danger of falling to grade. The highest levels of damage existed on the northeast side between the 80' and 70' levels (Photos 37 – 40) and on the south side at the 41' level (Photos 45 – 46). Based on visual observations, the lean of the upper elevations initiates near the 75' level. Photos 25 – 47 show this region.

Photo 32. Close-up of the bulged region with eroded joints (101' level, northwest side).

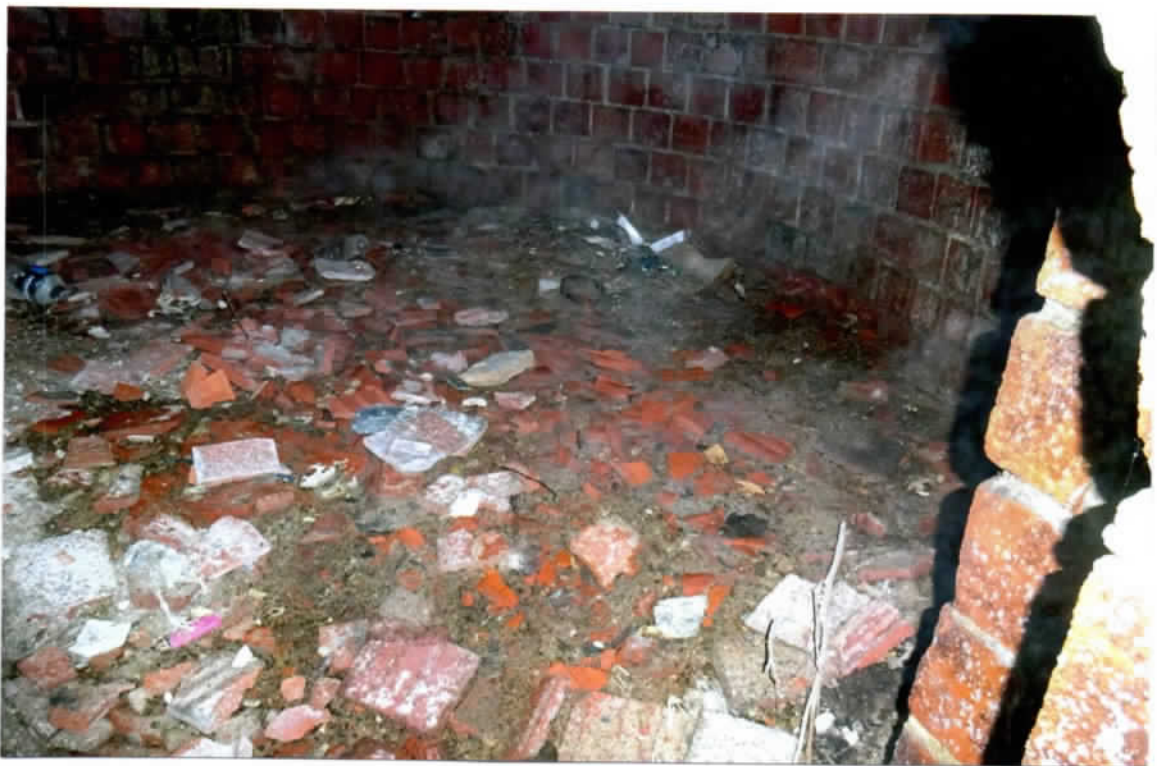
- Top of floor – Approximately 8" of debris and spalled brick faces remained in the base of the chimney. Photos 69 – 70 show the accumulated debris.

Photo 70. Approximately 8" of debris and brick faces in the chimney base near grade (south side).
Note the numerous brick faces in the debris.
