4th Street Parking Garage

Structural Condition Assessment Report

City of Bloomington

May 25, 2018

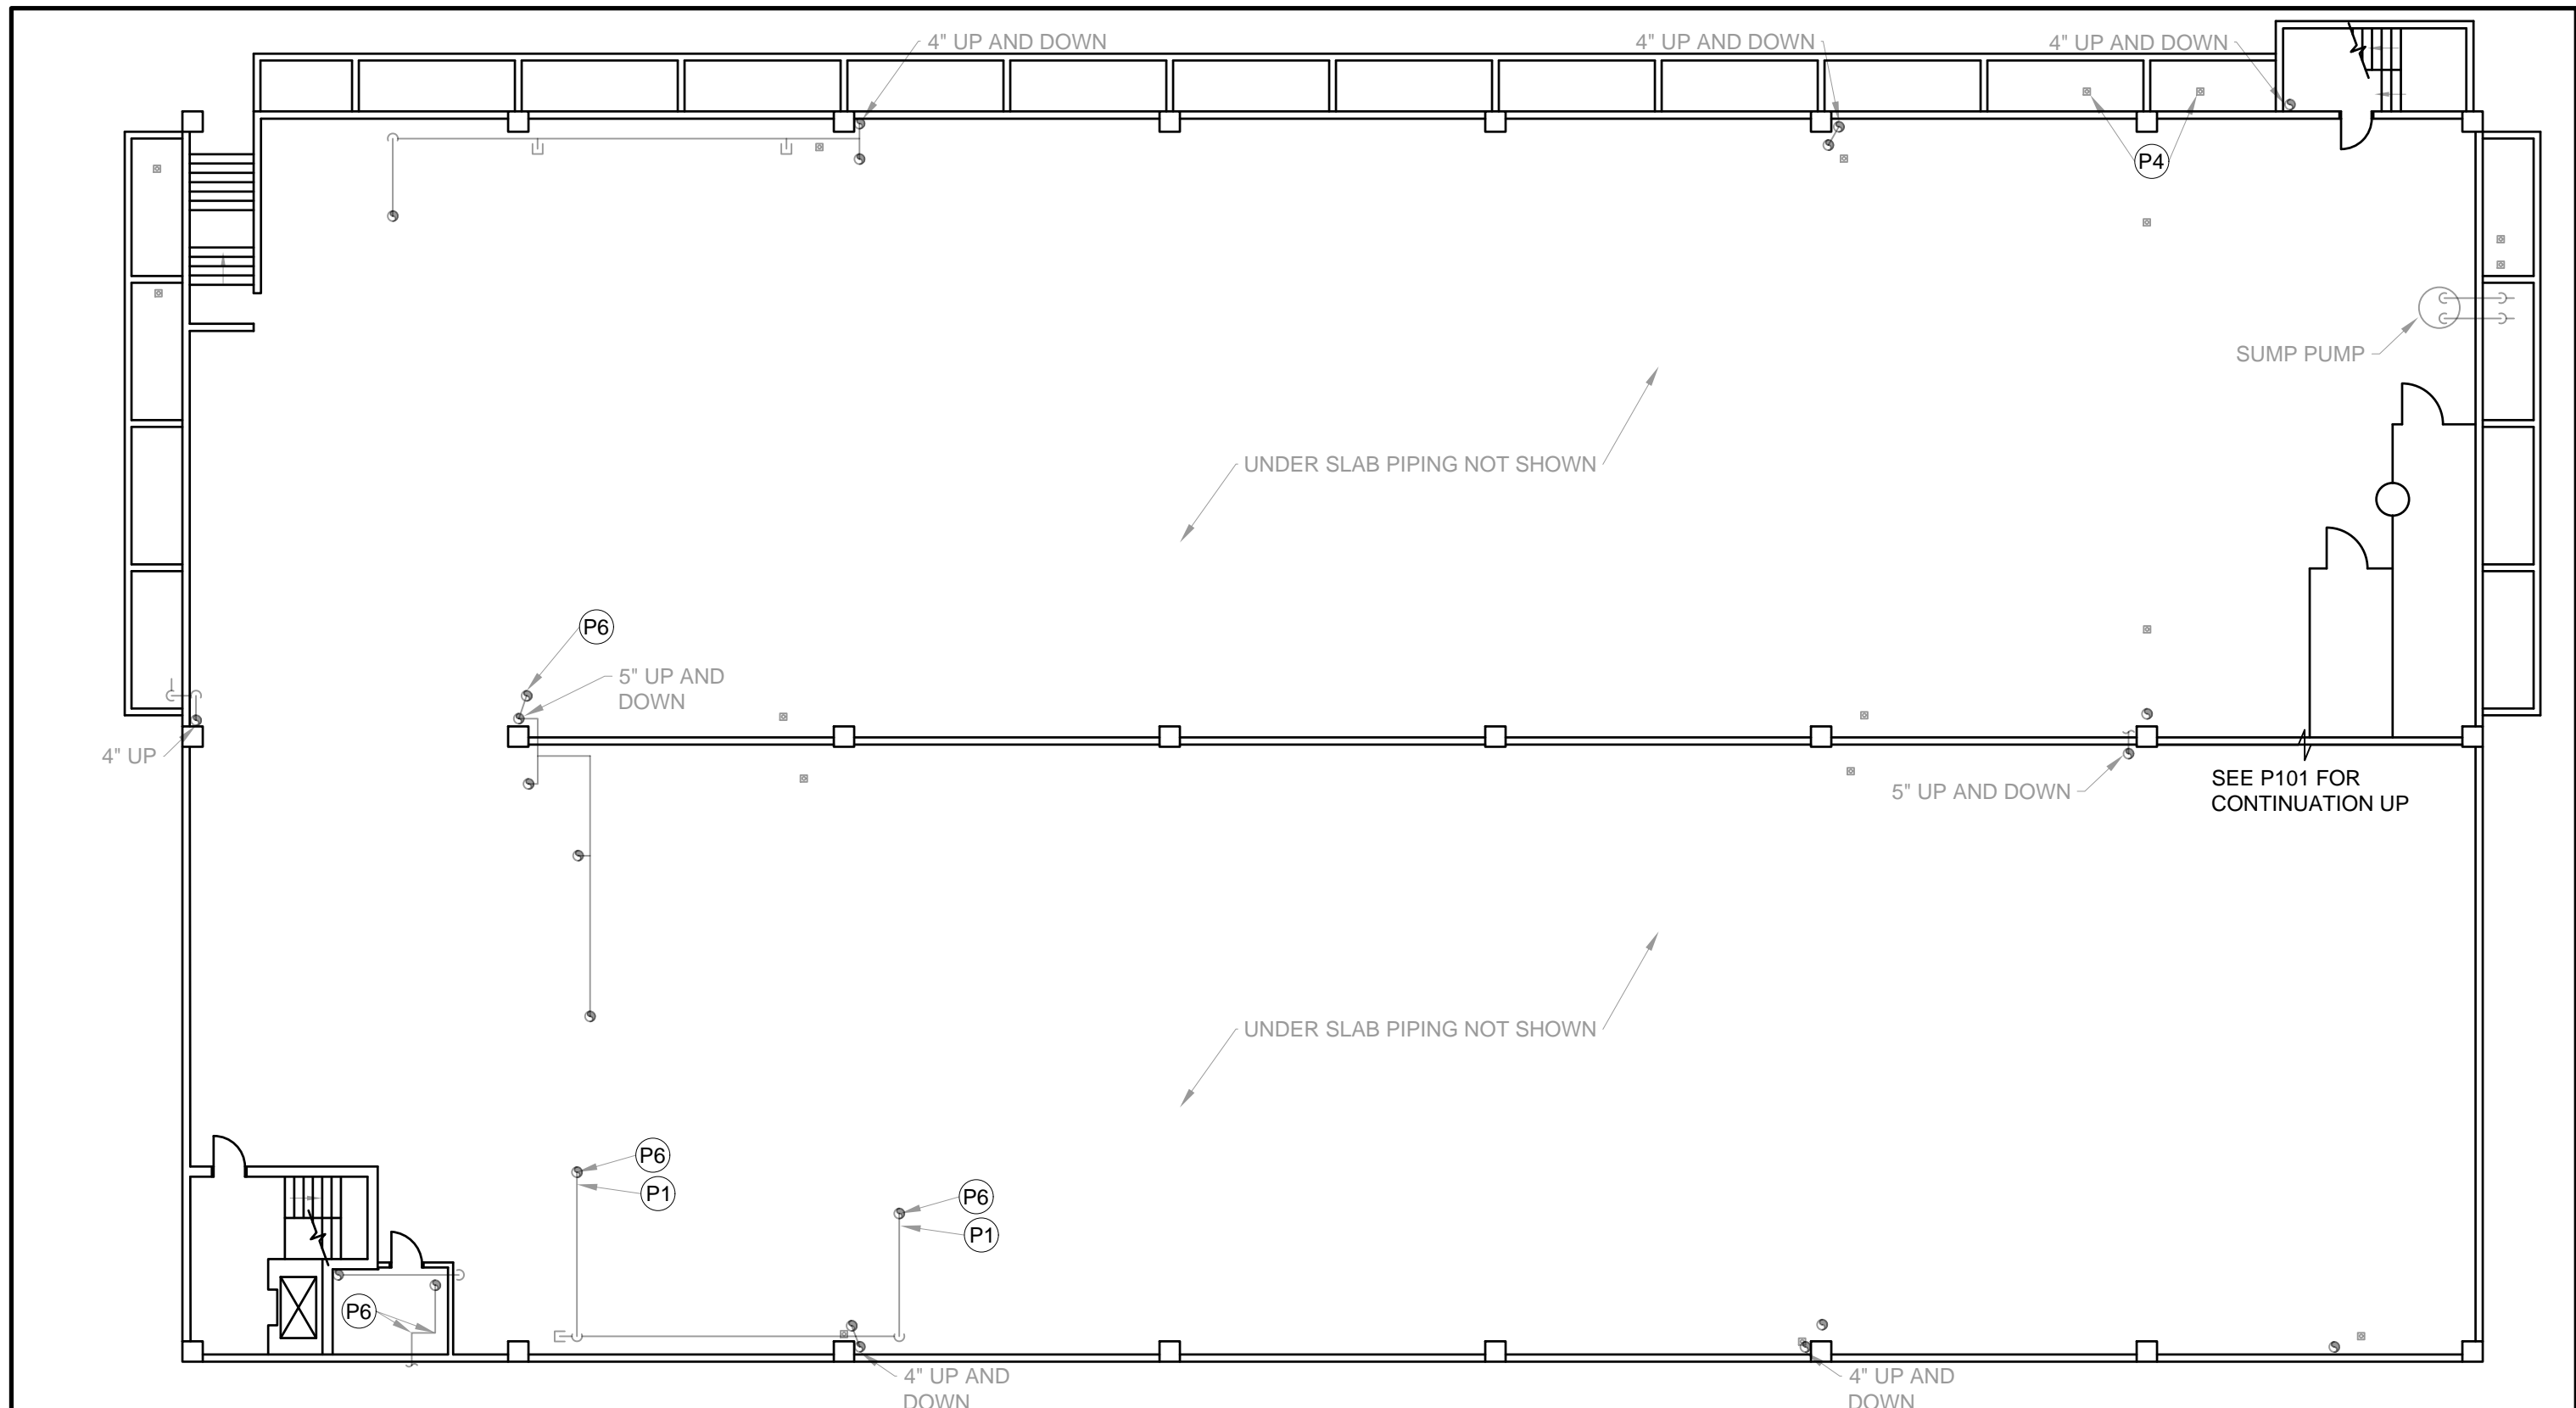
City of Bloomington 4th Street Garage Bloomington, IN			SHEET REF. P100
DRAINAGE PIPING STUDY	DESIGNED BY LMB	APPROVED BY LMB

The storm drain system for the parking garage is comprised of primarily hubless cast iron pipe and fittings with some PVC pipe and fittings. In general, the hubless cast iron piping and fittings are deteriorating. This report calls out the fittings needing the most attention and recommends that all the laterals be replaced because various hubless couplings are failing and leaking. It is further recommended that either new hubless fittings be installed, or new PVC piping and fittings. The attached inspection summary and drawings show locals with particularly notable damage, and apparent issues based on the walk through are attached. The repair items called out all fit into the "High" priority level matching the structural assessment. These repair items appear to either be currently leaking, or if not addressed will likely fail and cause additional leaks. Due to the nature of pipe deterioration, it is difficult to identify needed repairs for the lower priority levels. It is likely additional significant repairs will be needed every 3-5 years to keep the drainage system in operation for an extended period, based on the overall condition of the existing hubless drain pipes.

Various floor drains appeared to be clogged with debris. The parking deck, drains, and lateral piping should be cleaned out and inspected to ensure there are no further blockages.
