BHPC MEETING PACKET

Thursday March 24, 2022

Bloomington Historic Preservation Commission Meeting

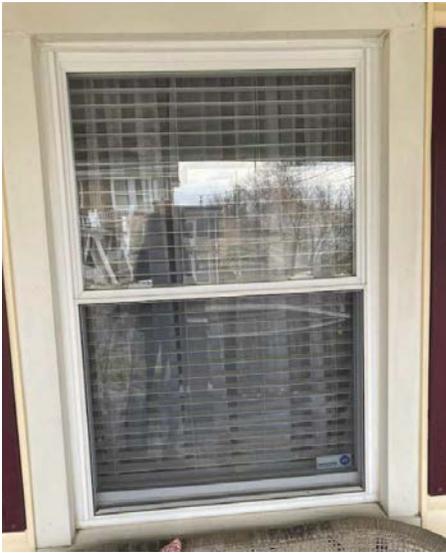
South (front) next to door

1. Failing seals and mechanics are primary reasons for replacing these windows.
2. Two small windows on the west side of house (pantry), are newer vinyl replacements and in good shape. They will remain in place.

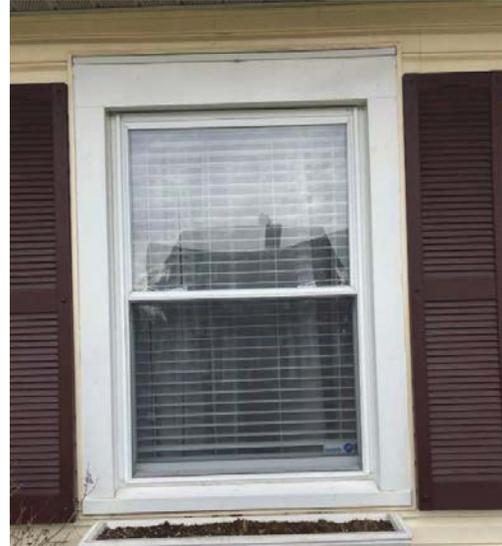
South (front bedroom)

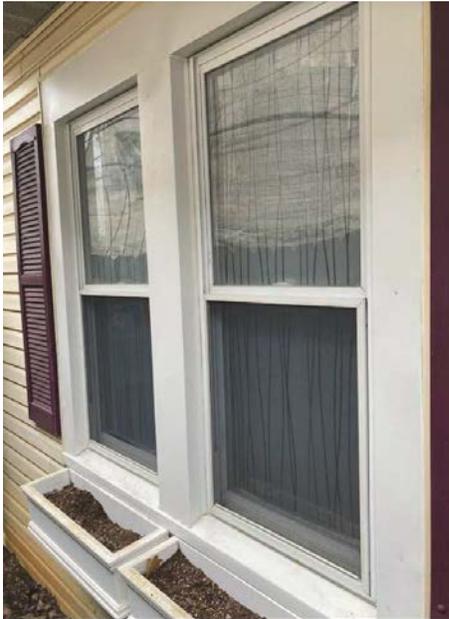
East (dining room)

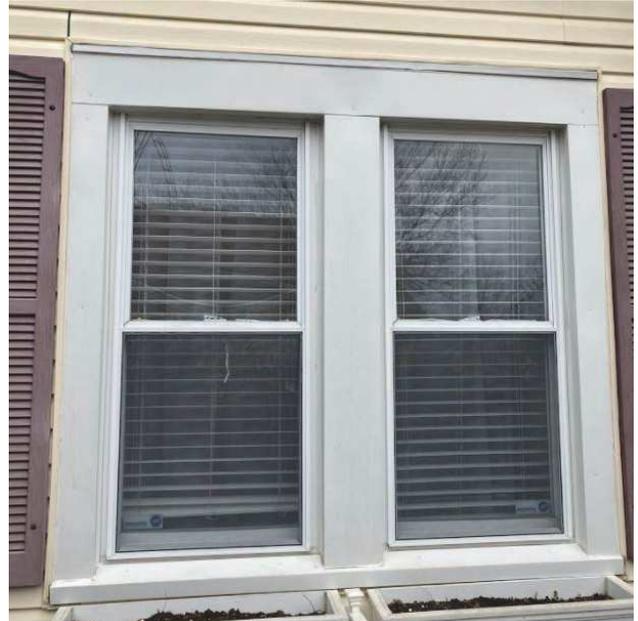
West (front bedroom)

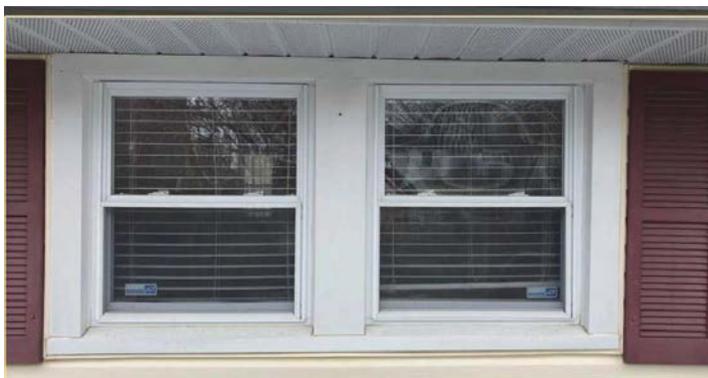
North (kitchen)

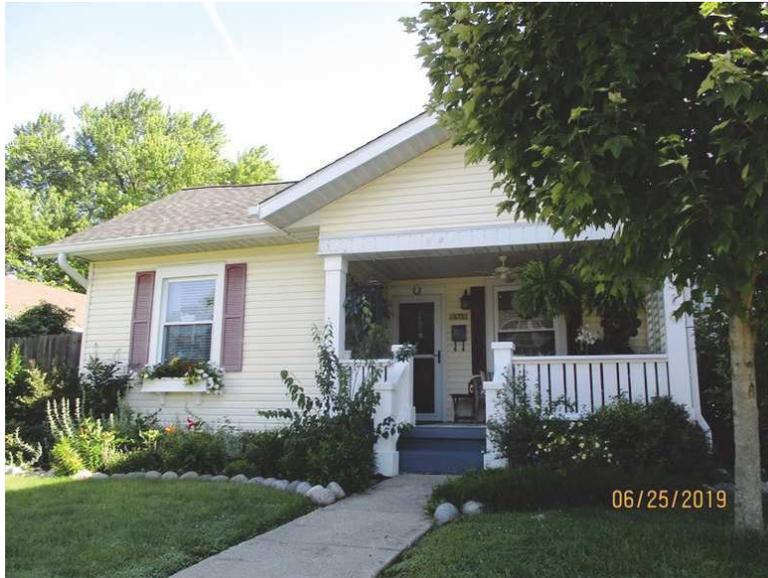
Current vinyl siding, shutters, and windows

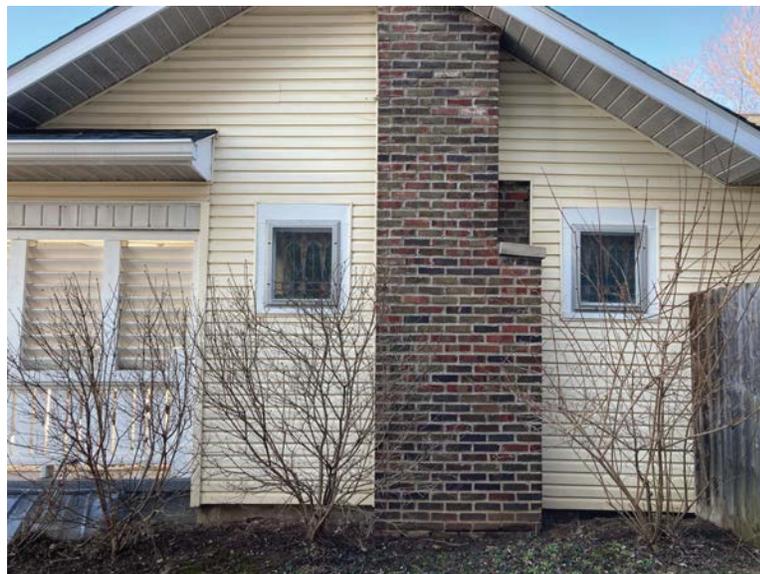
Alley side: Stained glass windows will remain in place

- Lap siding: original reveal is 4"
- Window openings will be maintained in current dimensions. Note: the original exterior window trim is currently covered with aluminum. This cover will be removed and the original trim restored as possible.
- Current windows are all vinyl replacements except for the two stained glass windows on either side of the chimney. These stained glass windows will remain in situ.

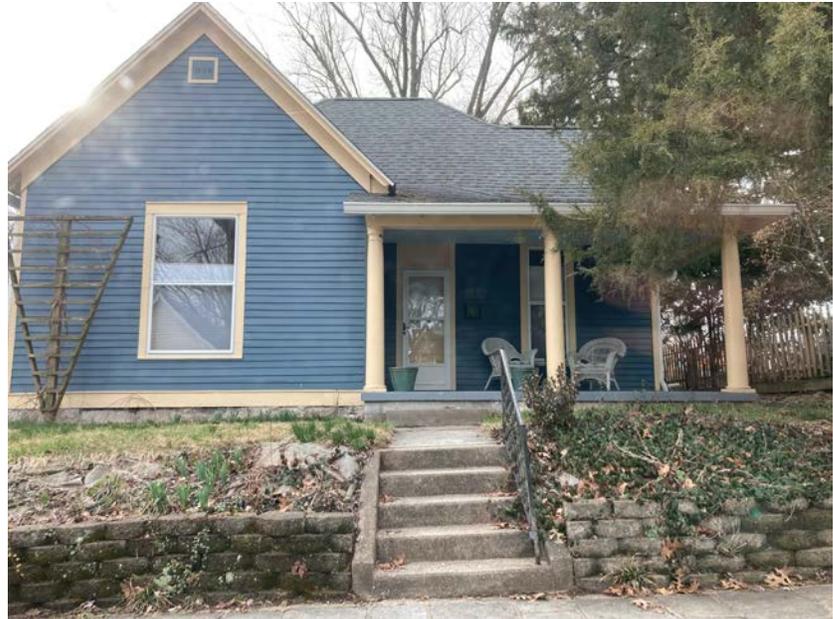
Golden Hands Construction recently restored the wood clapboard siding and trim on this house in Prospect Hill at 338 S Jackson.

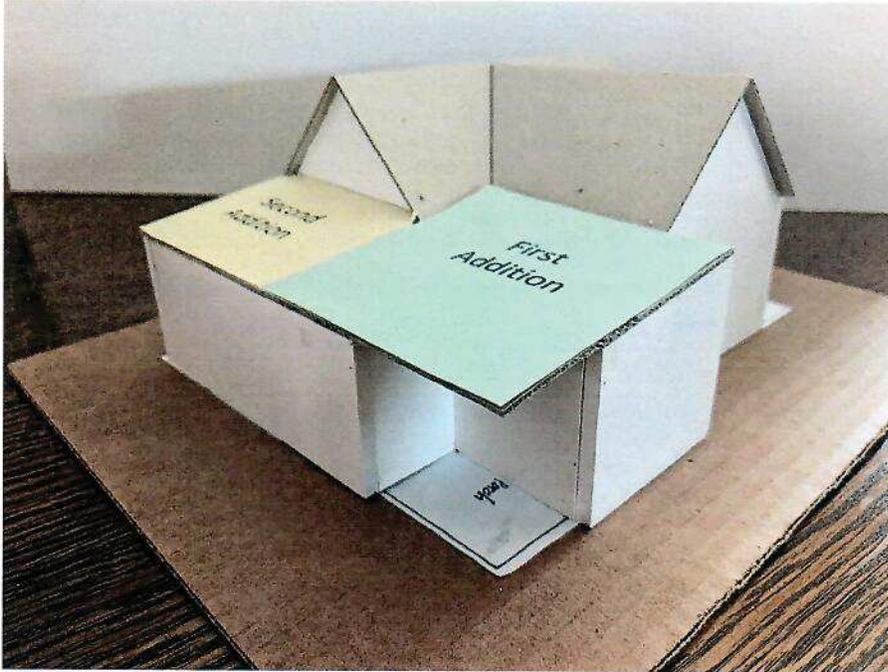
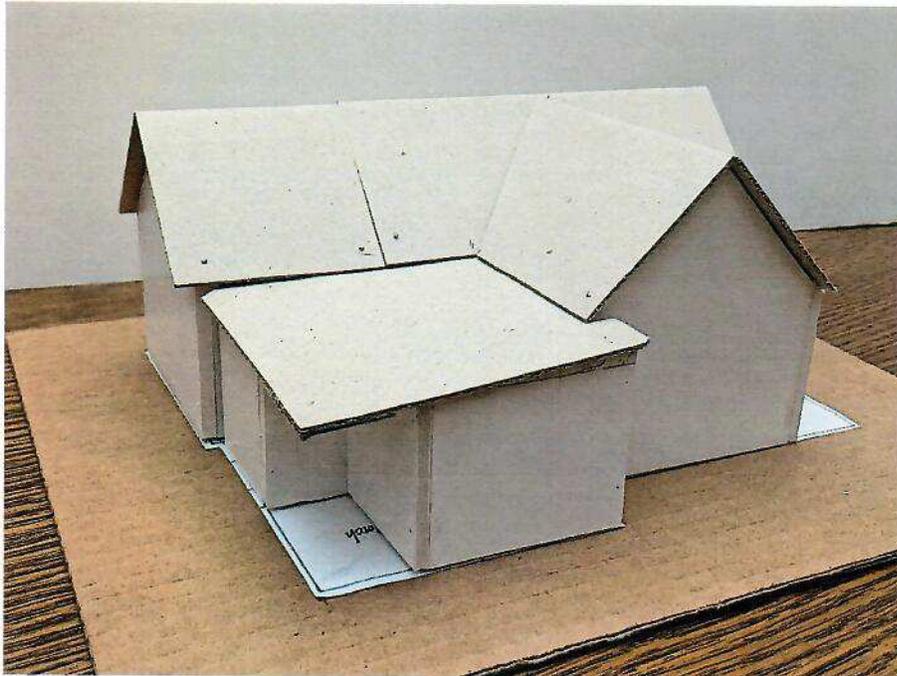
Model Showing Orientation of First and Second Additions to 619 W. Smith. The first addition will become the kitchen. The porch in the forefront is the back or side porch. The front porch, which was rebuilt by BRI, is to the right of the model.

Model of proposed configuration of the house showing the second addition rebuilt with a gable roof and the renovation of the first addition with a flat, shed style roof.

To replace the damaged area, we plan to rebuild the southeast corner of the house with a gabled roof to match the east-west orientation of the original house, thus extending the gable the whole length of the house). The flat roof of the first addition is only a temporary roof. It will be replaced with permanent roof, also flat, emulating the original first addition to the house. This roof will be raised slightly to bring ceiling height in that room from the current seven feet to eight feet. (The ceiling height of the original three rooms of the house are nine feet.)

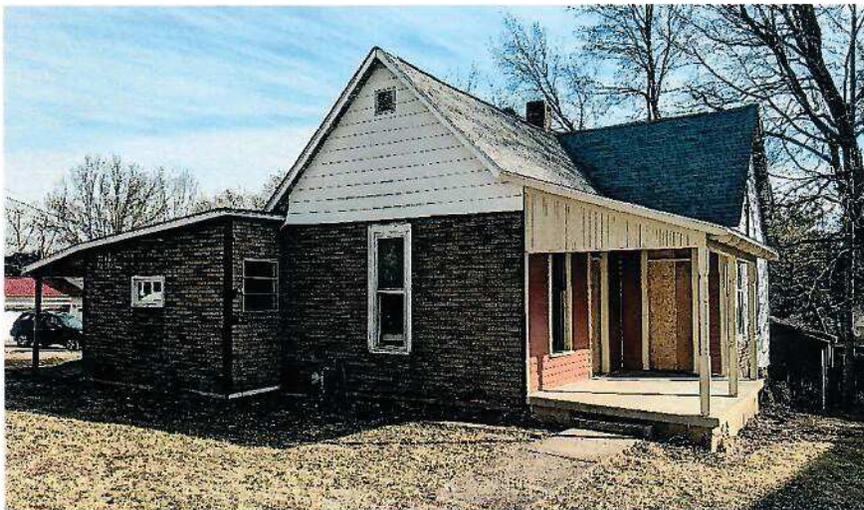
This is the Smith Avenue view, showing the front of the house and some aluminum siding removed. The rest of the aluminum siding and the insulbrick will be removed. The existing wood siding will be repaired (or replaced if necessary) and painted to match the porch, which was opened up, repaired and painted by BRI just before we bought the house.

The sloped roof will be replaced with a new roof in the kitchen (right side of photo). Most existing windows will be retained and repaired (or replaced if necessary). The small window in the kitchen (first addition, on the right in the photo below) will be replaced with a taller window similar to the existing double-hung windows.

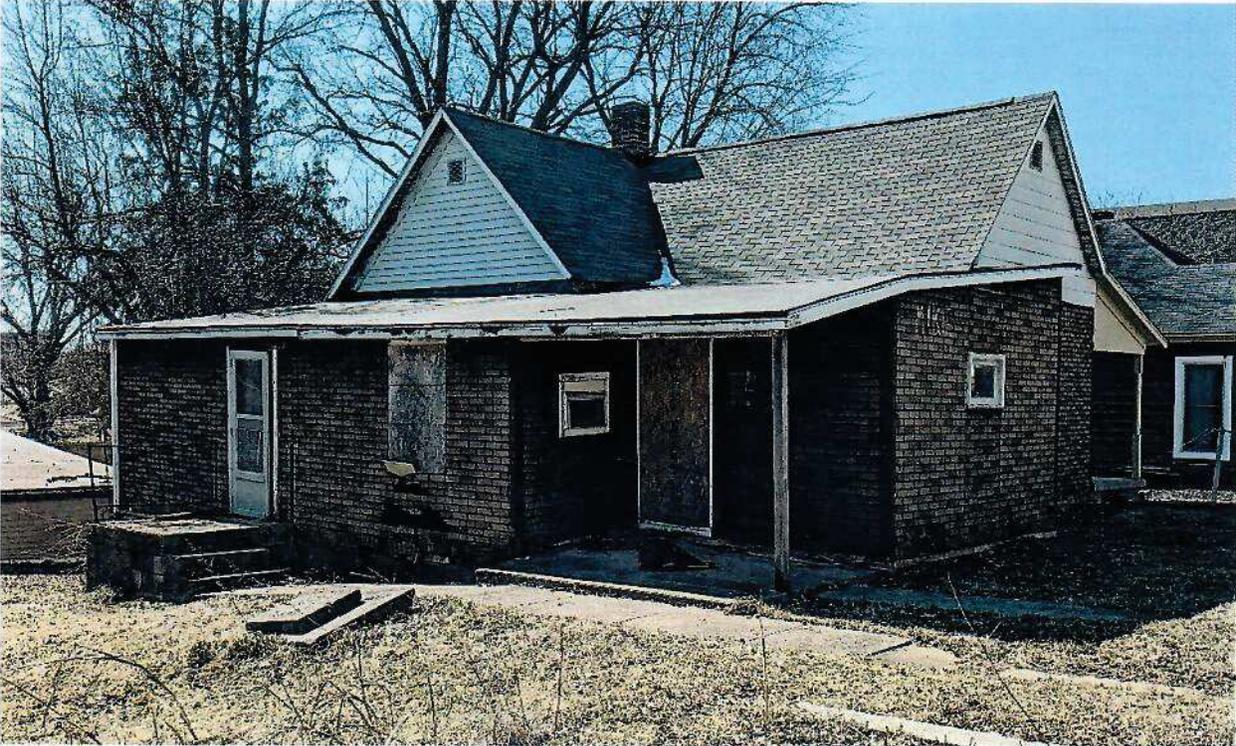
This is the east side of the house. The shed roof on this part of the house failed, which created serious damage to the house. Kevin Potter specified demolition of the east wall and roof structures as they are unstable. We plan to extend the gable to the east end of the house (since the wall and roof has to be replaced anyway). The existing door on the left side of the photo will be replaced with a window similar to the other double-hung windows in the house (this room will be a bedroom). The boarded-up window will be replaced with a double-hung window. We will reconstruct the back porch with a door into what will become the kitchen (where the little window is on the porch). The boarded up back door on the porch will become wall space for kitchen cabinets.

We have a report from Kevin Potter (the last three page of these documents), which was prepared for BRI, detailing the beams and other structures that need to be replaced. Golden Hands Construction and their contractors will do the work.

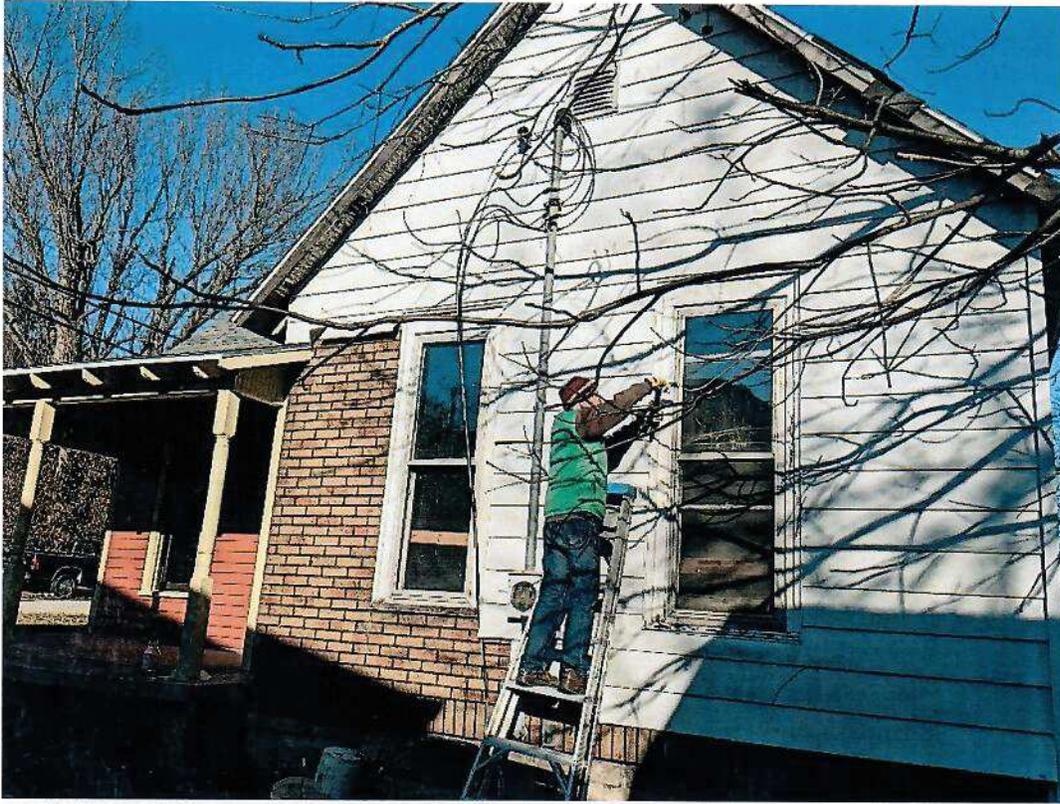
The west side of the house. The aluminum and insulrick siding will be removed and the clapboards repaired or replaced before painting.

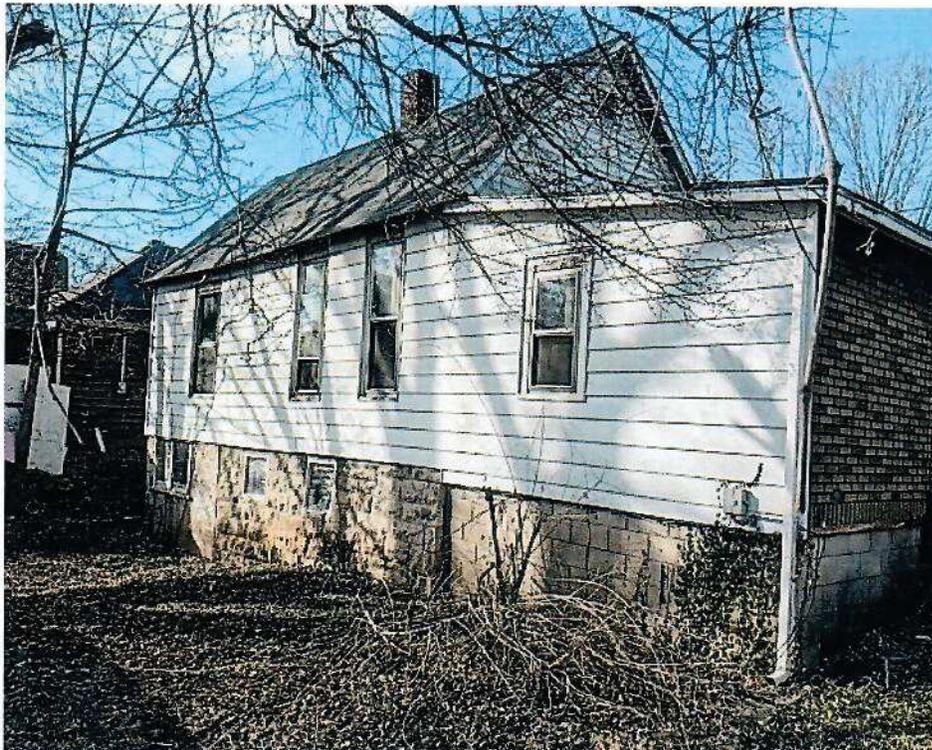
The south side of the house is not visible from West Smith or Howe Street, but this photo shows the gable we plan to extend to the east end of the house (the right side of the photo). The limestone basement is visible on the west (left) side of the photo, with the concrete block area that is only crawl space on the east side.

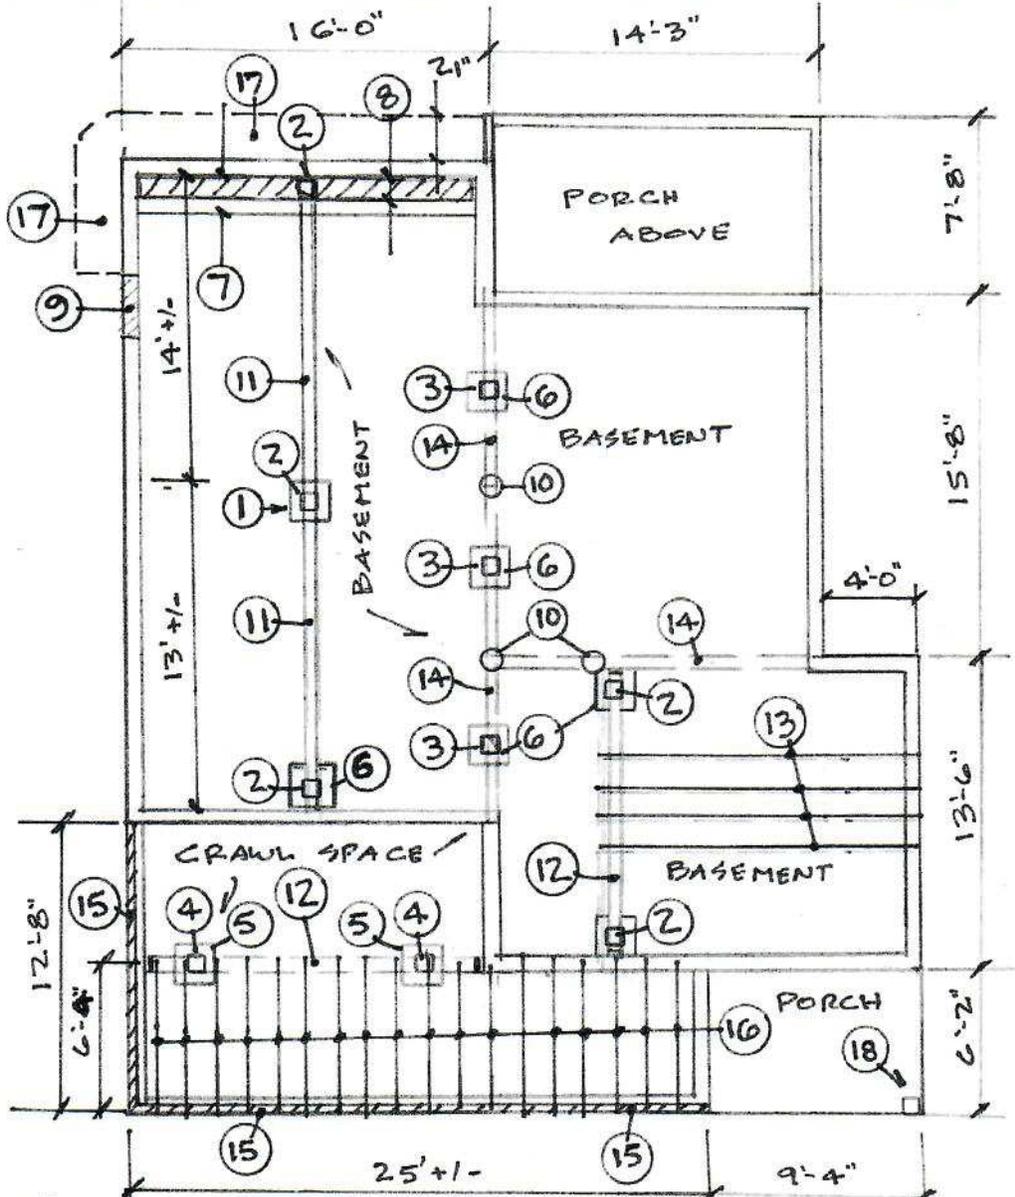
NORTH
1/8" = 1'-0"

- ⑦ ADD 18"x8" CONCRETE FOOTING AGAINST STONE WALL
- ⑧ ADD 24" HIGH 8" REINFORCED CONCRETE BLOCK WALL
- ⑨ RAISE DOOR SILL W/ 8" CONCRETE BLOCK 8" ABOVE FLOOR
- ⑩ EXISTING 8" ϕ WOOD POSTS
- ⑪ ADD 4 PLY 2x10 WOOD BEAM UNDER 2x8 JOISTS
- ⑫ ADD 4 PLY 2x8 WOOD BEAM FOR JOIST SUPPORT
- ⑬ SISTER NEW FULL LENGTH JOISTS TO 4 DAMAGED JOISTS
- ⑭ EXISTING BEAM TO REMAIN
- ⑮ REBUILD WALL W/ 2x4 FRAMING @ 16" O.C.
- ⑯ REMOVE FLOOR JOISTS- REPLACE W/ 2x8 @ 16" O.C.
- ⑰ EXCAVATE TO BOTTOM OF WALL- REPOINT ALL MORTAR JOINTS- WATERPROOF WALL- BACKFILL W/ CRUSHED STONE
- ⑱ REPLACE POST W/ TREATED 6x6 POST

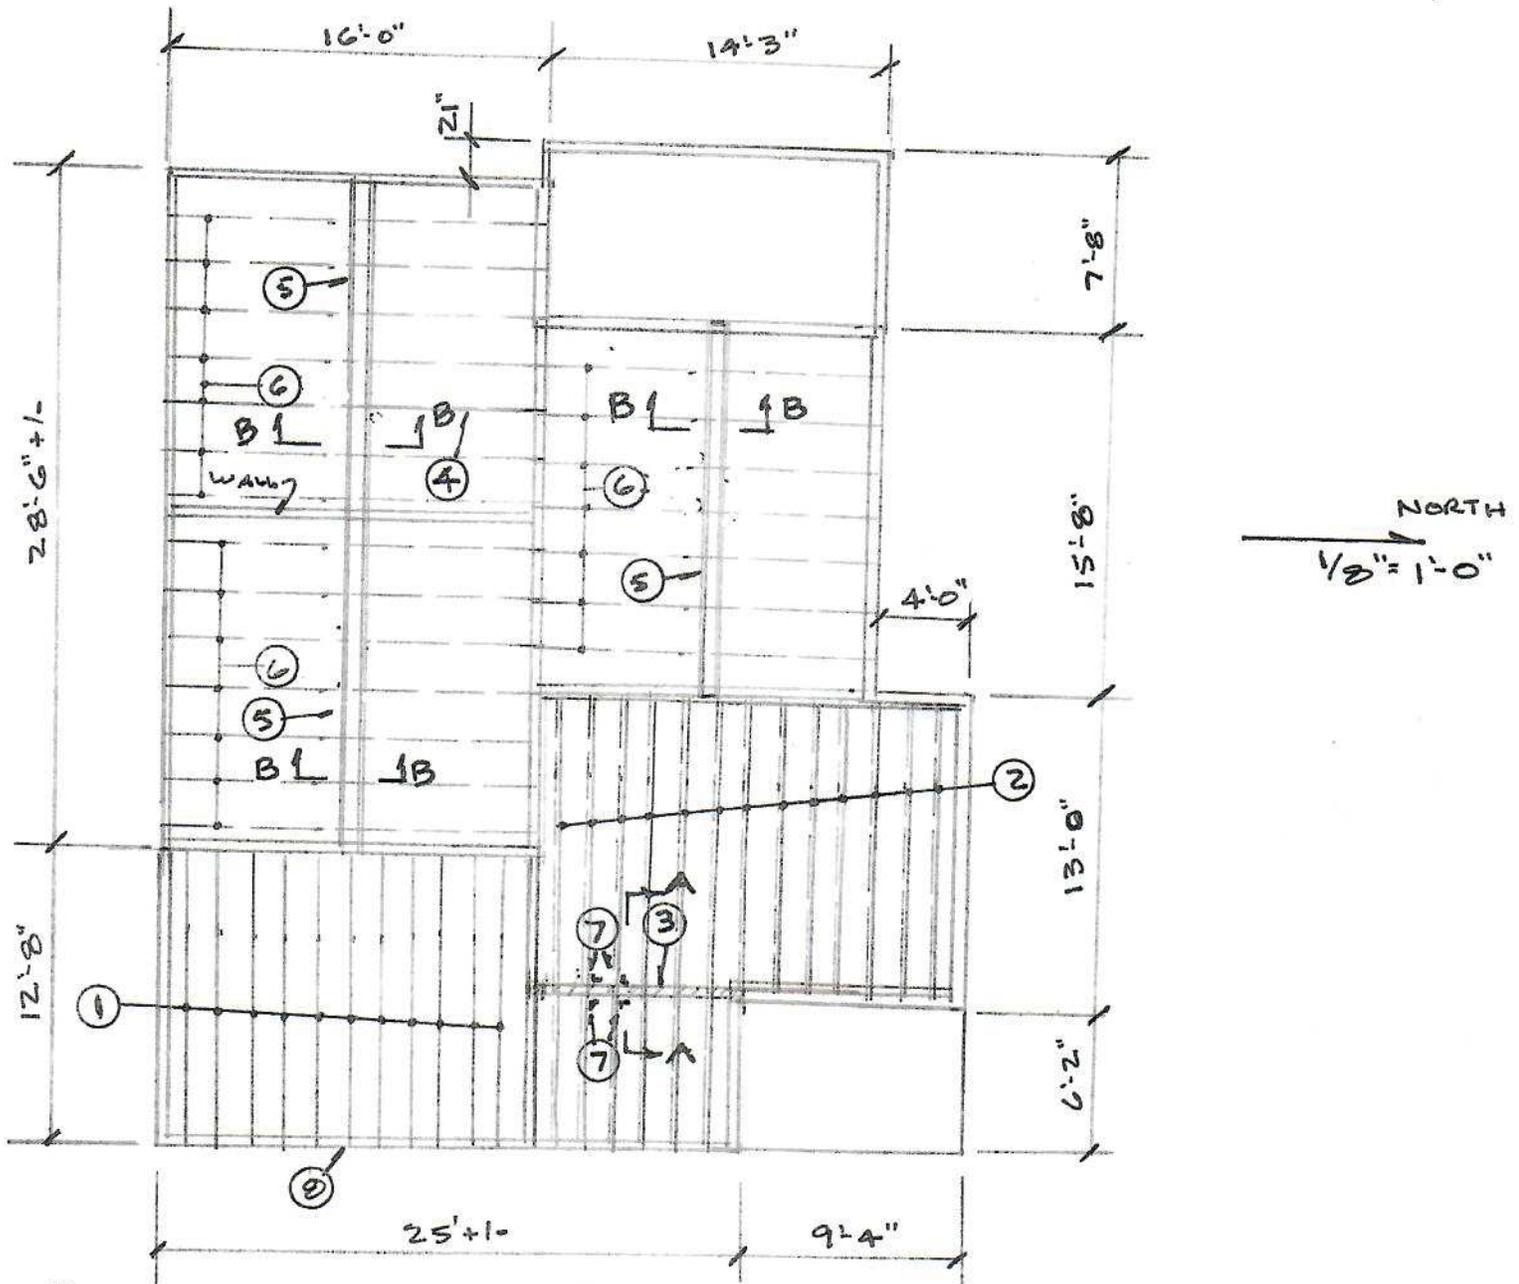
CEILING FRAMING

- ① ADD 2x6 ROOF FRAMING @ 16" O.C. BETWEEN EXISTING 2x4 RAFTERS
- ② SISTER FULL LENGTH 2x6 RAFTERS TO EXISTING 2x4 RAFTERS
- ③ ADD 3 PLY 2x8 WOOD HEADER TO ROOF SHEATHING
- ④ REPLACE BROKEN JOIST W/ DOUBLE 2x4 CEILING JOIST
- ⑤ 2x8 STIFFBACK ON TOP OF CEILING JOISTS - BEAR ON WAUWS AT BOTH ENDS
- ⑥ EXISTING 2x4 JOISTS @ 16" O.C.
- ⑦ ADD SIMPSON "LVS 26-2" JOIST HANGERS
- ⑧ REBUILD WALL W/ 2x4 FRAMING @ 16" O.C.

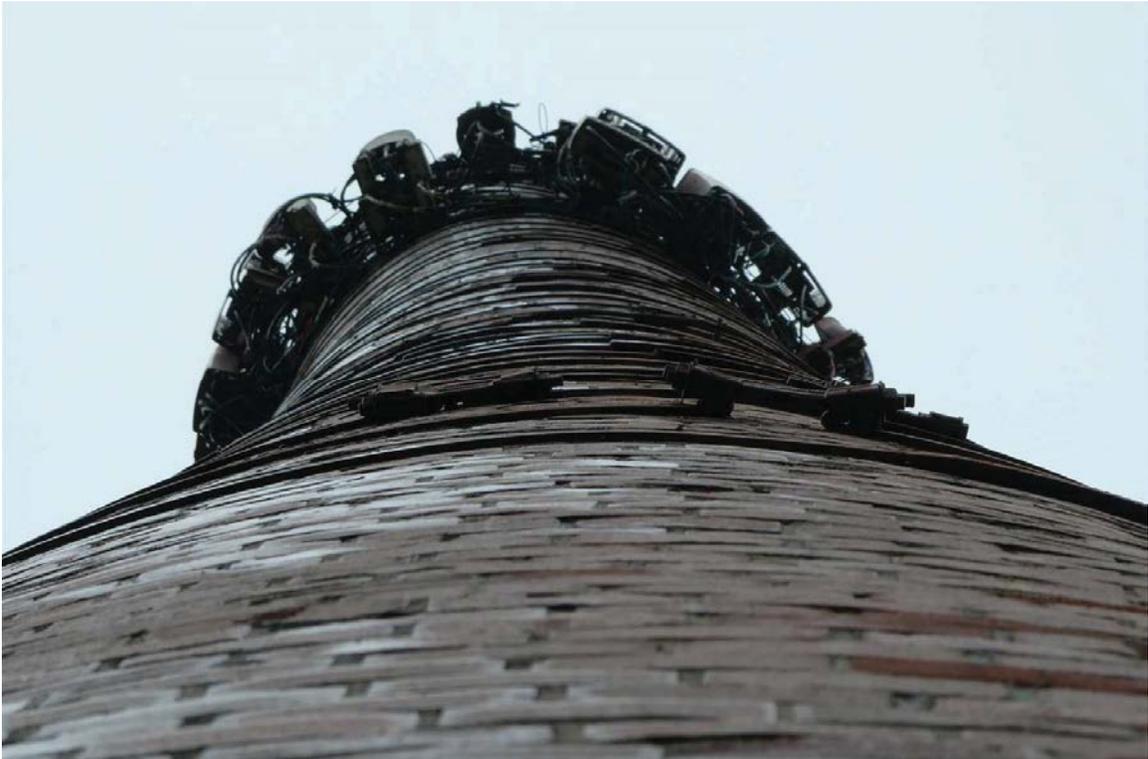
Photo 1 Looking up the wall of the stack on the southeast face.

The smokestack leans or tilts to the southeast. This is severe enough that it can be seen from ground level with the naked eye as shown in Photos 1 and 2. In 2017 we determined that the top of the stack was leaning 1 foot in every 10 and estimated that the overall tilt was in the order of several feet.

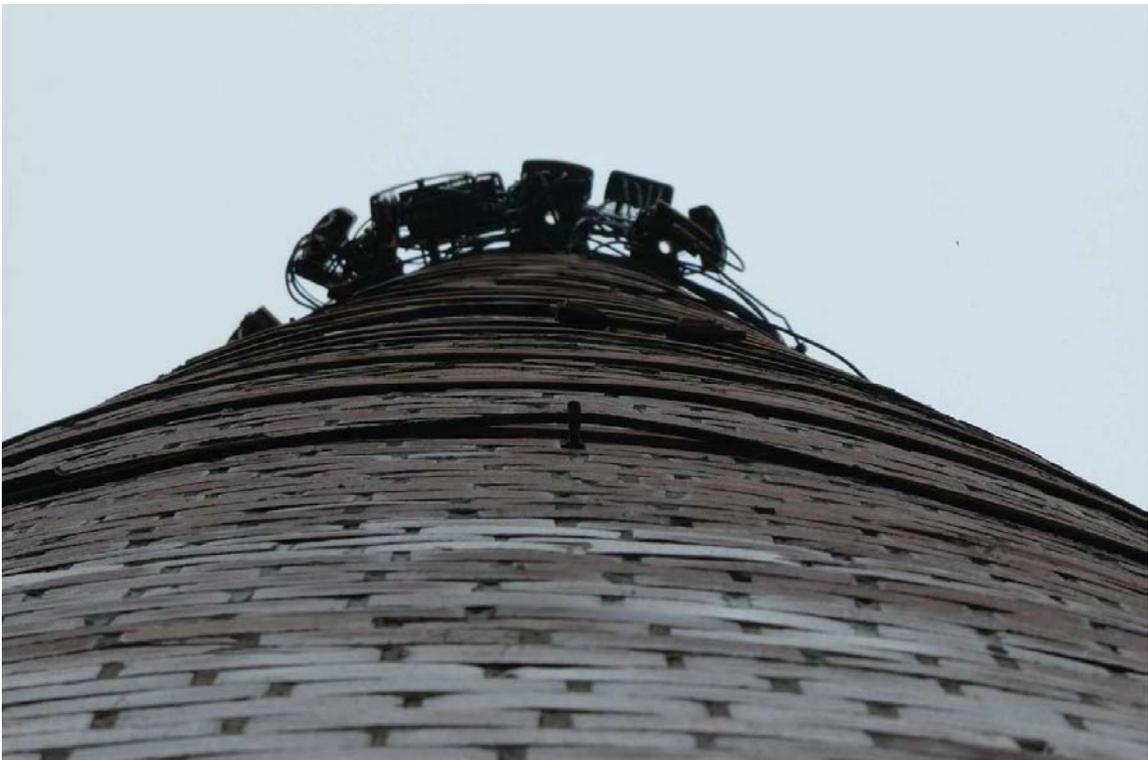
Photo 2 Looking up the wall of the stack on the opposite side as Photo 1.

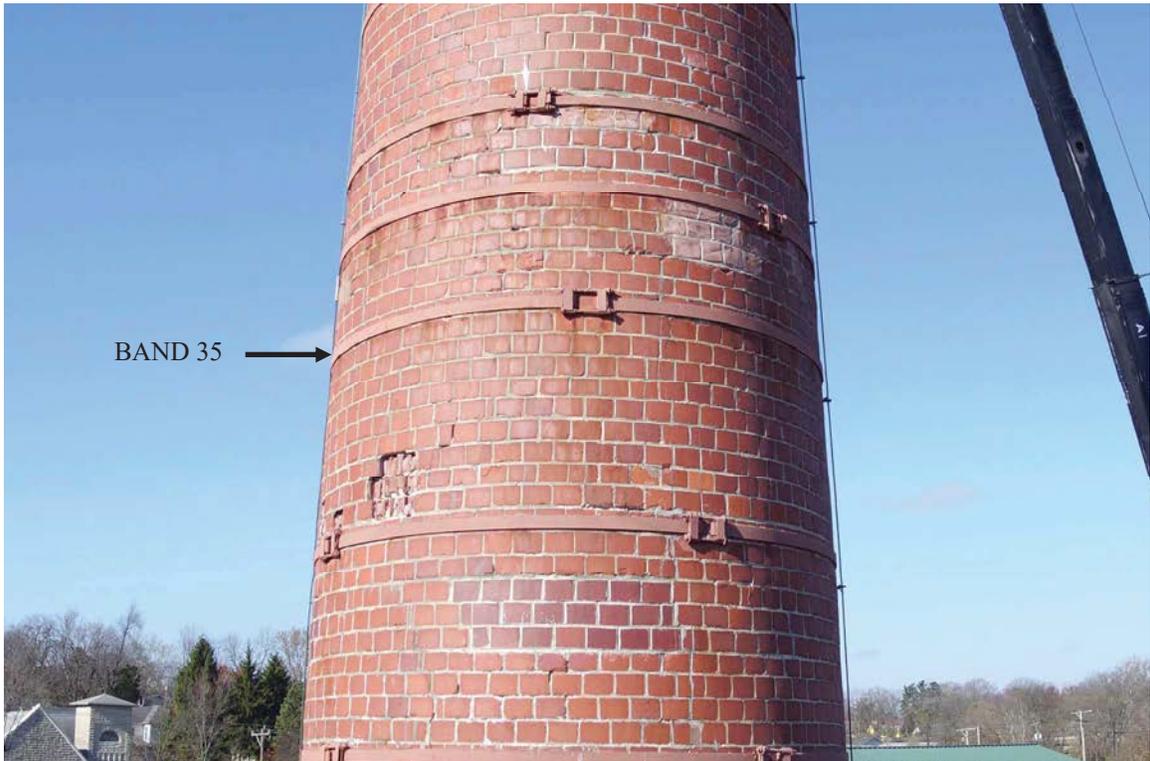
Photo 3 Photo taken in 2017.

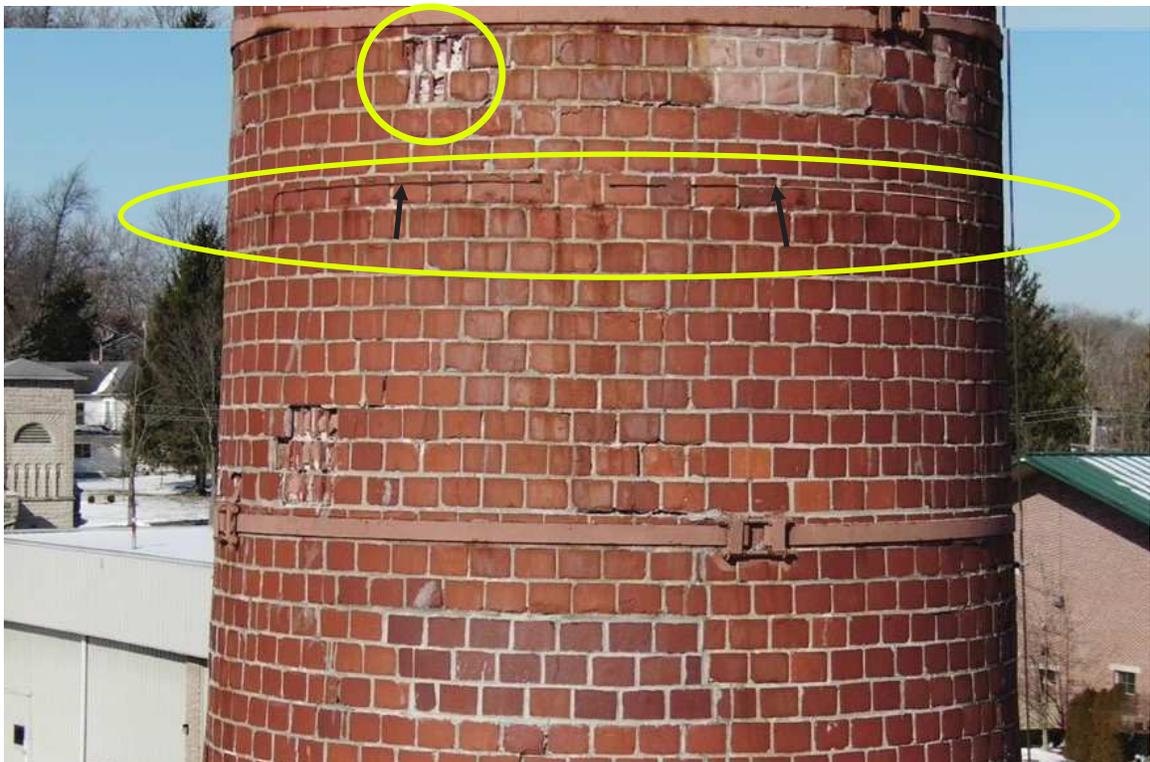
Photo 4 Photo taken in 2022. Band 35 is gone. Remnants of sealant at the top of the band are highlighted as is a new spall.

The drone was also utilized to create a series of vertical montages of the stack from different angles. The orientation of the montages attempted to copy a similar set of montages taken in 2017 so that the two sets could be compared. See Figures 14 through 16. In 2017 we observed 38 steel bands in the stack. The 2022 montages show band #35 down from the top is now missing. R & P reported only 37 steel bands when they performed their assessment in 2020 and noted there was evidence of one missing. Photos 3 and 4 show this location in 2017 and 2022. Rust stains and a bead of sealant are visible in the 2022 photo where the band was located.

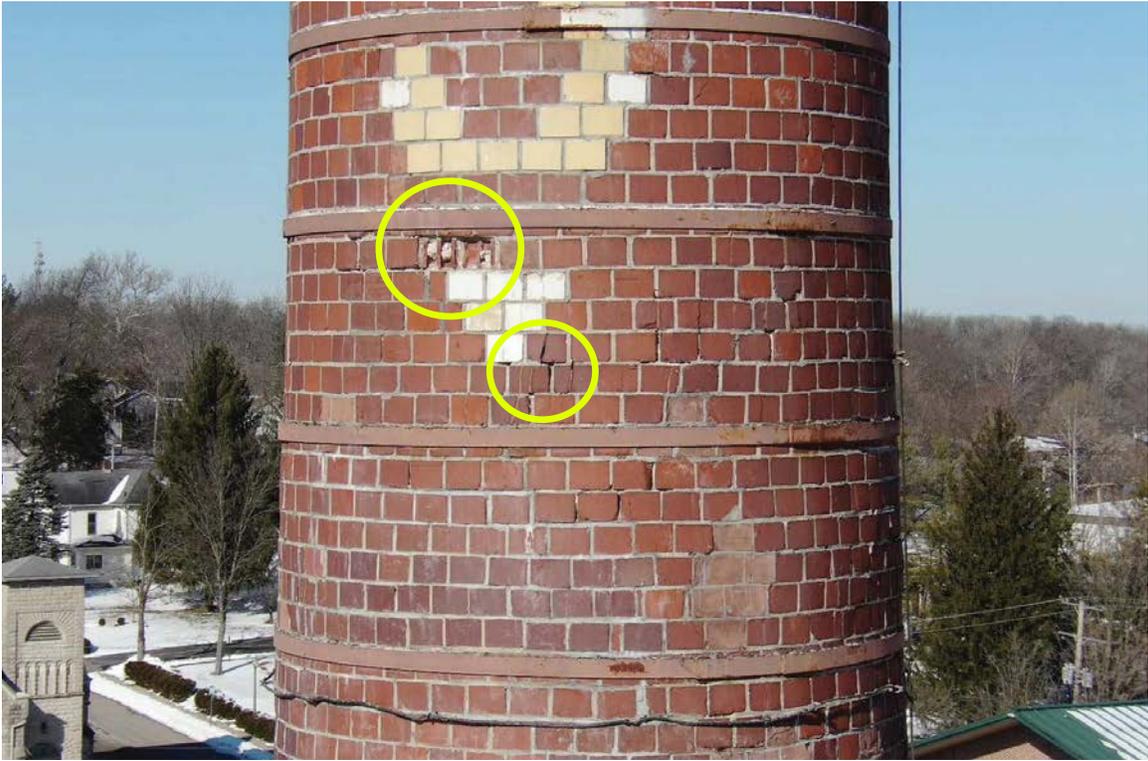
Photo 5 New spalls are highlighted in this 2022 photo.

Evidence of spalling was also compared between the 2017 and 2022 montages. There are 11 locations in 2022 where new spalling is visible. These generally occur in the south to southwest face of the stack between 60 and 100 foot levels. Examples are shown in Photos 5 and 6. Face shell spalling was also more evident at the foundation as shown in Photos 7 and 8.

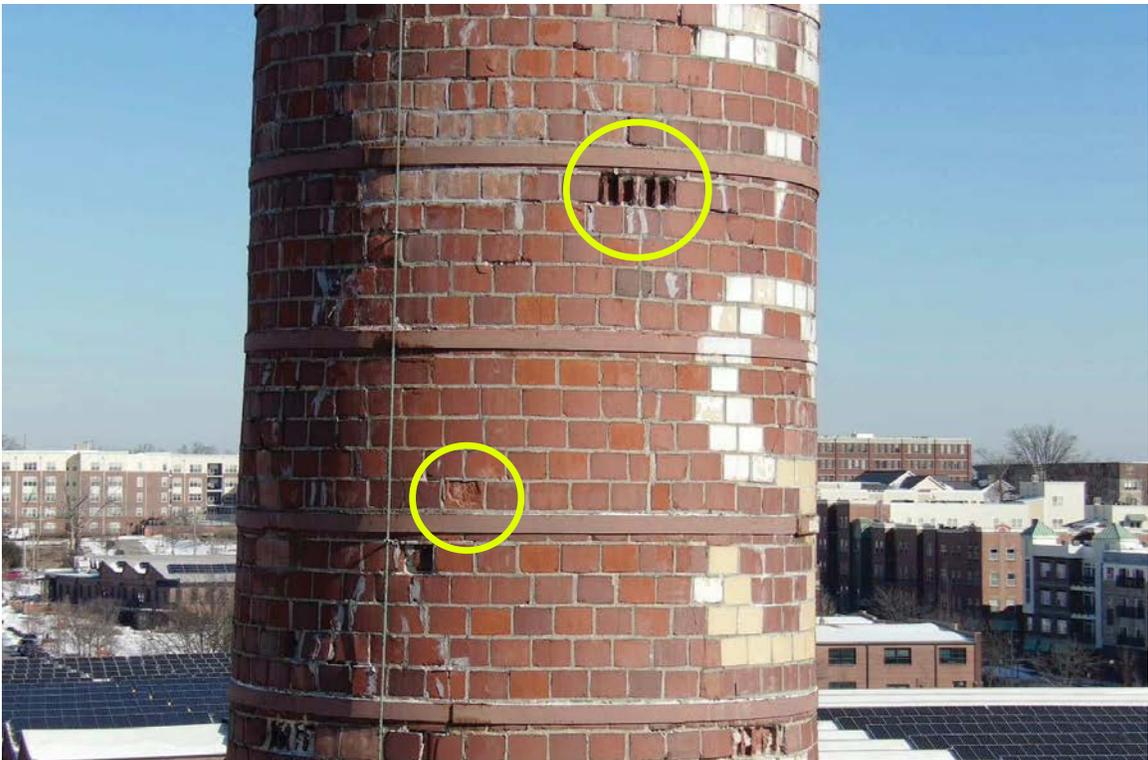
Photo 6 More new spalls are highlighted.

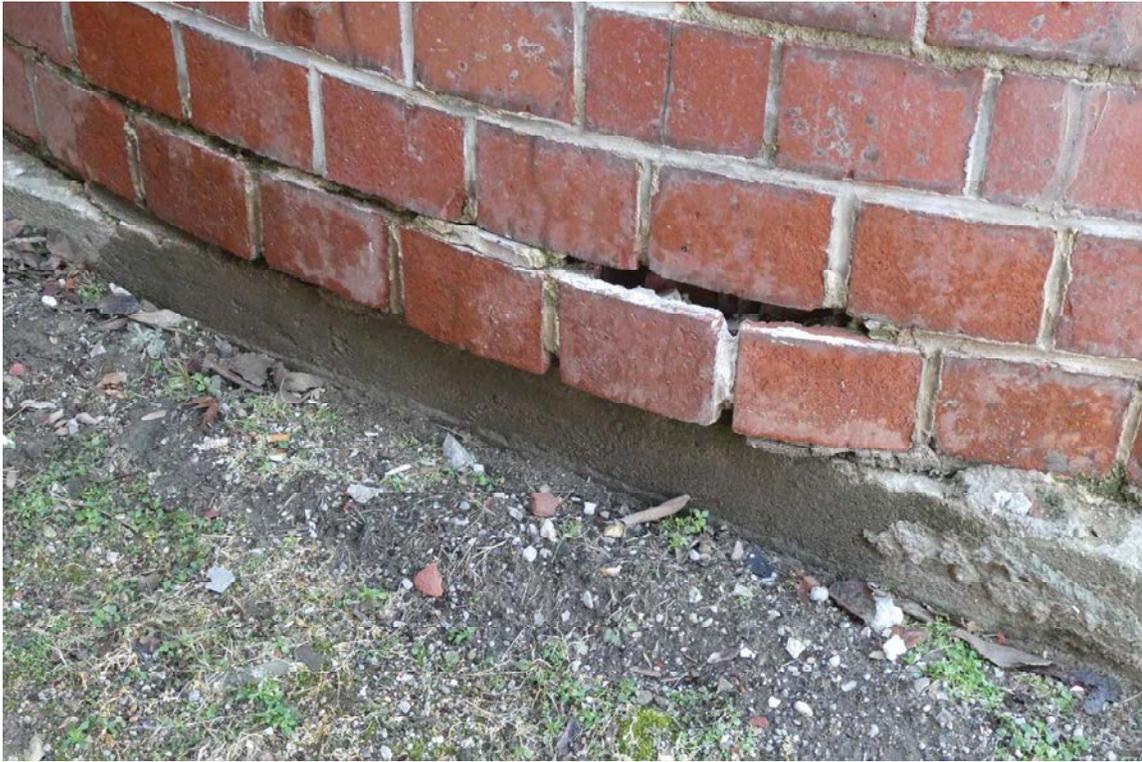
Photo 7
Spalling extends to the
base of the stack.

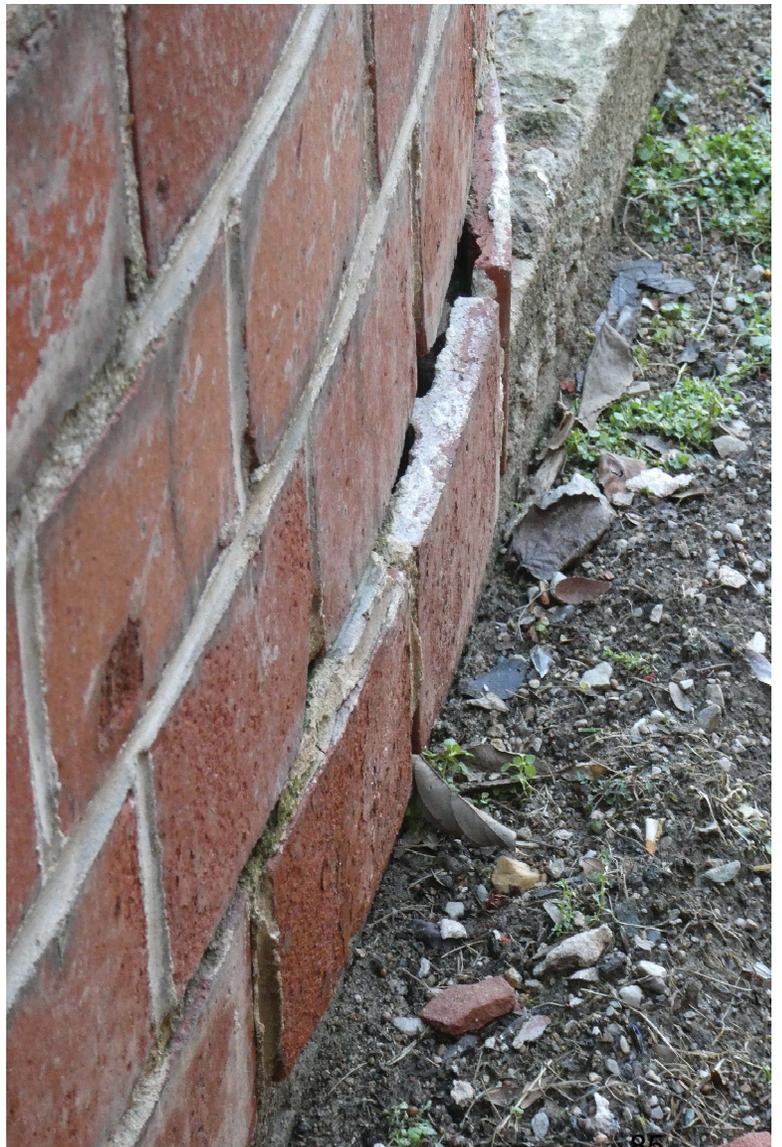
Photo 8
The face shells are splitting off from the body of
the brick.

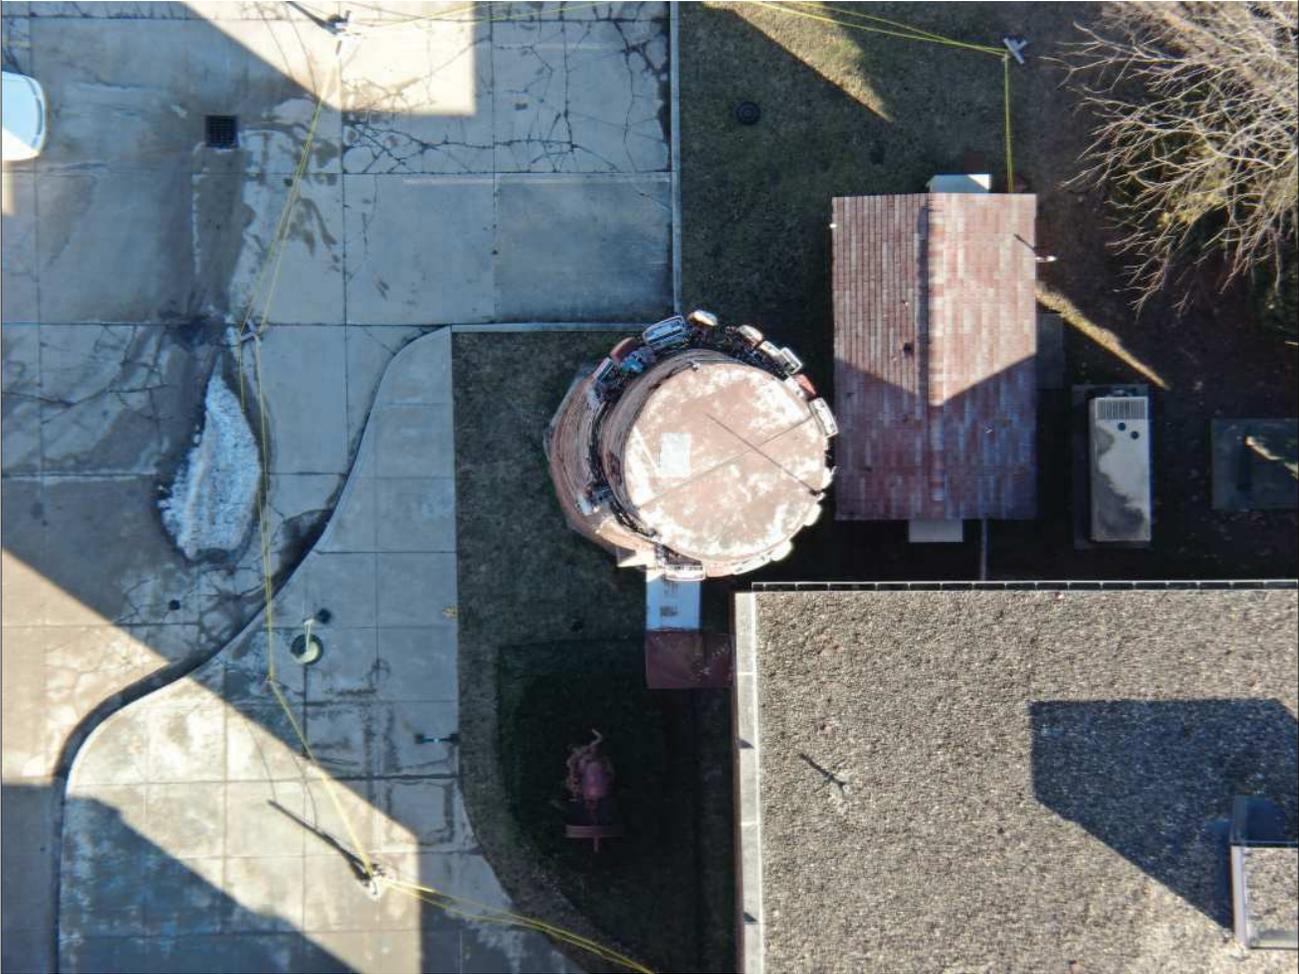
FIGURE 3

ARSEE ENGINEERS <small>CLIENT ORIENTED - BY DESIGN</small>	SINCE 1968	PLAN VIEW PHOTO		R1
		Project number	Project Number	
		Date	Issue Date	89
		Drawn by	Author	
		Checked by	Checker	
JOHNSON'S CREAMERY SMOKE STACK		Scale

from this vantage point. Figure 2 shows an image from our report in 2017 for comparison. This was created without the aide of a transit. A second method to determine the distortion used a remote controlled aerial drone to create a 3D point cloud of the stack. From this “measurements” can be made showing how far it is out of plumb. Figures 3 though 11A show pairs of aerial photographs and the 3D point cloud at various positions around the stack. The maximum distortion was found to be 2’-3½’ where the stack leans to the southeast. The stack appears to start to curve or lean to the southeast just above the 25 foot level. If the stack were to fall in the direction of the lean, much like a tree being cut down, it would fall as shown in Figure 12. The overall radius of 140’ from the center of the stack is also shown to get a sense of the danger zone.

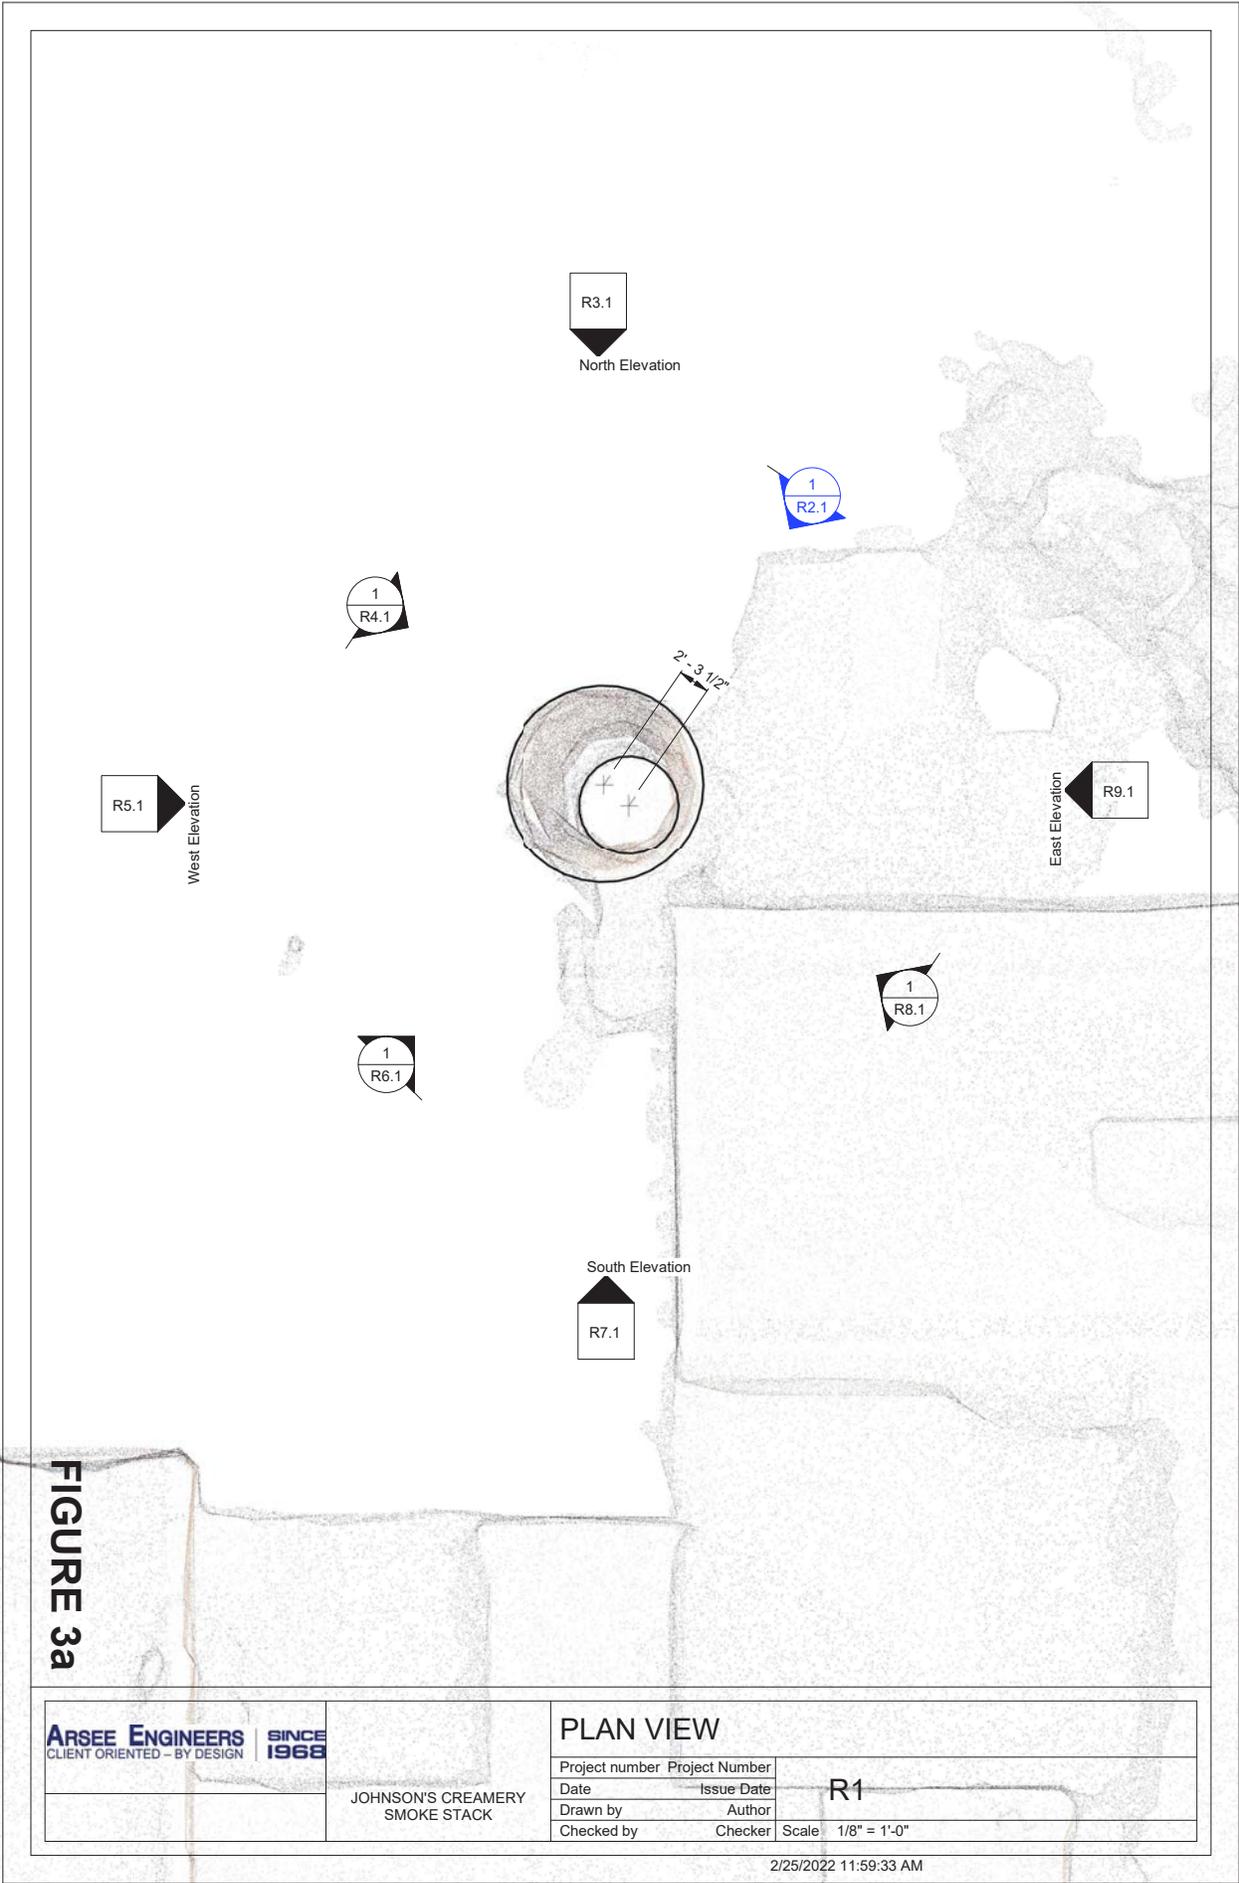
FIGURE 3a

ARSEE ENGINEERS CLIENT ORIENTED - BY DESIGN SINCE 1968	PLAN VIEW	
	Project number Date Drawn by Checked by	Project Number Issue Date Author Checker
JOHNSON'S CREAMERY SMOKE STACK	R1 Scale 1/8" = 1'-0"
