BHPC MEETING PACKET

Thursday March 24, 2022

Bloomington Historic Preservation Commission Meeting

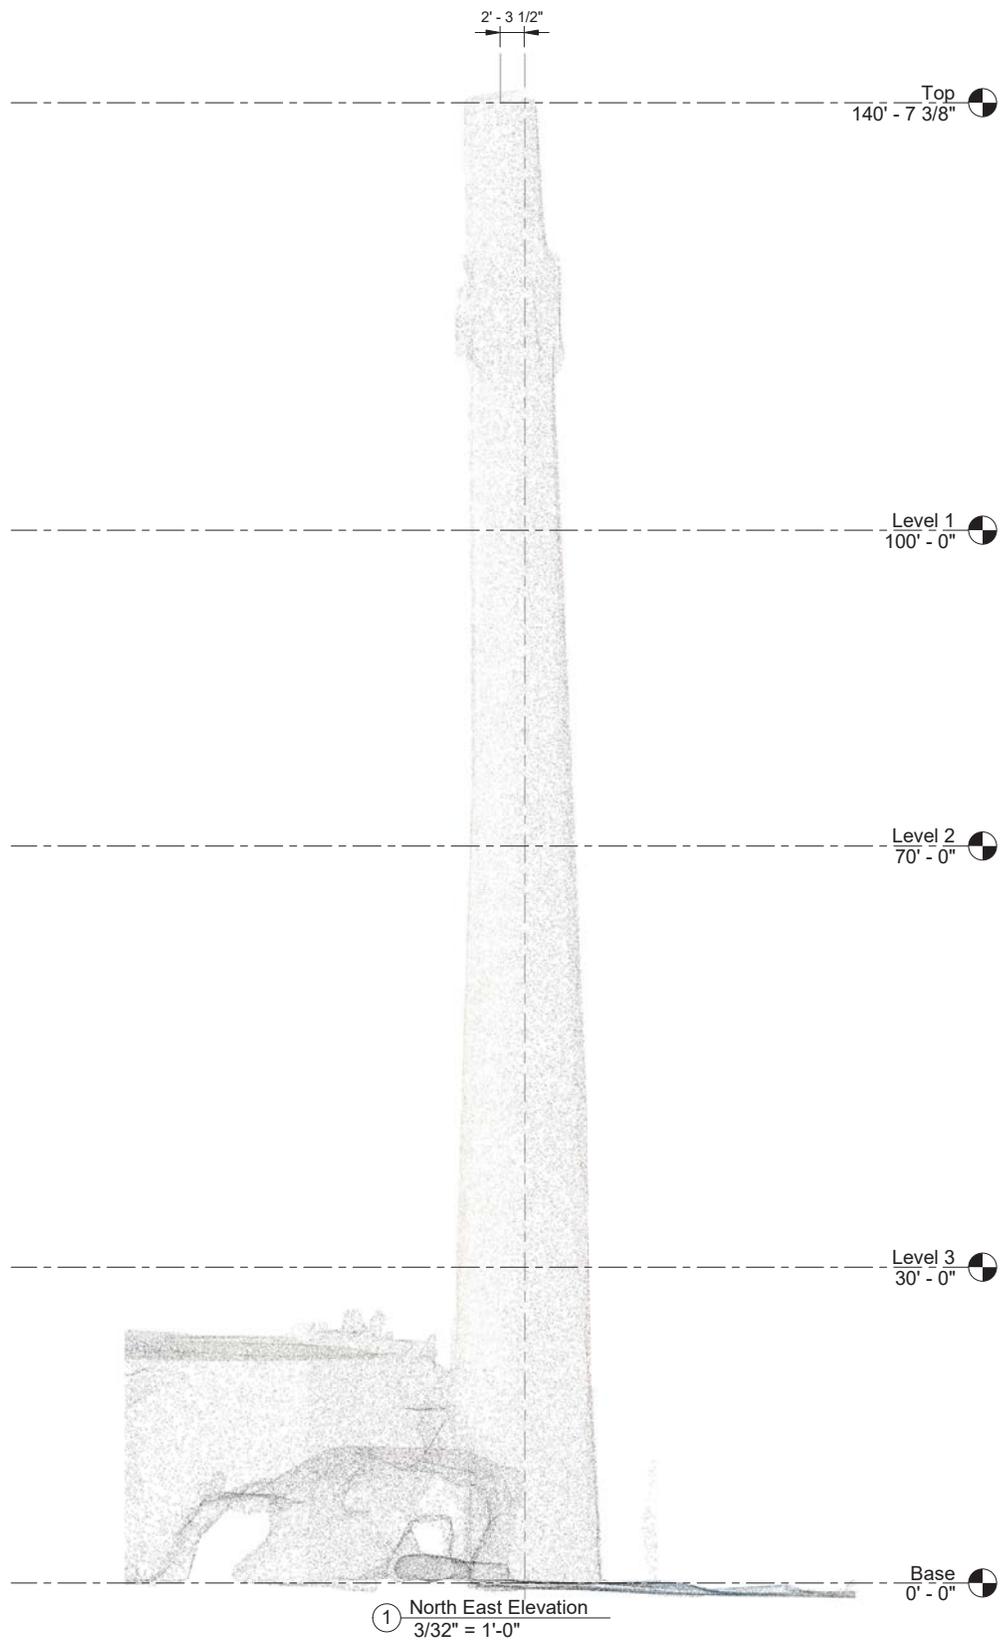
FIGURE 4a

① North East Elevation
3/32" = 1'-0"

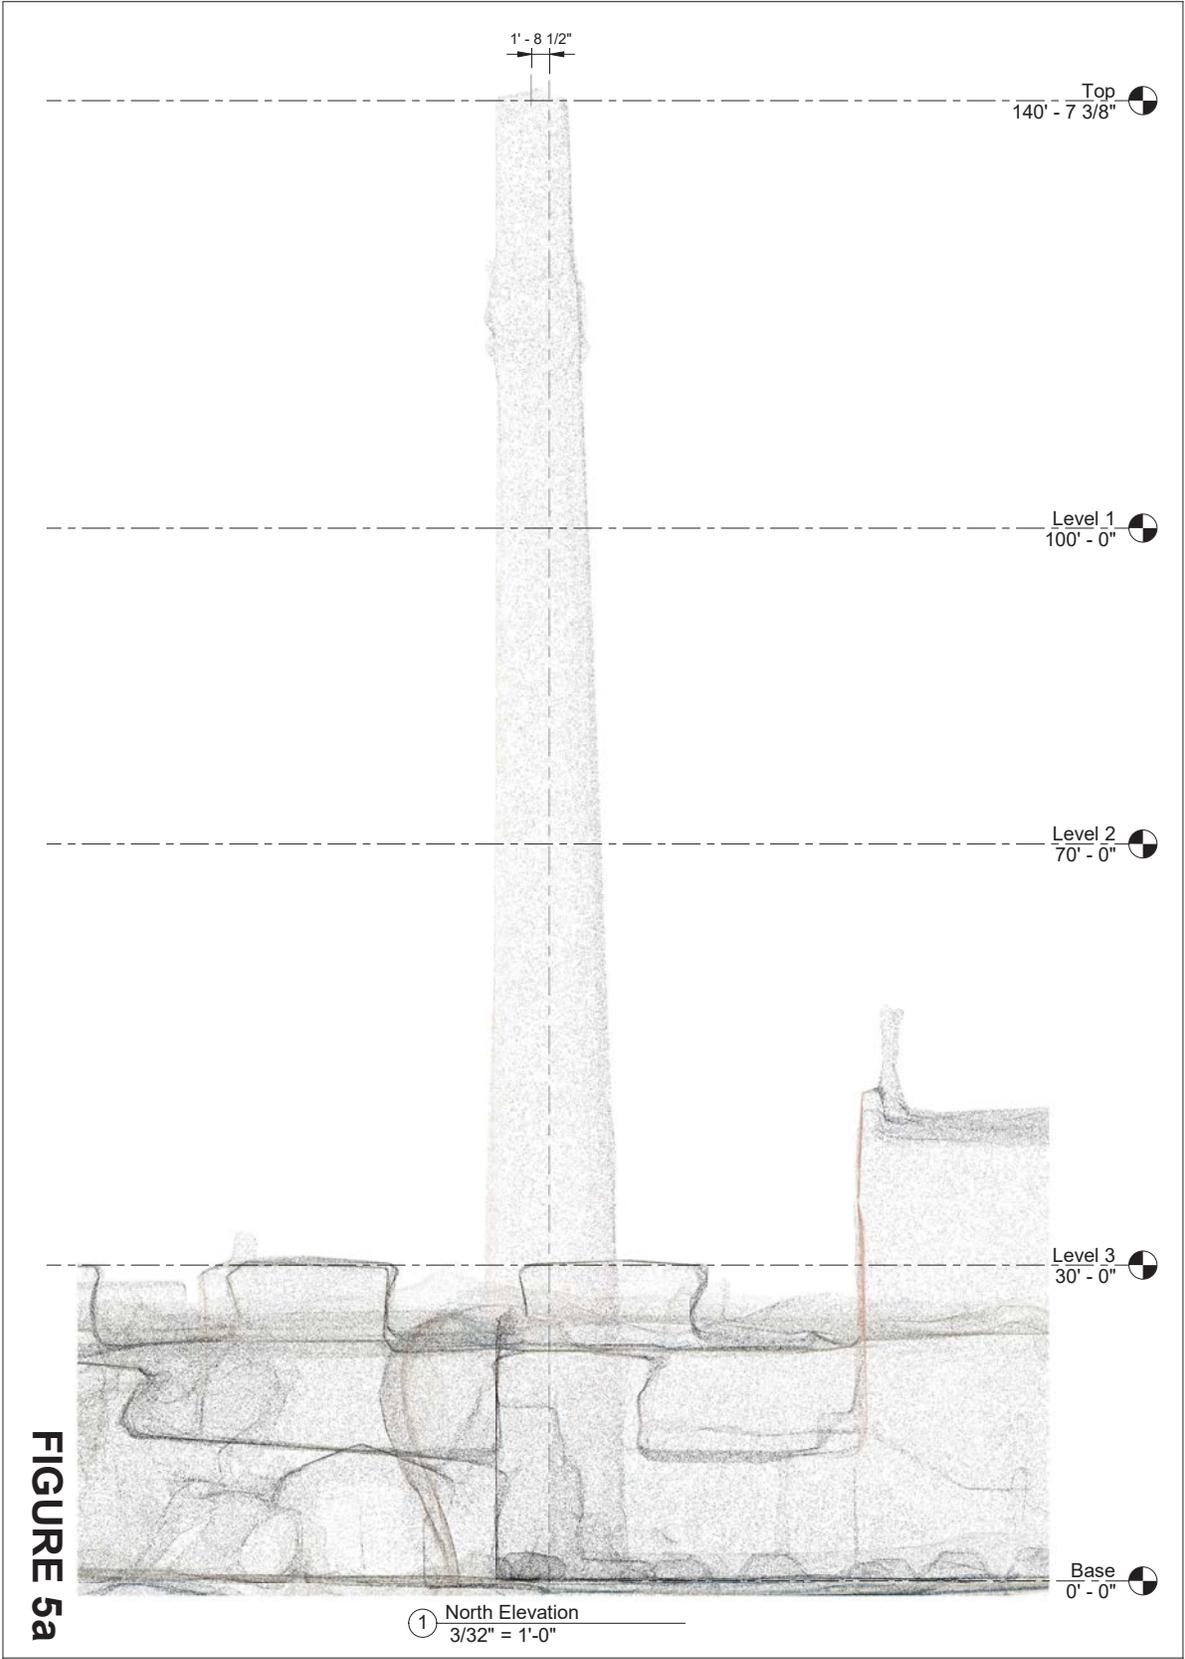
FIGURE 5a

① North Elevation
3/32" = 1'-0"

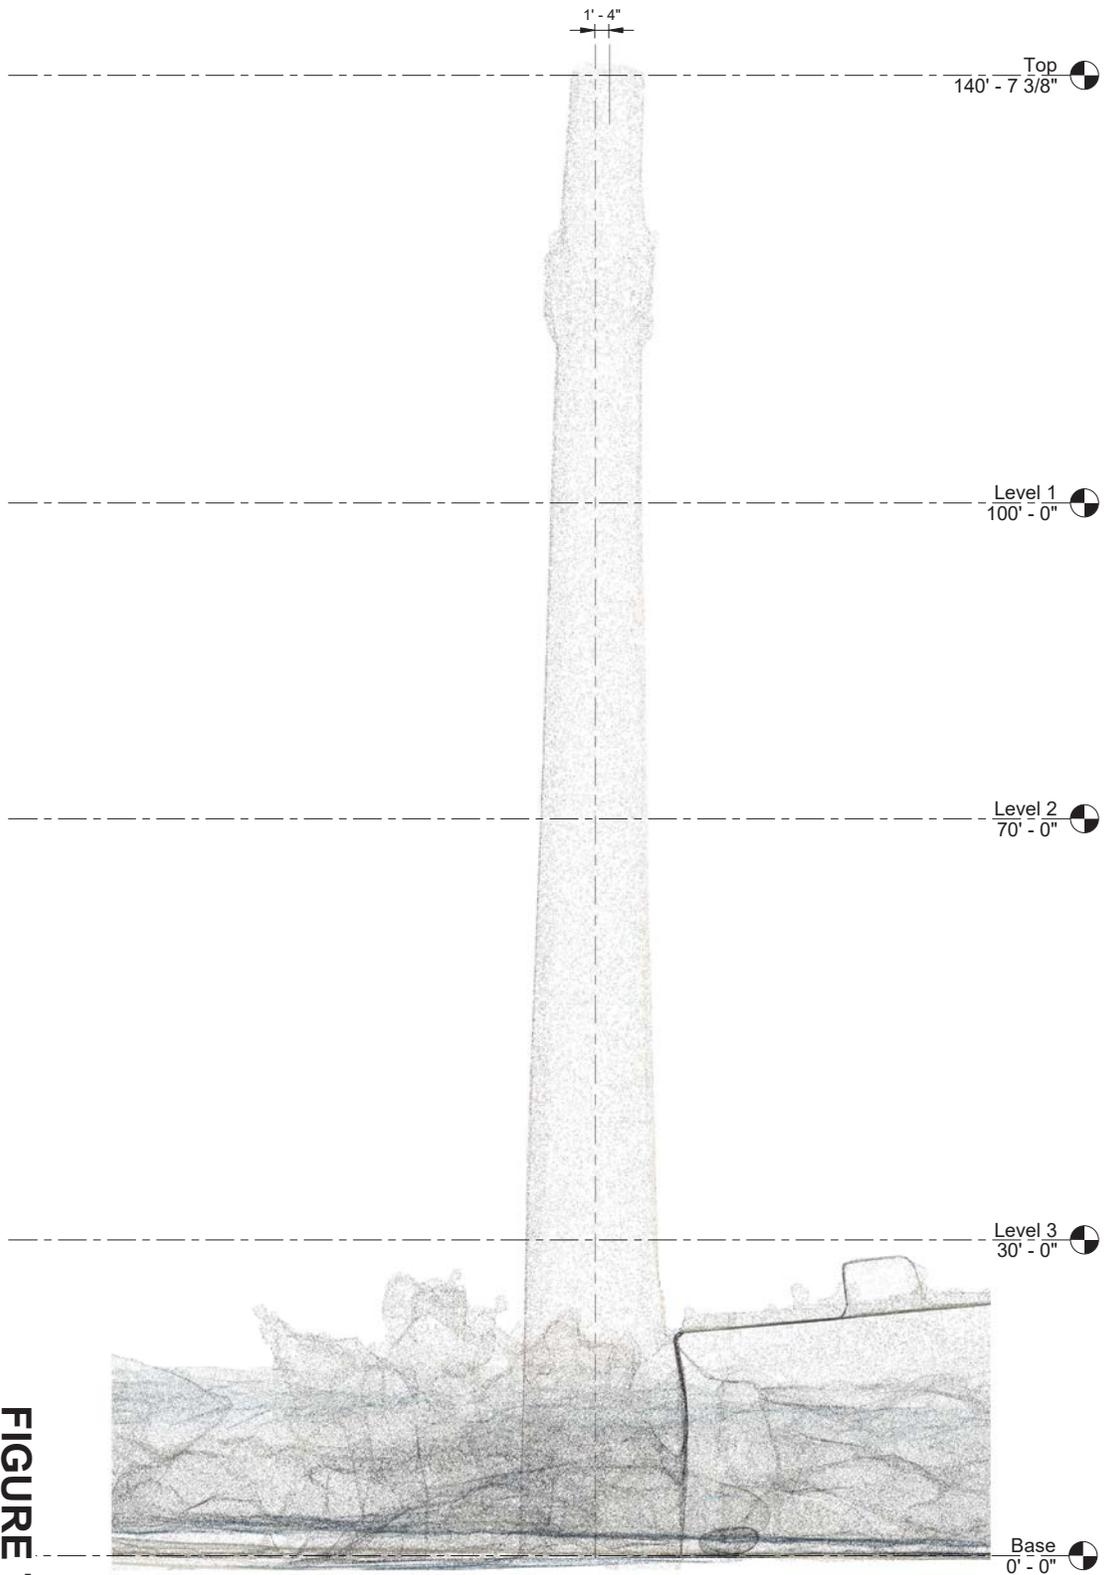
FIGURE 7a

① West Elevation
3/32" = 1'-0"

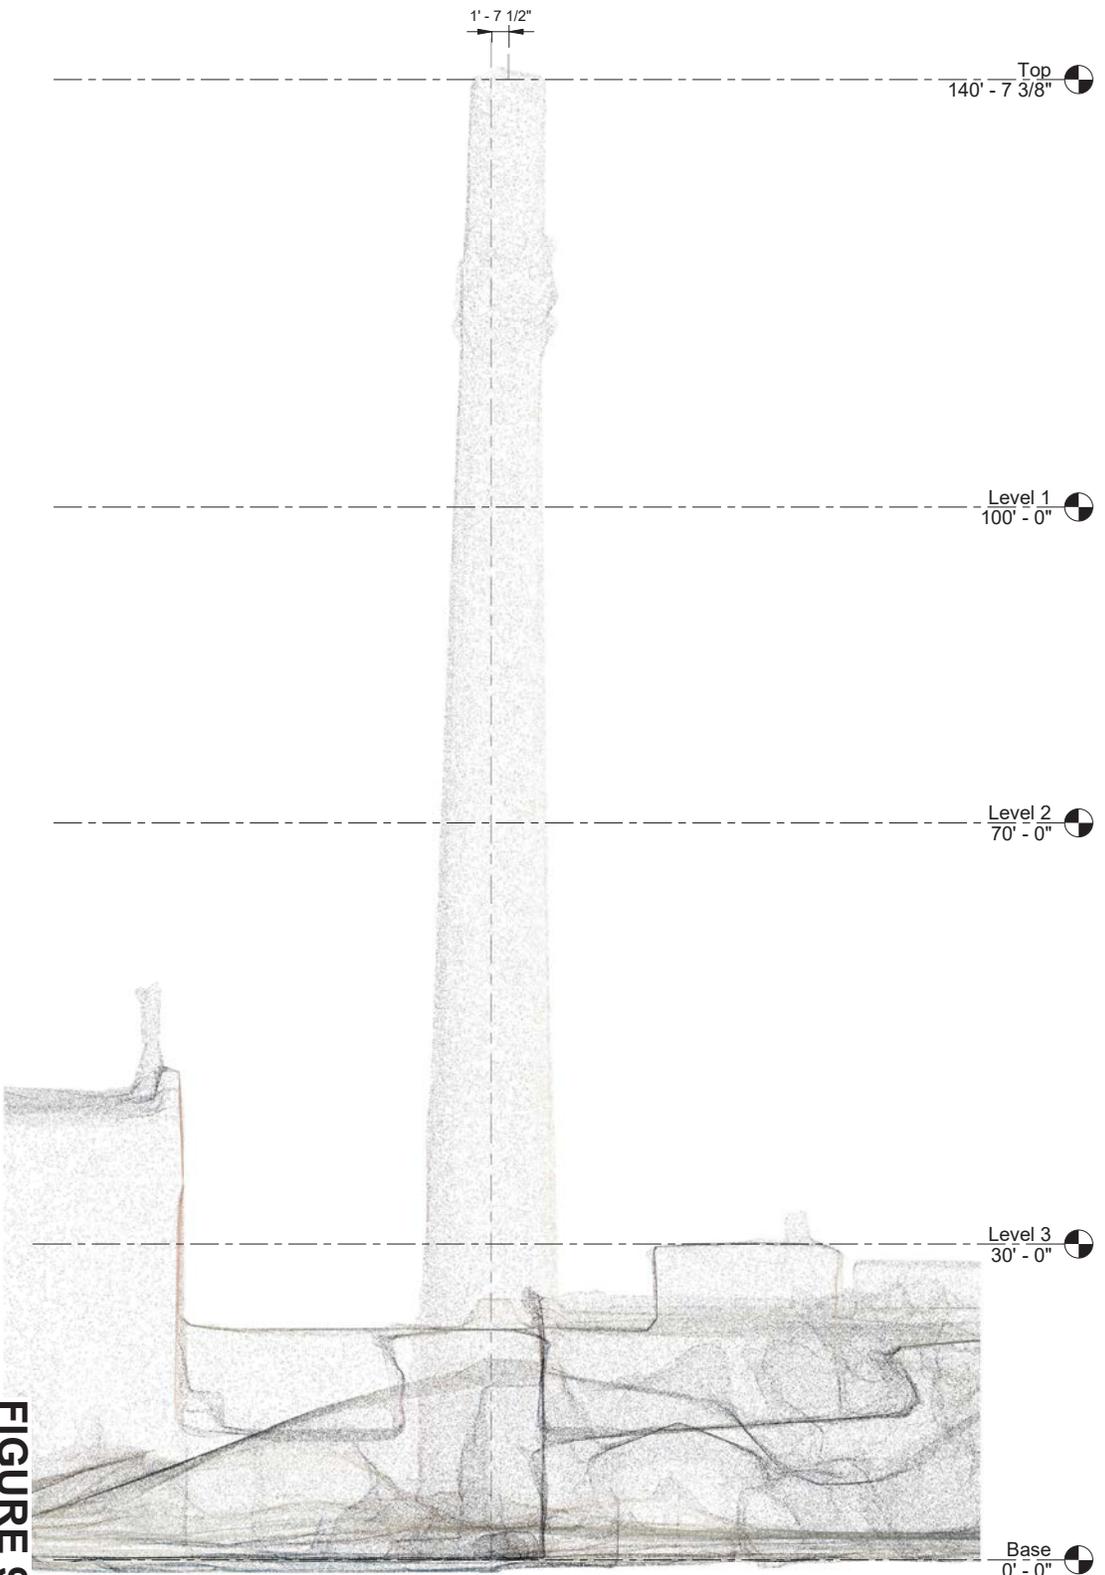
FIGURE 9a

① South Elevation
3/32" = 1'-0"

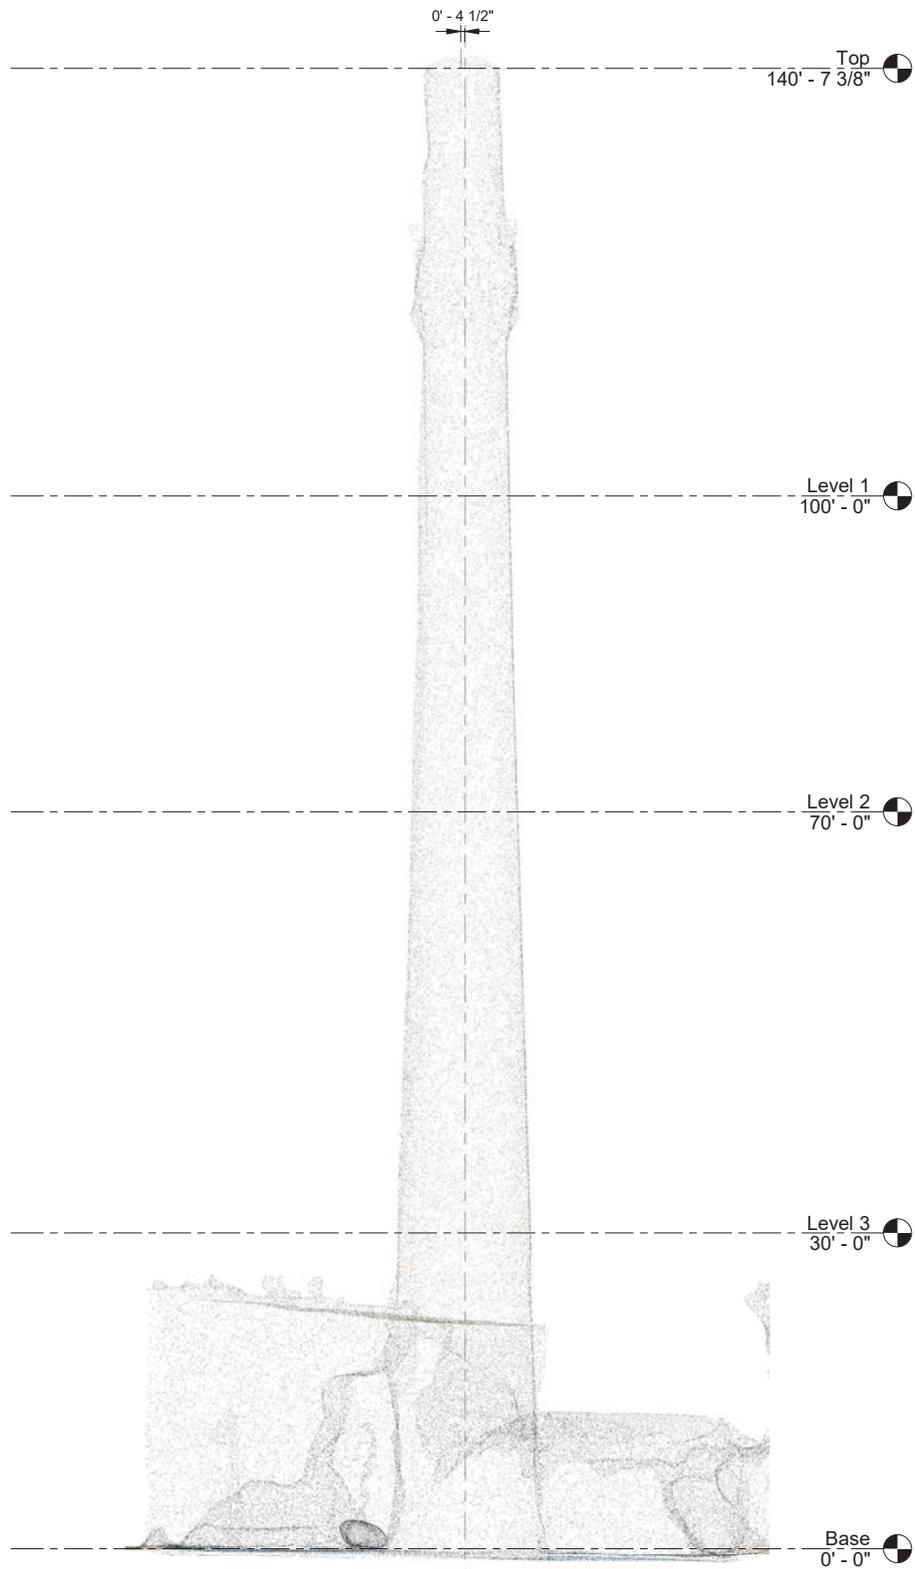
FIGURE 10a

① South East Elevation
3/32" = 1'-0"

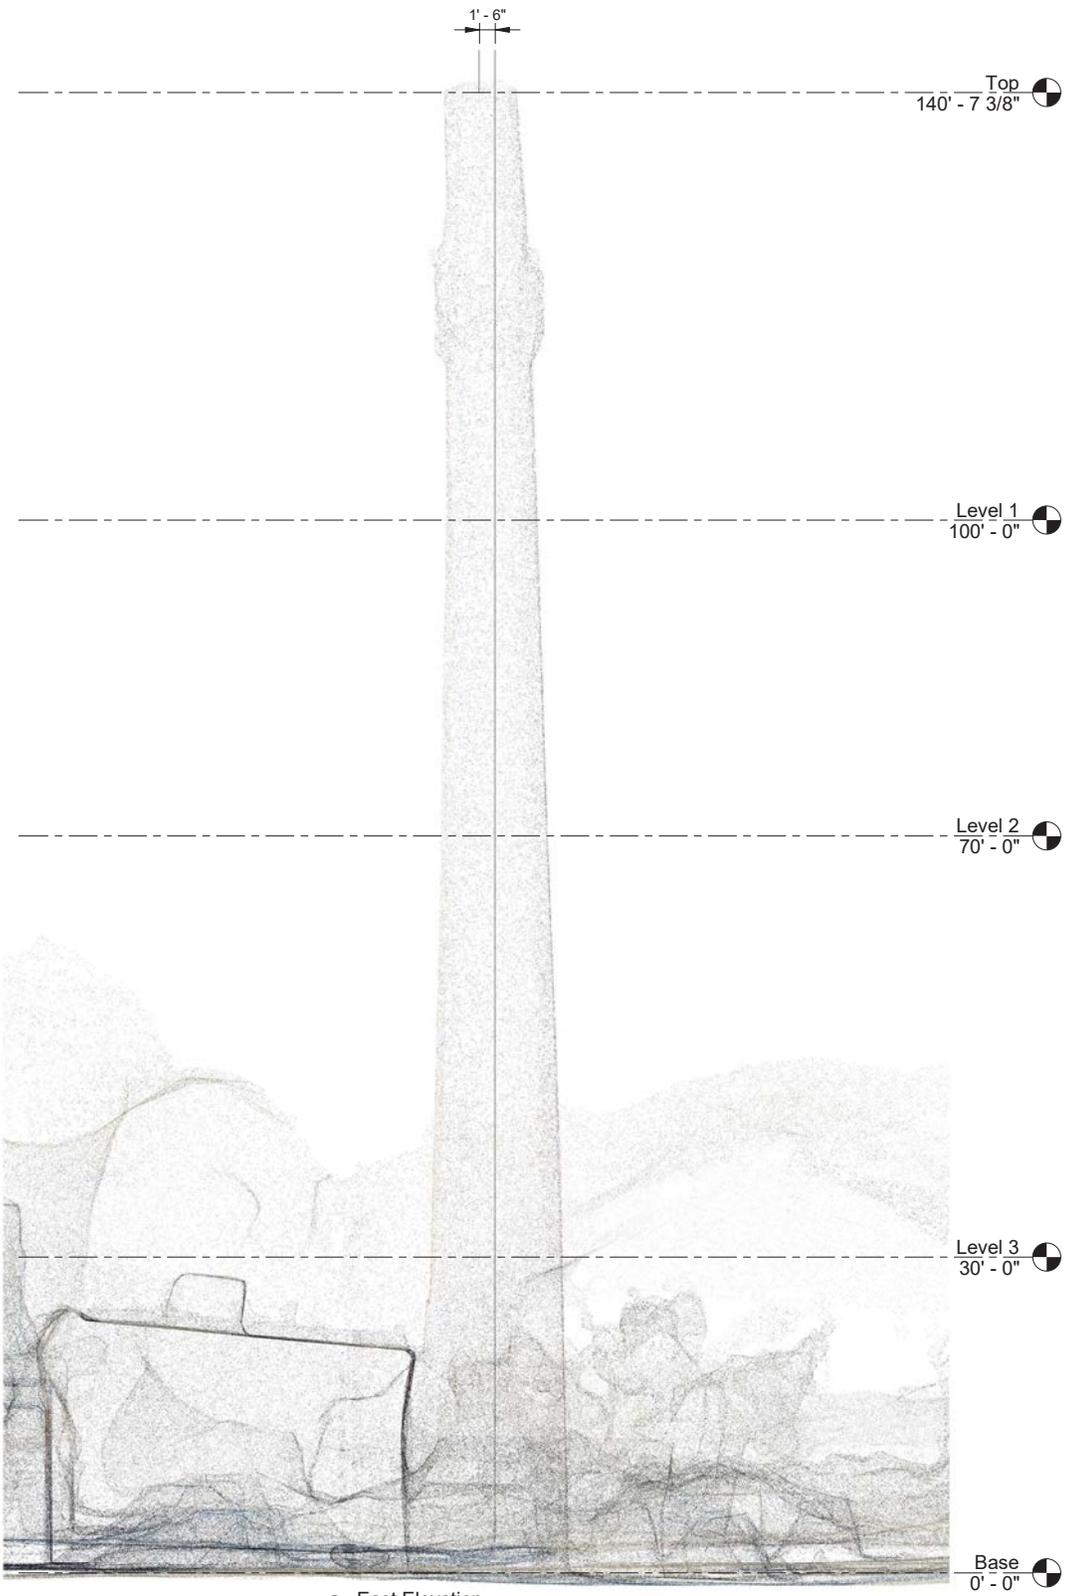
FIGURE 11a

① East Elevation
3/32" = 1'-0"

ARSEE ENGINEERS <small>CLIENT ORIENTED - BY DESIGN</small>	SINCE 1968	EAST ELEVATION	
		Project number Project Number Date Issue Date Drawn by Author Checked by Checker	R9.1 Scale 3/32" = 1'-0"
JOHNSON'S CREAMERY SMOKE STACK

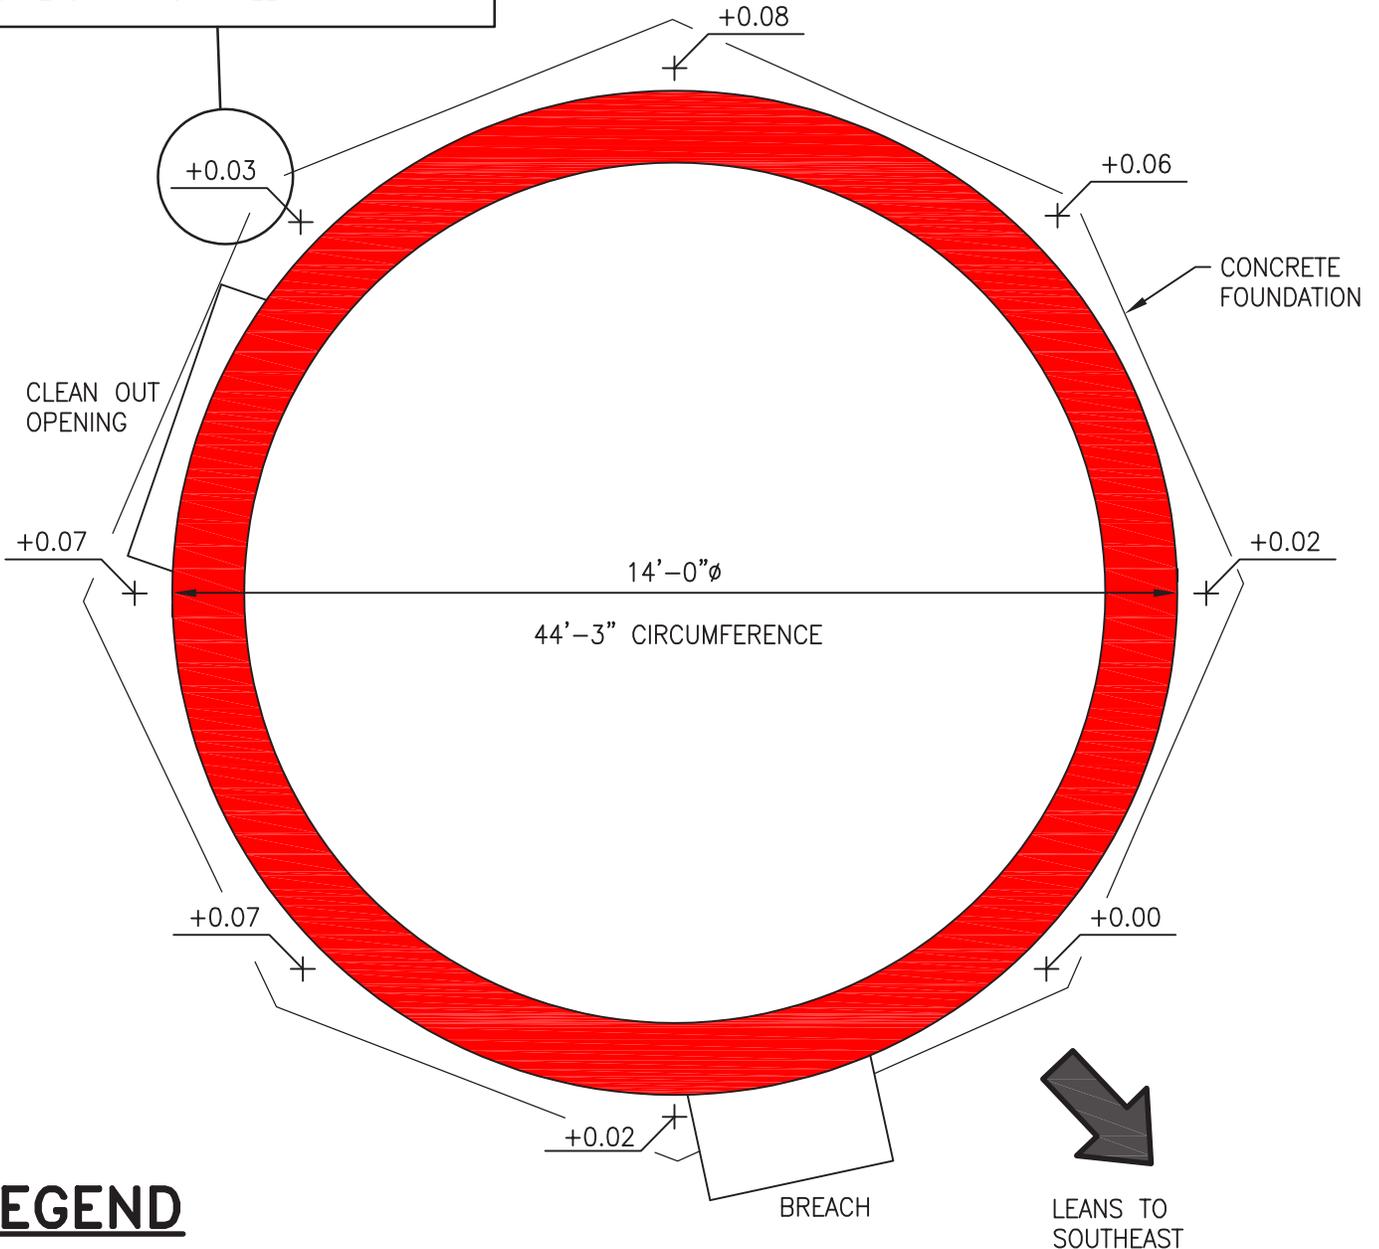
FIGURE 13

ASSUMING THIS IS AN ANOMALY, THE TOP OF THE FOUNDATION TILTS DOWN TO THE SOUTHEAST APPROXIMATELY 1".

X.XX
+ SPOT ELEVATION
IN FEET

Using a surveying level, elevations were taken at each of the eight corners of the octagonally shaped foundation. While one would not expect a foundation like this to be perfectly level there is a definite trend showing the foundation tilts to the southeast. See Figure 13. A 1 inch tilt in the 14 foot wide foundation corresponds to a 10 inch tilt out of vertical in the 140 foot tall stack. The apparent displacement of the concrete could be result of compression of a mud or clay seam in the bedrock in the southeast portion of the foundation causing it to “tilt” in that direction.

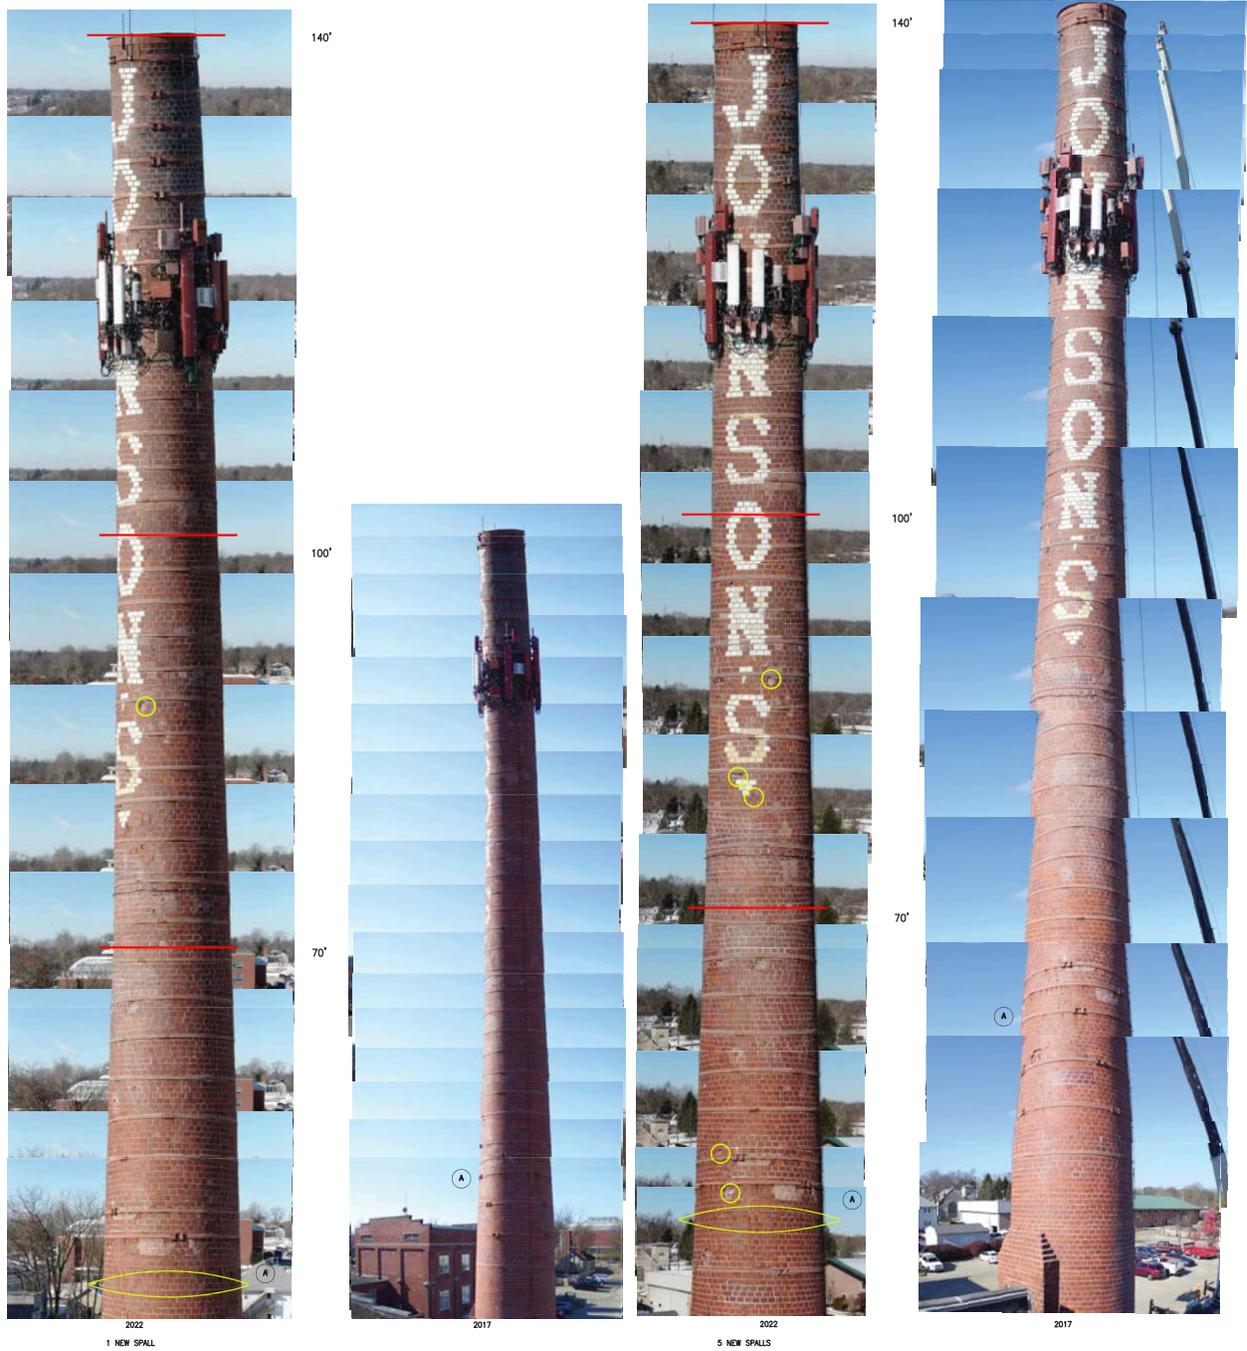
FIGURE 14

SHEET NO. S1	DRAWN BY SCALE DATE	CHECKED BY	PROJECT NO.	PROJECT NAME	DATE	JOHNSON CREAMERY SMOKE STACK 2017 - 2022 COMPARISON	CLIENT ORIENTED — BY DESIGN 9715 KINCAD DRIVE, SUITE 100 317.934-1182 PHONE FISHERS, INE0444-460374959 317.934-6590 FAX

The drone was also utilized to create a series of vertical montages of the stack from different angles. The orientation of the montages attempted to copy a similar set of montages taken in 2017 so that the two sets could be compared. See Figures 14 through 16. In 2017 we observed 38 steel bands in the stack. The 2022 montages show band #35 down from the top is now missing. R & P reported only 37 steel bands when they performed their assessment in 2020 and noted there was evidence of one missing. Photos 3 and 4 show this location in 2017 and 2022. Rust stains and a bead of sealant are visible in the 2022 photo where the band was located.

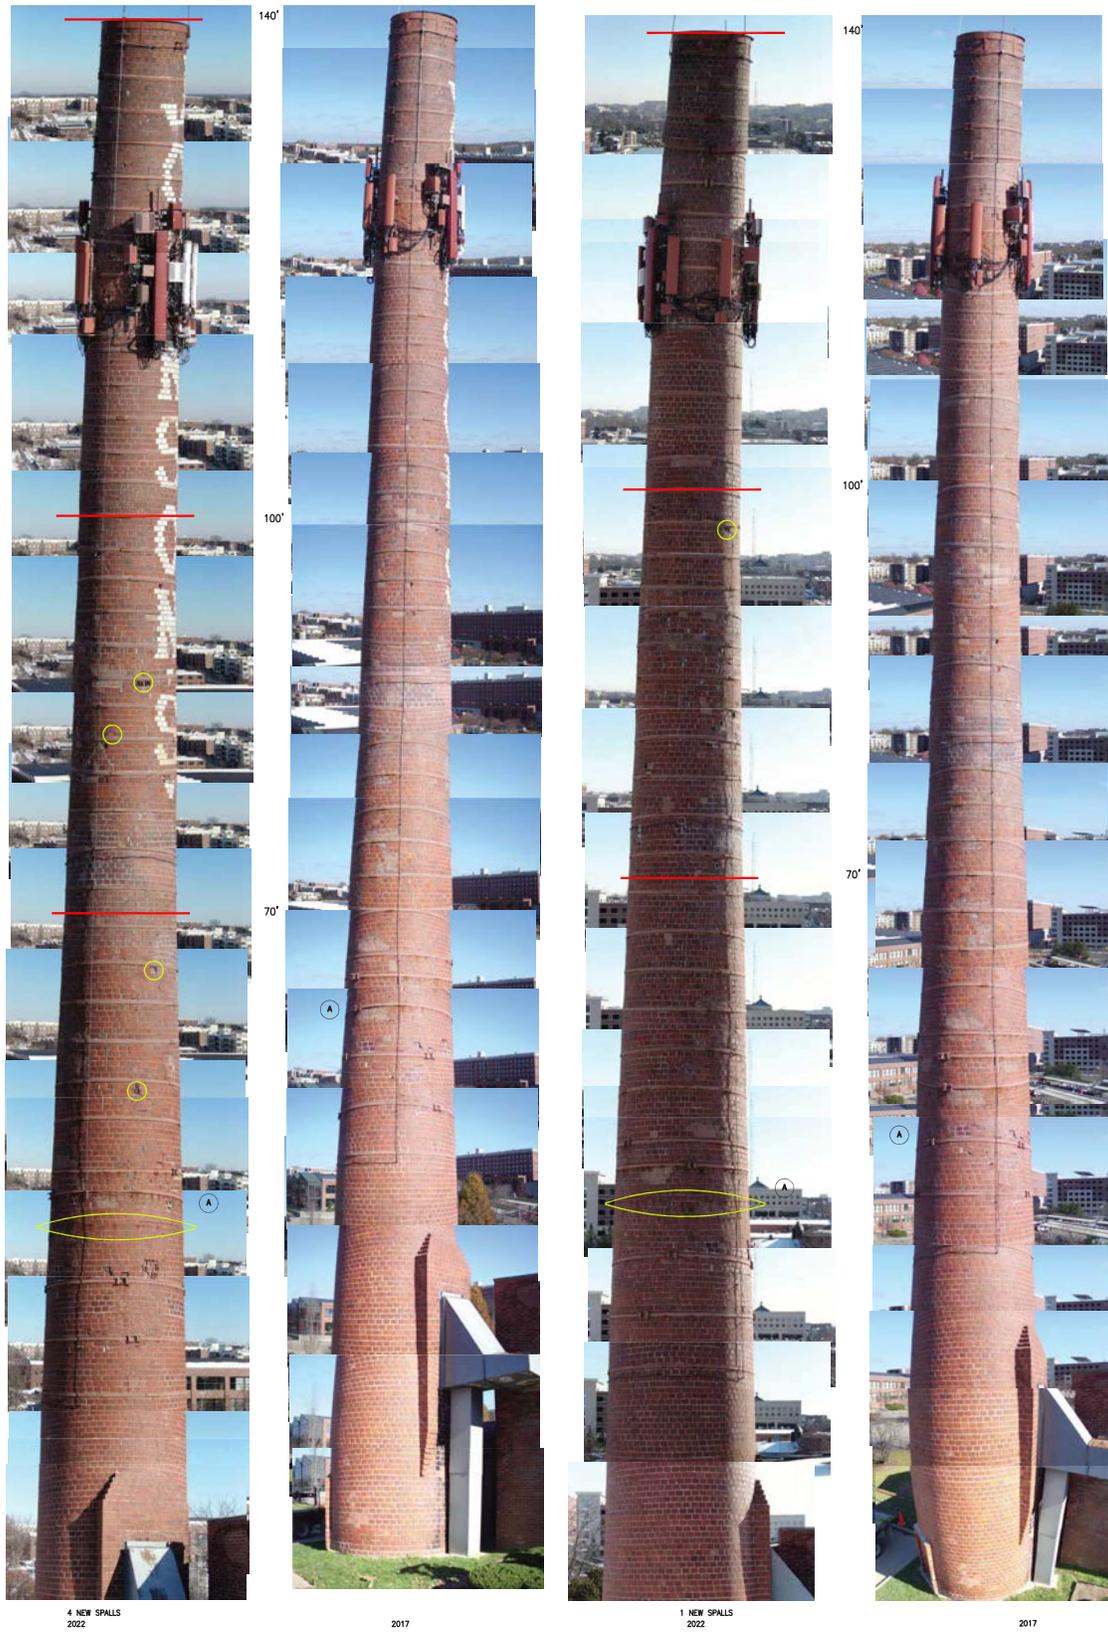
FIGURE 15

4 NEW SPALLS
2022

1 NEW SPALLS
2022

SHEET NO. S2	DRAWN BY DATE	CHECKED BY DATE	SCALE	TITLE SOUTH AND SW ELEVATIONS	NO.	REVISION	DATE	JOHNSON CREAMERY SMOKE STACK 2017 - 2022 COMPARISON	ARSEE ENGINEERS, INC. CLIENT ORIENTED — BY DESIGN 9715 KINCAD DRIVE, SUITE 100 317.934.4152 PHONE FISHERS, INDIANA 46037-4959 317.594.9590 FAX

Evidence of spalling was also compared between the 2017 and 2022 montages. There are 11 locations in 2022 where new spalling is visible. These generally occur in the south to southwest face of the stack between 60 and 100 foot levels. Examples are shown in Photos 5 and 6. Face shell spalling was also more evident at the foundation as shown in Photos 7 and 8.

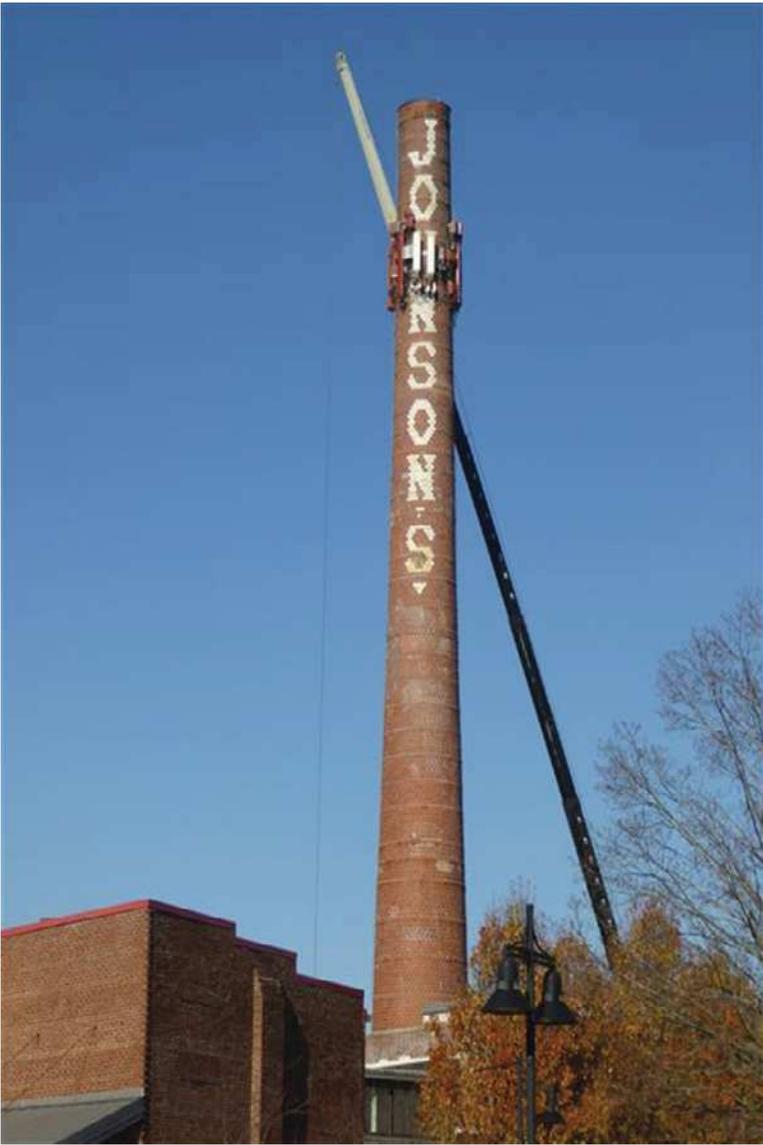
Overall view from the southeast.

This assessment has been limited to the masonry smokestack of the Johnson's Creamery facility in Bloomington, Indiana. The current stack is approximately 140 feet tall based upon measurements taken in the field and has a total of 38 steel bands encircling it as shown in Photo 1 and Figure 1. The "Johnson's" logo is prominently visible facing to the southeast. A review of the literature reveals the oldest portion of the Johnson's Creamery facility dates back to 1913 – 14. Photographs from the Monroe County Historical Society from the period of 1921 to 1943 show an earlier stack which has a slightly different configuration at the top and does not have the Johnson's logo. See Figures 2 through 4. A National Register nomination in 1995 reports "The current 178 foot smokestack replaced an earlier one in 1949." This nomination is included as Appendix A.

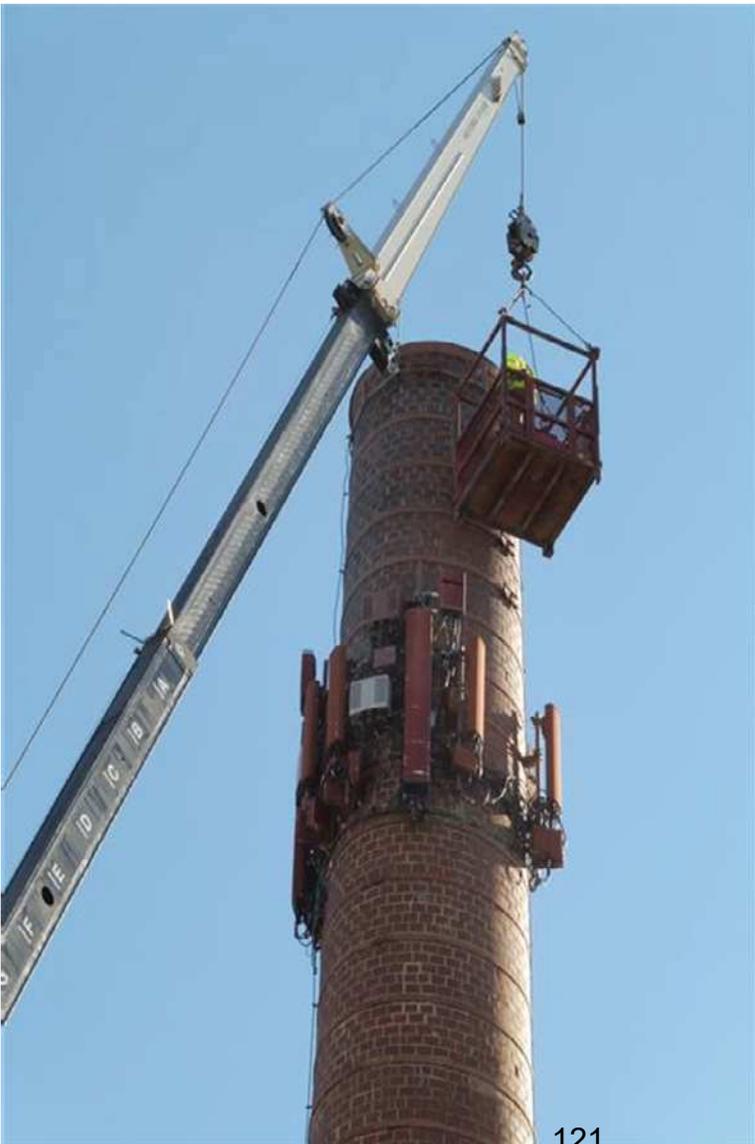
Photo 2

Close up observations were made from a crane and basket.

A visual assessment was performed on November 22nd. A 50 ton crane and man basket were used to observe and photograph the stack up close. Still and video images were recorded using a DJI Matrice 600 Pro drone. See Photos 2 through 4. Mortar samples were taken of both the original and repair mortars and are available for further analysis as the need may arise. A series of holes were drilled to a depth of two inches throughout the height of the stack to get a feel for the relative hardness of the mortar. No further testing or sampling was performed. A steel grate welded over the opening at the base of the stack prevented observation of the interior.

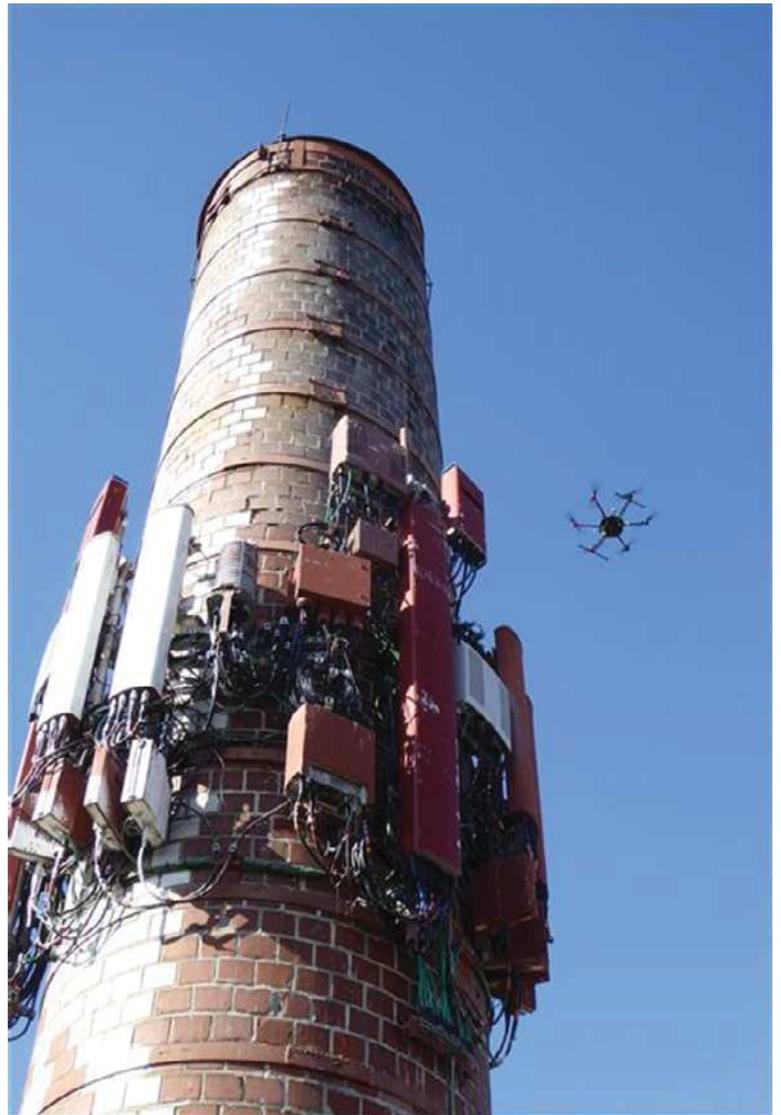
Photo 3

Video and still images were recorded with a drone.

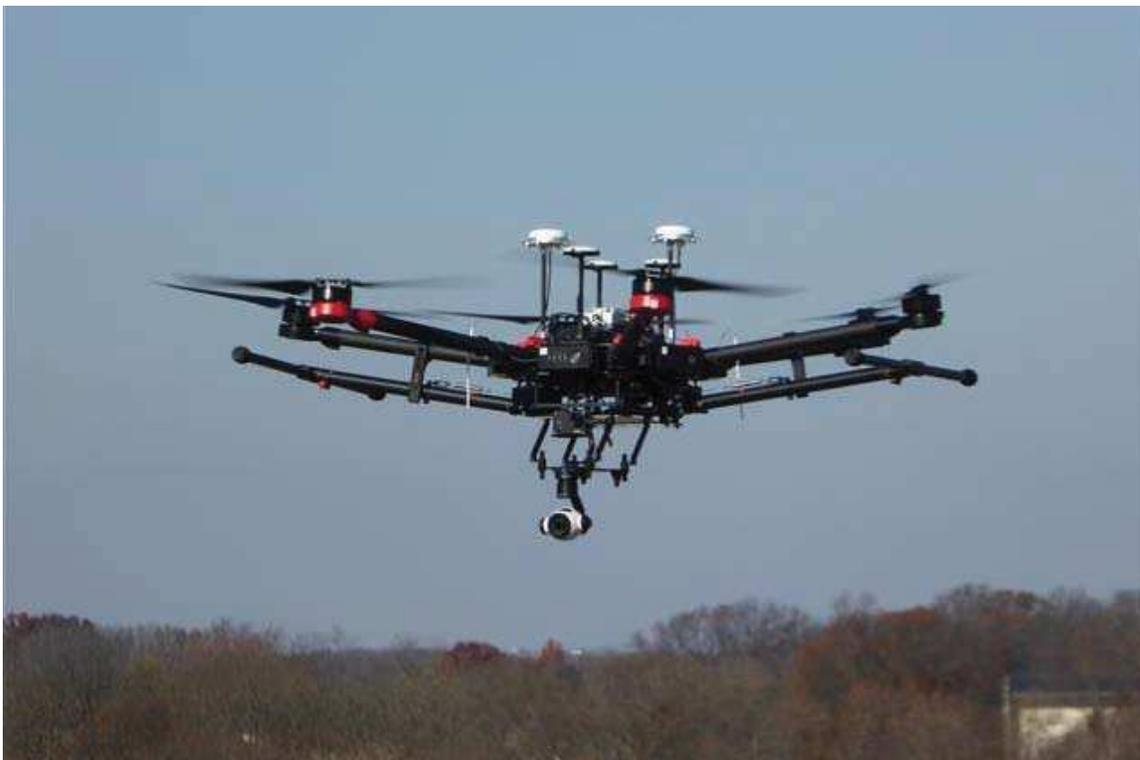
Photo 4

Close up of the drone.

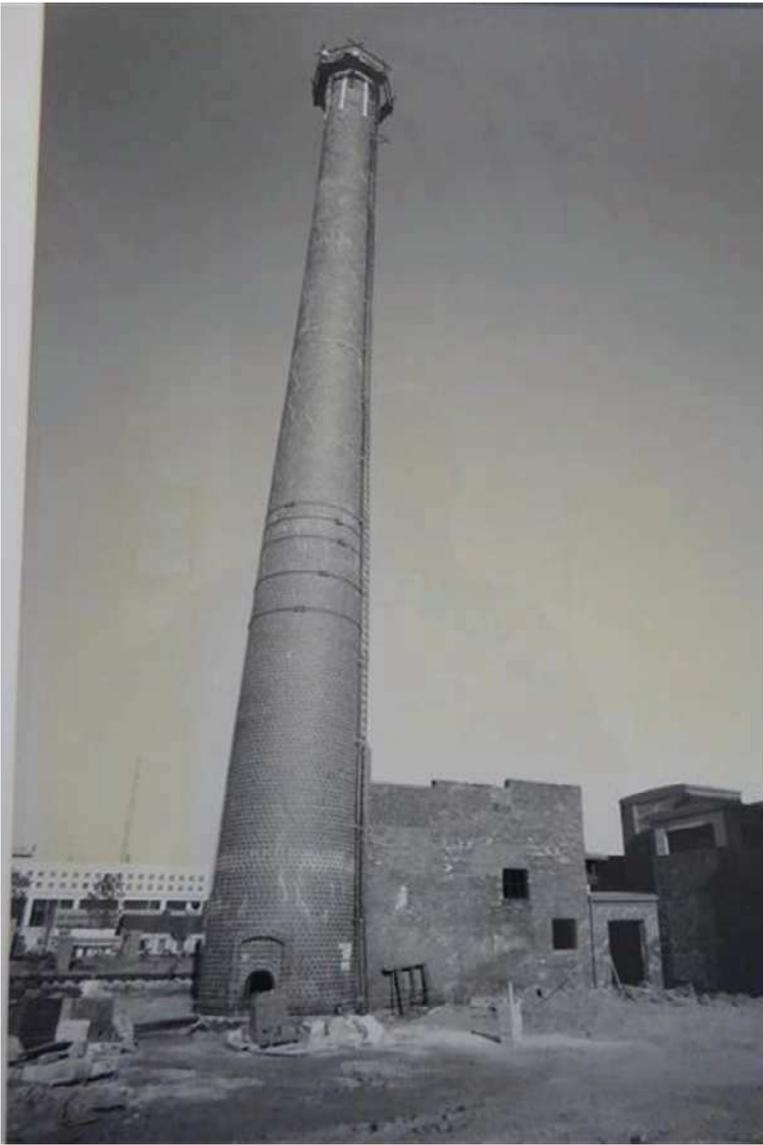
Photo 5

Historic photo (unknown year). It appears repairs are being made throughout the height of the stack. Bands 33 through 37 are visible...

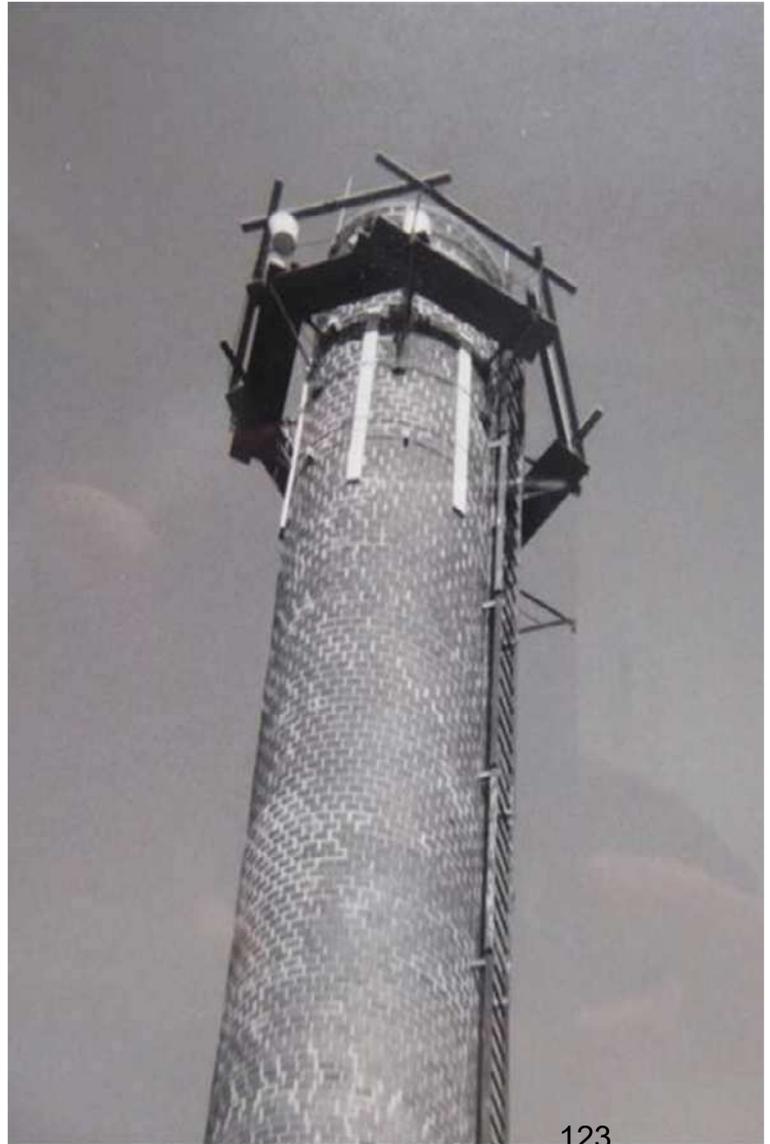
Photo 6

...and several bands have been installed at the top. The “larger” white mortar joints have been tuckpointed.

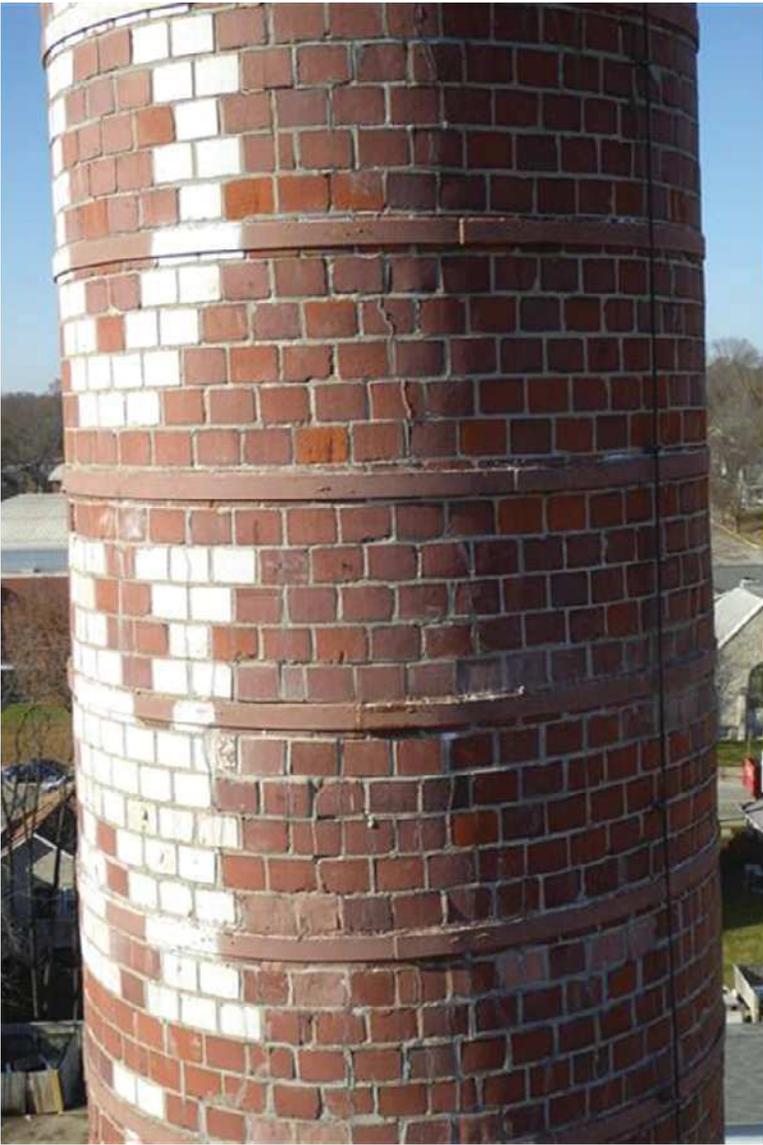
Photo 7

A total of 38 steel bands are currently in place on the stack.
