BHPC MEETING PACKET

Thursday March 24, 2022

Bloomington Historic Preservation Commission Meeting

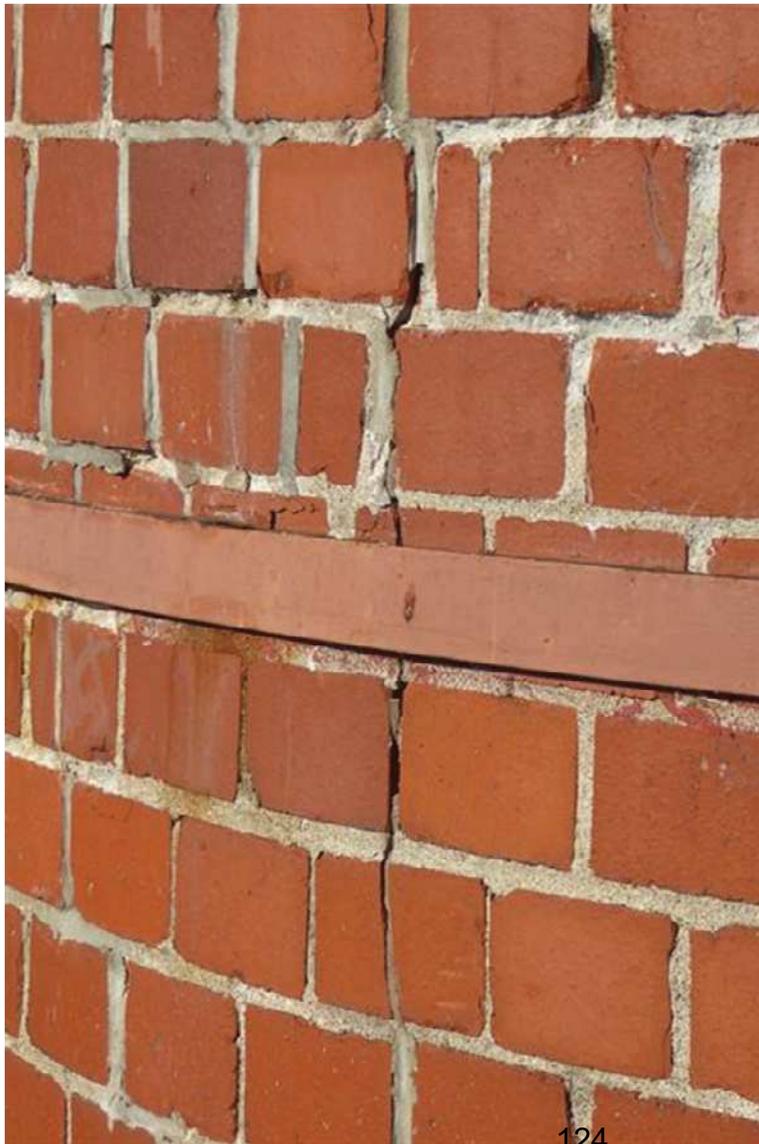
Photo 8

These were installed to address vertical cracking which occurs throughout the upper 100 feet of the stack.

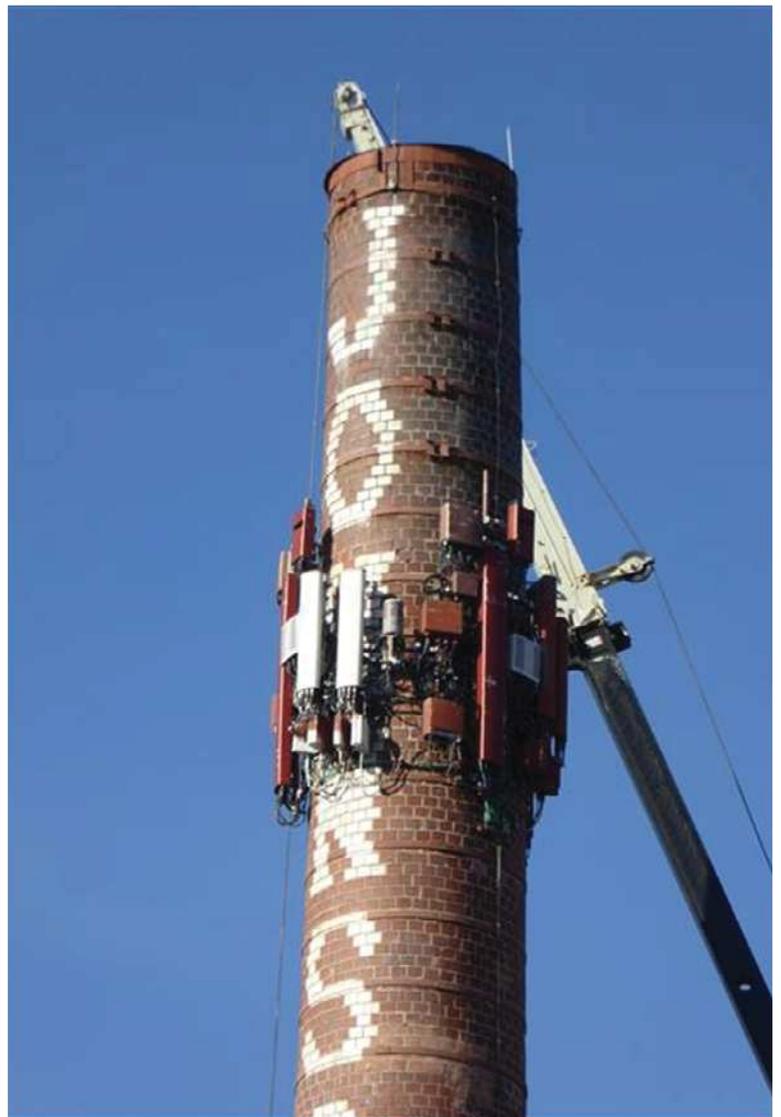
Photo 9

Closer view of bands and cell phone equipment in the upper portion of the stack.

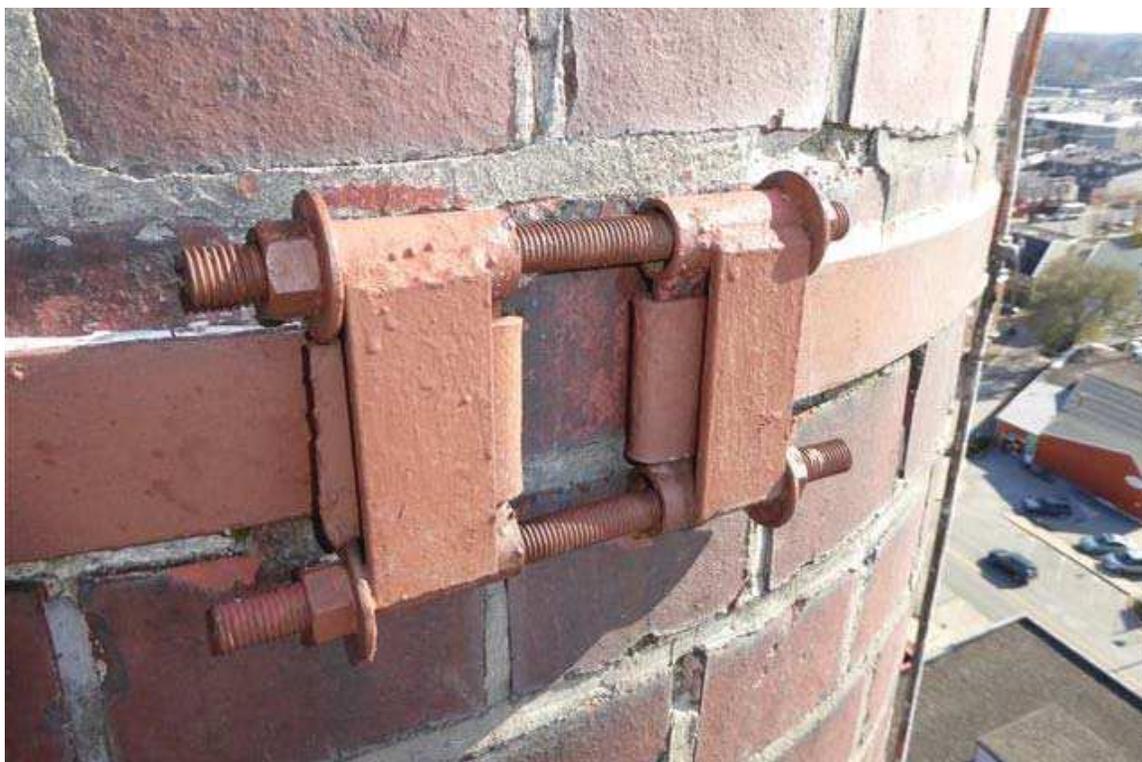
Photo 10

The 1/4 x 4 inch steel bands are secured with two, 3/4 inch diameter bolts.

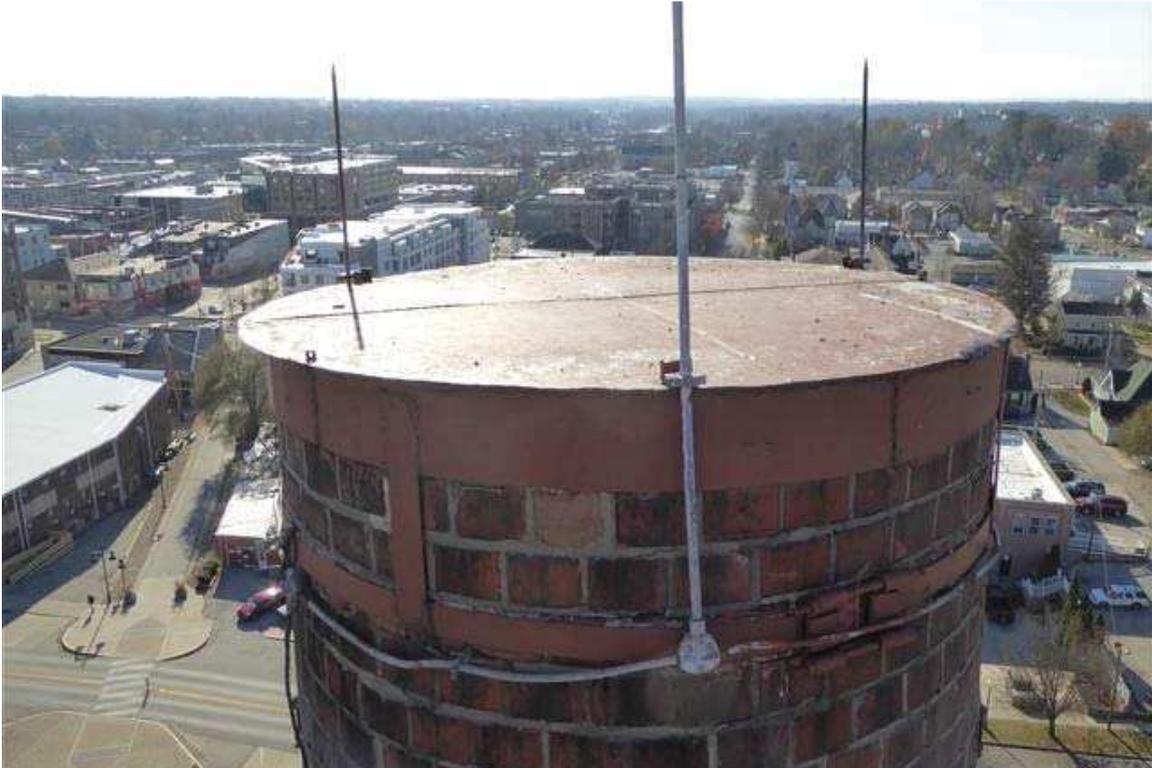
Photo 11 The top of the stack has been capped with a steel plate.

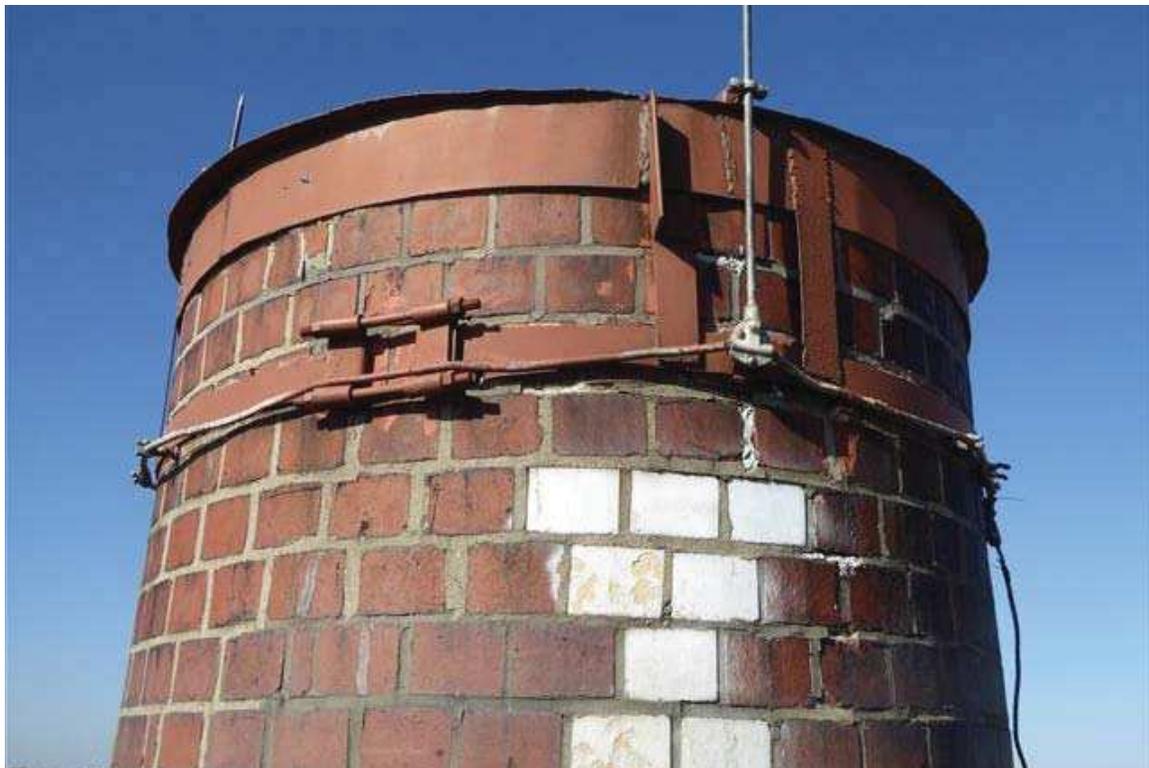
Photo 12 This prevents rain from falling inside but promotes freeze/thaw deterioration due to the “chimney effect” where warm, moist air rises and condenses on the inside face of the masonry.

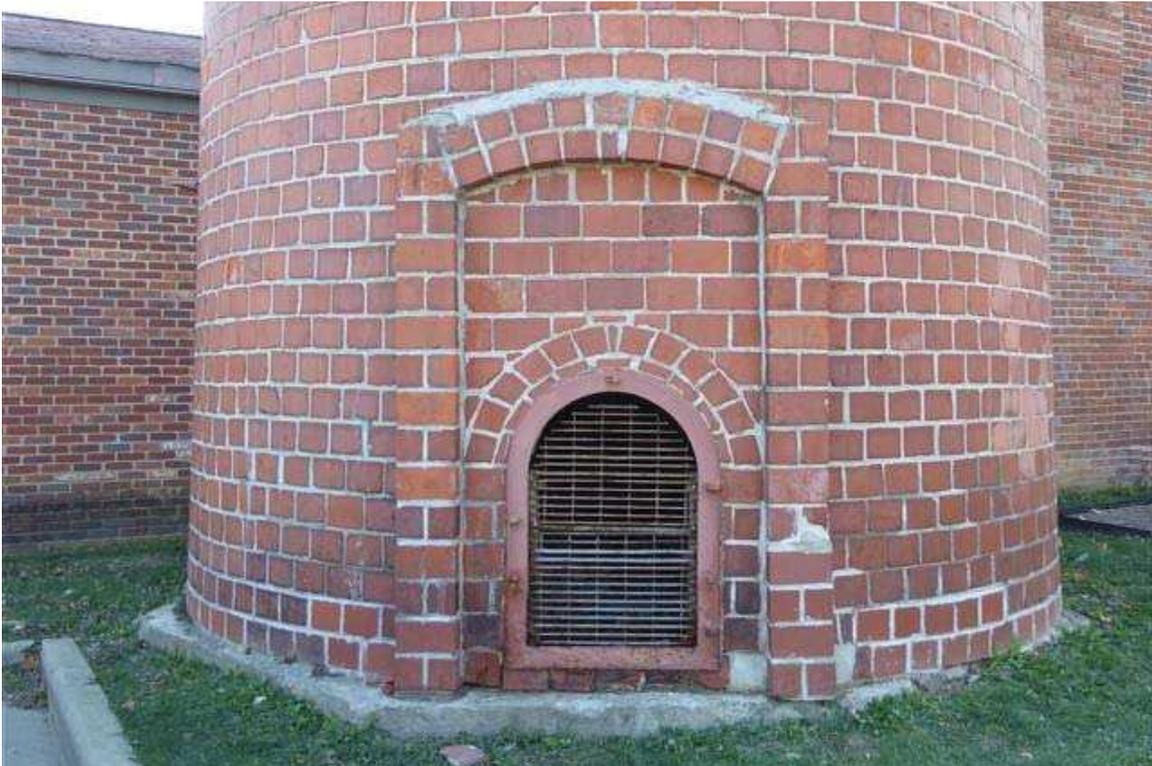
Photo 13 Opening at the base of the stack.

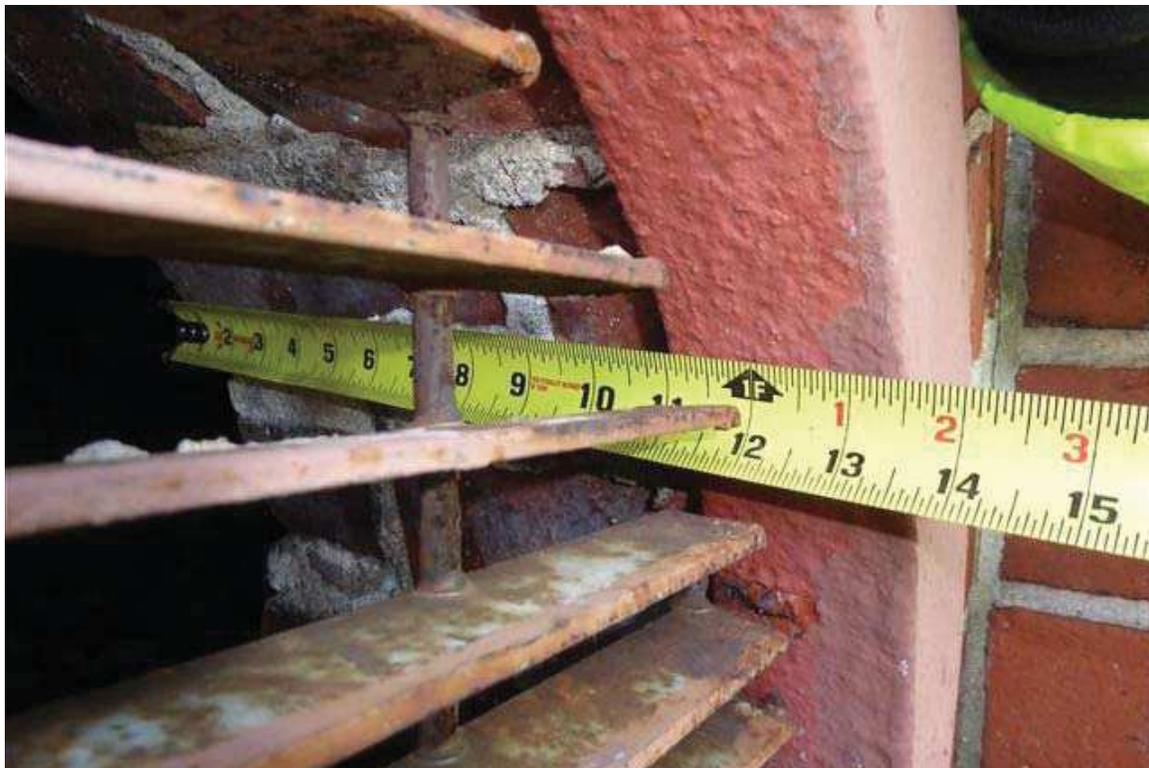
Photo 14 Wall thickness at the opening is 13 inches or 3 wythes of brick. This flares out to 5 wythes of brick or 20 inches in thickness on the sides of the opening.

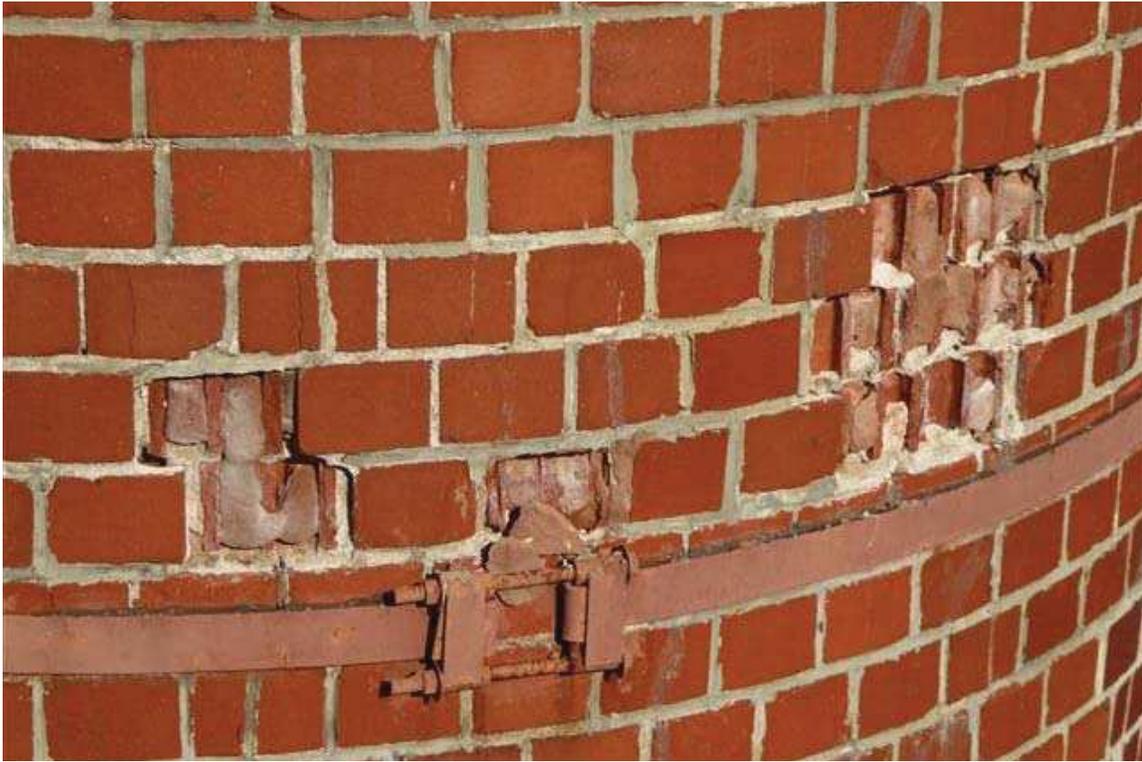
Photo 15

Faces of the brick have spalled in multiple locations.

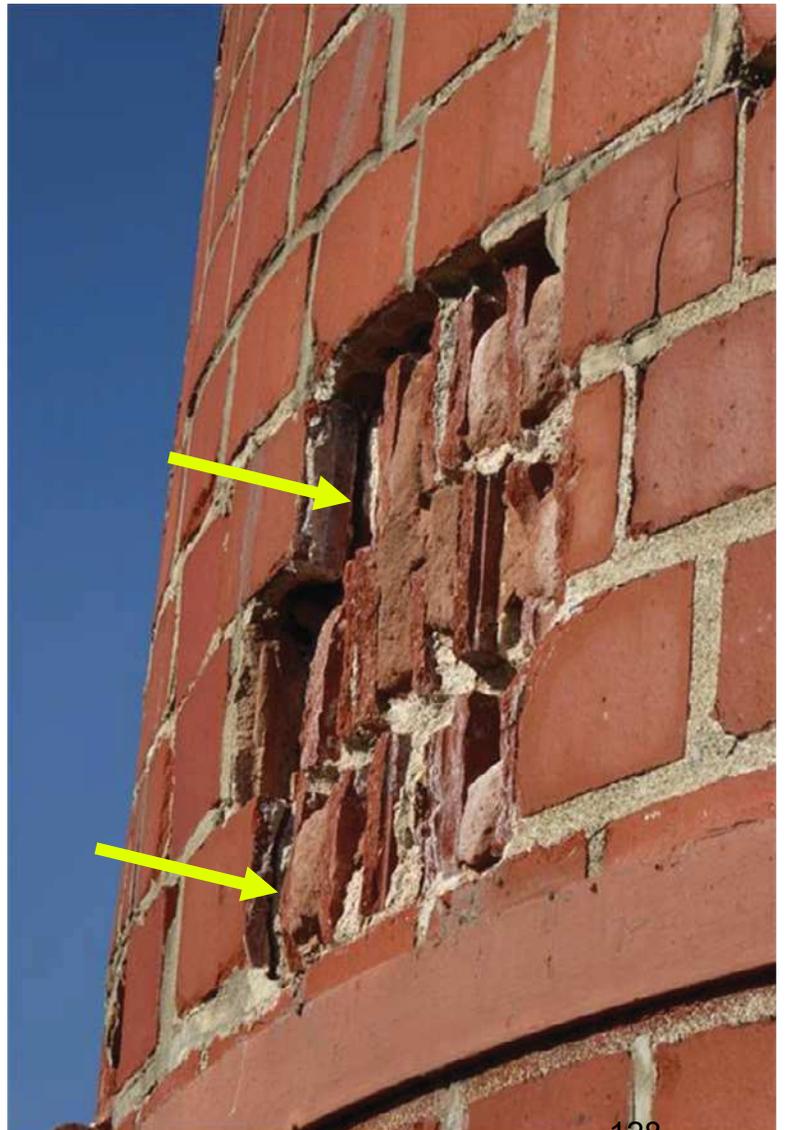
Photo 16

Splitting cracks running parallel to the face of the brick are visible adjacent to the "hole."

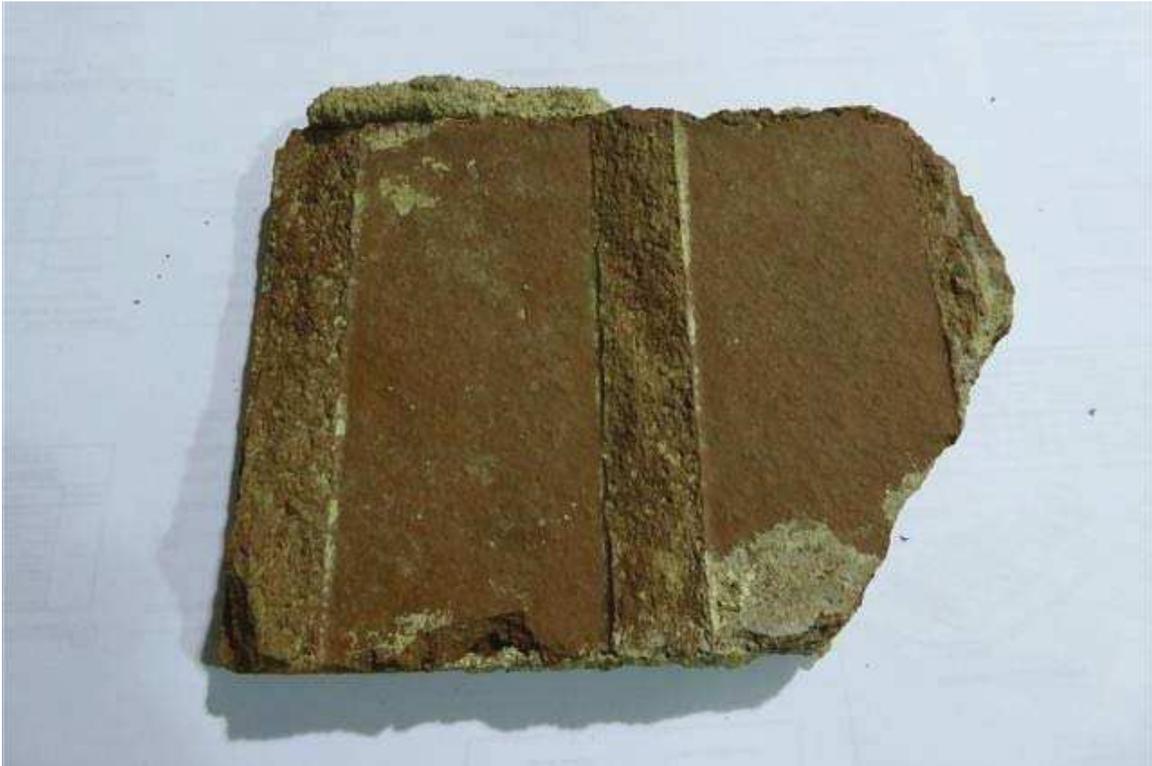
Photo 17 Interior face of a shard found on the ground.

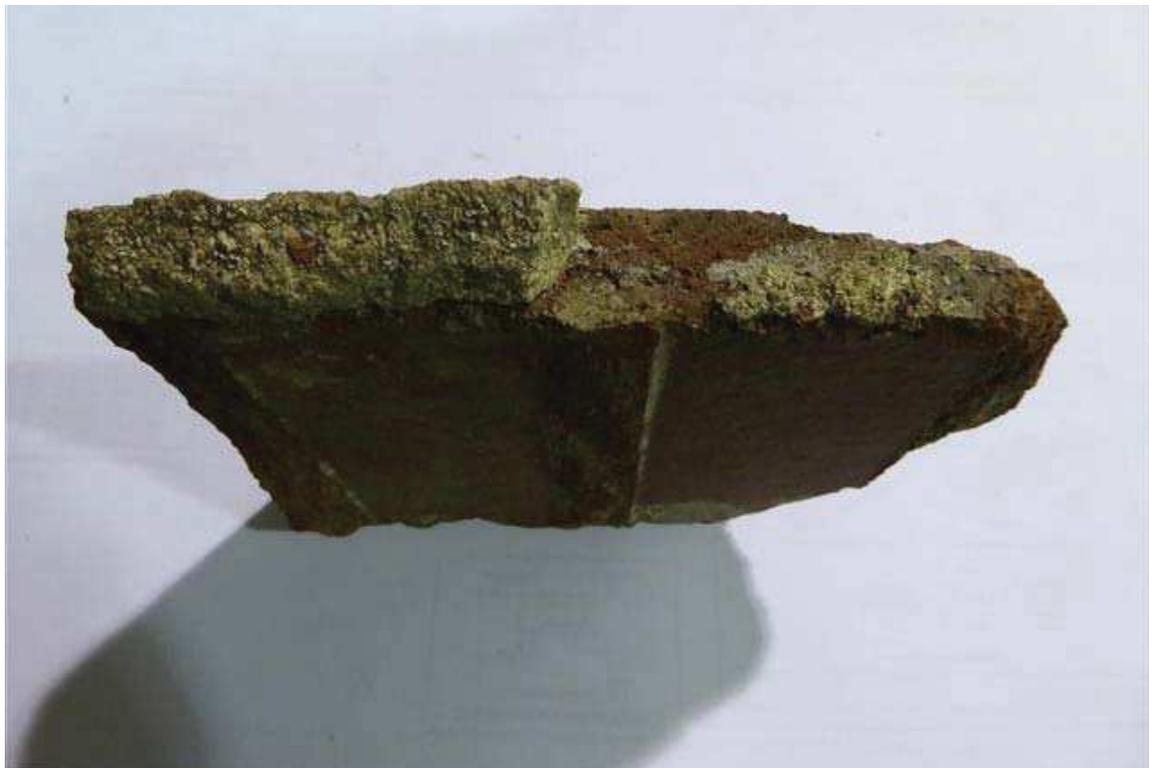
Photo 18 The outer face shell is only 3/4 inches thick.

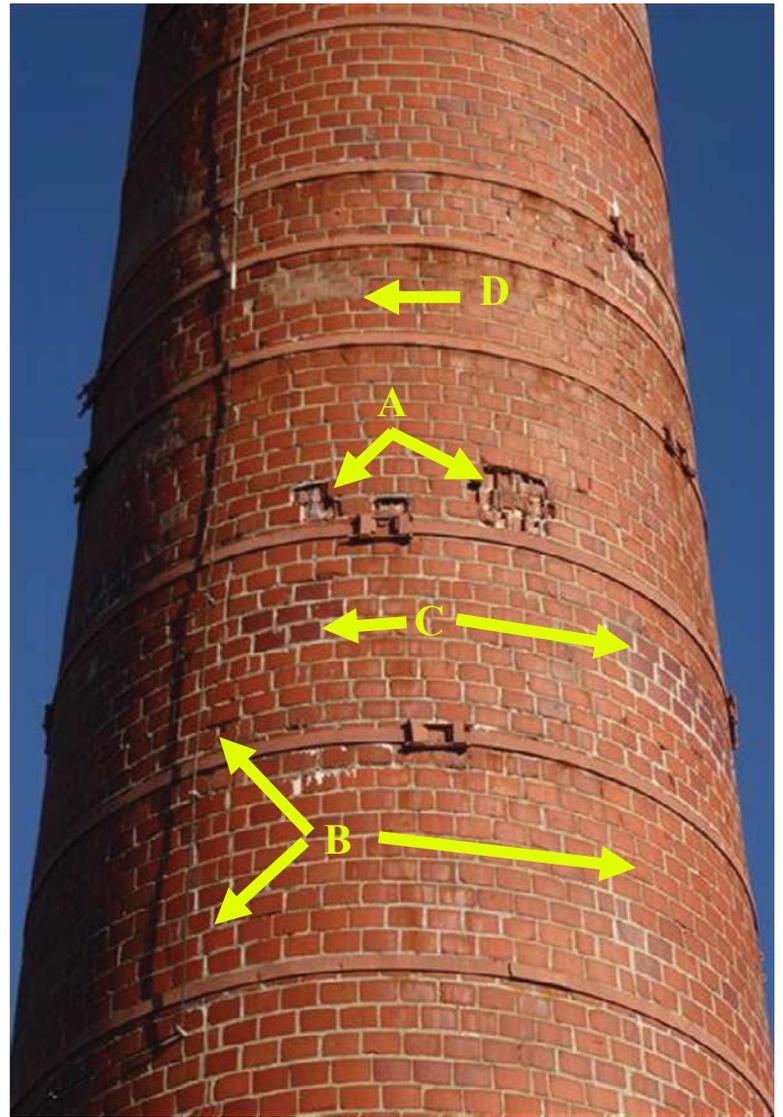
Photo 19

C=Spalled areas where brick were replaced with brick

D=Spalled areas where brick were replaced with patching compound

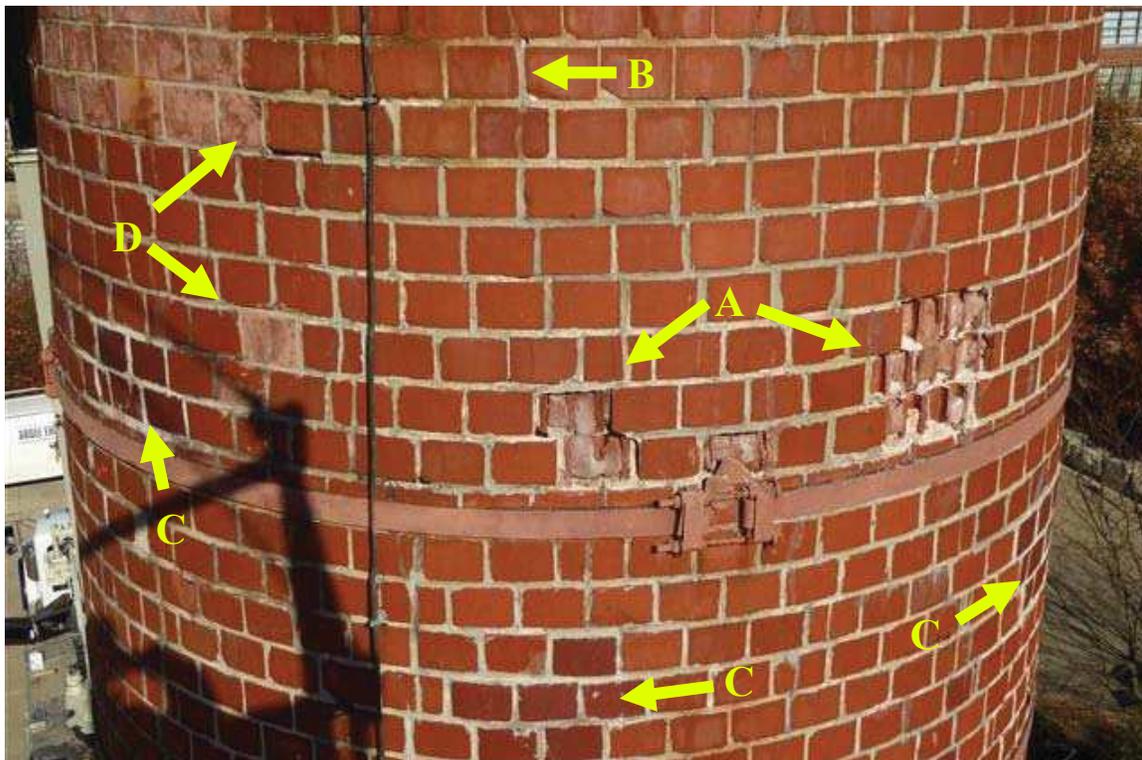
Photo 20

Closer view of these conditions.

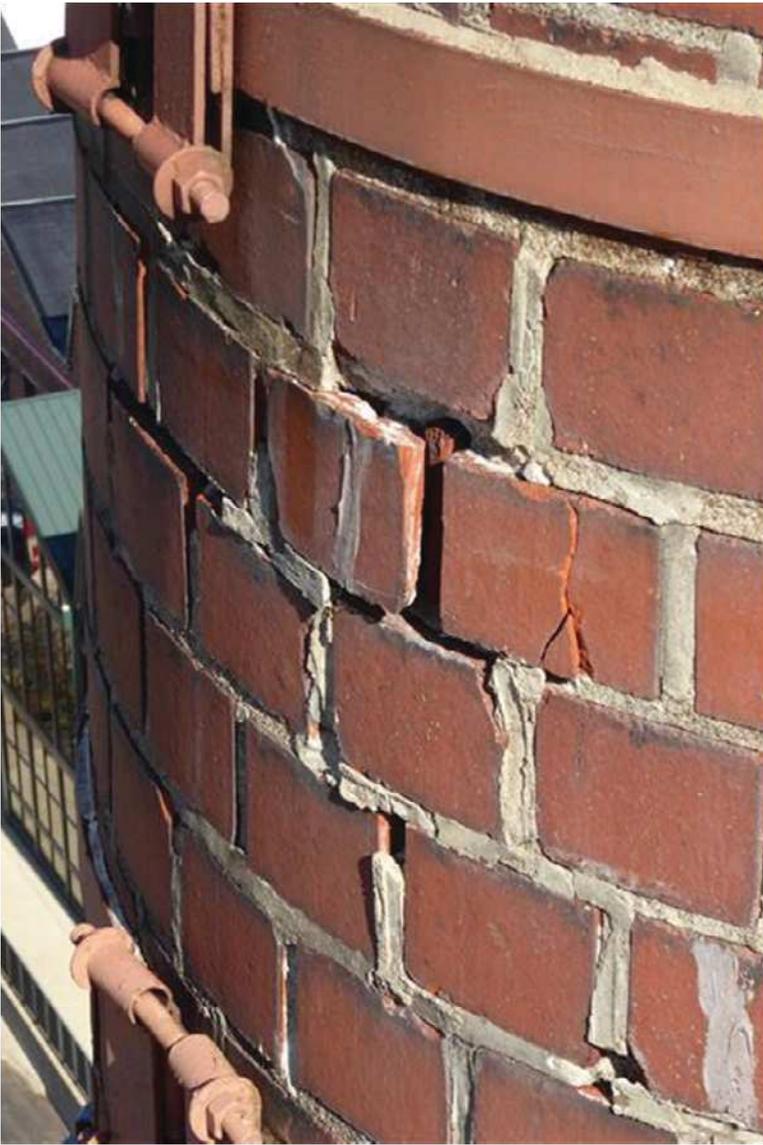
Photo 21

Loose shards of brick up higher in the stack.

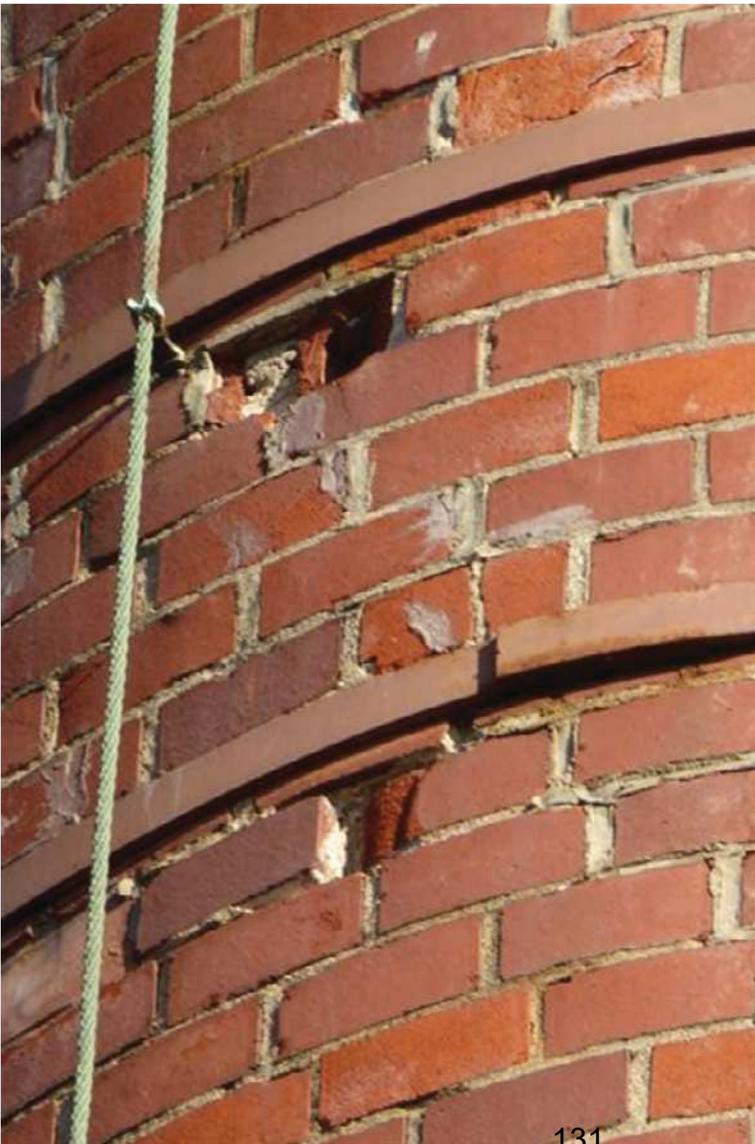
Photo 22

Such shards and spalls occur adjacent to longer vertical and/or stair step cracks.

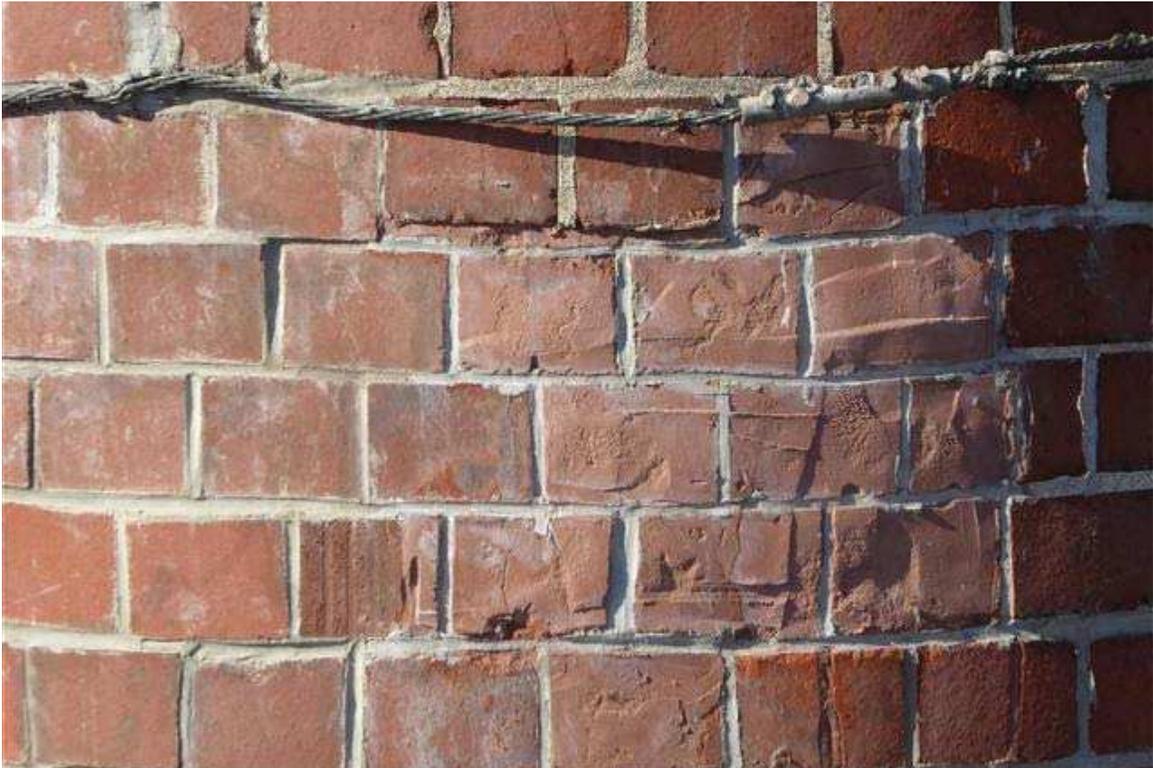
Photo 23 Cementitious patches have been used to replace spalled brick in numerous locations.

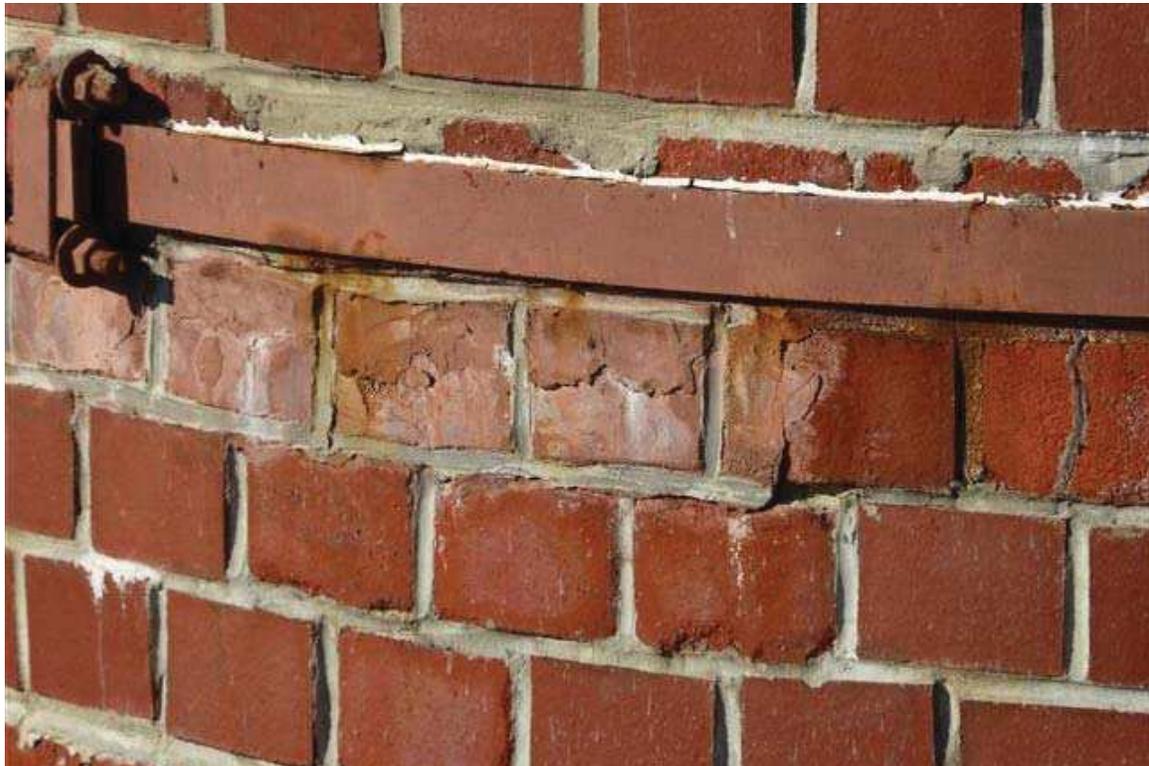
Photo 24 The patching material cracks and falls away itself.

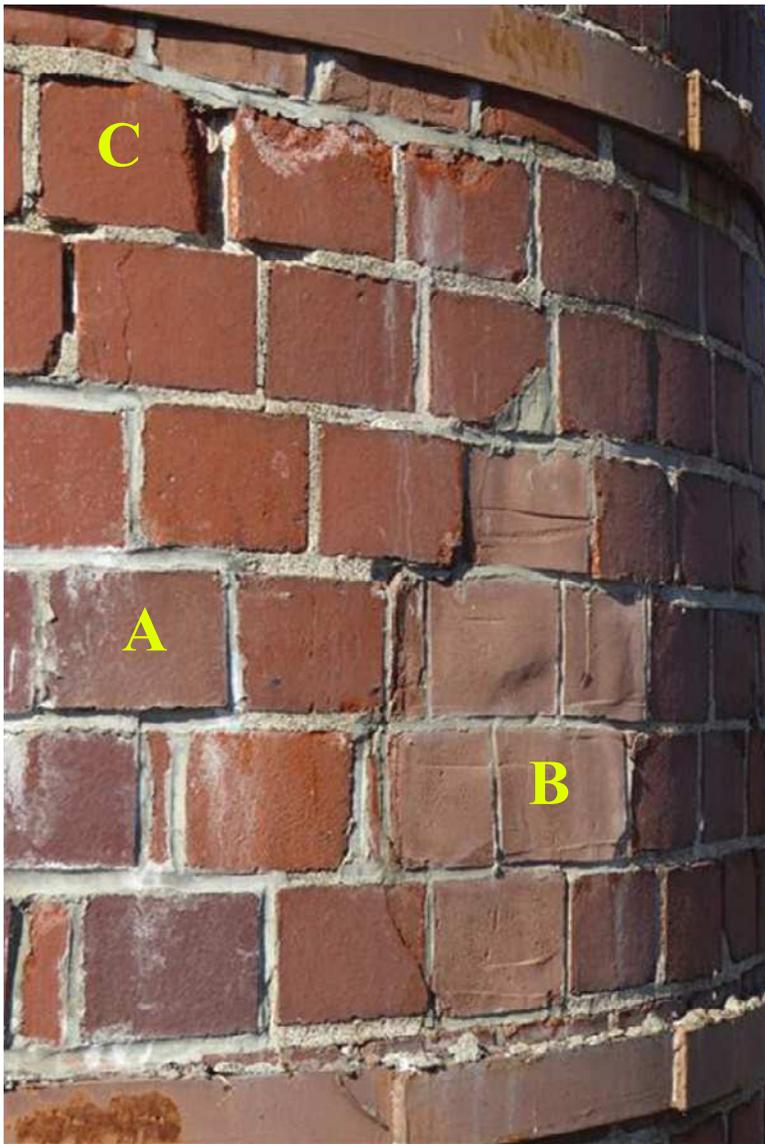
Photo 25

Area where multiple repairs have been made (probably at different times).

A=Brick were replaced with brick
B=Brick were patched
C=Eroded joints were tuckpointed

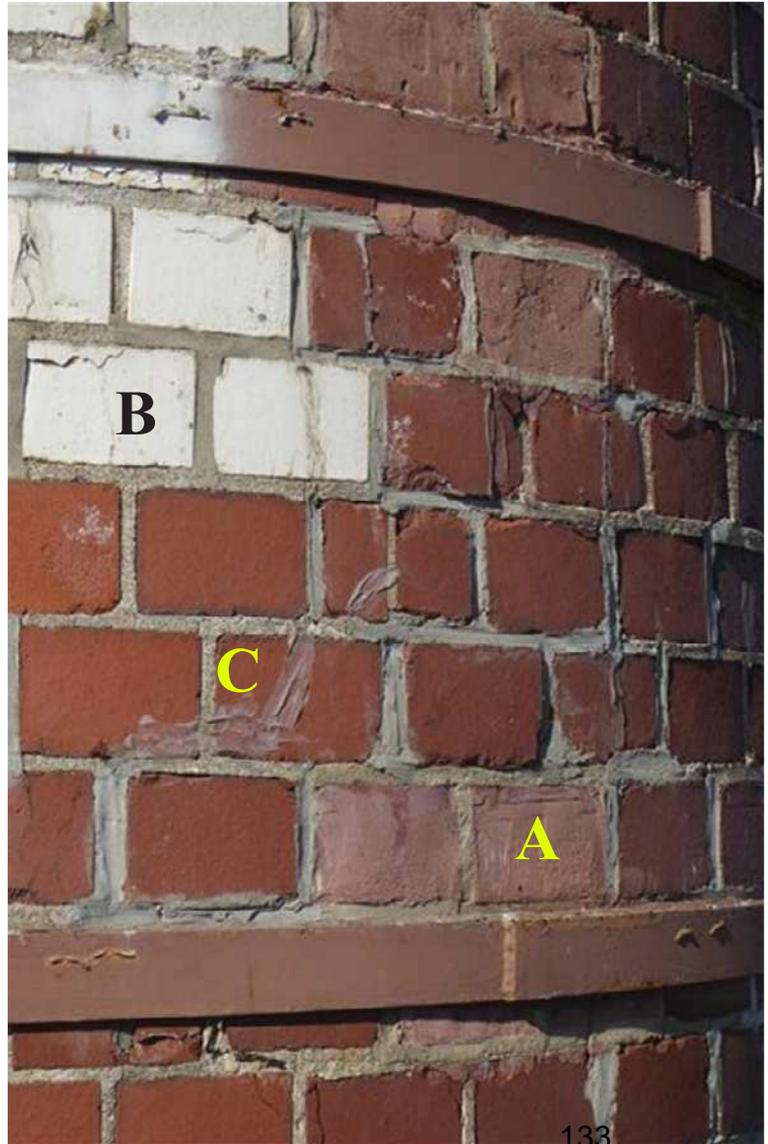
Photo 26

More multiple repair efforts.

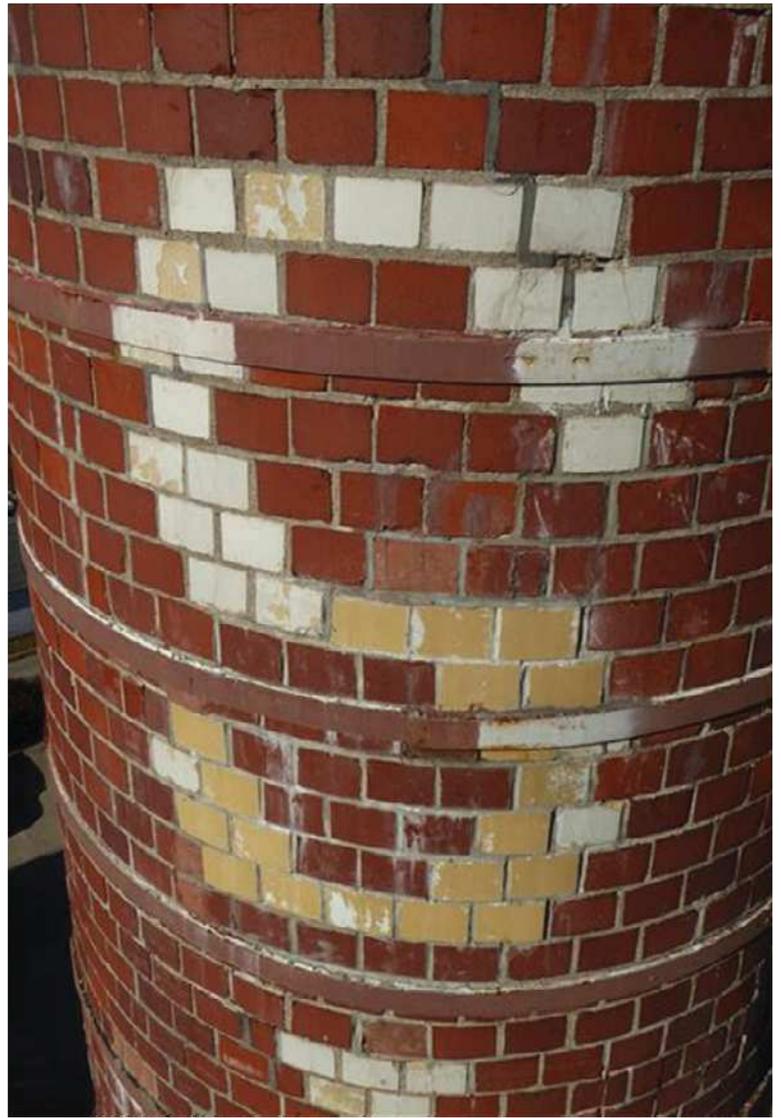
Photo 27

Several of the glazed tile in the "S" were replaced.

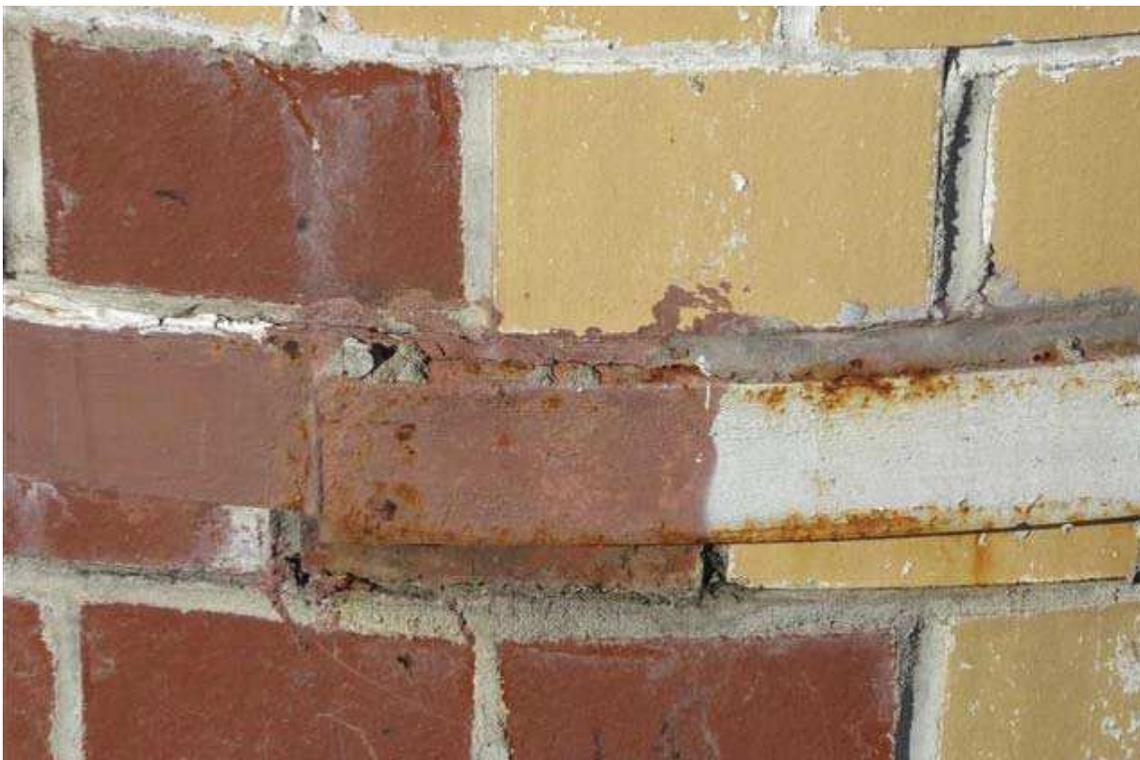
Photo 28

This occurred prior to the steel band being placed in this location.

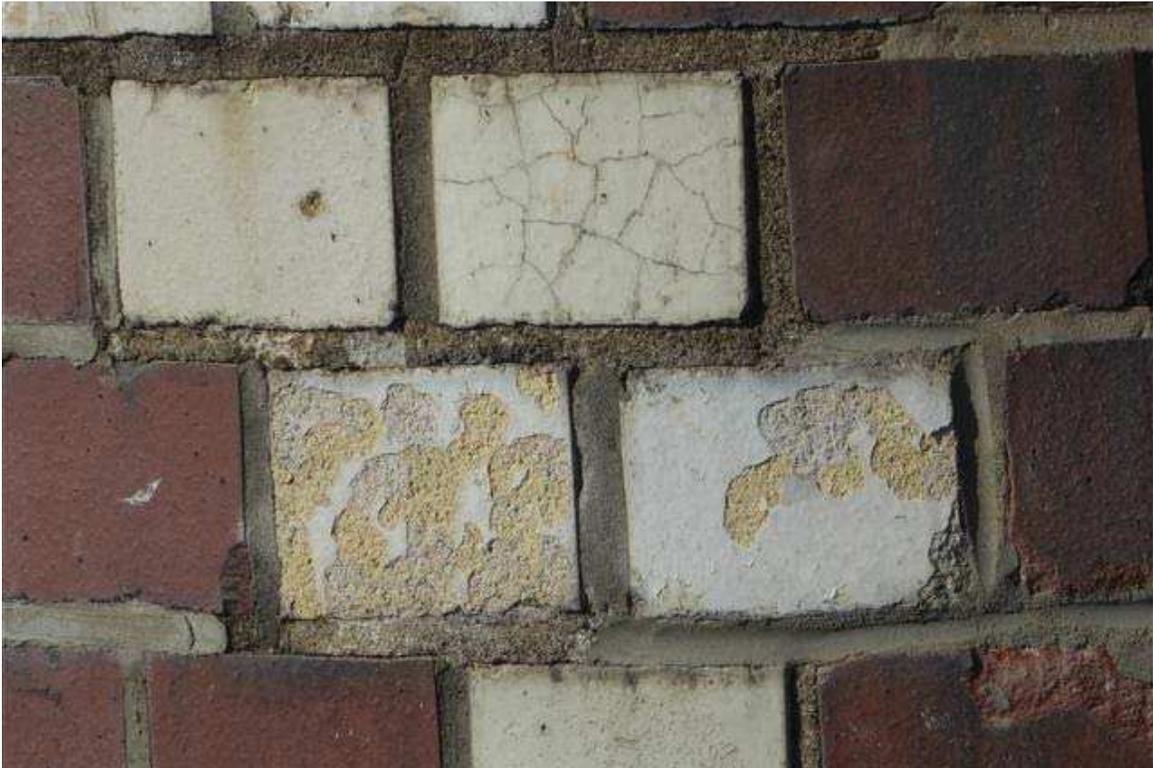
Photo 29 Glaze spalls continue to occur.

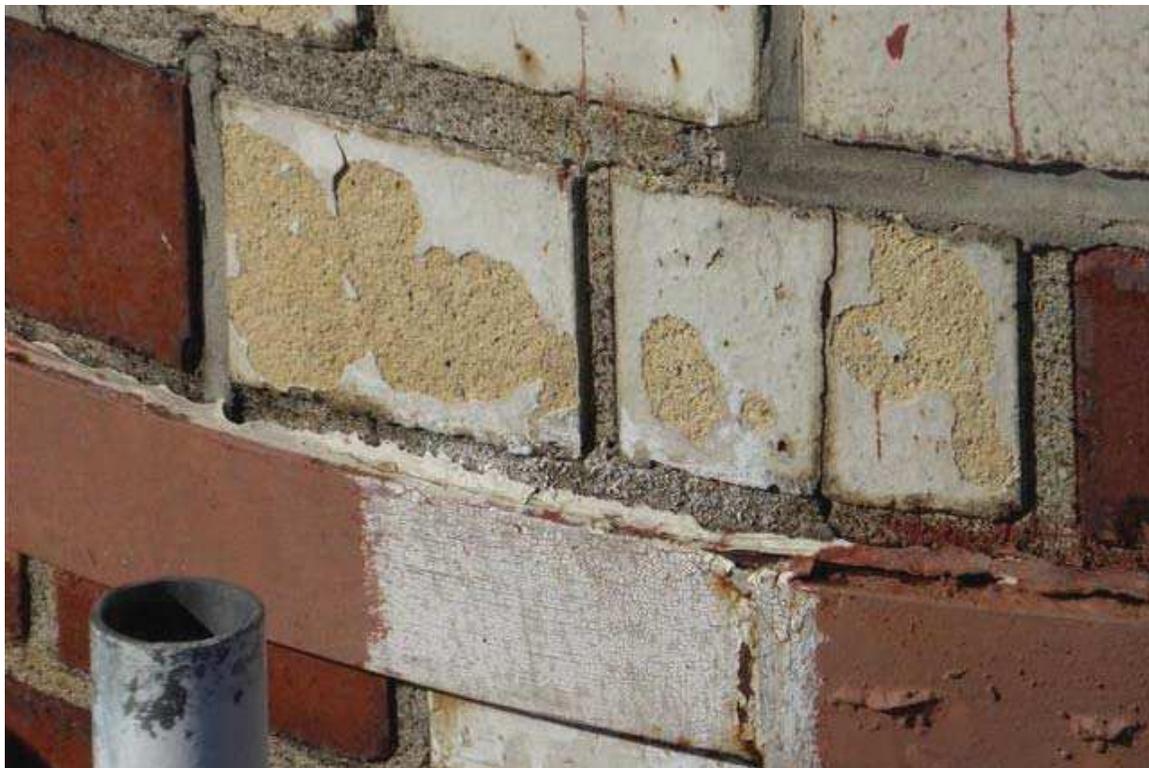
Photo 30 Similar condition in another location.

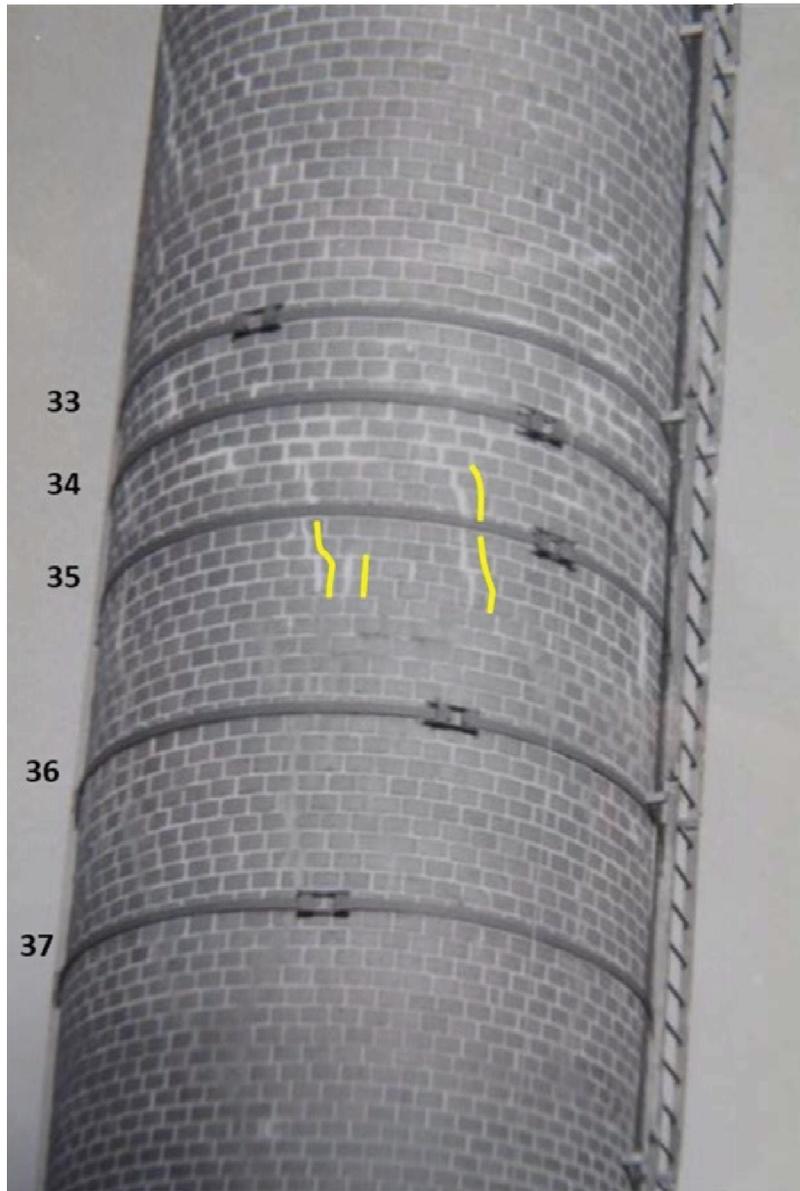
Photo 31
Historic photo showing bands 33 through 37 as seen from the southwest.

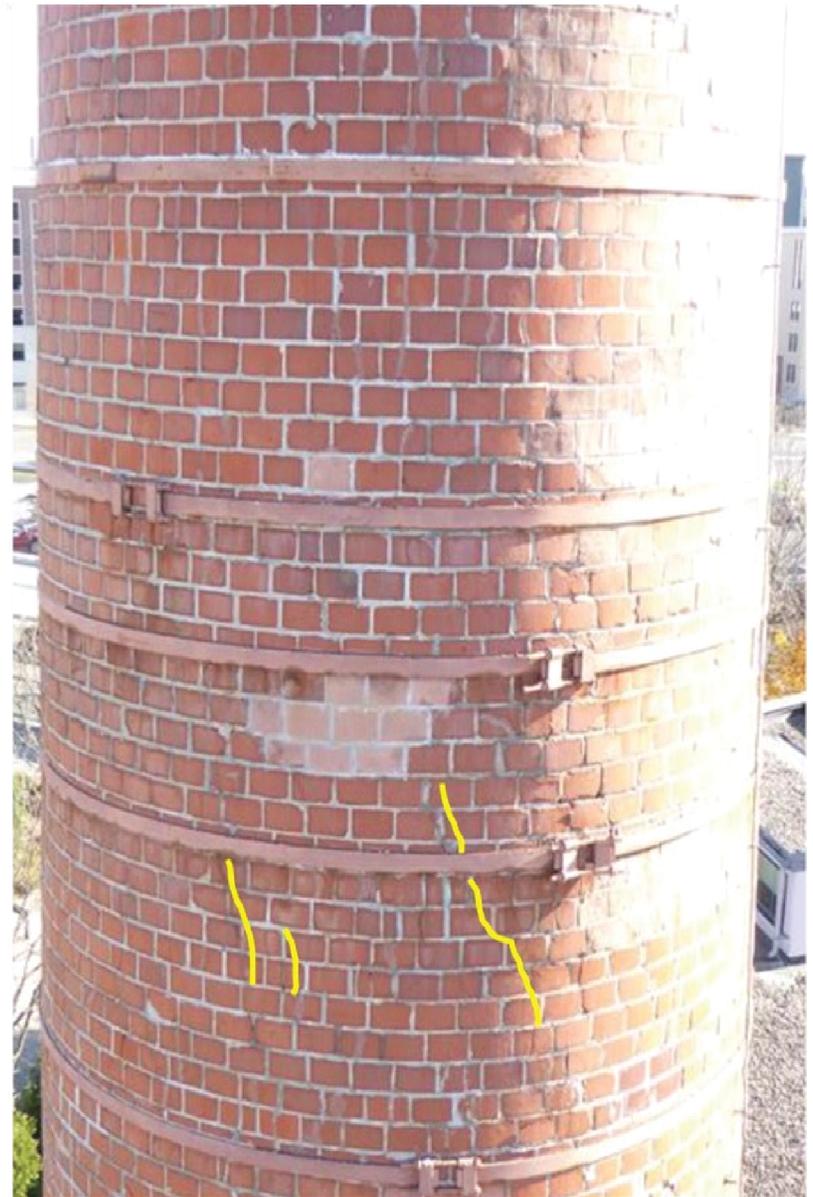
Photo 32
Tuckpointed cracks are still visible today AND many more cracks/spalls have occurred.
