BHPC MEETING PACKET

Thursday March 24, 2022

Bloomington Historic Preservation Commission Meeting

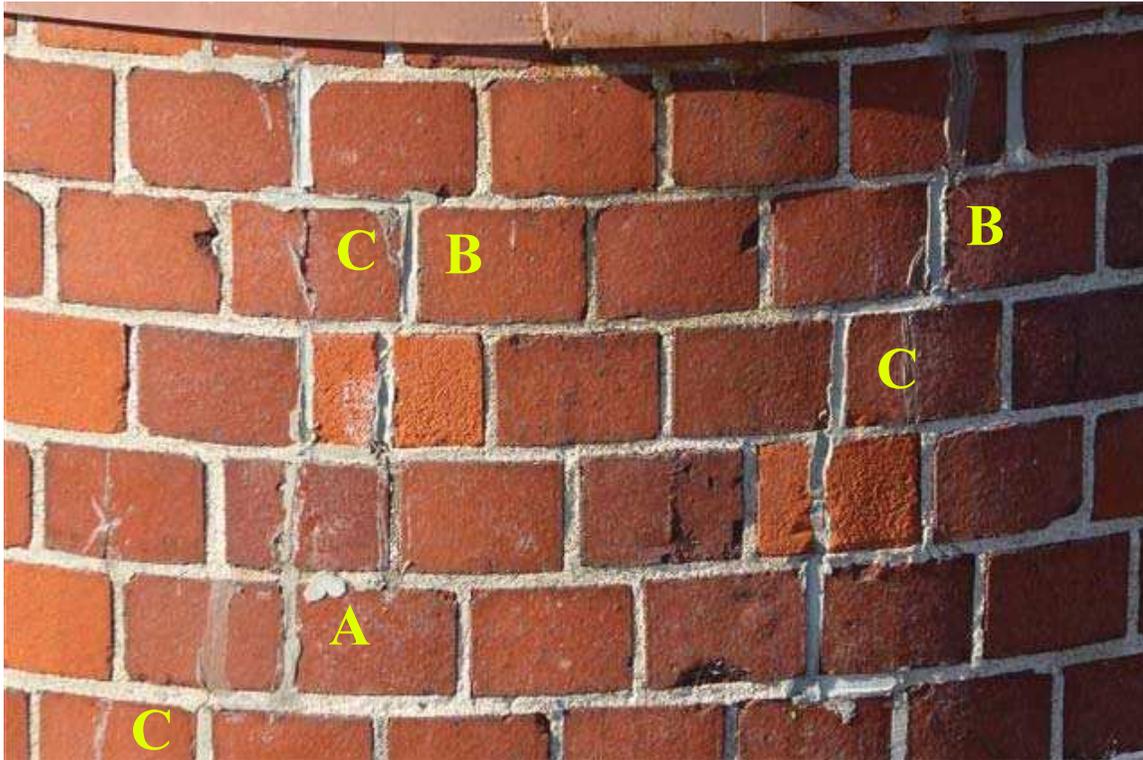
Photo 33

Three vintages of crack repair: A & B - different colors of tuckpointing mortar and C - face caulk.

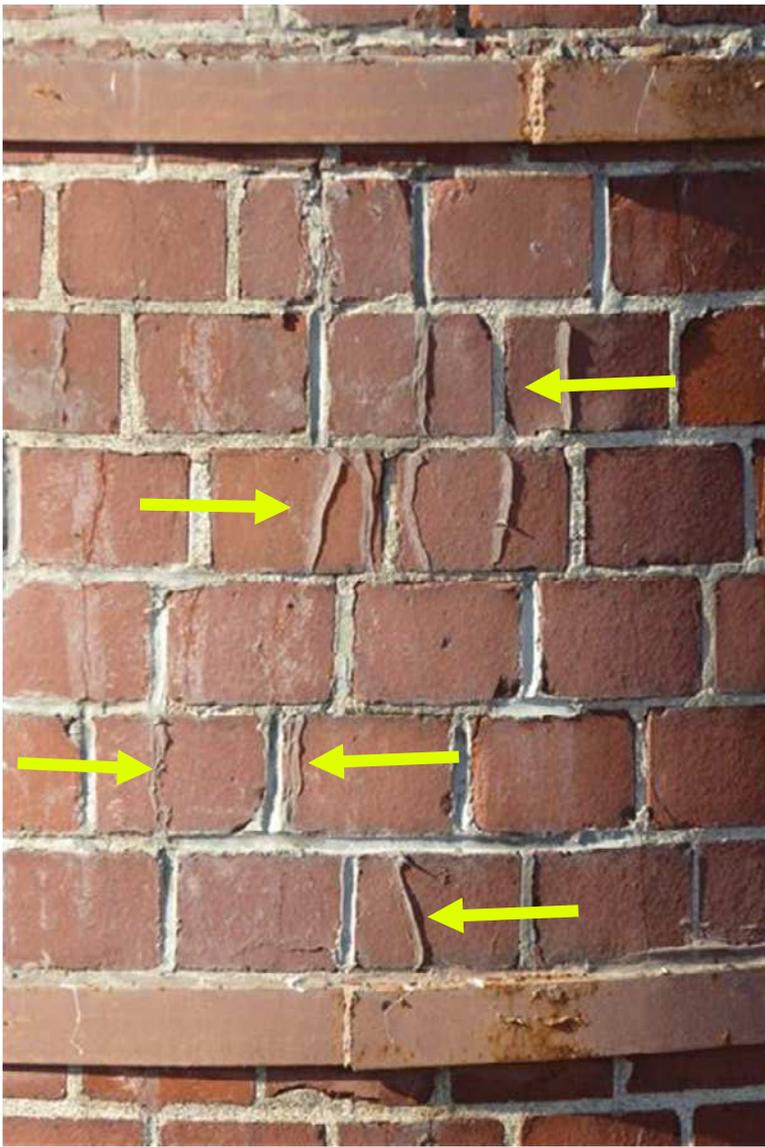
Photo 34

Yet another way of addressing cracks in the masonry.

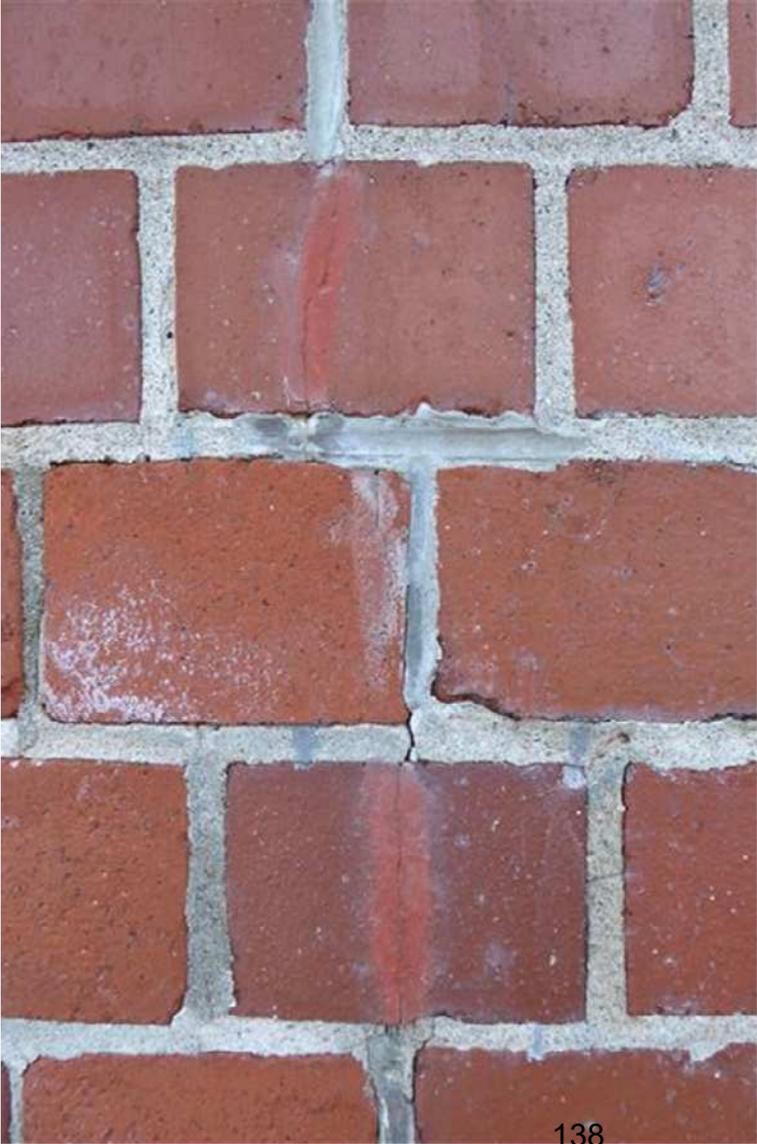
Photo 35

Face caulking over cracks.

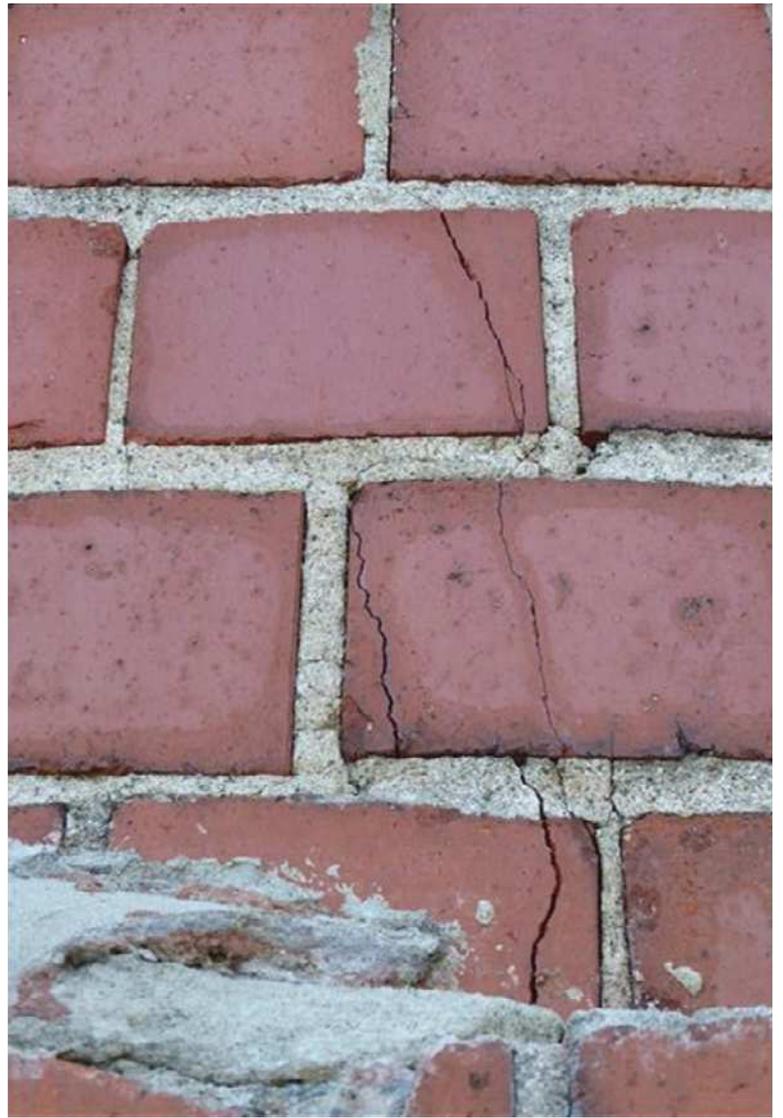
Photo 36

Face caulk with a different color of material.

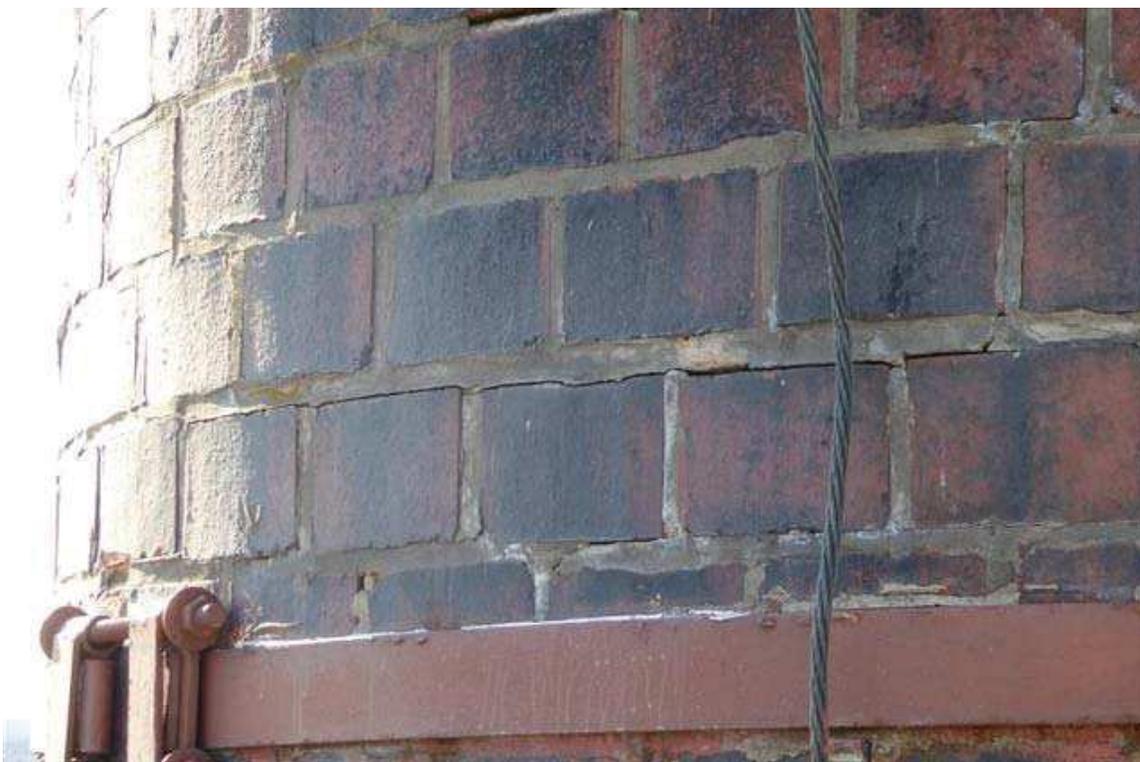
Photo 37

Unrepaired cracks lower in the stack...

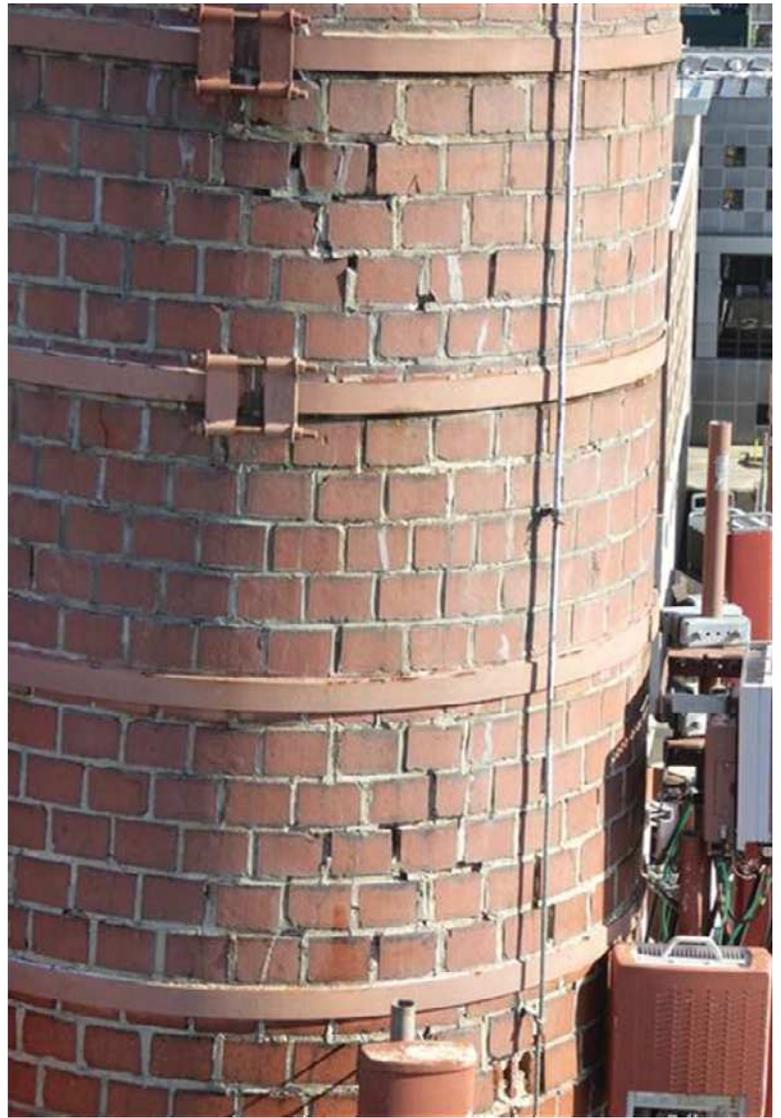
Photo 38

...and near the top of the stack.

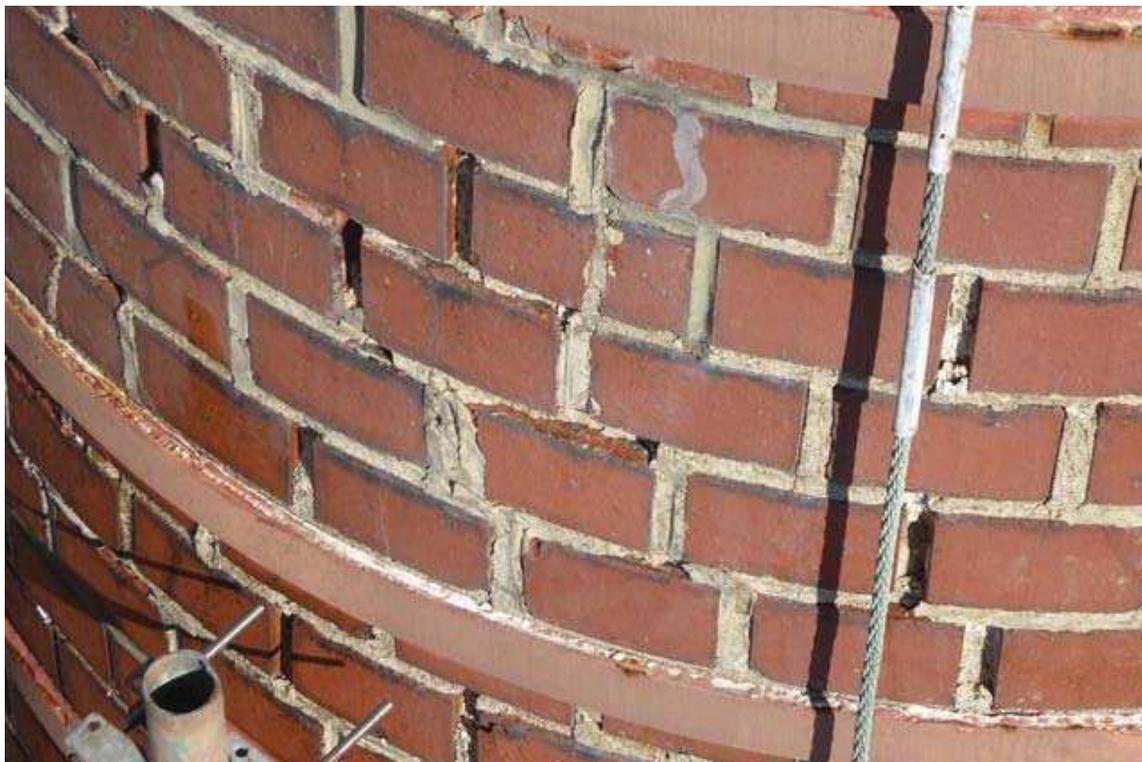
Photo 39

Tuckpointing mortar falls back out of the joints in multiple locations.

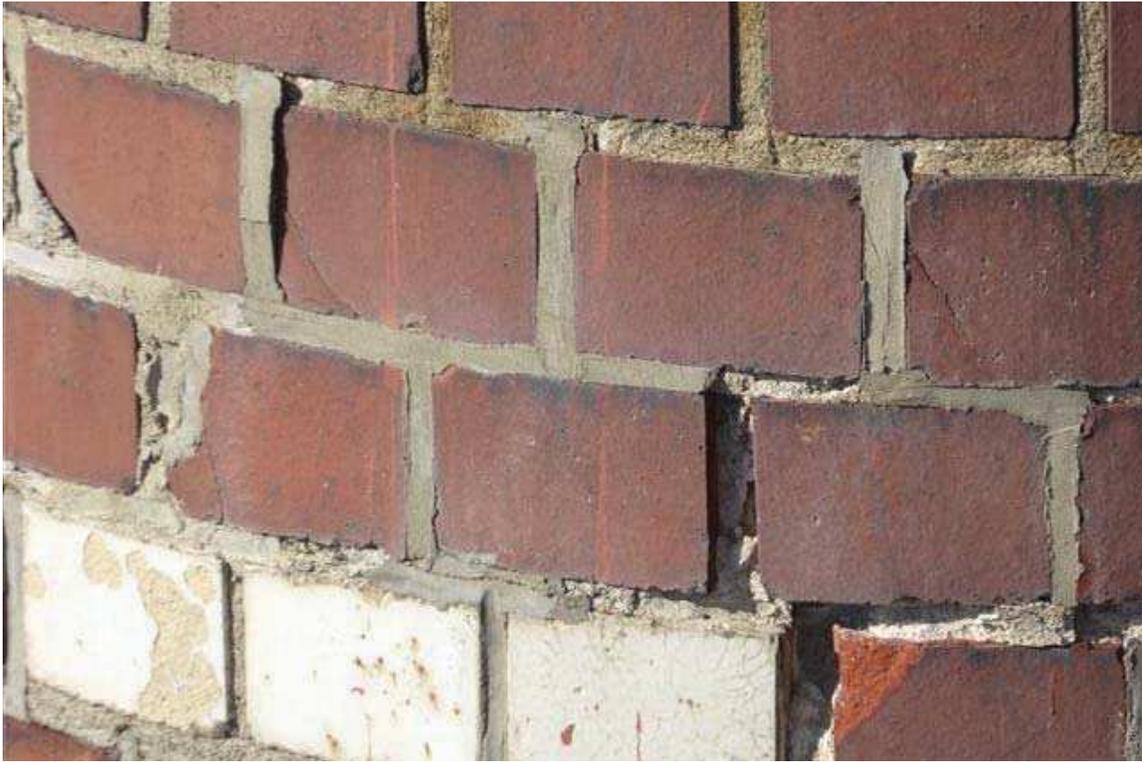
Photo 40

Closer view of one such area.

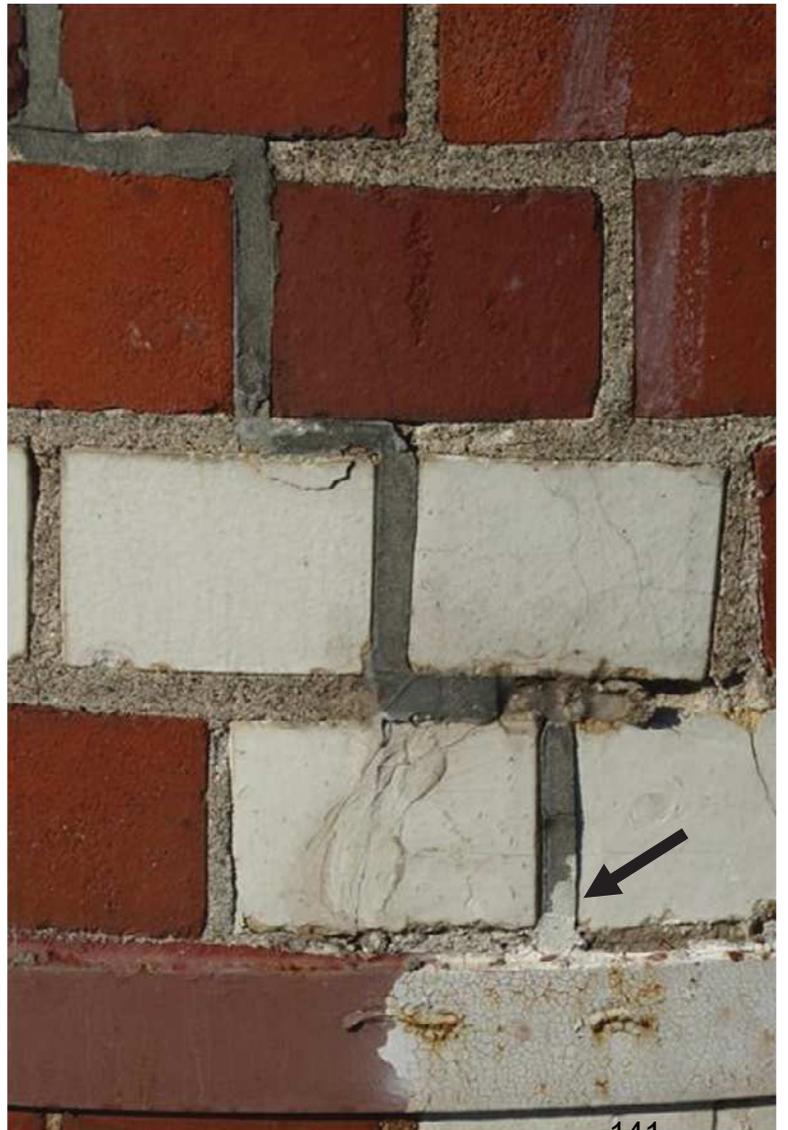
Photo 41

Similar condition in another location.

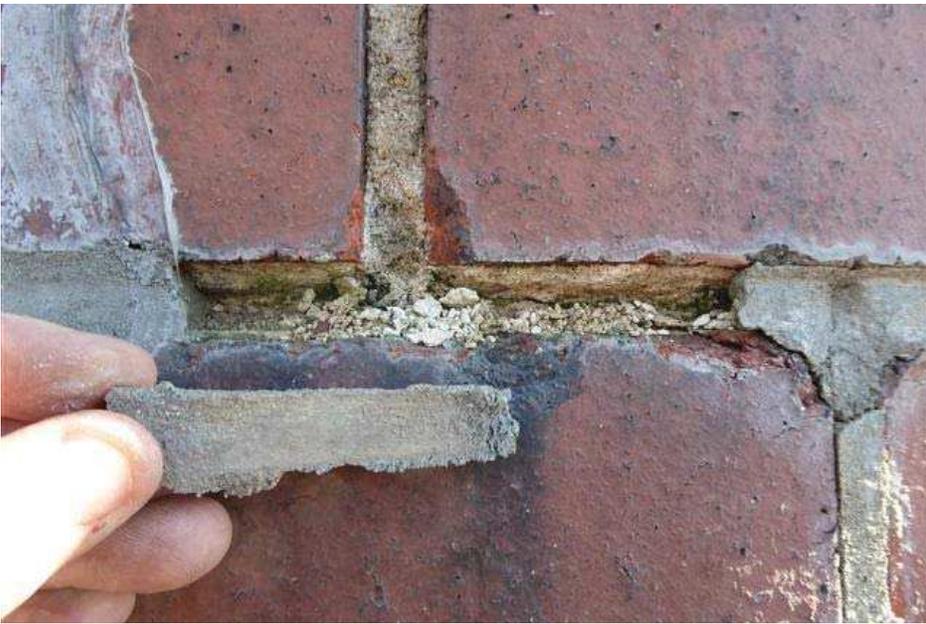
Photo 42

This repair mortar was painted over.

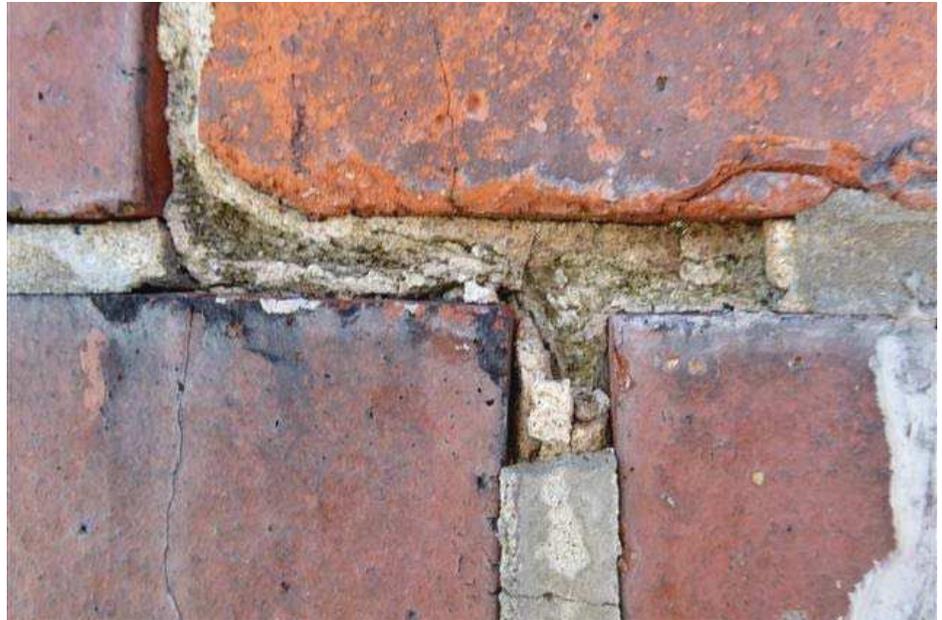
Photo 43A

Harder tuckpointing mortar is removed to reveal softer cracked/eroding original mortar.

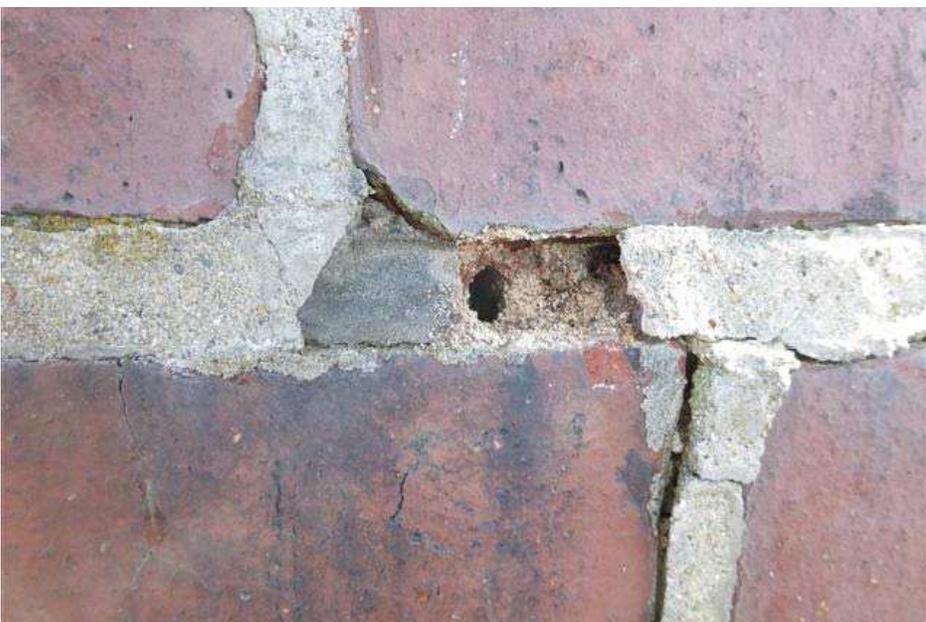
Photo 43B

Similar condition in another location.

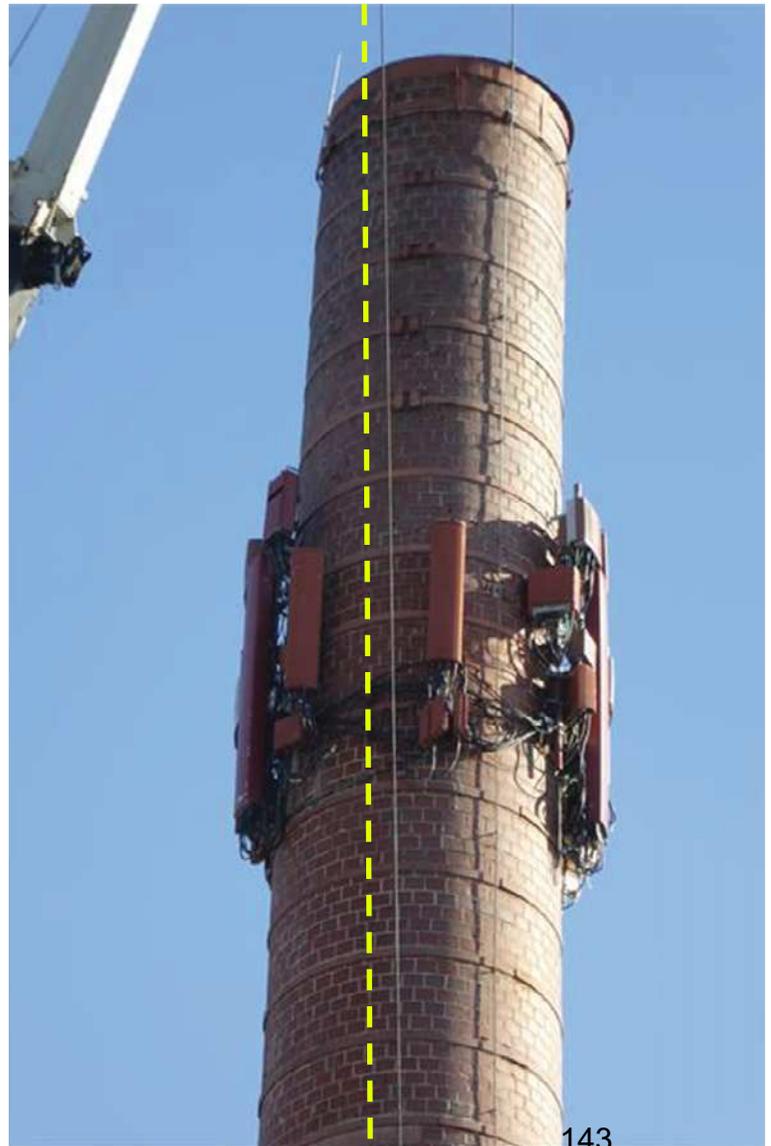
Photo 44

The crane wire serves as a giant plumb bob...

- New (unrepaired) cracks were observed. These occur throughout the height of the stack.
- The stack visibly leans to the south as shown in Figure 6 and Photos 44 through 47. Multiple reports indicate this condition has been present for a long period of time. Plumb bob measurements found the top of the stack is out of plumb at a slope of 1 to 10 or approximately 6.0°.

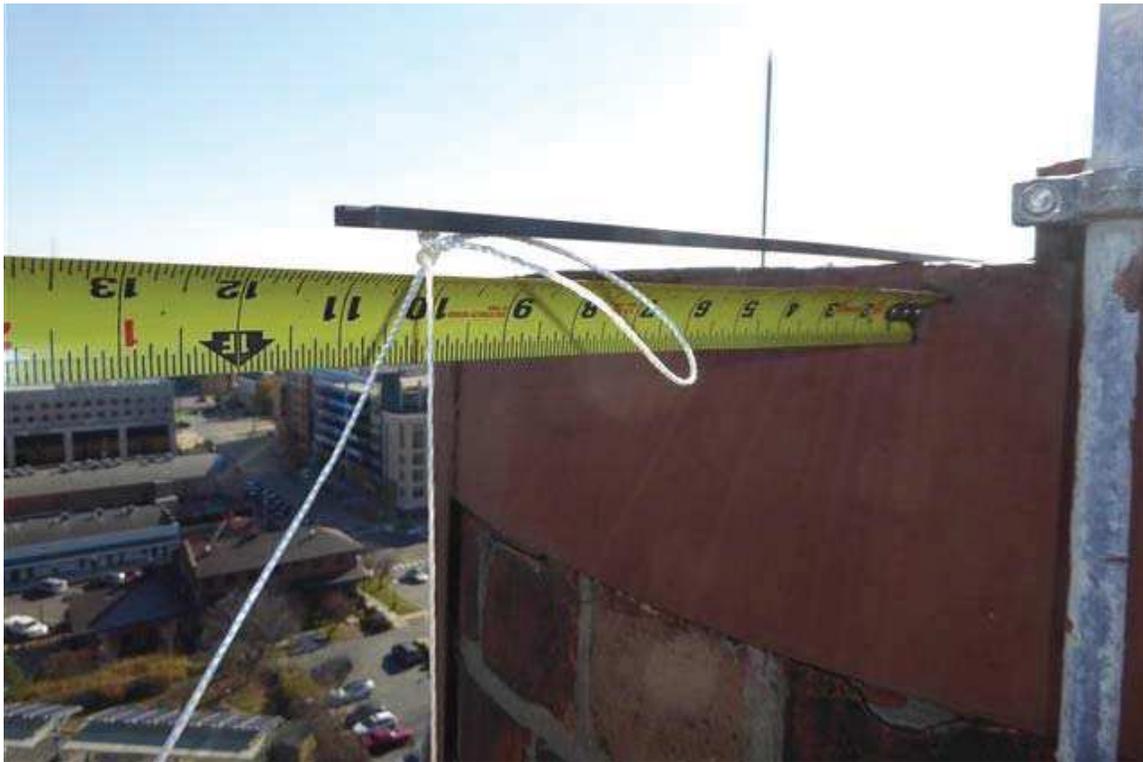
Photo 45

...demonstrating how much the stack leans.

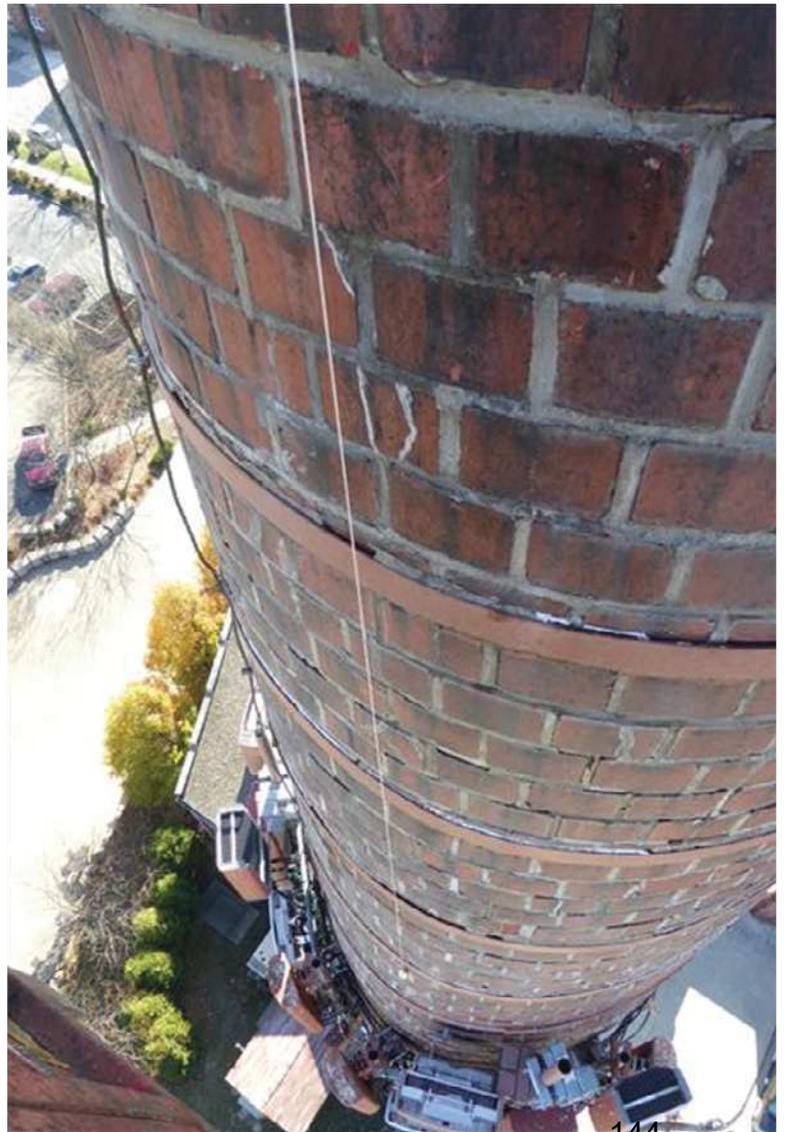
Photo 46

Measurements taken above the cell phone equipment revealed the top of the stack leans 10 inches in 90 inches.

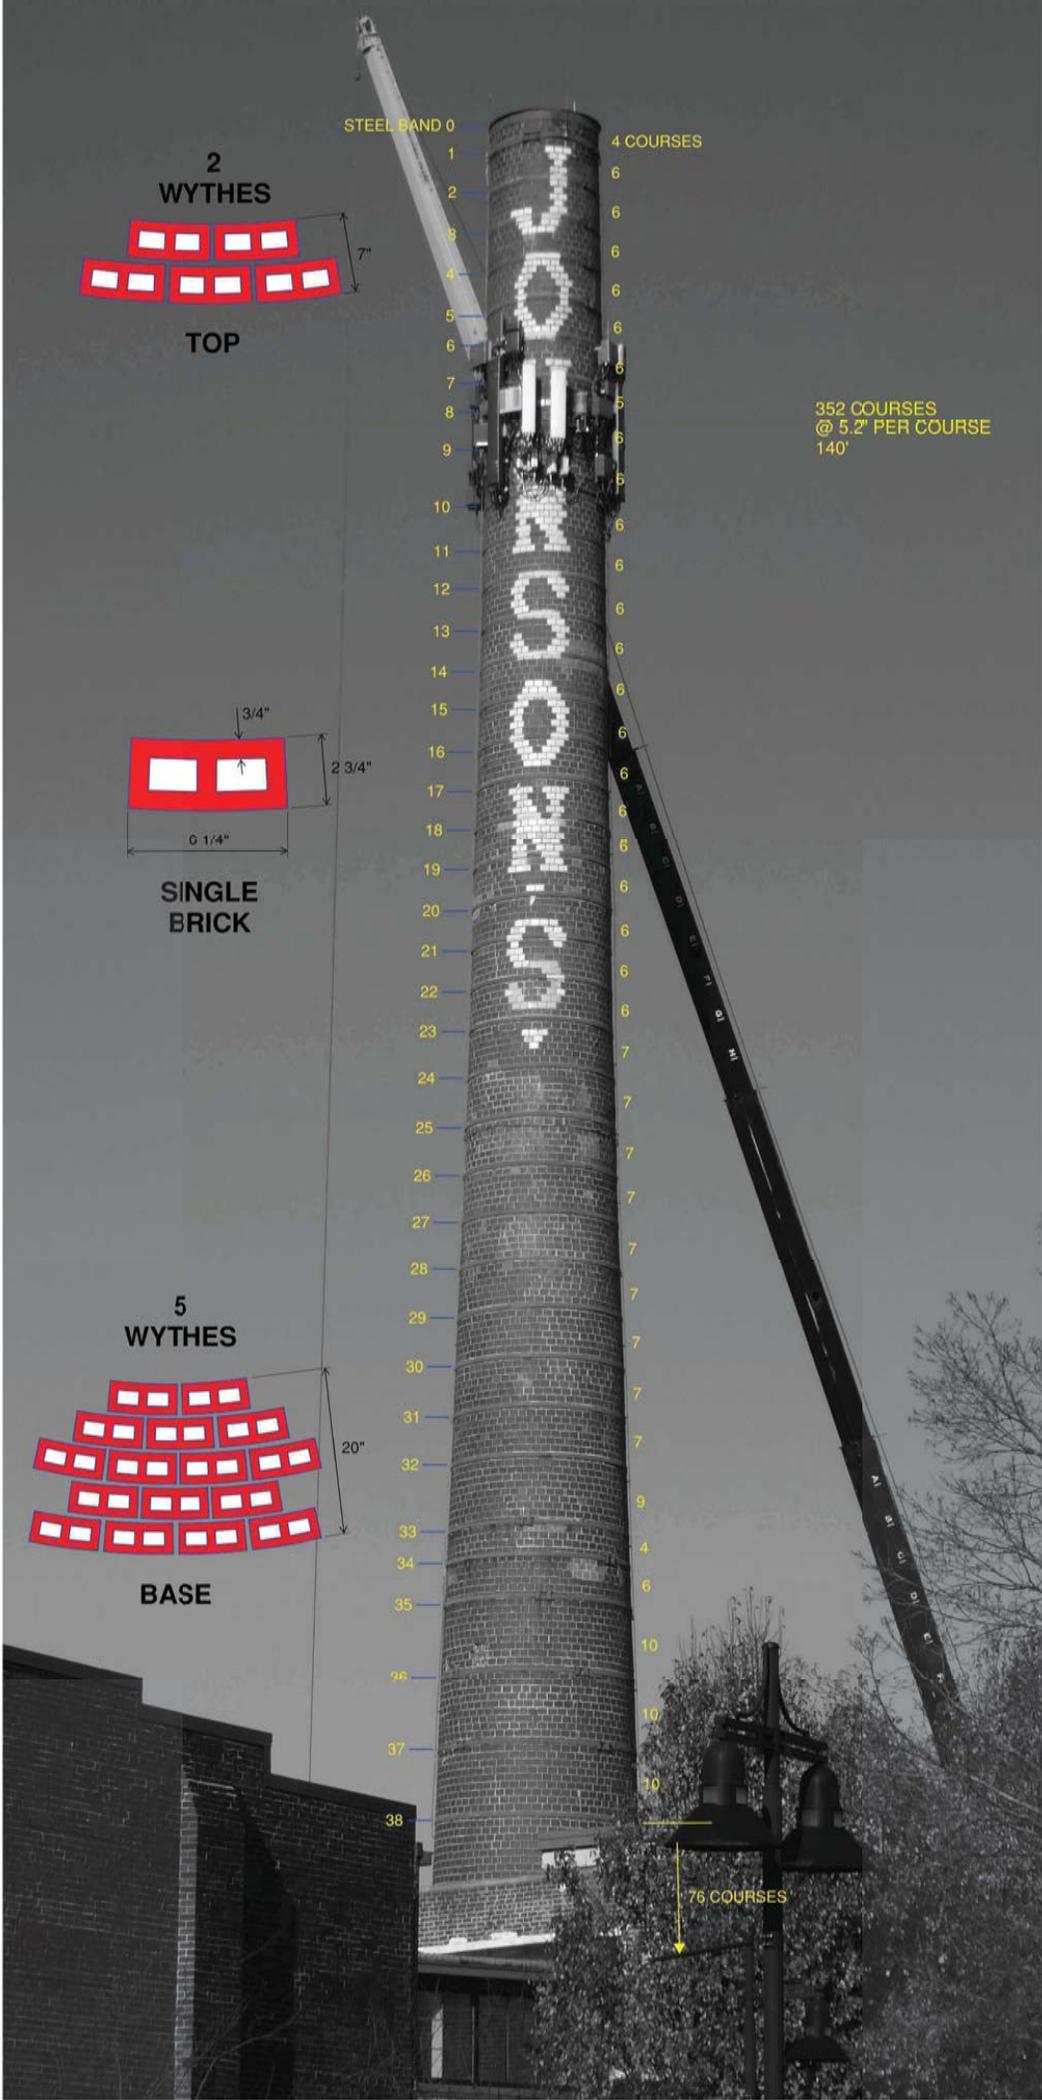
Photo 47

This was taken on the north side of the stack.

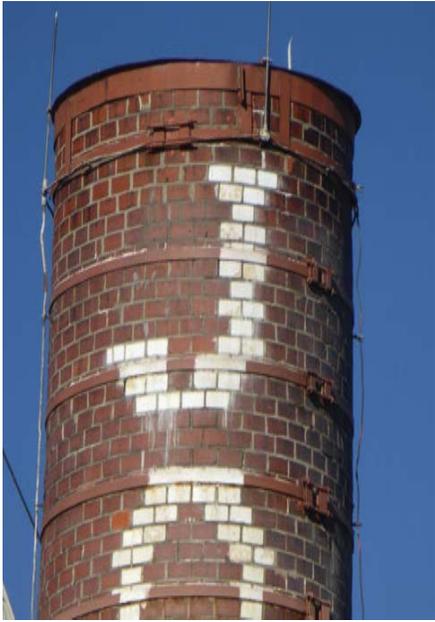
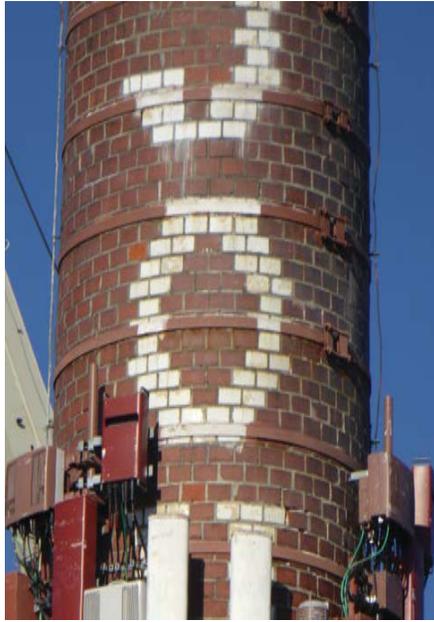
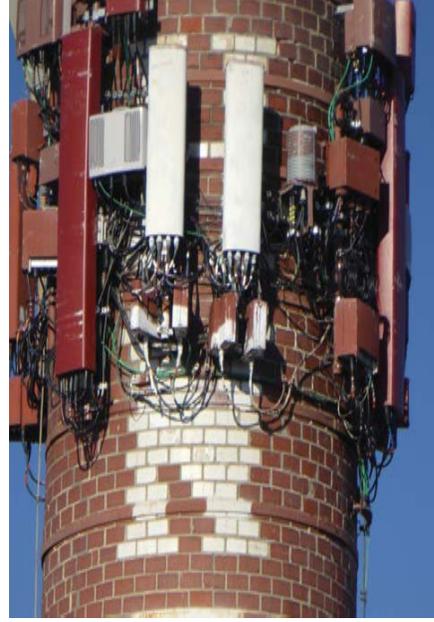
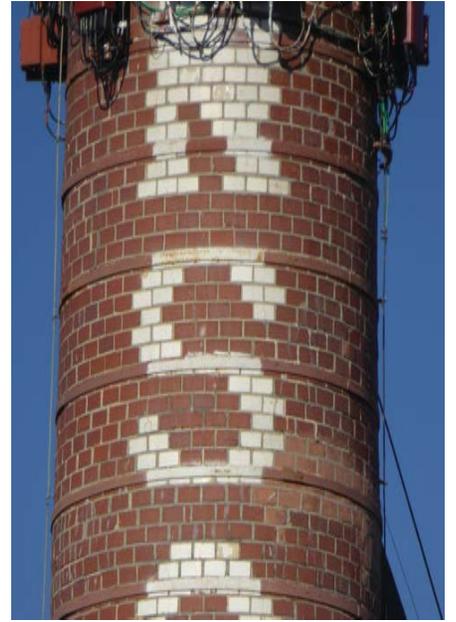
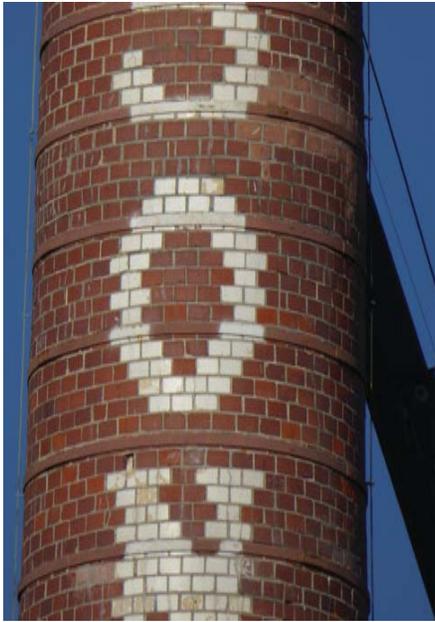
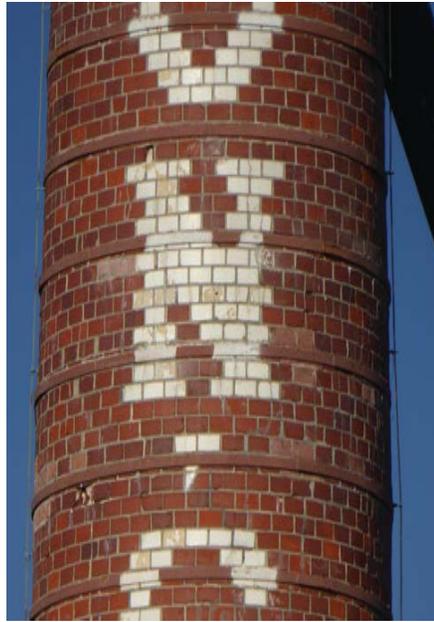
FIGURE 7

EAST

NORTHEAST

SOUTHWEST

- Montage views of the upper portion of the stack are shown in Figure 7. A montage of the logo on the southeast face is shown in Figure 8.
