# **ARSEE ENGINEERS, INC.**

IU Health Facility Assessment  
Bloomington, Indiana  
for

RE: IU Health Facility Assessment  
Bloomington, Indiana

## **EXECUTIVE SUMMARY**

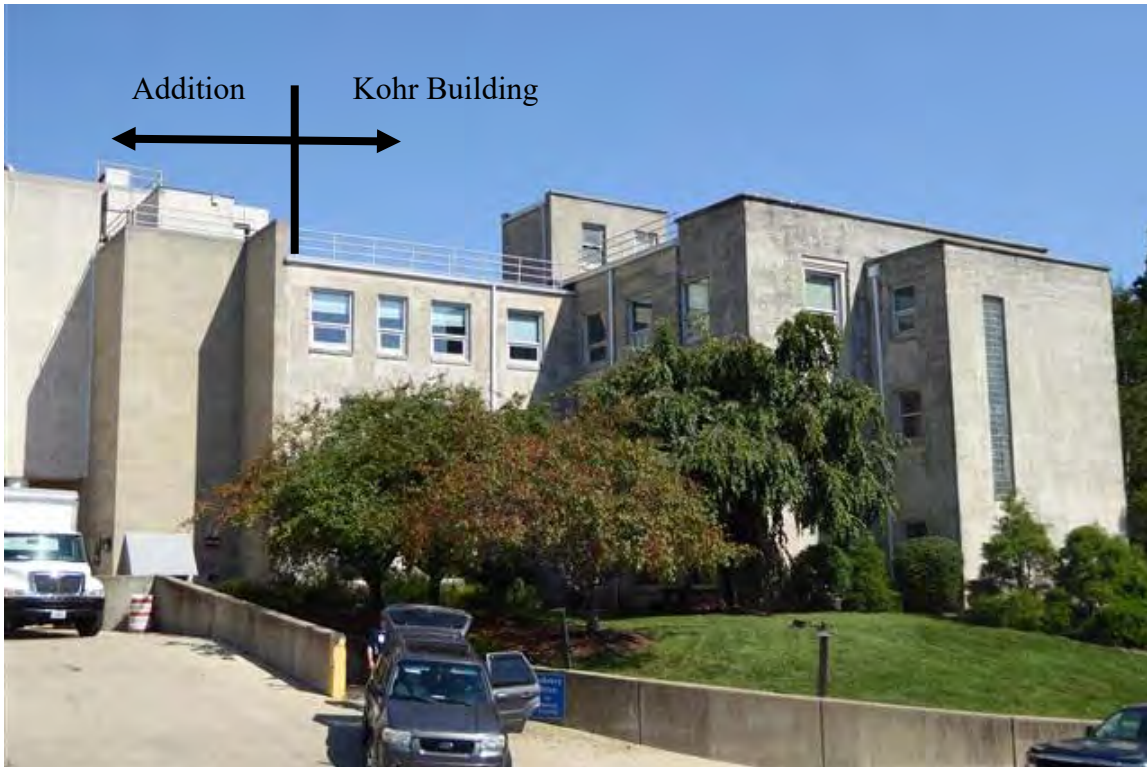
Photo 3

View from the southwest. The transition from the original Kohr Building to the newer section is shown.

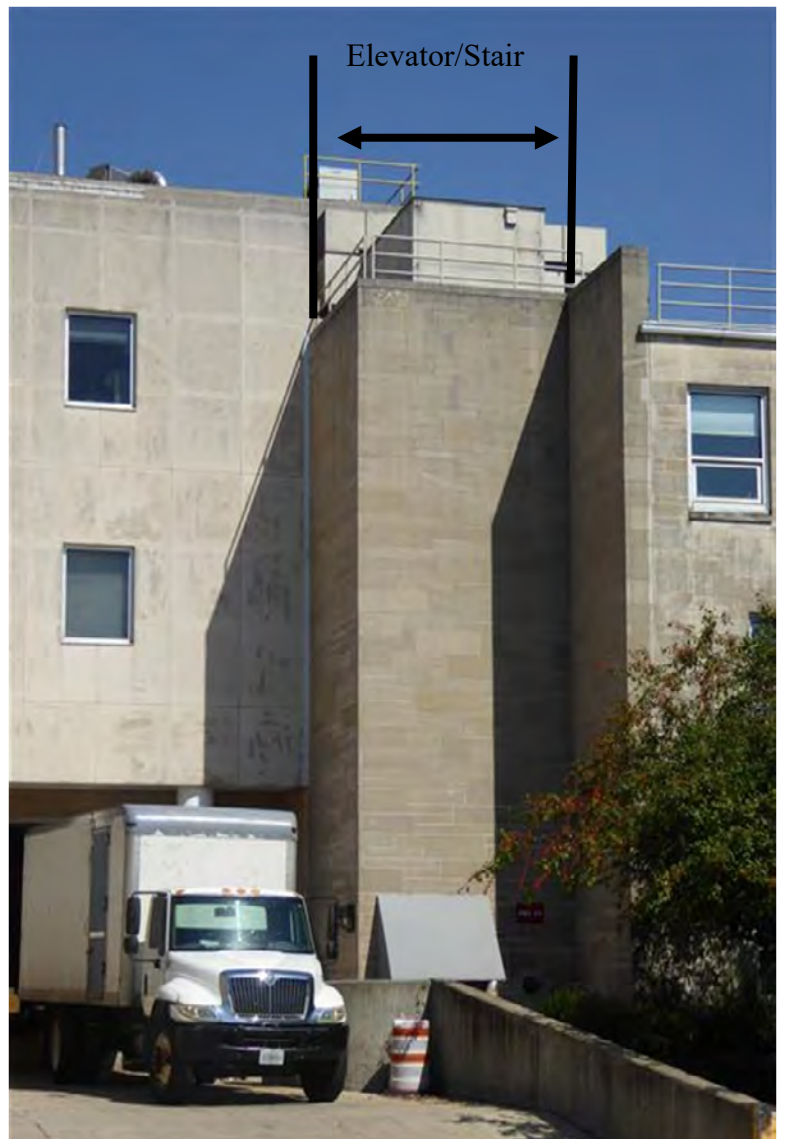
Photo 4

Closer view of the transition to the addition.

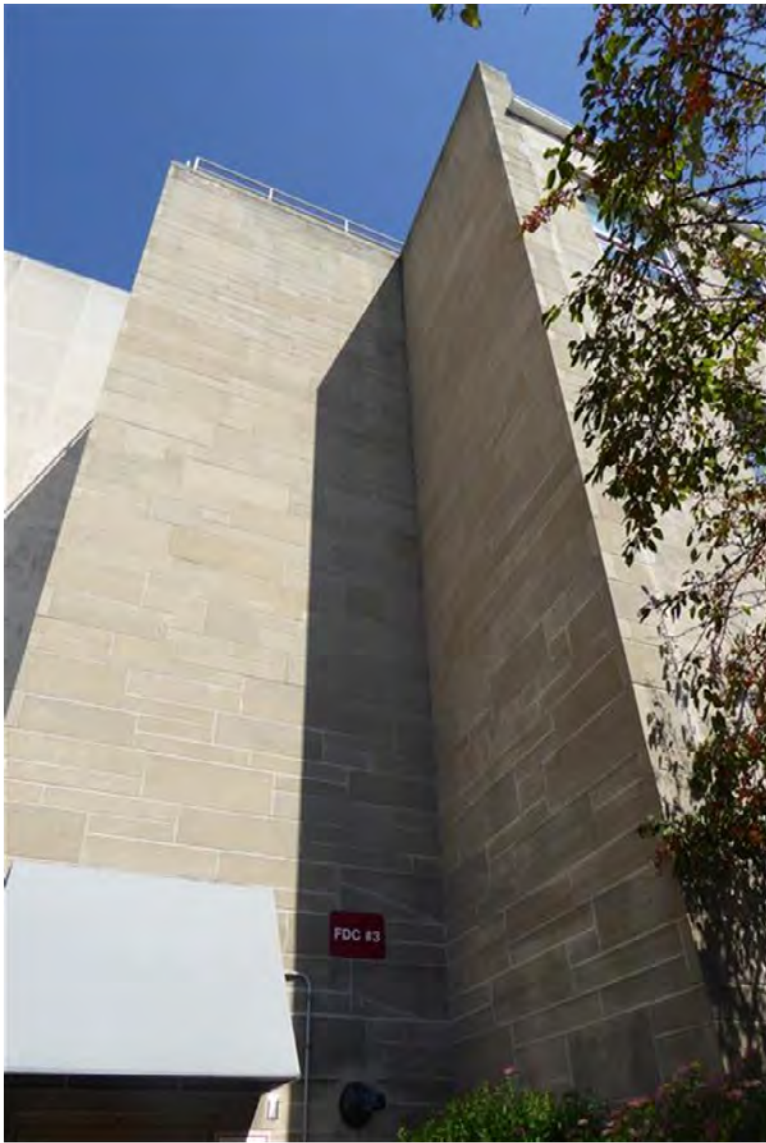
Photo 5

The west stairwell and elevator should be kept in the transition process.

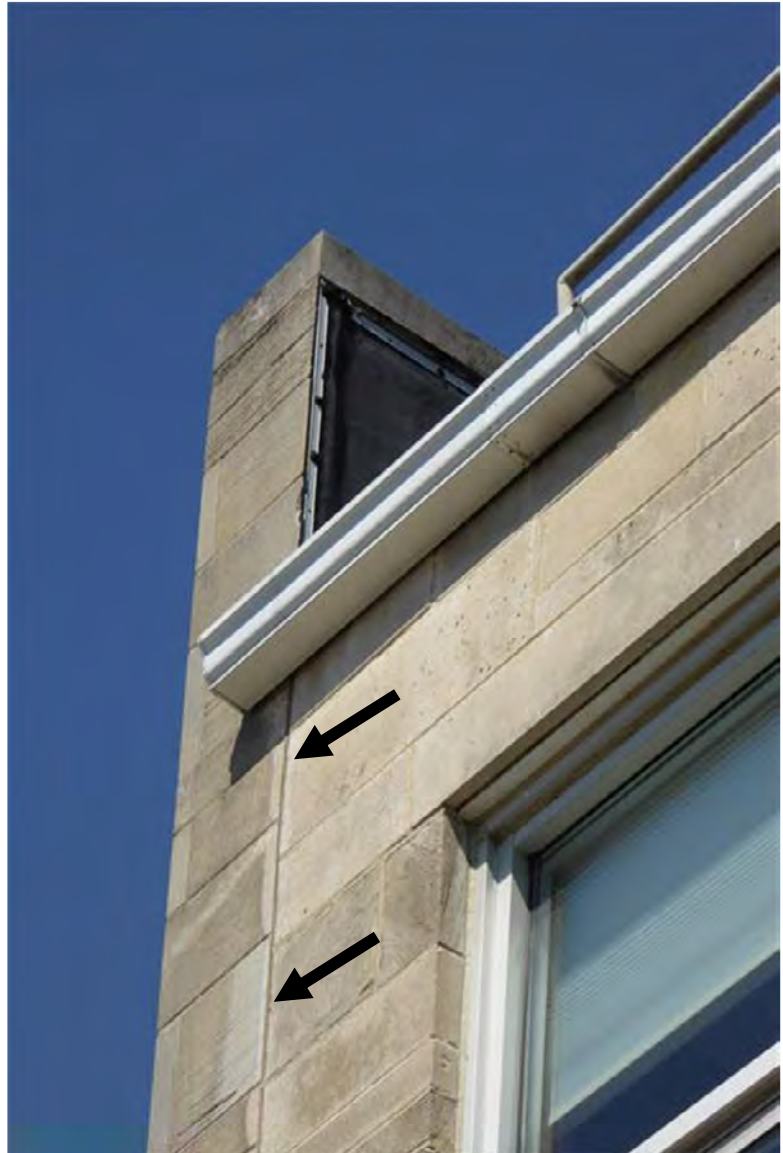
Photo 6

There is a caulk joint between the original building façade and the addition wall.

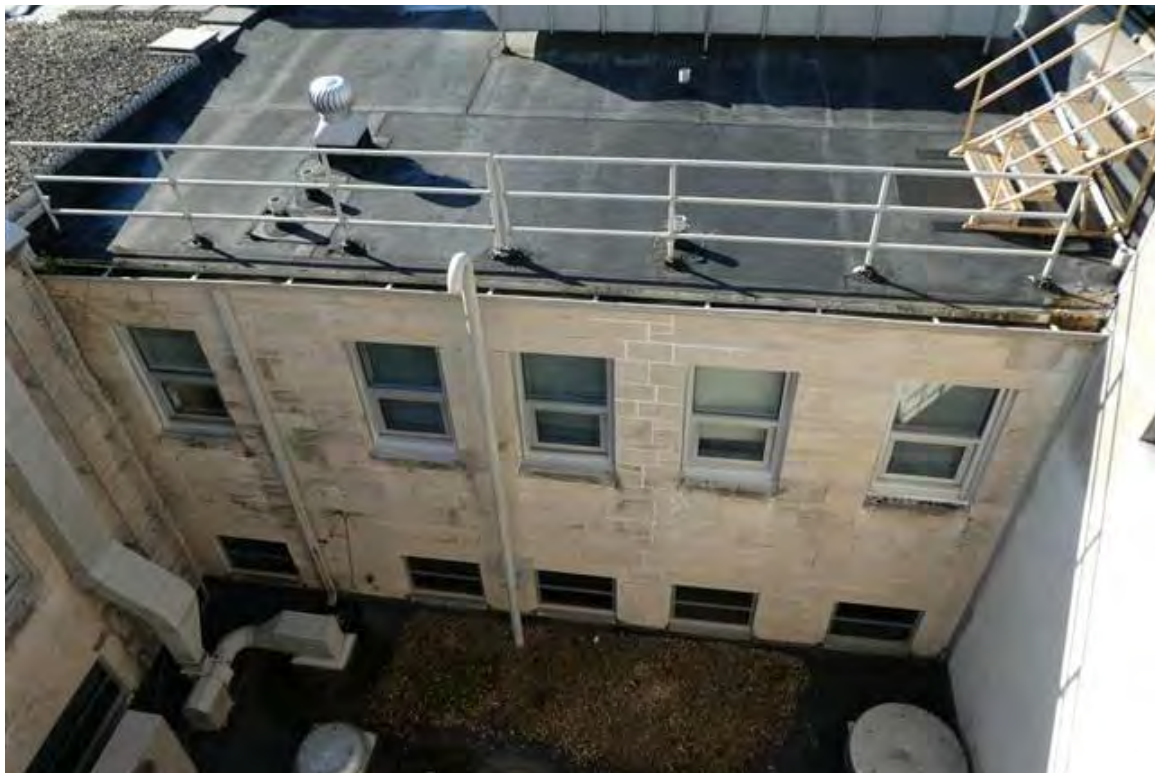
Photo 8 North face of the west wing of the Kohr Building. A lower addition extends up onto the 2nd floor windows.

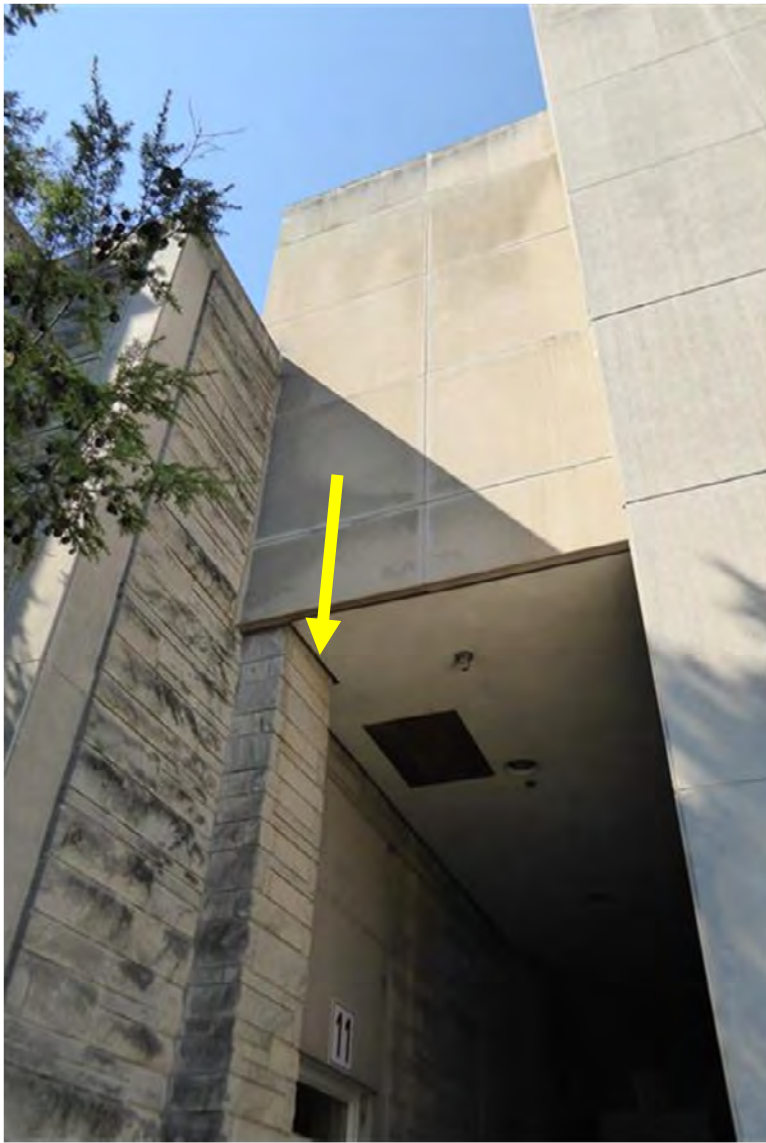
Photo 11

The addition which extends out to the north appears to be supported by something behind this limestone pilaster.

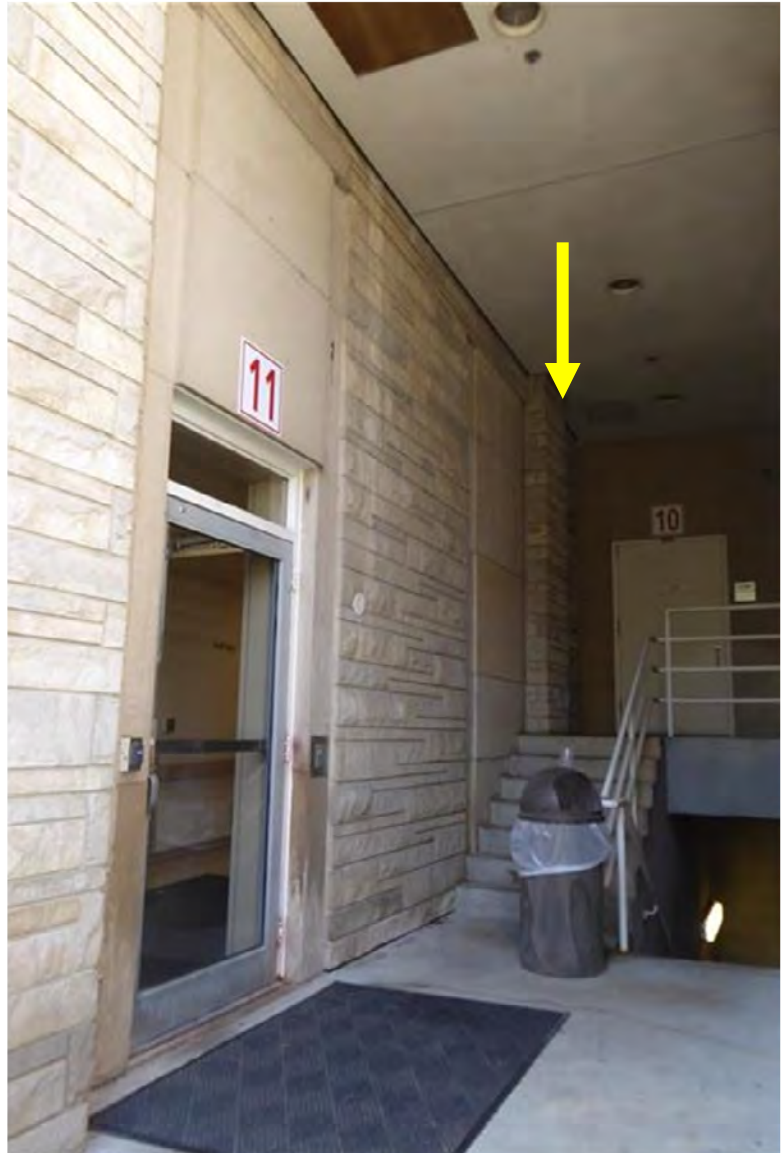
Photo 12

The original limestone is still visible in this north entry as is a second “new” limestone pilaster.

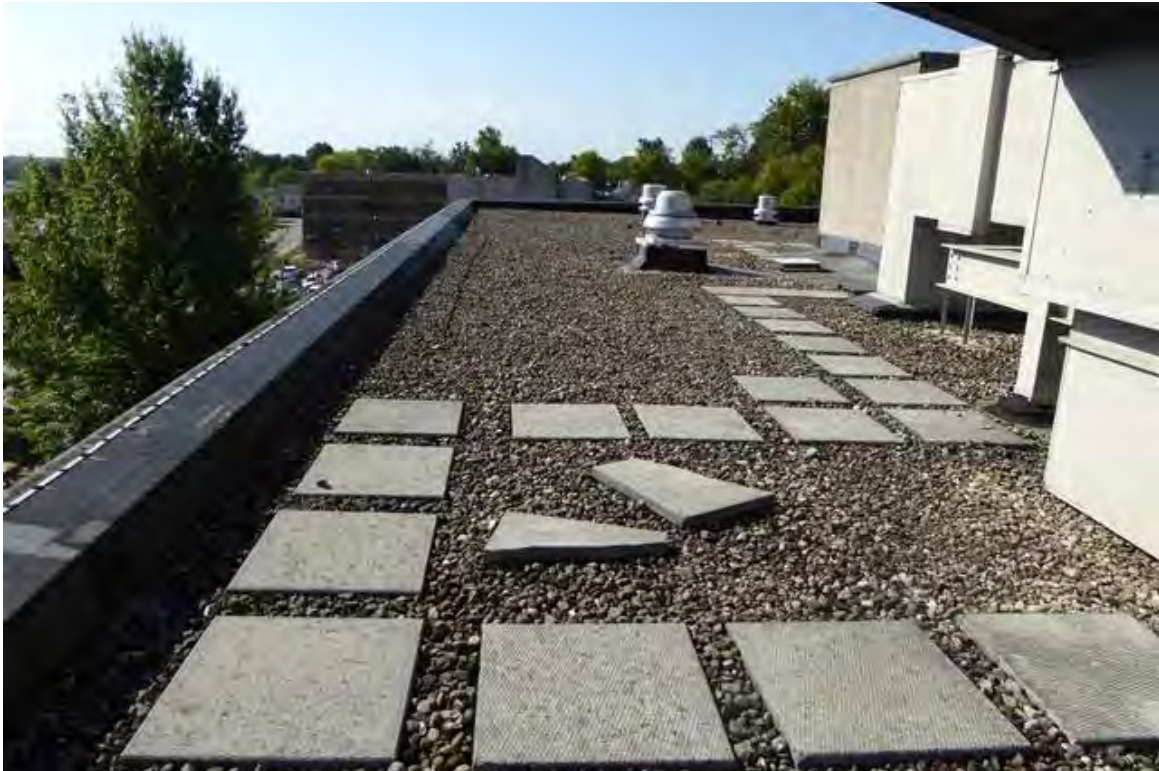
The main roof of the Kohr Building is covered with a ballasted EPDM membrane. It is reported to be at least 30 years old, and therefore, is considerably past its anticipated service life. The membrane turns up and over the back side of the limestone coping and is secured with a stainless steel termination bar with drive pins. While hospital staff report there are no known active leaks, there is ample evidence that problems can be anticipated in the foreseeable future. See Photos 13 through 18. We recommend all of the existing flat roofs be removed down to the structural deck and a new adhered EPDM membrane installed in its place when the building is repurposed.

Photo 13 The roof is covered with a ballasted EPDM. The roof is reported to be at least 30 years old.

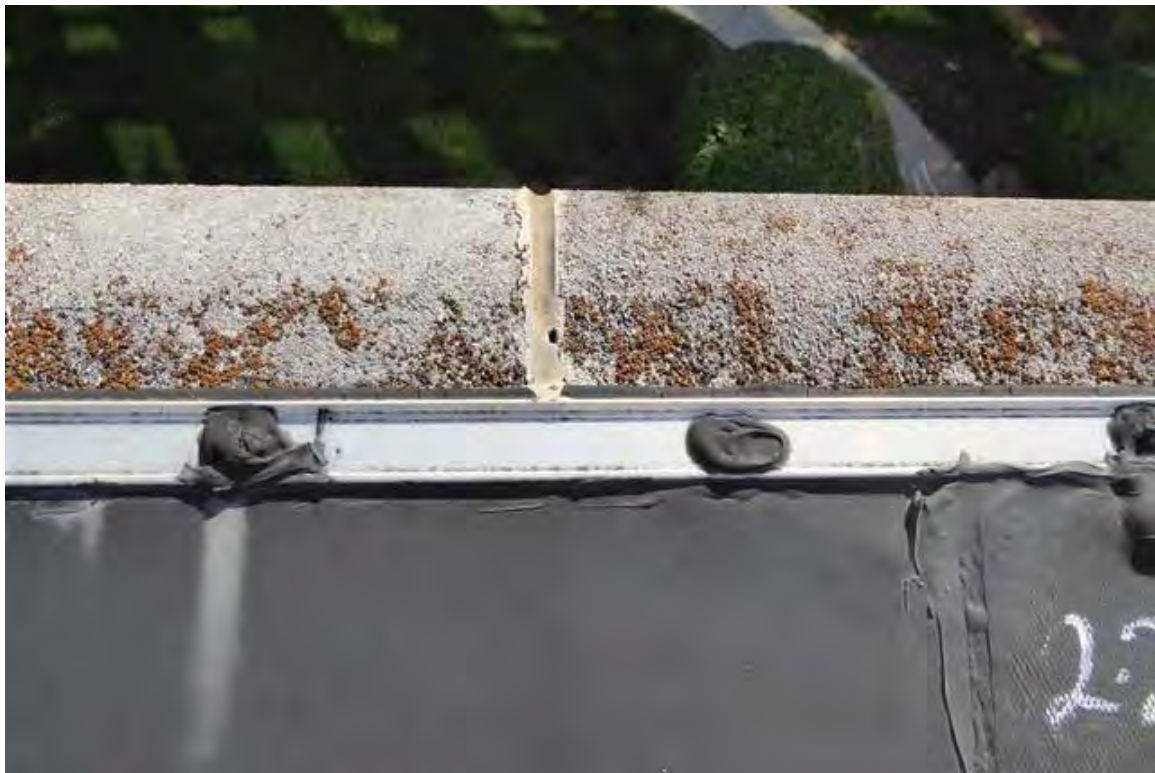
Photo 14 The membrane turns up over the back and top of the limestone coping and is secured with a termination bar.

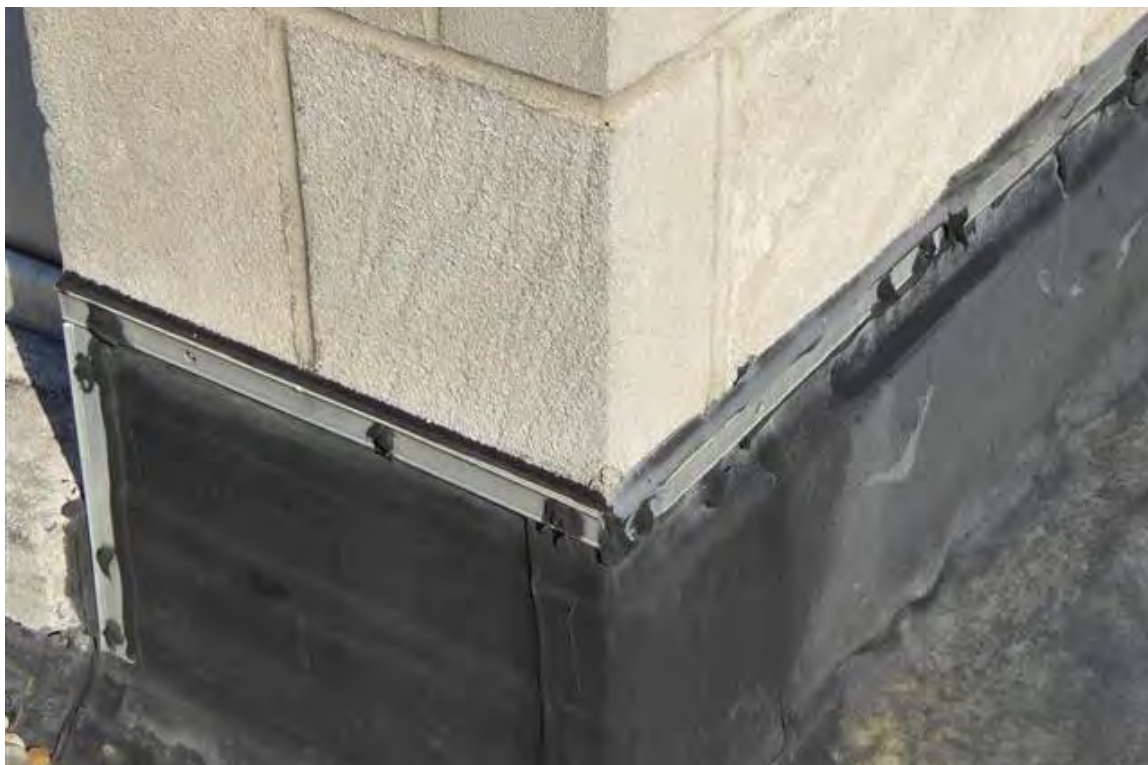
Photo 18

The membrane was turned up and glued to the limestone on the elevator penthouse. A termination bar holds it in place.

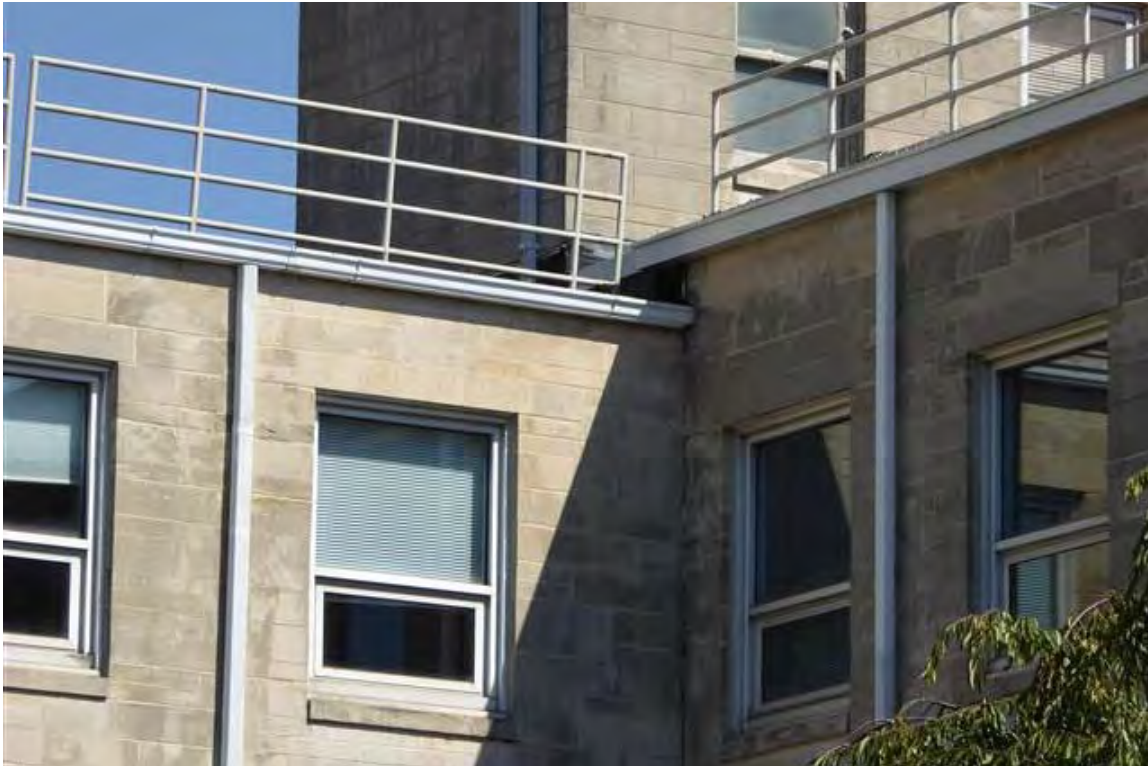
Photo 19

Each of the flat roofs is sloped to drain to a series of sheet metal gutters and downspouts as shown in Photos 19 through 22. Some of these elements have been replaced with cheaper residential style units. Original components are worn and showing their age. These should be replaced with new painted galvanized steel units to conform with the original design intent.

The roof drains to the west, north and south through a series of gutters and downspouts.

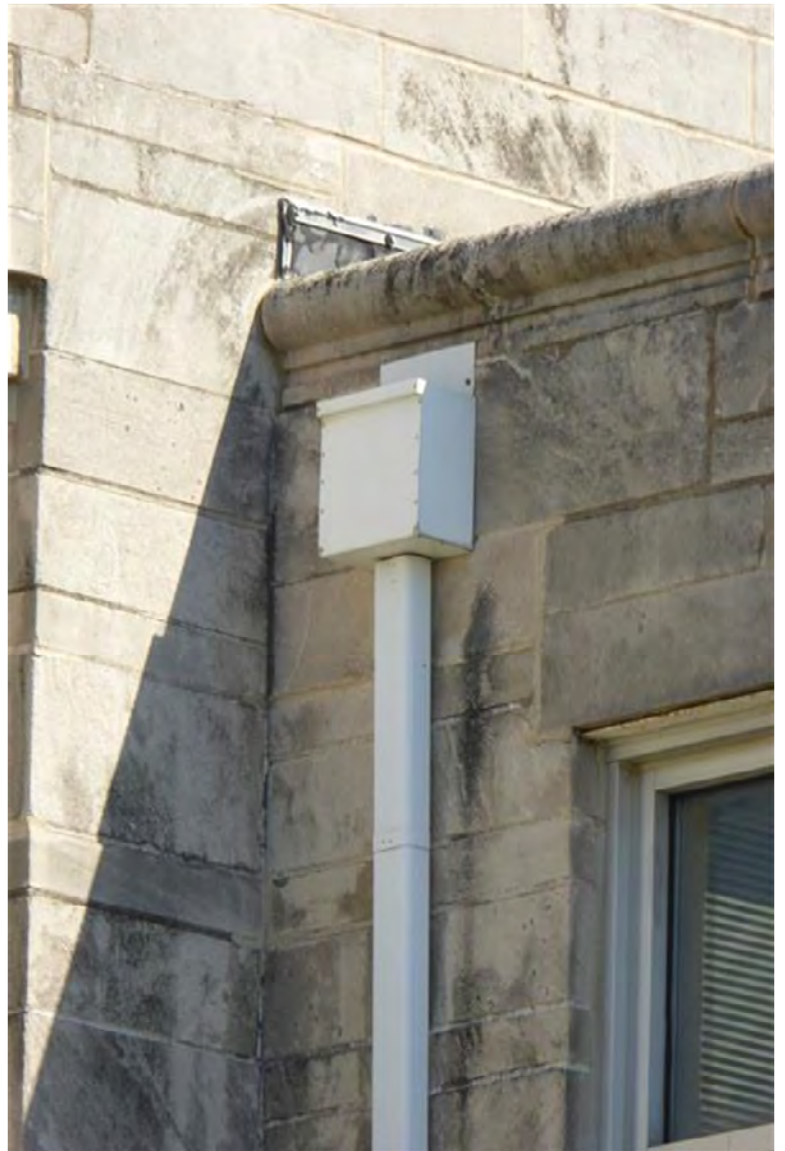
Photo 20

An original collector head is visible off the roof of the south stairwell.

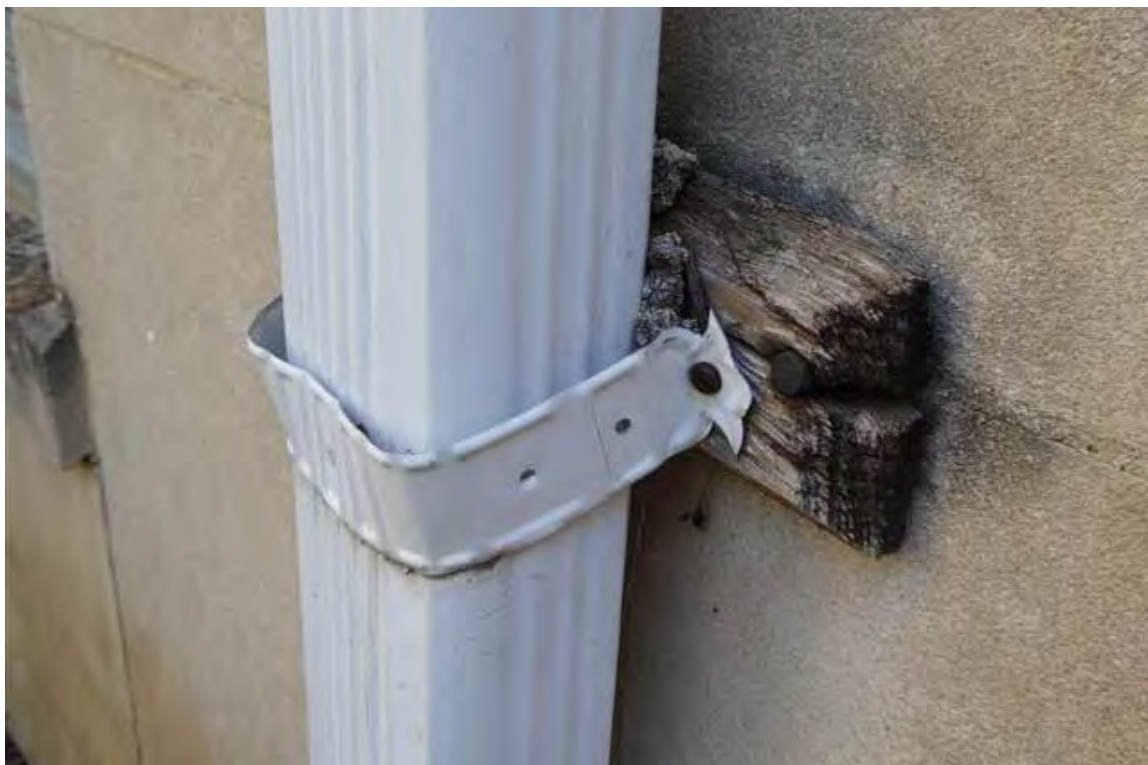
Photo 22

One of the original downspout connections. The downspouts have been replaced with residential style units.

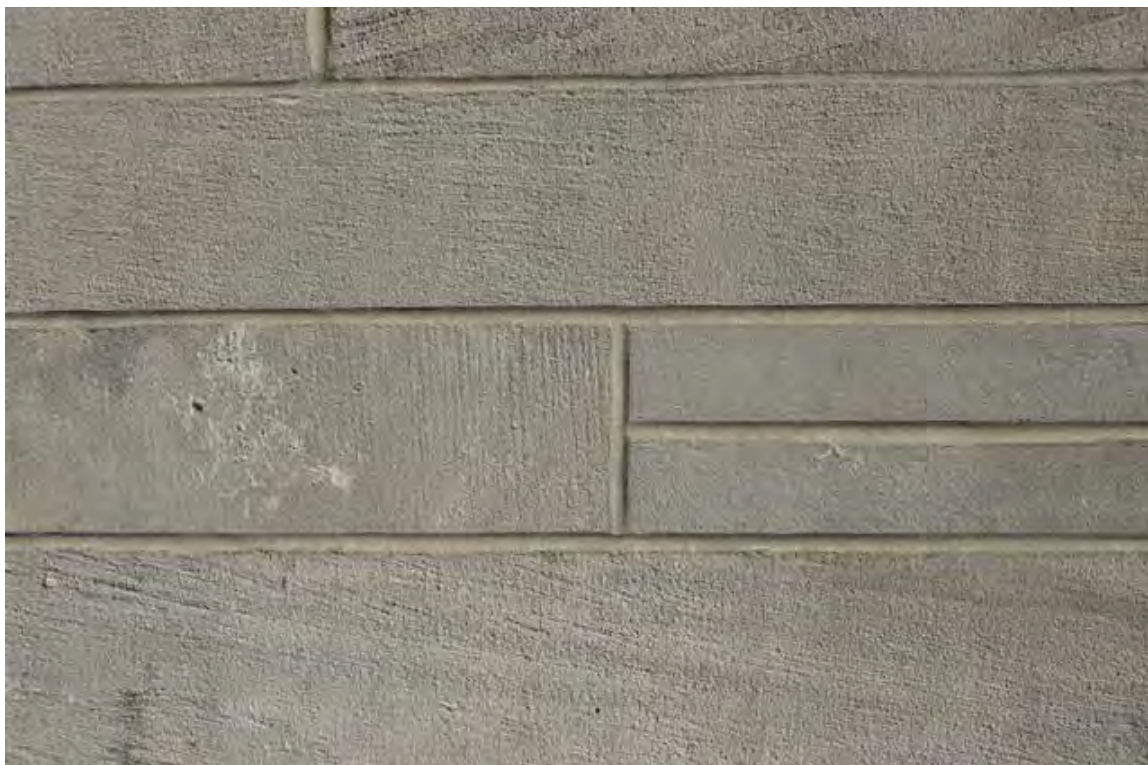
Photo 24

The exterior façade is composed of a mixture of random ashlar and cut limestone veneer. The stone itself is in very good condition for a building of this vintage. The mortar joints are also generally in very good condition as shown in Photos 23 and 24. That being said, there are some minor deficiencies which should be addressed if the building is to be saved and repurposed. Photos 25 through 32 show examples of these. They include cracked and/or eroded mortar, cracks and shards in limestone, loose patching material and organic deposits on portions of the masonry. All of these issues can be easily addressed if the building is to be salvaged.

Mortar joints are tooled to a concave profile and are generally in good condition.

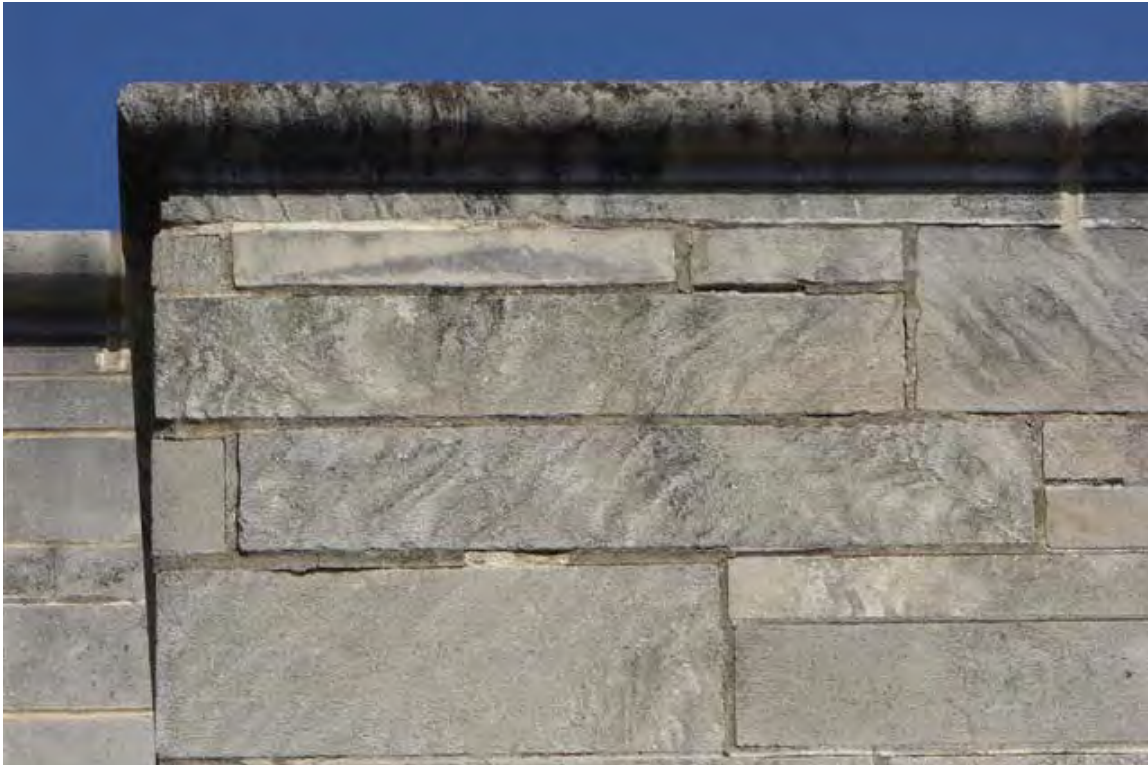
Photo 27

Joints near the top of the wall are wet most often. These need to be repointed.

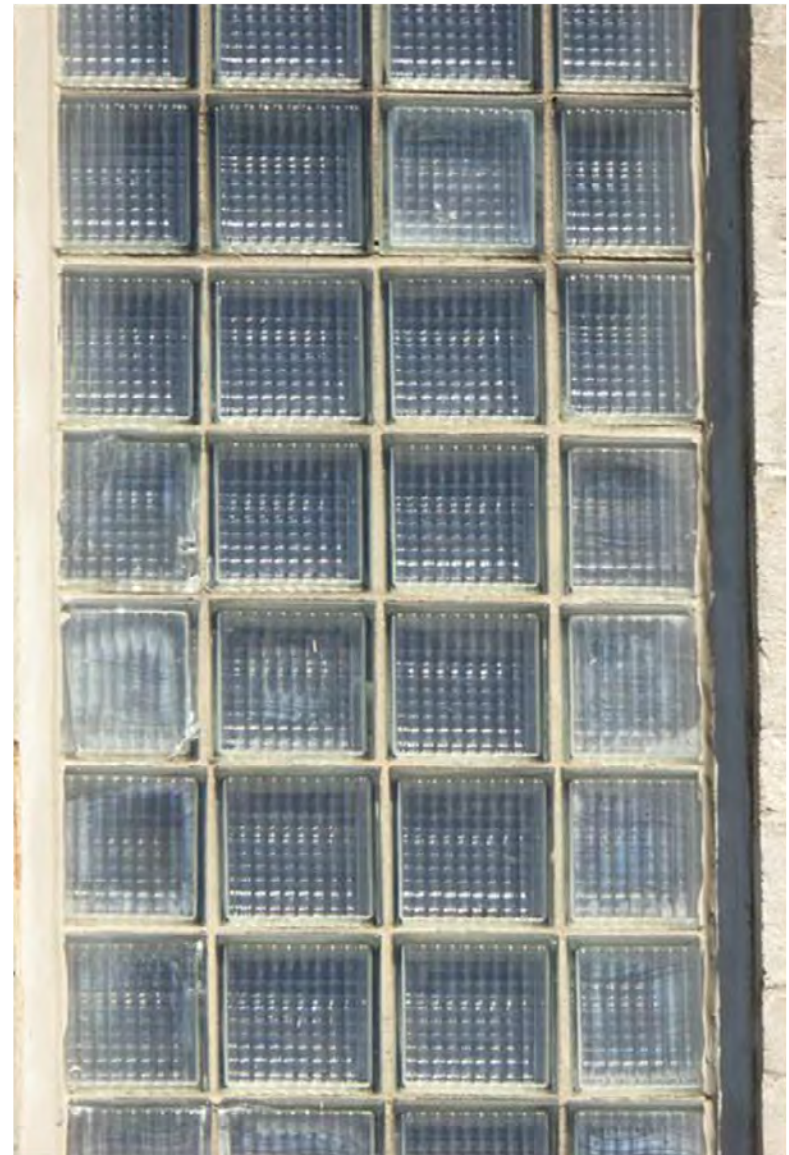
Photo 34

The glass block are generally in good condition and the mortar joints appear to be solid.

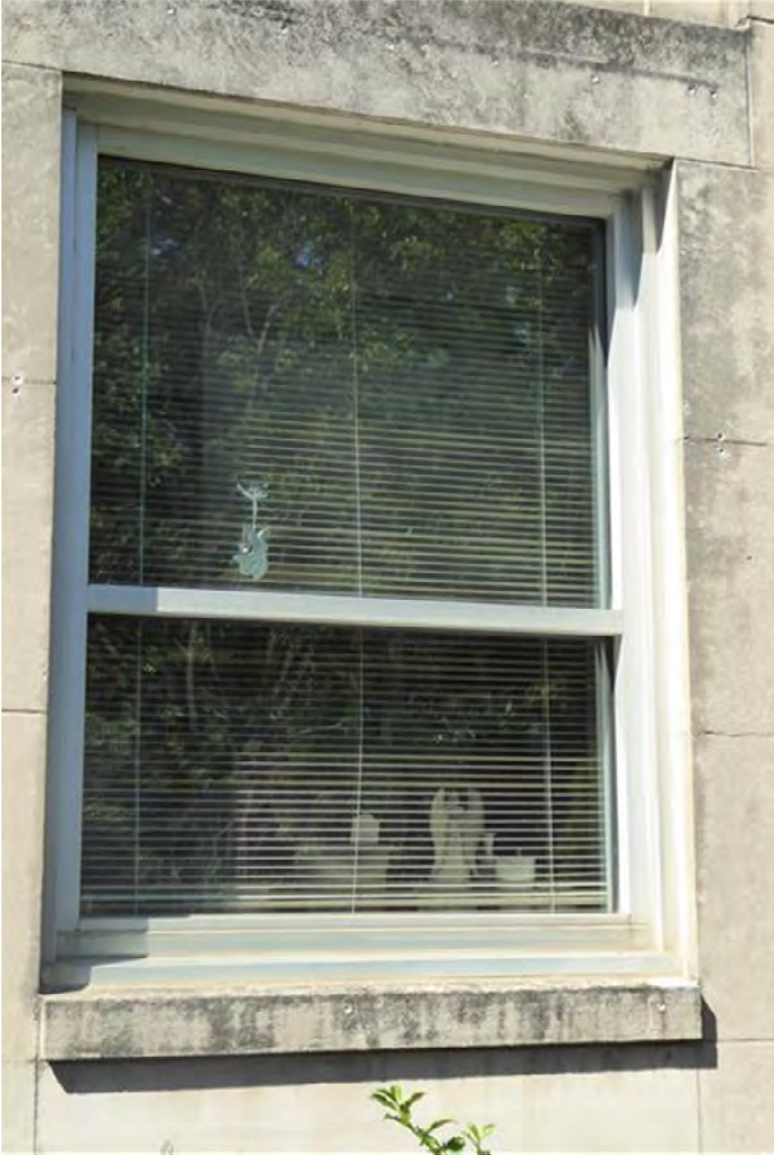
Photo 36

The majority of the glazing are replacement double hung aluminum frame windows that are reported to be at least 30 years old. They are in reasonably good condition and with proper maintenance can be expected to perform in a reasonable manner for ten years or more. An example of one of the original wood frame windows is still in service in the elevator penthouse. Glass block are found in the north and south stairwells. See Photos 33 through 38.

These double hung windows with aluminum frames are over 30 years old.

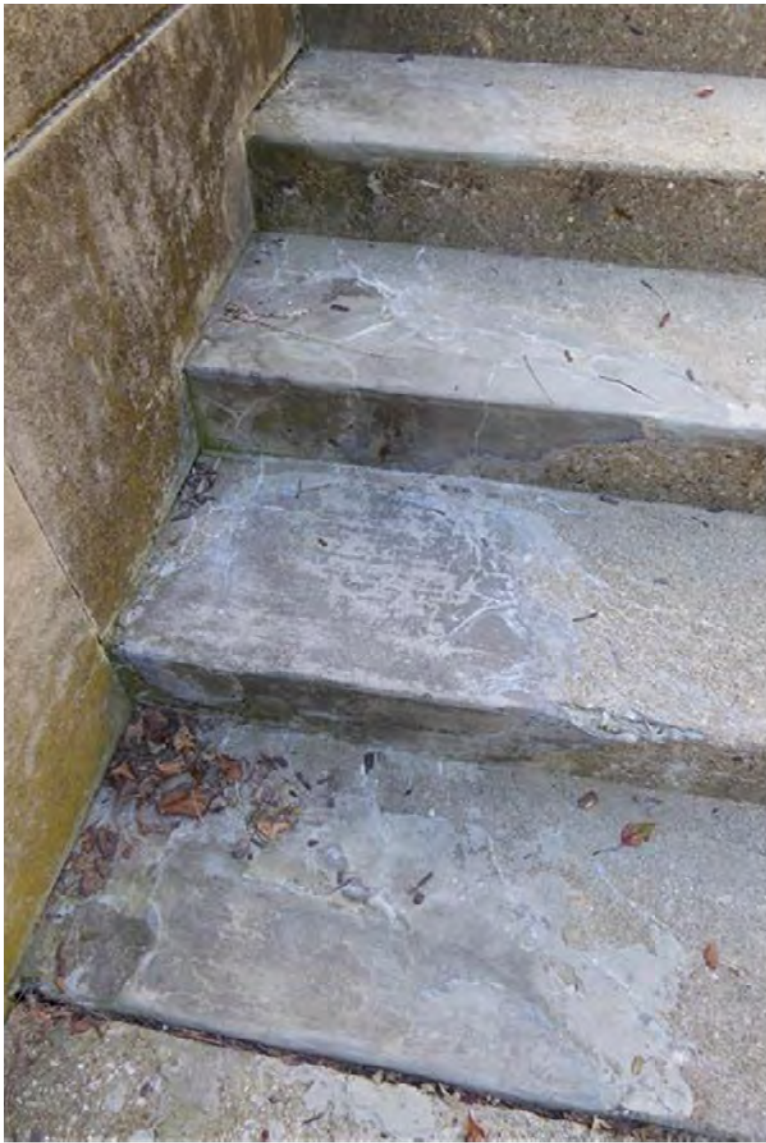
Photo 41

The concrete steps are beginning to deteriorate.

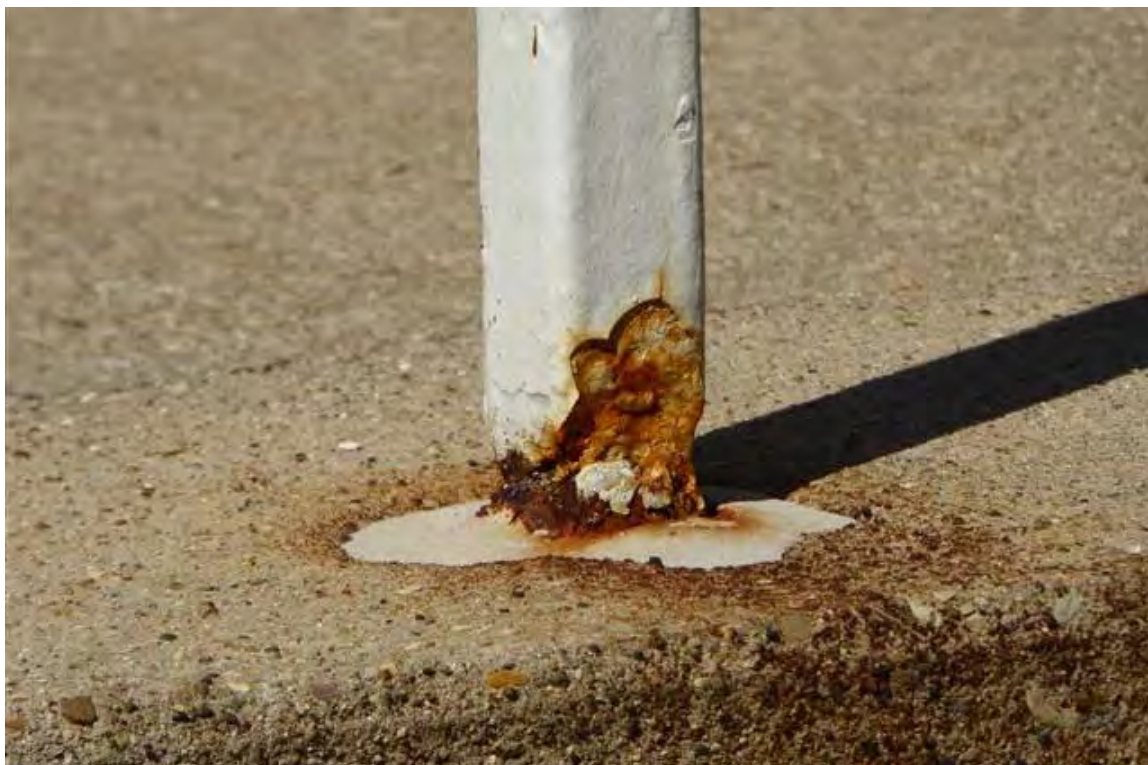
Photo 44

The hand railings do not meet current code requirements...

...and are severely corroded at the base of the posts.

The main entrance is on the east elevation of the building. A concrete walkway with steps extends down to South Rogers Street. The majority of this walkway will probably be redesigned so we have assumed that only the stairs, landings and limestone cheek walls shown in Photos 39 through 44 will remain part of the salvaged building. The limestone needs to be cleaned and repointed. Other repairs are minimal. The concrete steps are deteriorating due to freeze/thaw damage. We have included repairs to address cracking and spalling and installation of a traffic coating to protect the concrete from further deterioration. Finally, the handrails do not meet code and are generally in poor condition. We have included monies for new stainless steel handrails.

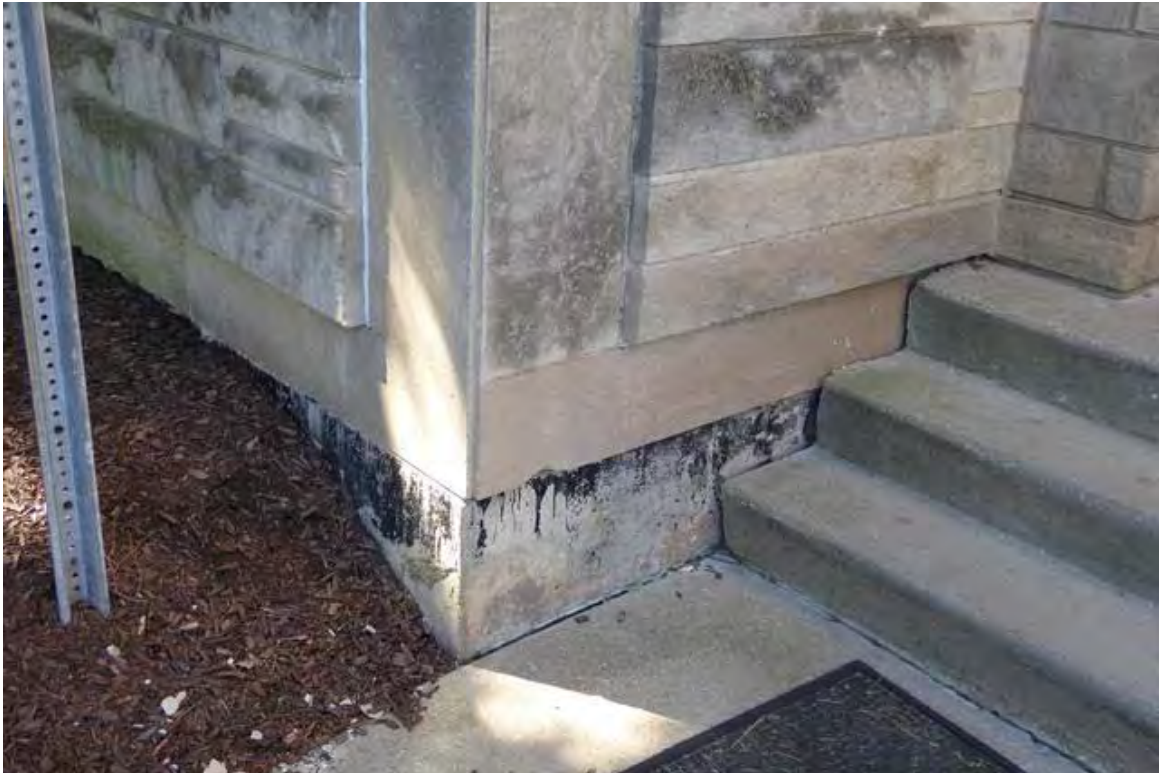
Staff did report evidence of water leaks into the basement along the east elevation of the building. Photos 45 through 48 show that the concrete basement wall was originally coated with a bitumen based waterproofing which has deteriorated badly. Planting beds extend up onto the face of the limestone masonry. As these absorb and retain moisture, they serve as reservoirs for water to migrate through cracks and joints into the building. Re-landscaping and lowering grade will help but may not solve all of the leaks. The most effective way to prevent further leaks is to excavate and expose the wall, install new waterproofing and perimeter drainage and re-landscape. However, without knowing the eventual use of the building/basement this cost may not be justified. We have included a separate line item on the cost estimate so this can be evaluated further.

Photo 45 The perimeter basement walls are made of poured concrete.

- Note B – Potentially excavate and expose the basement wall along the east elevation and install new waterproofing and perimeter drain tile to address water leaks into the basement.

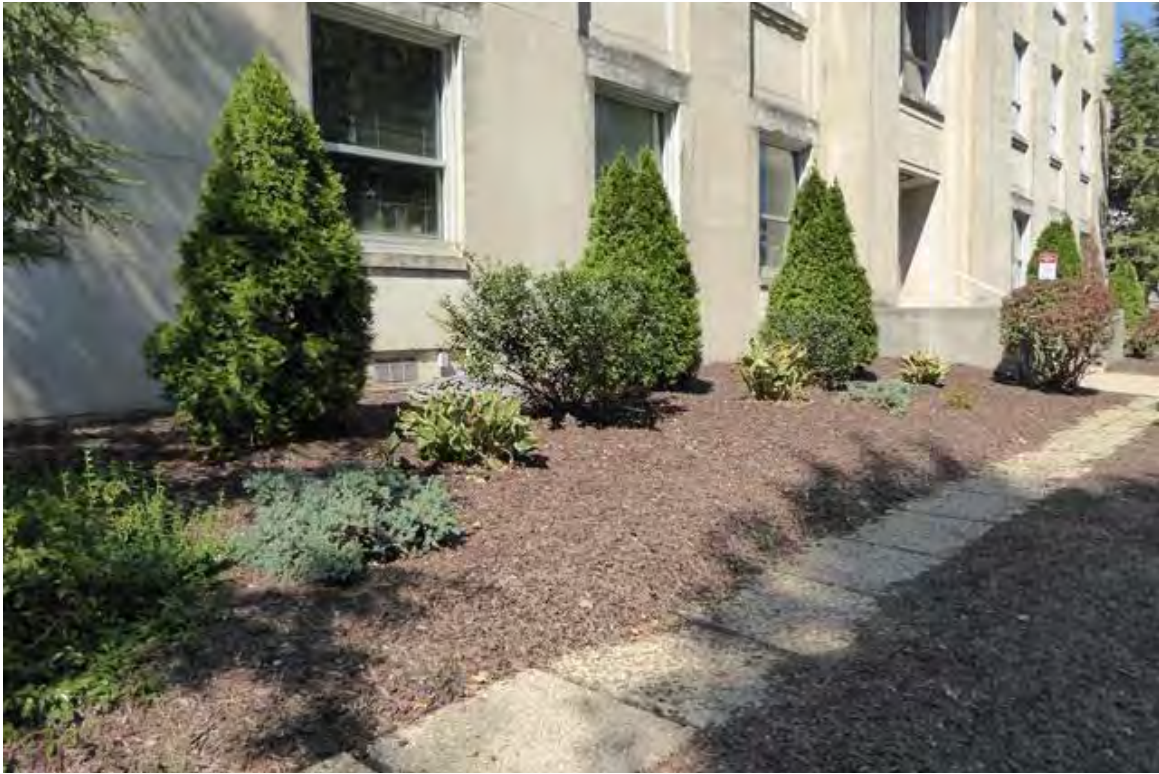
Photo 47 Plantings and landscaping beds...

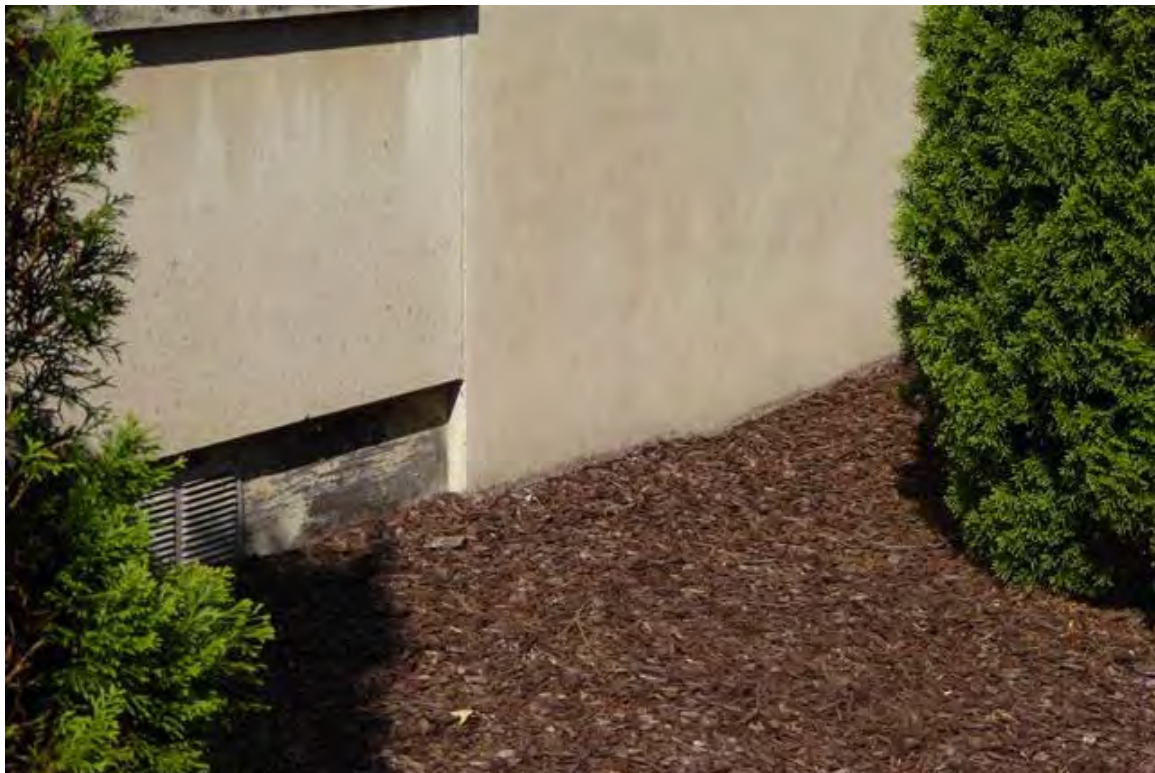
Photo 48 ...typically extend well up onto the face of the limestone.

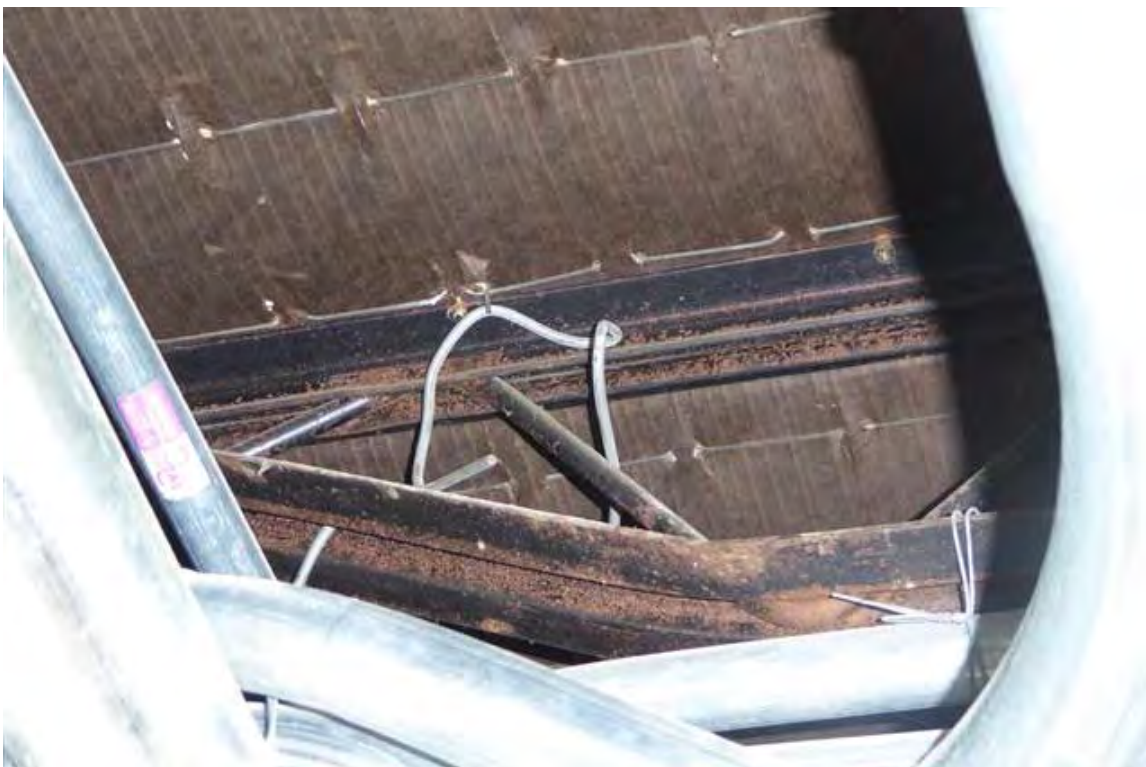
Photo 56

Steel bar joists support the roof slab. The roof slab is concrete which was supported in place with wire reinforced kraft paper.

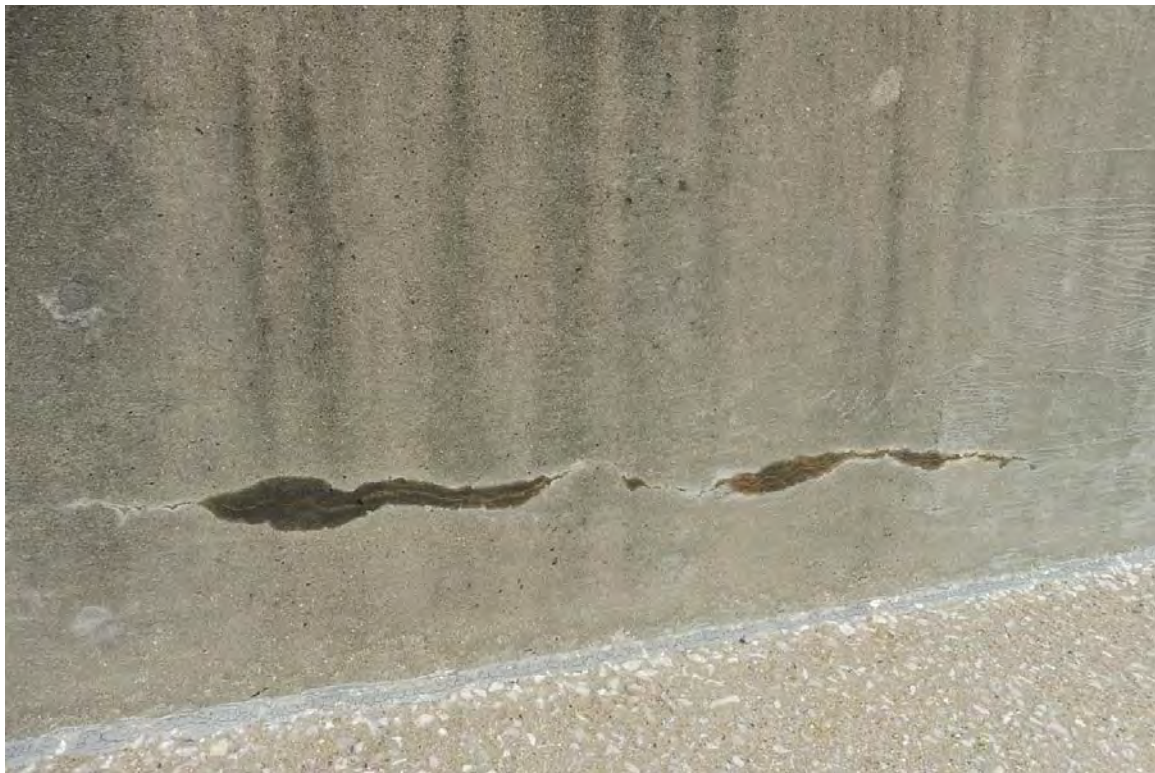
Photo 64 Close-up view of Photo 5.

The overall concrete structure is in fairly good condition given its age. There were, however, some localized areas of the structure that warrant further mentioning. We observed cracks and grease stains at some of the post-tensioned beams as seen in Photos 63 through 68. The cracks in the face of the beams follow the usual parabolic shape of the post-tensioned tendon reinforcing steel that
