# **ARSEE ENGINEERS, INC.**

IU Health Facility Assessment  
Bloomington, Indiana  
for

RE: IU Health Facility Assessment  
Bloomington, Indiana

## **EXECUTIVE SUMMARY**

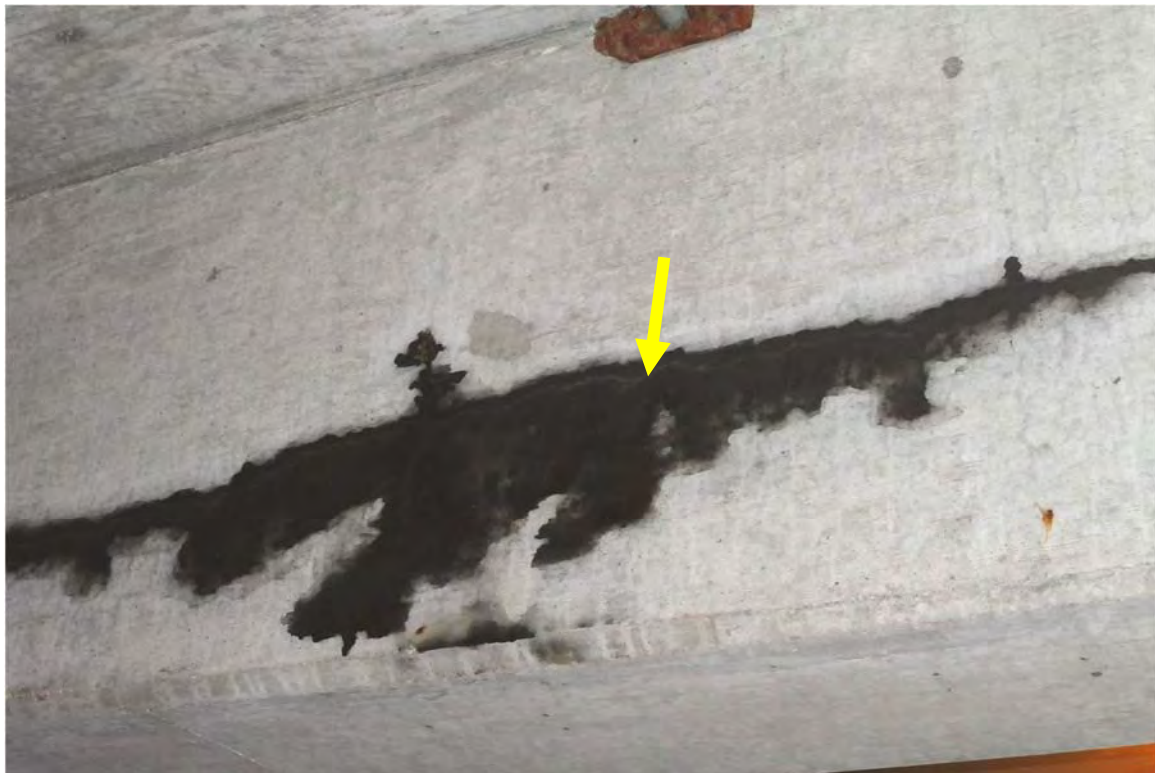
The overall concrete structure is in fairly good condition given its age. There were, however, some localized areas of the structure that warrant further mentioning. We observed cracks and grease stains at some of the post-tensioned beams as seen in Photos 63 through 68. The cracks in the face of the beams follow the usual parabolic shape of the post-tensioned tendon reinforcing steel that

Photo 66 Close-up view of Photo 7. Note the crack seen through the grease staining.

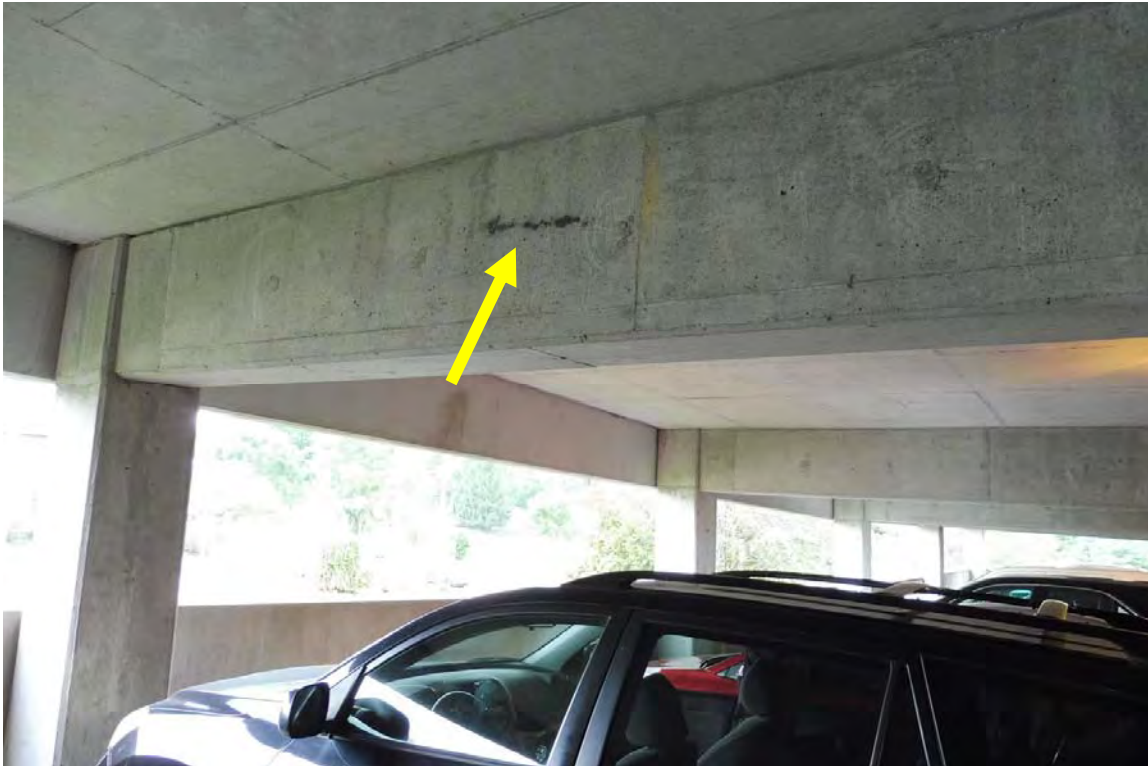
Photo 67

Examples of two additional beam locations where grease staining...

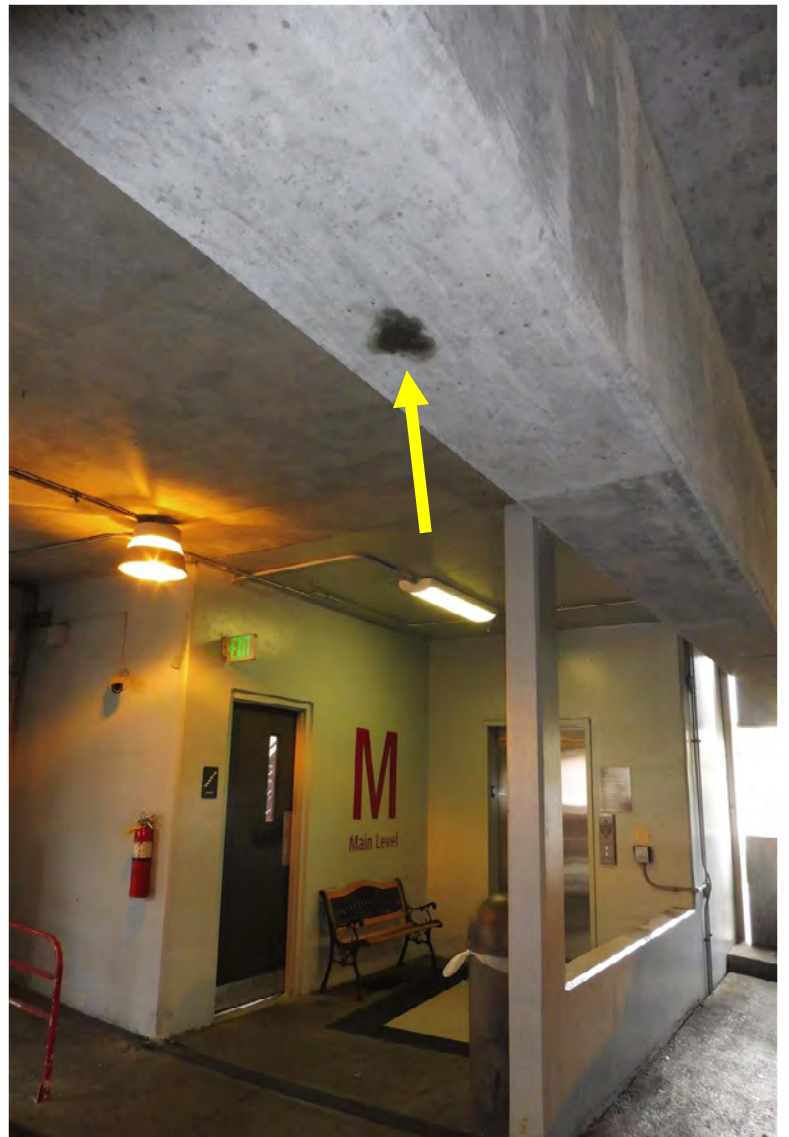
Photo 68

...was observed during the assessment.

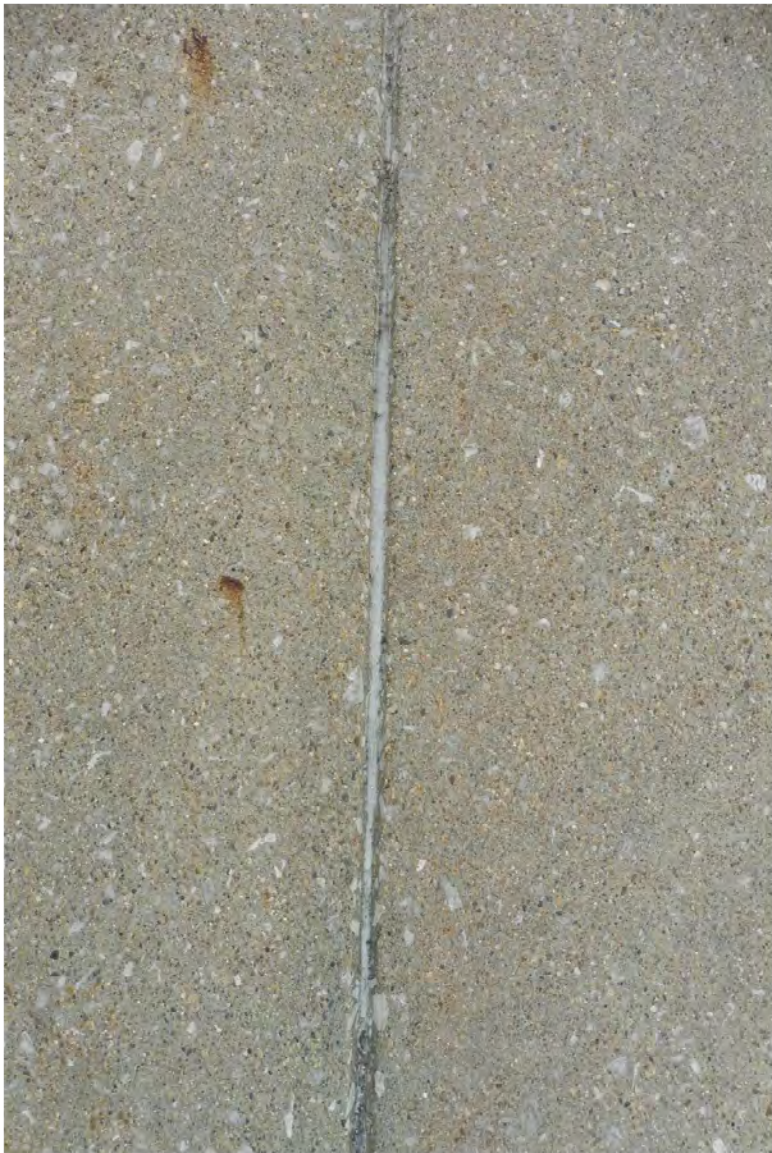
Photo 69

Horizontal sealant joints in the garage are limited to the floor slab pour strip as seen here and...

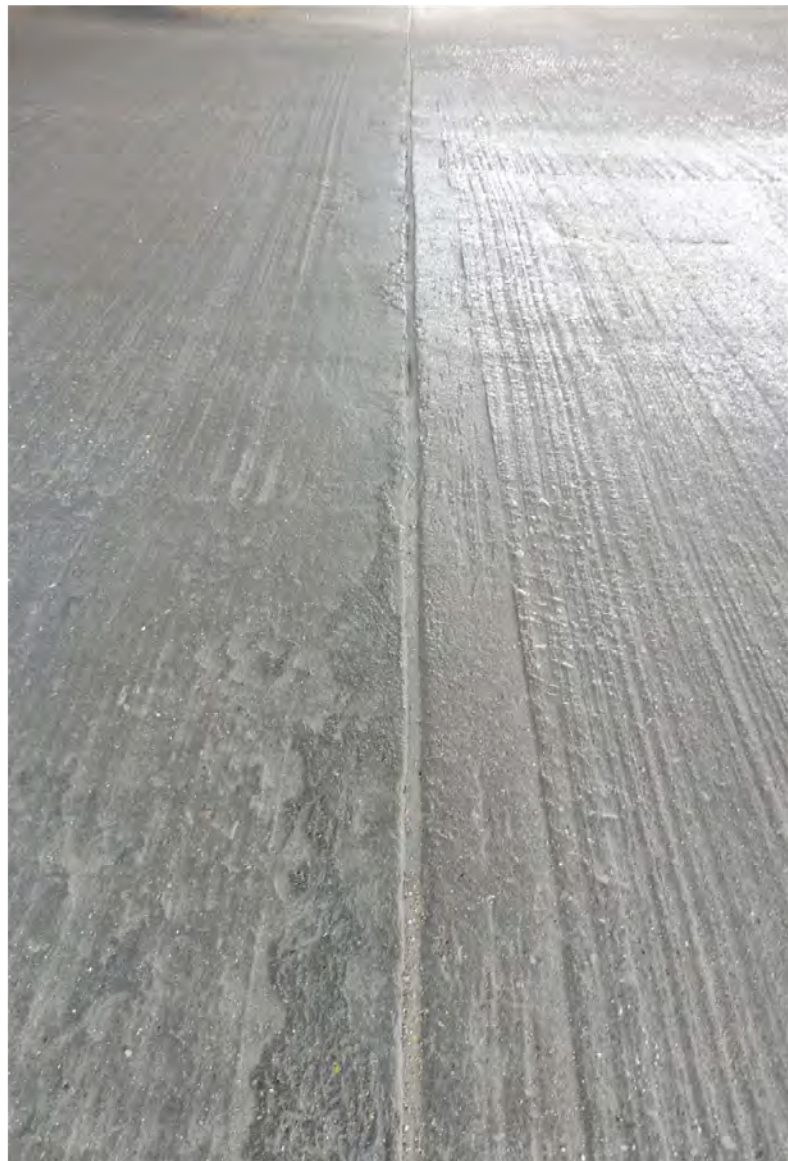
Photo 70

...the construction joints located at the vehicle turn at the north end of the garage. Generally these sealant joints were found to be in fairly good condition.

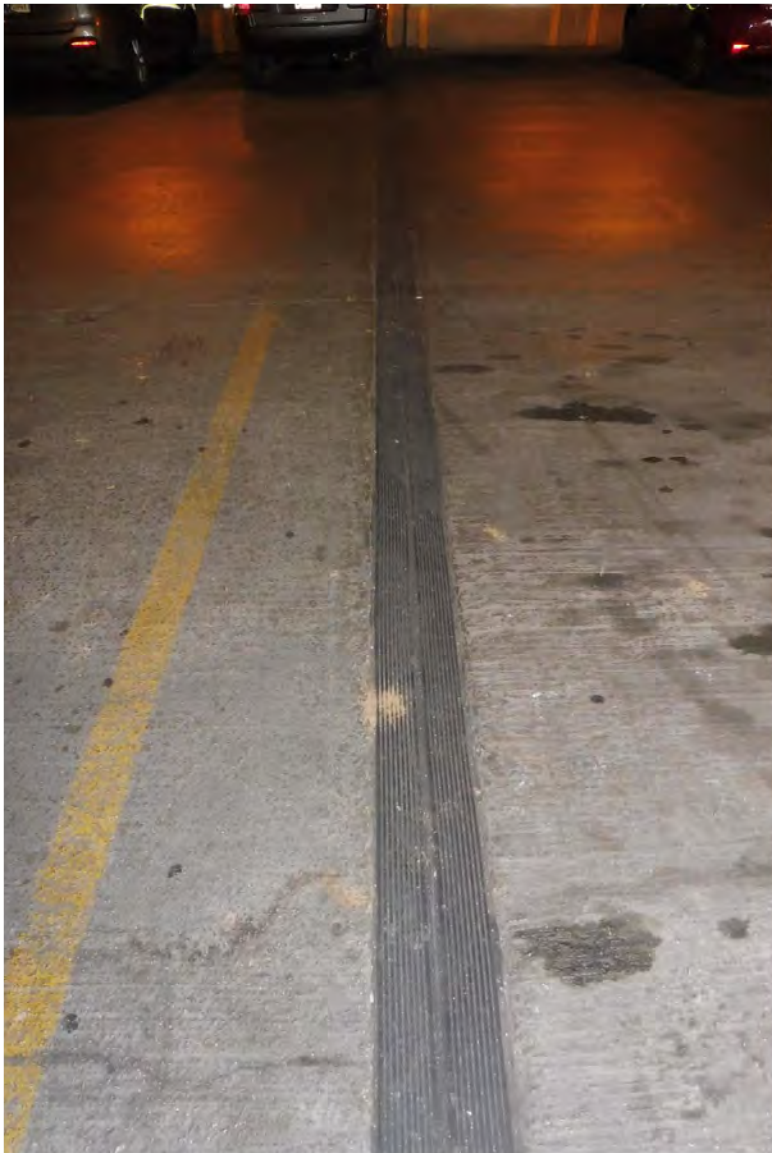
Photo 79

The winged expansion joint installed at the transition between the slab-on-grade and the post-tensioned slab was in good condition. The sealant joints along the perimeter of the winged joint, however, have adhesively failed in multiple areas as shown in Photos 79 and 80. That sealant should be replaced to maintain a watertight perimeter along the winged joint. If left untreated, moisture can infiltrate the perimeter and damage the joint and adjacent concrete.

The only expansion joint in the garage exists at the transition between the post-tensioned deck and the slab-on-grade.

The joint is in fairly good condition, but the perimeter sealant has failed in multiple locations and should be replaced.

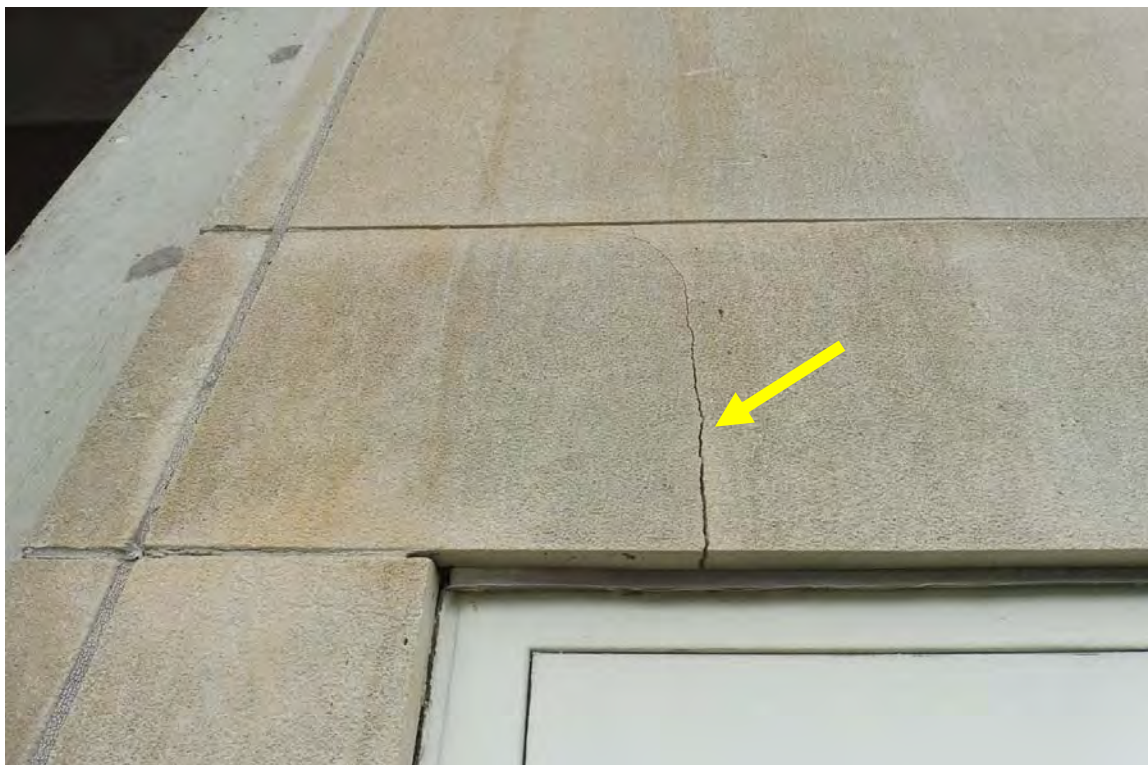
Photo 84

Limestone veneer panels were installed adjacent to the curtain wall system on the stair towers. Moisture has migrated through some of the panels leaving behind efflorescence staining as shown in Photo 83. The limestone panel directly over the grade level entrance to the northeast stair tower is cracked as shown in Photo 84. The sealant between limestone panels was generally in poor condition as shown in Photos 85 and 86. It has reached its service life and should be replaced.

Cracked limestone panel over the northeast stair grade level entrance.

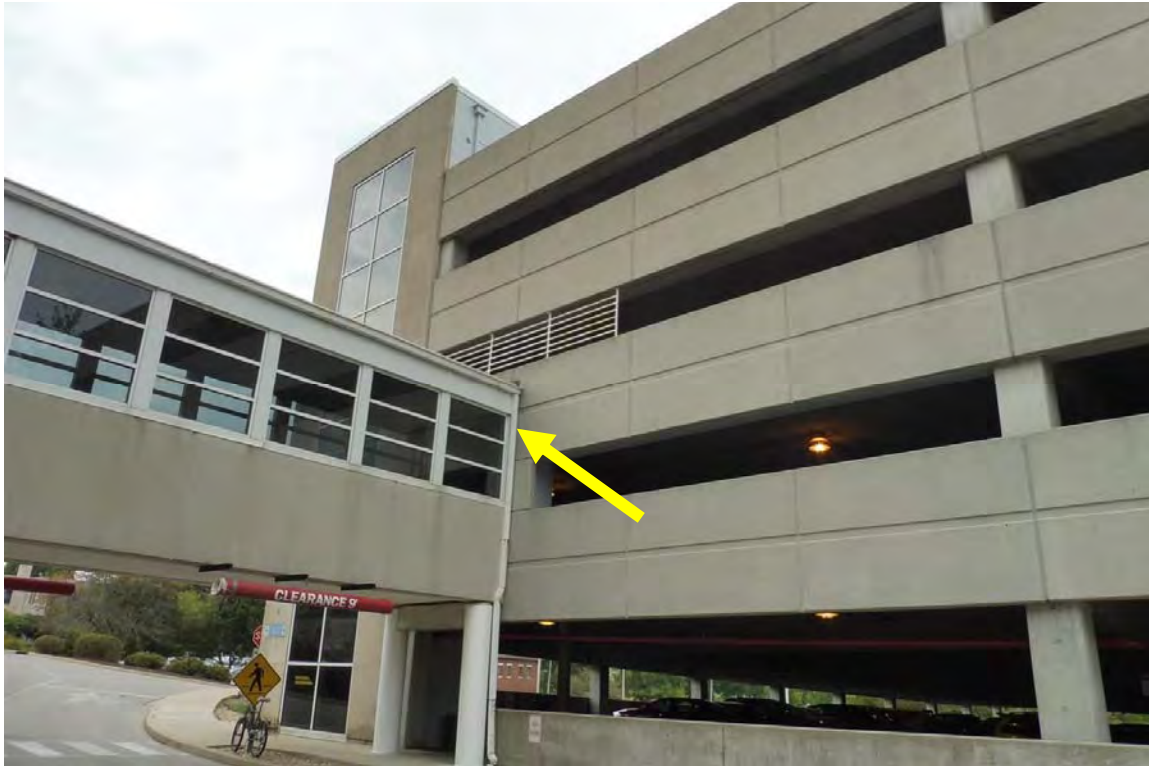
Photo 95

through several different options which may include installing a steel guardrail system, rework of the existing precast spandrel or replacement of that spandrel that matches the existing. Photos 95 and 96 illustrate the bridge condition at the garage south elevation.

With the proposed demolition of the hospital connector bridge...

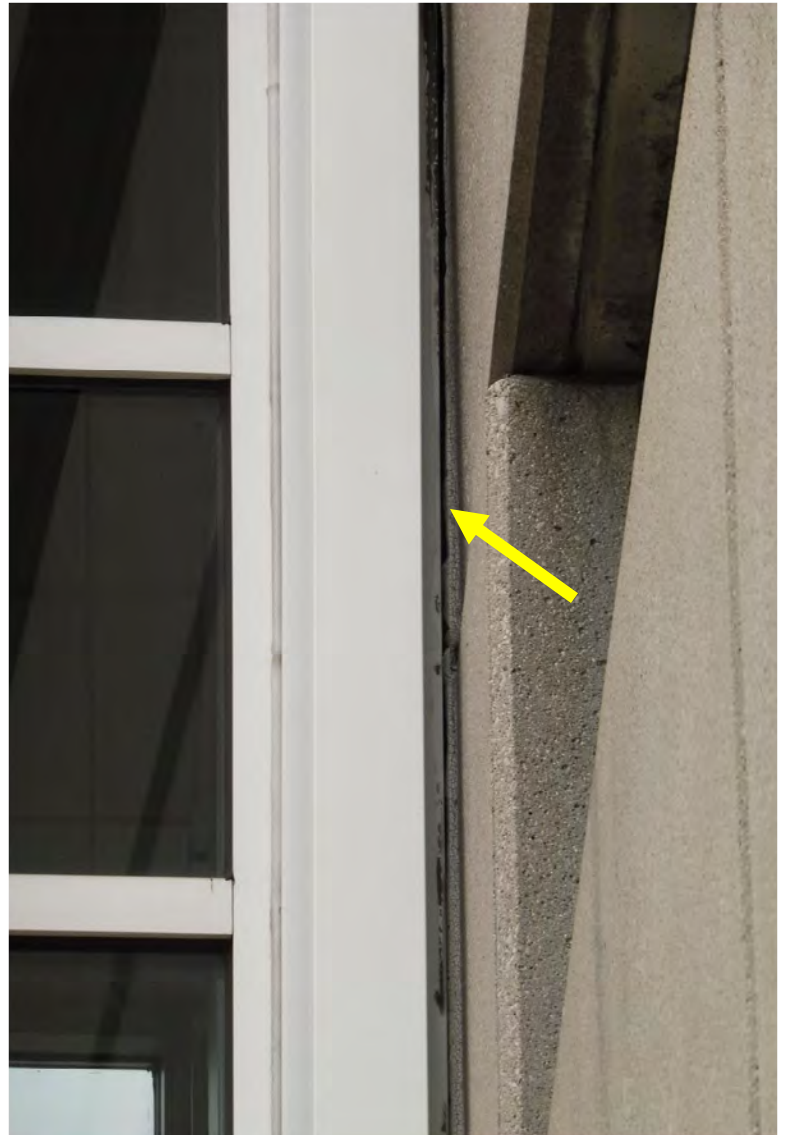
Photo 96

...rework of the existing precast spandrel will be necessary to create a Code compliant guardrail.

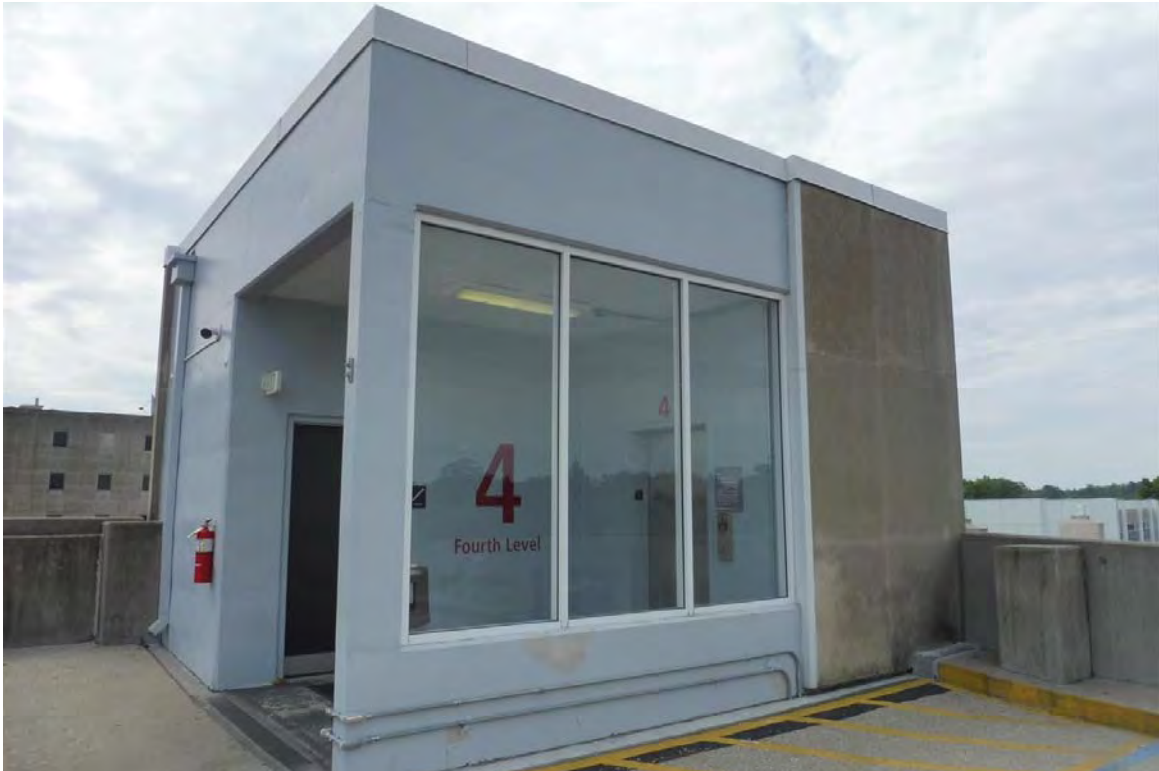
Corrosion of steel elements and failed coatings was commonly observed in the southwest stair/elevator tower. Photos 99 and 100 illustrate the roof level enclosure, corrosion of door frames and floor coating condition. Water has been migrating into the stairwell through the gap below the roof level door as seen in Photos 101 and 102. As a result, corrosion of metal surfaces and failed interior wall coatings have occurred. Photos 103 and 104 show the corrosion damage observed on several of the hollow metal doors and frames. Corrosion of the metal stair pan risers and supporting elements was also noted as seen in Photos 105 and 106. A door sweep should be installed on each of the doors accessing the stairwell to minimize moisture infiltration.

Photo 99 The southwest stair and elevator tower at the roof level.

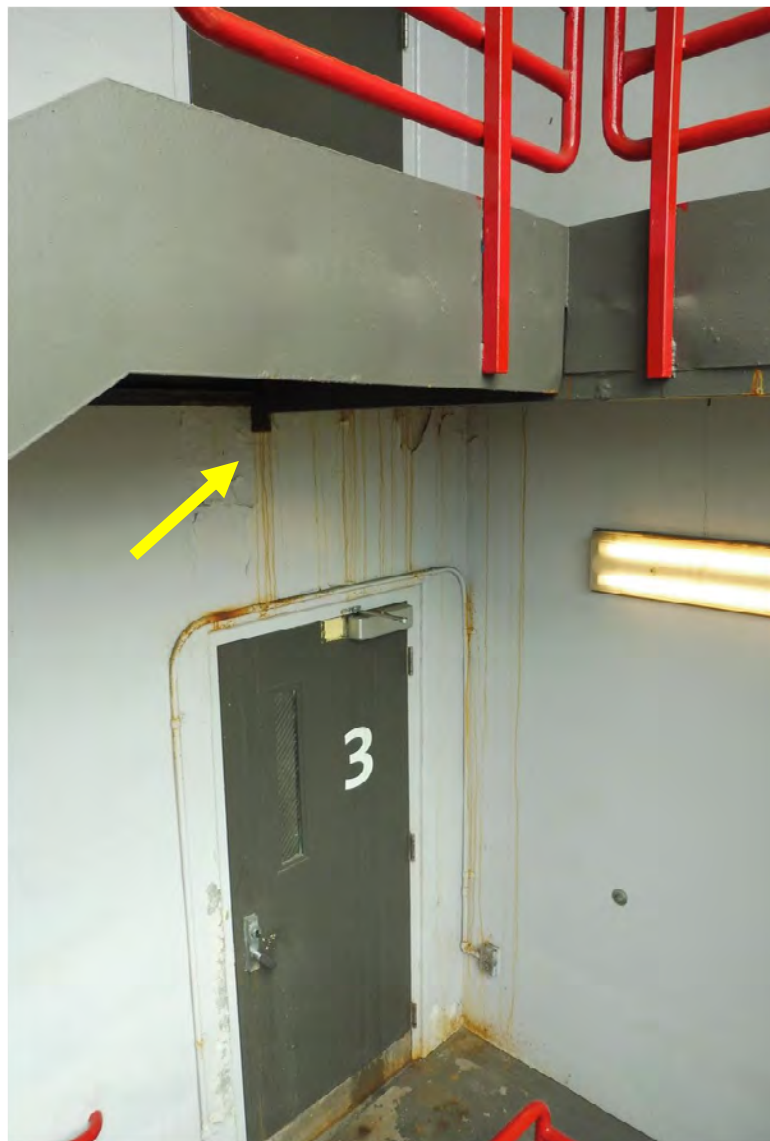
Photo 102

With no evidence of water infiltration from the roof above, it appears the water is entering the stair through the gap below the roof level door. We suggest a door sweep be installed to help minimize the water travel underneath the door.

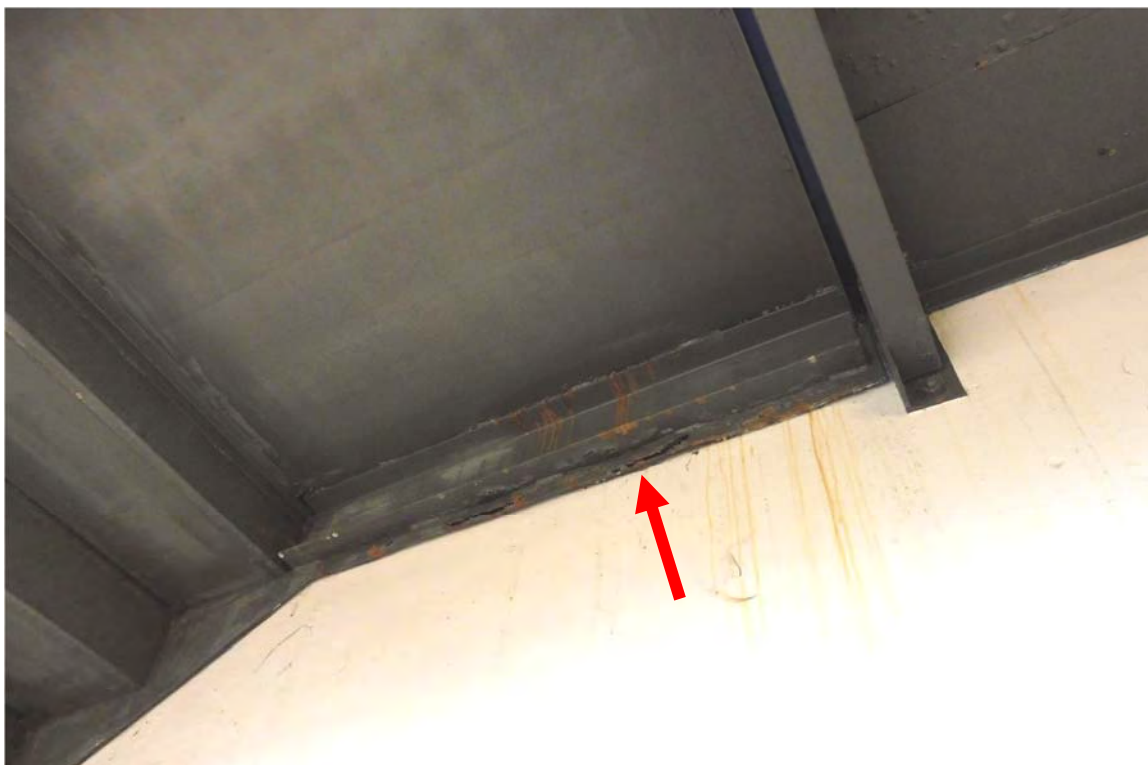
Photo 106

...as well as localized areas of the metal pan stair structure itself.

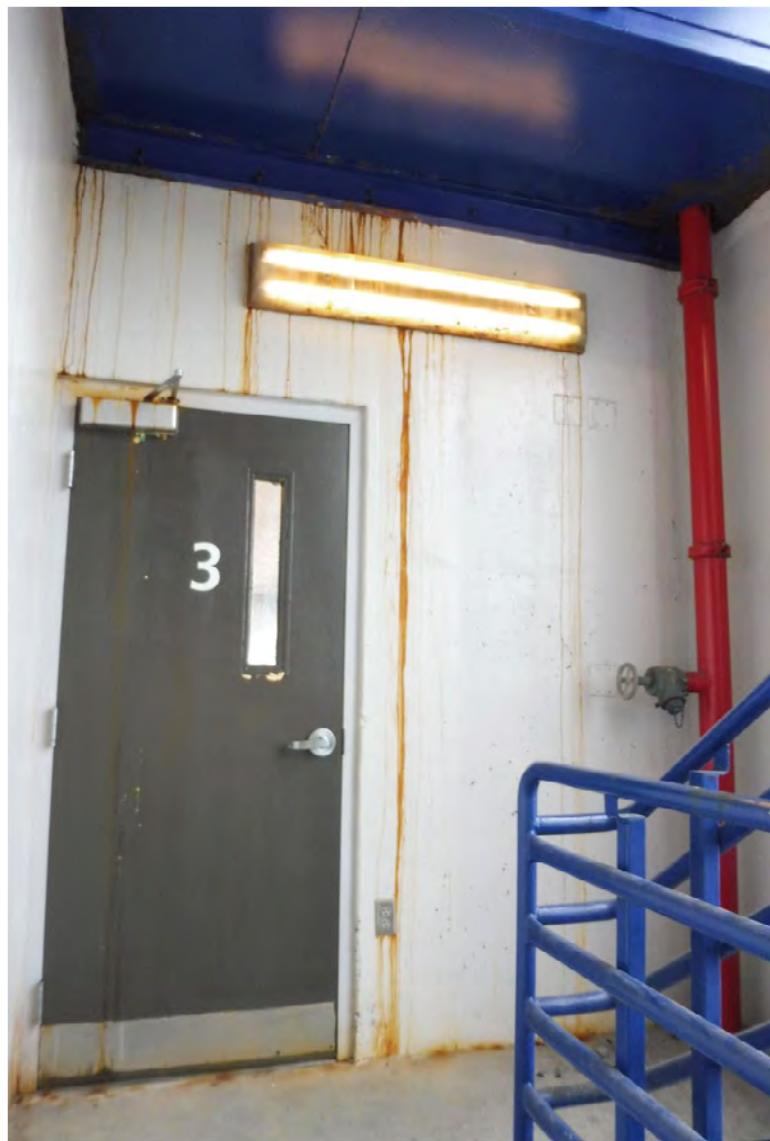
Photo 114

Water migration beneath the roof level door has led to failed coatings and corrosion of the metal pan stair structure below as shown in Photos 112 through 114. Damage associated with the water infiltration from the roof level extended down to Level 2 as shown in Photos 115 and 116. Below Level 2, the corrosion and coating damage lessened. The blue coating on the stair pans and handrails in those areas was generally in fair condition. Corrosion on the undersides of the handrails was observed as shown in Photo 117, which has likely resulted from improper surface preparation.

Corrosion of the roof level landing metal pan. The perimeter channel is also corroded as a result of the water infiltration.

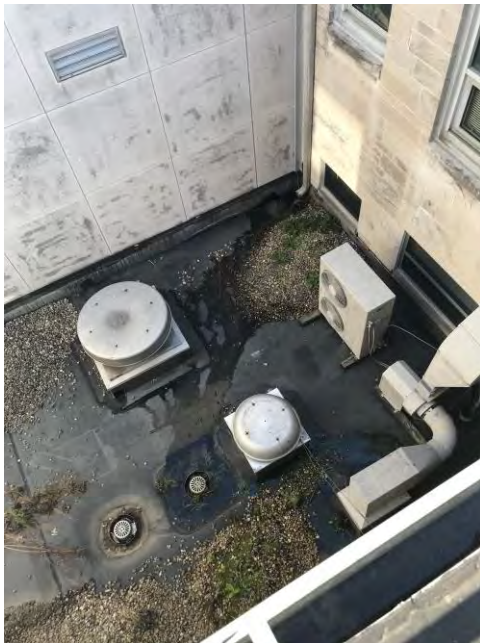
The communications room is served by a dedicated split-system ductless heat pump that was installed in 1982, but which still works.

Heat pump, on right

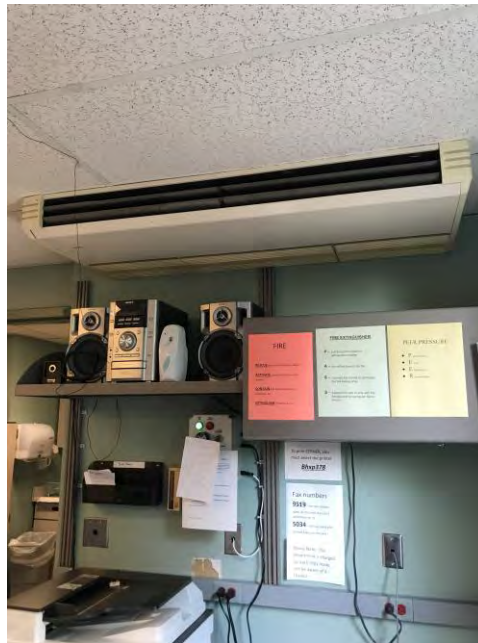
Indoor fan-coil for heat pump

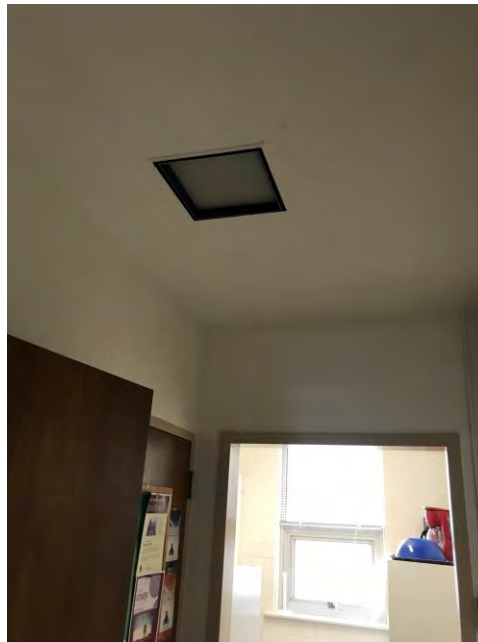
Typical recessed downlight

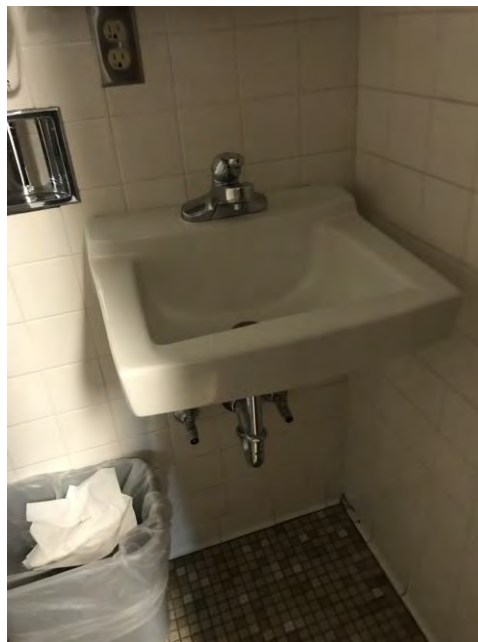
Typical lavatory

For plumbing, most of the piping should have significant remaining useful life, although new configurations could cause extensive replacement. All of the fixtures are antiquated and should be replaced with modern low-water-usage fixtures with automatic controls (flush valves and faucets). It will be necessary to have a water line brought in from the local utility with a meter per their requirements.

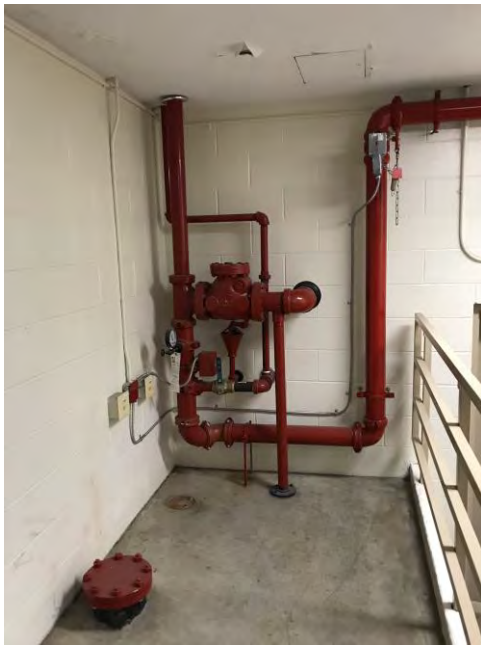
The building has full wet-pipe automatic fire suppression sprinkler protection and a fully automatic addressable fire alarm system. The sprinkler system was originally fed from a local fire line entering from the south but that has been changed so the system is now a branch of the much larger system in the adjacent hospital.

Fire riser with abandoned source line in the foreground

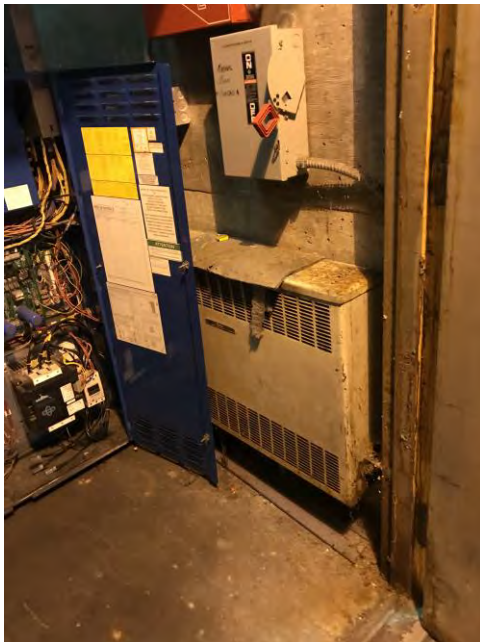
Elevator machine room heater

In the case of HVAC, the lower level exhaust fan should be checked and tested to verify that it still operates as needed. The electric heater in the elevator machine room is in poor condition and should be replaced.

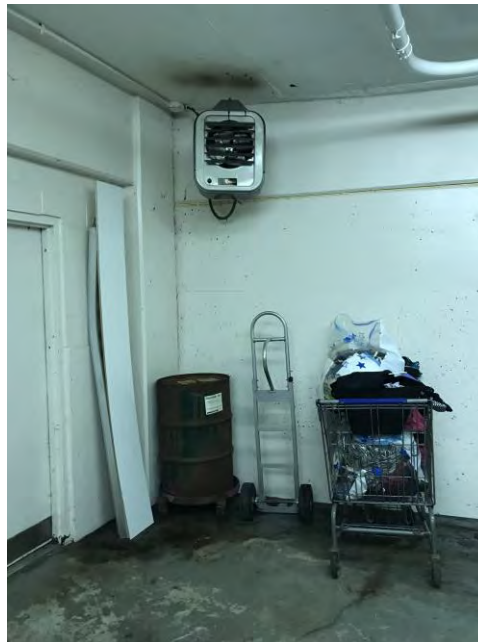
Shop heater

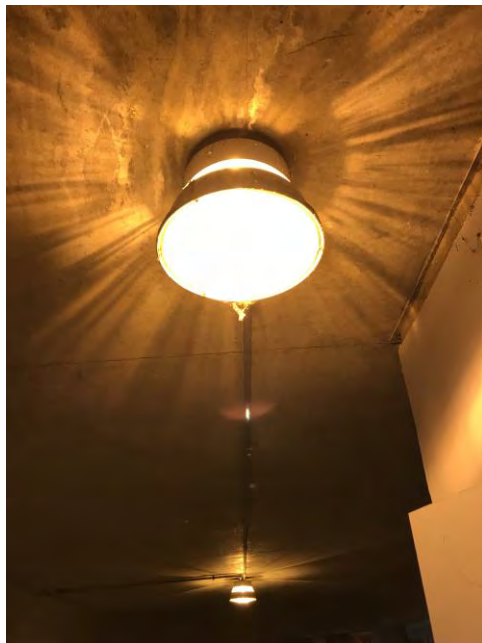
Interior garage fixtures

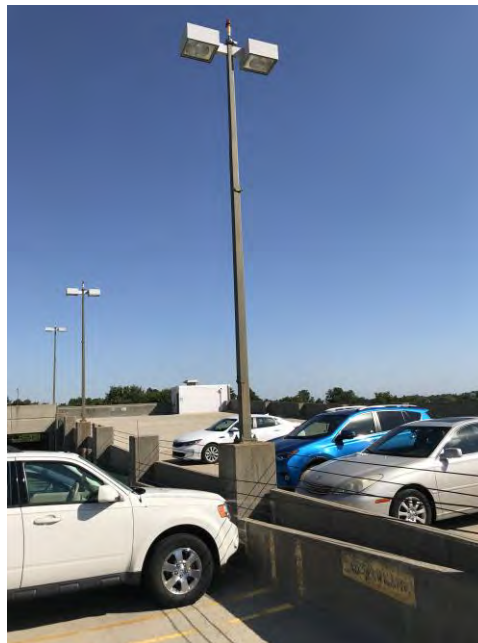
Pole-mounted fixtures on the roof

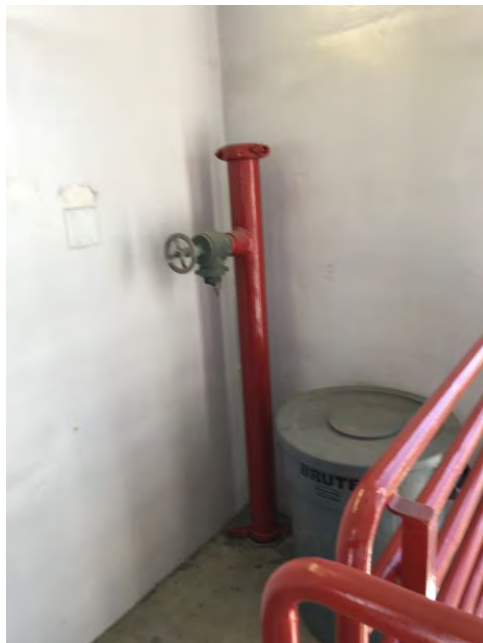
Standpipe

The building has fire suppression standpipes in the stair towers but no sprinkler coverage. There is also an emergency call system.

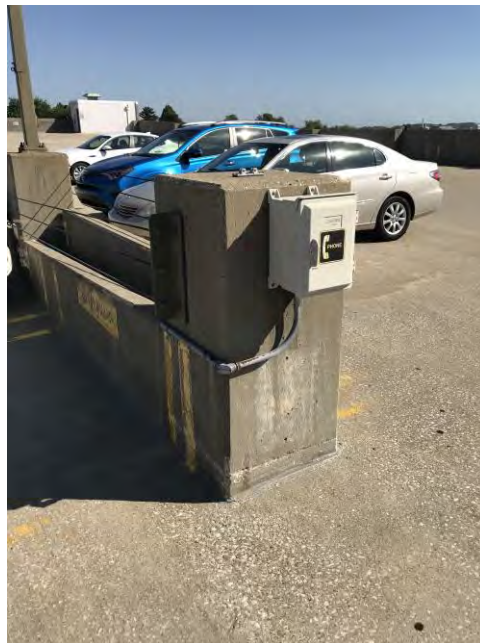
Emergency call box
